# COMPLETION REPORT PERR 001

YILLI RREUNG HOUSING ABORIGINAL CORPORATION ICN: 4241 | ABN: 48 983 249 337

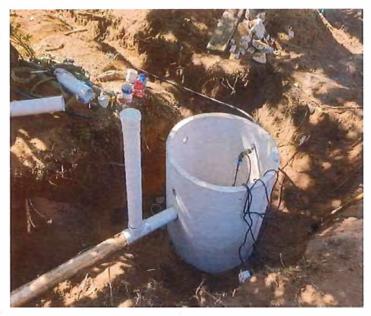
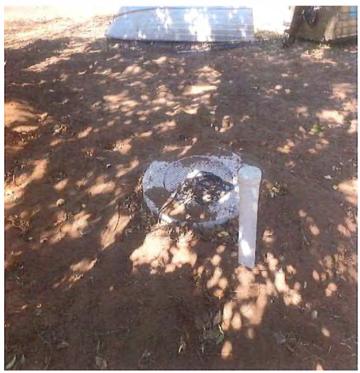
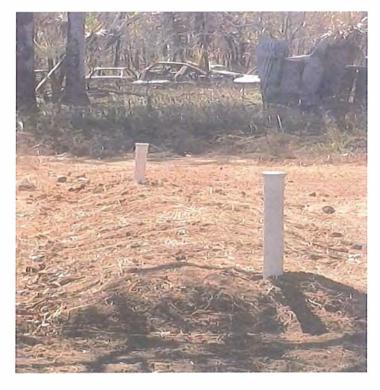
Installation of the
Septic overflow pit
and realm drain
installation to prevent
the possibility of
effluent reaching the
natural pristine
coastline
