Kulaluk

2 Condition assessment

5.2 Existing infrastructure condition assessment

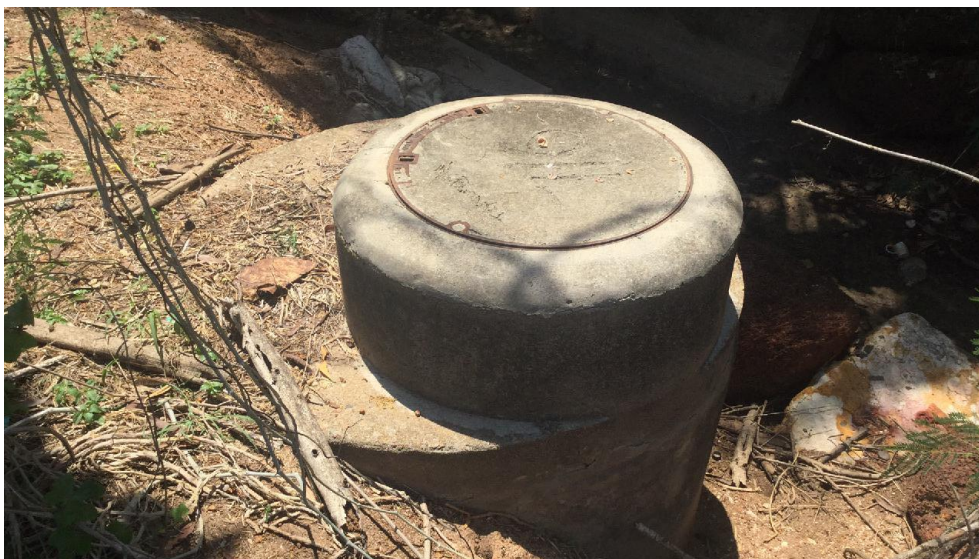
Figure 1 Sewer manhole, condition: *very good*

The manholes were rated as very good and do not require any maintenance works at this stage.

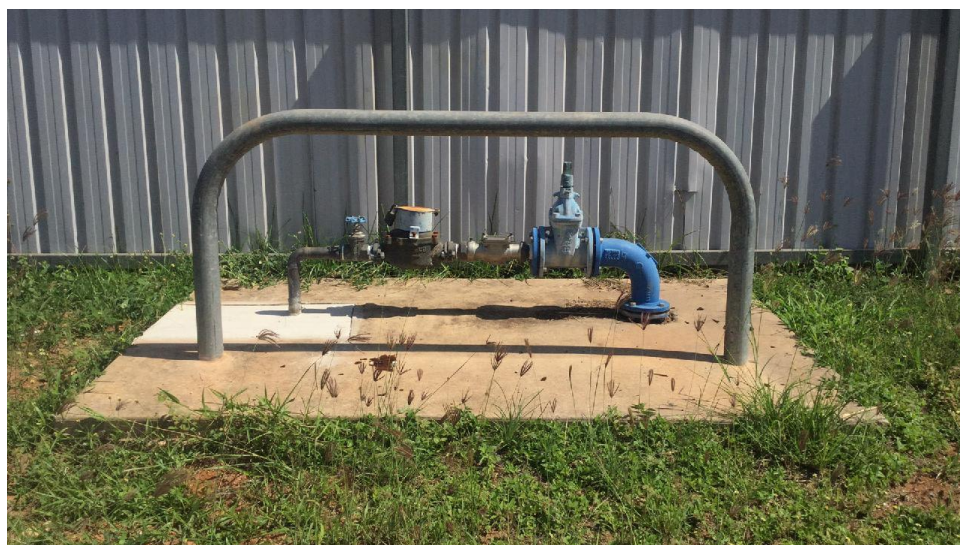
Figure 3 Water meter (bulk), condition: *good*

The only water supply asset located within Kulaluk is a bulk water meter and no immediate maintenance is required.

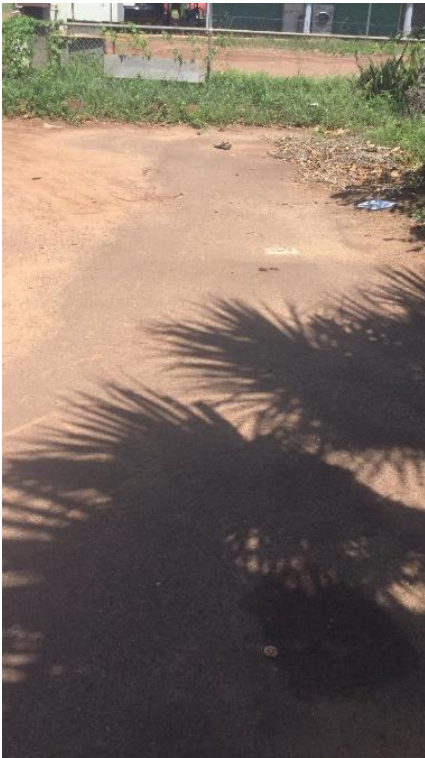
The carpark within Kulaluk is in good condition and only requires some general maintenance to clean some of the dirt and vegetation away.

Figure 4 Carpark, condition: *good*

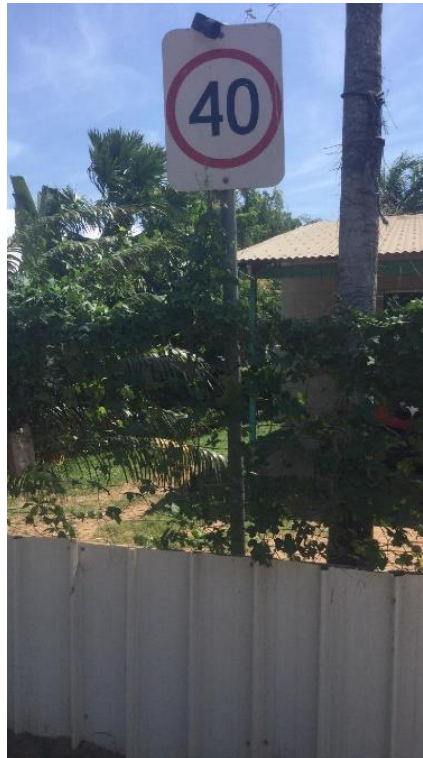
The four signs in Kulaluk all vary in condition from poor to excellent, it is recommended that remedial works are done to the sign in poor condition.

Figure 5 Sign, condition: *poor*

- Replace one 40 km/hr sign and post
- Clean one sign
- Repair edge break and shoulder
- Reseal three roads - approximately 1920 m²
- Fill and reseal – three potholes
- Repair cracks

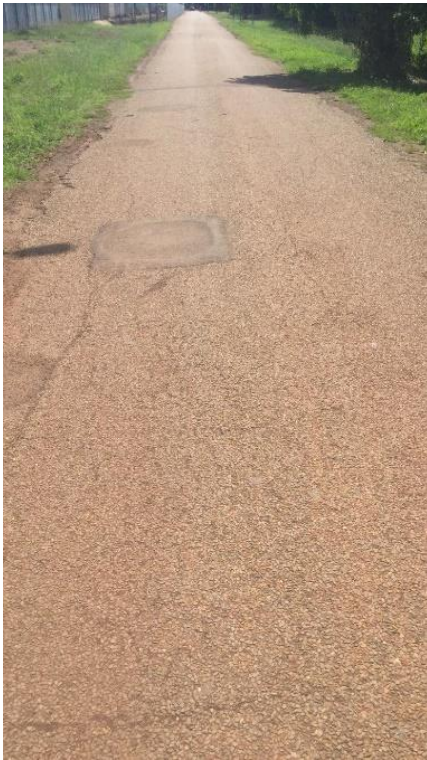
Figure 6 Pavement, condition: good

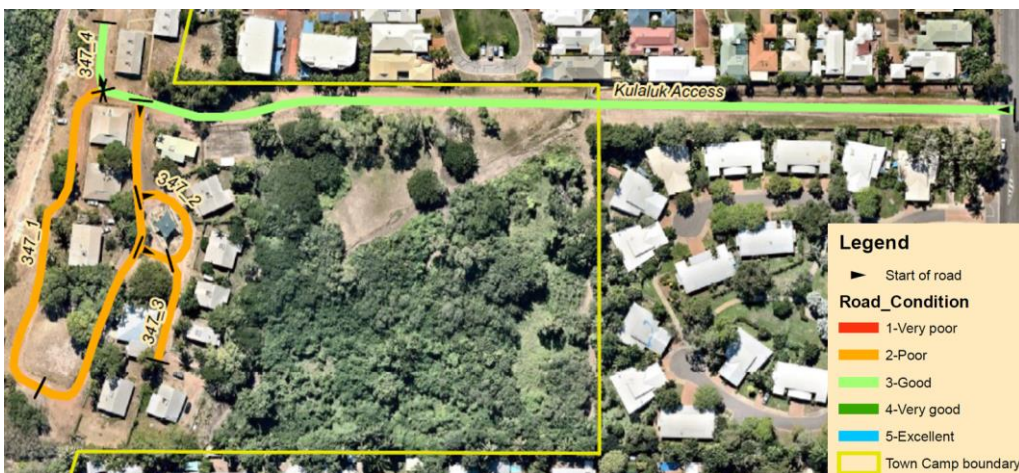
Figure 7 Road condition assessment

Table 8 below and Figure 7 show the condition of the roads within Kulaluk community for specific segments. The roads in poor condition are recommended to have maintenance work undertaken.

The main road into Kulaluk was rated as having good condition, although there were significant edge breaks and some potholes. The road network within Kulaluk is in poor condition and requires significant maintenance and/or upgrades. As the roads have undulation and pavement failure, it is likely that there are more significant issues to do with the subgrade or drainage that will require remediation before the road can be resealed.

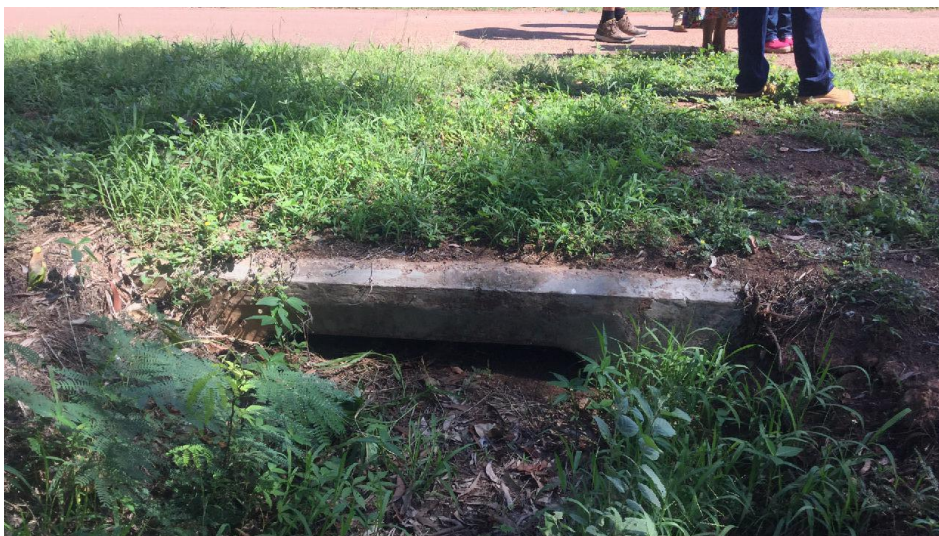
Figure 8 Culvert, condition: *poor*

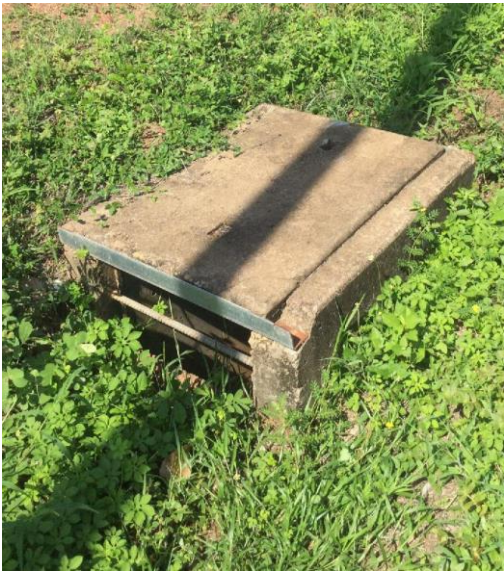
Figure 9 Letterbox pit, condition: *good*

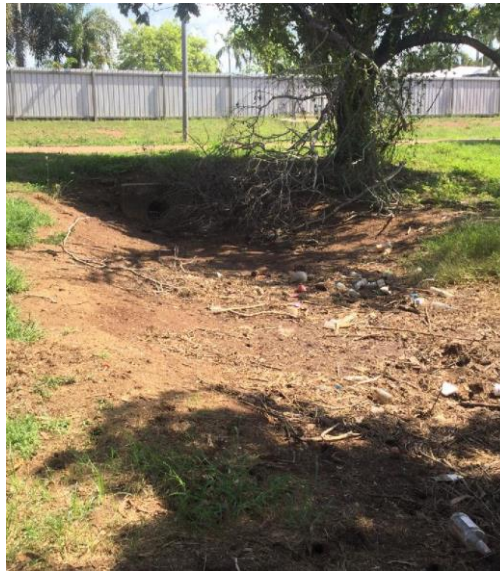
Figure 10 Swale, condition: *poor*

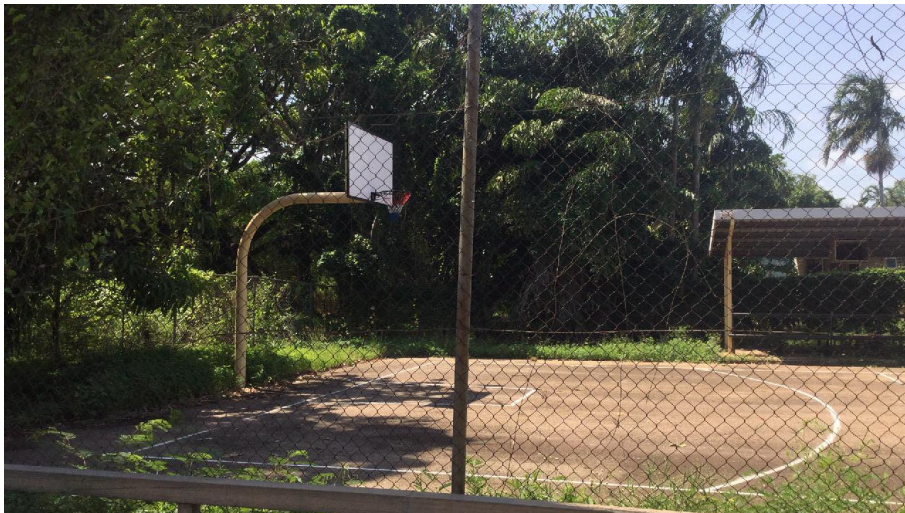
Figure 11 Basketball court, condition: *Good*

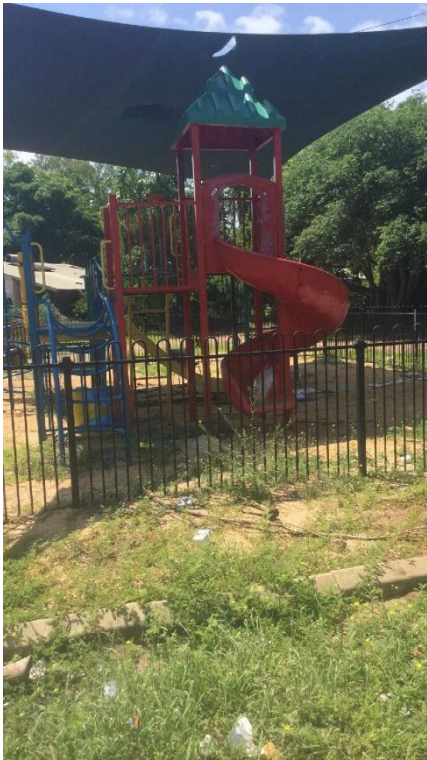
Figure 12 Playground, condition: *Good*

The playground was rated to have poor appearance, due to the paint peeling, debris, weeds, and tears in the shade cloth, however the condition of the playground was rated as good since the structure had minimal defects.

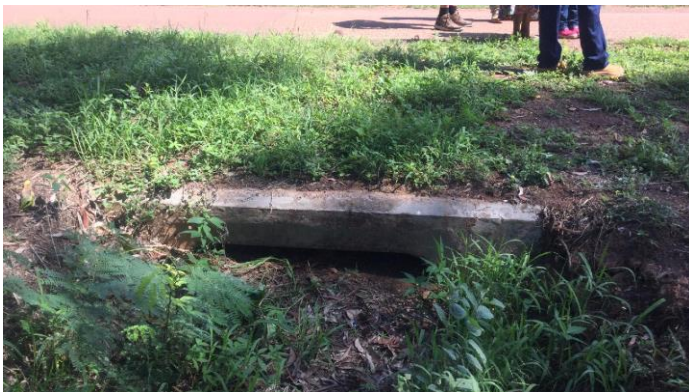
Insp ID: 116 Group 1 - Darwin, Jabiru, Adelaide River Kulaluk

Stormwater Infrastructure:	Culverts
Culvert Type:	RCBC
Diameter (mm):	
Width (mm):	1200
Culvert Depth (mm):	
Culvert Length (m):	
Culvert Condition:	2 - Poor
Culvert Blockage (%):	80
Culvert Comments:	Can't tell depth or length. Helen advised drains will be removed after dl
Culvert Head Wall:	No Access
Safety Grate:	No Access
Headwall Blockage:	
Headwall Condition:	
Headwall Comment:	
End Wall:	Yes
End Wall condition:	3 - Good
EW Comment:	Blocked

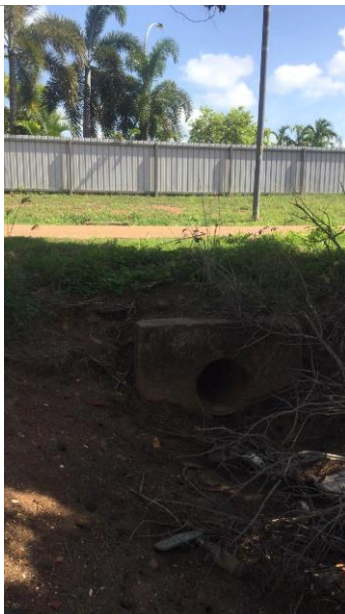
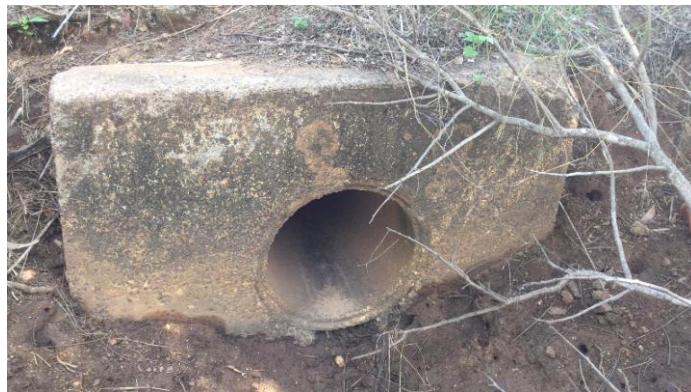
Insp ID: 118 Group 1 - Darwin, Jabiru, Adelaide River Kulaluk

Stormwater Infrastructure:	Culverts
Culvert Type:	RCP
Diameter (mm):	450
Width (mm):	
Culvert Depth (mm):	
Culvert Length (m):	11
Culvert Condition:	3 - Good
Culvert Blockage (%):	10
Culvert Comments:	
Culvert Head Wall:	NA
Safety Grate:	NA
Headwall Blockage:	
Headwall Condition:	
Headwall Comment:	Letterbox pit
End Wall:	Yes
End Wall condition:	3 - Good
EW Comment:	Scour around sides of end wall

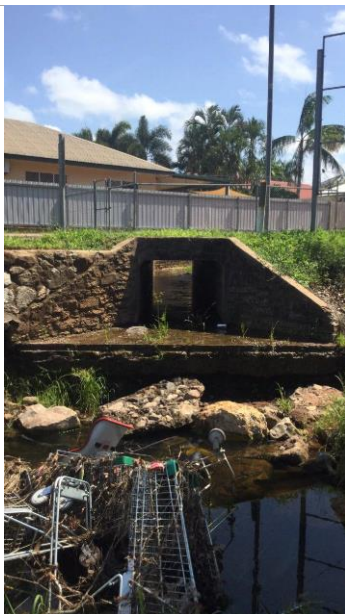
Insp ID: 123 Group 1 - Darwin, Jabiru, Adelaide River Kulaluk

Stormwater Infrastructure:	Culverts
Culvert Type:	RCBC
Diameter (mm):	
Width (mm):	1200
Culvert Depth (mm):	900
Culvert Length (m):	10
Culvert Condition:	3 - Good
Culvert Blockage (%):	
Culvert Comments:	
Culvert Head Wall:	No Access
Safety Grate:	No
Headwall Blockage:	
Headwall Condition:	
Headwall Comment:	In locked easement
End Wall:	Yes
End Wall condition:	3 - Good
EW Comment:	Some cracking and scour around endwall

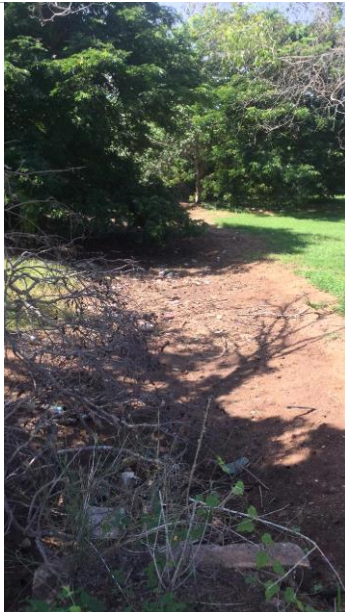
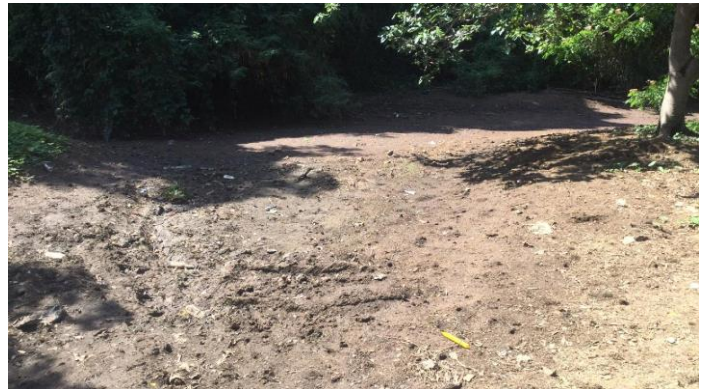
Kulaluk

Stormwater Infrastructure:	Swales
Type of lining:	No Lining
Are dimensions uniform along drain:	No
Base Width (m):	2
Overall Width (m):	6.6
Swale Depth (m):	0.7
Length of Batter 1 (m):	2.3
Length of Batter 2 (m):	2.3
Swale Condition:	2 - Poor
Swale Ponding:	No
Drain flooded at time of inspection:	No
Swale Comments:	Full of debris

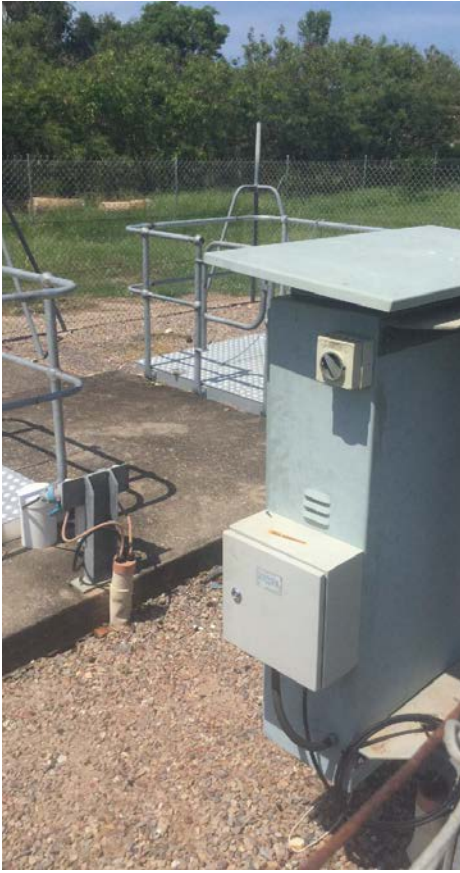
Figure 1 Pump station, condition: *good*

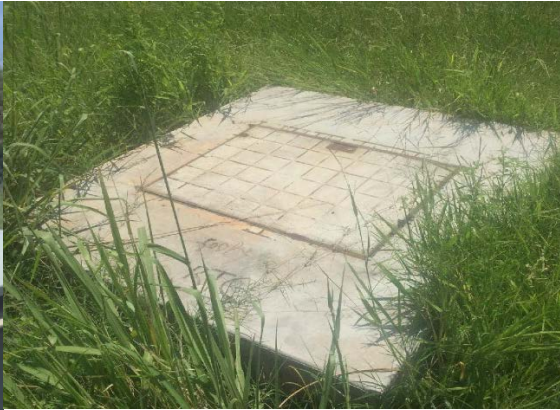
Figure 2 Sewer manhole, condition: *very good*

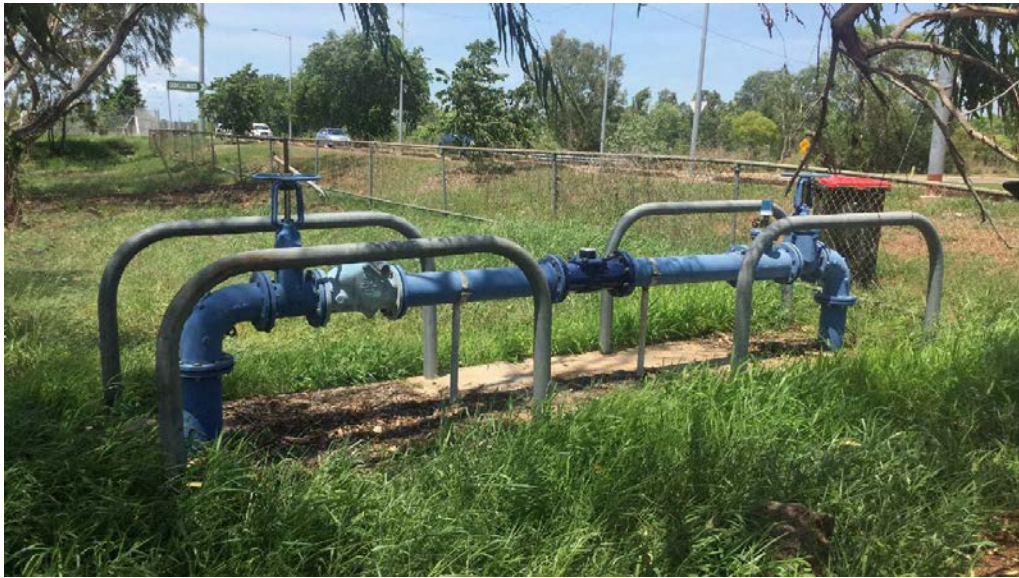
Figure 5 Water meter (bulk), condition: *very good*

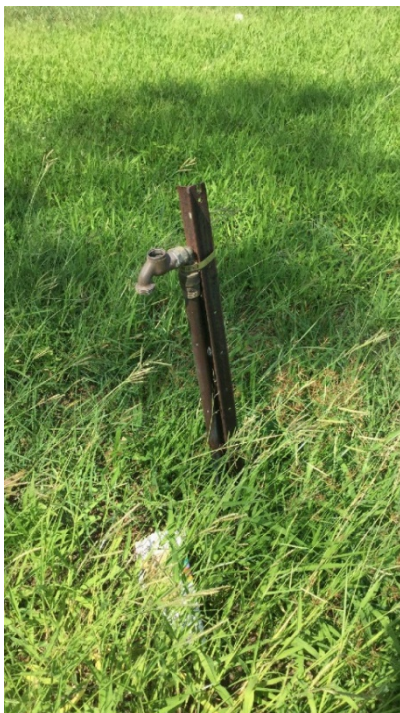
Figure 6 Tap, condition: *very poor*

A single tap was found to be in very poor condition. The tap handle was missing at the time of inspection and is recommended to be replaced.

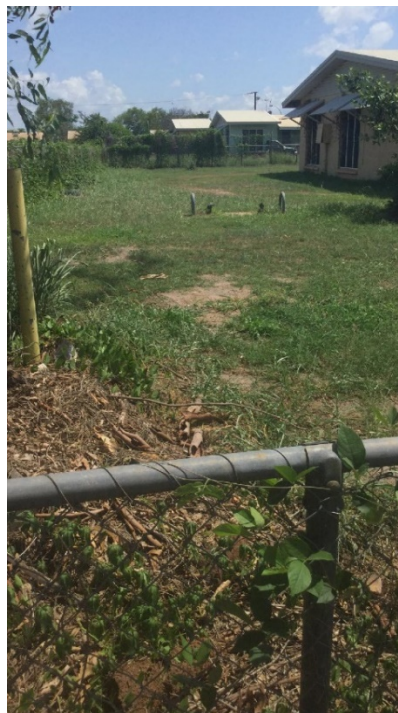
Figure 7 Water meter (lot), condition: *good*

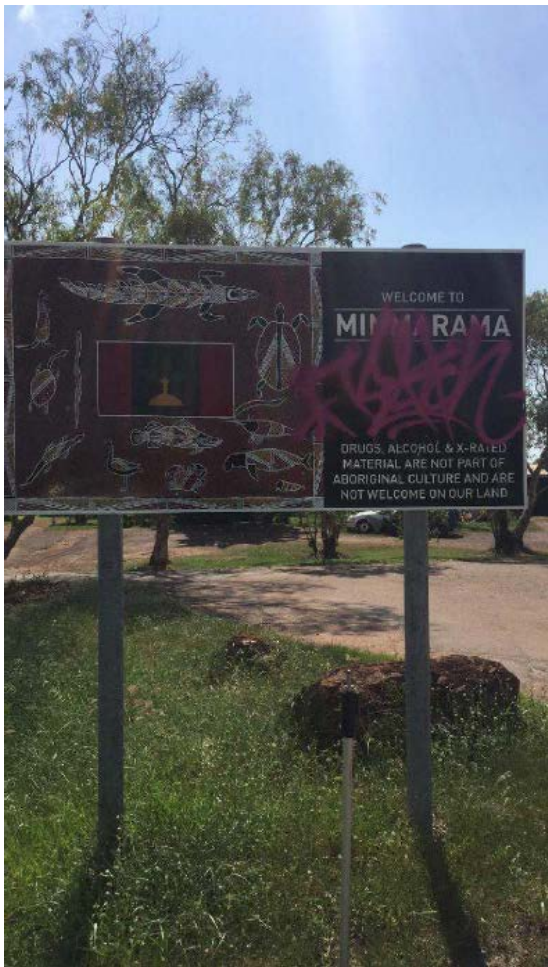
Figure 8 Minmarama Park welcoming sign, condition: *poor*

The only road furniture in Minmarama Park was a sign rated poor due to the graffiti, (refer Figure 8).

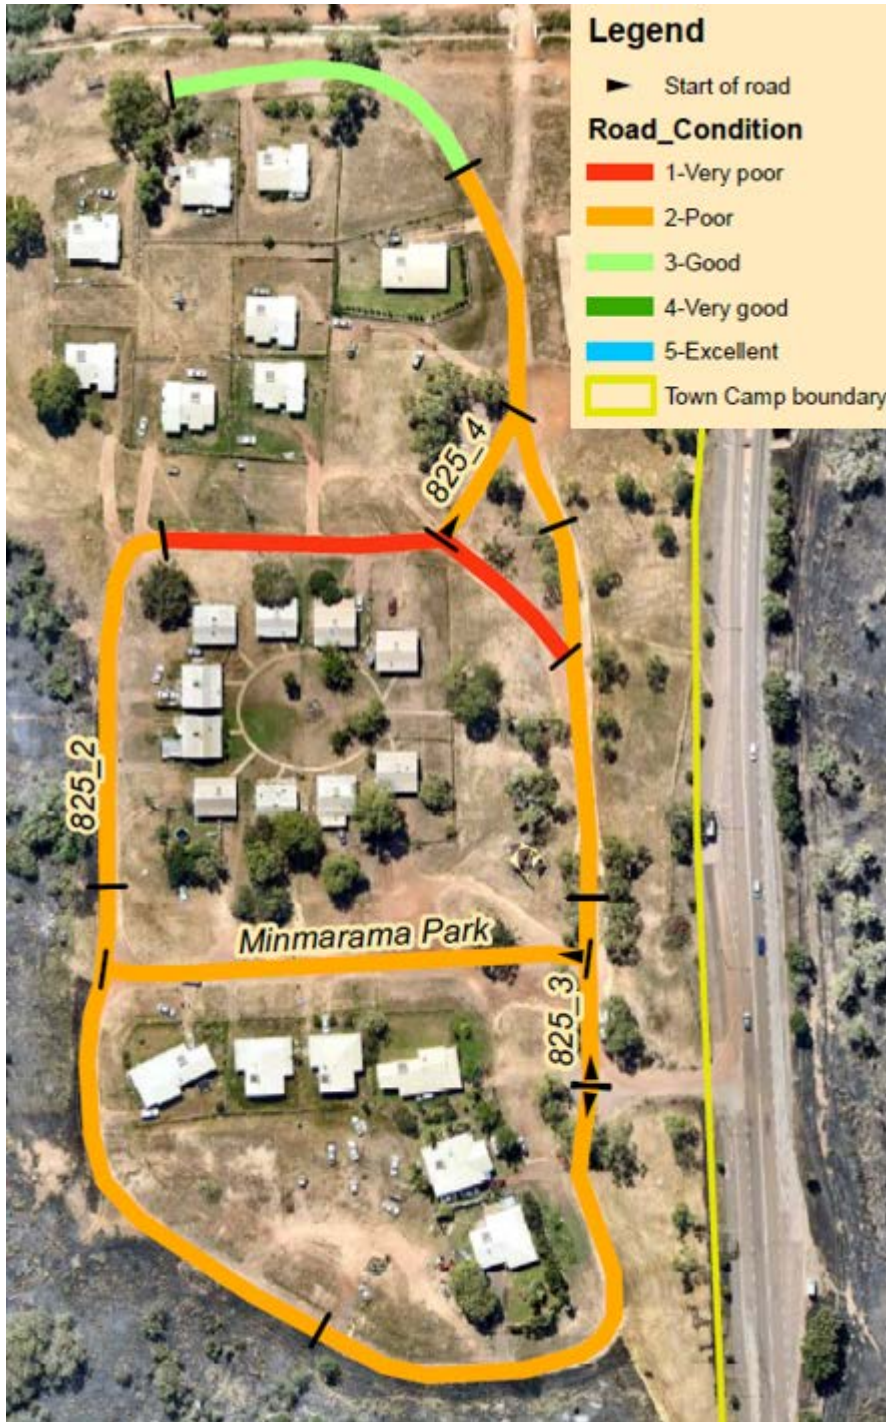
Figure 9 Minmarama Park road network condition

Road name	Chainage start(km)	Chainage end (km)	Road segment condition (1-5)	Defects and associated condition (1-5)
825_2	0	0.15	2	-5% of road has potholes, varying size (3)
	0.15	0.3	2	-50% of the road has undulations -10% of road has potholes (2)
	0.3	0.4	2	-Surface failures (2) -6 x Potholes (2) -Undulations (2) -Edge breaks (2)
	0.4	0.52	1	-Edge breaks (1) -10 x Potholes
825_3	0	0.05	2	-5% of sealed section has crocodile cracks (4) -Edge breaks (3)
	0.05	0.15	2	-12 x Potholes (2) -10 x Undulation
	0.15	0.25	2	-Potholes (2) -Edge Breaks (3) -Undulations (3)
	0.25	0.34	3	-Edge Breaks (3) -Undulations (3)
825_4	0	0.04	2	-5 x Surface cracks (3) -30 x Undulation (2)
Minmarama Park	0	0.13	2	-Edge breaks (1) -3 x potholes (3)

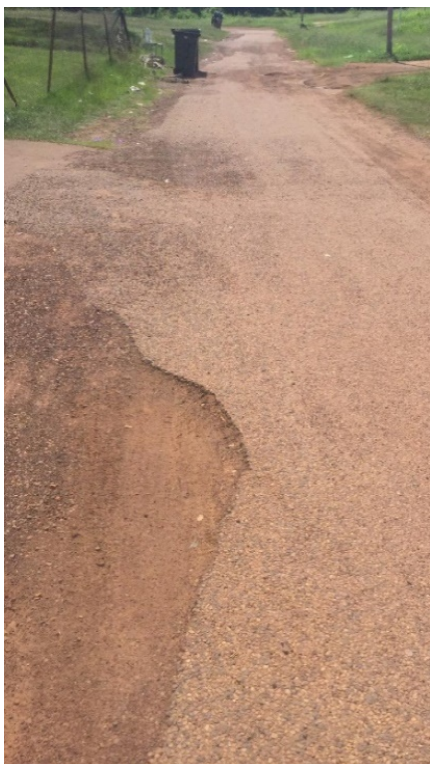
Figure 10 Typical sealed road, condition: *poor*

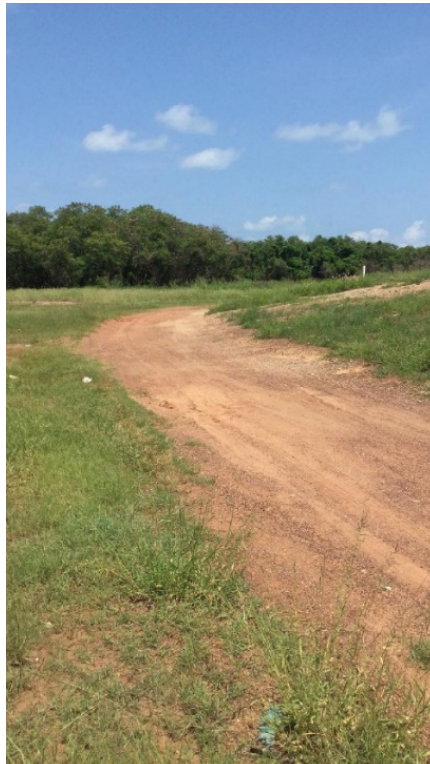
Figure 11 Typical unsealed road, condition: *poor*

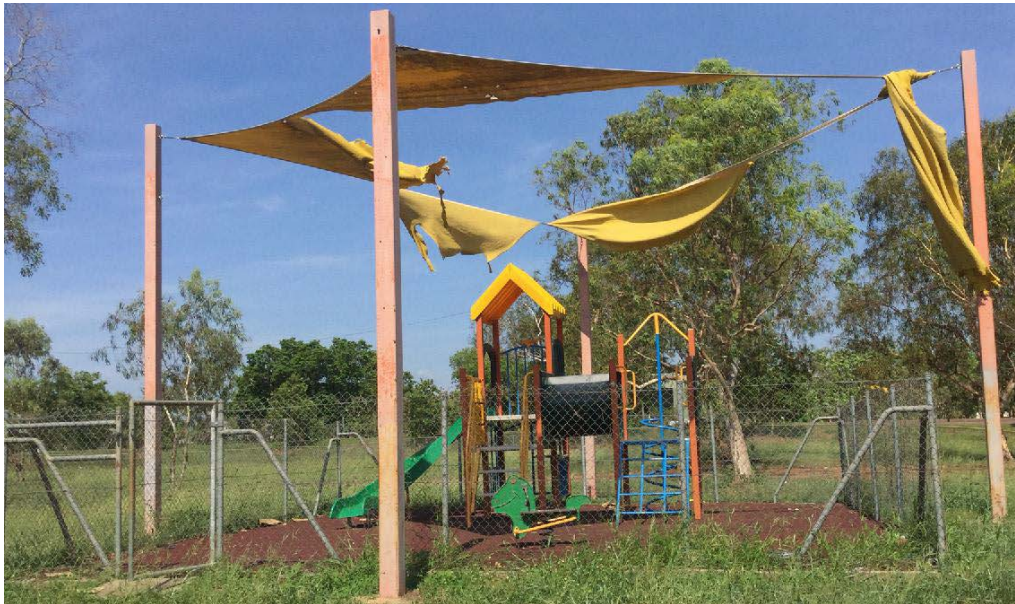
Figure 14 Playground, condition: *good*

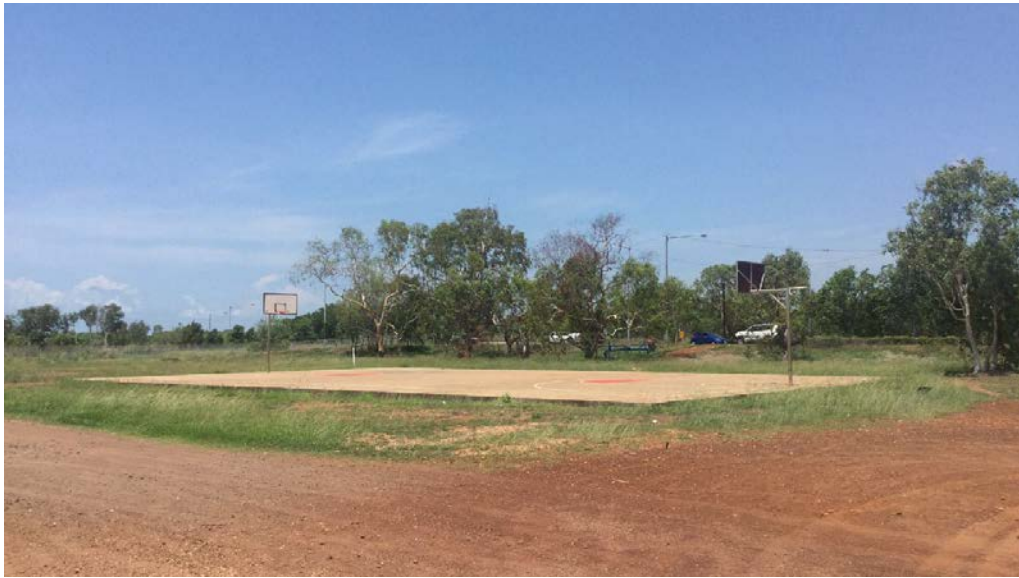
Figure 15 Basketball court, condition: *good*

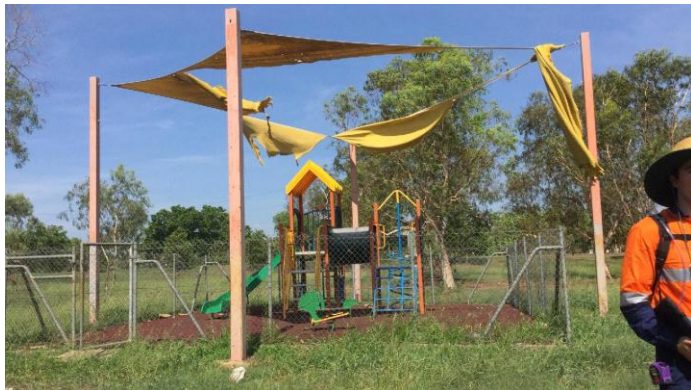
Minmarama Park

Inspection Type:	Shade Structure
Shade Structure Type:	Play ground
Shade Floor Type:	Rubber Mats
Roof Type:	Shadecloth
Width (mm):	
Length (mm):	
Appearance:	3
Appearance Comment:	
Condition:	3 - Good
Comment:	Torn shadecloth

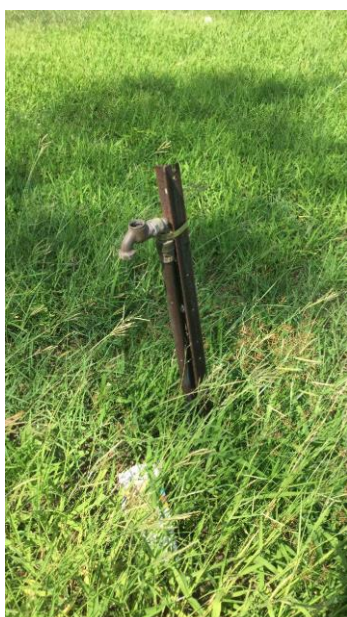
Tap Condition: 1 - Very Poor

Tap Comment: No tap handle
