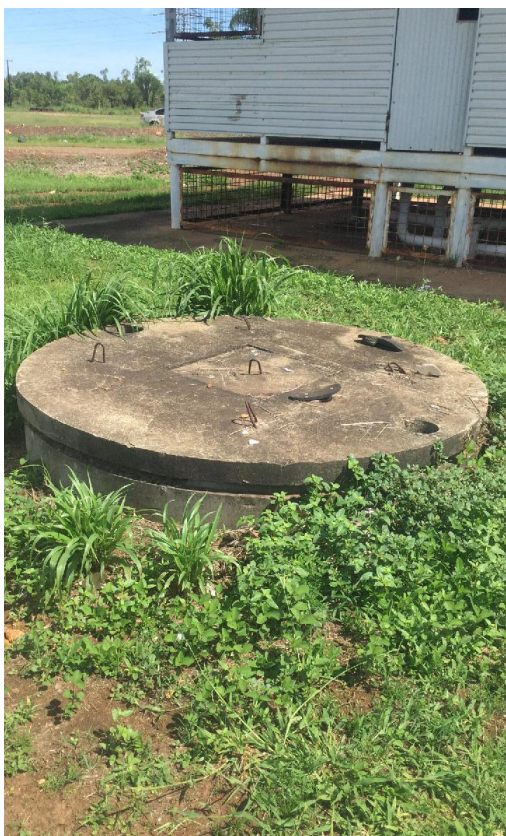
Figure 1 Septic tank outside
ablution block

The septic tanks were rated from very poor to good condition. It is not recommended that any maintenance works are undertaken on these as the sewer network should be upgraded with a reticulation main, as per PWC standards.

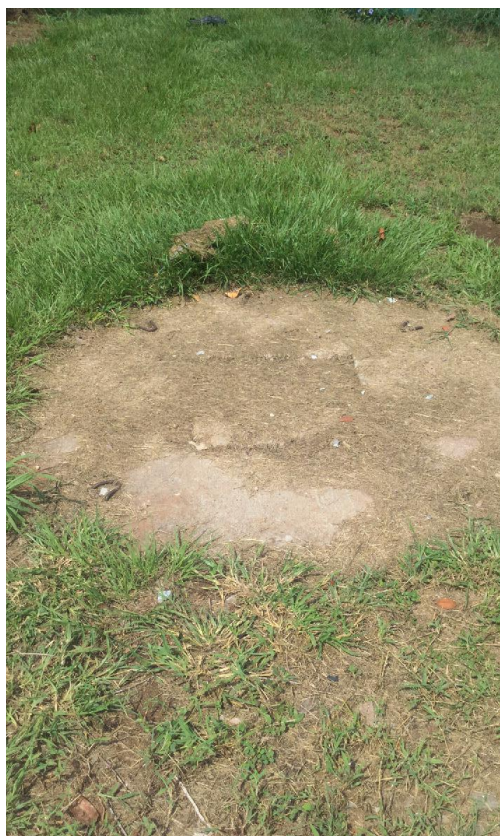
Figure 2 Septic tank

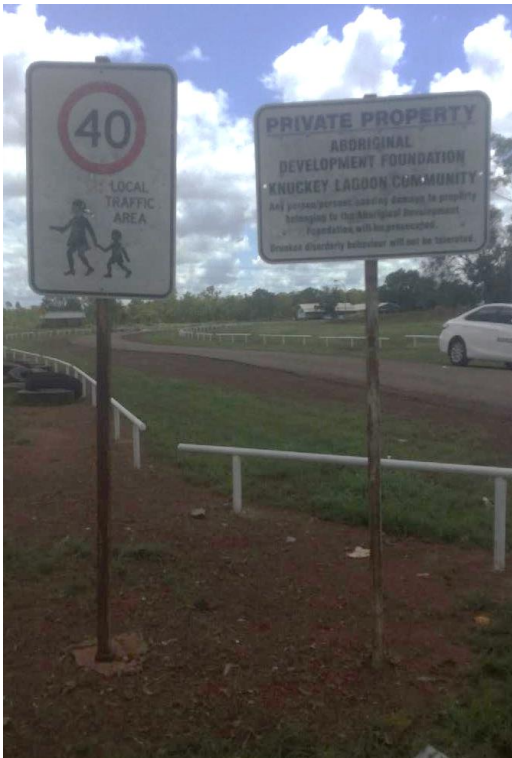
The six signs around Knuckey Lagoon are all good condition with the exception of one. The five good signs can simply be cleaned and all graffiti removed whereas the poor condition sign needs to be replaced.

Figure 7 Sign, condition: *poor*

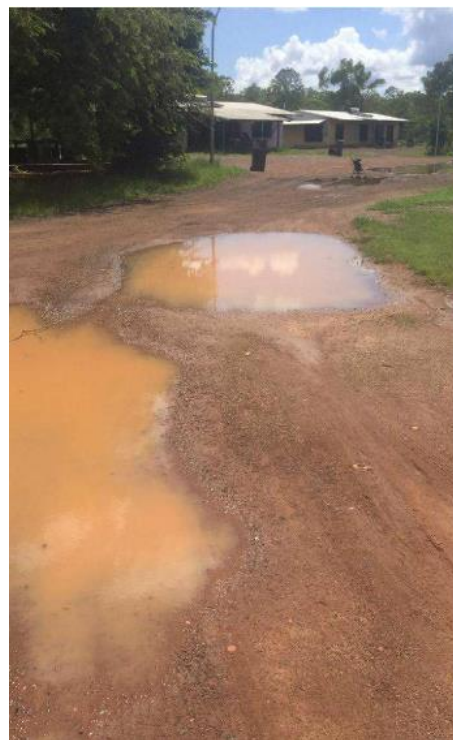
Figure 8 Pavement, condition: *very poor*

The infrastructure that was assessed as very poor or poor is recommended to be upgraded to prevent failure in the future. The following works are recommended to upgrade the current infrastructure;

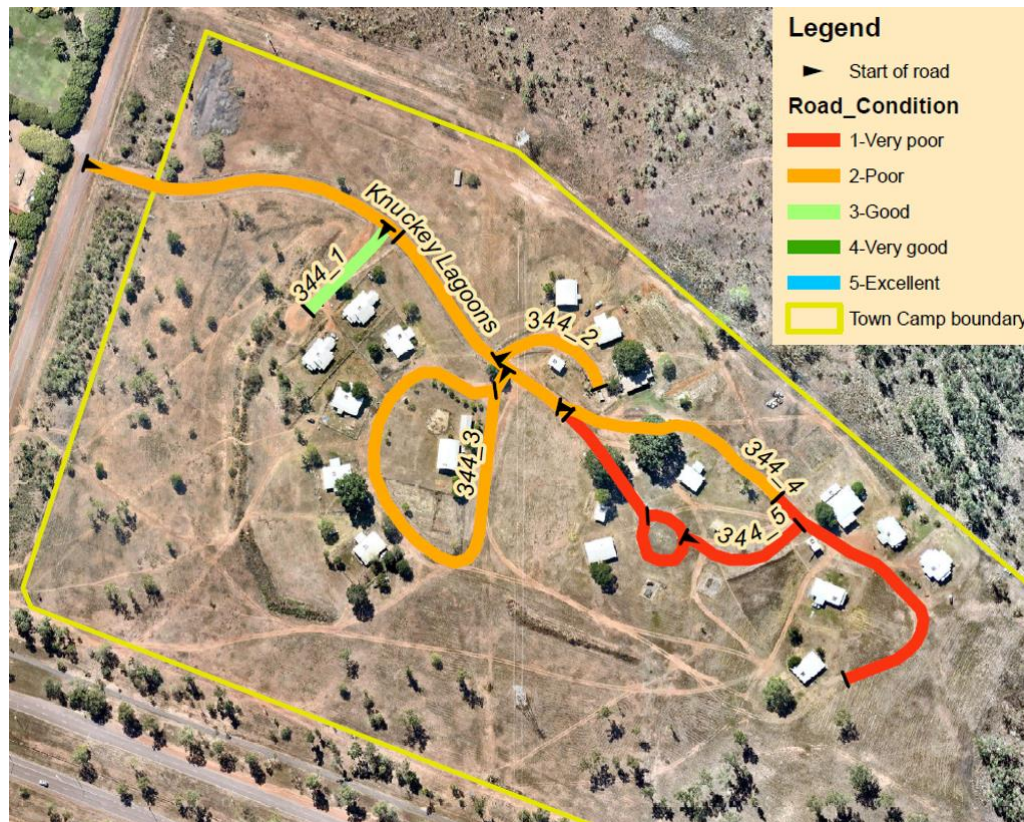
Figure 9 Knuckey Lagoon road conditions

Road Name	Chainage start (km)	Chainage end (km)	Road segment condition (1-5)	Defects and associated condition (1-5)
344_1	0	0.07	3	-20% of road has edge breaks (2)
344_2	0	0.08	2	-5% of road has potholes (2) -20% of road has stone loss (2) -50% of road has graffiti or rubbish (wheelie bin on the road) (2)
344_3	0	0.34	2	-5% of the road has potholes (2) -30% of road has stone loss (3)

Road Name	Chainage start (km)	Chainage end (km)	Road segment condition (1-5)	Defects and associated condition (1-5)
				-20% of road has edge breaks (2)
344_4	0	0.15	2	-5% of road has undulations (2)
	0.15	0.33	1	-40% undulations (1)
344_5	0	0.08	1	-30% surface failure (1)
Knuckey Lagoon	0	0.2	2	-60% of road has edge breaks (2) -5% of road has surfacing cracks (2) -10% of road has stone loss (2)
	0.2	0.35	2	-20% stone loss (2) -30% edge breaks (2) -5% surfacing cracks (2)
	0.35	0.51	1	-10% stone loss (1) -5% surfacing cracks (2) -20% edge breaks (2)

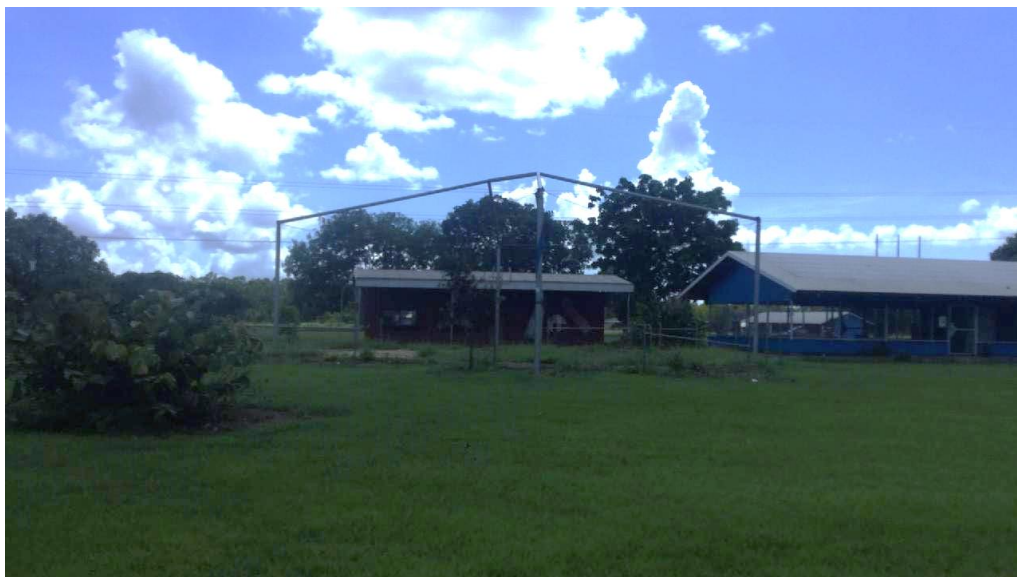
Figure 10 Playground, condition: *very poor*

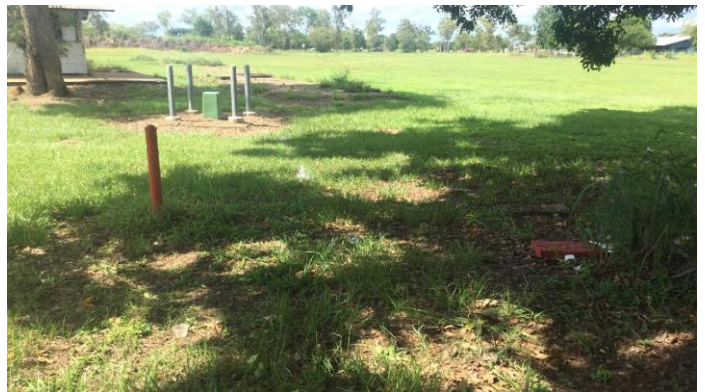
FH Comment: Post near hydrant

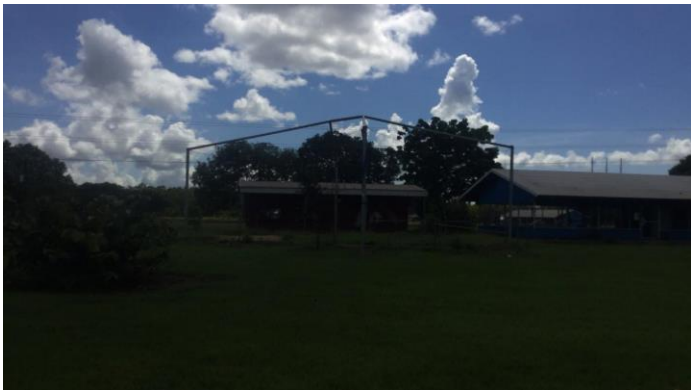
Inspection Type: Shade Structure
Shade Structure Type: Play ground
Shade Floor Type: Sand
Roof Type: Shadecloth
Width (mm):
Length (mm):
Appearance: 2
Appearance Comment:
Condition: 1 - Very Poor
Comment: Looks like old playground area, no playground, no shadecloth

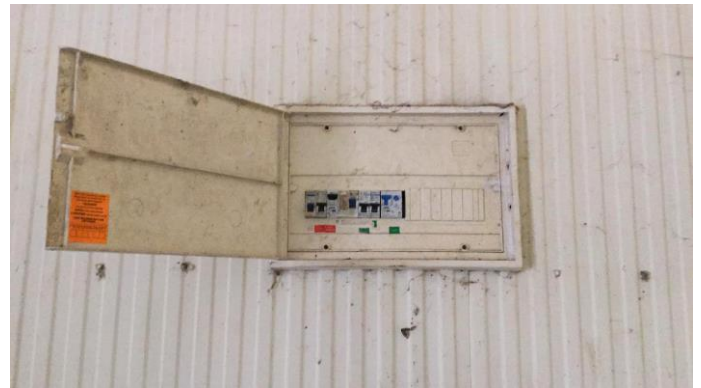
Meter Comment: Blank plates are missing on CB slot. Indoor SB, Cond 3

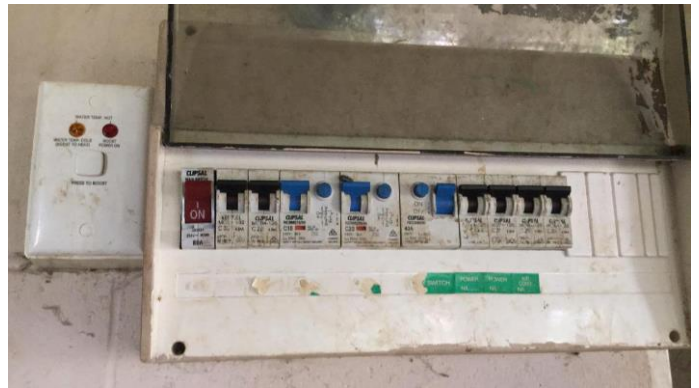
Meter Comment: Blank plates are missing on CB slot. Indoor SB, Cond 3

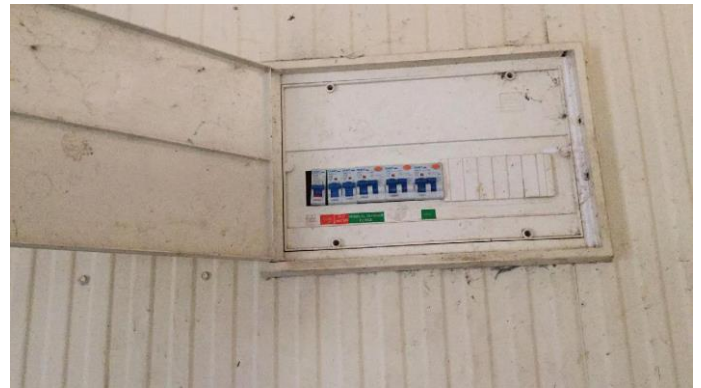
Meter Comment: Blank plates are missing on CB slot. Indoor SB, Cond 3

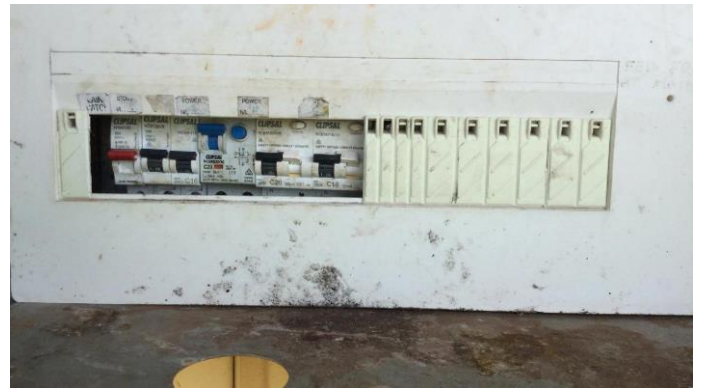
Meter Comment: CBs are in poor condition.

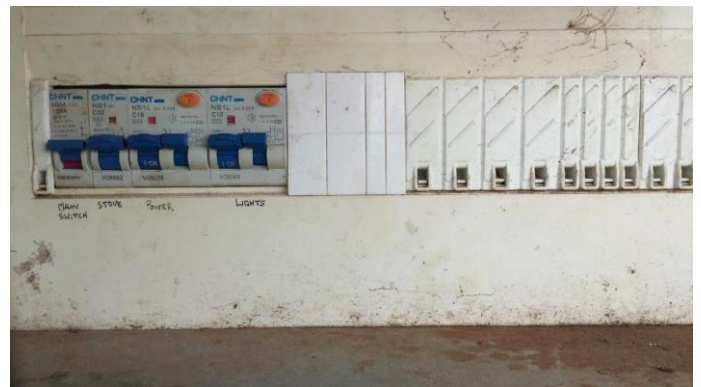
Meter Comment: Meter box is damaged. Indoor SB, Cond 3

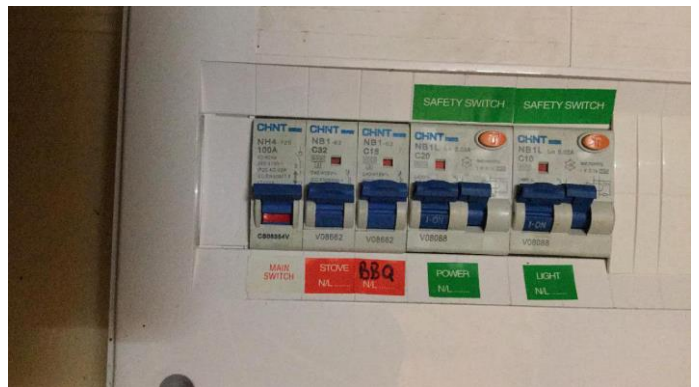
Meter Comment: Blank plates are missing on CB slot. Indoor SB, Cond 3

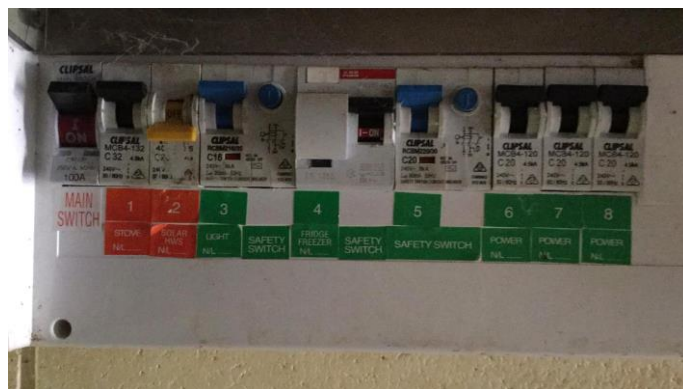
Meter Comment: Blank plates are missing on CB slot. Indoor SB, Cond 3

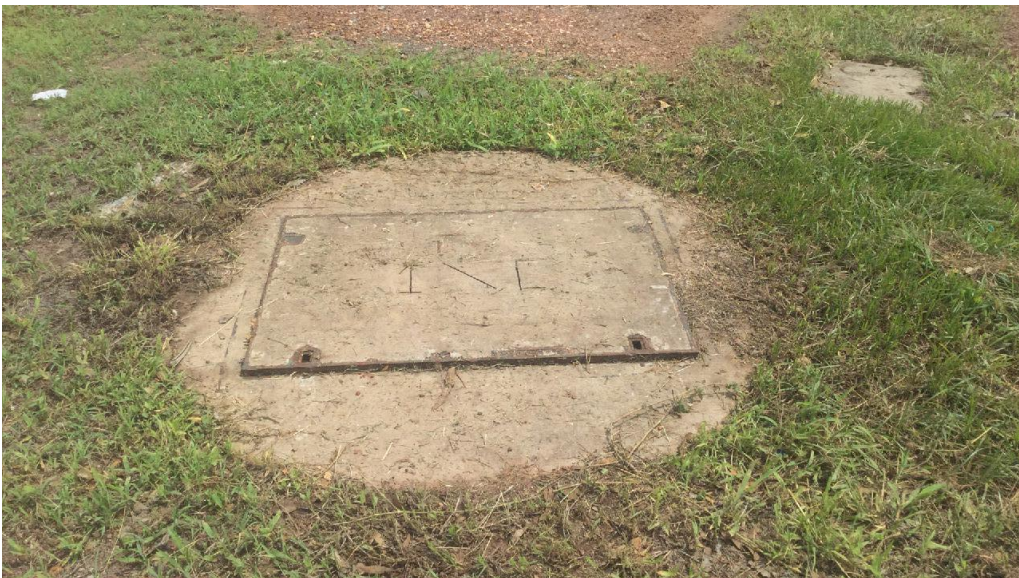
Figure 2 Sewer manhole (good condition)

The manholes were rated as 'good' and 'very good' and do not require any maintenance works at this stage. During the inspection it was noted that some of the manholes had some rust on the lid, or the lid was not sitting properly.

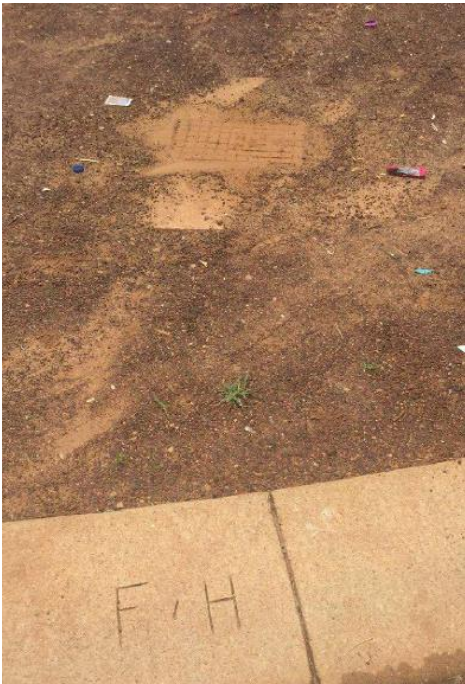
Figure 4 Fire hydrant, condition: *good*

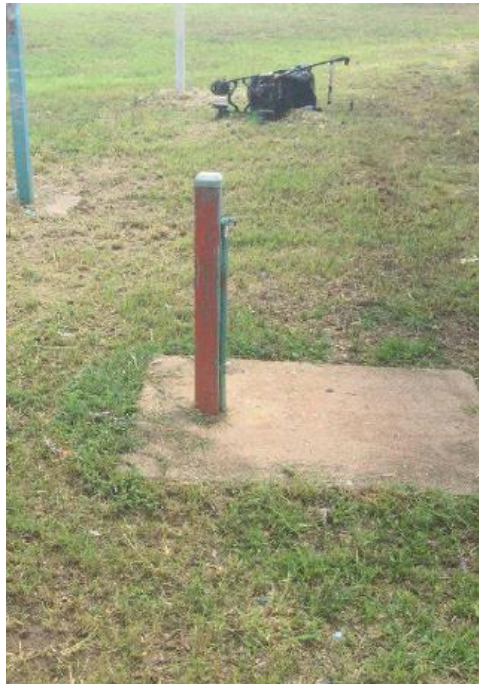
Figure 5 Tap, condition: *very poor*

Several taps were found to be in very poor and poor condition. In total, seven taps need replacing.

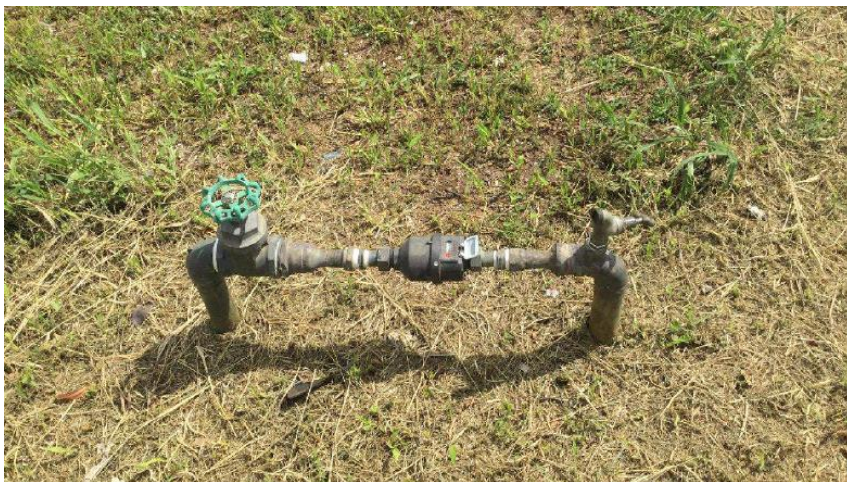
Figure 6 Water meter (lot), condition: *good*

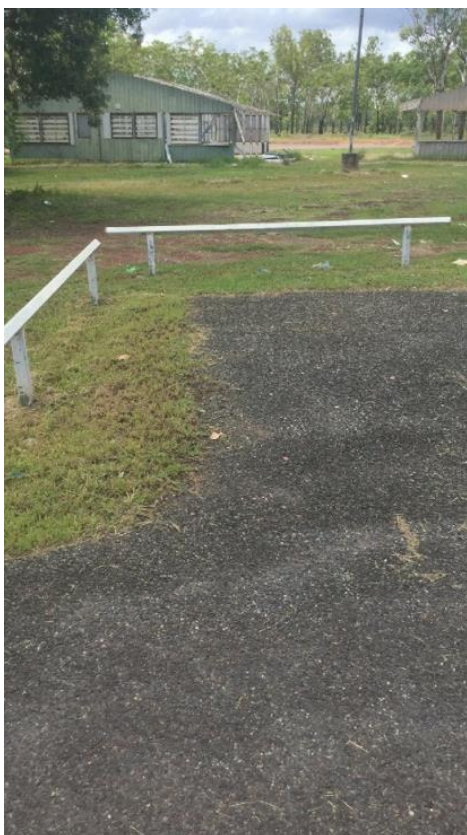
Figure 7 Carpark, condition: *good*

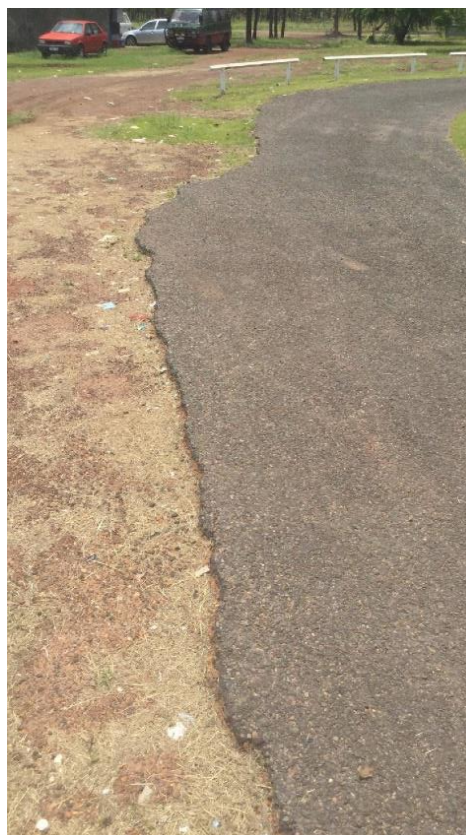
Figure 8 Pavement edge breaks, condition: *poor*

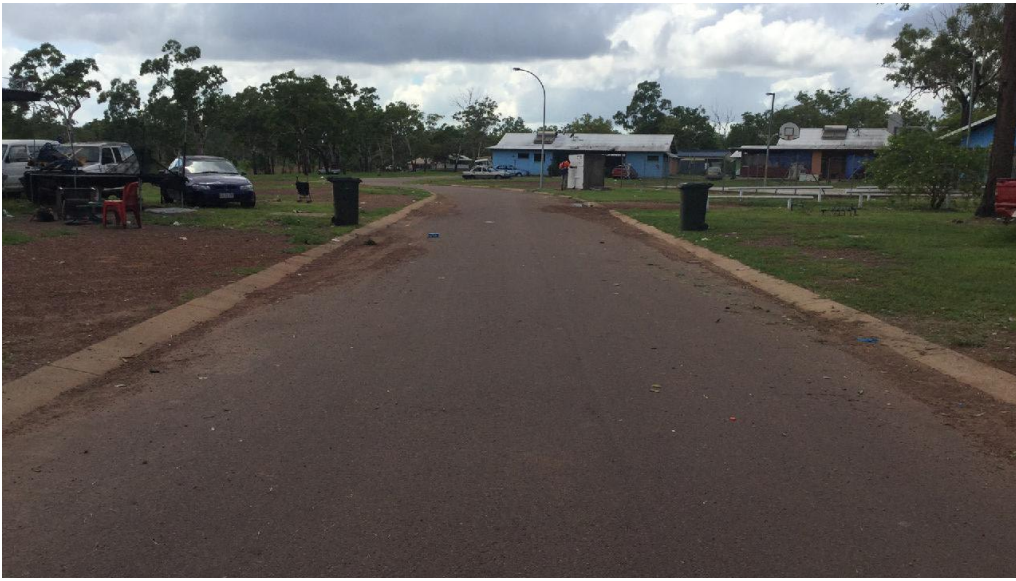
Figure 9 Pavement, condition: *good*

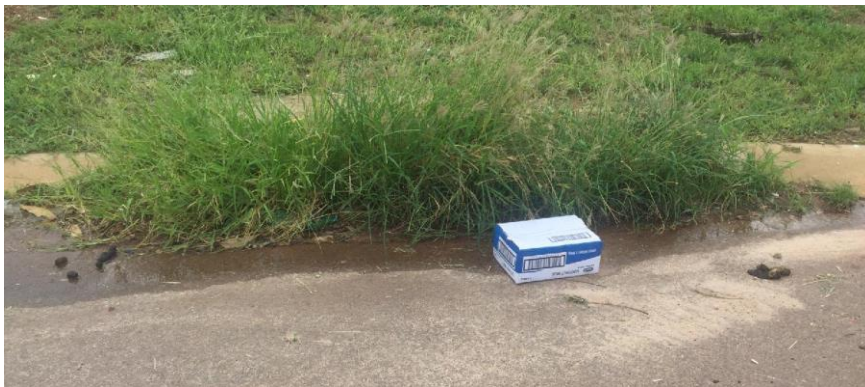
Figure 11 Side entry pit, condition: *good (structure good, blockage very poor)*

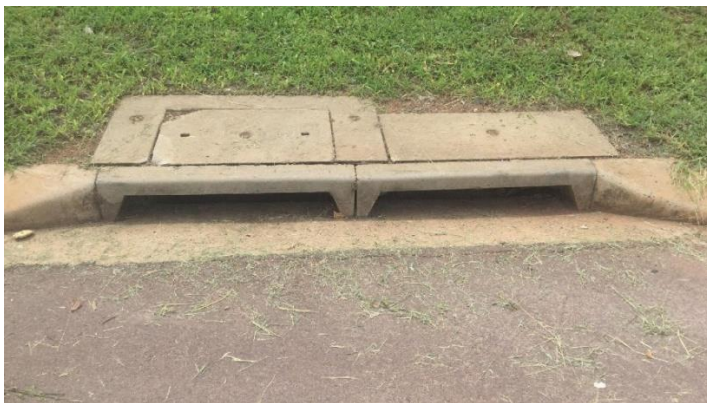
Figure 12 Side entry pit, condition: *good*

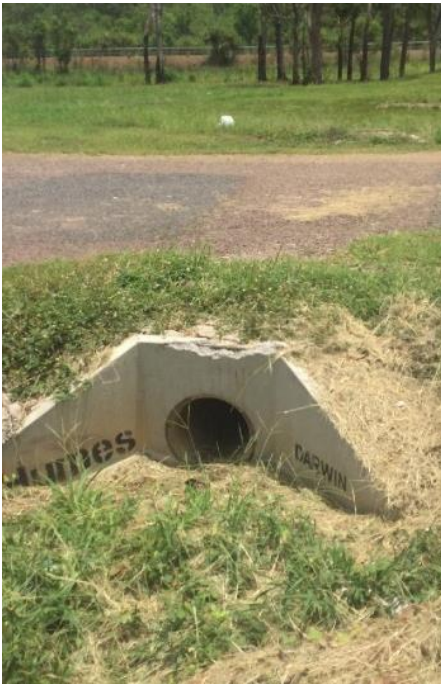
Figure 13 Headwall DN375, condition: *good*

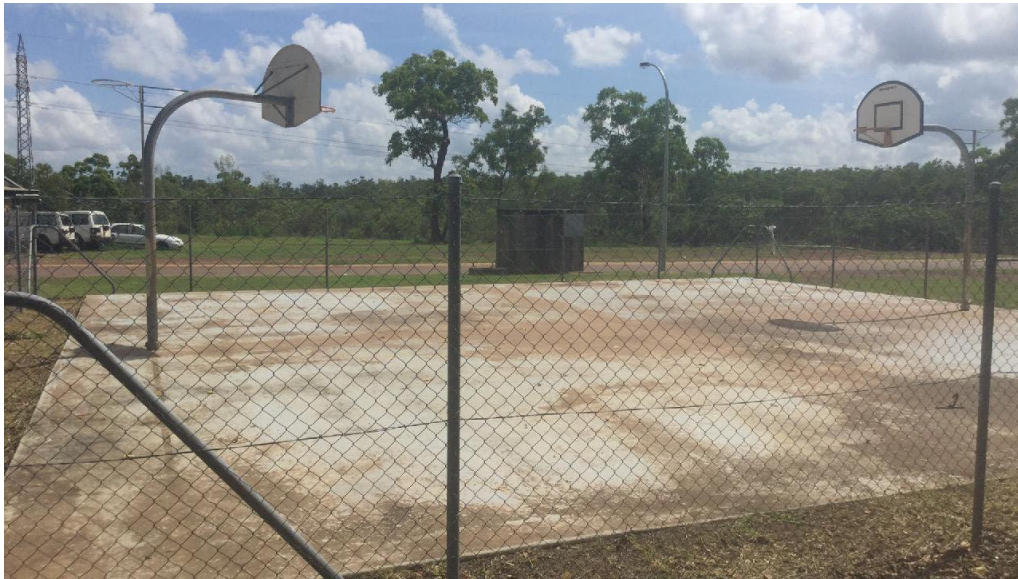
Figure 15 Basketball court, condition: *good*

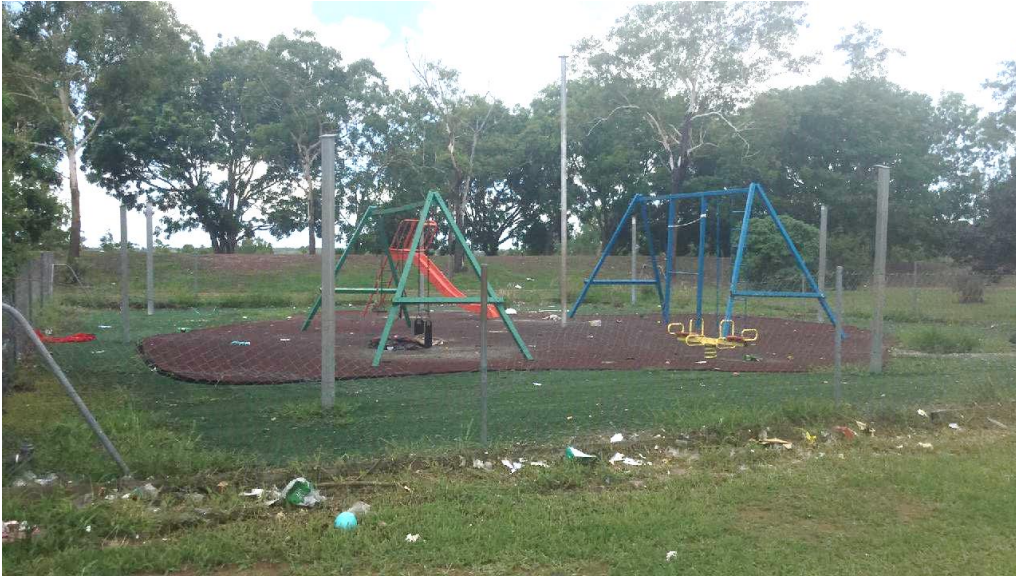
Figure 16 Playground, condition: *poor*

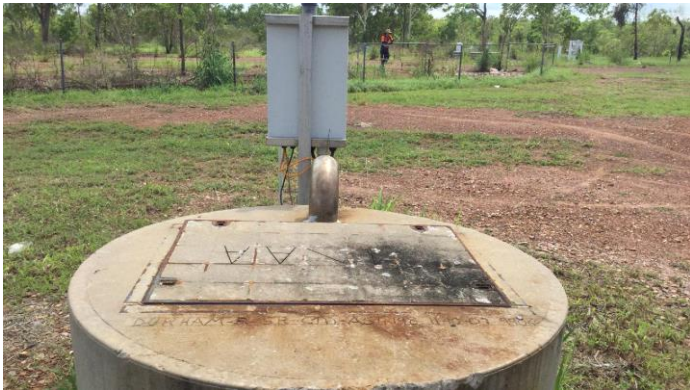
What Sewerage Asset are you capturing: Manholes
MH Cover Shape: Rectangular
Manhole Cover Diam (mm):
Manhole Length (mm): 1000
Manhole Width (mm): 700
Manhole Condition: 3 - Good
Notes on Lid: 1/AA
Comments: Some rust

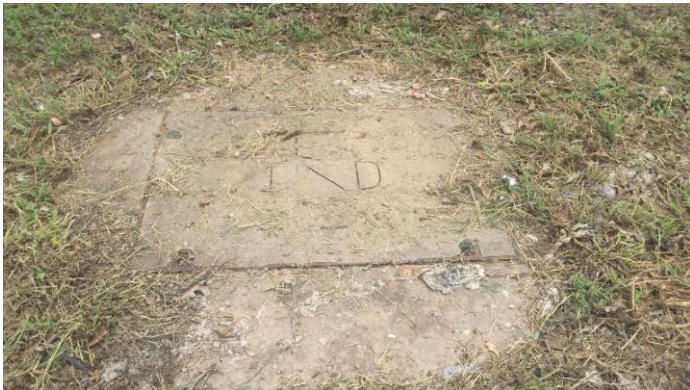
What Sewerage Asset are you capturing: Manholes
MH Cover Shape: Rectangular
Manhole Cover Diam (mm):
Manhole Length (mm): 1000
Manhole Width (mm): 700
Manhole Condition: 3 - Good
Notes on Lid: 1/D
Comments: Some rust

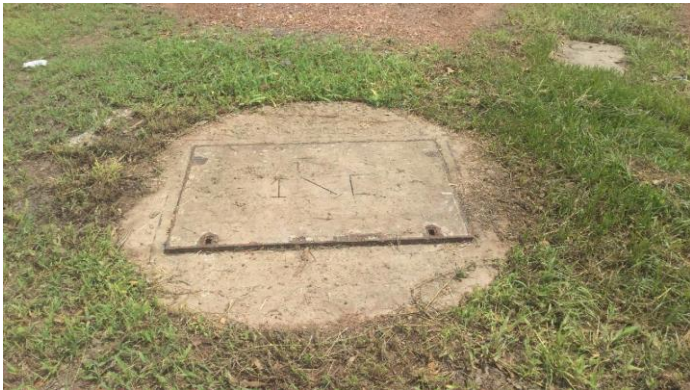
What Sewerage Asset are you capturing: Manholes
MH Cover Shape: Rectangular
Manhole Cover Diam (mm):
Manhole Length (mm): 1000
Manhole Width (mm): 700
Manhole Condition: 3 - Good
Notes on Lid: 1/C
Comments: Some rust

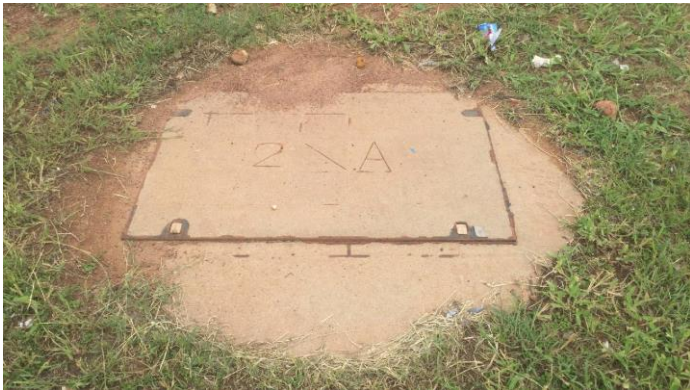
Comments: Some dirt and rust

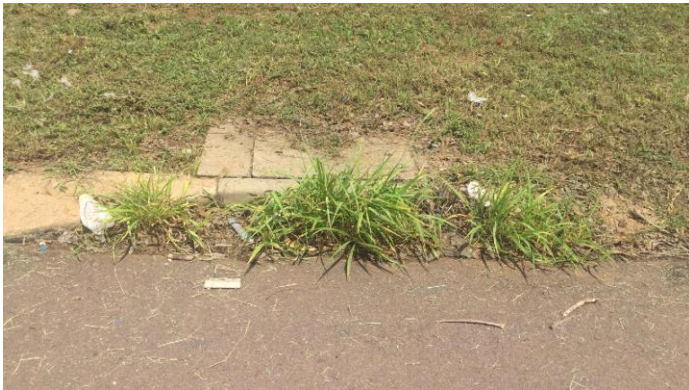
Stormwater Infrastructure:	SEP
Number of Bays:	1
On grade or sag pit:	On Grade
Both sides of road:	Left
Condition:	2 - Poor
Blockage (%):	90
Comment:

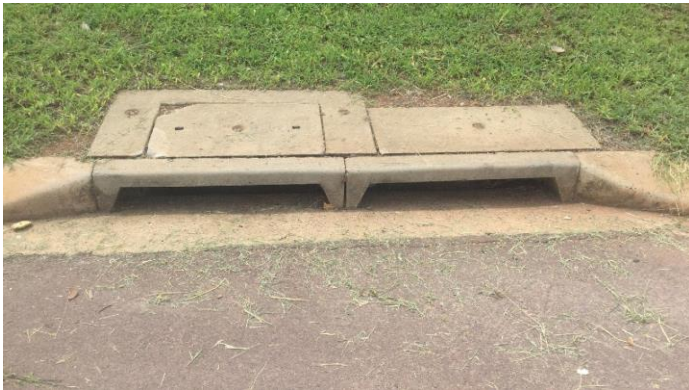
Stormwater Infrastructure:	SEP
Number of Bays:	2
On grade or sag pit:	
Both sides of road:	Left
Condition:	3 - Good
Blockage (%):	0
Comment:	Some concrete damage

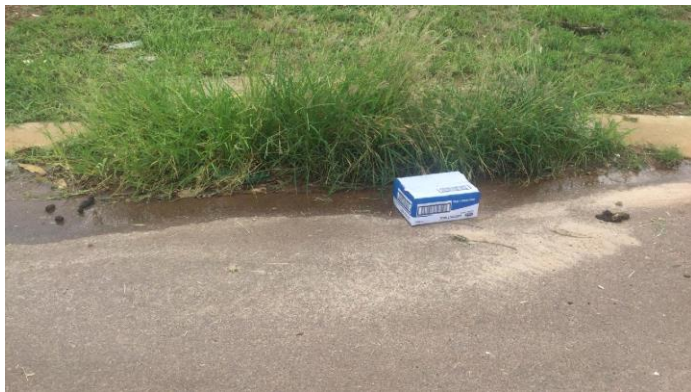
Stormwater Infrastructure: SEP
Number of Bays: 2
On grade or sag pit:
Both sides of road:
Condition: 3 - Good
Blockage (%): 100
Comment:

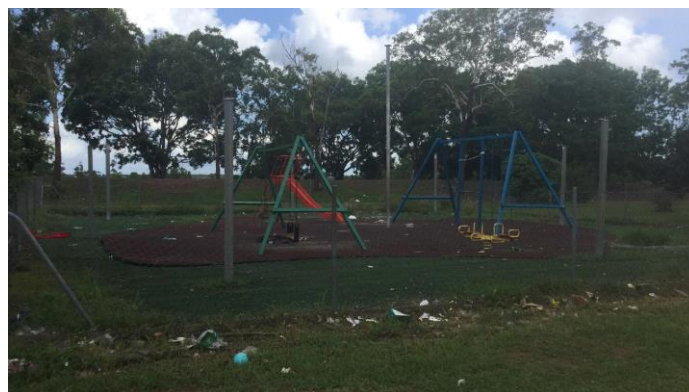
Inspection Type:	Shade Structure
Shade Structure Type:	Play ground
Shade Floor Type:	Rubber Mats
Roof Type:	Not Covered
Width (mm):	20
Length (mm):	20
Appearance:	2
Appearance Comment:	Rubbish, paint peeling
Condition:	2 - Poor
Comment:

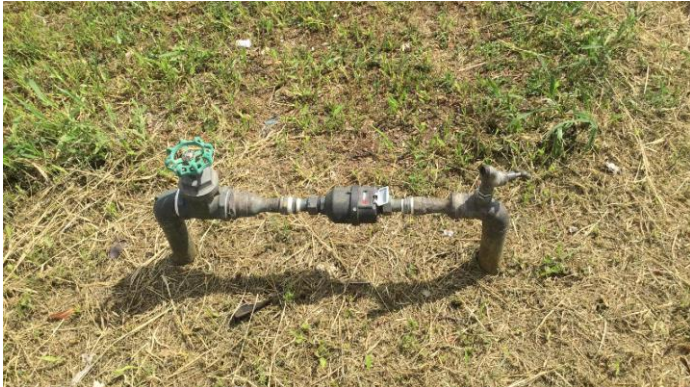
Lot Water Meter Comment: Has a tap as well, tap doesn't work
