### NT Town Camp Road Assessments

#### 403 - Palmerston Indigenous Village (Palmerston)

## Civil Infrastructure

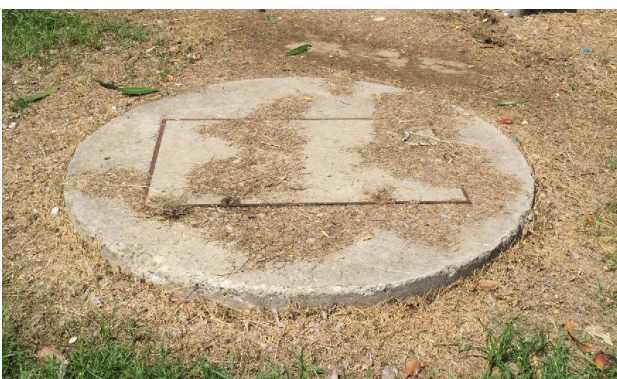
Figure 1 Manhole, condition: *good*

The manholes were rated as good and very good and do not require any maintenance works at this stage. It was noted that one of the manholes has some concrete damage (refer Figure 1), however this is not affecting the structural integrity of the manhole.

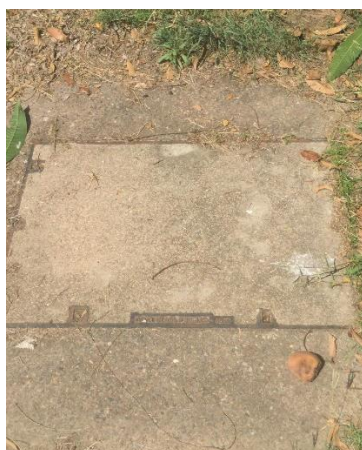
Figure 2 Manhole, condition: *very good*

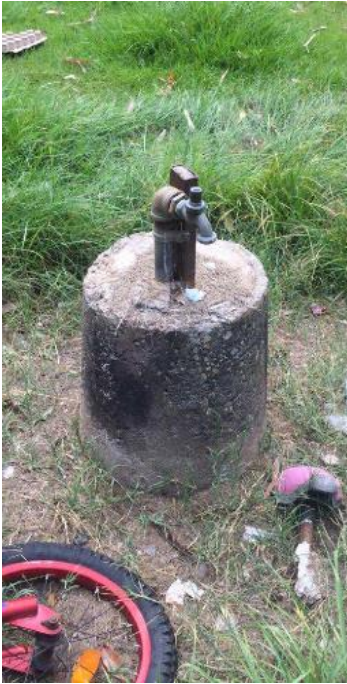
Figure 4 Tap, condition: *very good*

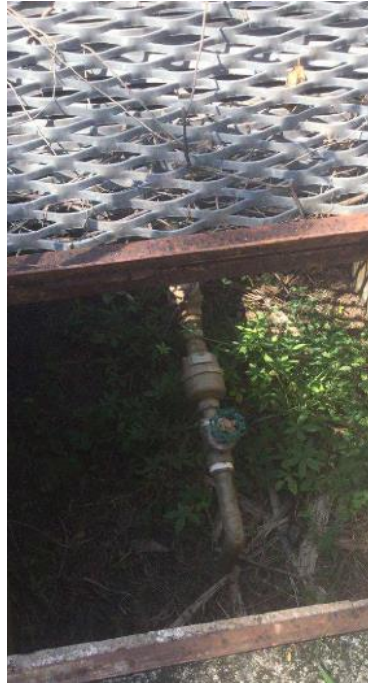
Figure 5 Water meter (bulk), condition: *good*

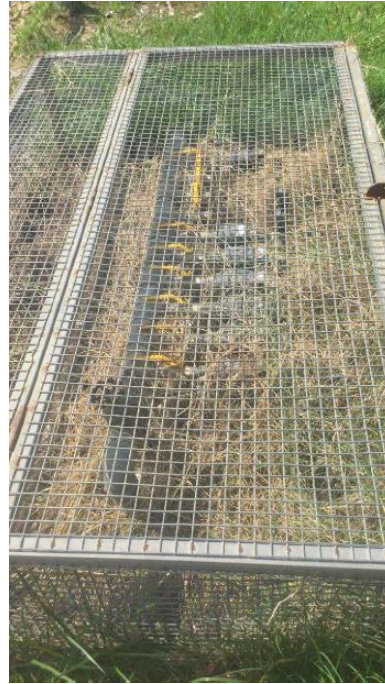
Figure 6 Water meter (lot), condition: *good*

Two taps were assessed as being in very poor condition. It is recommended these two taps are removed and replaced with new taps. Figure 6 shows a cage surrounding seven lot meters. Dense grass is clearly visible in the cage which should be cleared.

- Clear overgrown grass from existing water meter cage. (Maintenance for current water meters).
- Replace two taps.

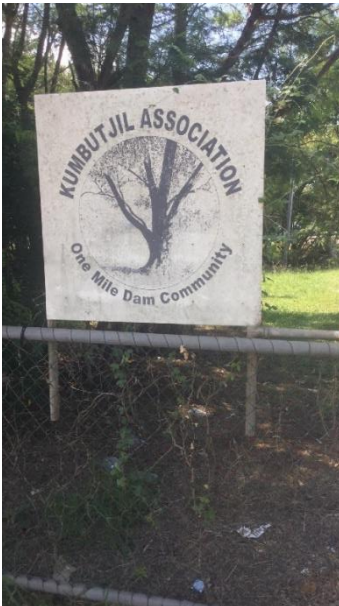
Figure 7 Sign, condition: *poor*

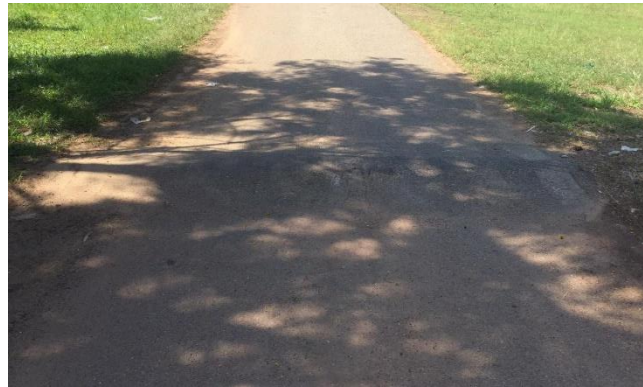
Figure 8 Speed hump, condition: *poor*

- Clean entrance sign
- Repair 5 potholes
- Repaint speed bump, as seen in Figure 8
- Repair 11 m of edge breaks
- Repair approximately 56 m<sup>2</sup> of pavement cracks
- General tidy up of approximately 210m of road

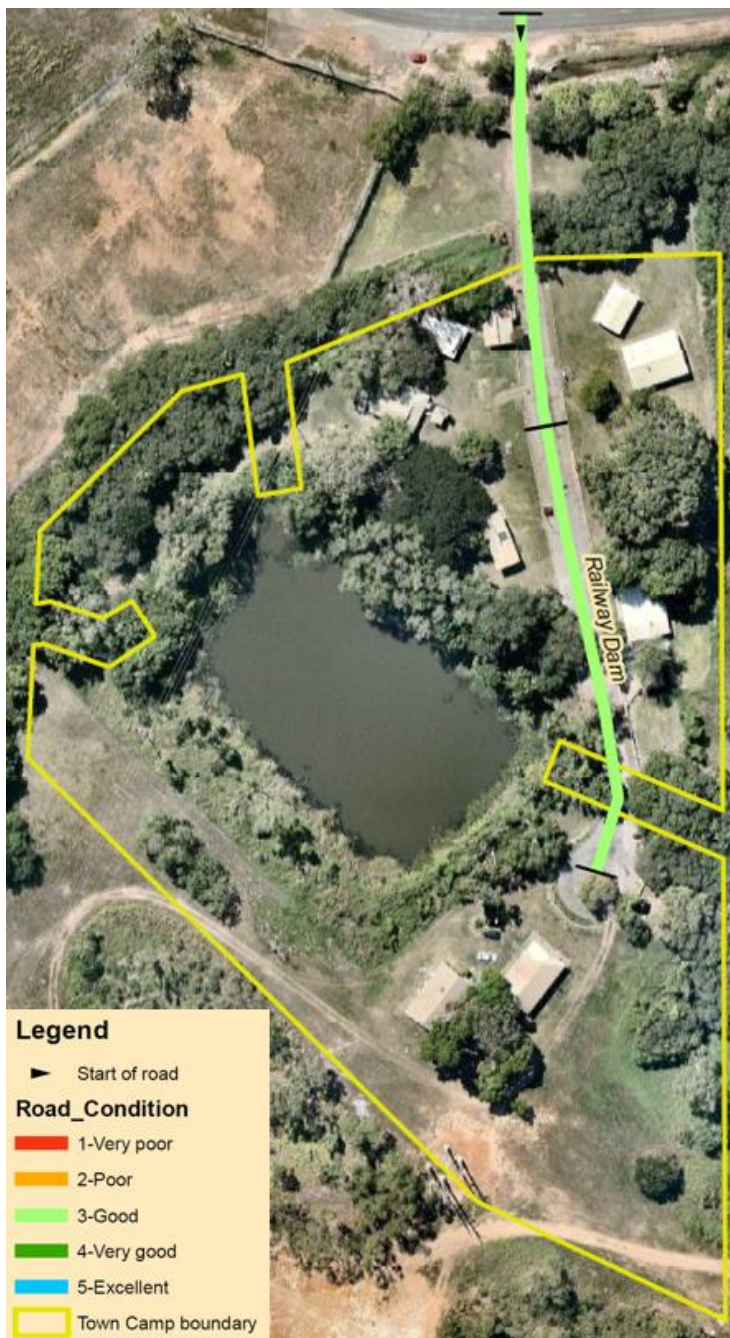
Figure 9 Railway Dam road network

The main road into Railway Dam was rated as having good condition, although there were edge breaks and some potholes. The layout of the road network is sufficient for the current number of houses.

It is recommended that the road is upgraded to a two lane network with all associated stormwater drainage assets. It is also recommended that a road safety audit is undertaken to determine where signage, line marking, etc. are required.

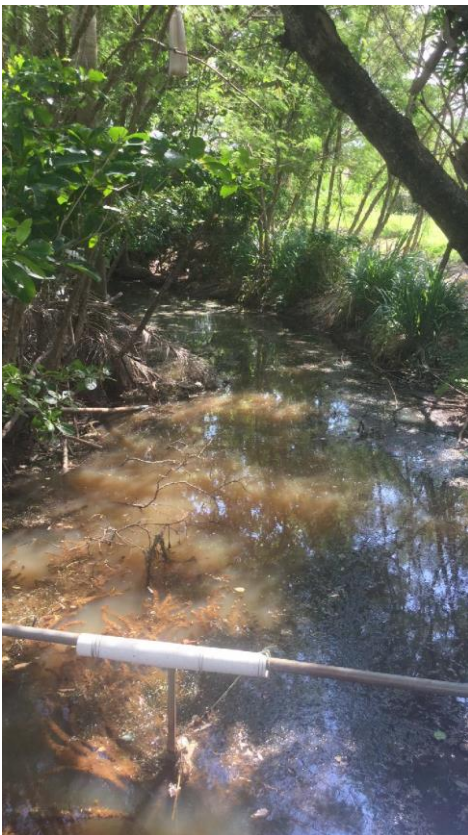
Figure 10 Drain with ponding

Three swales were assessed as having very poor condition due to extensive ponding issues, debris and trees/branches affecting the flow of the water. It is recommended that these drains are cleaned out and the batters and invert level remediated to ensure the water flows away efficiently. Reshaping the swales to remove the stagnant water will also lead to a reduction in biting insects and mosquitoes.

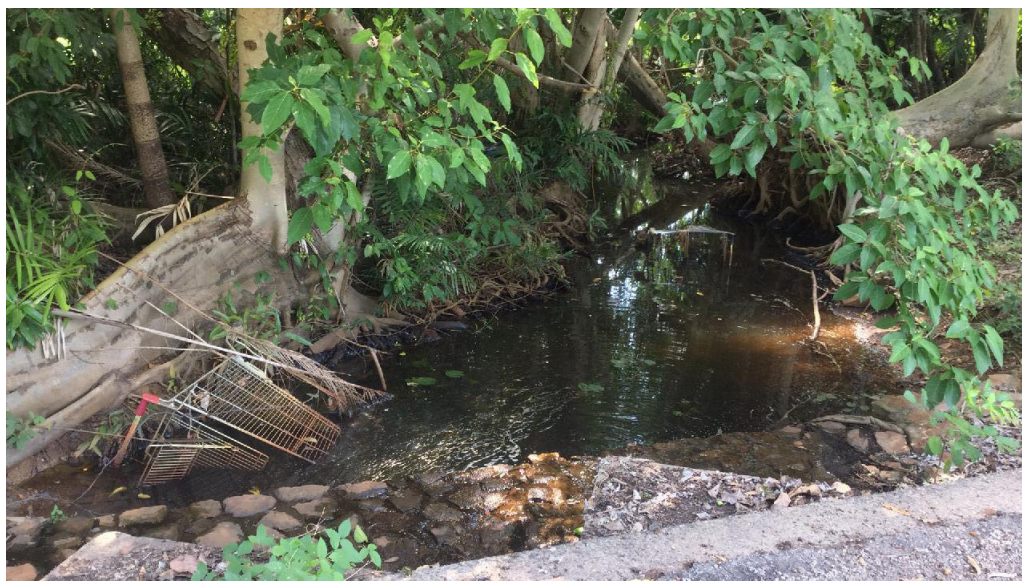
Figure 12 Drain with ponding and debris at Railway Dam

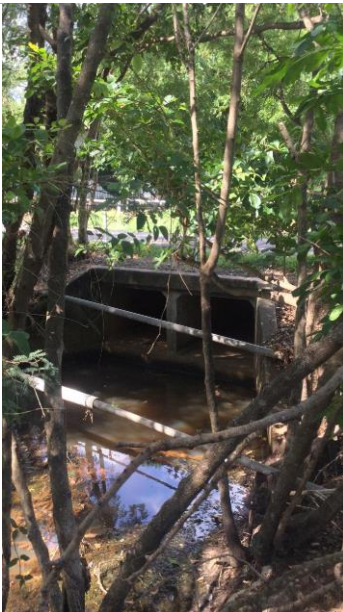
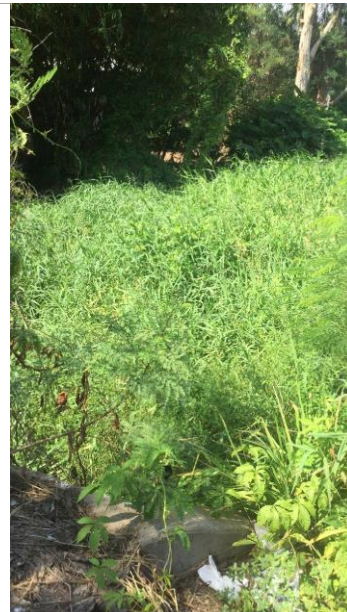
Stormwater Infrastructure:	Culverts
Culvert Type:	RCBC
Diameter (mm):	
Width (mm):	900
Culvert Depth (mm):	900
Culvert Length (m):	9
Culvert Condition:	3 - Good
Culvert Blockage (%):	10
Culvert Comments:	
Culvert Head Wall:	Yes
Safety Grate:	No
Headwall Blockage:	
Headwall Condition:	3 - Good
Headwall Comment:	Dense vegetation
End Wall:	Yes
End Wall condition:	4 - Very Good
EW Comment:	Some scour around end wall

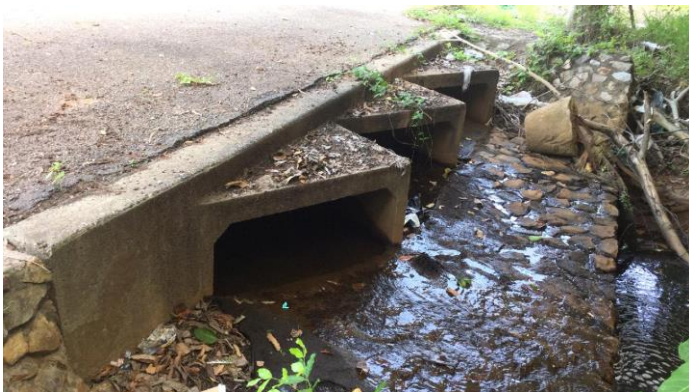
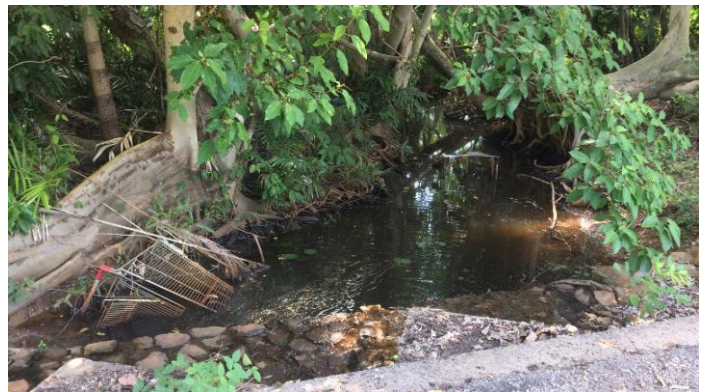
Stormwater Infrastructure:	Culverts
Culvert Type:	RCBC
Diameter (mm):	
Width (mm):	1200
Culvert Depth (mm):	450
Culvert Length (m):	9
Culvert Condition:	3 - Good
Culvert Blockage (%):	
Culvert Comments:	
Culvert Head Wall:	Yes
Safety Grate:	No
Headwall Blockage:	
Headwall Condition:	3 - Good
Headwall Comment:	Debris blocking culverts
End Wall:	Yes
End Wall condition:	3 - Good
EW Comment:	Debris and scour around endwall

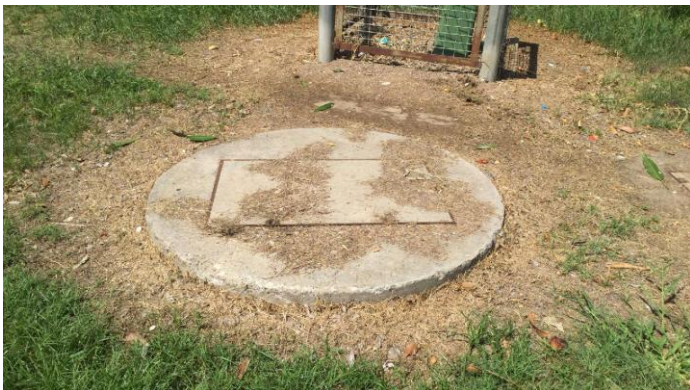
Comments: Some concrete damage at edges

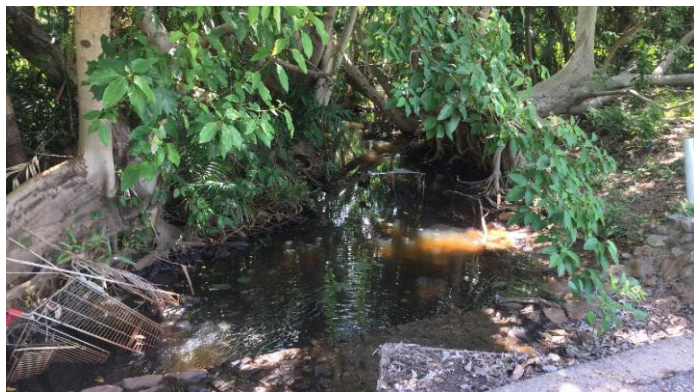
Stormwater Infrastructure:	Swales
Type of lining:	Tree roots
Are dimensions uniform along drain:	No Access
Base Width (m):	
Overall Width (m):	
Swale Depth (m):	
Length of Batter 1 (m):	
Length of Batter 2 (m):	
Swale Condition:	2 - Poor
Swale Ponding:	Yes
Drain flooded at time of inspection:	Yes
Swale Comments:	Not defined, debris, Ponding and stagnant water

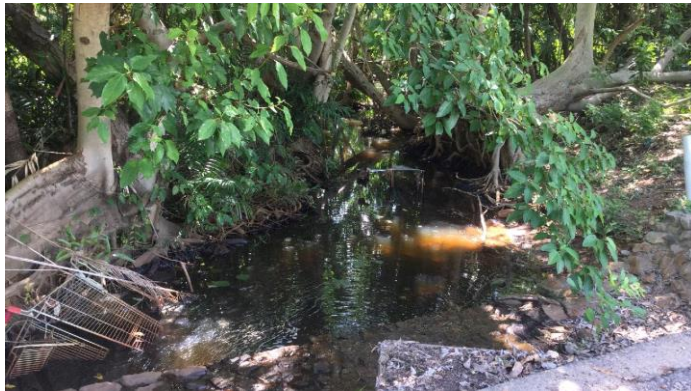
Stormwater Infrastructure:	Swales
Type of lining:	Tree roots
Are dimensions uniform along drain:	No Access
Base Width (m):	
Overall Width (m):	
Swale Depth (m):	
Length of Batter 1 (m):	
Length of Batter 2 (m):	
Swale Condition:	2 - Poor
Swale Ponding:	Yes
Drain flooded at time of inspection:	Yes
Swale Comments:	Not defined, debris, Ponding and stagnant water

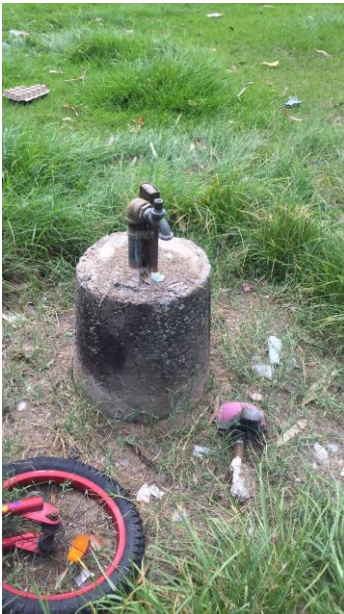
Tap Condition: 1 - Very Poor

Tap Comment: No tap handle

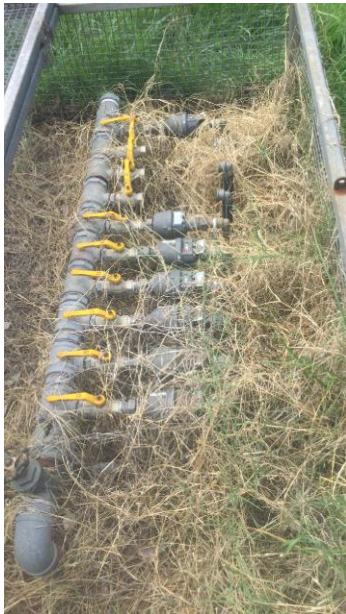
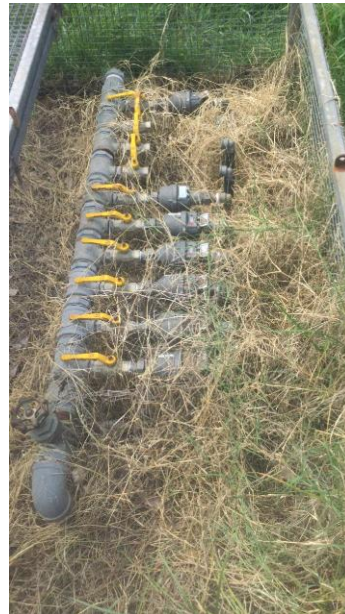
Lot Water Meter Condition: 3 - Good

Lot Water Meter Comment: 7 lot meters connected in arrangement

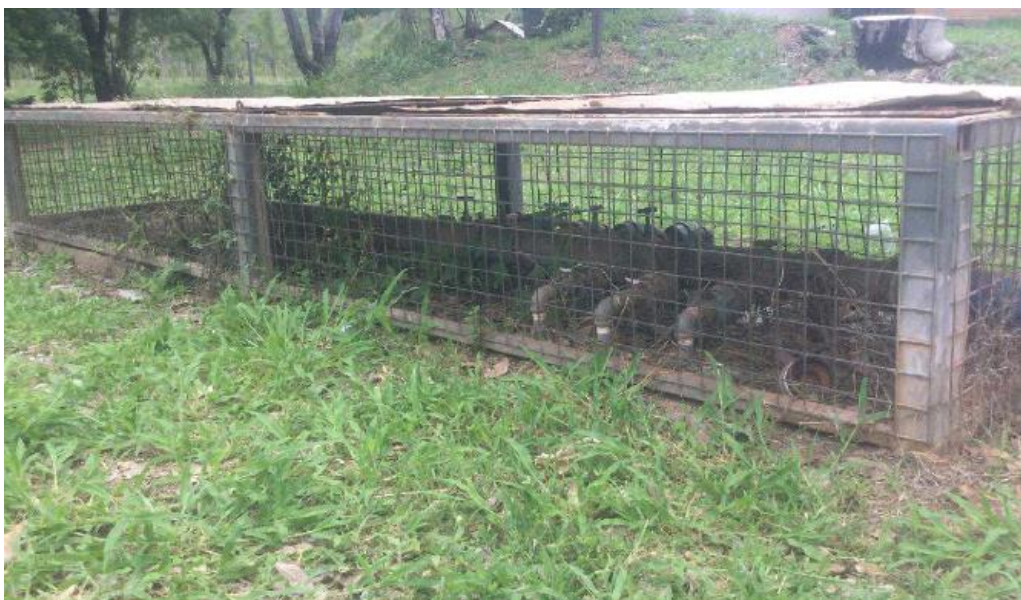
A total of eight lot meters in a single cage were inspected. Minor maintenance works are required for these lot meters including; clearing cage of weeds and rubbish, identifying and repairing leaks. No critical breaks were observed, however a small amount of water pooling below the water meters indicates leaks are present. The fire hydrants are in generally good condition however are in need of a repaint.

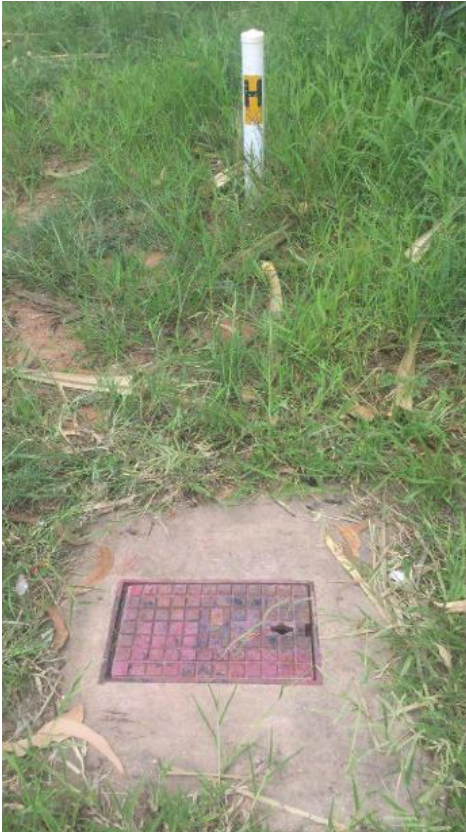
Figure 3 Fire hydrant, condition: *good*

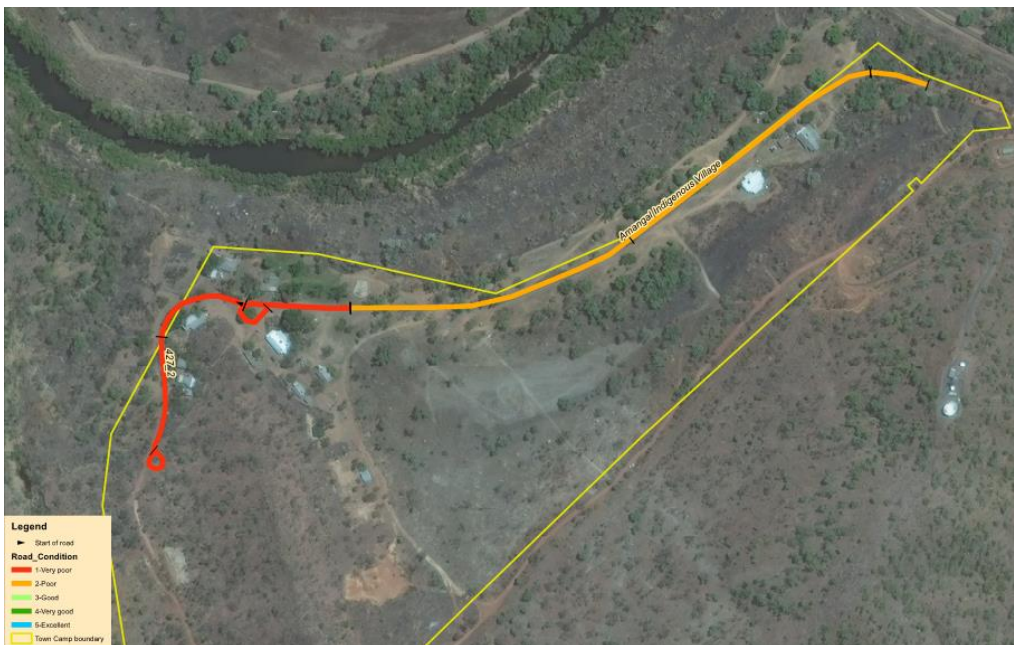
Figure 4 Road network condition assessment

The road network within the Amangal community consists of spray sealed roads. These roads are either in very poor or poor condition, as shown in Figure 4. There are also numerous tracks which appear to be used frequently that are not included in the inspection and report. There was no road furniture, such as signs, carparks, footpaths etc. at Amangal.

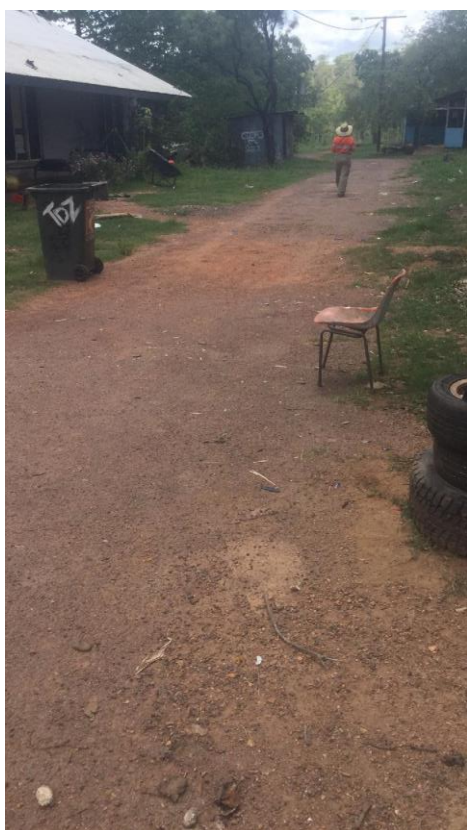
Figure 5 Pavement, condition: *very poor*

Figure 5 and Figure 6 show typical conditions of the internal road network at Amangal. As all roads within the community are at a condition poor or very poor, it is recommended that they are resealed to prevent future failure and to increase road safety within the community.

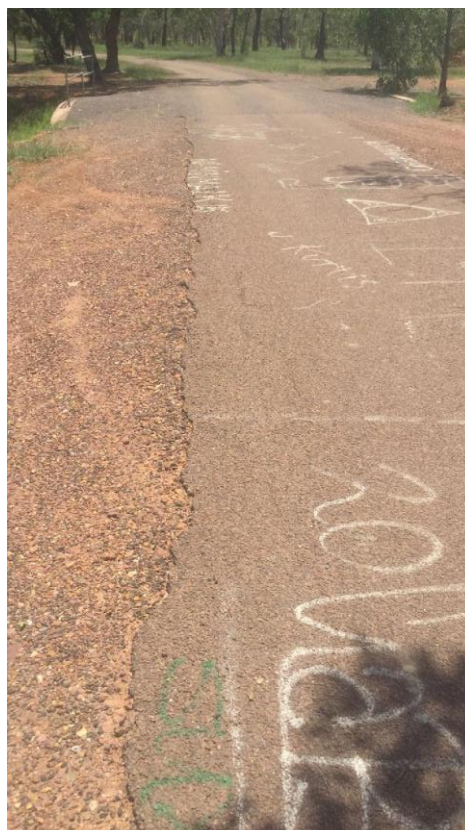
Figure 6 Pavement, condition: *poor*

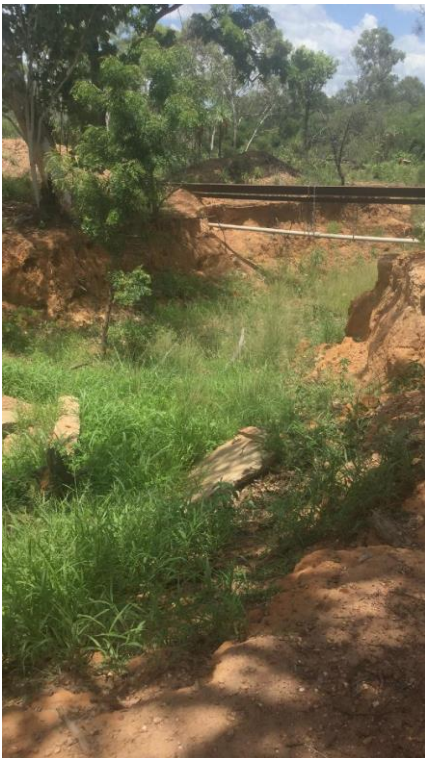
Figure 7 Swale, condition: *very poor*

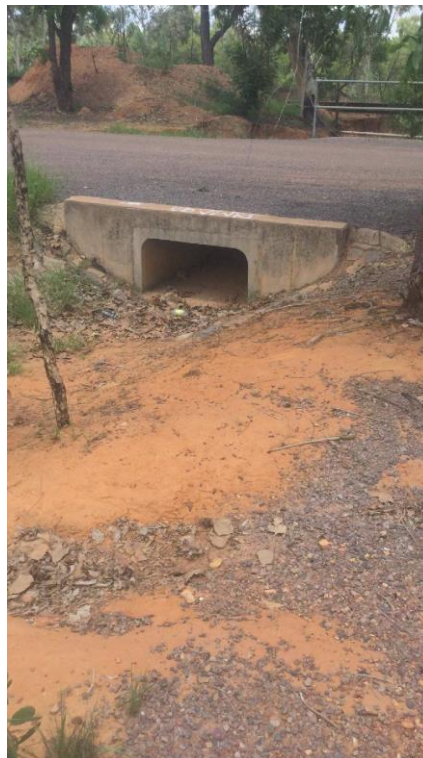
Figure 8 Headwall and culvert, condition: *very good*

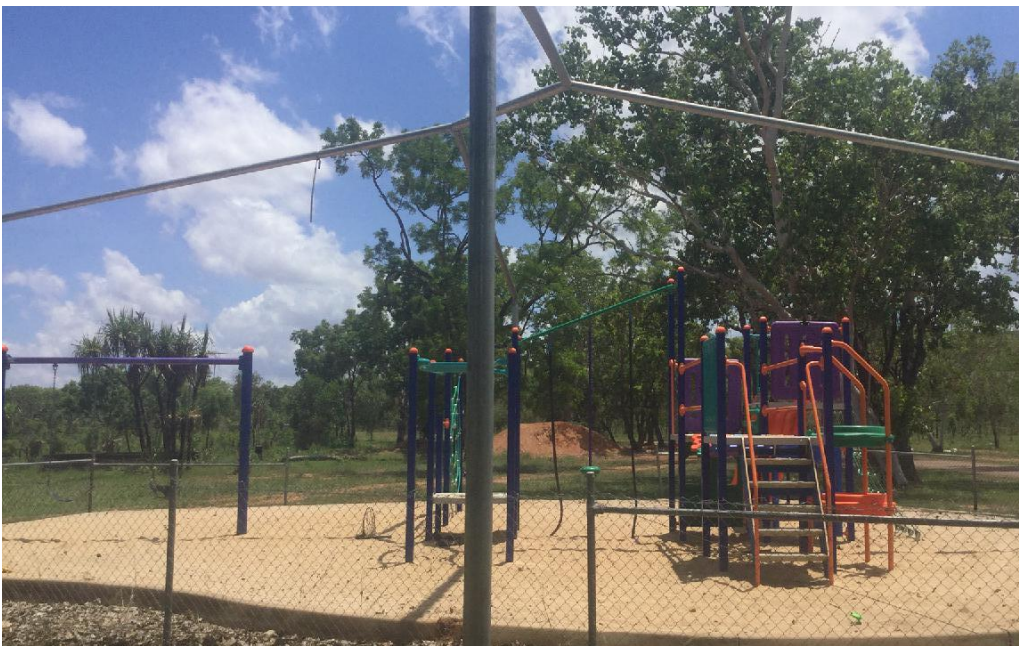
Figure 9 Playground, condition: *very good*

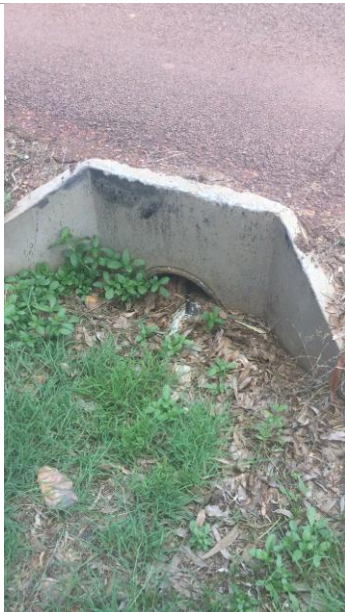
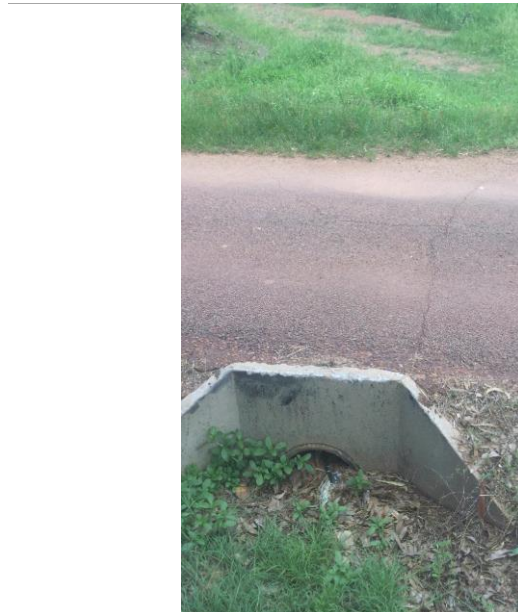
Stormwater Infrastructure:	Culverts
Culvert Type:	RCP
Diameter (mm):	350
Width (mm):	
Culvert Depth (mm):	
Culvert Length (m):	
Culvert Condition:	1 - Very Poor
Culvert Blockage (%):	90
Culvert Comments:	
Culvert Head Wall:	Yes
Safety Grate:	No
Headwall Blockage:	
Headwall Condition:	2 - Poor
Headwall Comment:	50
End Wall:	No
End Wall condition:	
EW Comment:

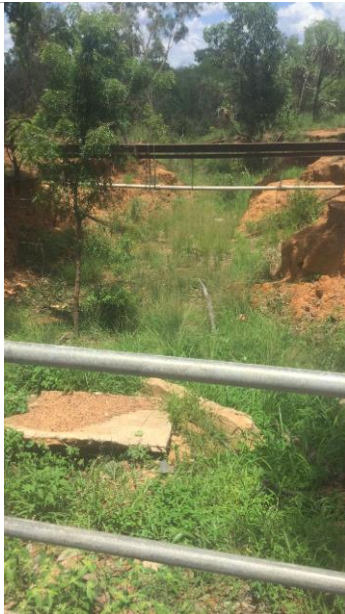
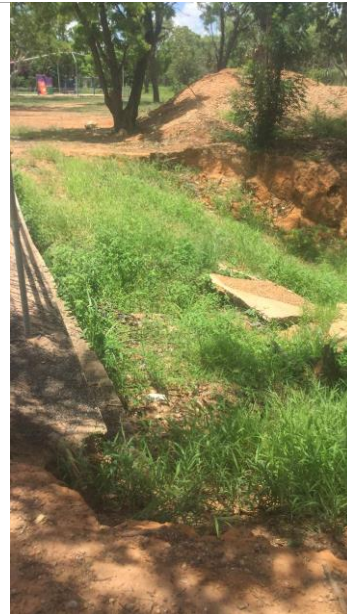
Stormwater Infrastructure:	Swales
Type of lining:	Natural Grasses
Are dimensions uniform along drain:	No
Base Width (m):	
Overall Width (m):	
Swale Depth (m):	2.5
Length of Batter 1 (m):	
Length of Batter 2 (m):	
Swale Condition:	1 - Very Poor
Swale Ponding:	No
Drain flooded at time of inspection:	No
Swale Comments:	Heavy erosion dimensions not indeterminable

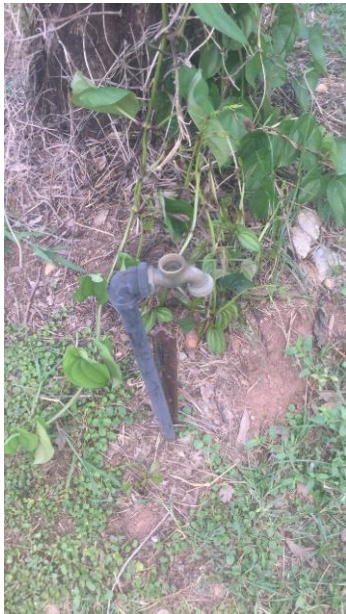
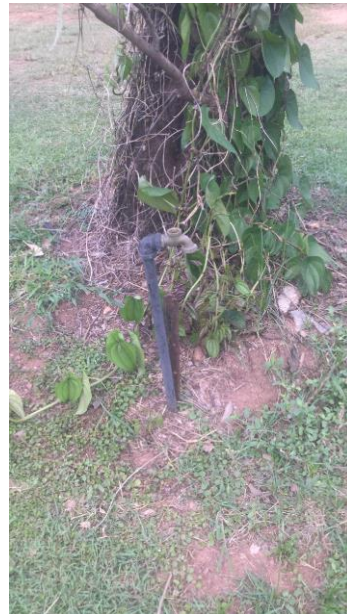
Tap Condition: 1 - Very Poor

Tap Comment: No head, doesn't work

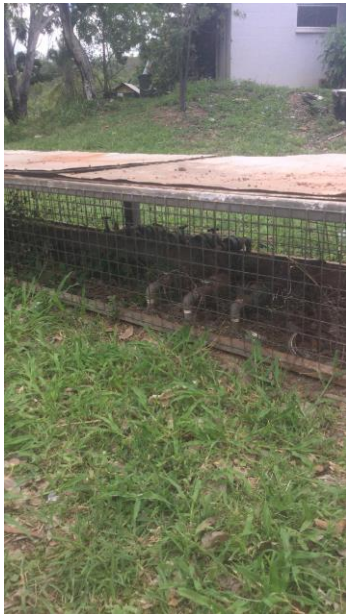
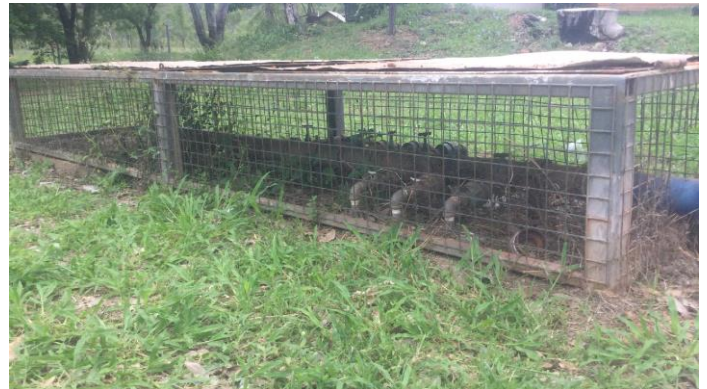
Lot Water Meter Condition: 2 - Poor

Lot Water Meter Comment: 8 connected water meters inside box

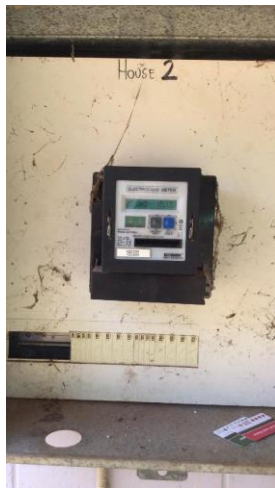
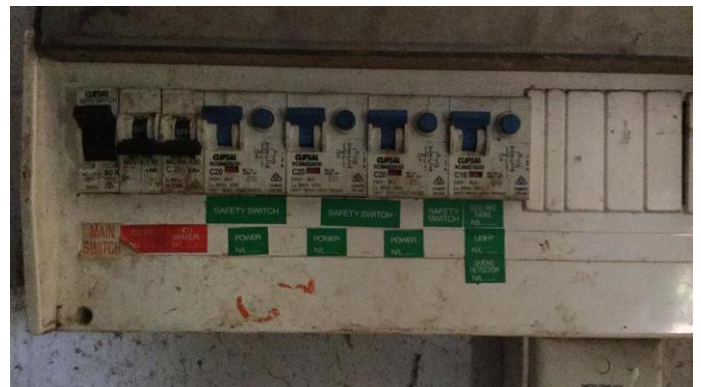
Meter Comment: Blank plates are missing on CB slot. Indoor SB, Cond 3
