# Northern Territory Town Camps

## Civil Infrastructure

Kargaru (East Side Camp)

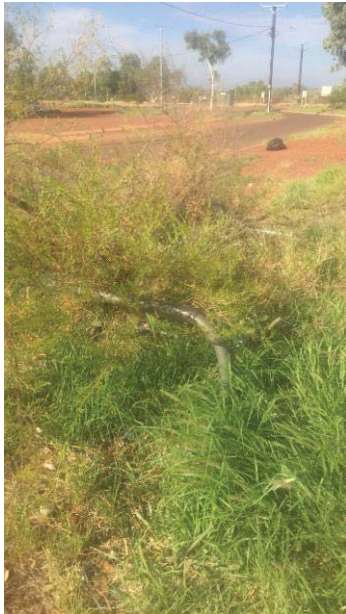
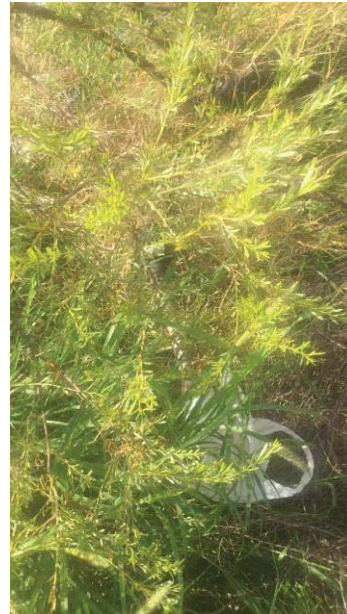
Lot Water Meter Condition: 2 - Poor

Lot Water Meter Comment: Torres and grass covering meter

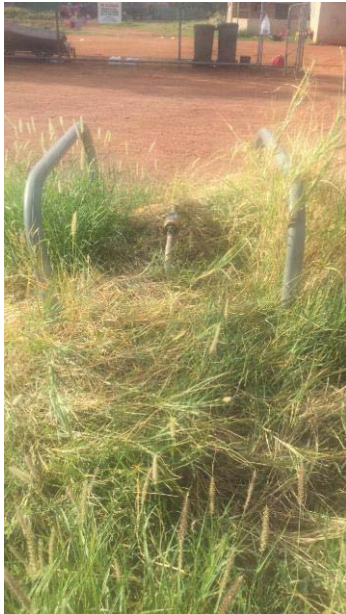
Lot Water Meter Condition: 3 - Good

Lot Water Meter Comment: Grass overgrown around meter

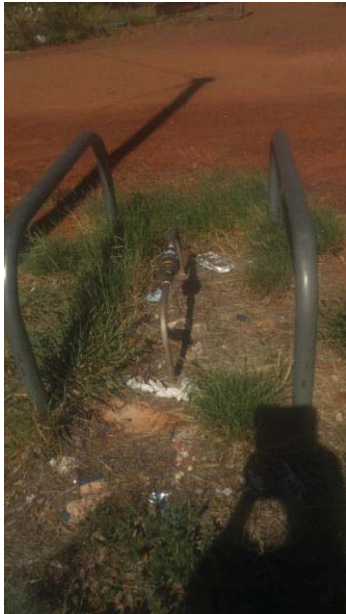
Lot Water Meter Condition: 3 - Good

Lot Water Meter Comment: No handle

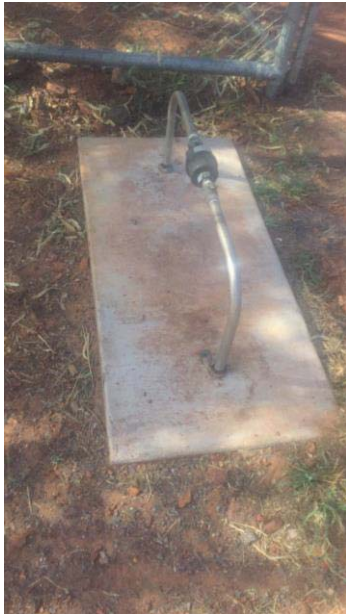
Lot Water Meter Condition: 2 - Poor

Lot Water Meter Comment: No tap handle

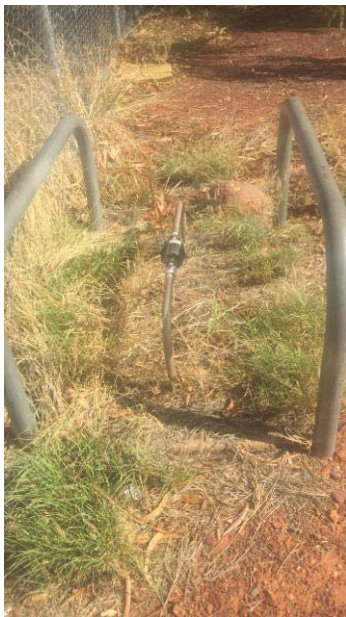
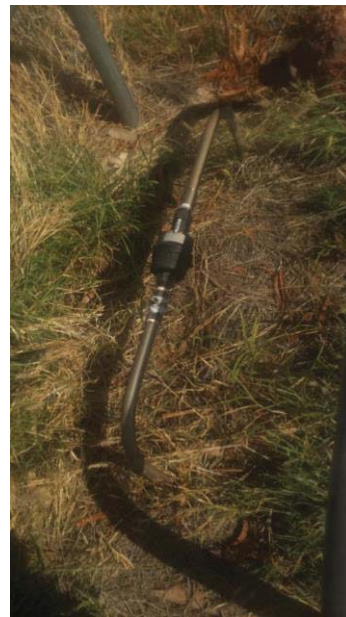
Lot Water Meter Condition: 2 - Poor

Lot Water Meter Comment: Leaking, calcium build up, no handle

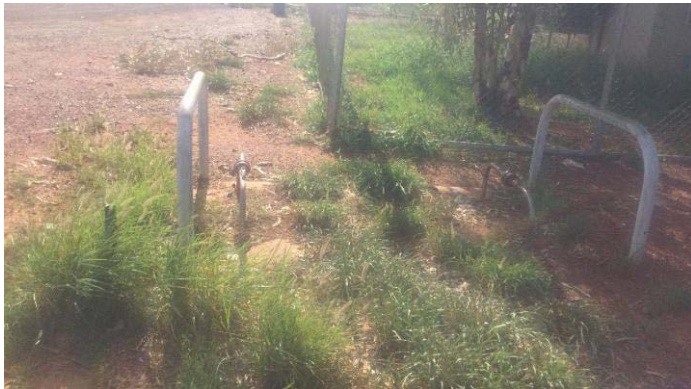
Lot Water Meter Condition: 3 - Good

Lot Water Meter Comment: Two water meters

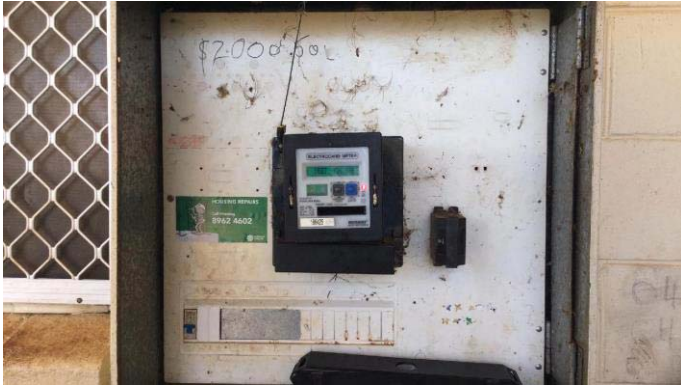
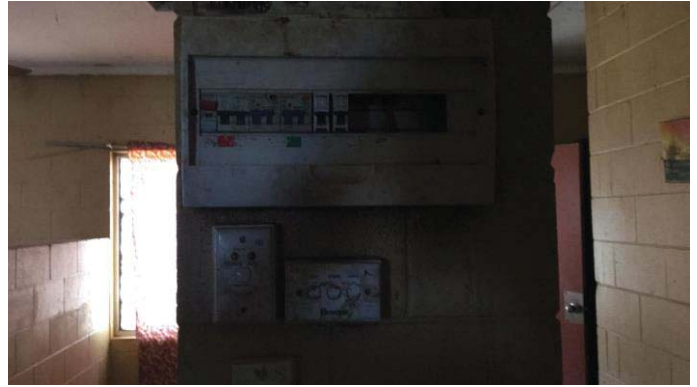
Meter Condition: 3

Meter Comment: Indoor SB, Cond 2, Blank plates are missing on CB slot.

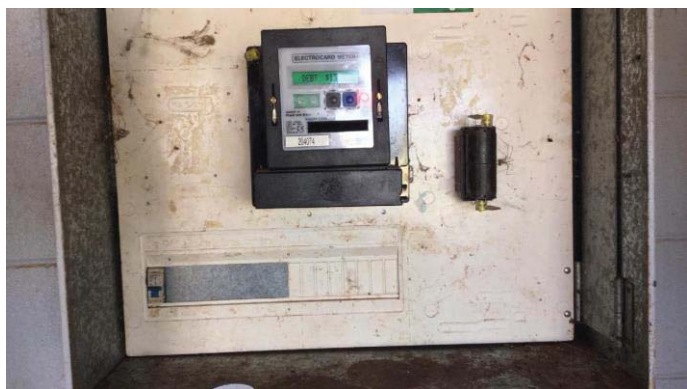
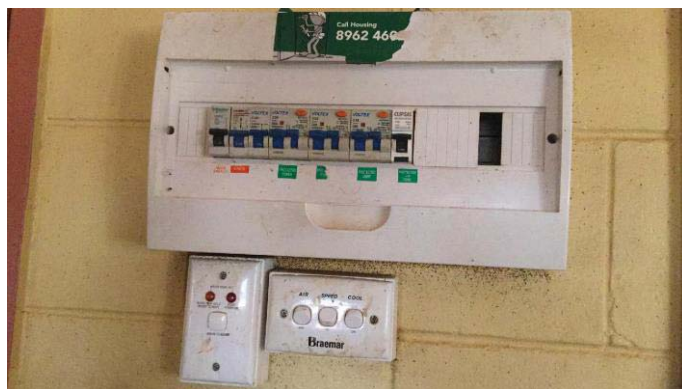
Meter Condition: 3

Meter Comment: Indoor SB, Cond 2, Blank plates are missing on CB slot.

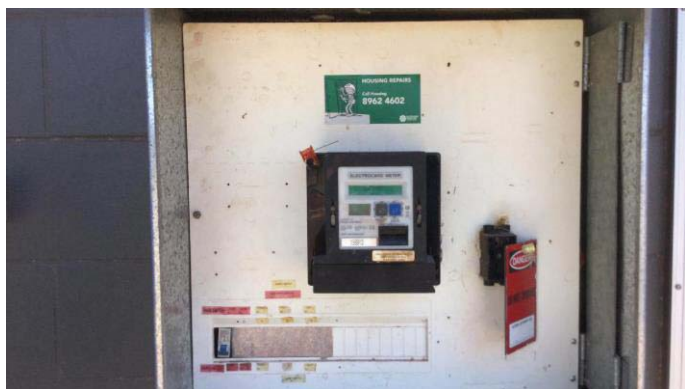
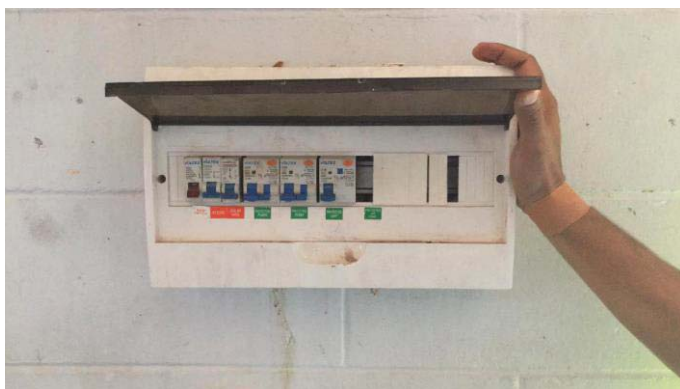
Meter Condition: 3

Meter Comment: Indoor SB, Cond 2, Blank plates are missing on CB slot.

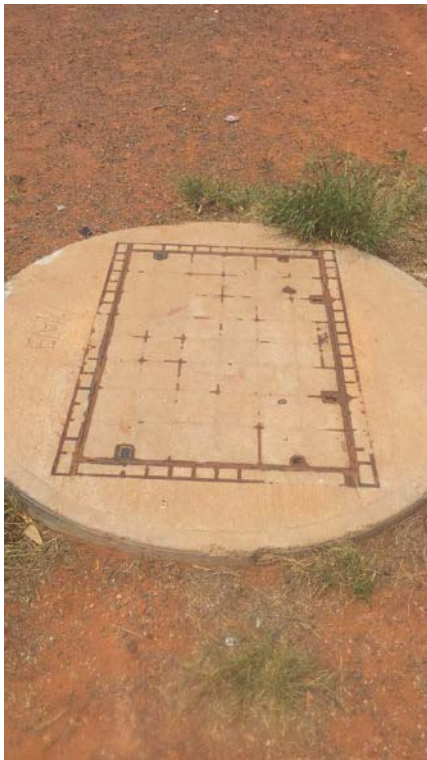
Figure 1 Sewer manhole, condition: *good*

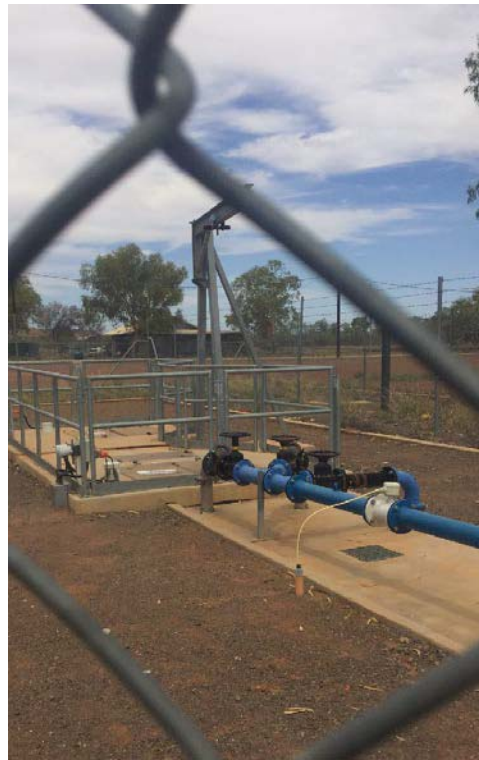
Figure 2 Sewage pump station, condition: *good*

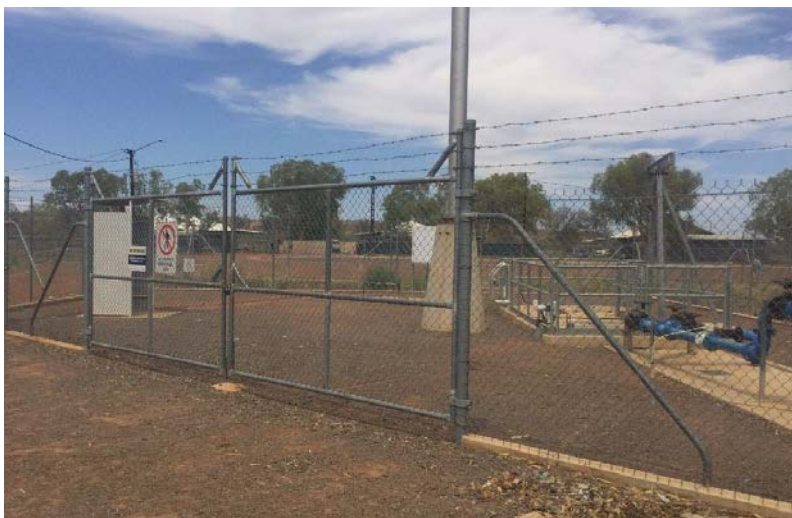
Figure 3 Sewage pump station, condition: *good*

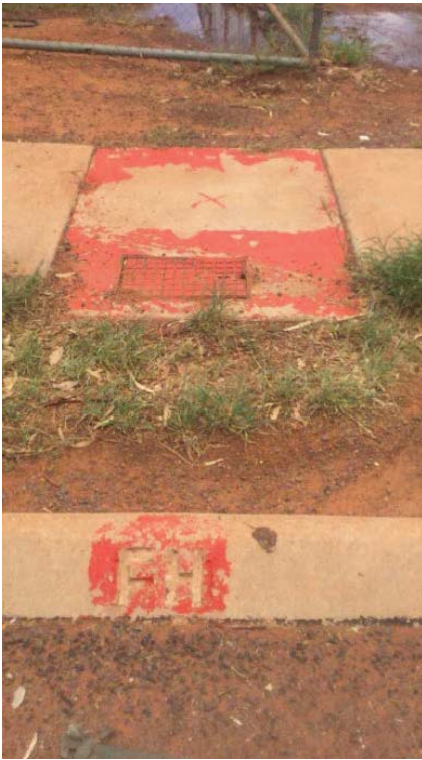
Figure 5 Fire hydrant, condition: *poor*

Two fire hydrants were assessed as being in poor condition. The assessment was due to the faded and peeling paint on the hydrant hindering the visibility. It is recommended that both hydrants are repainted.

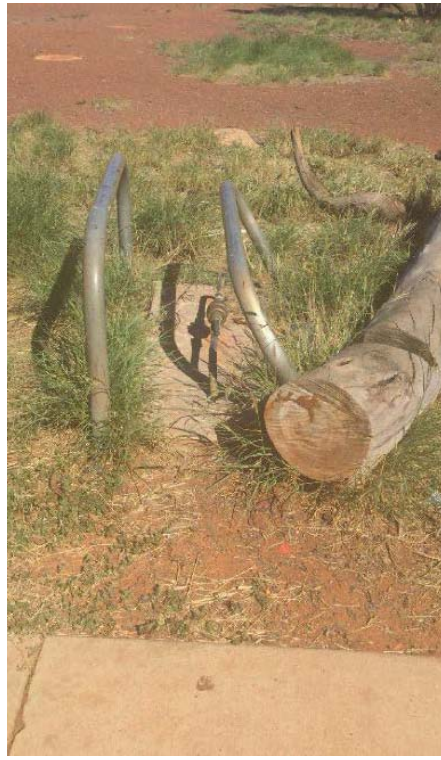
Figure 6 Water meter (residential lot), condition: *poor*

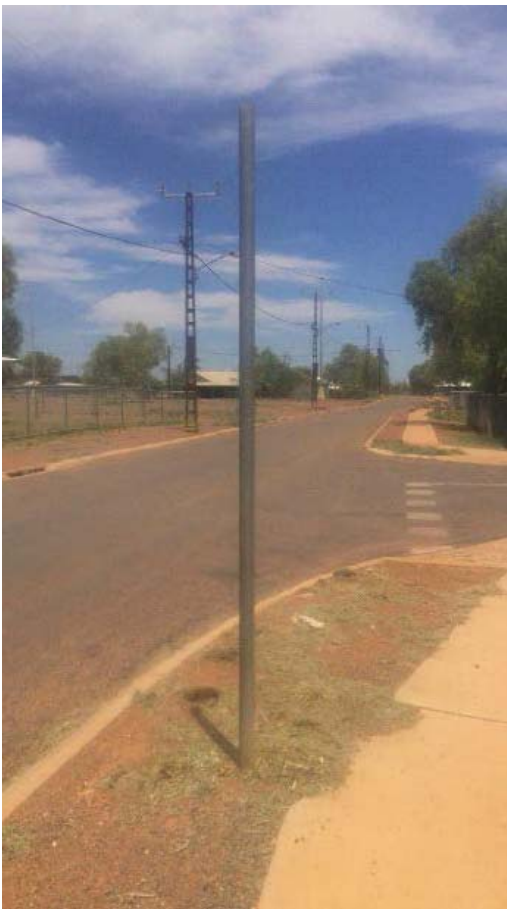
Figure 7 Sign, condition: *very poor*

The majority of the signs in the community were in poor condition, two sign posts were missing the sign altogether. It is recommended that a total of six signs are replace.

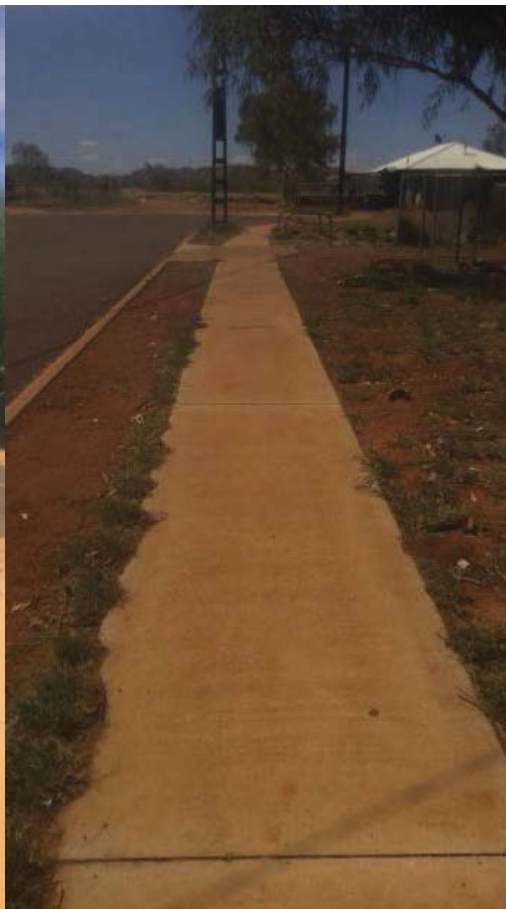
Figure 8 Footpath, condition: *good*

The footpaths within the community were generally in good condition. Some small areas of the footpaths were partially covered by dirt and grass. It is recommended that the footpaths are cleared. This is for aesthetic purposes and is not seen as critical maintenance for the infrastructure.

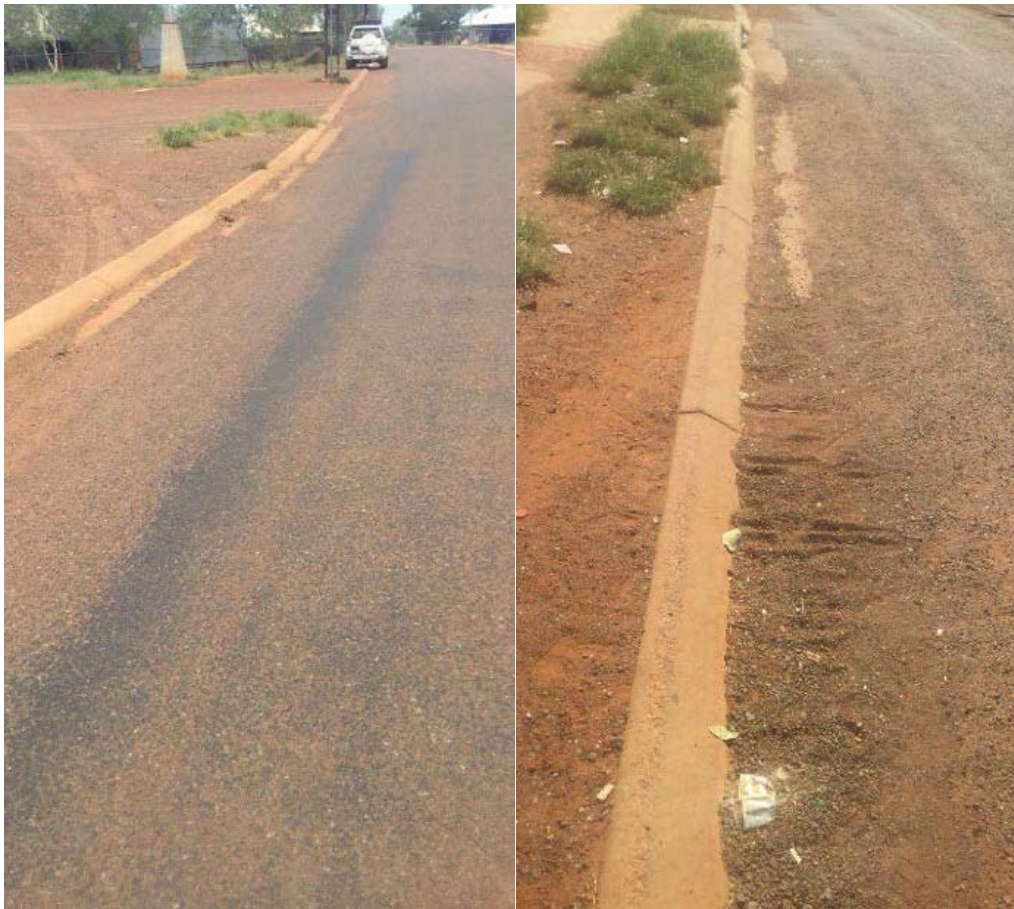
Figure 10 Ngalpa Ngalpa, condition: *good* Figure 11 246\_1, condition: *good*

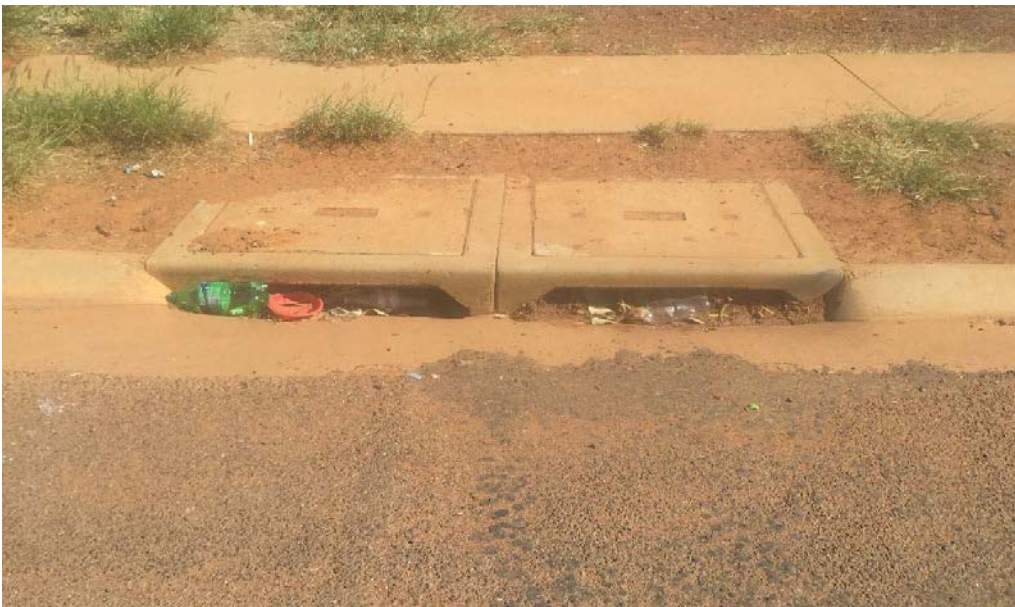
Figure 12 Two bay side entry pit, condition: *good*

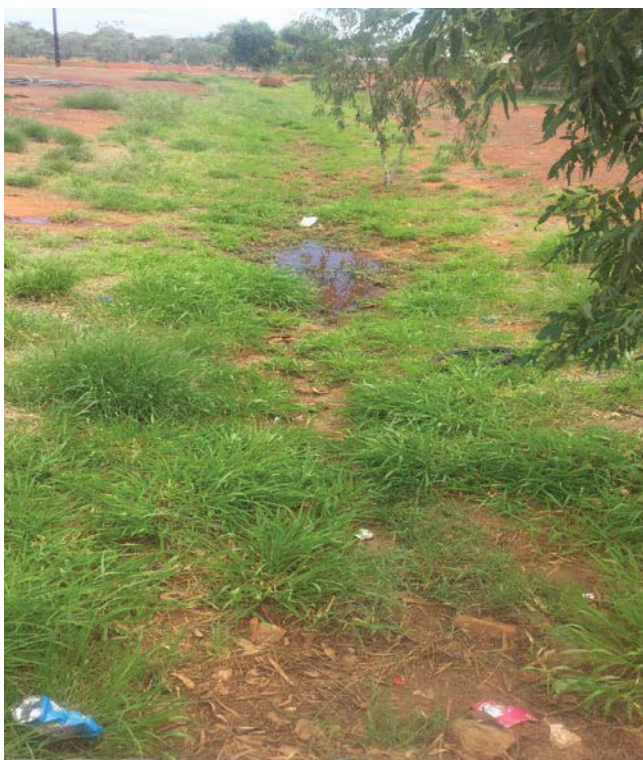
Figure 13 Swale, condition: *good*. Ponding due to hose left on nearby.

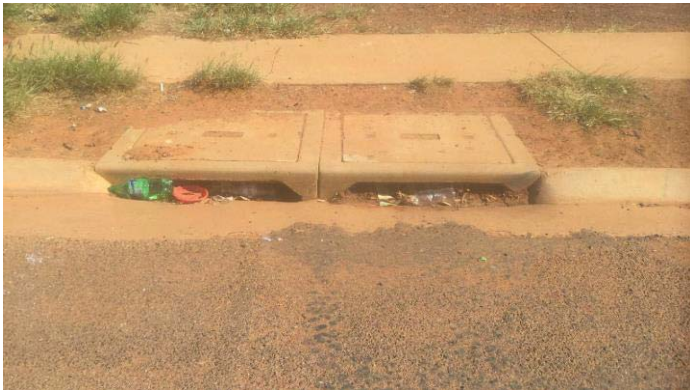
Stormwater Infrastructure: SEP  
Number of Bays: 2  
On grade or sag pit:  
Both sides of road: Right  
Condition: 3 - Good  
Blockage (%): 80  
Comment:

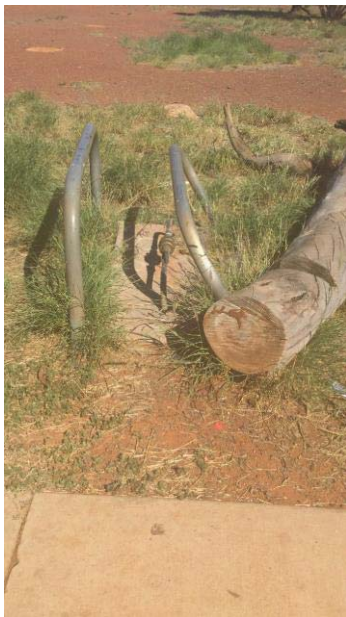
Lot Water Meter Condition: 2 - Poor

Lot Water Meter Comment: Bollard is bent, water meter ok

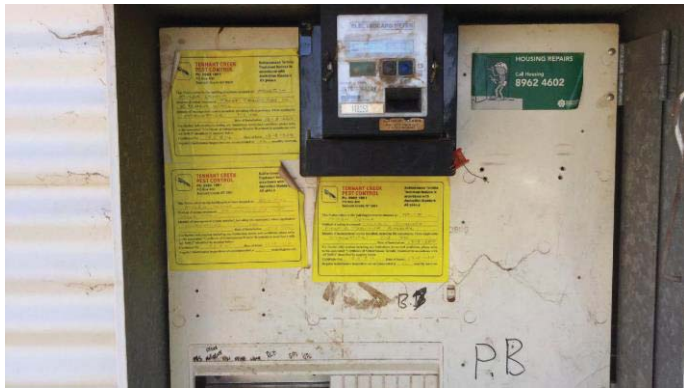
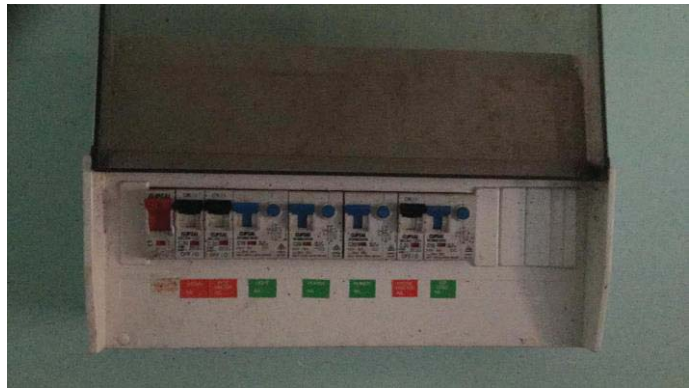
Meter Comment: Blank plates are missing on CB slot. Indoor SB, Cond 3

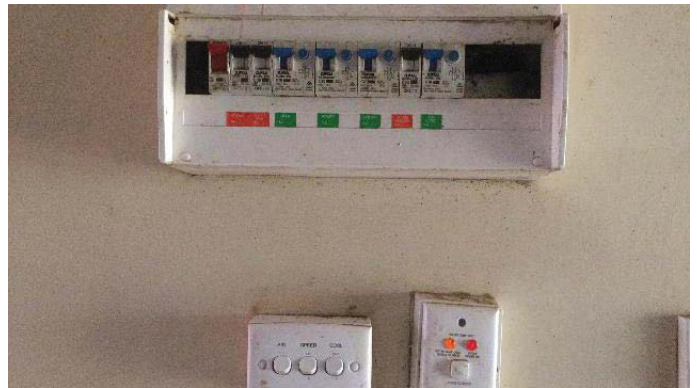
Meter Comment: Condition of CB not assessed. Indoor SB, Cond 2, Blank plates are missing on CB slot.
