# COMPLETION REPORT NGAT 003

YILLI RREUNG HOUSING ABORIGINAL CORPORATION ICN: 4241 | ABN: 48 983 249 337

# Summary

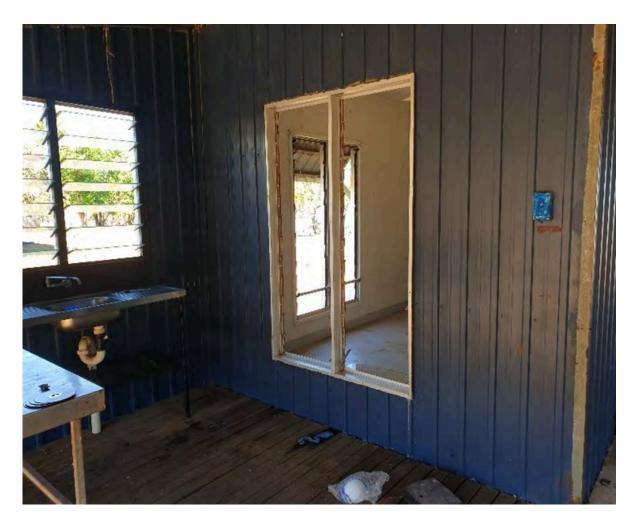
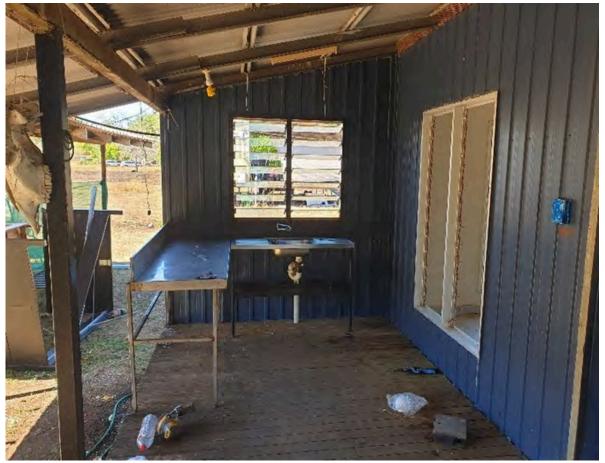
## **Kitchen Before**

The old kitchen area before the installation of the new kitchen and kitchen wall

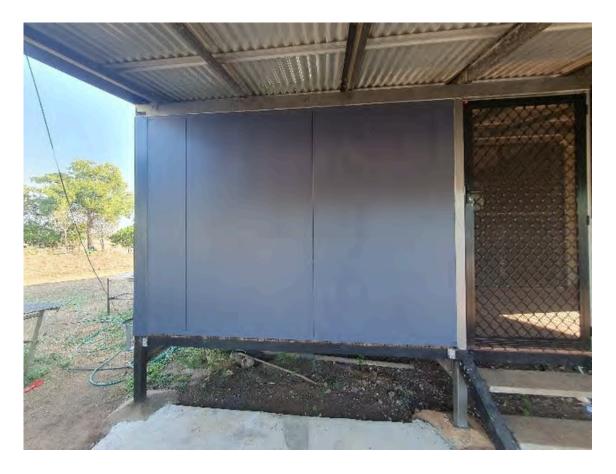
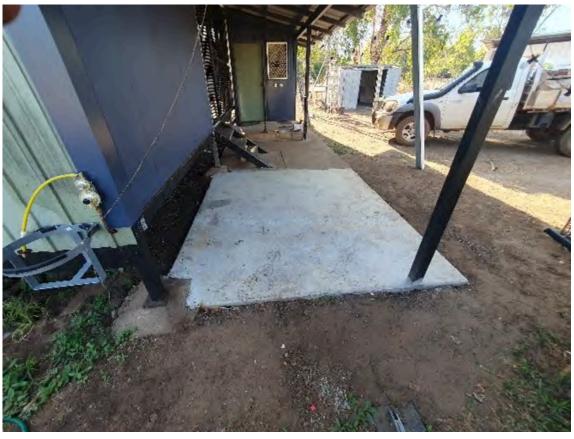
New wall panel for the kitchen and concrete slab installed with the roof line at the rear now level with the rest of the house

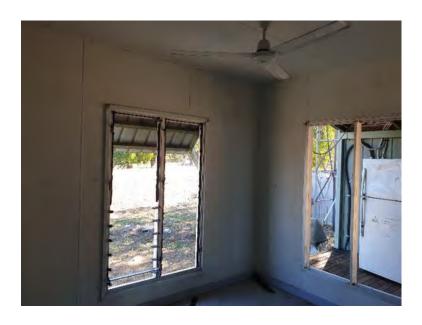
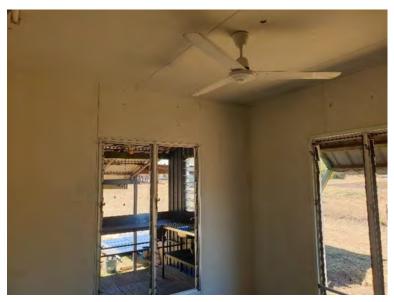
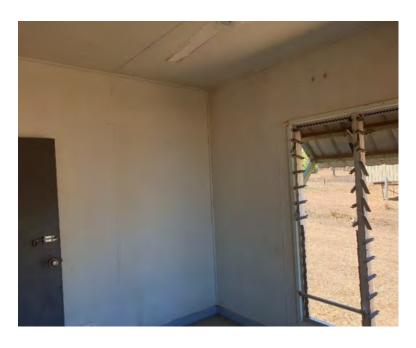
### **Bedrooms Before**

The old bedrooms before repainting, tiles and new electrical fittings that were dull and uninviting

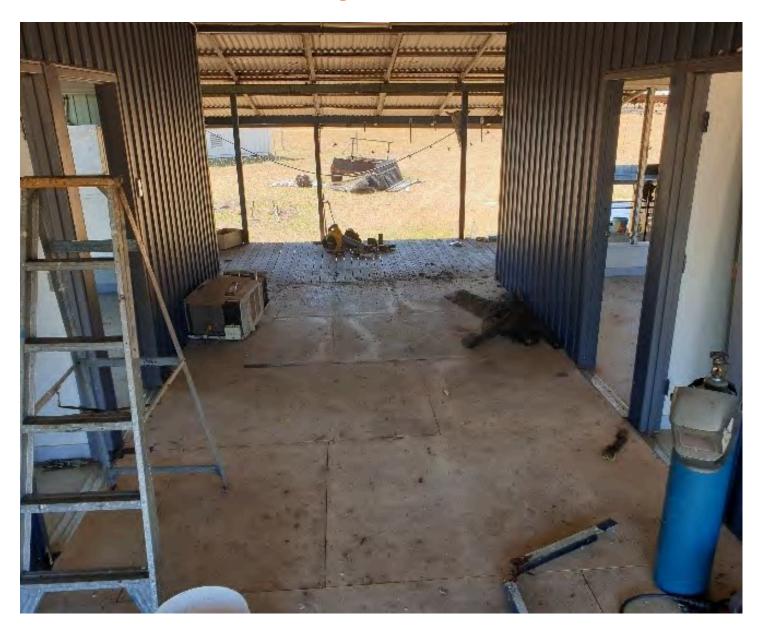
# **Living Area Before**

You can also see in the above picture the living area flooring and before the rear screens and doors are fitted

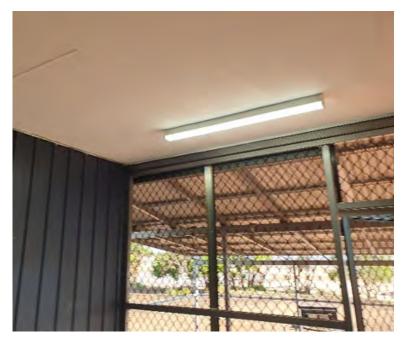
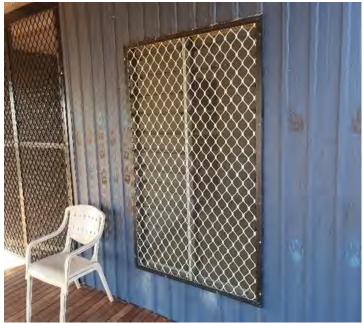
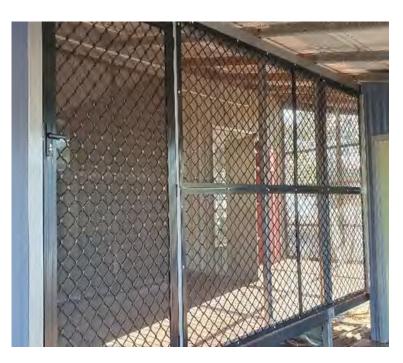
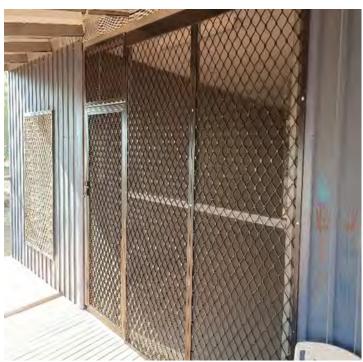
### New living area with screens

All steel is painted in rust conversion and rust preventative paint to prevent further corrosion and the deck was constructed out of termite treated LVL timber. The new screen door gives a new security level to the house with a new wall panel for the kitchen

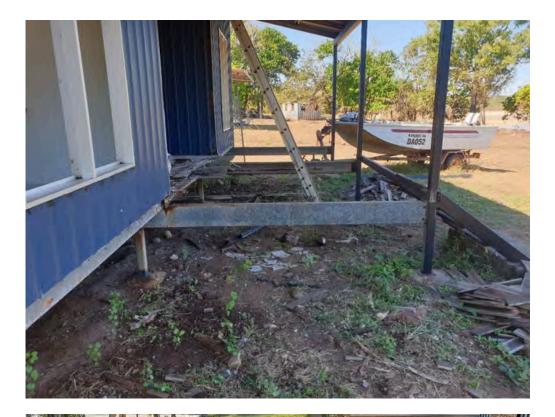
**Before**

The below picture shows the old deck removed and the empty space before the new deck installation. The removal and replacement of the existing window louvre channels was necessary because of rust and proximity to the ocean

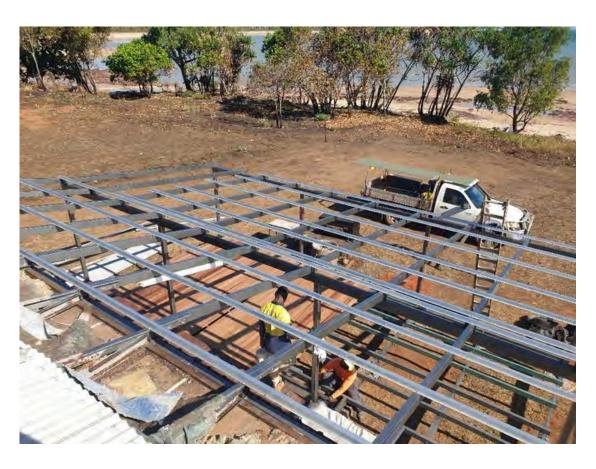
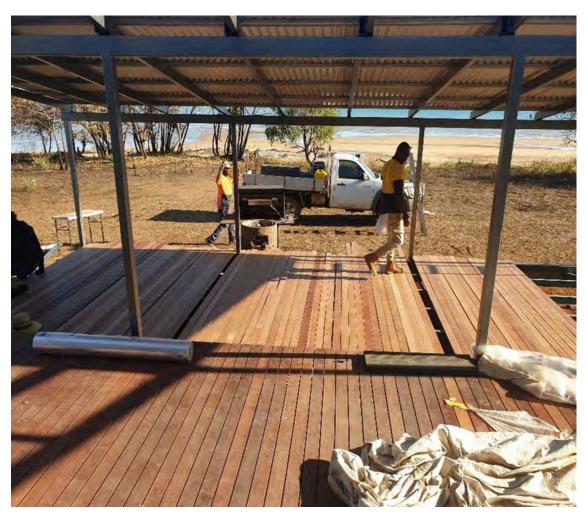
Deck & Verandah Before

New deck and verandah extension under construction

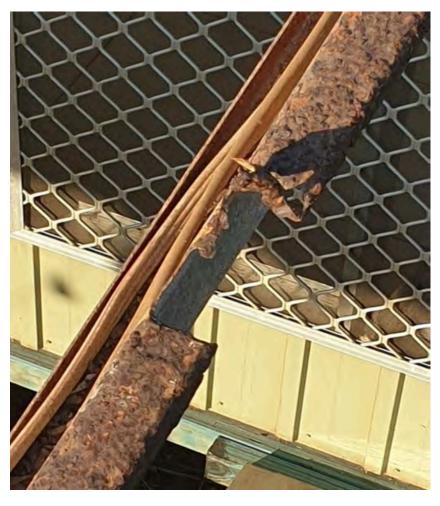
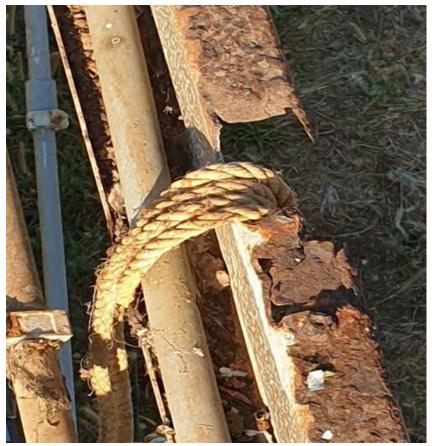
#### **Roof Before**

As you can see in these pictures the extent of the corrosion in the roof rafters. These were replaced and a new roof structure erected

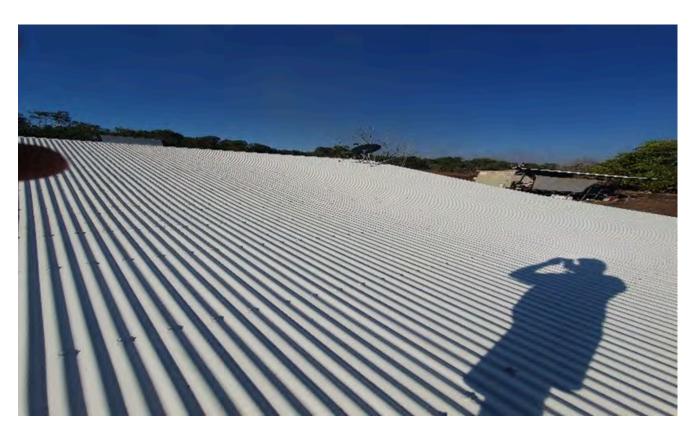
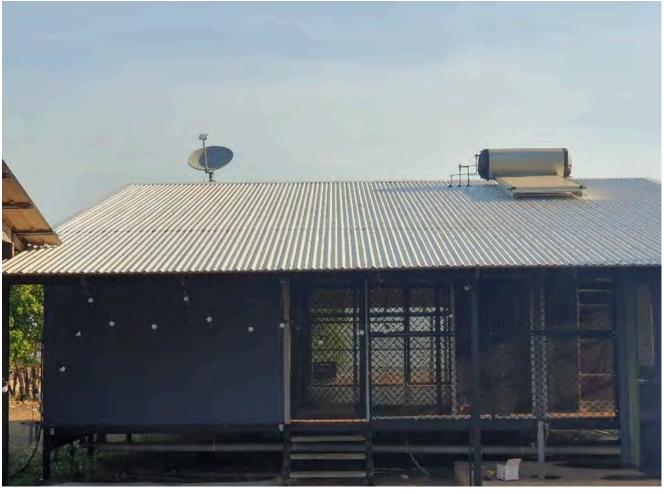
Roof After
The roof was replaced with new colorbond sheets

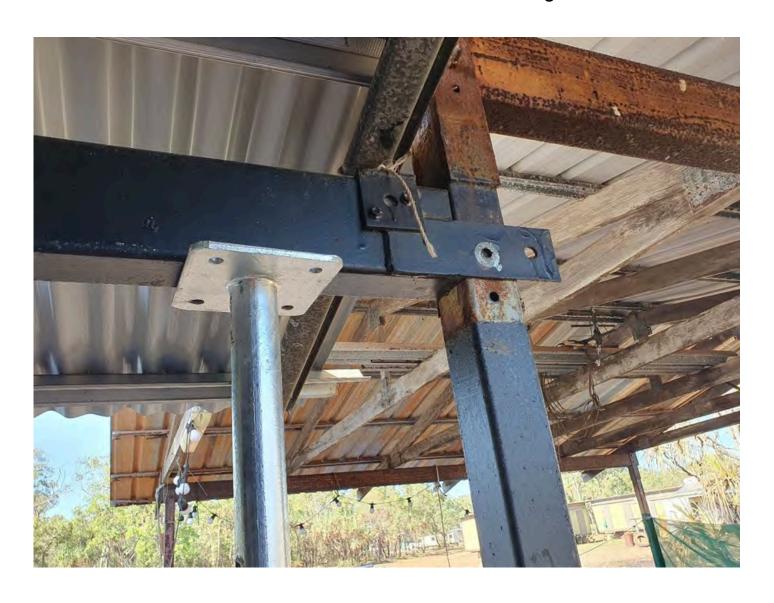
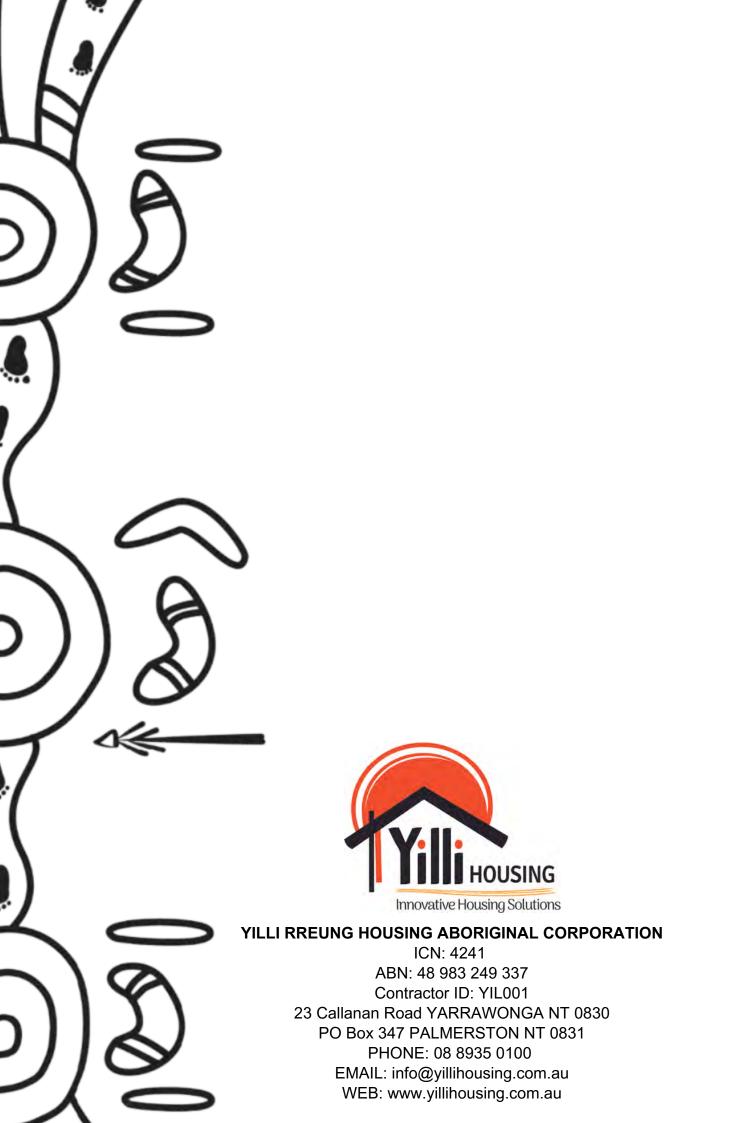
# Rear verandah roof raised for better alignment
