# Appendix B

## Municipal and essential infrastructure

# Elliott North & South Camp

# Elliott North Camp

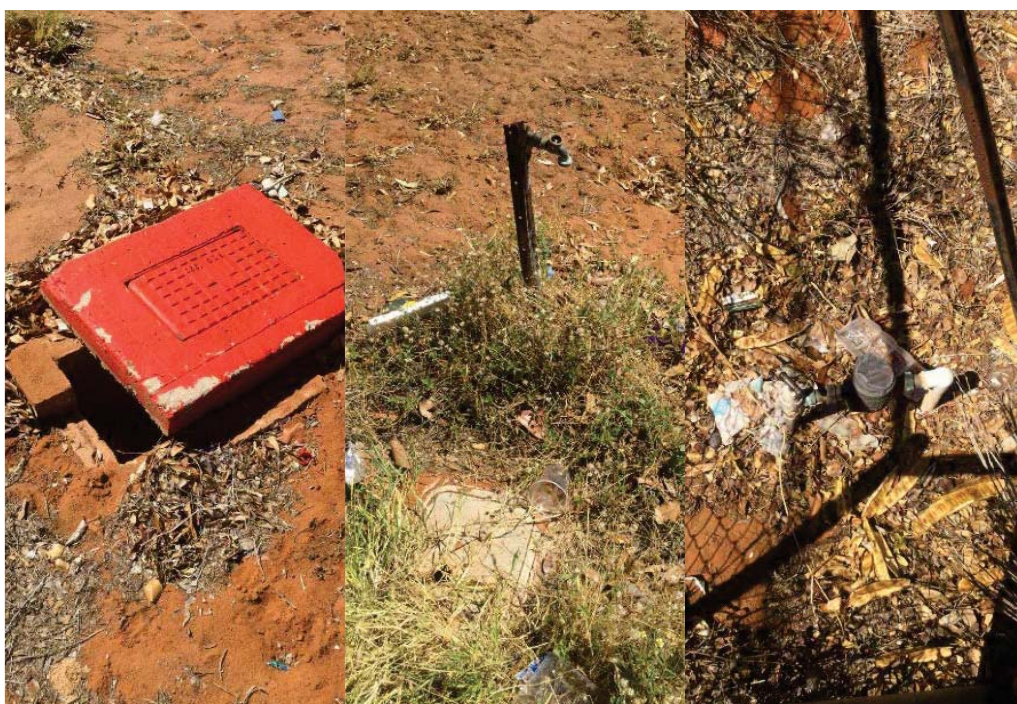
Figure 2 Fire hydrant, condition: *very poor*

Figure 3 Tap, condition: *very poor*

Figure 4 Water tank, condition: *poor*

A fire hydrant and a tap were assessed as being in very poor condition and both should be replaced. Minor repairs are also needed on another tap which has a bent pipe and may require a replacement handle. Further maintenance is required on a single lot water meter to clear calcium build up.

- Restore fire hydrant pit
- Replace one tap
- Repair one tap
- Remove calcium build up from one residential lot water meter

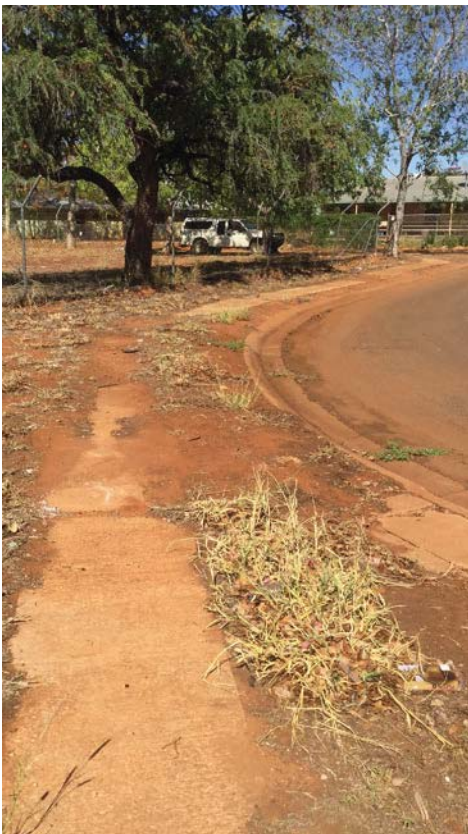
Figure 5 Footpath, condition: *poor*

The footpaths within Elliott North were generally in poor to very poor condition. The footpaths were overgrown with weeds and grass, covered in dirt or debris, and some sections were non-existent. It is recommended that the footpath is repaired for the entire community. This may include sections of rebuilding the footpath, or just a general tidy up.

- Seal cracks on all roads – 550 m<sup>2</sup> has been allowed for in the cost estimates.
- Clean out gutters – 50 m has been allowed for in the cost estimates.
- Repair and rebuild footpath – approximately 1500 m
- Replace three signs (Keep Left, 20 km/hr, Jingulu St Jibarda St road name sign)

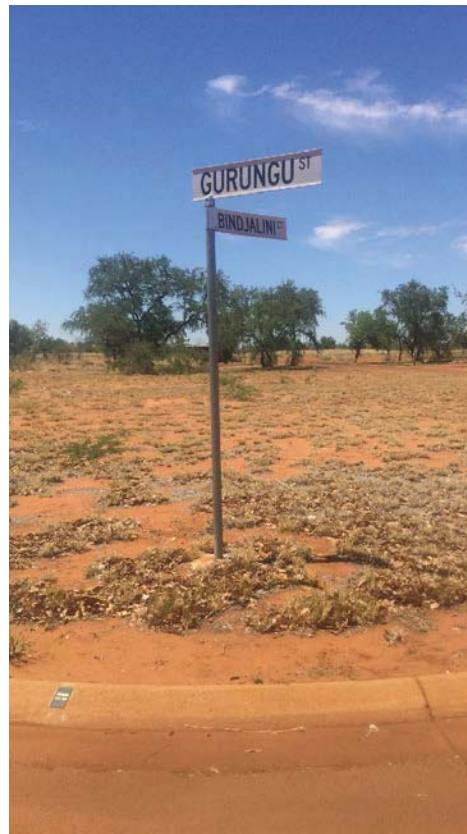
Figure 6 Signs, condition: *very good*

The signs in the community were generally in very good condition, with the exception of three signs that were in poor condition. It is recommended that the three signs are replaced.

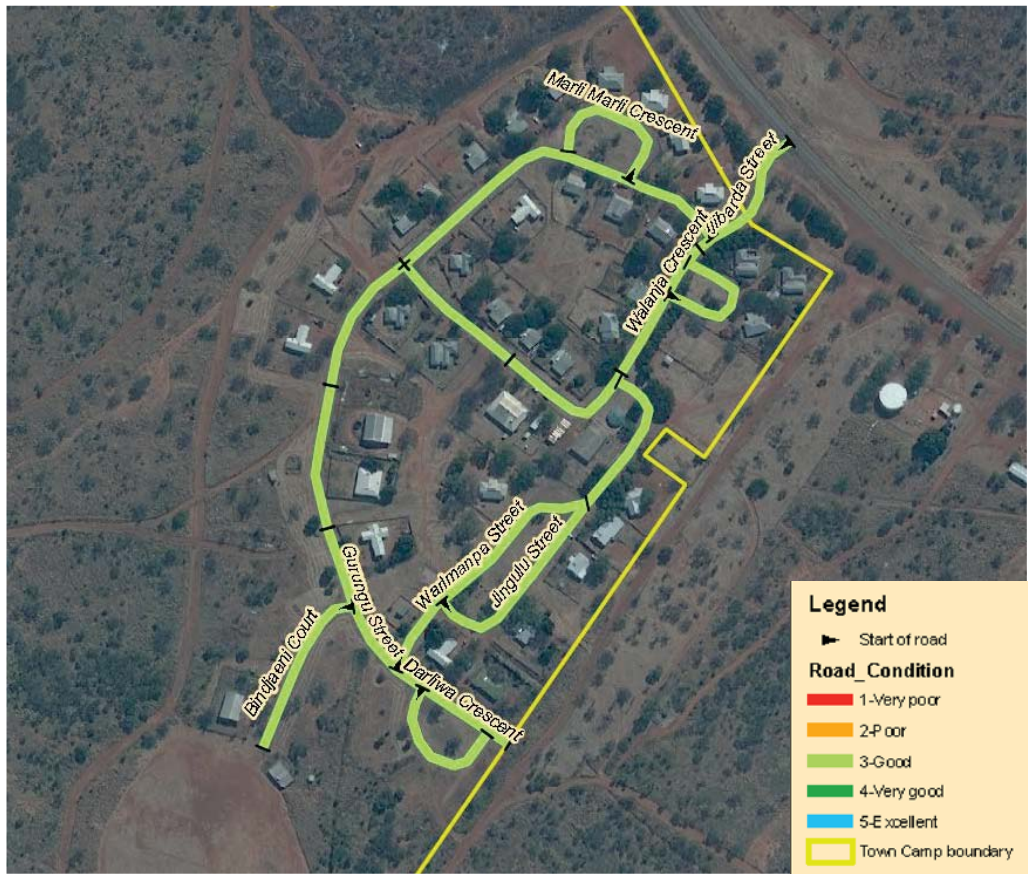
Figure 7 Community road network

Table 5 below details the condition of the roads within Elliott North Camp for specific segments. Figure 7 shows a map of the road network with the condition ratings, road name, and chainage direction. Note, the percentage refers to the percentage of that particular road segment which experiences the defect.

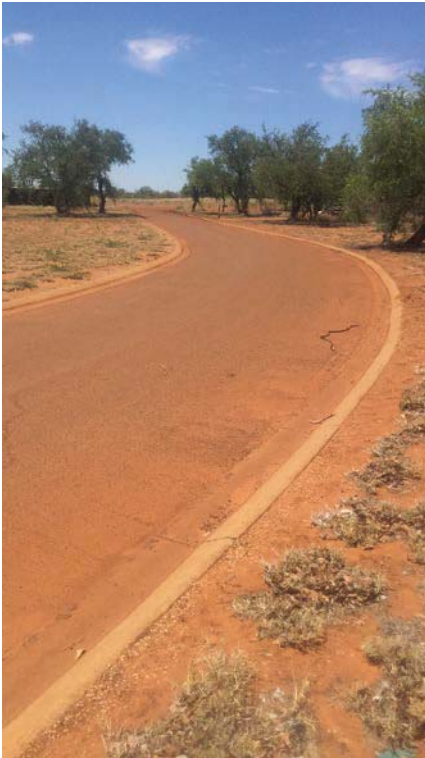
Figure 8 Bindjaeni Court, condition: *good*

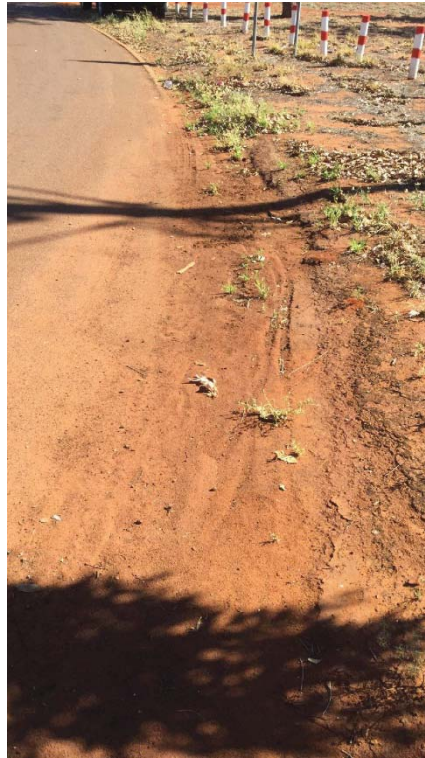
Figure 9 Ijibarda Street, gutters filled with dirt, condition: *poor*

The roads in Elliott North Camp were all generally in good condition. The most common defect was that the pavement had surface cracks and the gutters were filled with dirt in some areas.

It is recommended that the cracks are sealed to prevent further damage to the pavement. It is also recommended that the gutters are cleaned out to improve the stormwater drainage and to prevent blockages in the stormwater drainage pipes.

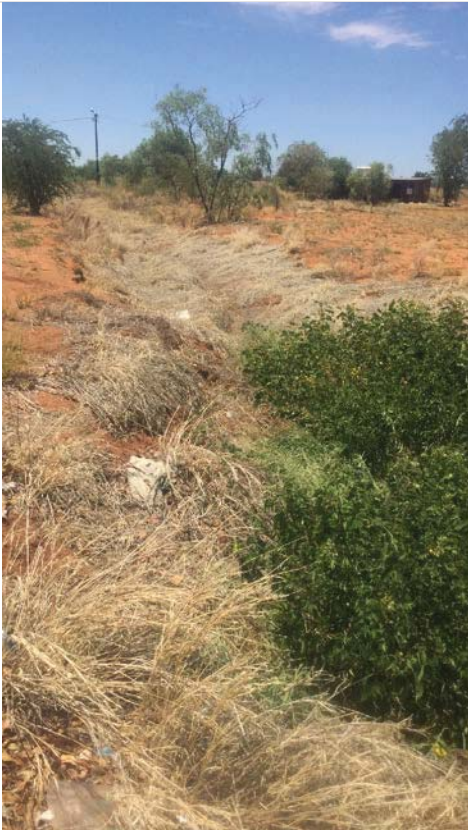
Figure 10 Swale, condition: *poor*

The swale as rated in poor condition due to having trees and debris in the swale. It is recommended that the trees are removed to improve the hydraulic efficiency.

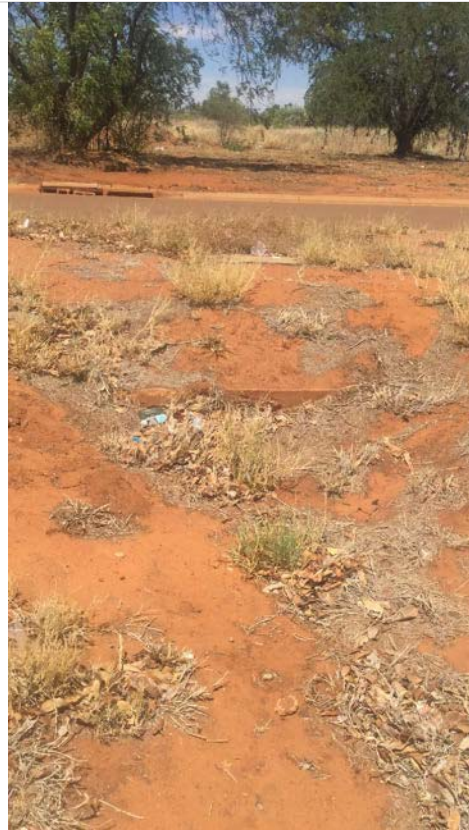
Figure 11 Culvert headwall, condition: *very poor*

The culverts were rated in poor and very poor condition. Three culverts were blocked up to 50%, 90% and 100% respectively. It is recommended that the culverts, and swales upstream and downstream of the culverts are cleared out.

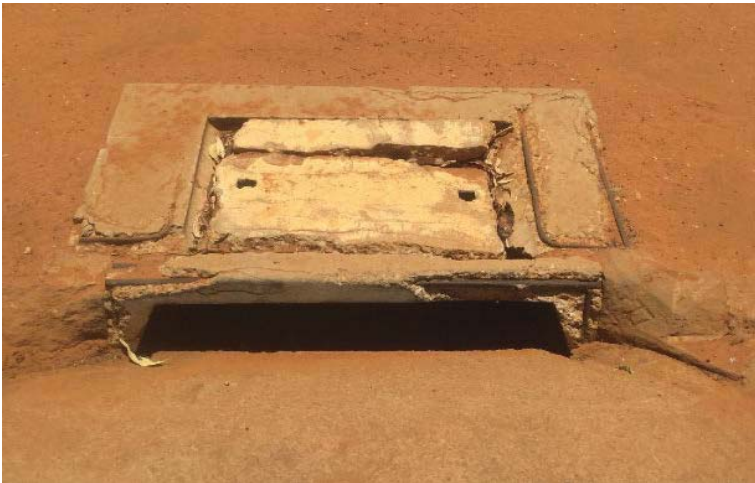
Figure 12 One bay side entry pit, condition: *poor*

Approximately 70% of the side entry pits investigated were found to be in poor condition. Although generally the hydraulic capacity was not affected, the side entry pits were damaged and appear to be quite old. It is recommended that the lid and surrounding concrete of all side entry pits assessed as poor are replaced.

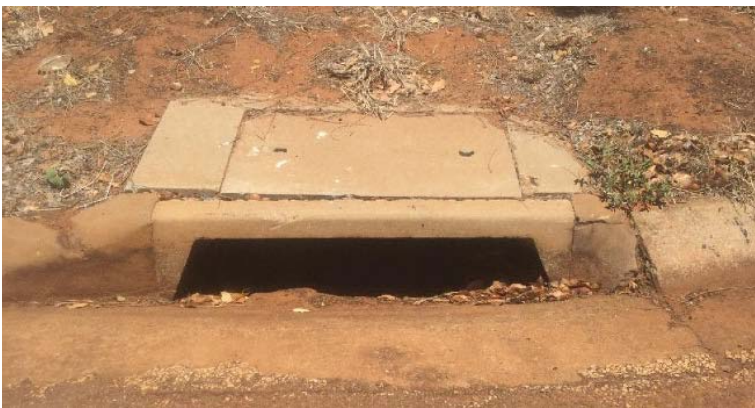
Figure 13 One bay side entry pit, condition: *good*

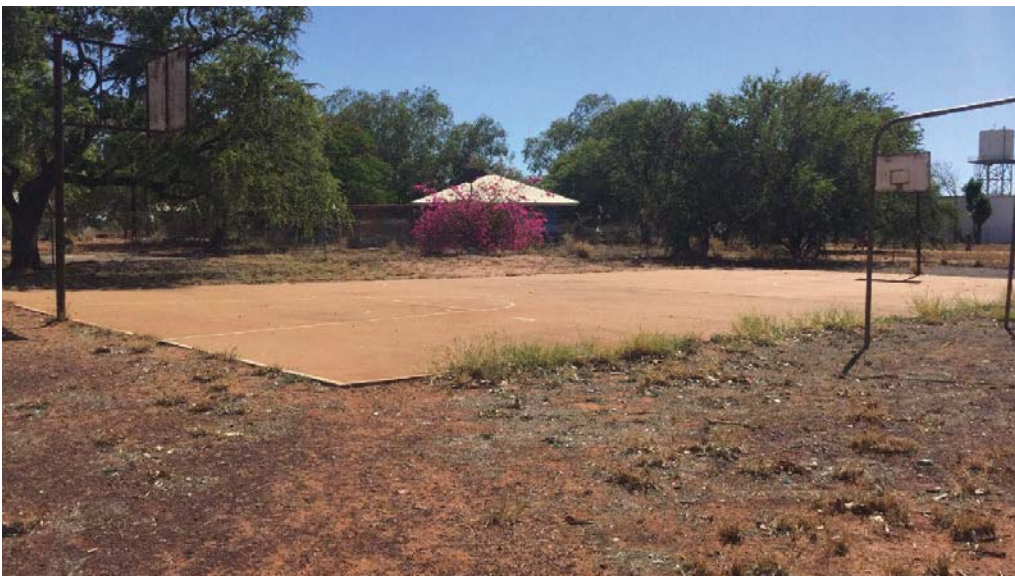
Figure 14 Basketball court, condition: *poor*

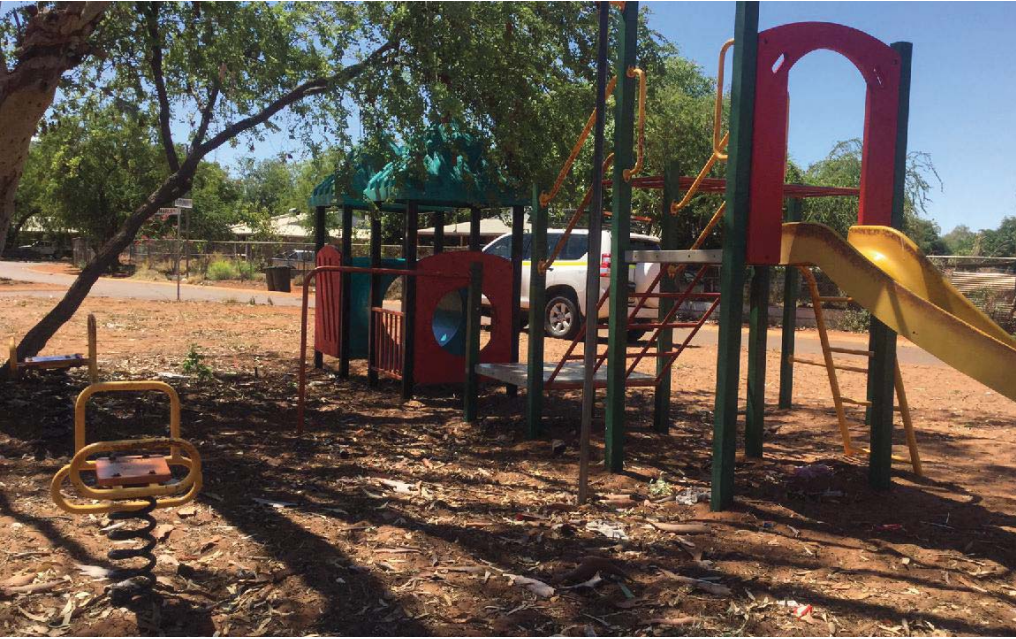
Figure 15 Playground 1, condition: *good*

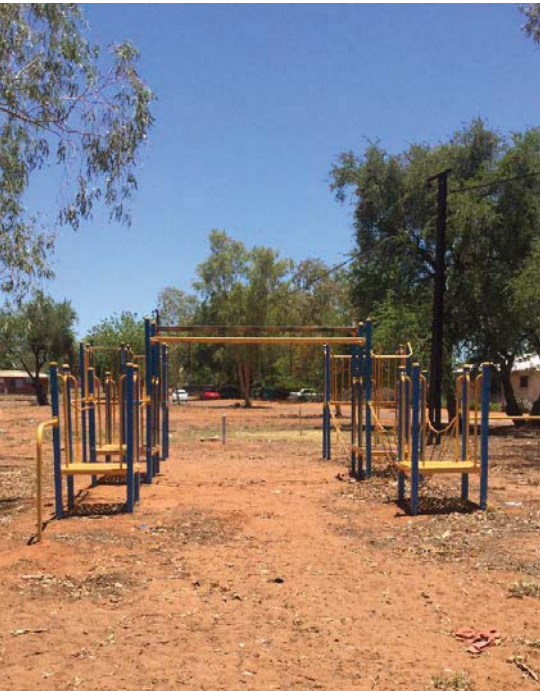
Figure 16 Playground 2, condition: *good*

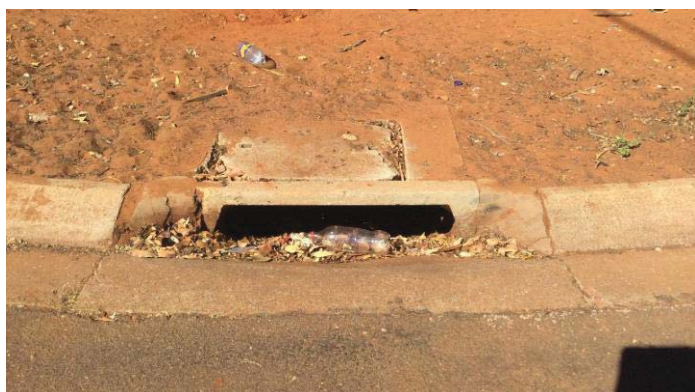
Stormwater Infrastructure:	SEP
Number of Bays:	1
On grade or sag pit:	
Both sides of road:	Left
Condition:	2 - Poor
Blockage (%):	10
Comment:	Leaves inside pit too, can't tell % blocked. Broken lid

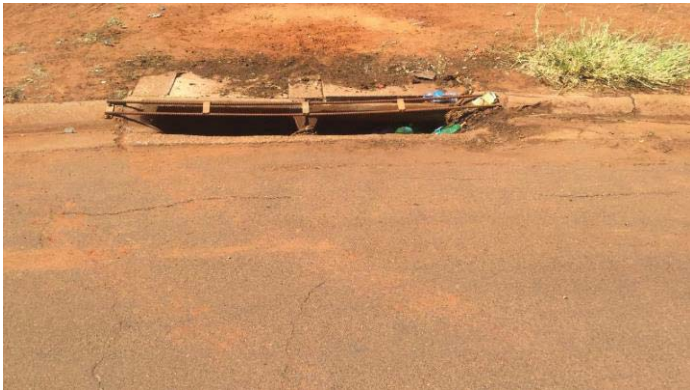
Stormwater Infrastructure:	SEP
Number of Bays:	2
On grade or sag pit:	Sag
Both sides of road:	Left
Condition:	2 - Poor
Blockage (%):	50
Comment:	Blocked inside. Anecdotal reports of flooding

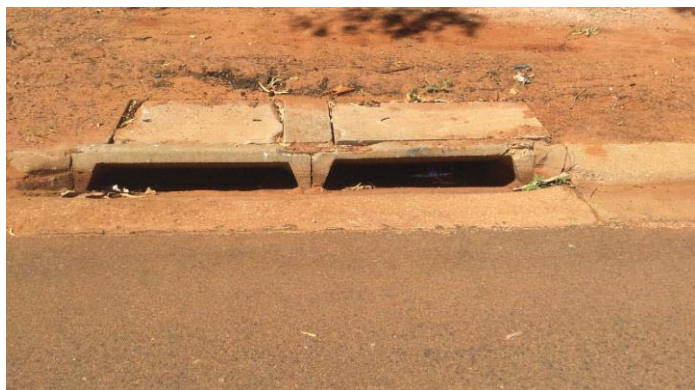
Stormwater Infrastructure:	SEP
Number of Bays:	2
On grade or sag pit:	
Both sides of road:	Left
Condition:	2 - Poor
Blockage (%):	50
Comment:	Blockage inside , concrete damaged

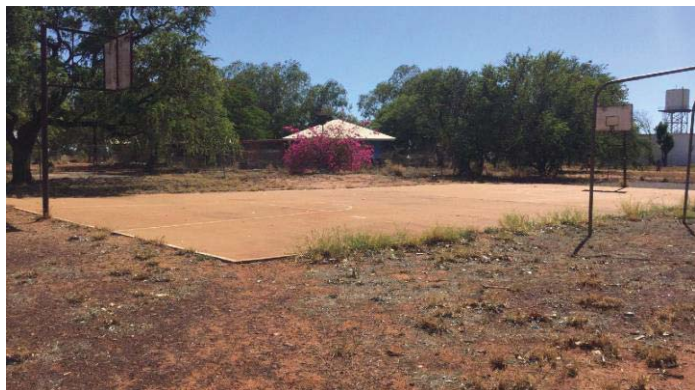
Inspection Type:	Shade Structure
Shade Structure Type:	Basket Ball Court
Shade Floor Type:	Concrete
Roof Type:	Not Covered
Width (mm):	
Length (mm):	
Appearance:	1
Appearance Comment:	Glass on court, no basketball hoops, no shade
Condition:	2 - Poor
Comment:

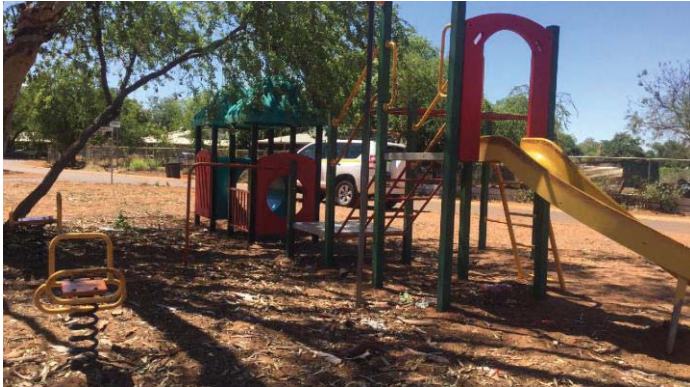
Inspection Type:	Shade Structure
Shade Structure Type:	Play ground
Shade Floor Type:	Sand
Roof Type:	Not Covered
Width (mm):	
Length (mm):	
Appearance:	3
Appearance Comment:	Some rust and paint peeling
Condition:	3 - Good
Comment:

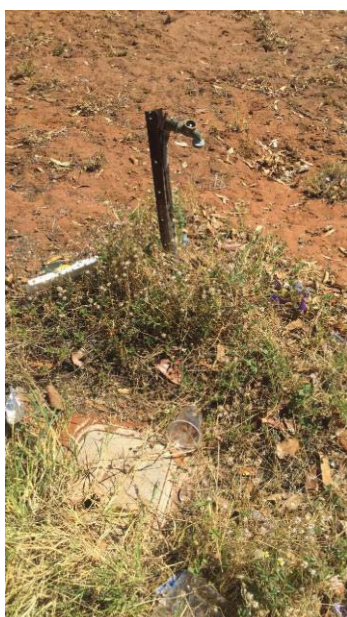
Tap Comment: No tap handle

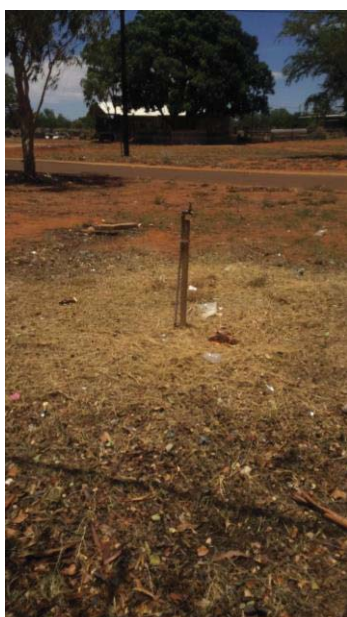
Tap Comment: Tap works, calcium build up on outside

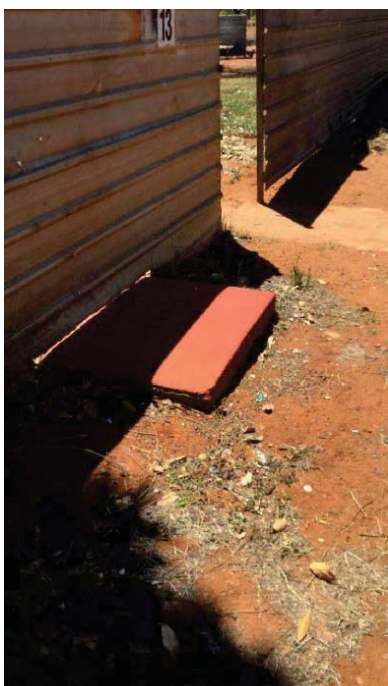
Figure 2 Fire hydrant, condition: *good*

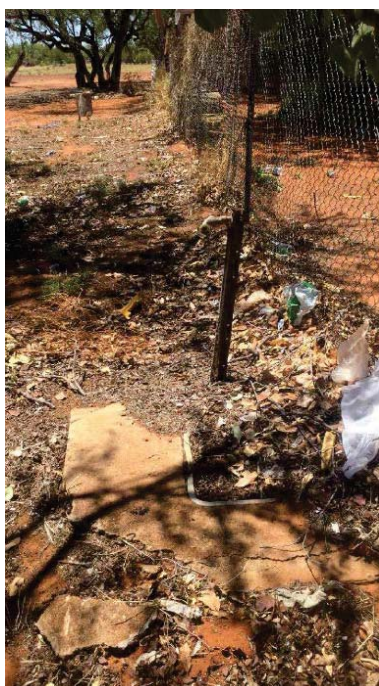
Figure 3 Tap, condition: *very poor*

A tap was found in very poor condition and should be replaced. Furthermore, two residential water meters require maintenance works to remove calcium build up and leaks.

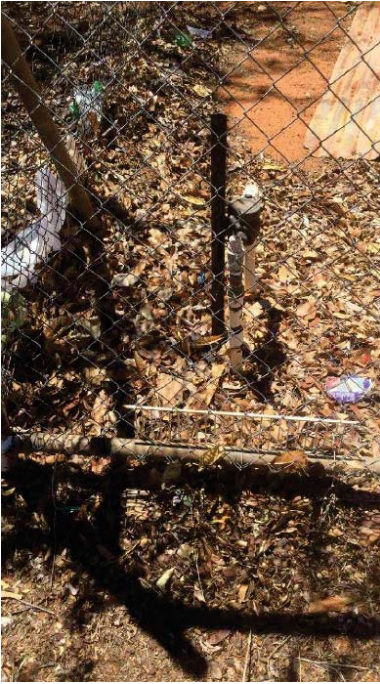
Figure 4 Water meter (lot), condition: *poor*

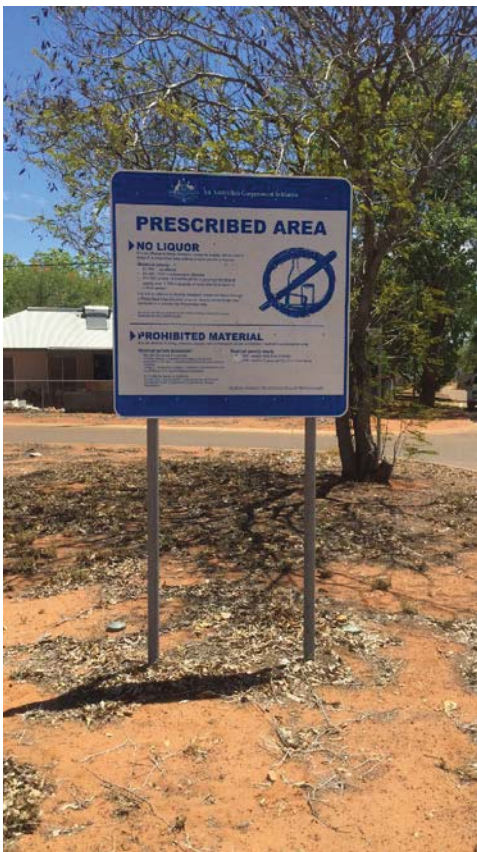
Figure 5 Sign, condition: *good*

The signs in Elliott South community were generally of good and very good condition. It appears as though the road name signs have been recently installed. No upgrades are required. There were no footpaths in the community.

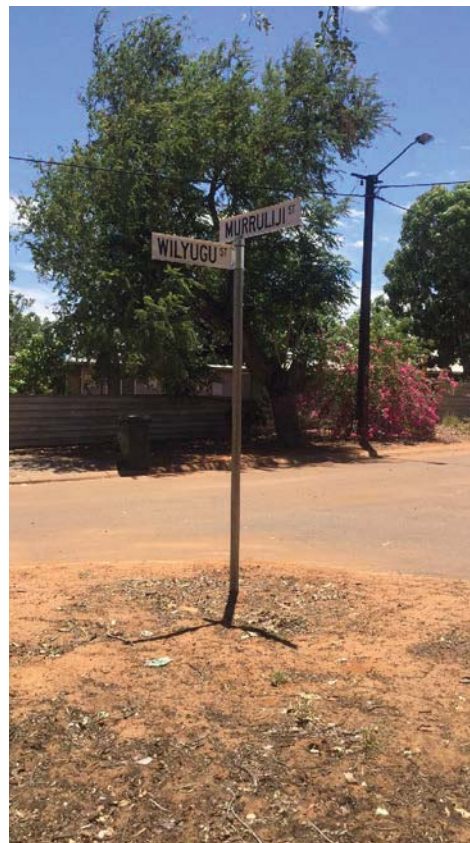
Figure 6 Sign, condition: *very good*

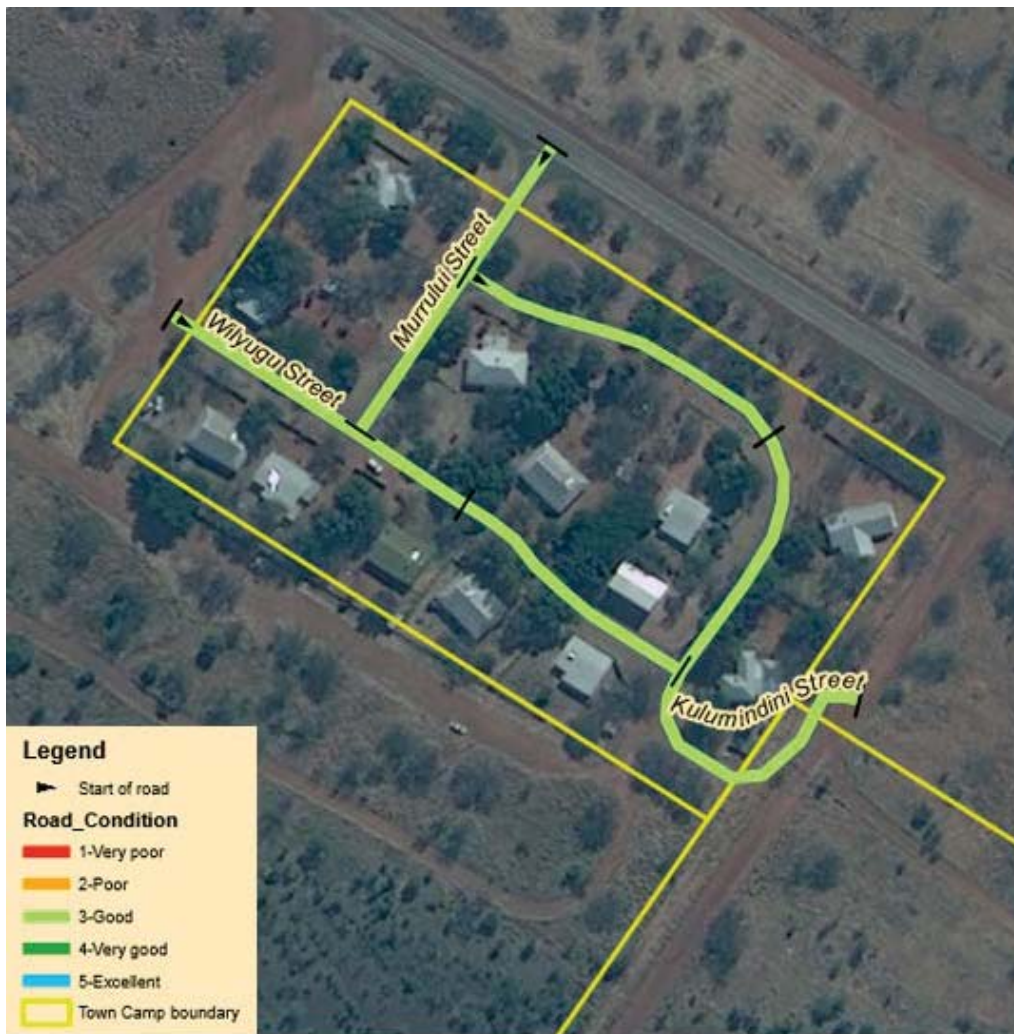
Figure 7 Elliott South Camp road network

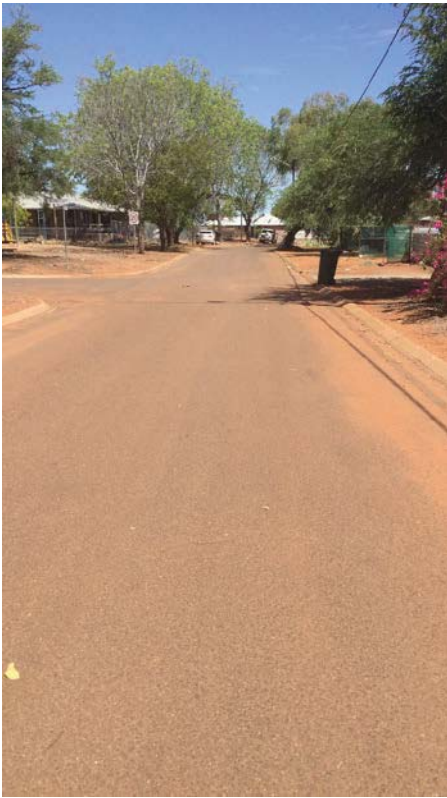
Figure 8 Wilyugu Street, condition: *good*

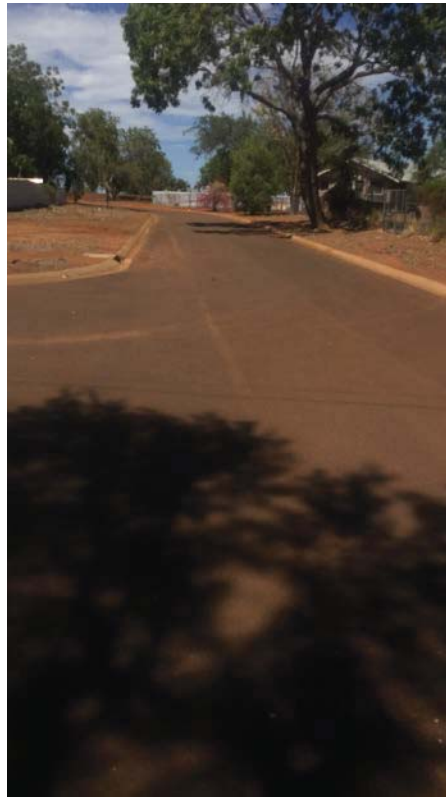
Figure 9 Kulumindini Street, condition: *good*

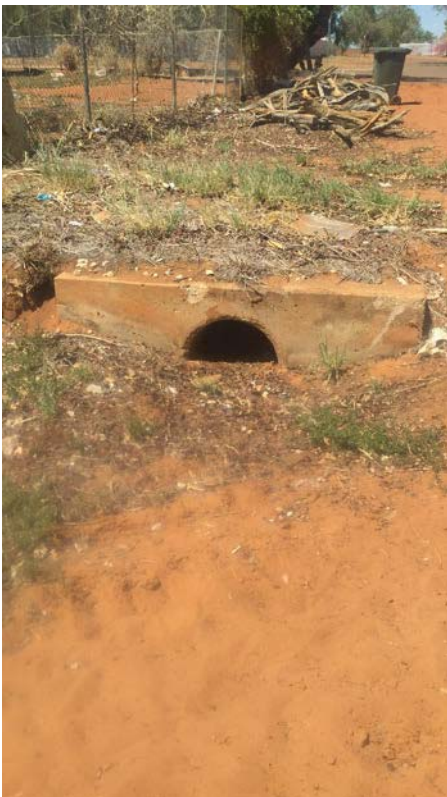
Figure 10 Culvert endwall, condition: *good*, blockage: *50%*

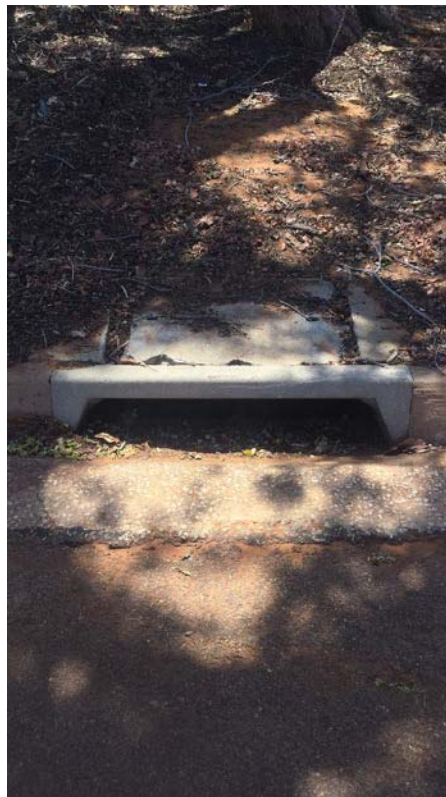
Figure 11 One bay side entry pit, condition: *poor*

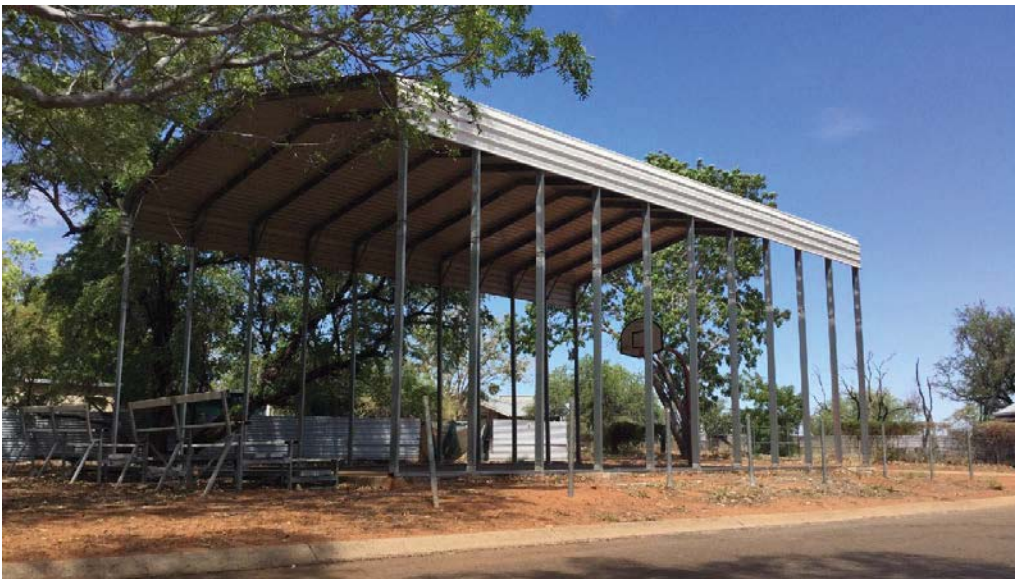
Figure 12 Basketball court, condition: very good

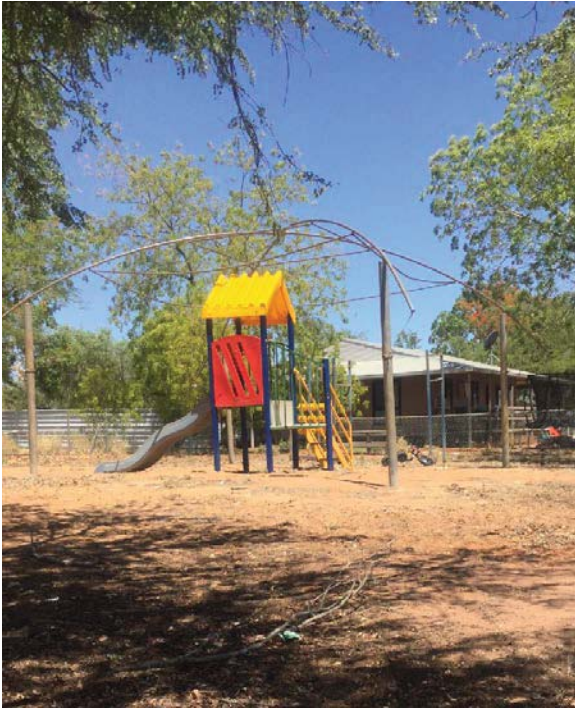
Figure 13 Playground, condition: *poor*

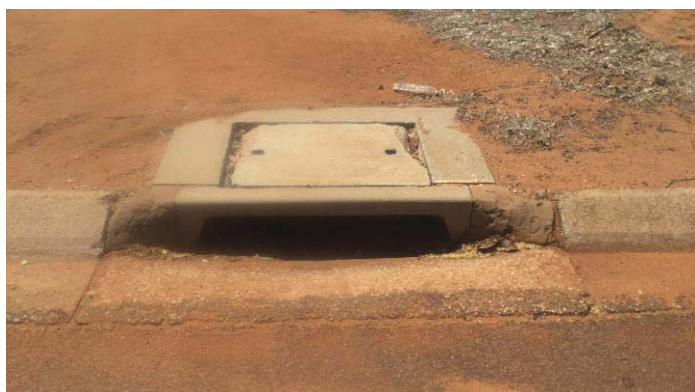
Stormwater Infrastructure:	SEP
Number of Bays:	1
On grade or sag pit:	
Both sides of road:	Left
Condition:	2 - Poor
Blockage (%):	10
Comment:	Broken lid

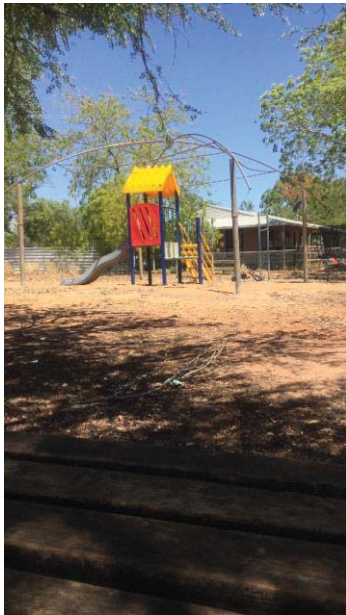
Inspection Type:	Shade Structure
Shade Structure Type:	Play ground
Shade Floor Type:	Sand
Roof Type:	Shadecloth
Width (mm):	
Length (mm):	
Appearance:	3
Appearance Comment:	
Condition:	2 - Poor
Comment:	Shadecloth non existent

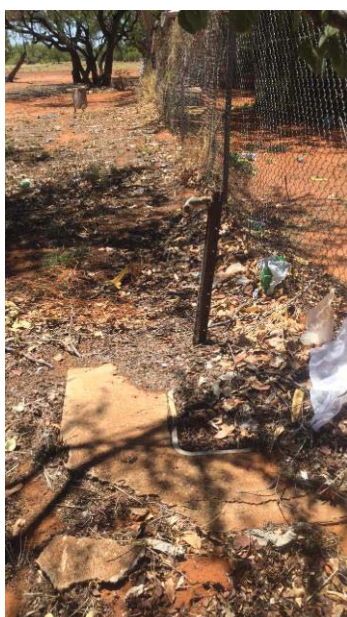
Tap Comment: No handle

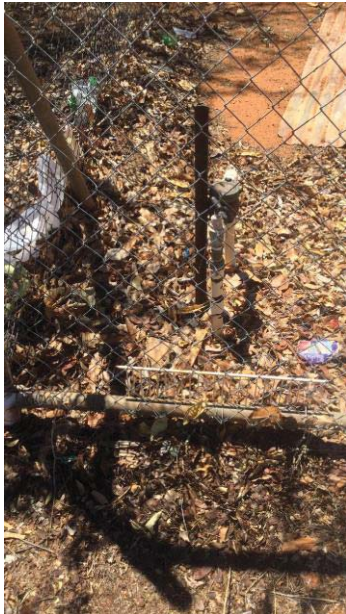
Lot Water Meter Comment: Calcium build up on outside

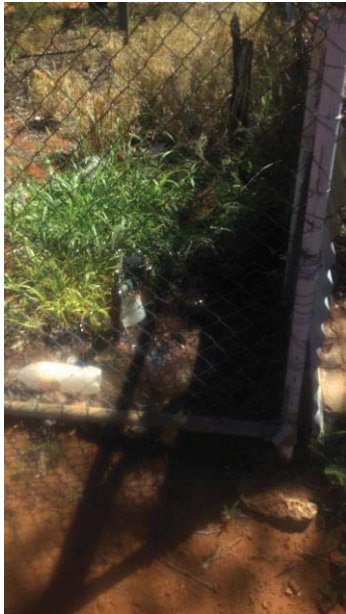
Lot Water Meter Comment: Leaking
