## Northern Territory Town Camps

### Electrical Infrastructure

## 2 Condition assessment

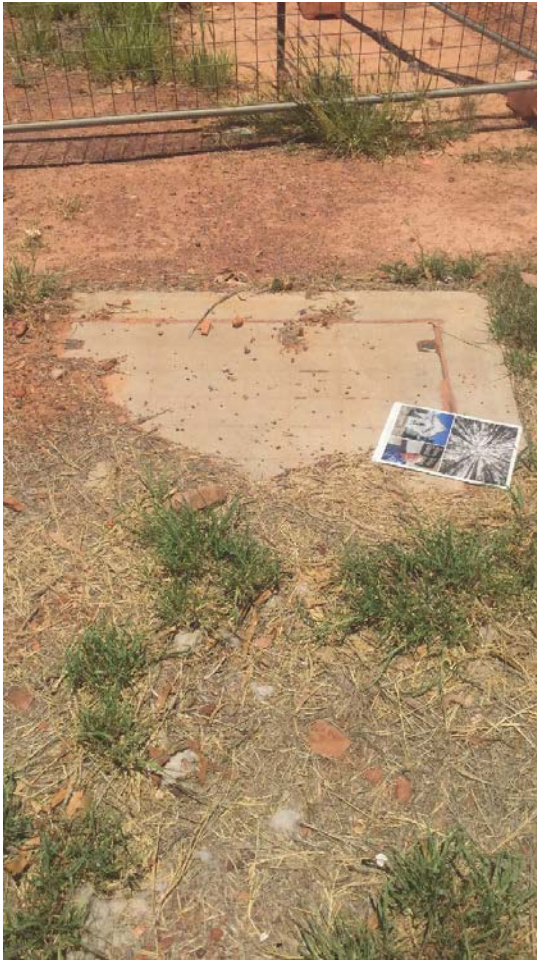
Figure 1 Sewer manhole, condition: *good*

All sewer infrastructure that was assessed during the site inspection is in good or very good condition and does not require any maintenance.

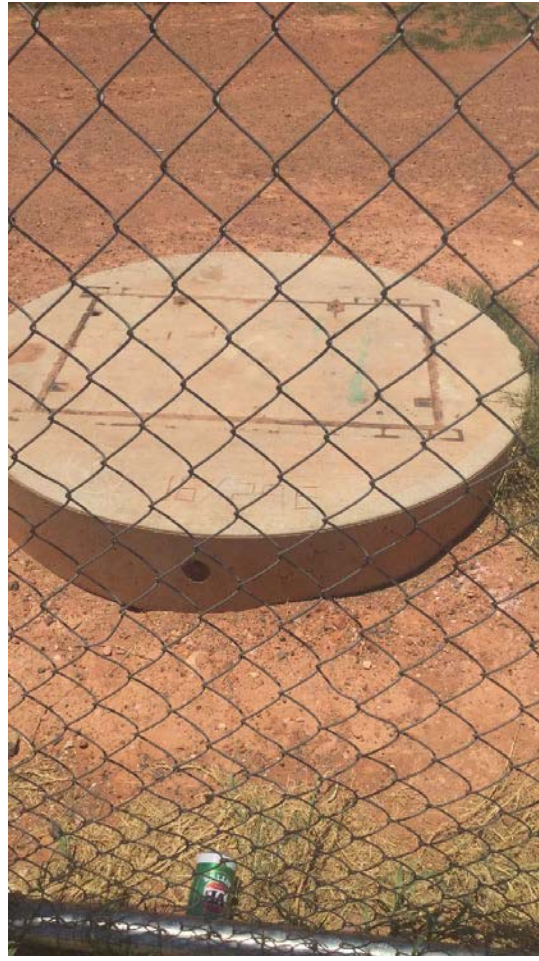
Figure 2 Sewer manhole, condition: *very good*

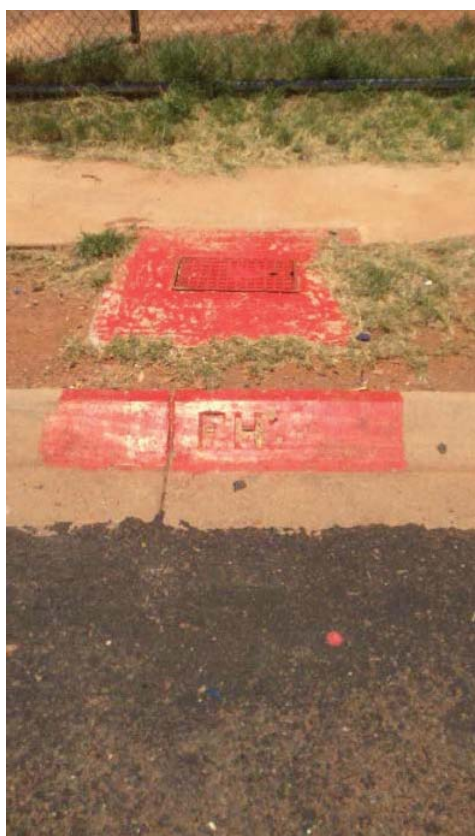
Figure 4 Fire hydrant, condition: *very good*

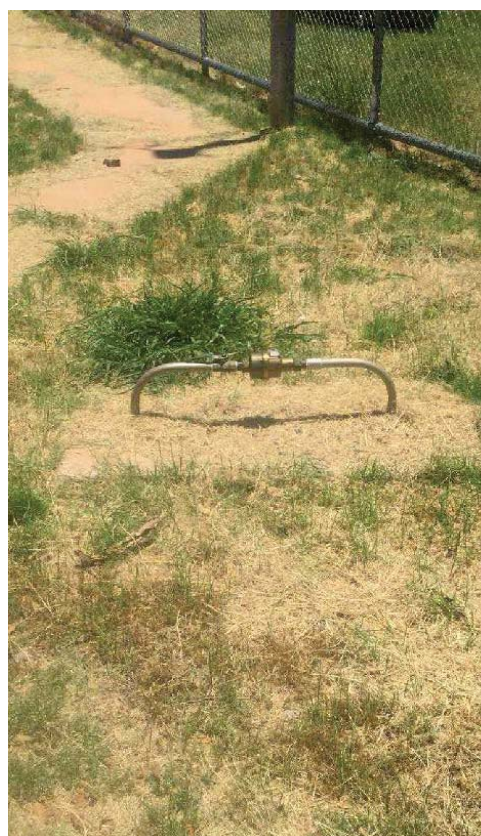
Figure 5 Water meter (lot), condition: *good*

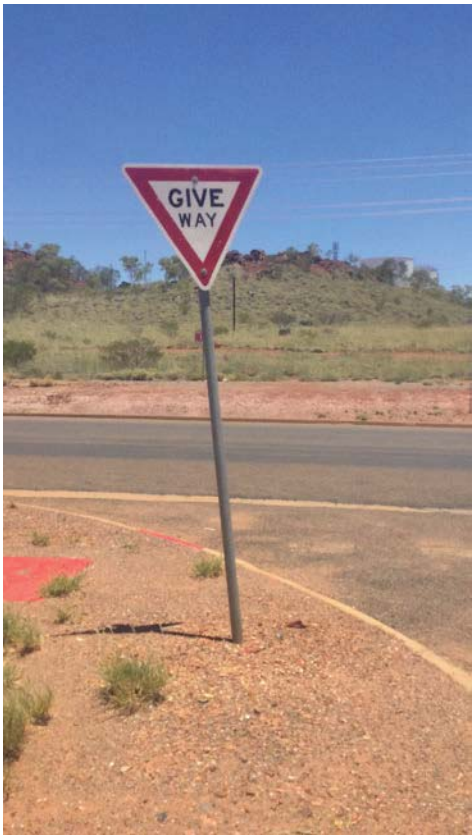
Figure 6 Sign, condition: *very good*

There were two give way signs at Blueberry Hill and both were in very good condition, although one sign was slightly on a lean, as shown in Figure 6.

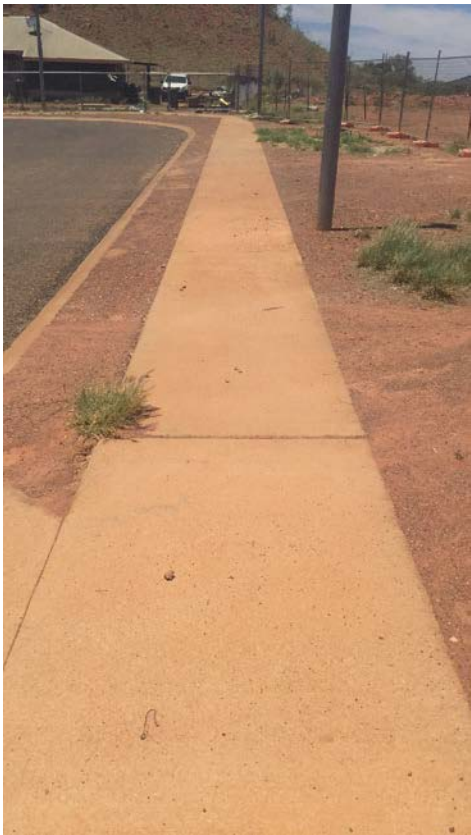
Figure 7 Footpath, condition: *good*

The footpath in Blueberry Hill is generally in good condition, although a general tidy up is required to remove weeds and dirt on the path.

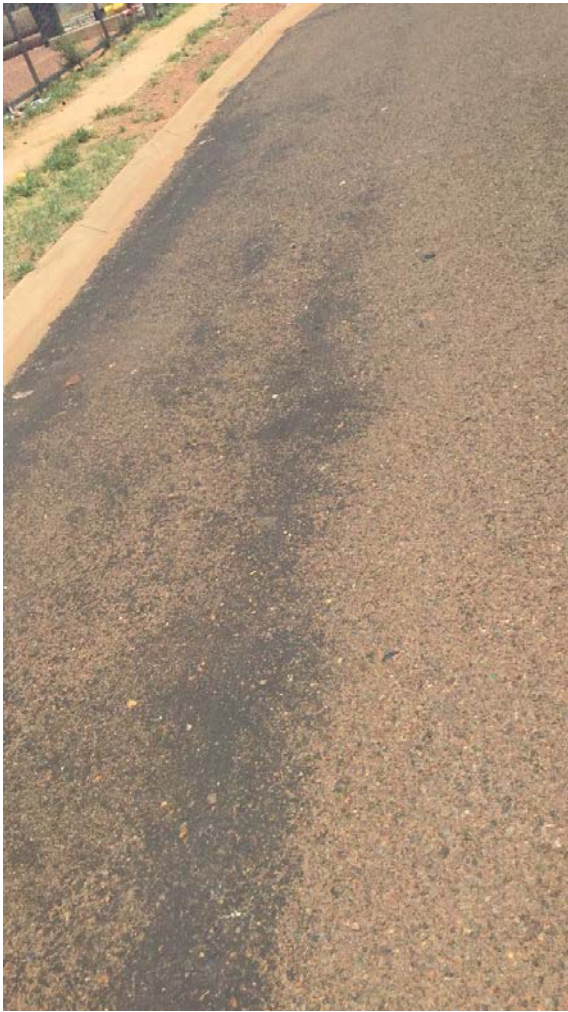
| Road name | Chainage start (km) | Chainage end (km) | Condition (1 to 5) | Defects and associated condition |
|---|---|---|---|---|
| 215_1 | 0.0 | 0.140 | 3 | -30% of road has bleeding (3) |

Figure 9 Road 215\_1 with bitumen bleeding, condition: *good*

There are no maintenance works required for the near future, however the bleeding defect should be inspected regularly to determine when repair works are required.

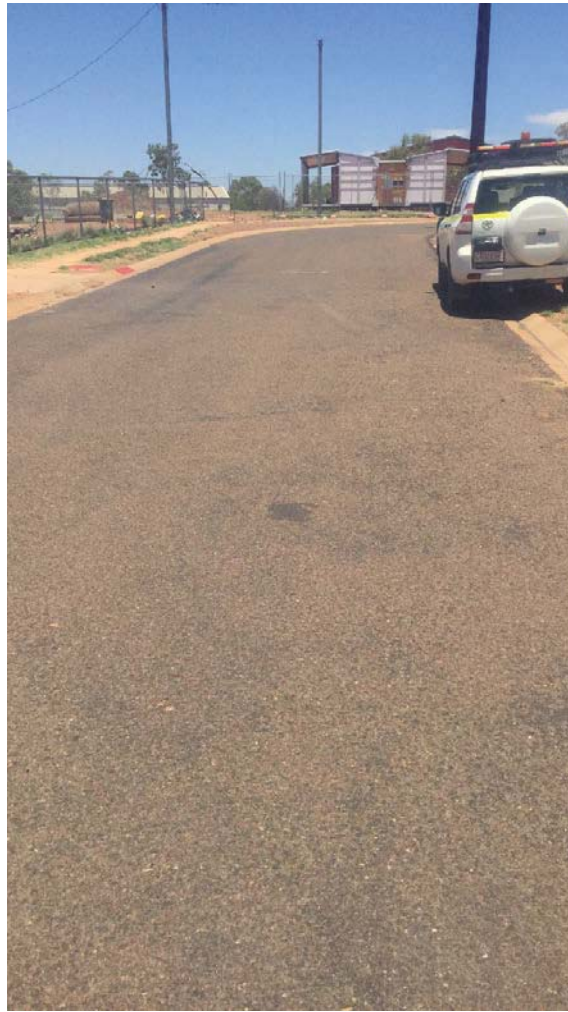
Figure 10 Road 215\_1, condition: *good*

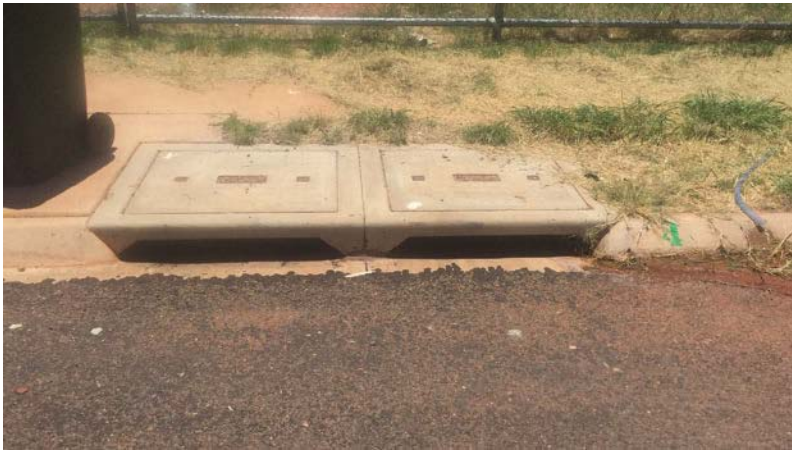
Figure 11 Two bay side entry pit, condition: *very good*

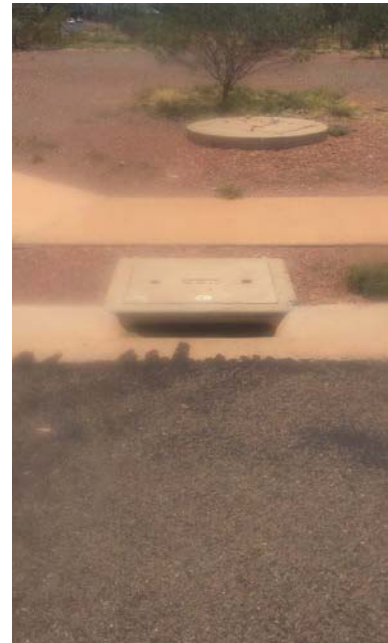
Figure 12 One bay side entry pit, condition: *very good*

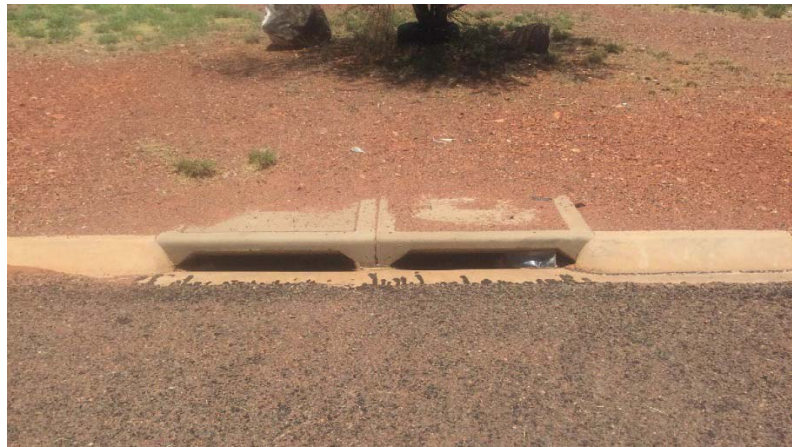
Figure 13 Two bay side entry pit, condition: *very good*

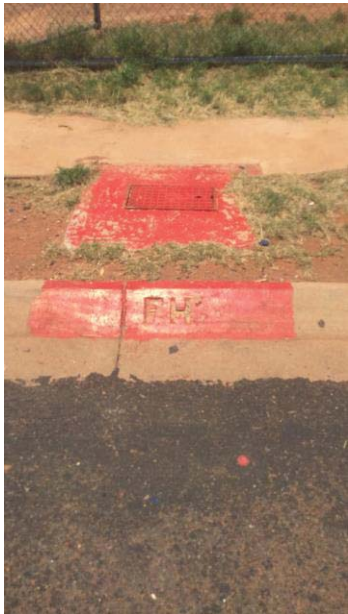
FH Condition: 3 - Good

FH Comment: Paint starting to fade

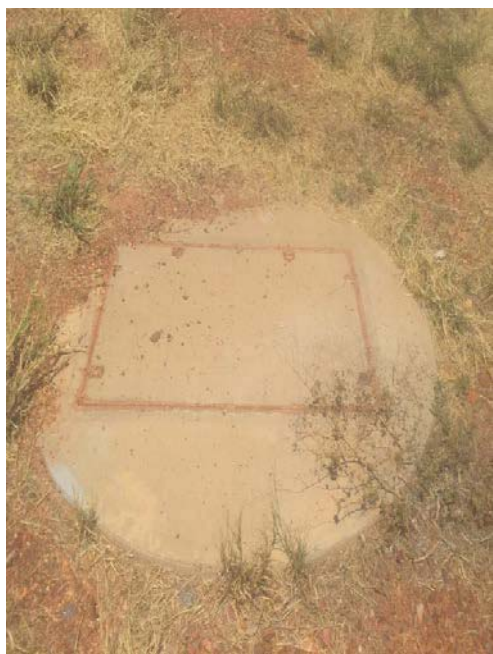
Figure 1 Sewer manhole, condition: *good*

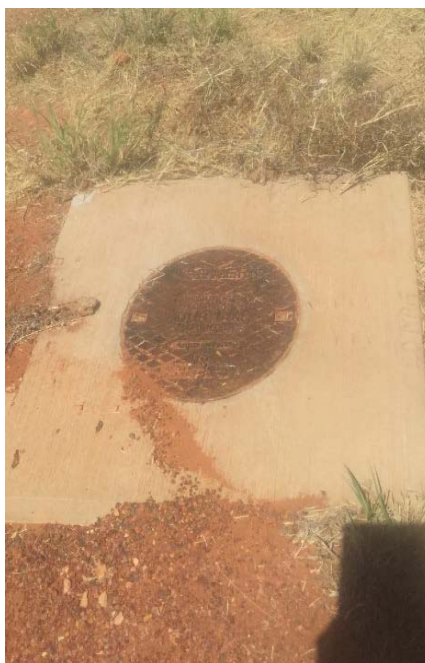
Figure 2 Sewer manhole, condition: *very good*

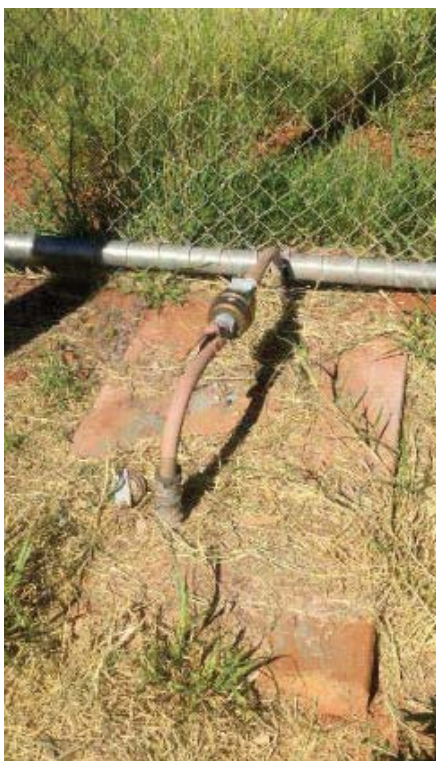
Figure 4 Water meter (lot), condition: *good*

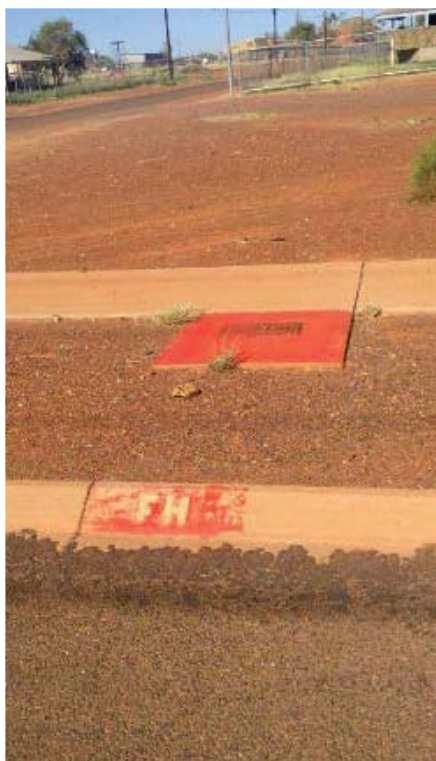
Figure 5 Fire hydrant, condition: *good*

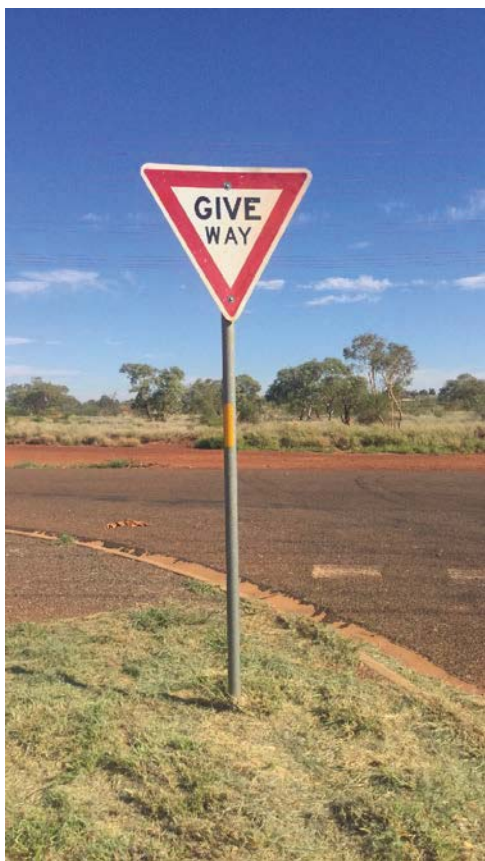
Figure 6 Sign, condition: *good*

The condition of the signs varied across Dump Camp. In general, the street name signs were in poorer condition than the give way signs. There were a few instances of there being no sign, despite there being a post. It is recommended that the signs

are repaired or replaced. One sign was bent and leaning over the road. This will also need to be replaced.

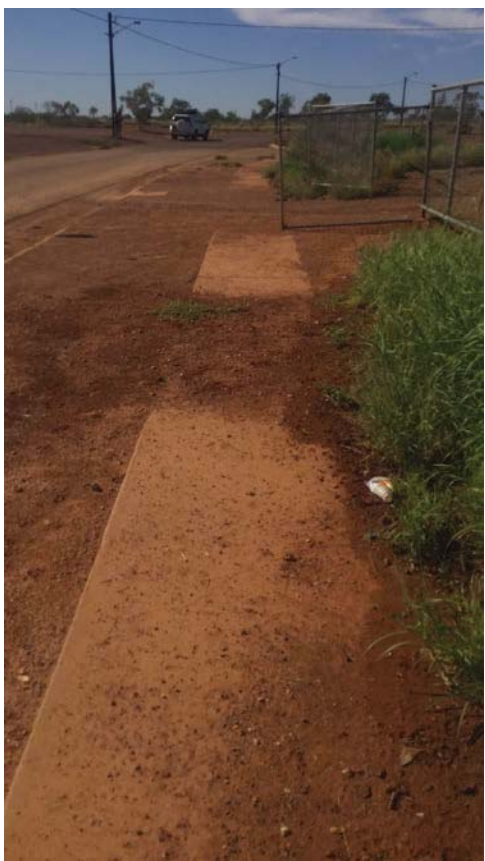
Figure 7 Footpath, condition: *good*

The footpaths were in good and very good condition, however they all require a general tidy up to remove weeds, grass, debris and dirt on the path.

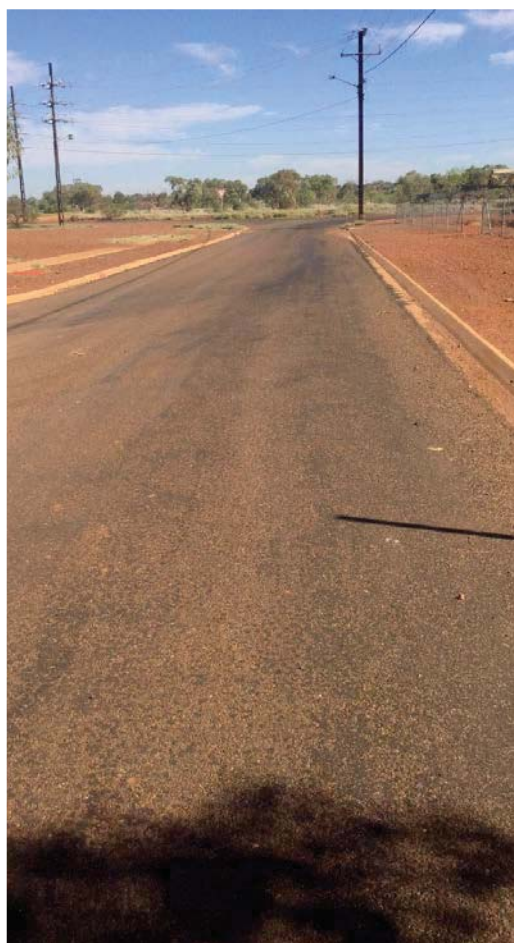
Figure 9 Gurungu Street, condition: *good*

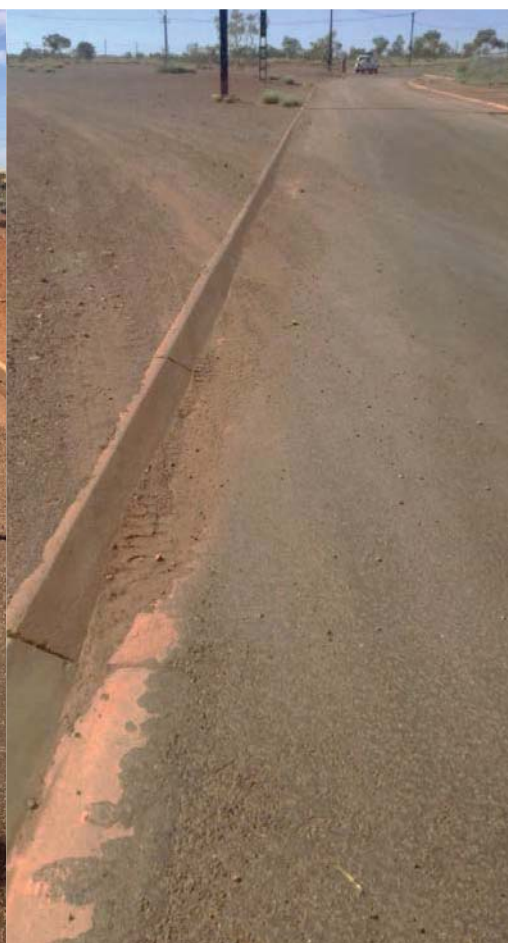
Figure 10 Gurungu Street, condition: *good*

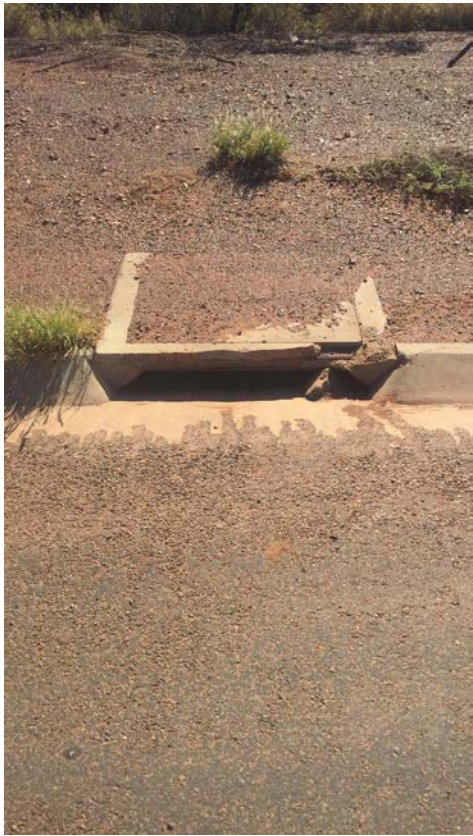
Figure 11 One bay side entry pit, condition: *very poor*

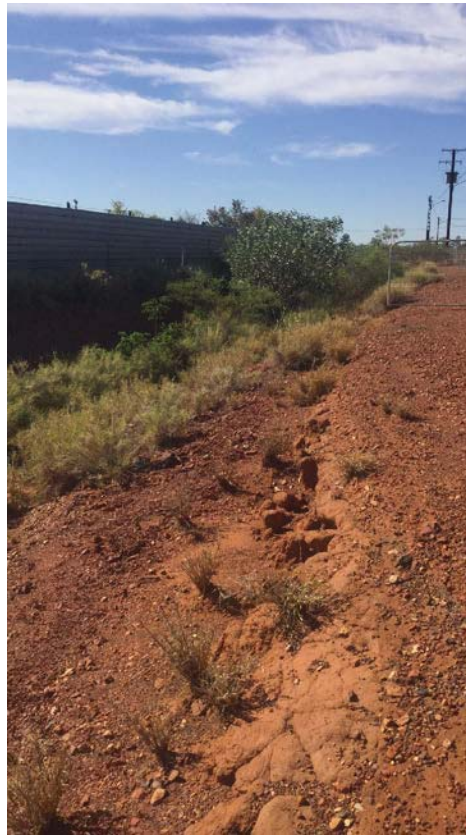
Figure 12 Swale, condition: *good*

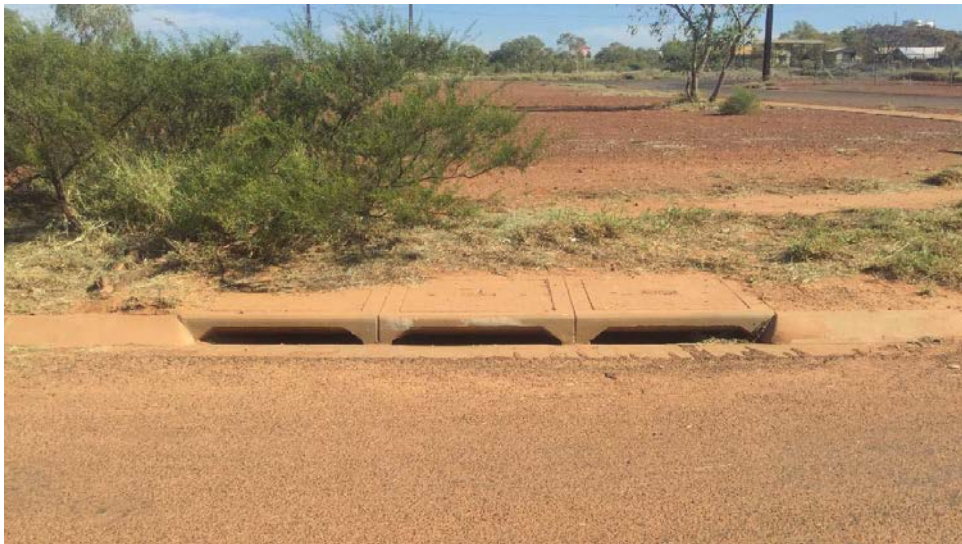
Figure 13 Three bay side entry pit, condition: *very good*

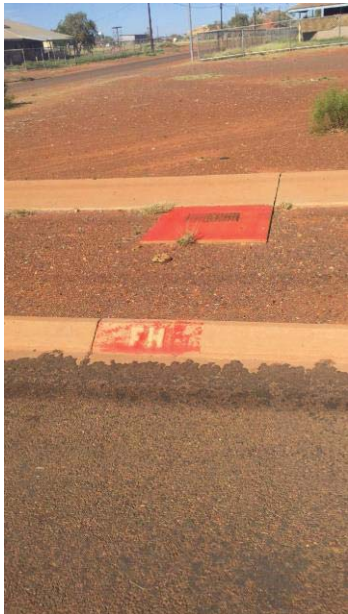
FH Condition: 3 - Good

FH Comment: Kerb marker paint is fading

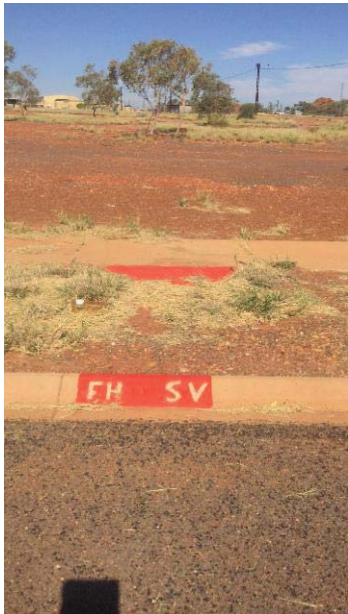
FH Condition: 4 - Very Good

FH Comment: Covered in grass

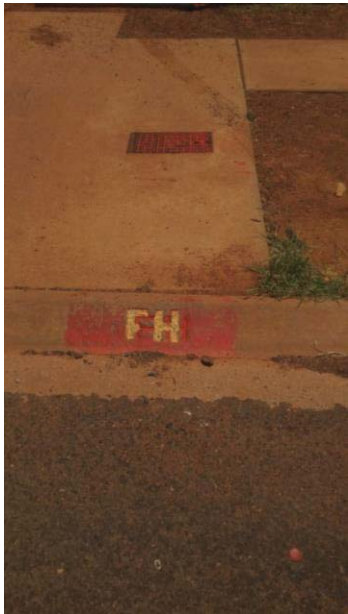
FH Condition: 4 - Very Good

FH Comment: In driveway

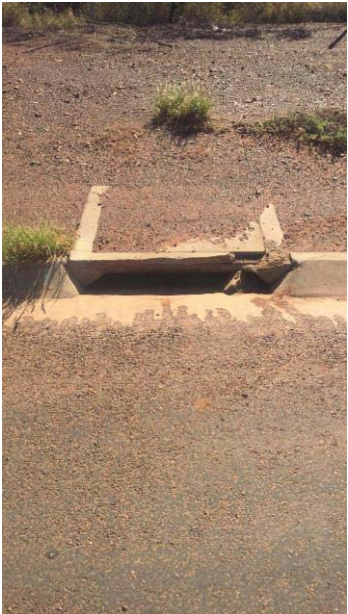
Blockage (%):10

Comment:Broken concrete

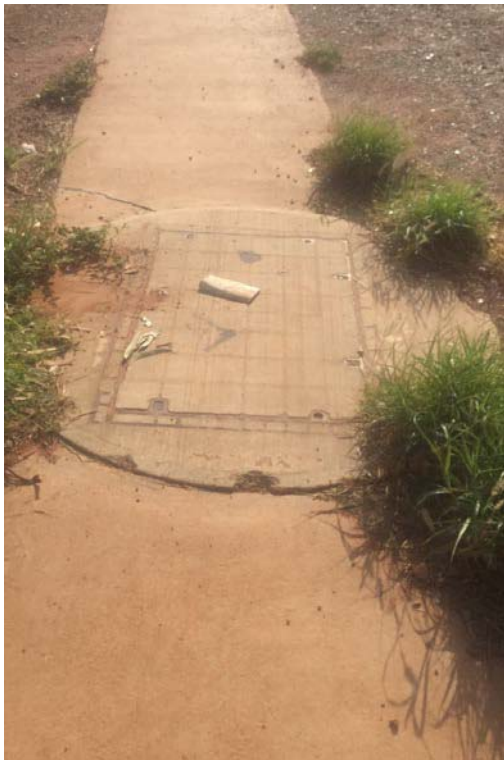
Figure 1 Sewer manhole, condition: *good*

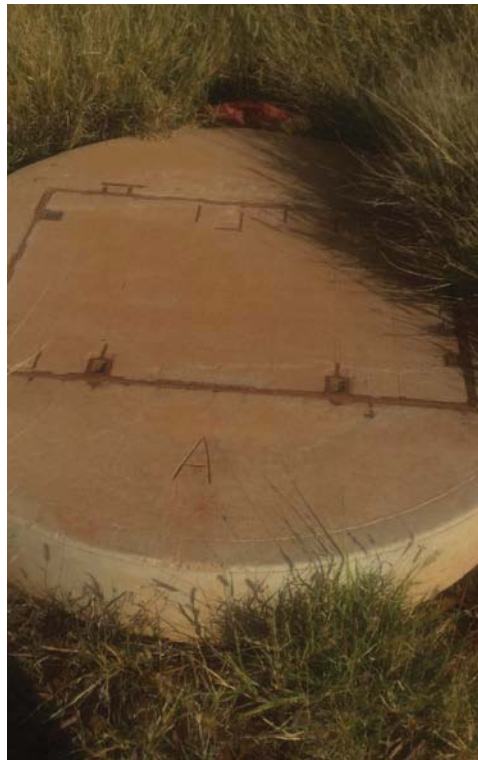
Figure 2 Sewer manhole, condition: *very good*

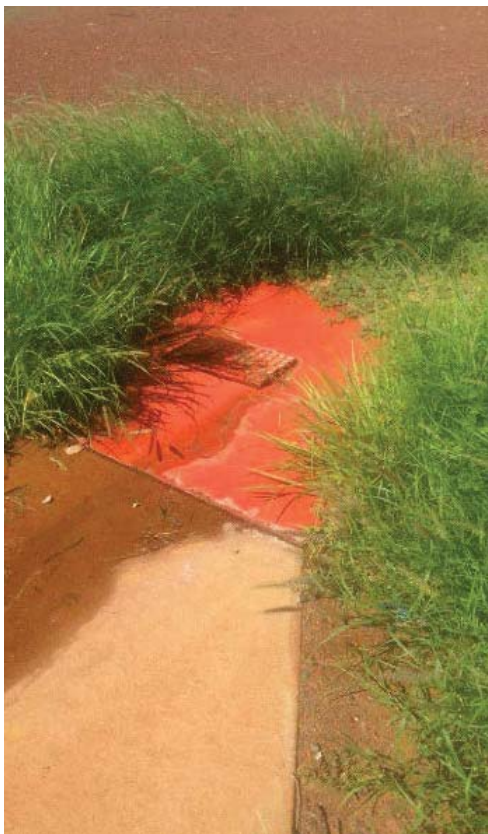
Figure 4 Fire hydrant, condition: *poor*

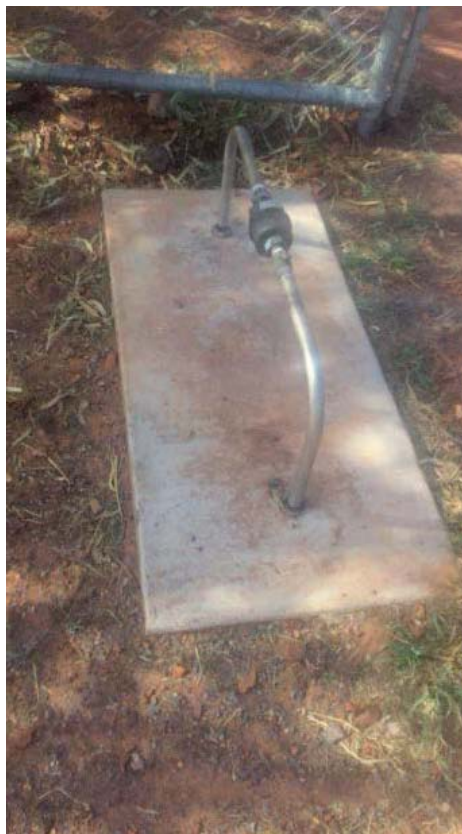
Figure 5 Water meter (lot), condition: *poor*

Three of the residential lot water meters were assessed as being in poor condition due to missing handles. It is recommended that the handles are replaced.

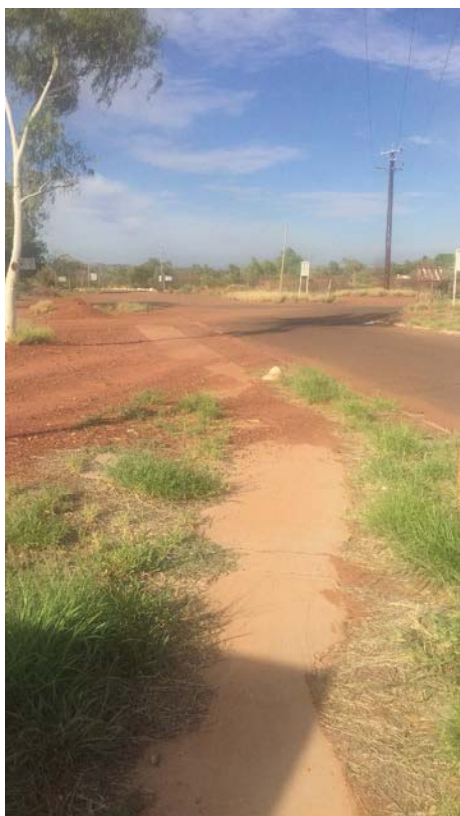
Figure 6 Footpath, condition: good

The footpaths in Kargaru were generally in good condition, however there were some weeds and grass overgrowing the path, and some graffitti and dirt on the path. Overall, the paths require a general tidy up.

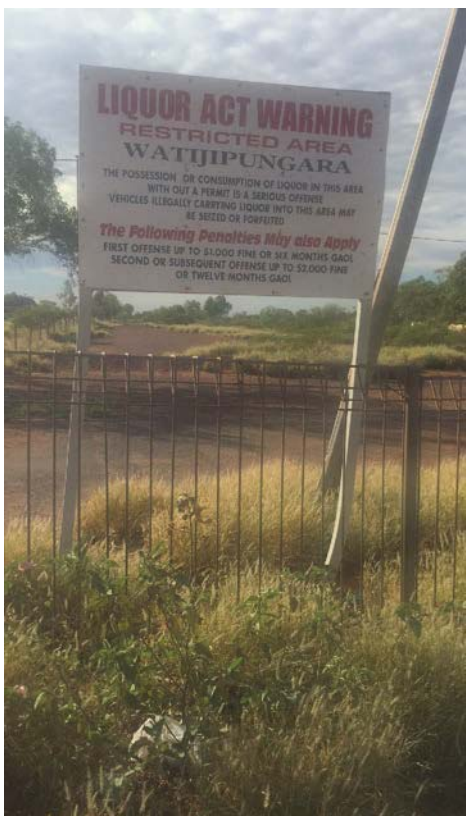
Figure 7 Sign, condition: good

The signs in Kargaru were in poor and good conditions. The poor condition signs were the liquor act warning and the camp name signs at the front of the

community, while the road signs within the community were in good condition. It is recommended that the signs in poor condition are replaced.

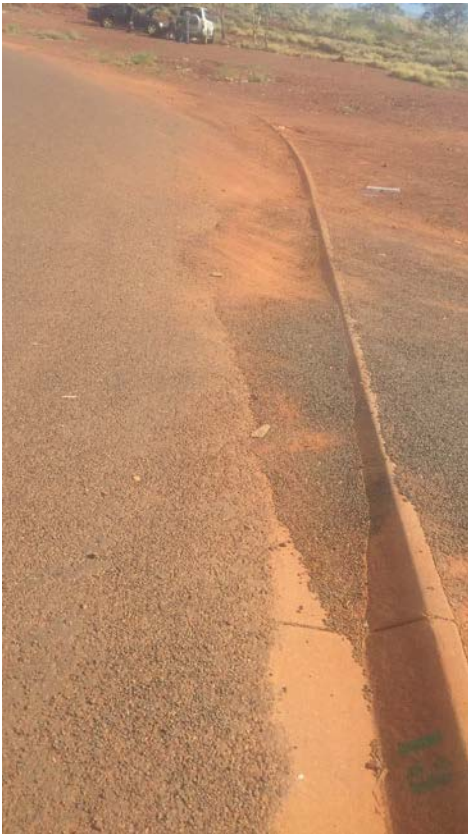
Figure 9 Road 238\_4, condition: *poor*

The roads were generally in a good condition, except for the gutters being full with dirt and gravel, and the general appearance of one road was poor due to graffiti and rubbish.

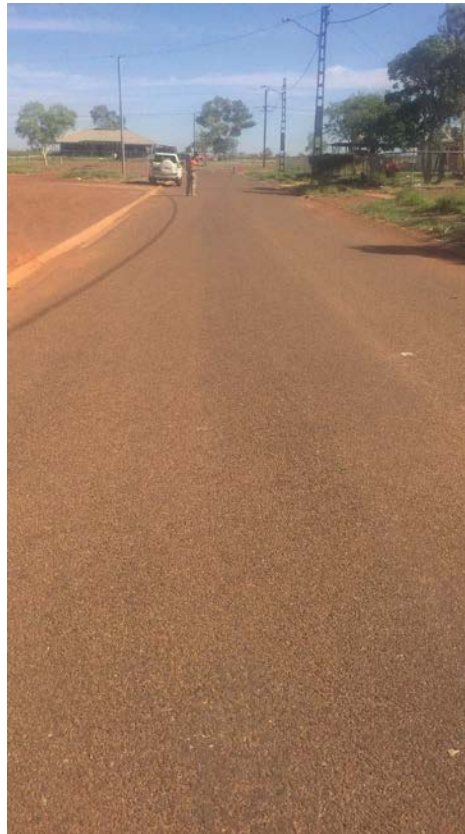
Figure 10 Road 238\_4, condition: *good*

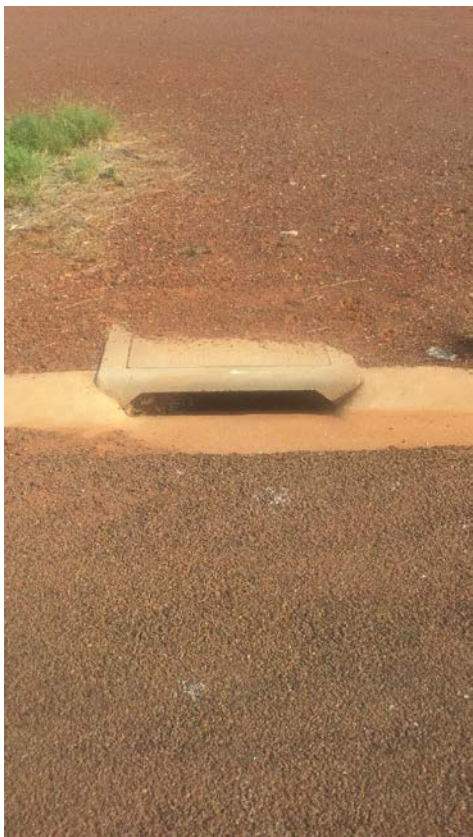
Figure 11 One bay side entry pit, condition: *good*

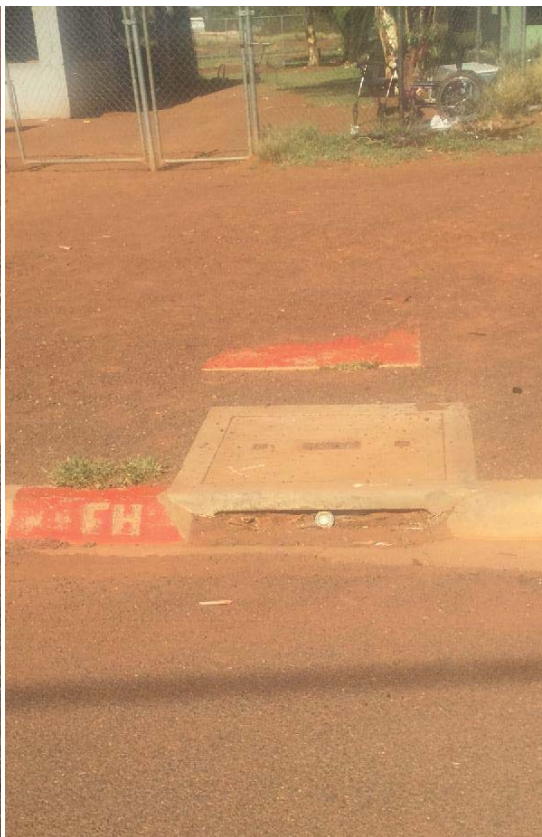
Figure 12 One bay side entry pit, condition: *poor*, blockage: *100%*

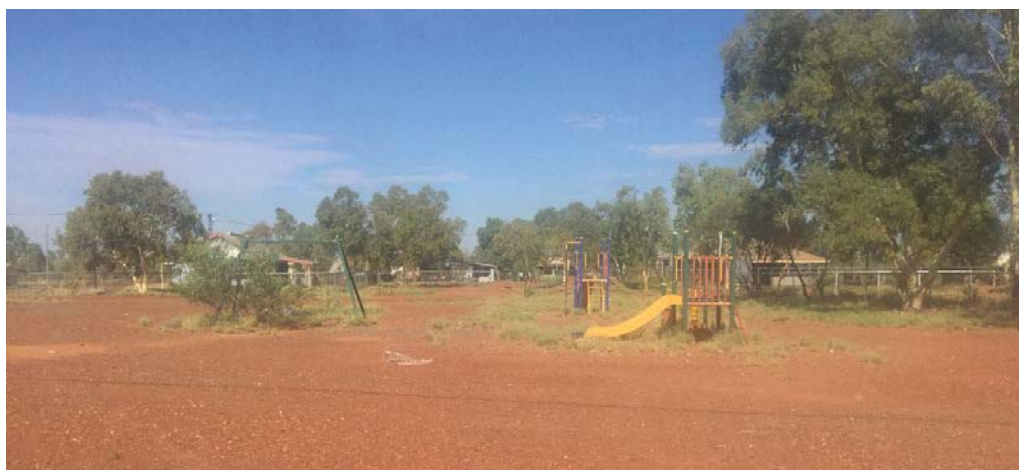
Figure 13 Playground, condition: *poor*
