Northern Territory Camps

Civil Infrastructure

Group 5 - Borroloola

Yanyula

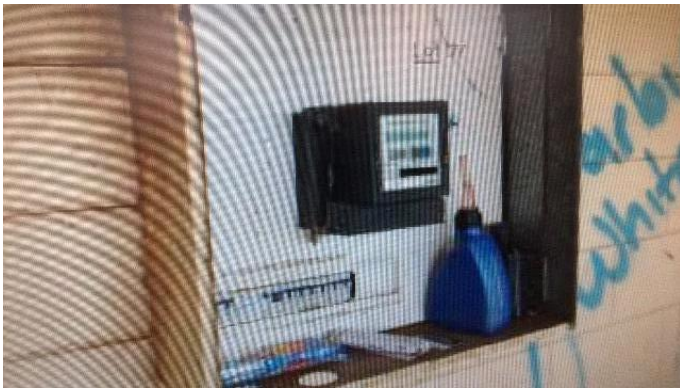
Meter Comment: Blank plates are missing on CB slot.

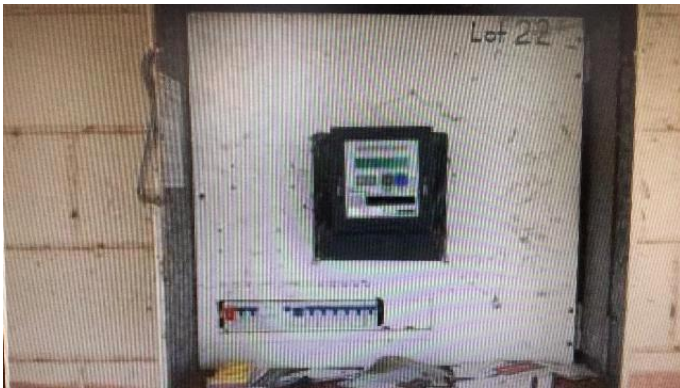
Meter Comment: Blank plates are missing on CB slot.

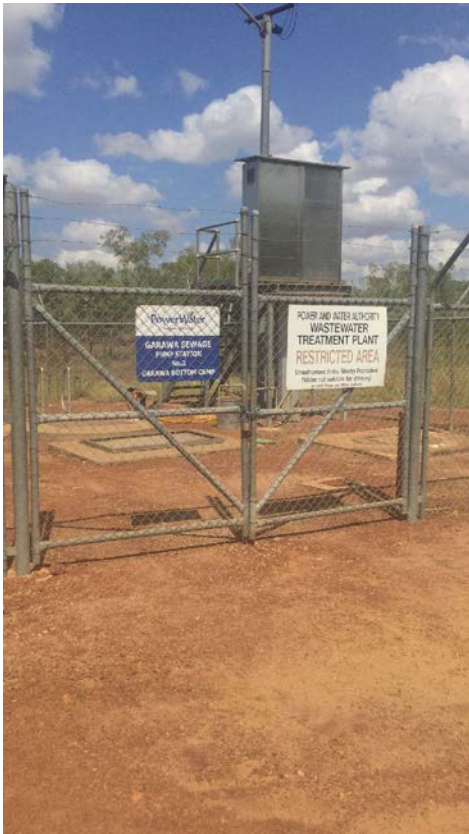
Figure 1 Sewage pump station, condition: *good*

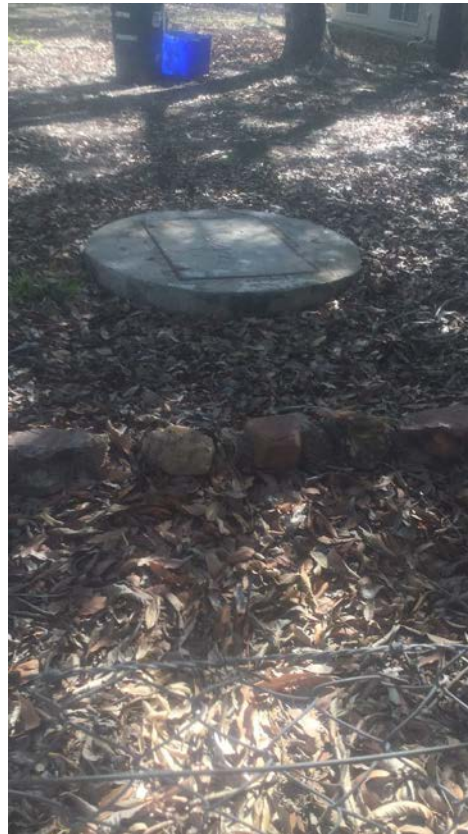
Figure 2 Sewer manhole, condition: *good*

The sewer manholes were in good condition. One was noted to be within a property boundary, and another was a steel lid. It appears as though the current sewer network is not located within the road reserve or easements, which is not in accordance with PWC guidelines.

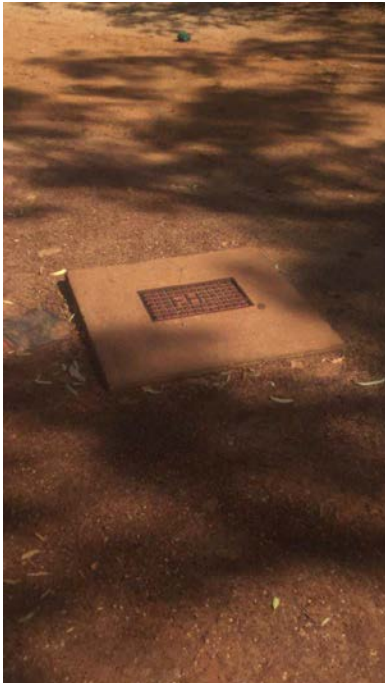
Figure 3 Fire hydrant, condition: *good*

The fire hydrants were assessed as being in good condition however, both require painting on the concrete cover. A single residential lot water meter requires a tap handle to be replaced.

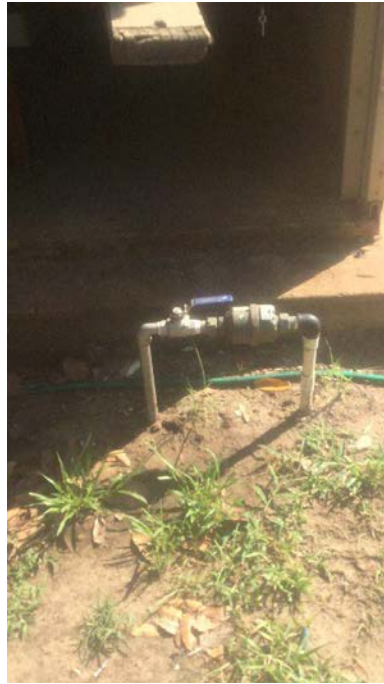
Figure 4 Residential lot water meter, condition: *good*

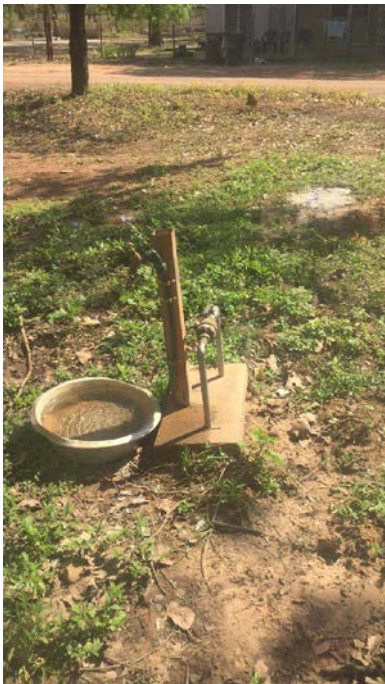
Figure 5 Tap, condition: *good*

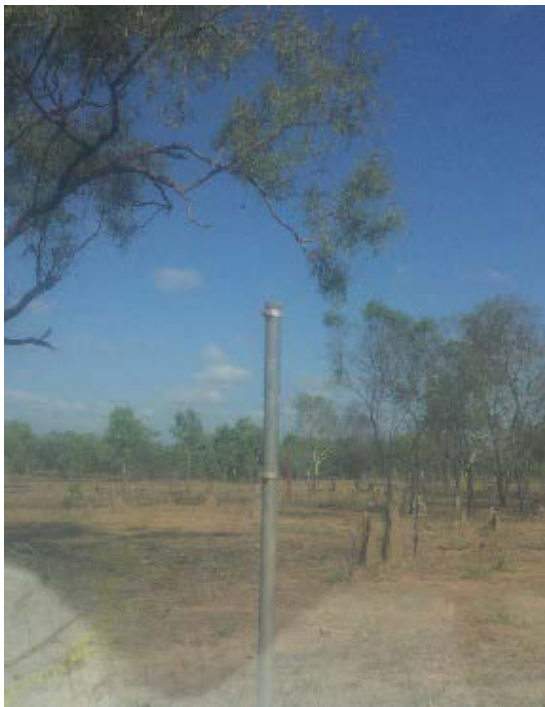
Figure 6 Sign, condition; *very poor*

The sign was in very poor condition as there was no sign, only a post. It is assumed that the sign was a speed limit sign. It was noted during inspections that speed humps were not painted and no warning signage was installed, it is recommended that these changes are made.

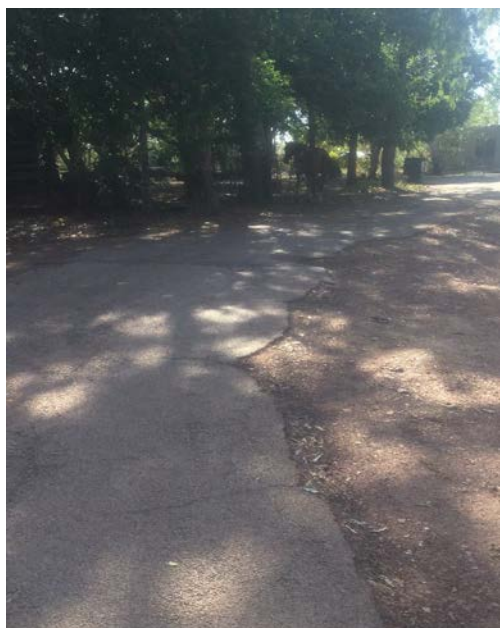
The roads at Garawa 2 were in poor and very poor condition. There were significant edge breaks, surface cracking, potholes, drainage issues and obstructions. It is recommended that the roads are resealed and the edge breaks repaired. It is also recommended that a stormwater drainage study is undertaken to determine where culverts can be installed.

Figure 8 Road, condition: *very poor*

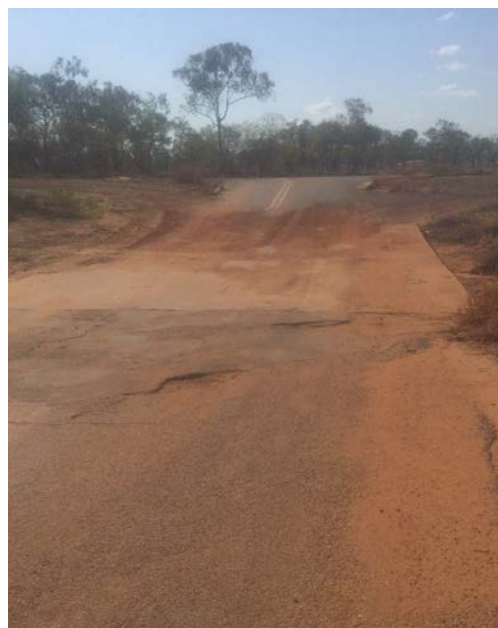
Figure 9 Garawa Two access road, condition: *very poor*

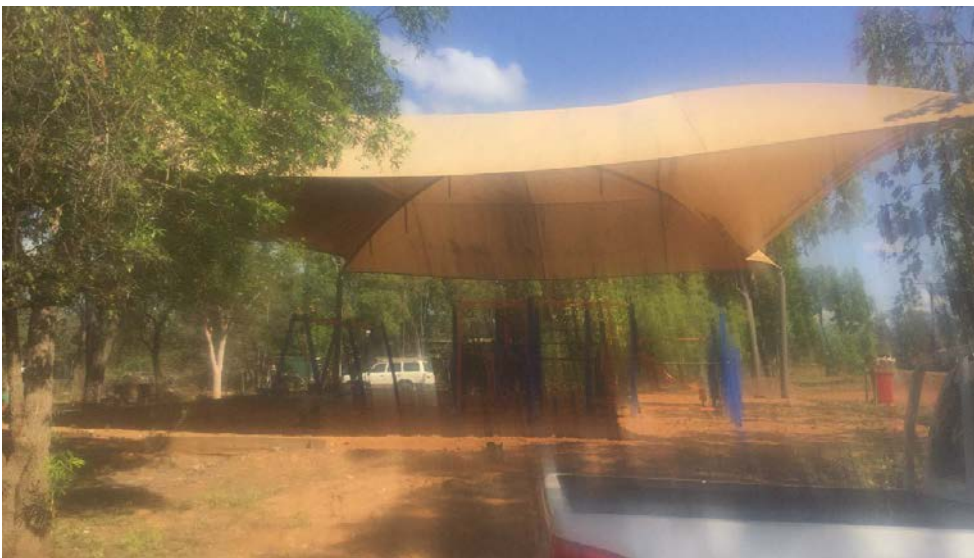
Figure 10 Basketball court, condition: *good*

The playground was in good condition. No immediate maintenance works are required.

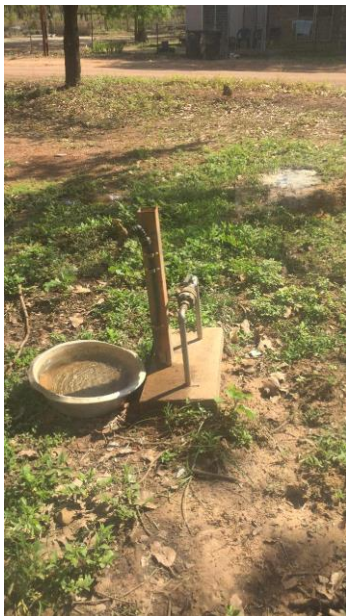
Tap Comment: Water main leaking nearby

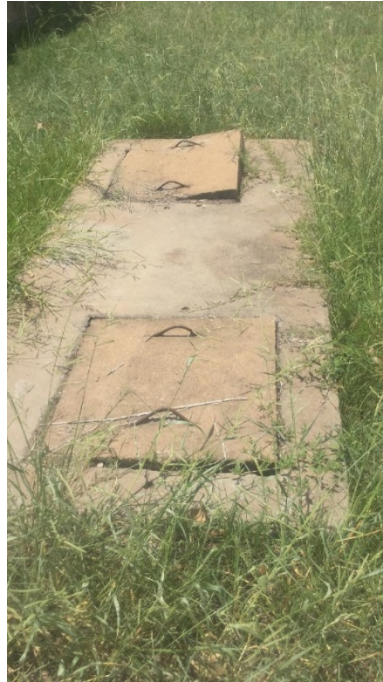
Figure 5 Sewer manhole, condition: very poor

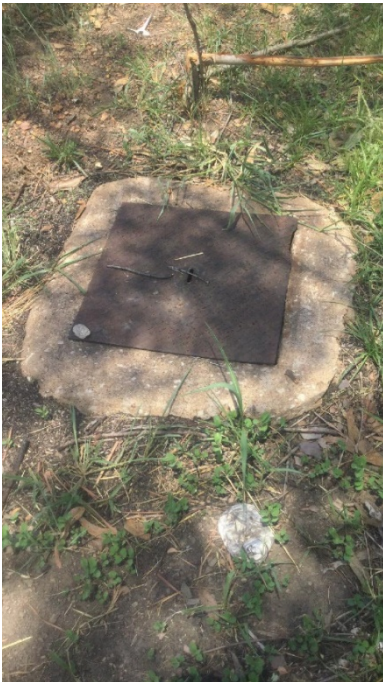
Figure 6 Sewer manhole, condition: very poor

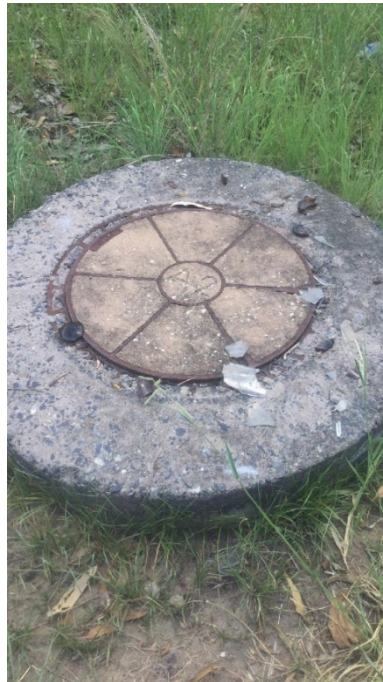
Figure 7 Sewer manhole, condition: poor

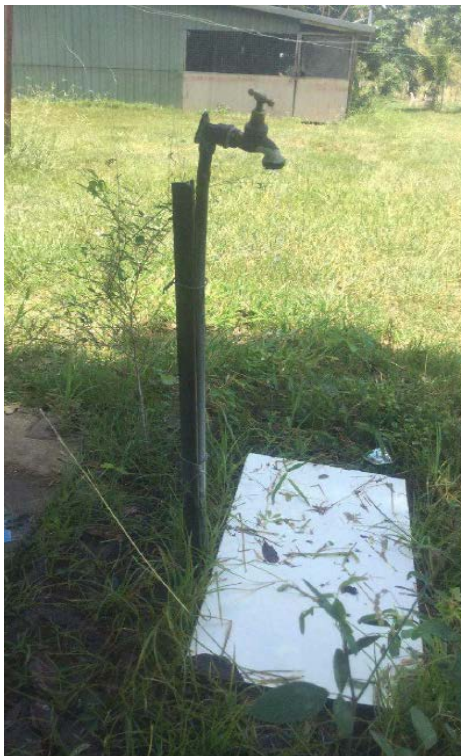
Figure 9 Tap, condition: *very poor*

A single tap was the only water infrastructure found within Pine Creek Compound. The tap is in very poor condition and is recommended to be replaced.

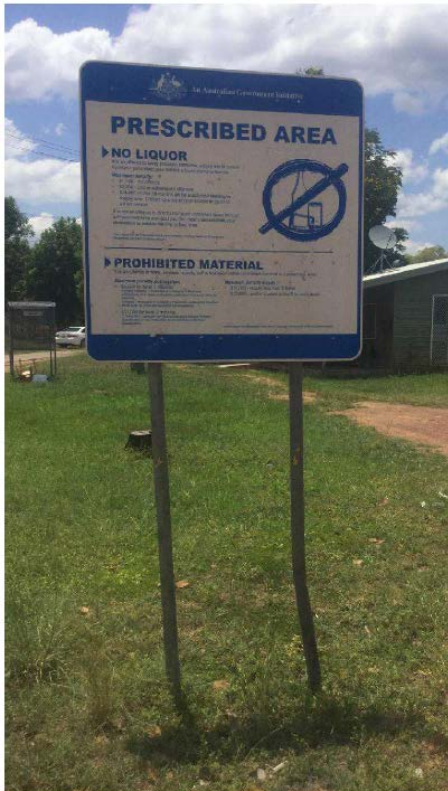
Aside from one sign in poor condition there was no other road furniture assessed.

Figure 10 Sign, condition; *poor*

It is recommended that the sign be repaired as the post holding it is slightly bent. It is also recommended that a road safety audit is undertaken to determine where signage, line marking, etc. are required.

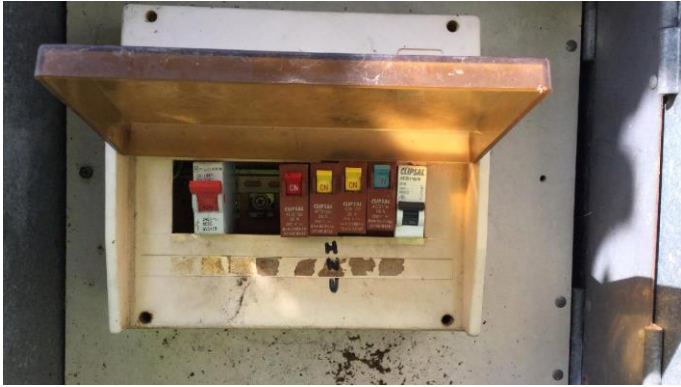
Meter Comment: Indoor SB, Cond 2, Blank plates are missing on CB slot.

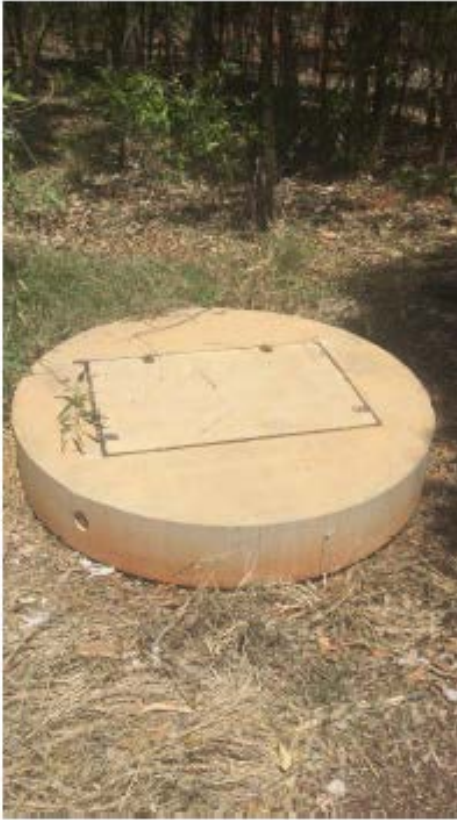
Figure 1 Sewer manhole, very good condition

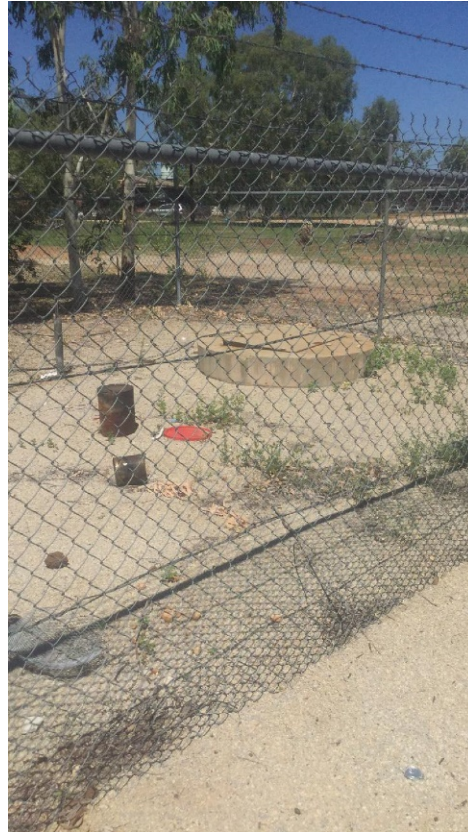
Figure 2 Sewage pump station, good condition

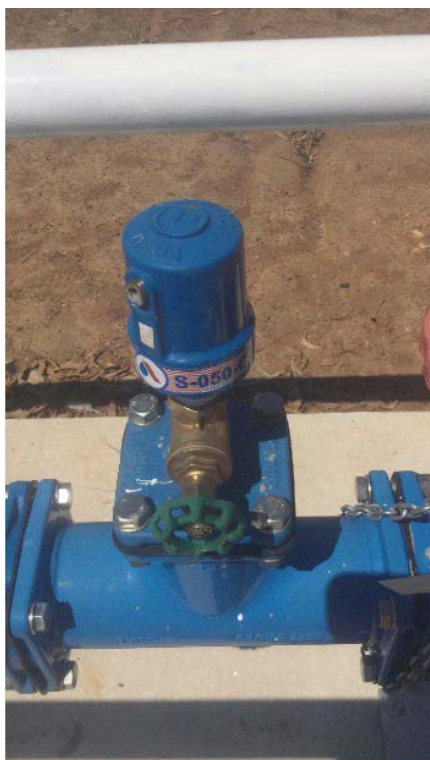
Figure 4 Air valve, condition: *excellent*

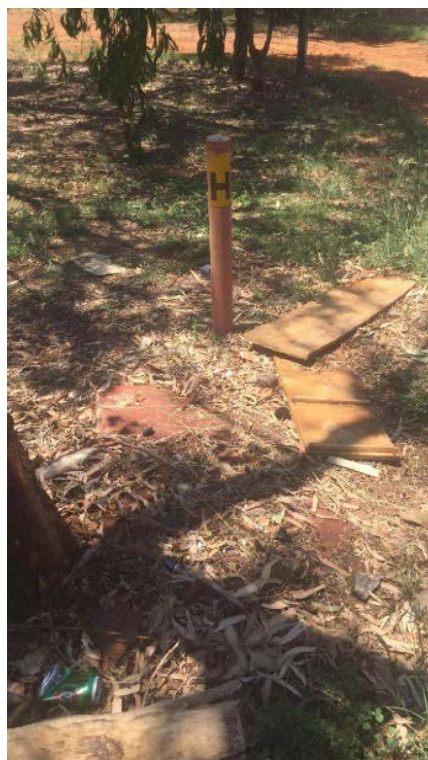
Figure 5 Fire hydrant, condition: *poor*

The fire hydrant was assessed as being in poor condition although no major work is required for this hydrant, simply clearing the area and repainting to ensure visibility is recommended. All three residential water meters found on site require replacing. It is recommended that residential lot meters are added for all lots.

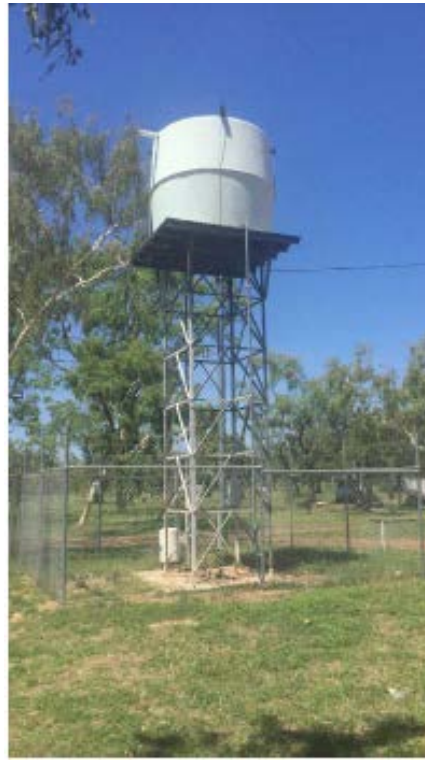
Figure 7 Water tank, condition: *good*

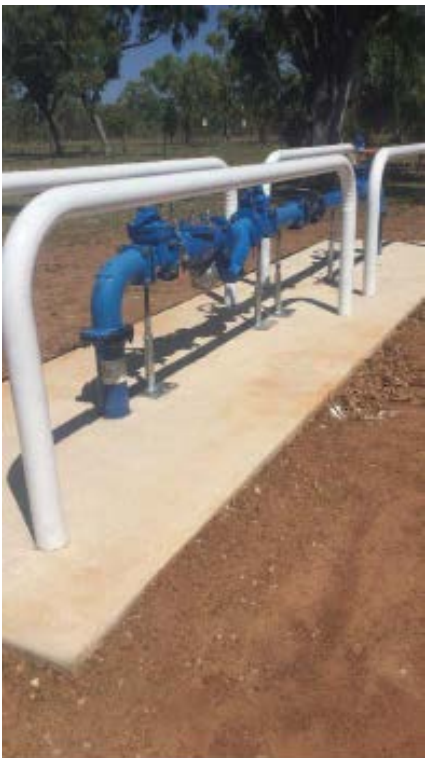
Figure 8 Water meter (bulk), condition: *excellent*

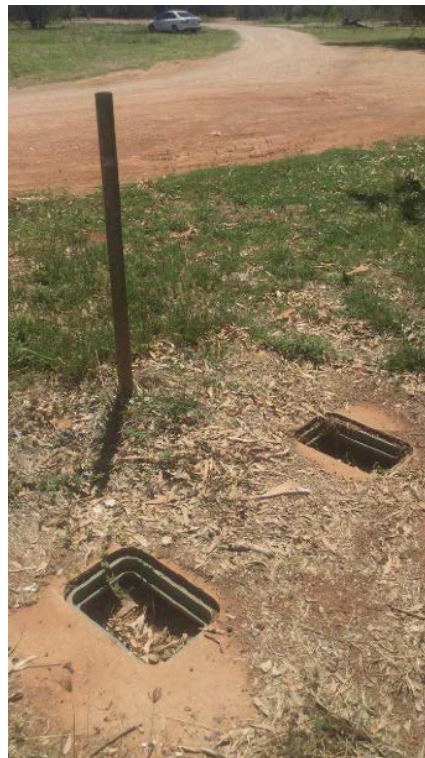
Figure 9 Water meter (lot), condition: *very poor*

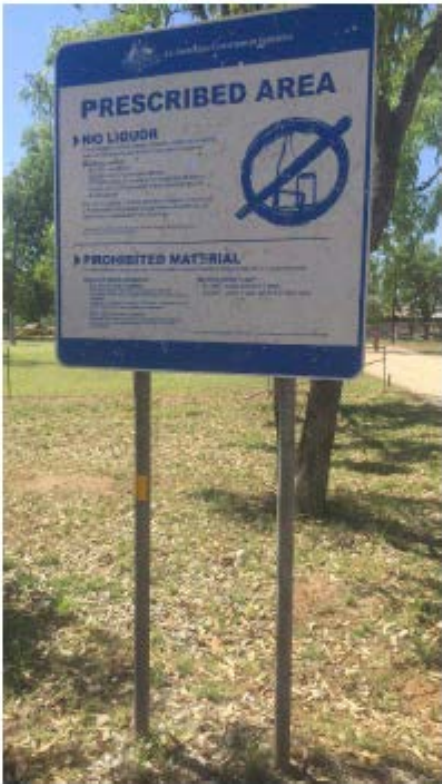
Figure 10 Sign, condition: *poor*

Aside from one poor condition sign here was no other road furniture. It is recommended that the sign be cleaned to remove any graffiti.

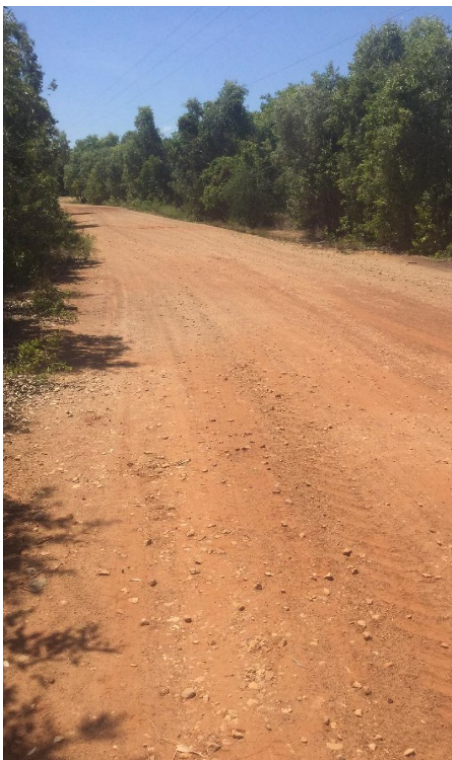
Figure 12 Pavement, condition: *poor*

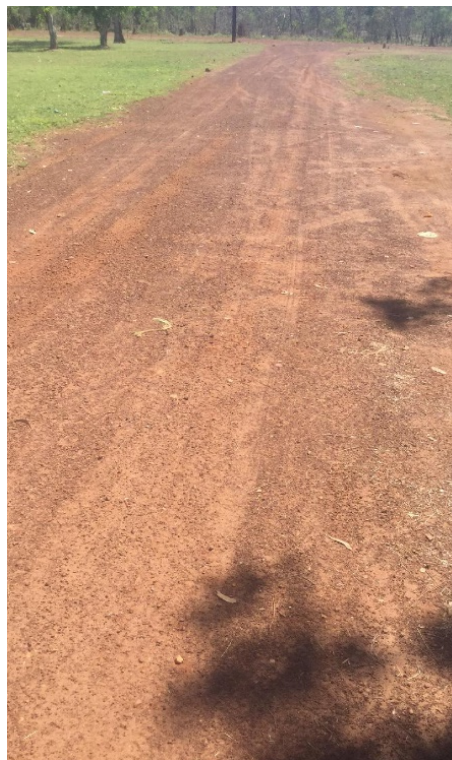
Figure 13 Pavement, condition: *good*

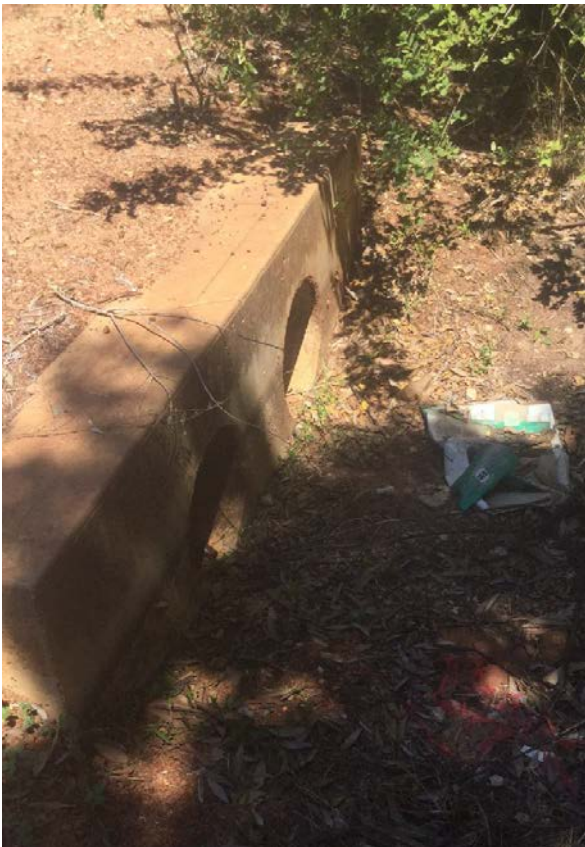
Figure 14 Twin RCP culvert and headwall, condition: *good*

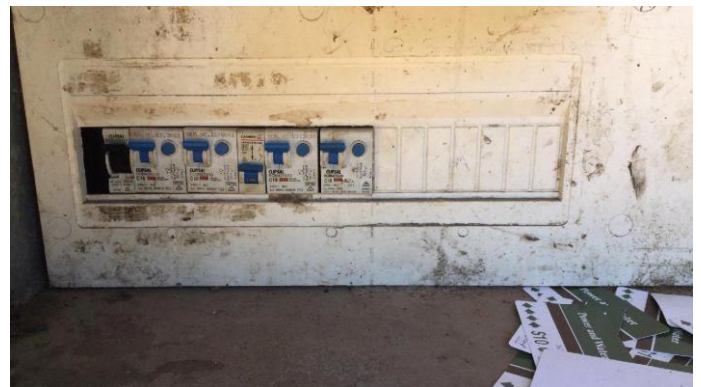
Meter Comment: Blank plates are missing on CB slot.
