DINYBULU
REGIONAL SERVICES
RAMINGINING

HHIPN00006 Ngangalala Housing Upgrades

House 10 - Ngangalala Completion Report

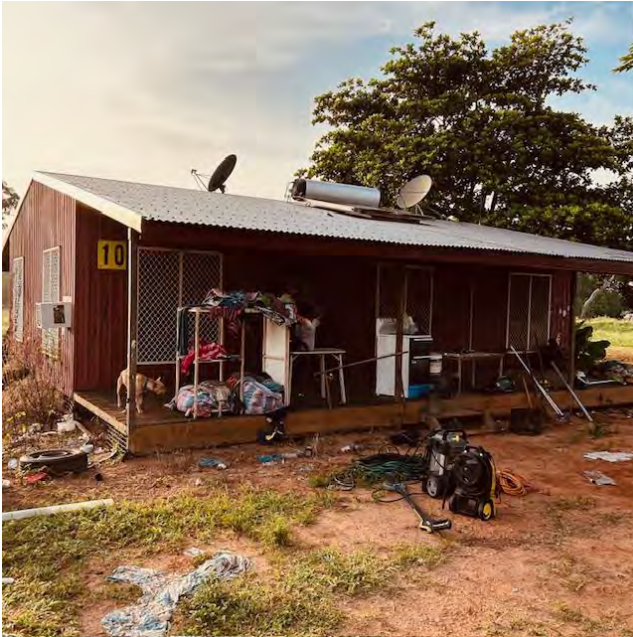
Front of House

House in Poor structural condition where existing wet areas are located,

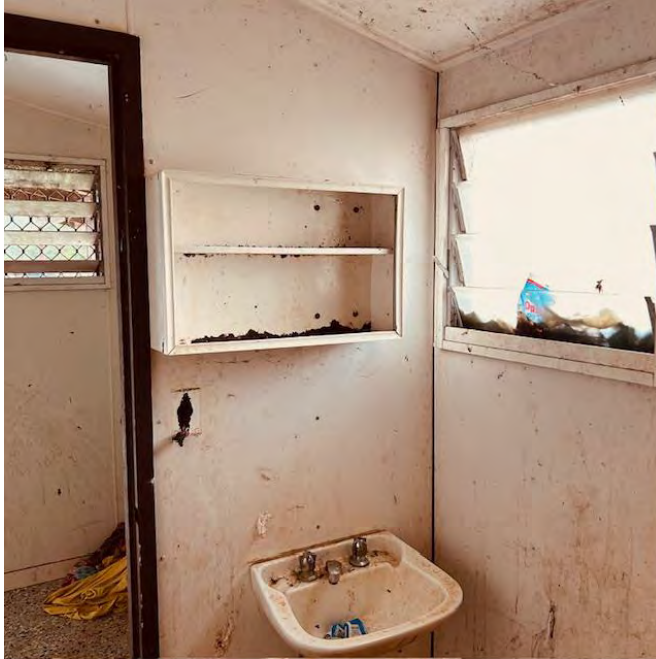
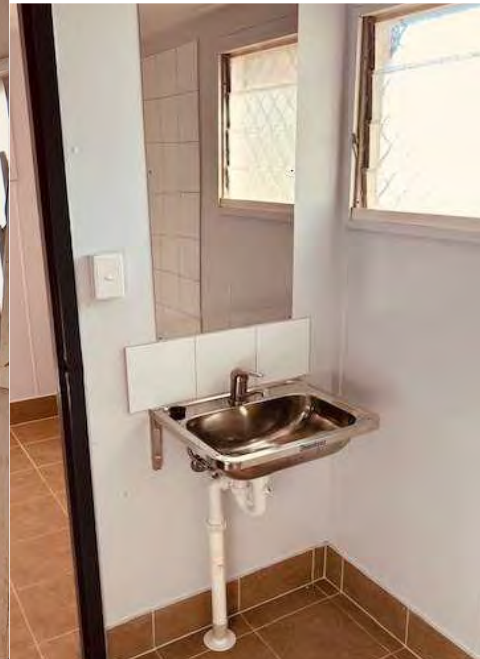
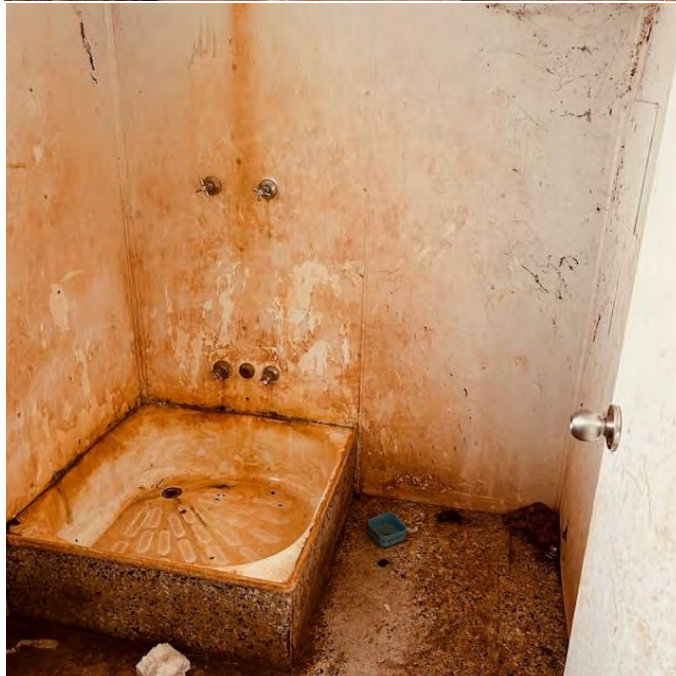
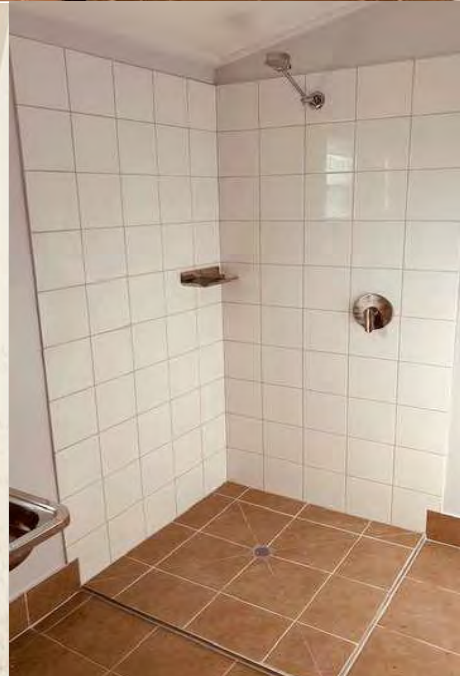
Bathroom

- Scope identified replacing 3 bearers and 15 joists in the external back verandah
- 12m @ 3 bearers identified in the scope continue under the bathroom
- Among other things, scope only identified replacing floorboards in the bathroom on the assumption that the joists under the bathroom are in good condition
- When floorboards have been removed, it has exposed 10 joists under the bathroom are corroded. It is our opinion that without replacing these joists the final structure integrity of the floor will be comprised.
- We recommended replacing 3m @ 10 joists under the bathroom.

Demolish Existing Bathroom, including cladding, shower base and other plumbing fixtures and flooring

Replace wall sheeting with 6mm FC Sheet, Floor 19mm FC Sheet, Tile Complete shower wall and floor and splash back to sink area
