## HHIPN00006 Ngangalala Housing Upgrades

# House 2 - Ngangalala Completion Report

## Project Summary – House 2

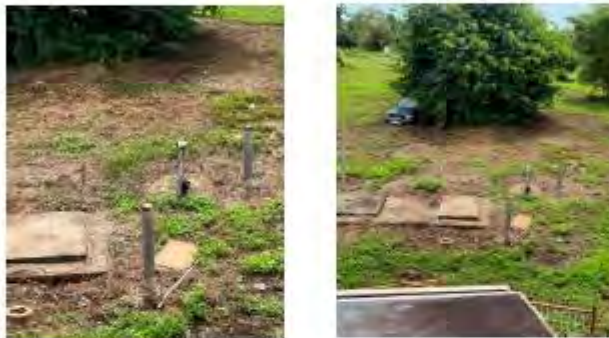
Current Photos of Lot 2 Septic System

(A). The drainage component of the Septic system is in poor condition and will require excavation to replace what is believed to be a broken section of pipe between the house and the septic pit.

(B). However, the pump system is in good condition.
