HHIPN00006 Ngangalala Housing Upgrades

House 8 - Ngangalala Completion Report

Project Summary – House 2

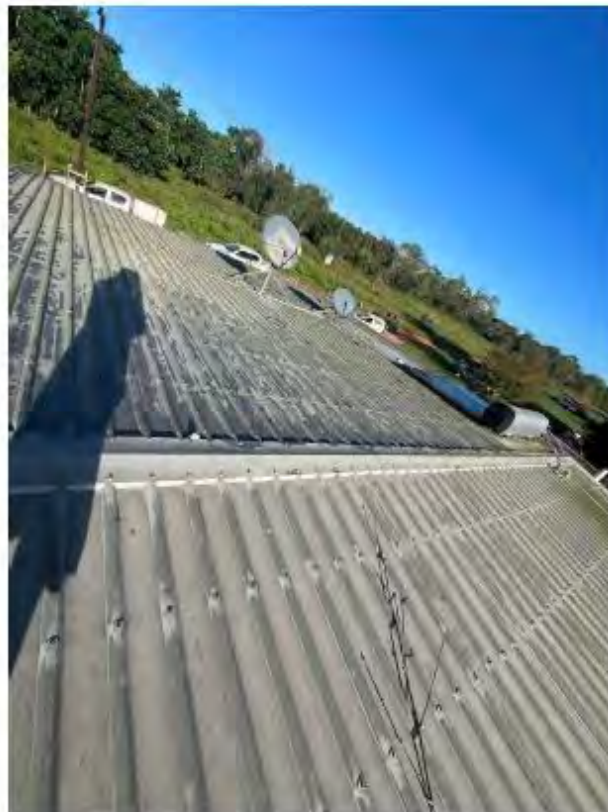
The Solar hot water system at lot 8 is currently working and is in good condition.

The expected life span of the current Solar system on house is approximately 5 - 10 years.

The community wide water pressure issue is a factor as to why the Solar is not operating at maximum capacity and pressure.

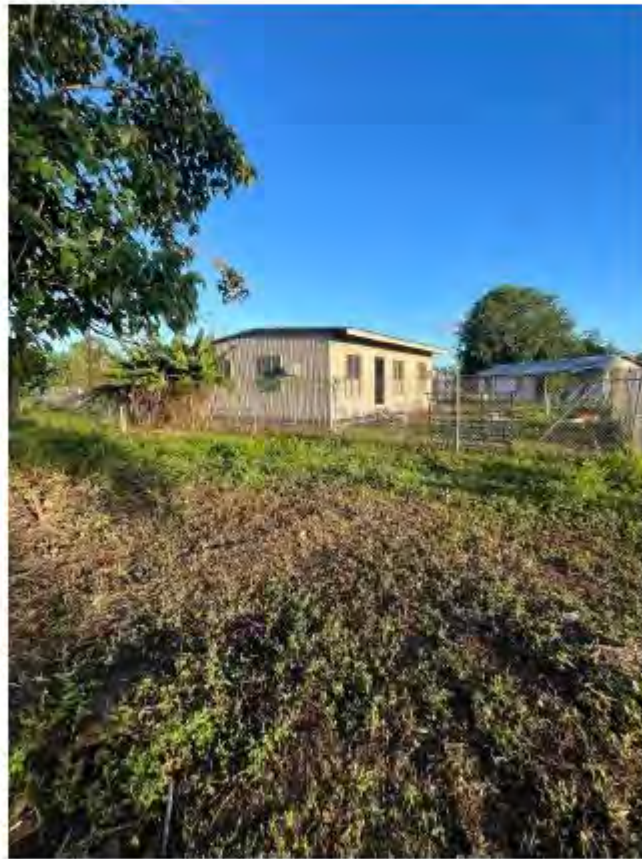
The septic system at lot 8 is a Gravity soakage system and is currently operating as required.

No further action is required on the septic system.
