HHIPN00006 Ngangalala Housing Upgrades

House 9 - Ngangalala

Completion Report

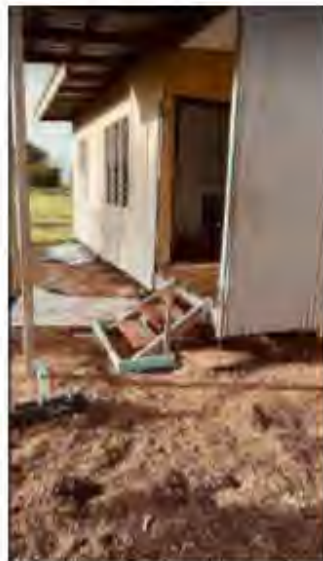
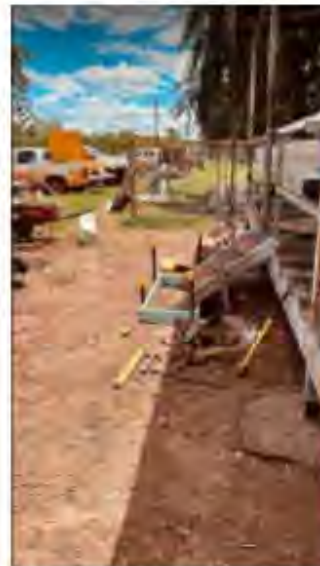
- (A) There is no concrete landing at the front and rear stairs which we recommend to have in place
- (B) We recommend 1200mm x 750mm concrete landing slab 100mm thick to meet BCA compliance
- (C) Please refer to the photos below
