Completion Report

Homelands Housing and Infrastructure Program

HHIP2500001 Rockhole Community

Civil & Housing Refurbishment

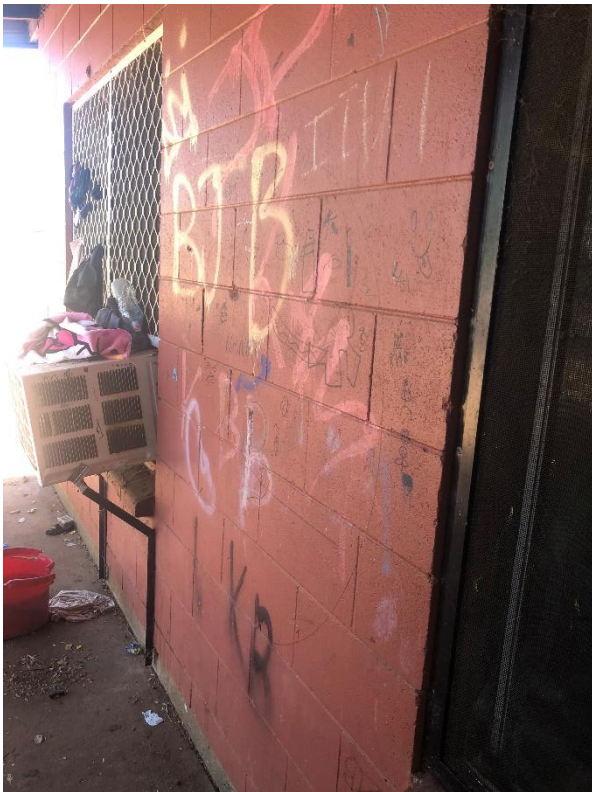
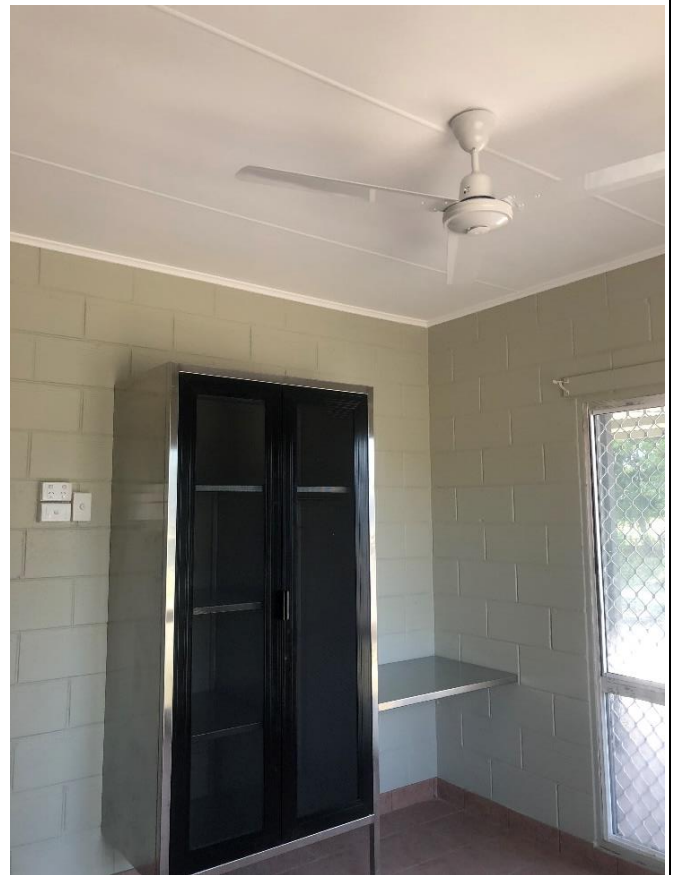
Bedroom 2

No internal photo to show as access was restricted during the initial scoping of works.
