# Completion Report

NTWP00013 - NT Wide - Solar Replacement -

- Burrum House 1 Solar Power and Re Roof Project

House 1 Standalone System Replacement

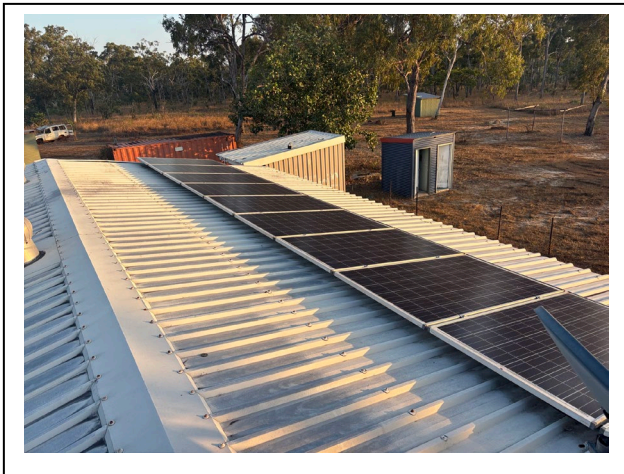
Old solar panels on house

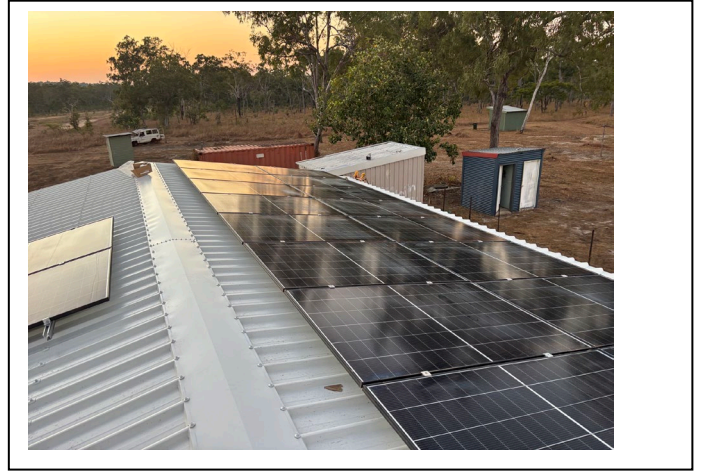
New solar

- Install 20 x 440W solar panels
- Install 25kWh x Lithium batteries.
- Install 1 x Victron Inverter Charger 5000.
- Install 1 x Victron MPPT RS450/100 solar regulator.
- Install 1 x control panel.

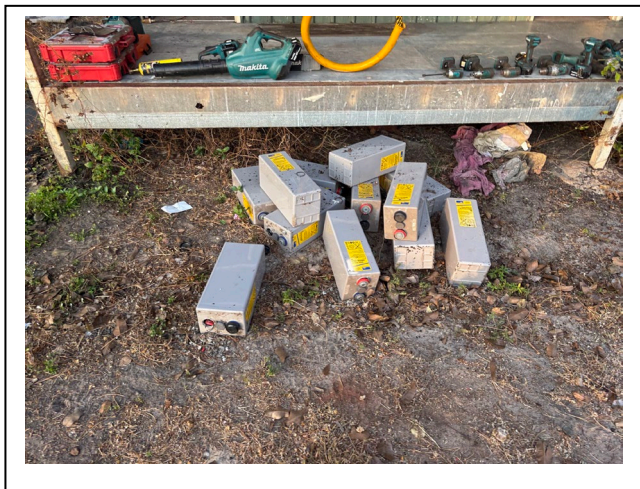
Old Battery bank

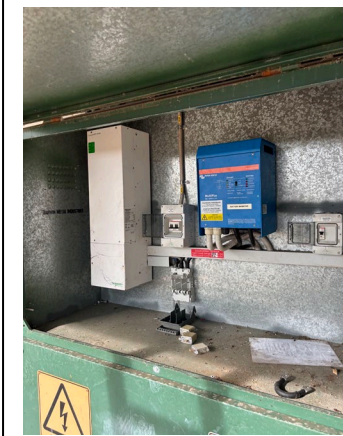
Old solar connection

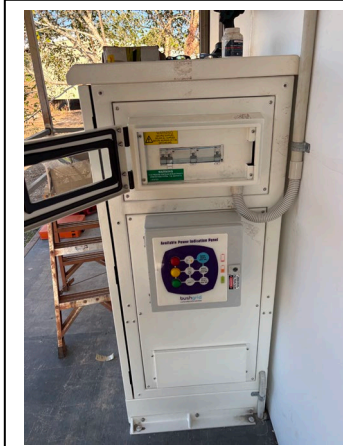
New switchboard and light indication panel for load

- Install 1 x load shedding main switchboard (metal enclosed) with a load shedding and indication panel to show battery state of charge and available appliances. Light indication and colour stickers will be on each application.

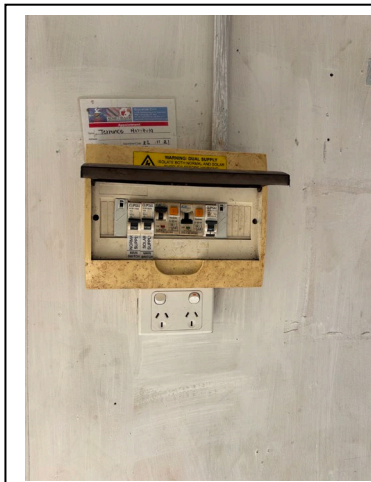
Removed old DB

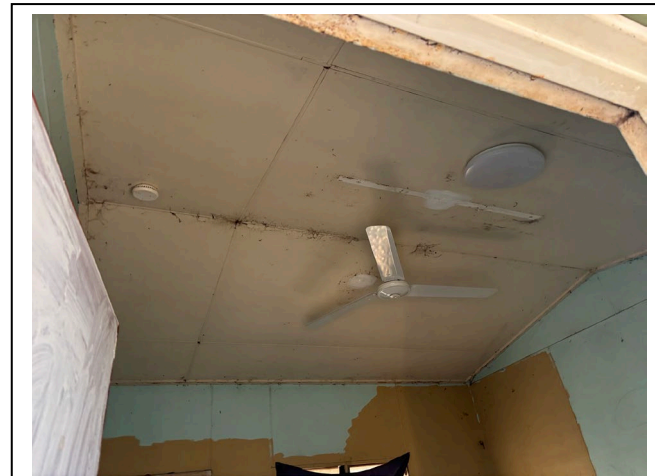
New fans and lighting

- Replace wires where required and surface mount if applicable.
- Install new LED fittings.
- Allow for 1 new LED light, fan, and power point per room.
- Install lights and power in outdoor areas.
- Install 2 x outside LED flood lights.
- Install 1 x AC circuit with load shedding control.
- Install 2 x AC isolators for AC connection.

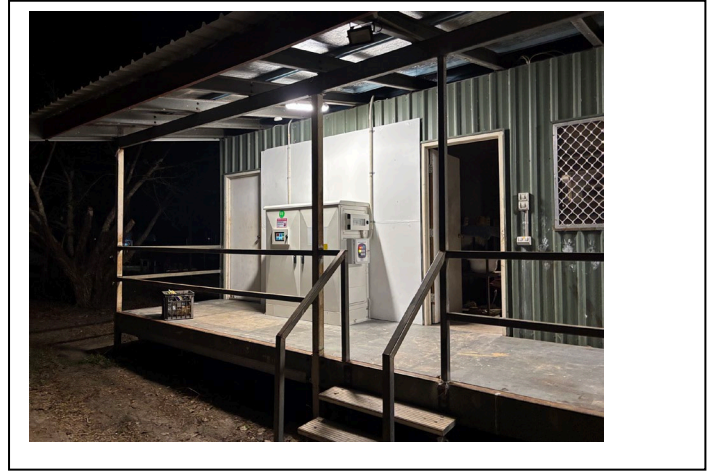
New inverter enclosure

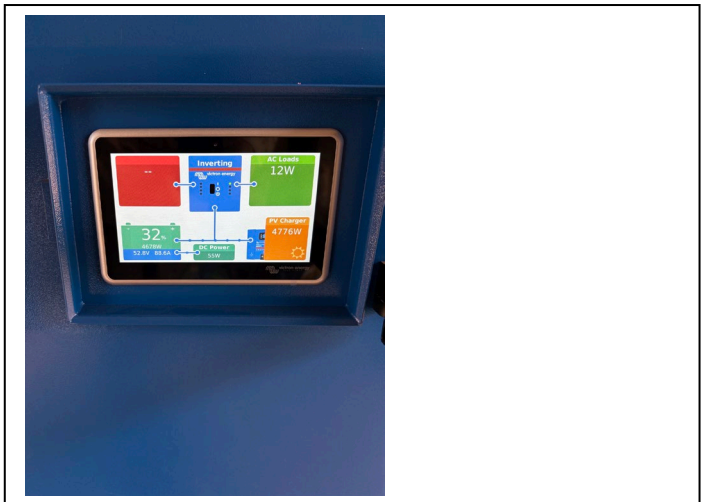
Display and control
