NT Town Camp Infrastructure Assessments: Sewerage

87 - Larapinta Valley (Alice Springs)

Northern Territory Town Camps

Civil Infrastructure

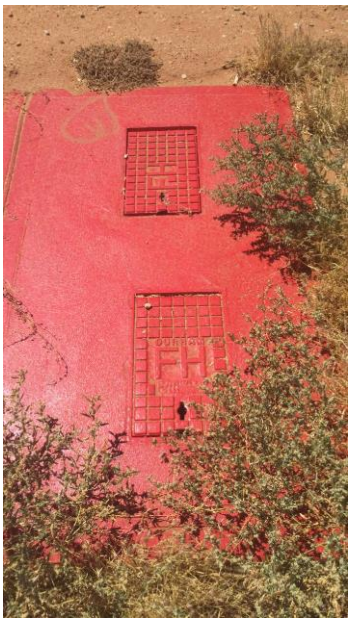
Single or Double:	Double
Sluice Valve:	Yes
Above or Below ground:	Below ground
FH Leakage:	No Access
Bollards around hydrant:	No
FH Condition:	5 - Excellent
FH Comment:

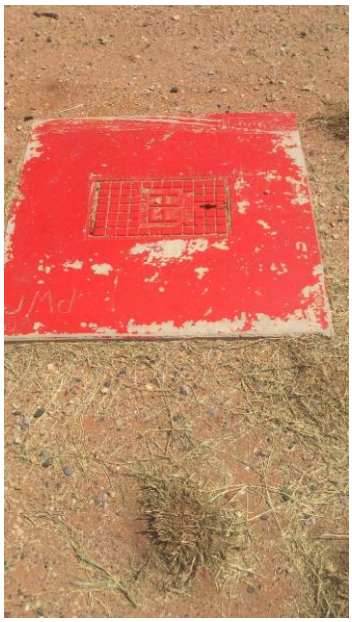
Single or Double:	Single
Sluice Valve:	Yes
Above or Below ground:	Below ground
FH Leakage:	No Access
Bollards around hydrant:	No
FH Condition:	4 - Very Good
FH Comment:	Some pealing paint

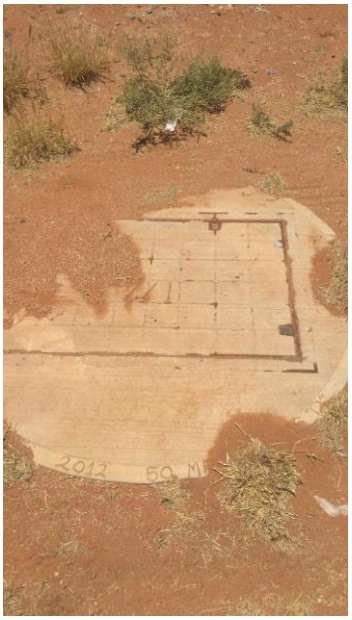
Insp ID: 464	Group 4 - Alice Springs	Yarrenty Altere (Larapinta Valley)

What Sewerage Asset are you capturing:	Manholes
MH Cover Shape:	Rectangular
Manhole Cover Diam (mm):	
Manhole Length (mm):	1000
Manhole Width (mm):	700
Manhole Condition:	4 - Very Good
Notes on Lid:	Class d
Comments:

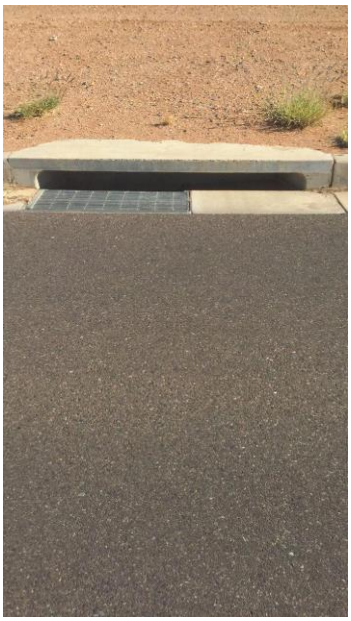
Insp ID: 332	Group 4 - Alice Springs	Yarrenty Altere (Larapinta Valley)

Stormwater Infrastructure:	SEP
Number of Bays:	2
On grade or sag pit:	
Both sides of road:	Both
Condition:	5 - Excellent
Blockage (%):	
Comment:

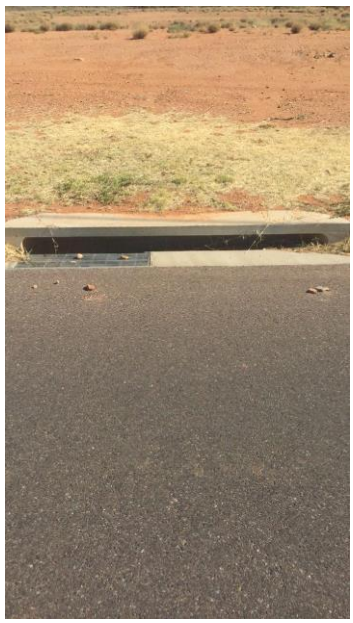
Insp ID: 346	Group 4 - Alice Springs	Yarrenty Altere (Larapinta Valley)

Stormwater Infrastructure:	SEP
Number of Bays:	2
On grade or sag pit:	
Both sides of road:	Both
Condition:	4 - Very Good
Blockage (%):	
Comment:

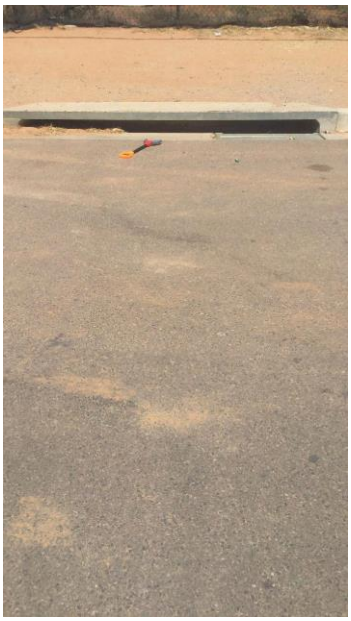
Insp ID: 378 Group 4 - Alice Springs Yarrenty Altere (Larapinta Valley)

Stormwater Infrastructure:	SEP
Number of Bays:	3
On grade or sag pit:	
Both sides of road:	Right
Condition:	4 - Very Good
Blockage (%):	10
Comment:

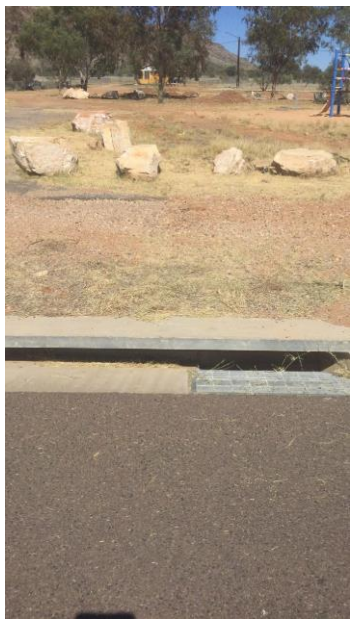
Stormwater Infrastructure:	SEP
Number of Bays:	2
On grade or sag pit:	
Both sides of road:	Both
Condition:	5 - Excellent
Blockage (%):	
Comment:	Light debris

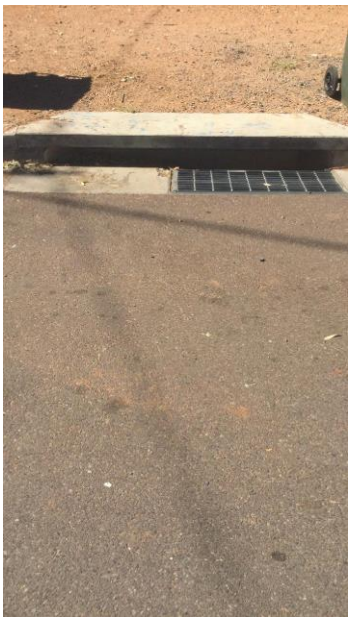
Insp ID: 426	Group 4 - Alice Springs	Yarrenty Altere (Larapinta Valley)

Stormwater Infrastructure:	SEP
Number of Bays:	2
On grade or sag pit:	
Both sides of road:	Right
Condition:	4 - Very Good
Blockage (%):	
Comment:

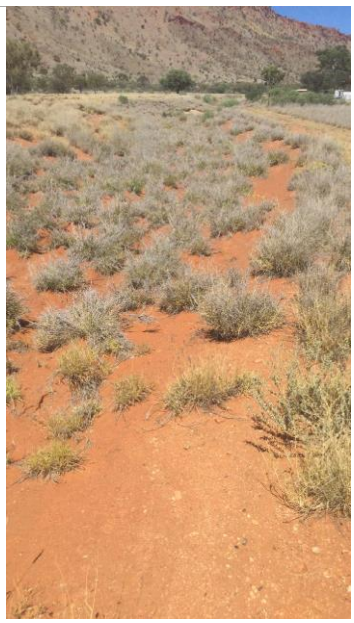
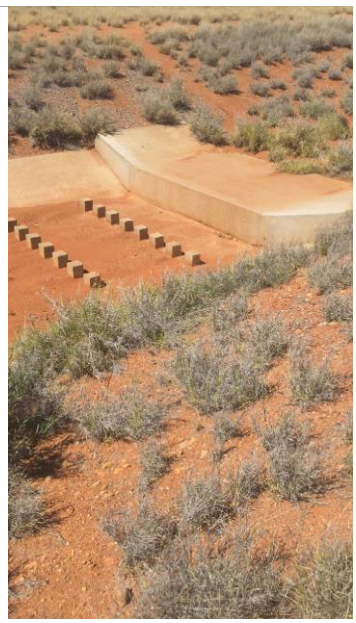
Stormwater Infrastructure:	Swales
Type of lining:	Natural Grasses
Are dimensions uniform along drain:	Yes
Base Width (m):	3
Overall Width (m):	7
Swale Depth (m):	1.2
Length of Batter 1 (m):	2
Length of Batter 2 (m):	2
Swale Condition:	3 - Good
Swale Ponding:	No
Drain flooded at time of inspection:	No
Swale Comments:	Drop structures along Swale

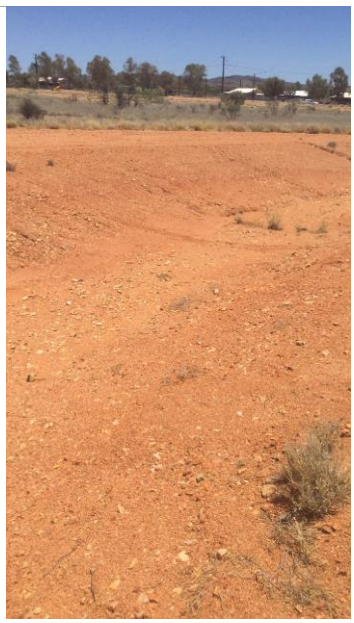
Insp ID: 478 Group 4 - Alice Springs Yarrenty Altere (Larapinta Valley)

Stormwater Infrastructure:	Swales
Type of lining:	No Lining
Are dimensions uniform along drain:	Yes
Base Width (m):	2.5
Overall Width (m):	7.5
Swale Depth (m):	1.5
Length of Batter 1 (m):	2.5
Length of Batter 2 (m):	2.5
Swale Condition:	4 - Very Good
Swale Ponding:	No
Drain flooded at time of inspection:	No
Swale Comments:

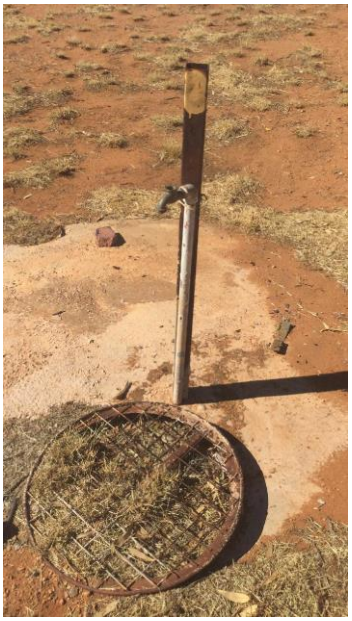
Diameter(mm):	25
Tap Leakage:	No
Tap Condition:	1 - Very Poor
Tap Comment:	Broken

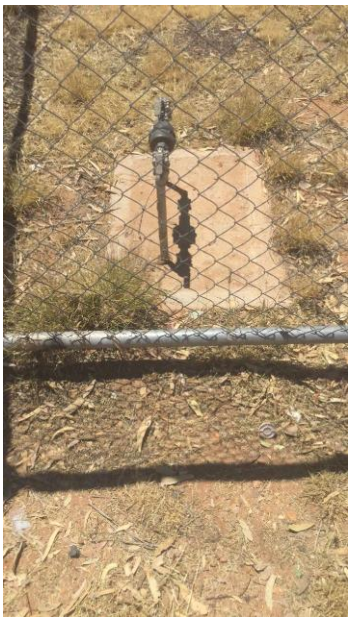
Water Meter Type:	Lot
Bulk Water Meter Size (mm):	
Bulk Water Meter Condition:	
Bulk Water Meter Comment:	
Lot Number:	7
Lot Water Meter Size:	25
Lot Water Meter Condition:	4 - Very Good
Lot Water Meter Comment:

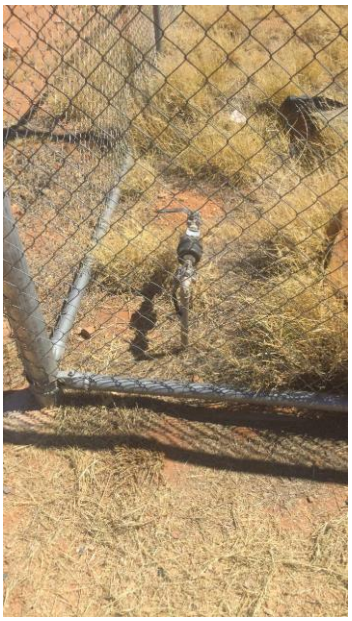
Water Meter Type:	Lot
Bulk Water Meter Size (mm):	
Bulk Water Meter Condition:	
Bulk Water Meter Comment:	
Lot Number:	
Lot Water Meter Size:	25
Lot Water Meter Condition:	3 - Good
Lot Water Meter Comment:

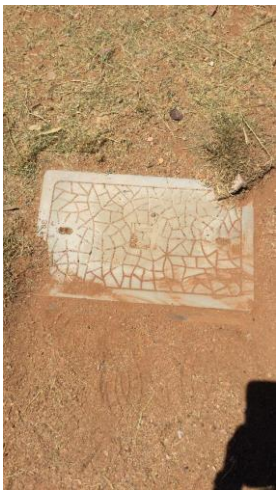
Insp ID: 196	Group 4 - Alice Springs	Yarrenty Altere (Larapinta Valley)

What Comms Category are you capturing:	Distribution
What is distribution method to households:	Underground
Is it Shared with PWC:	
Is there Anti-climb barrier provided for this pole:	
What is Pole construction type:	
Is street light fitted:	
Is there concrete collar around the base of pole:	
What is the condition of tap off to house:	
What is the condition of pole:	
How many Lots are connected to this pole:	
Is there access to Pits to take a photo:	No
What is Pit Condition:	3
Underground Comments:

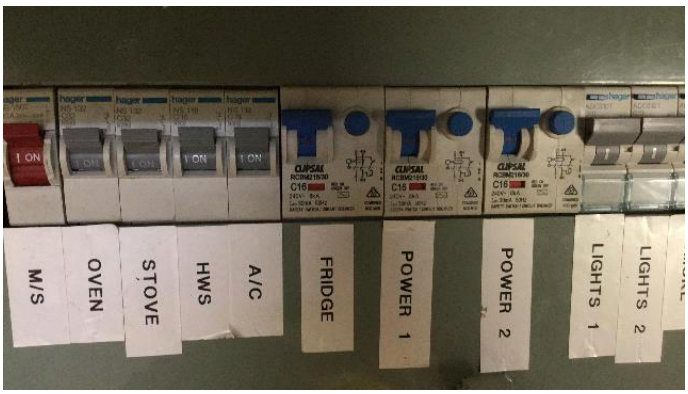
Meter Type: Prepaid

Meter Switchboard Cond: 2

Meter Condition: 3

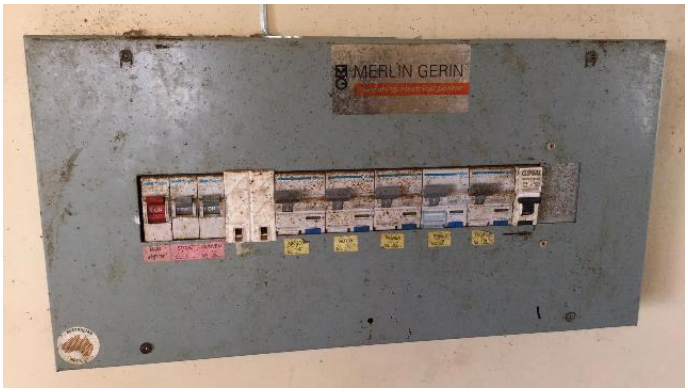
Meter Type:	Prepaid
Meter Switchboard Cond:	3
Meter Condition:	3
Meter Comment:	Indoor SB, Cond 3
Comments:

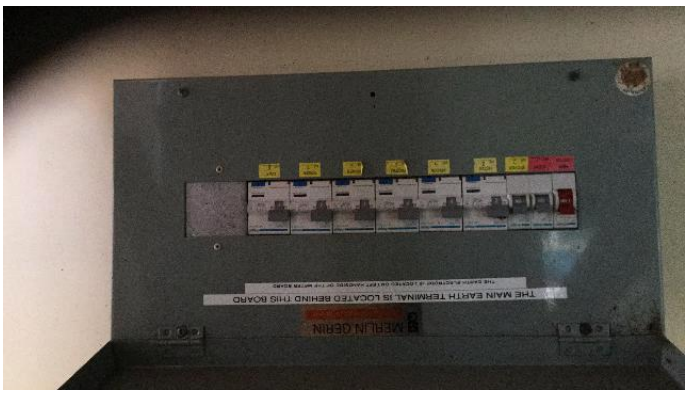
Meter Type: Prepaid

Meter Switchboard Cond: 3

Meter Condition: 3

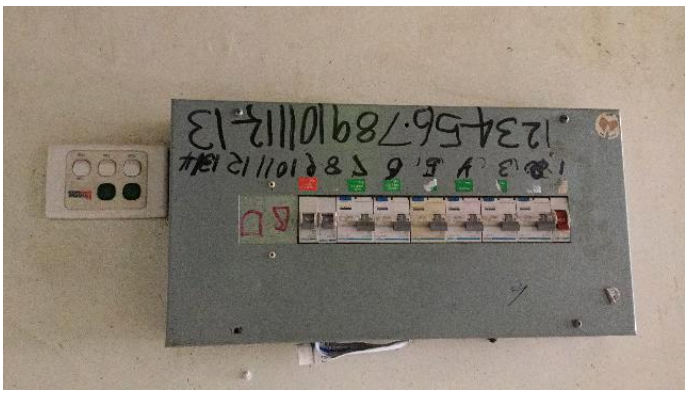
Meter Type:	Prepaid
Meter Switchboard Cond:	3
Meter Condition:	3
Meter Comment:	Indoor SB, Cond 3
Comments:

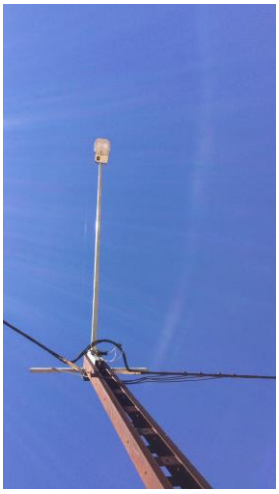
What Category are you capturing:	Overhead Poles
What is Pole Material type:	Welded
What is the condition of pole:	3
How is the pole planted:	Concrete
What is the Condition of plant:	3
Is street light fitted:	Yes
Street Light Power Supply:	
Street Light Type	S70D 10
Street Light Watts	70
Street Light Condition	3
Street Light Height	
What is the type of service:	Three
What is the HV voltage level:	400
What is the arrangement of connected cables:	Twisted
Are there isolators on the pole:	No
What is the Condition:	3
How many Lots are connected to this pole:	0
Overhead Pole Comments:	Surface rusted

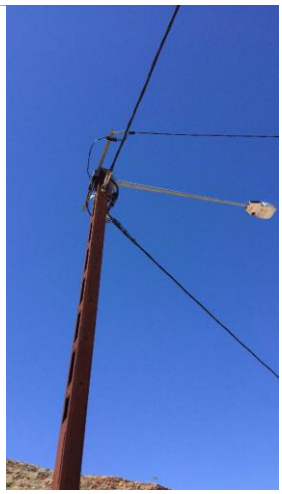
What Category are you capturing:	Overhead Poles
What is Pole Material type:	Welded
What is the condition of pole:	3
How is the pole planted:	Concrete
What is the Condition of plant:	3
Is street light fitted:	Yes
Street Light Power Supply:	
Street Light Type	S150C 11
Street Light Watts	150
Street Light Condition	3
Street Light Height	
What is the type of service:	Three
What is the HV voltage level:	400
What is the arrangement of connected cables:	Twisted
Are there isolators on the pole:	No
What is the Condition:	3
How many Lots are connected to this pole:	0
Overhead Pole Comments:	Surface rusted

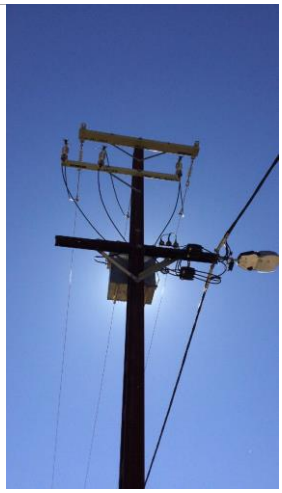
What Category are you capturing:	Overhead Poles
What is Pole Material type:	Welded
What is the condition of pole:	3
How is the pole planted:	Concrete
What is the Condition of plant:	3
Is street light fitted:	Yes
Street Light Power Supply:	
Street Light Type	S150C 11
Street Light Watts	150
Street Light Condition	3
Street Light Height	
What is the type of service:	Combined
What is the HV voltage level:	11000
What is the arrangement of connected cables:	Parallel
Are there isolators on the pole:	Yes
What is the Condition:	3
How many Lots are connected to this pole:	0
Overhead Pole Comments:	Surface rusted

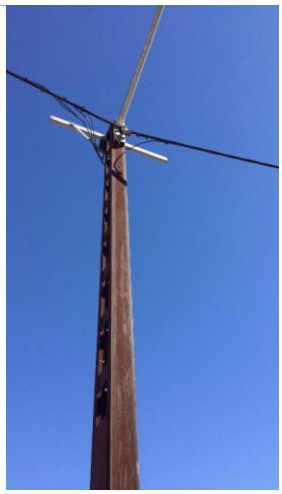
What Category are you capturing:	Overhead Poles
What is Pole Material type:	Welded
What is the condition of pole:	3
How is the pole planted:	Concrete
What is the Condition of plant:	3
Is street light fitted:	Yes
Street Light Power Supply:	
Street Light Type	S70D 11
Street Light Watts	70
Street Light Condition	3
Street Light Height	
What is the type of service:	Three
What is the HV voltage level:	400
What is the arrangement of connected cables:	Twisted
Are there isolators on the pole:	No
What is the Condition:	3
How many Lots are connected to this pole:	0
Overhead Pole Comments:	Surface rusted

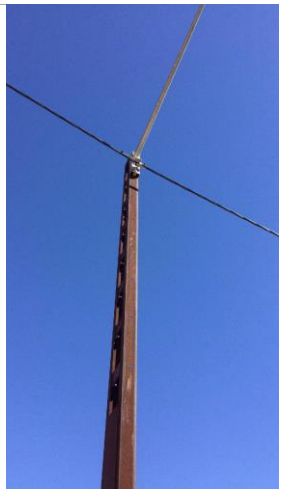
What Category are you capturing:	Overhead Poles
What is Pole Material type:	Welded
What is the condition of pole:	3
How is the pole planted:	Concrete
What is the Condition of plant:	3
Is street light fitted:	Yes
Street Light Power Supply:	
Street Light Type	S70D 11
Street Light Watts	70
Street Light Condition	2
Street Light Height	
What is the type of service:	Three
What is the HV voltage level:	400
What is the arrangement of connected cables:	Twisted
Are there isolators on the pole:	No
What is the Condition:	3
How many Lots are connected to this pole:	0
Overhead Pole Comments:	Surface rusted

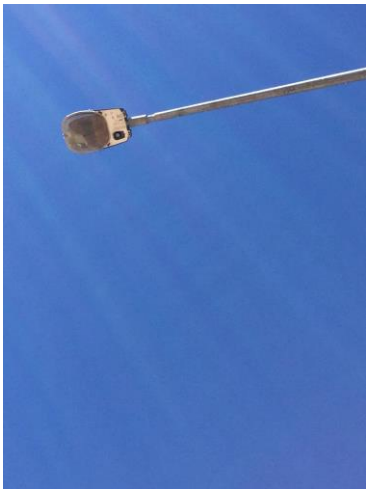
What Category are you capturing:	Overhead Poles
What is Pole Material type:	Welded
What is the condition of pole:	3
How is the pole planted:	Concrete
What is the Condition of plant:	3
Is street light fitted:	Yes
Street Light Power Supply:	
Street Light Type	S150C 11
Street Light Watts	150
Street Light Condition	3
Street Light Height	
What is the type of service:	Three
What is the HV voltage level:	400
What is the arrangement of connected cables:	Twisted
Are there isolators on the pole:	No
What is the Condition:	3
How many Lots are connected to this pole:	2
Overhead Pole Comments:	Surface rusted

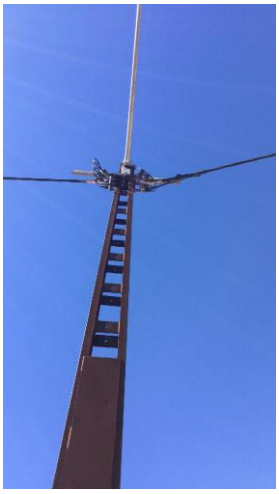
What Category are you capturing:	Overhead Poles
What is Pole Material type:	Welded
What is the condition of pole:	3
How is the pole planted:	Concrete
What is the Condition of plant:	3
Is street light fitted:	Yes
Street Light Power Supply:	
Street Light Type	S70D 11
Street Light Watts	70
Street Light Condition	3
Street Light Height	
What is the type of service:	Three
What is the HV voltage level:	400
What is the arrangement of connected cables:	Twisted
Are there isolators on the pole:	No
What is the Condition:	3
How many Lots are connected to this pole:	1
Overhead Pole Comments:	Surface rusted

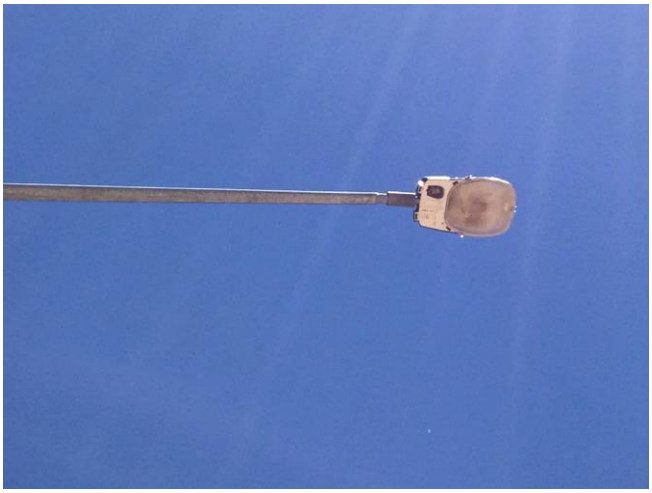
What Category are you capturing:	Overhead Poles
What is Pole Material type:	Welded
What is the condition of pole:	3
How is the pole planted:	Concrete
What is the Condition of plant:	3
Is street light fitted:	Yes
Street Light Power Supply:	
Street Light Type	S150C 11
Street Light Watts	150
Street Light Condition	3
Street Light Height	
What is the type of service:	Three
What is the HV voltage level:	400
What is the arrangement of connected cables:	Twisted
Are there isolators on the pole:	No
What is the Condition:	3
How many Lots are connected to this pole:	2
Overhead Pole Comments:	Surface rusted

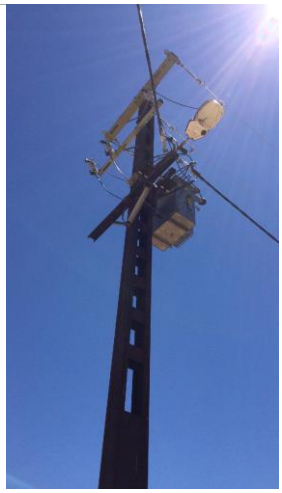
What Category are you capturing:	Overhead Poles
What is Pole Material type:	Welded
What is the condition of pole:	3
How is the pole planted:	Concrete
What is the Condition of plant:	3
Is street light fitted:	Yes
Street Light Power Supply:	
Street Light Type	S150C
Street Light Watts	150
Street Light Condition	2
Street Light Height	
What is the type of service:	Combined
What is the HV voltage level:	11000
What is the arrangement of connected cables:	Parallel
Are there isolators on the pole:	Yes
What is the Condition:	3
How many Lots are connected to this pole:	0
Overhead Pole Comments:	Surface rusted

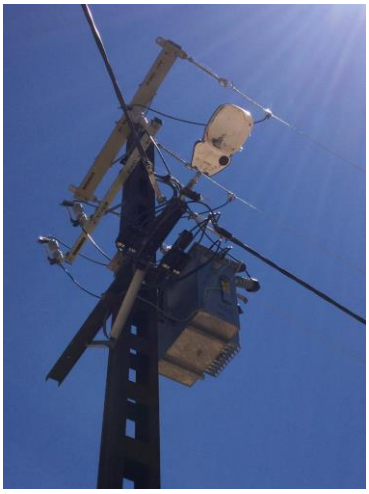
What Category are you capturing:	Overhead Poles
What is Pole Material type:	Welded
What is the condition of pole:	3
How is the pole planted:	Concrete
What is the Condition of plant:	3
Is street light fitted:	Yes
Street Light Power Supply:	
Street Light Type	S150C
Street Light Watts	150
Street Light Condition	3
Street Light Height	
What is the type of service:	Combined
What is the HV voltage level:	11000
What is the arrangement of connected cables:	Parallel
Are there isolators on the pole:	No
What is the Condition:	3
How many Lots are connected to this pole:	0
Overhead Pole Comments:	Surface rusted

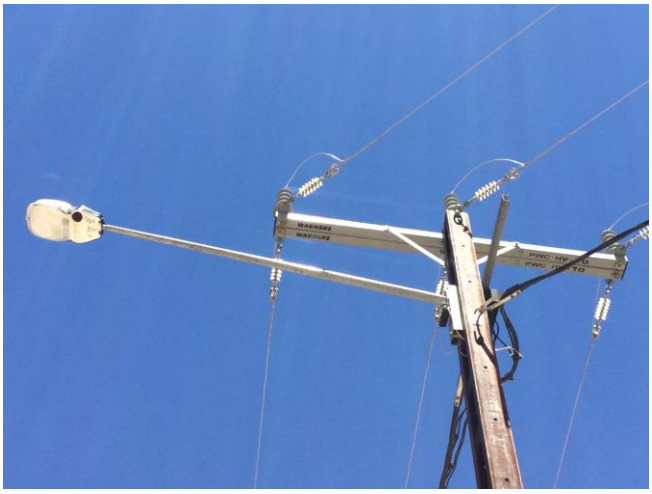
What Category are you capturing:	Overhead Poles
What is Pole Material type:	Welded
What is the condition of pole:	3
How is the pole planted:	Concrete
What is the Condition of plant:	3
Is street light fitted:	Yes
Street Light Power Supply:	
Street Light Type	S150C
Street Light Watts	150
Street Light Condition	3
Street Light Height	
What is the type of service:	Combined
What is the HV voltage level:	11000
What is the arrangement of connected cables:	Parallel
Are there isolators on the pole:	No
What is the Condition:	3
How many Lots are connected to this pole:	2
Overhead Pole Comments:	Surface rusted

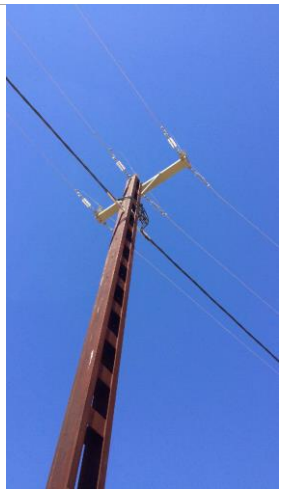
What Category are you capturing:	Overhead Poles
What is Pole Material type:	Welded
What is the condition of pole:	3
How is the pole planted:	Concrete
What is the Condition of plant:	3
Is street light fitted:	No
Street Light Power Supply:	
Street Light Type	
Street Light Watts	
Street Light Condition	
Street Light Height	
What is the type of service:	Combined
What is the HV voltage level:	11000
What is the arrangement of connected cables:	Parallel
Are there isolators on the pole:	
What is the Condition:	3
How many Lots are connected to this pole:	0
Overhead Pole Comments:	Surface rusted

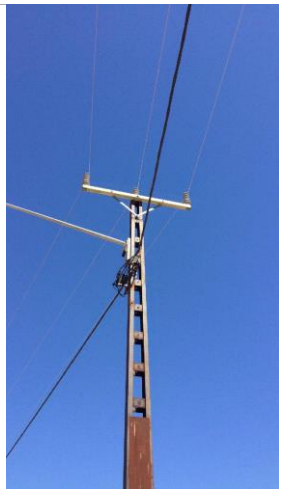
What Category are you capturing:	Overhead Poles
What is Pole Material type:	Welded
What is the condition of pole:	3
How is the pole planted:	Concrete
What is the Condition of plant:	3
Is street light fitted:	Yes
Street Light Power Supply:	
Street Light Type	S150C
Street Light Watts	150
Street Light Condition	3
Street Light Height	
What is the type of service:	Combined
What is the HV voltage level:	11000
What is the arrangement of connected cables:	Parallel
Are there isolators on the pole:	Yes
What is the Condition:	3
How many Lots are connected to this pole:	0
Overhead Pole Comments:	Surface rusted

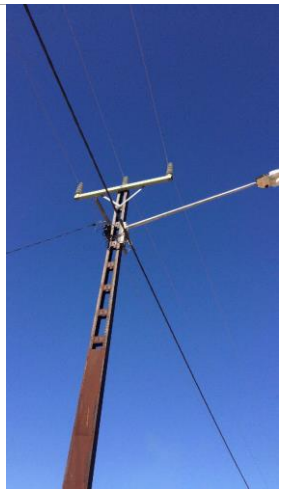
What Category are you capturing:	Overhead Poles
What is Pole Material type:	Welded
What is the condition of pole:	3
How is the pole planted:	Concrete
What is the Condition of plant:	3
Is street light fitted:	Yes
Street Light Power Supply:	
Street Light Type	S150C 11
Street Light Watts	150
Street Light Condition	3
Street Light Height	
What is the type of service:	Combined
What is the HV voltage level:	11000
What is the arrangement of connected cables:	Parallel
Are there isolators on the pole:	No
What is the Condition:	3
How many Lots are connected to this pole:	1
Overhead Pole Comments:	Surface rusted

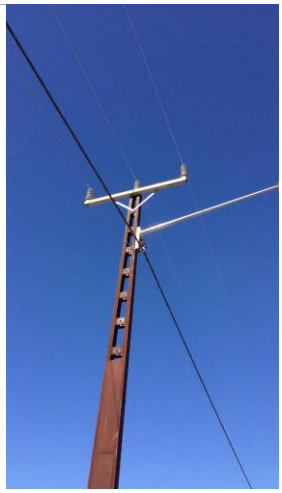
What Category are you capturing:	Overhead Poles
What is Pole Material type:	Welded
What is the condition of pole:	3
How is the pole planted:	Concrete
What is the Condition of plant:	2
Is street light fitted:	Yes
Street Light Power Supply:	
Street Light Type	S150C 11
Street Light Watts	150
Street Light Condition	3
Street Light Height	
What is the type of service:	Combined
What is the HV voltage level:	11000
What is the arrangement of connected cables:	Parallel
Are there isolators on the pole:	No
What is the Condition:	3
How many Lots are connected to this pole:	0
Overhead Pole Comments:	Concrete cracked. Pole surface rusted

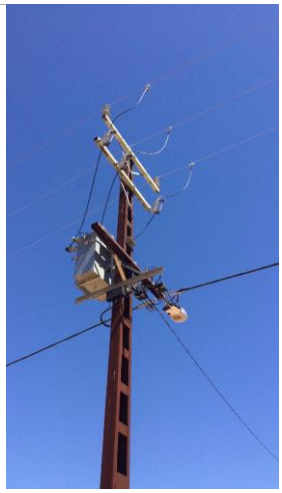
What Category are you capturing:	Overhead Poles
What is Pole Material type:	Welded
What is the condition of pole:	3
How is the pole planted:	Concrete
What is the Condition of plant:	3
Is street light fitted:	Yes
Street Light Power Supply:	
Street Light Type	S150C 11
Street Light Watts	150
Street Light Condition	1
Street Light Height	
What is the type of service:	Combined
What is the HV voltage level:	11000
What is the arrangement of connected cables:	Parallel
Are there isolators on the pole:	Yes
What is the Condition:	3
How many Lots are connected to this pole:	0
Overhead Pole Comments:	Surface rusted

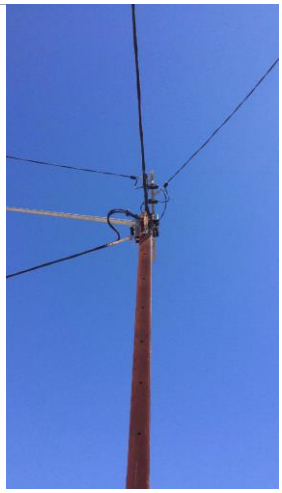
What Category are you capturing:	Overhead Poles
What is Pole Material type:	Welded
What is the condition of pole:	3
How is the pole planted:	Direct
What is the Condition of plant:	3
Is street light fitted:	Yes
Street Light Power Supply:	
Street Light Type	S70D 11
Street Light Watts	70
Street Light Condition	3
Street Light Height	
What is the type of service:	Three
What is the HV voltage level:	400
What is the arrangement of connected cables:	Twisted
Are there isolators on the pole:	No
What is the Condition:	3
How many Lots are connected to this pole:	2
Overhead Pole Comments:	Surface rusted

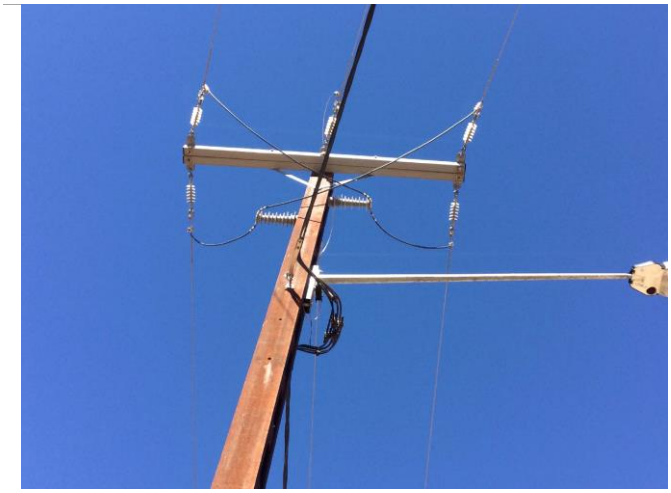
Insp ID: 229 Group 4 - Alice Springs Yarrenty Altere (Larapinta Valley)

What Category are you capturing:	Overhead Poles
Is street light fitted:	Yes
Street Light Power Supply:	
Street Light Type	S150C 11
Street Light Watts	150
Street Light Condition	2
Street Light Height

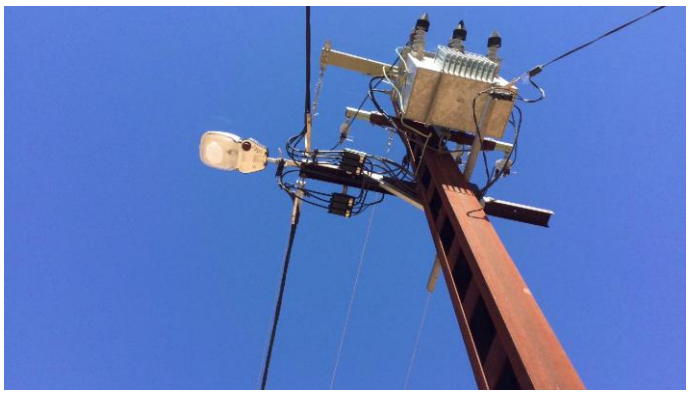
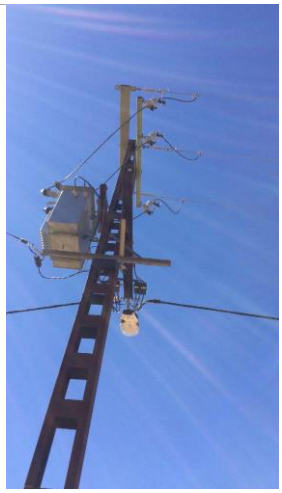
Insp ID: 233 Group 4 - Alice Springs Yarrenty Altere (Larapinta Valley)

What Category are you capturing:	Overhead Poles
Is street light fitted:	Yes
Street Light Power Supply:	
Street Light Type	S150C 11
Street Light Watts	150
Street Light Condition	3
Street Light Height

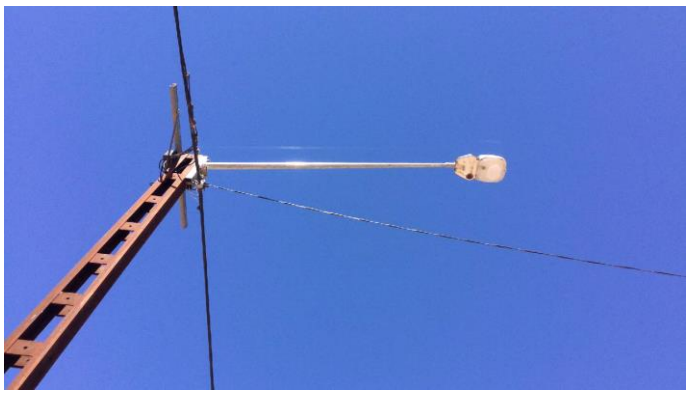
Insp ID: 236 Group 4 - Alice Springs Yarrenty Altere (Larapinta Valley)

What Category are you capturing:	Overhead Poles
Is street light fitted:	Yes
Street Light Power Supply:	
Street Light Type	S150C 11
Street Light Watts	150
Street Light Condition	3
Street Light Height

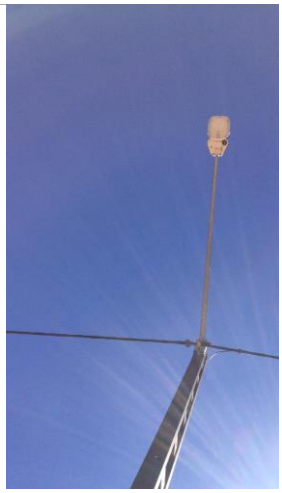
Insp ID: 238 Group 4 - Alice Springs Yarrenty Altere (Larapinta Valley)

What Category are you capturing:	Overhead Poles
Is street light fitted:	Yes
Street Light Power Supply:	
Street Light Type	S150C 15
Street Light Watts	150
Street Light Condition	3
Street Light Height

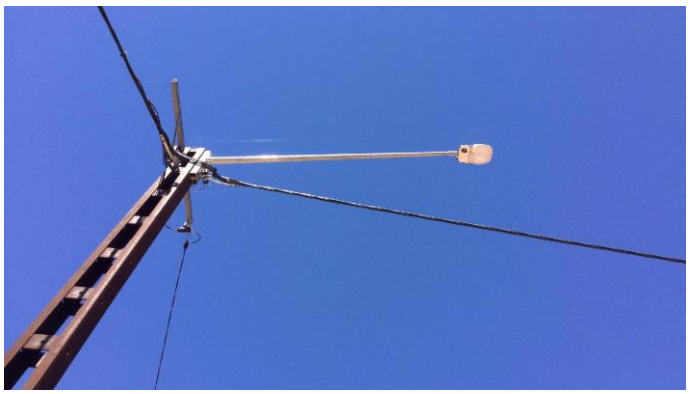
Insp ID: 241 Group 4 - Alice Springs Yarrenty Altere (Larapinta Valley)

What Category are you capturing:	Overhead Poles
Is street light fitted:	Yes
Street Light Power Supply:	
Street Light Type	S70D 11
Street Light Watts	70
Street Light Condition	3
Street Light Height

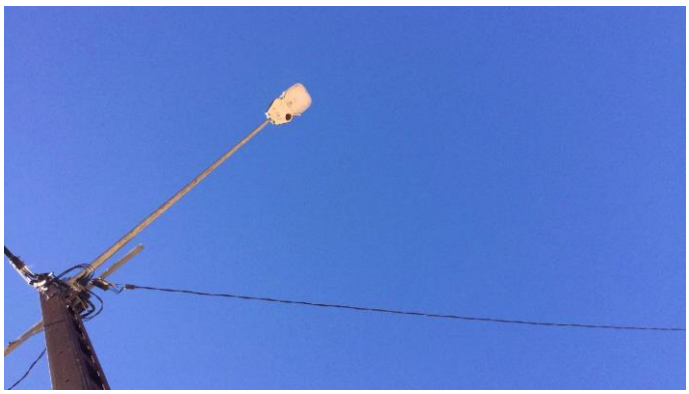
Insp ID: 243 Group 4 - Alice Springs Yarrenty Altere (Larapinta Valley)

What Category are you capturing:	Overhead Poles
Is street light fitted:	Yes
Street Light Power Supply:	
Street Light Type	S150C 11
Street Light Watts	150
Street Light Condition	3
Street Light Height

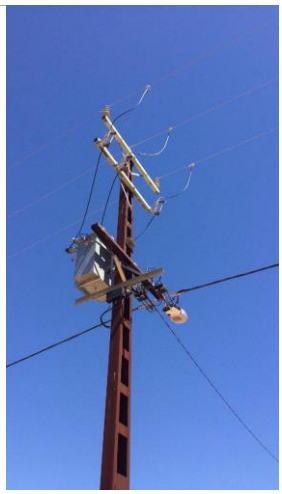
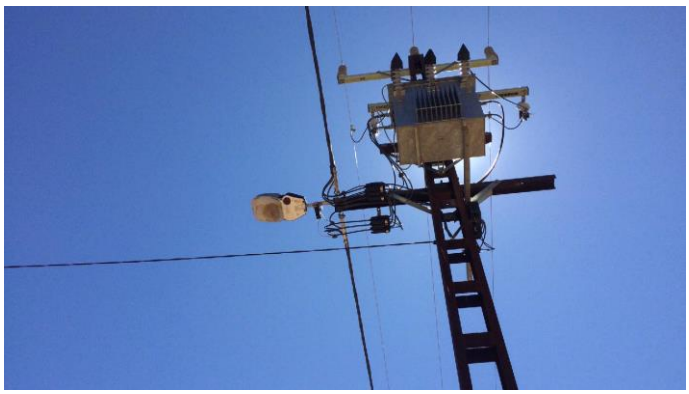
Insp ID: 246 Group 4 - Alice Springs Yarrenty Altere (Larapinta Valley)

What Category are you capturing:	Overhead Poles
Is street light fitted:	Yes
Street Light Power Supply:	
Street Light Type	S150C 11
Street Light Watts	150
Street Light Condition	1
Street Light Height

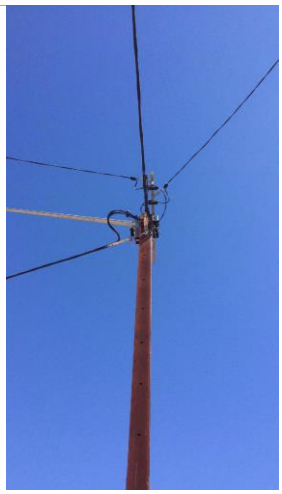
Insp ID: 250	Group 4 - Alice Springs	Yarrenty Altere (Larapinta Valley)

What Category are you capturing:	Overhead Poles
Is street light fitted:	Yes
Street Light Power Supply:	
Street Light Type	S70D 11
Street Light Watts	70
Street Light Condition	3
Street Light Height

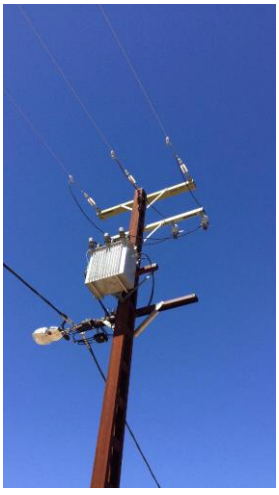
Insp ID: 181 Group 4 - Alice Springs Yarrenty Altere (Larapinta Valley)

What Category are you capturing:	Transformers
What is Transformer installation method:	Pole
If method know:	11SS1P
What is the condition of the mounting:	3
What is Transformer Rating:	Unknown
Is there access to transformers name plate to take a photo:	No
What is the condition of transformer:	3
What is cable type to transformer:	PVC insulated. Black.
What is cable size to transformer:	
Is there switch gear or fusing associated with the transformer:	Cut out fuse
Transformer Comment:

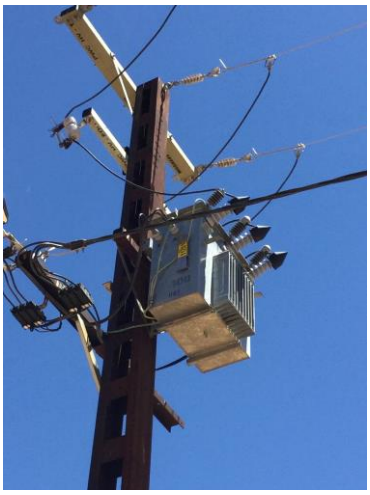
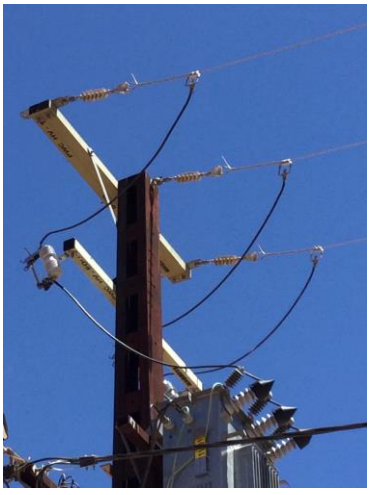
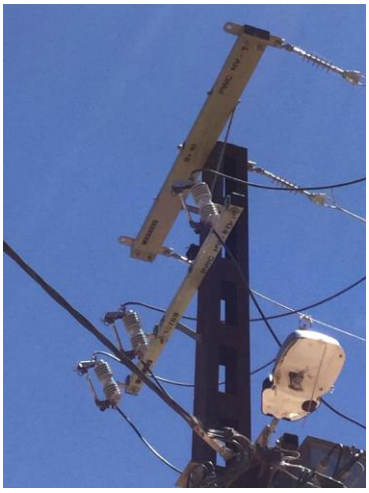
Insp ID: 195 Group 4 - Alice Springs Yarrenty Altere (Larapinta Valley)

What Category are you capturing:	Transformers
What is Transformer installation method:	Pole
If method know:	11SS1P
What is the condition of the mounting:	3
What is Transformer Rating:	Unknown
Is there access to transformers name plate to take a photo:	No
What is the condition of transformer:	3
What is cable type to transformer:	PVC insulated black
What is cable size to transformer:	
Is there switch gear or fusing associated with the transformer:	Cut out fuse
Transformer Comment:

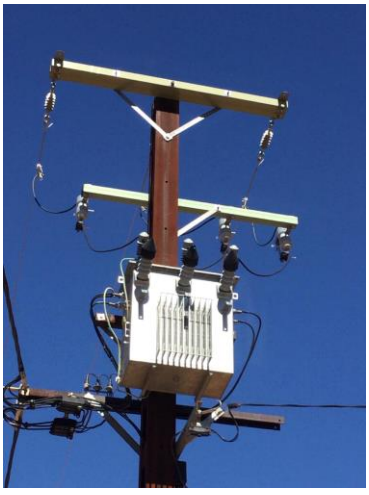
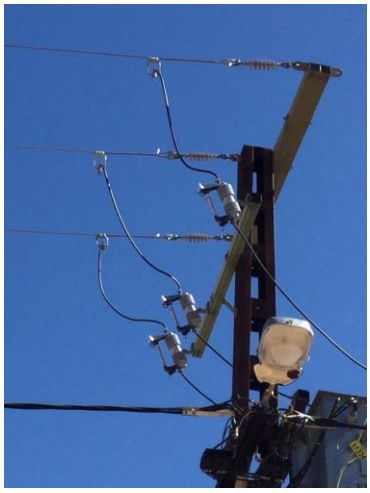
Insp ID: 232 Group 4 - Alice Springs Yarrenty Altere (Larapinta Valley)

What Category are you capturing:	Transformers
What is Transformer installation method:	Pole
If method know:	11SS1P
What is the condition of the mounting:	3
What is Transformer Rating:	Unknown
Is there access to transformers name plate to take a photo:	No
What is the condition of transformer:	3
What is cable type to transformer:	PVC insulated black
What is cable size to transformer:	
Is there switch gear or fusing associated with the transformer:	Cut out fuse
Transformer Comment:

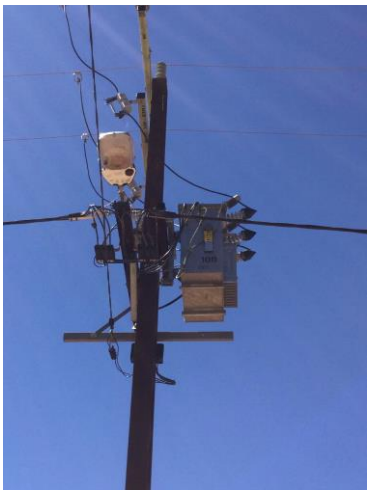
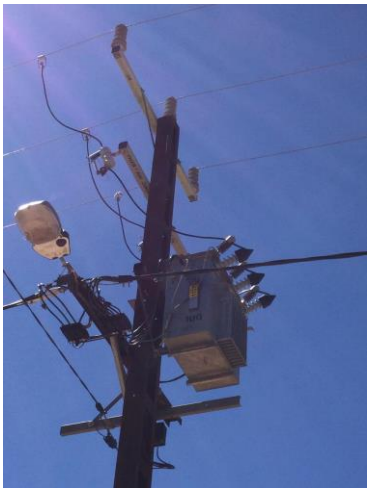
Insp ID: 245 Group 4 - Alice Springs Yarrenty Altere (Larapinta Valley)

What Category are you capturing:	Transformers
What is Transformer installation method:	Pole
If method know:	11SS1P
What is the condition of the mounting:	3
What is Transformer Rating:	Unknown
Is there access to transformers name plate to take a photo:	No
What is the condition of transformer:	3
What is cable type to transformer:	PVC insulated black
What is cable size to transformer:	
Is there switch gear or fusing associated with the transformer:	Cut out fuse
Transformer Comment:
