Kulaluk

2 Condition assessment

5.2 Existing infrastructure condition assessment

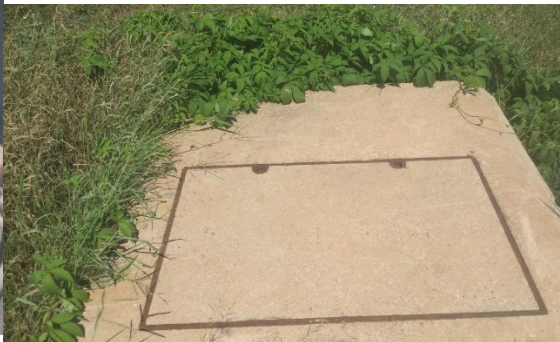
Figure 3 Sewer manhole, condition: *very good*

The manholes were rated as very good and do not require any maintenance works at this stage.
