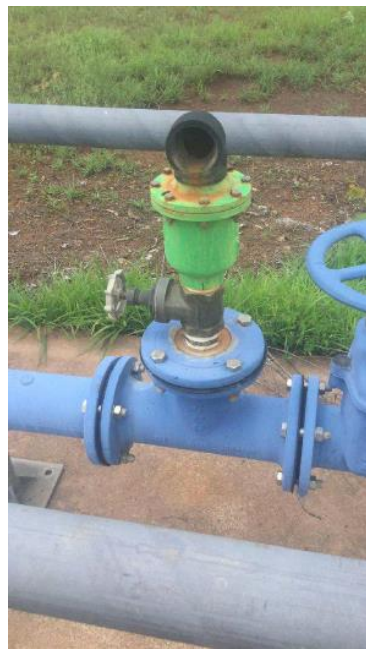
Figure 5 Air valve, condition: *good*

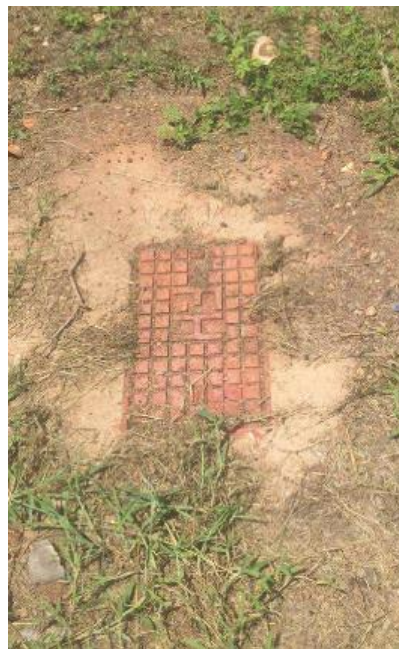
Figure 6 Fire hydrant, condition: *poor*

One fire hydrant was assessed as being in poor condition due to overgrown grass, debris around the access lid, and faded paint. This fire hydrant requires some minor maintenance works to repair.

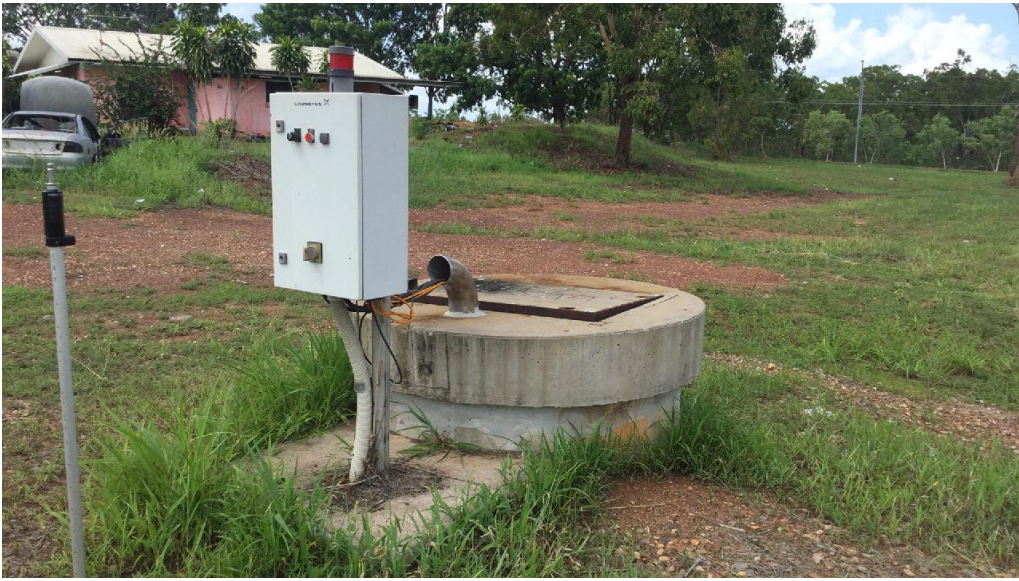
Figure 1 Temporary sewage pump station at Palmerston Town Camp

It is recommended that the septic tank and absorption trench arrangement is upgraded by replacing it with a main connecting to a trunk main in Palmerston. For the purpose of the cost estimates, 1200 m of DN150 PVC rising main, and a new sewage pump station have been allowed for.

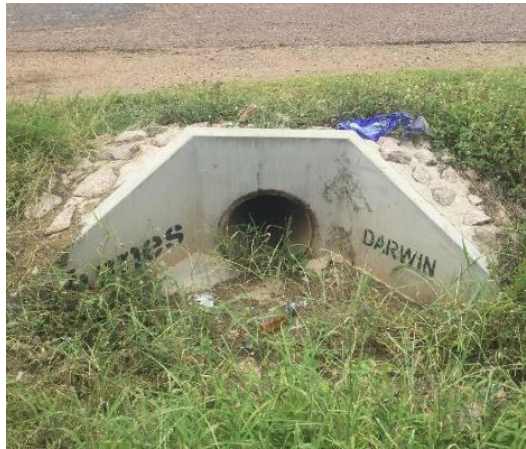
Figure 14 Headwall DN375, condition: *very good*

As shown in **Error! Reference source not found.** to Figure 12, the condition rating is based on the structural integrity of the side entry pit or headwall, it does not necessarily take into account how blocked the asset is. It is recommended that the side entry pits and culverts are cleared out so they work effectively and to reduce flooding/ponding.
