### NT Town Camp Road Assessments

#### 403 - Palmerston Indigenous Village (Palmerston)

## Civil Infrastructure

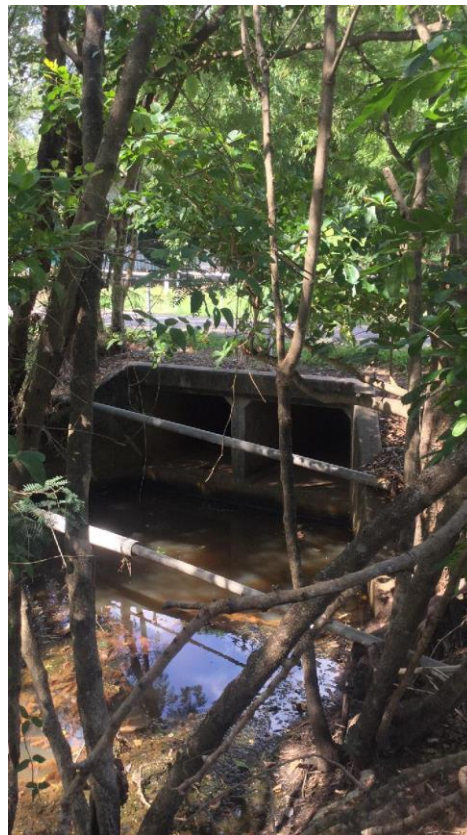
Figure 11 Culverts and drain with ponding

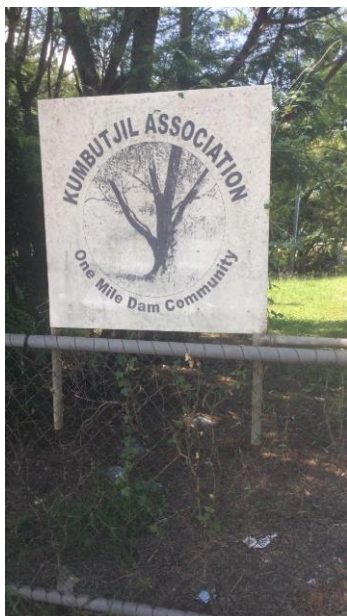
Sign Comment: Paint faded

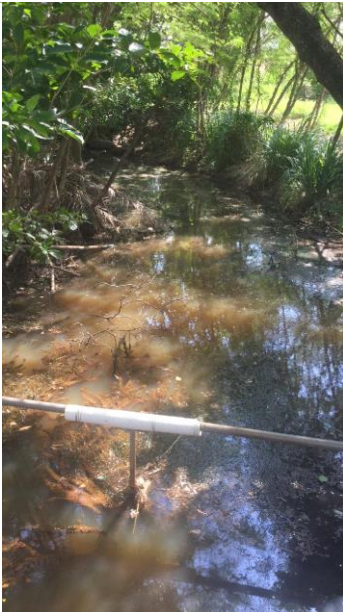
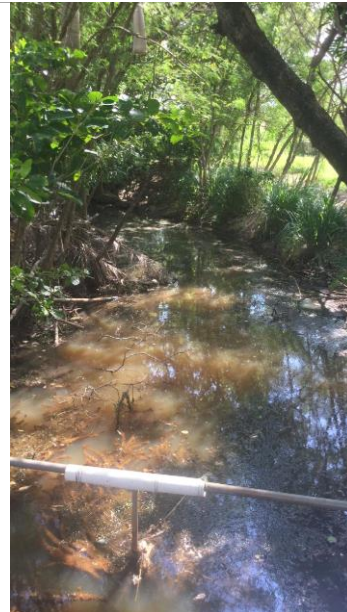
Extensive ponding, unable to attain Swale dimensions

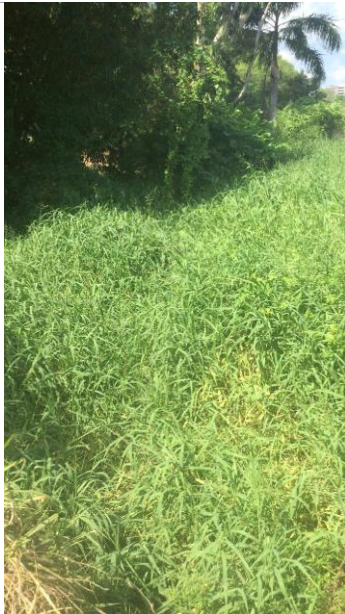
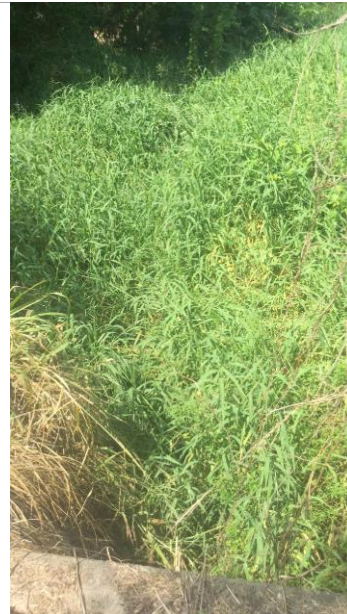
Heavily overgrown, characteristics not attainable

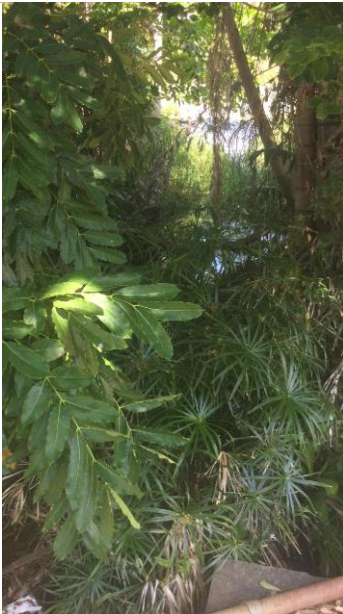
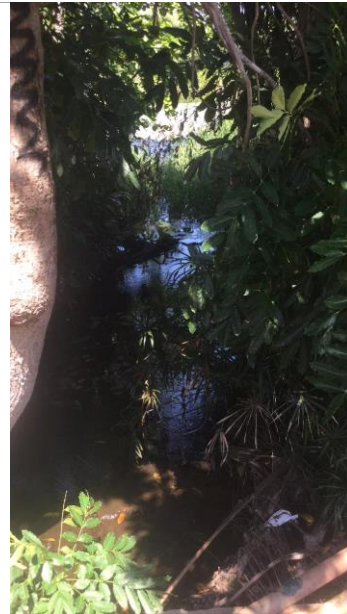
Swale upstream of culvert, connected to dam

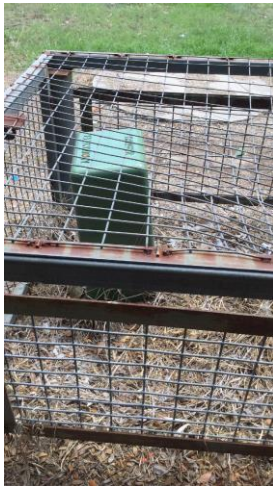
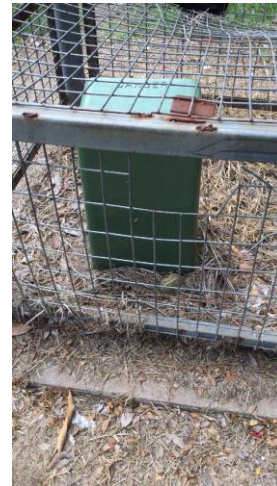
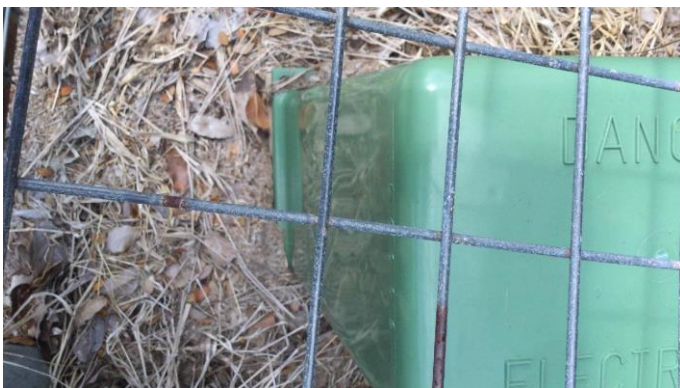
Condition Comments:

Missing bolts

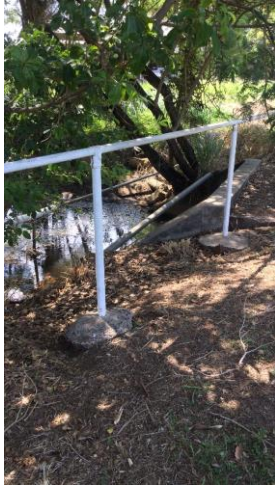
**What Category are you capturing:** Pits and Conduits

**Comments:** Main supply to camp is prone to flooding and telecommunications conduit

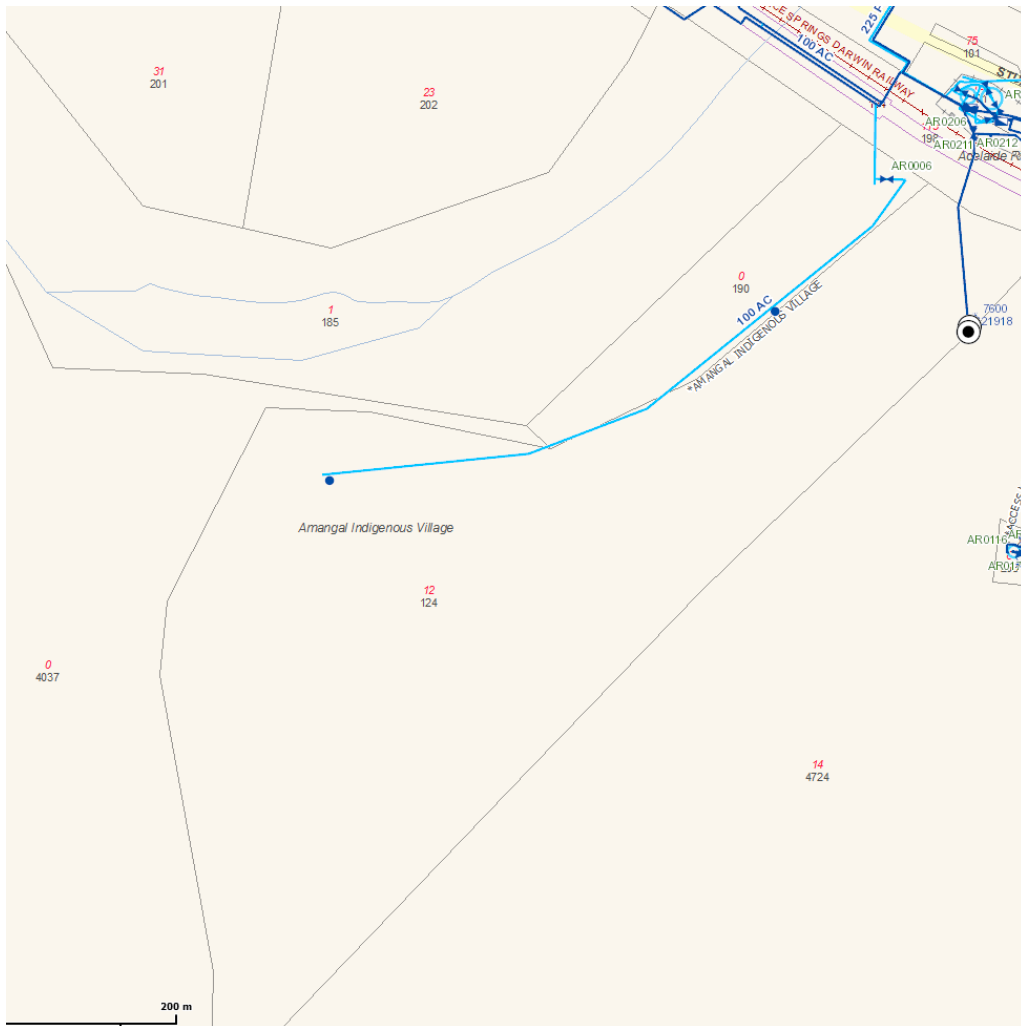
Figure 1 Amangal water main

The water main serving Amangal is a DN100 AC pipe with a single supply point and no network looping.

The water supply assets within Amangal are believed to be owned by Aboriginal Development Foundation Incorporated, but are the responsibility of Yilli Rreung Housing Aboriginal Corporation to maintain. The water is supplied from PWC owned water mains outside of the community. Figure 1 below shows the DN100 AC reticulation main servicing Amangal community.

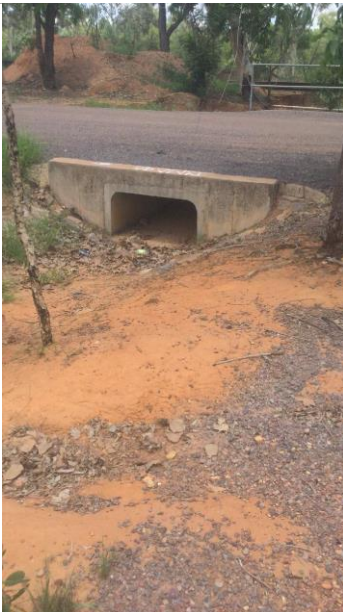
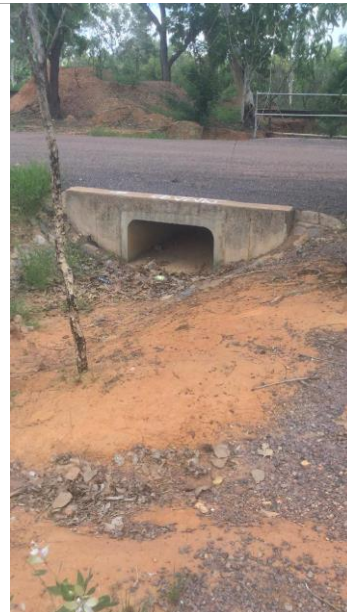
Insp ID: 1844      Group 1 - Darwin, Jabiru, Adelaide River      Amangal

Stormwater Infrastructure:	Culverts
Culvert Type:	RCBC
Diameter (mm):	
Width (mm):	1200
Culvert Depth (mm):	60
Culvert Length (m):	10
Culvert Condition:	4 - Very Good
Culvert Blockage (%):	
Culvert Comments:	
Culvert Head Wall:	Yes
Safety Grate:	No
Headwall Blockage:	
Headwall Condition:	4 - Very Good
Headwall Comment:	
End Wall:	Yes
End Wall condition:	4 - Very Good
EW Comment:

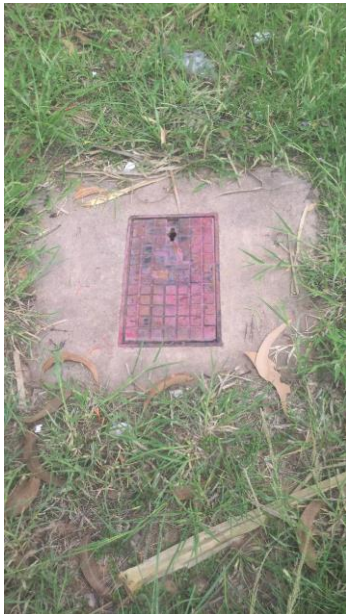
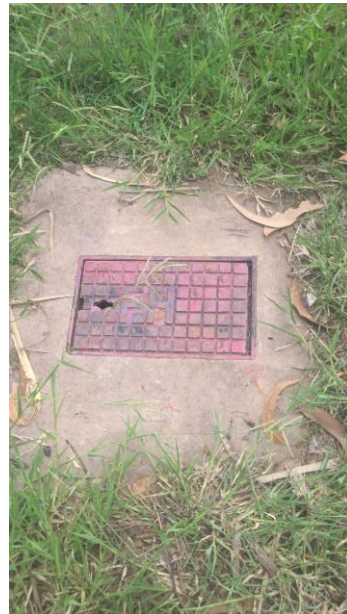
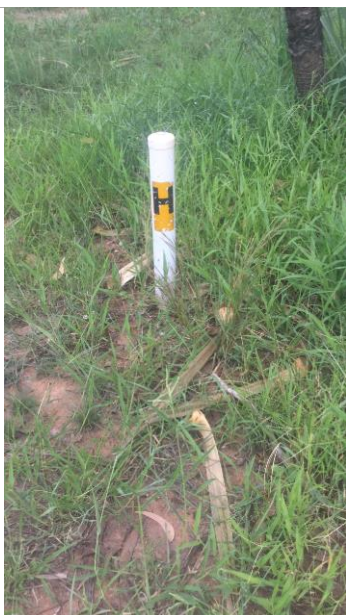
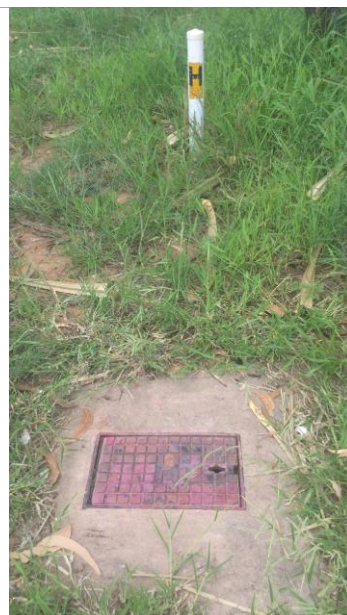
FH Condition: 3 - Good

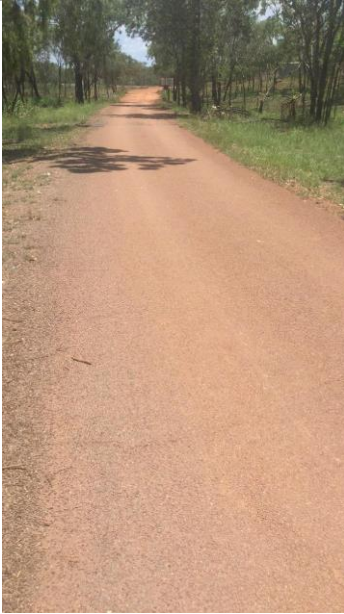
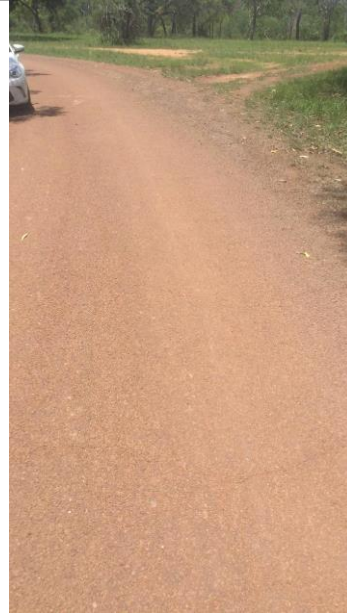
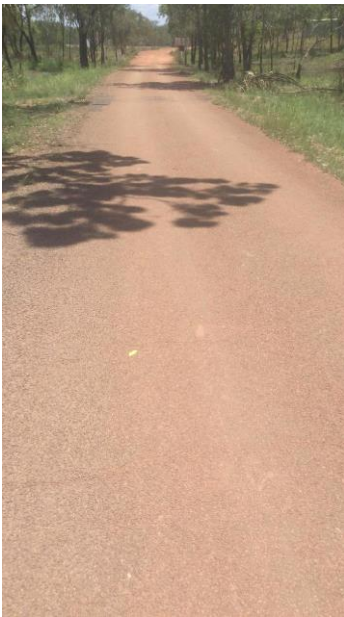
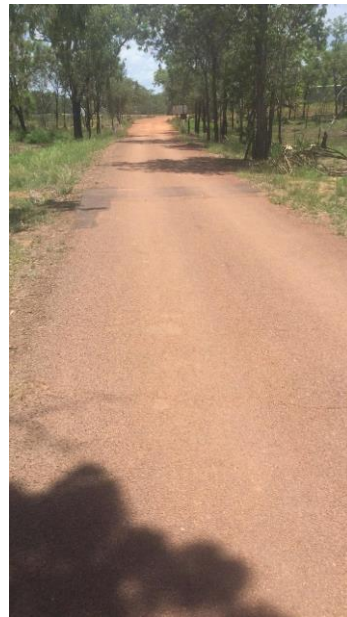
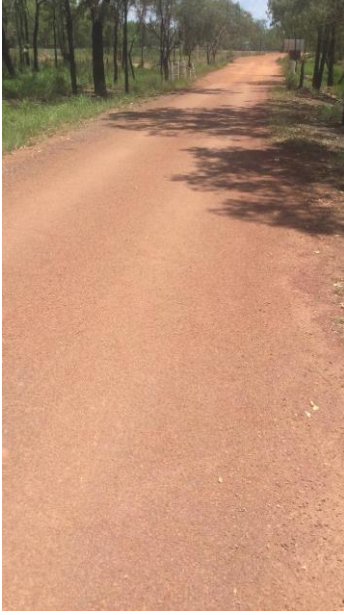
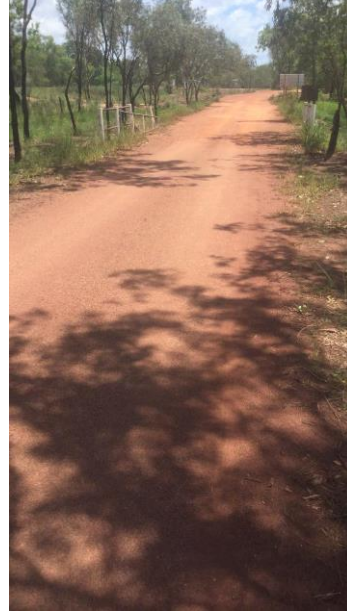
Inspection Date 9/12/2016 12:42:17 PM

Road Condition: 2 - Poor

Defect Type	Defect QTY	Defect Condition	Defect Comments
Surfacing Cracks	5	3 - Good	Percent

Shoulder Type	Width	Dropoff(mm)	Erosion	Condition	Shoulder Comments
Unsealed		30

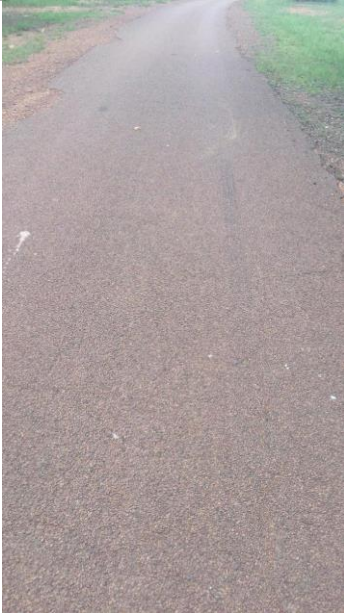
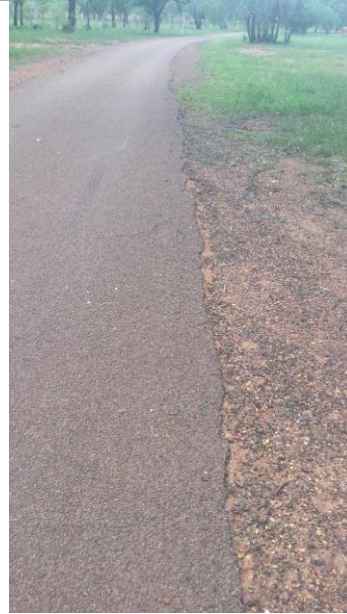
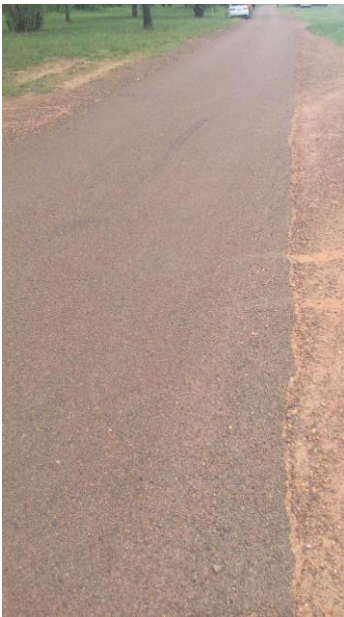
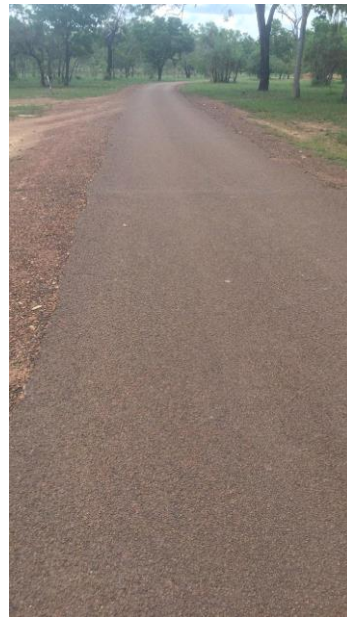
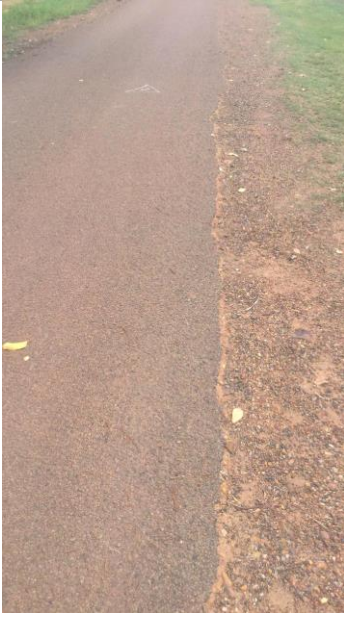
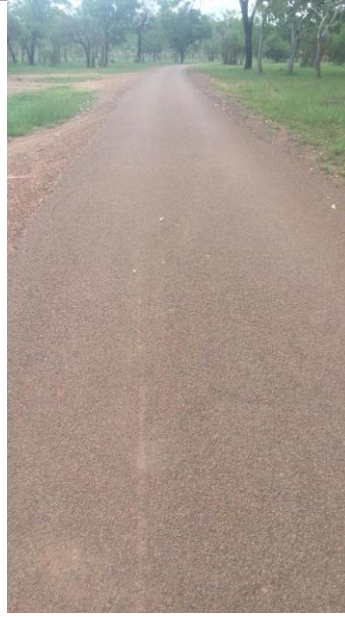
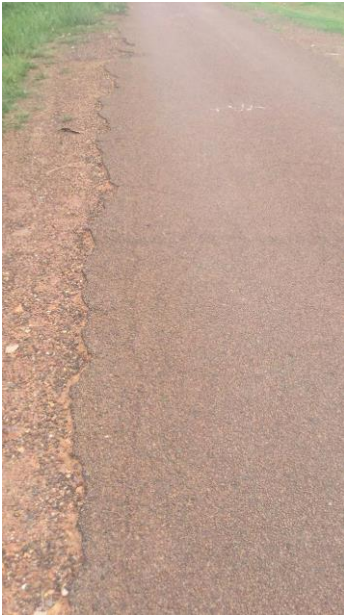
Inspection Date 9/12/2016 12:27:22 PM

Road Condition: 2 - Poor

Defect Type	Defect QTY	Defect Condition	Defect Comments
Surfacing Cracks	5	2 - Poor	Percent
Edge Breaks	75	2 - Poor

Shoulder Type	Width	Dropoff(mm)	Erosion	Condition	Shoulder Comments
Unsealed		40		3

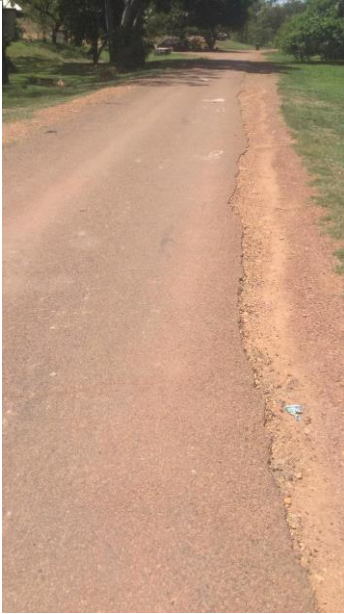
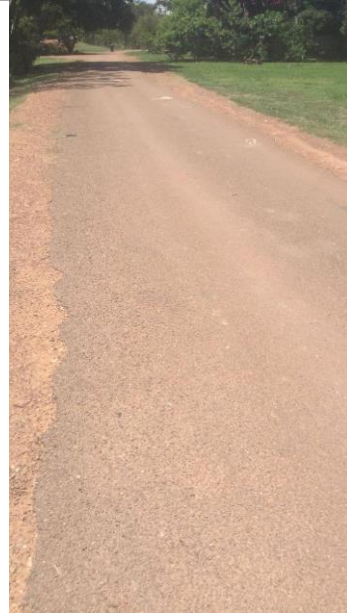
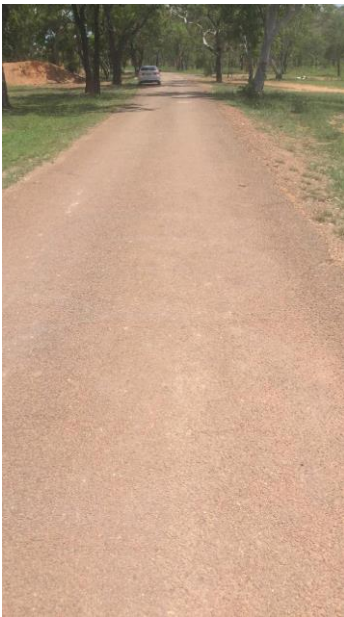
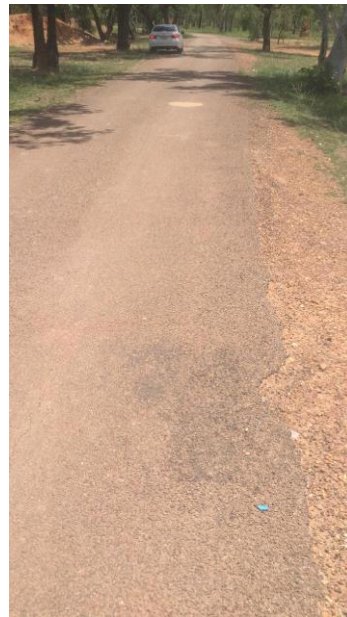
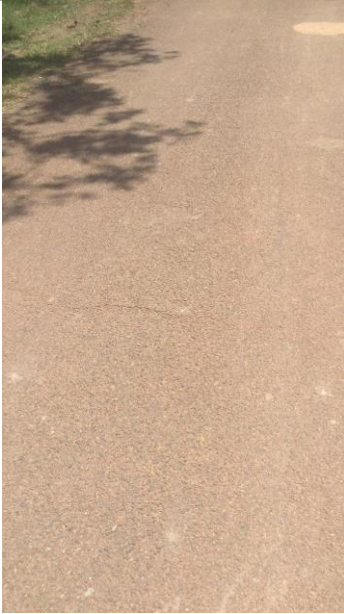
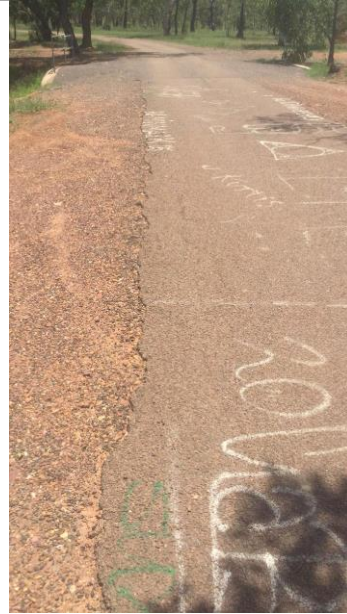
Inspection Date 9/12/2016 12:10:19 PM

Road Condition: 2 - Poor

Defect Type	Defect QTY	Defect Condition	Defect Comments
Edge Breaks	75	1 - Very Poor	Percent
Surfacing Cracks	5	2 - Poor	Percent

Shoulder Type	Width	Dropoff(mm)	Erosion	Condition	Shoulder Comments
Unsealed		80		2

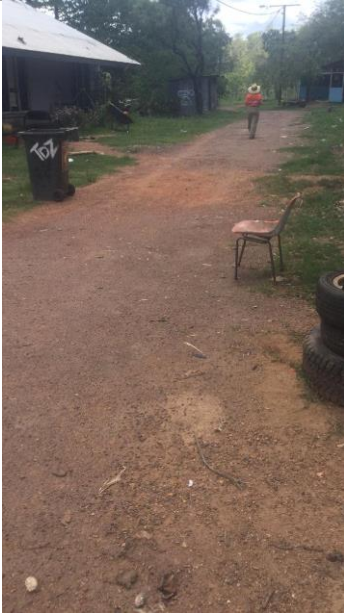
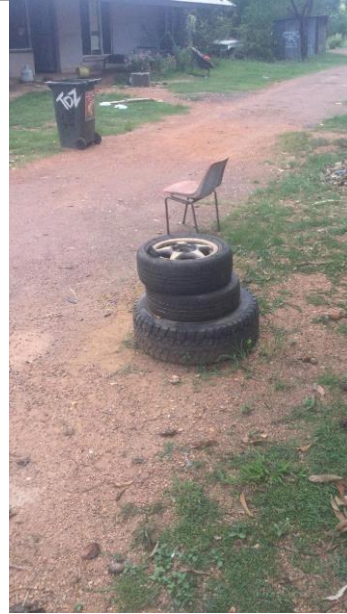
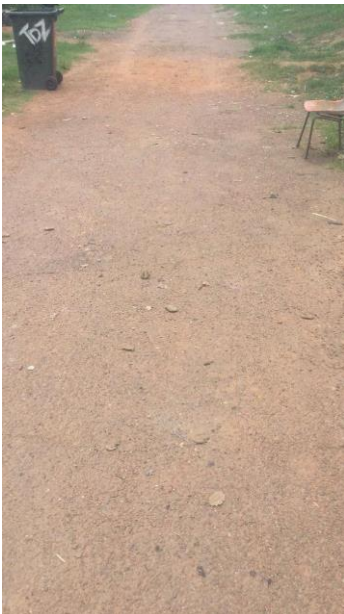
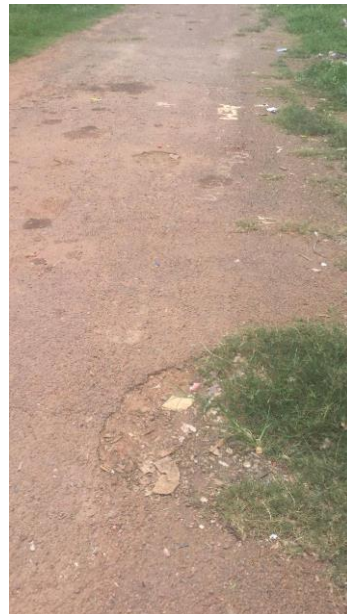
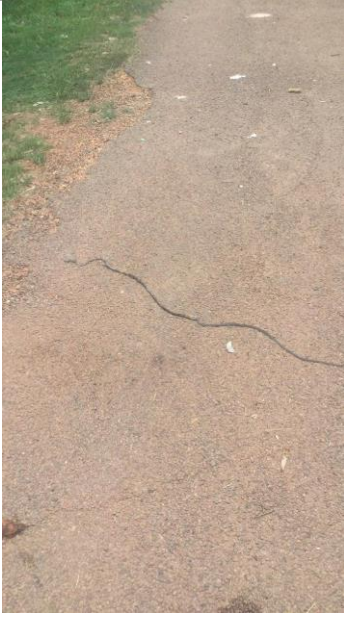
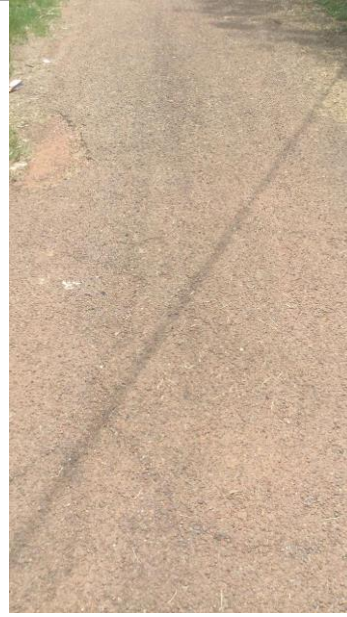
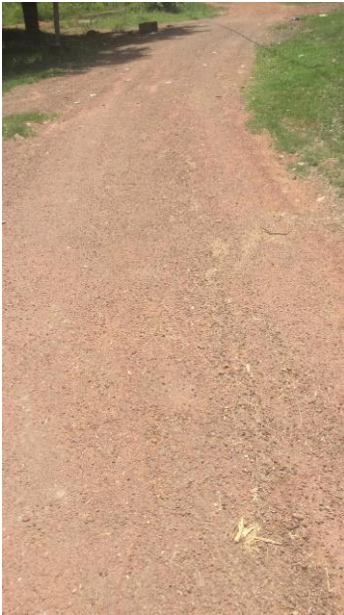
Inspection Date 9/12/2016 11:40:01 AM

Road Name: 427\_2  
What are you inspecting: Pavements  
Ch From (km): 0  
Ch To (km): 0.09  
Road Type: Sealed - asphalt  
Section Width (m): 3.2  
Road Condition: 1 - Very Poor  
General Comment:

Defect Type	Defect QTY	Defect Condition	Defect Comments
Surfacing Failure		1 - Very Poor	
Edge Breaks	20	2 - Poor	Percent
General Appearance		1 - Very Poor

Shoulder Type	Width	Dropoff(mm)	Erosion	Condition	Shoulder Comments
Unsealed		20

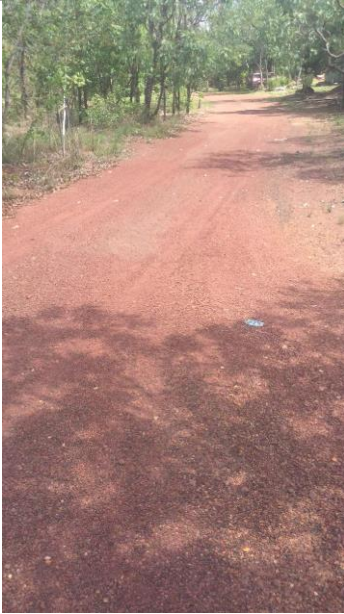
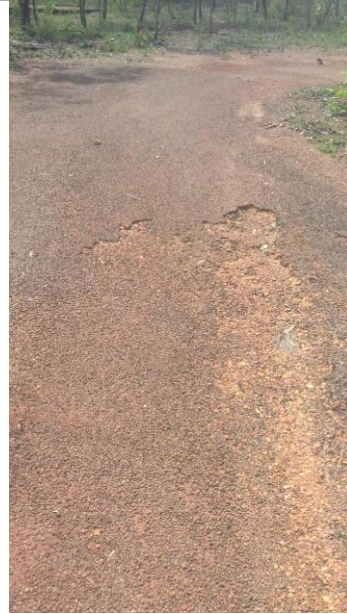
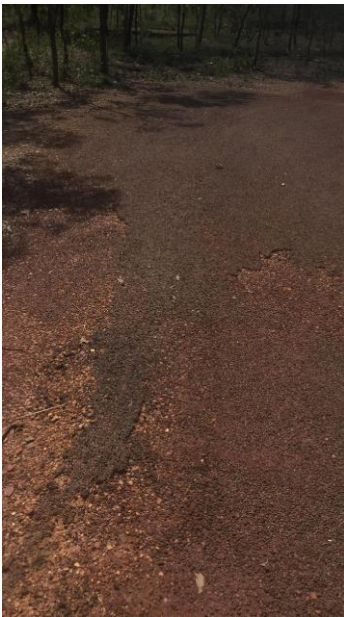
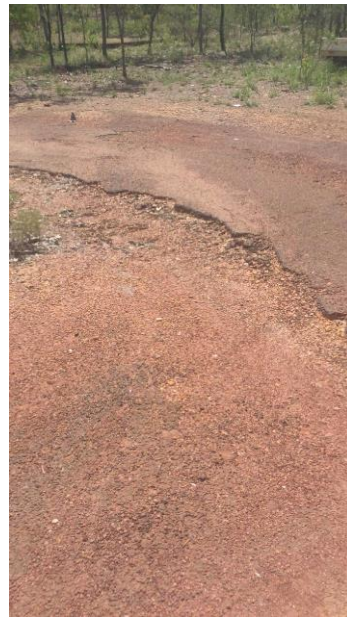
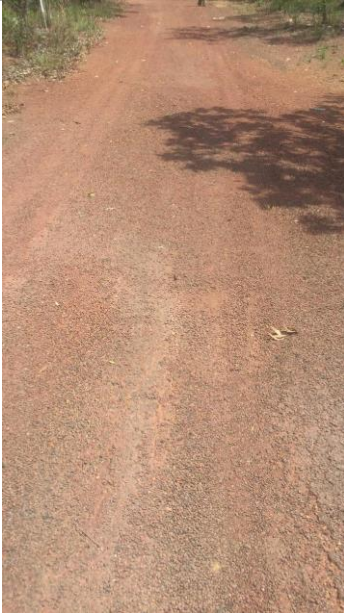
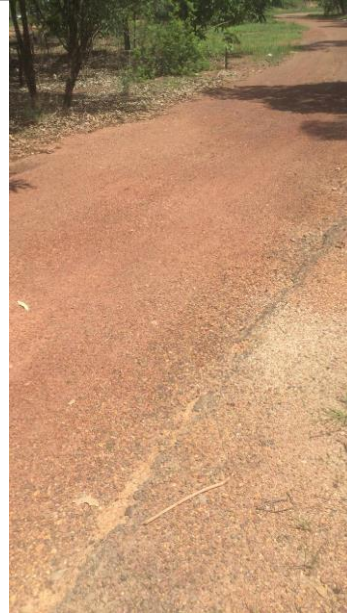
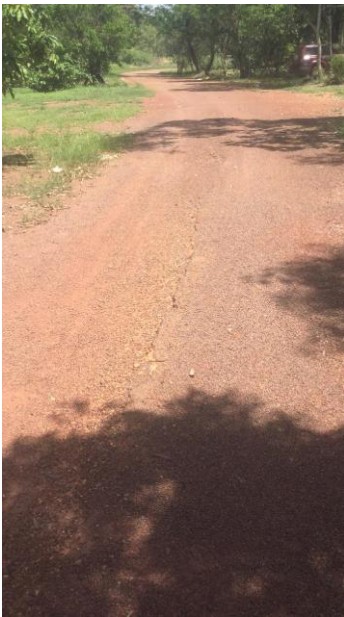
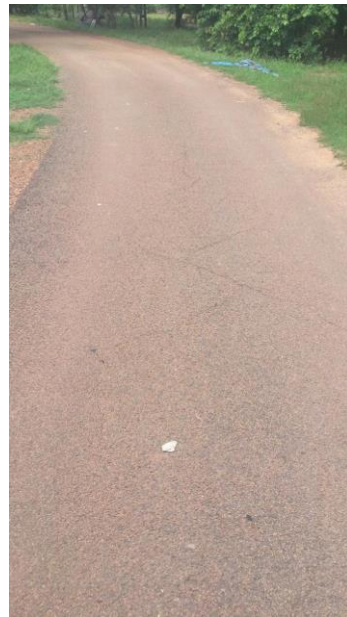
Inspection Date 9/12/2016 11:13:10 AM

Road Name: 427\_2  
What are you inspecting: Pavements  
Ch From (km): 0  
Ch To (km): 0.27  
Road Type: Sealed - spray seal  
Section Width (m): 3.8  
Road Condition: 1 - Very Poor

**General Comment:** Road was previously sealed however almost entirely broken

Defect Type	Defect QTY	Defect Condition	Defect Comments
Surfacing Failure	70	1 - Very Poor

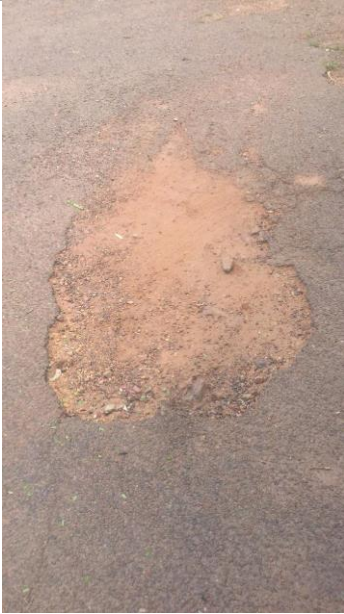
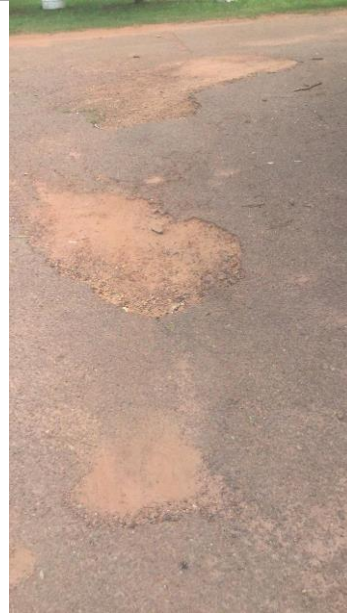
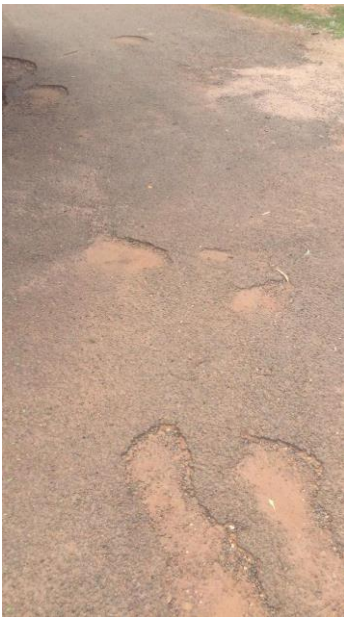
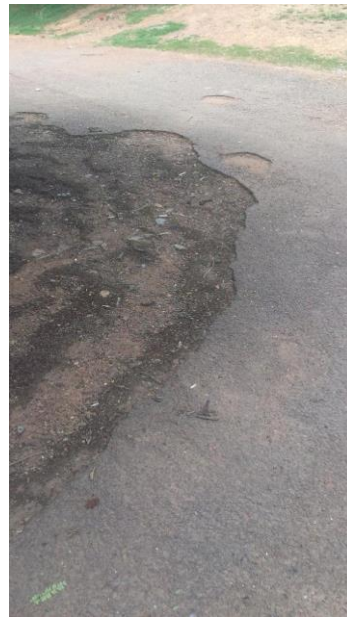
Inspection Date 9/12/2016 11:28:37 AM

Road Condition: 1 - Very Poor

Defect Type	Defect QTY	Defect Condition	Defect Comments
Potholes	10	1 - Very Poor	Percent
Edge Breaks	20	1 - Very Poor	Percent

Shoulder Type	Width	Dropoff(mm)	Erosion	Condition	Shoulder Comments
Unsealed		50		2

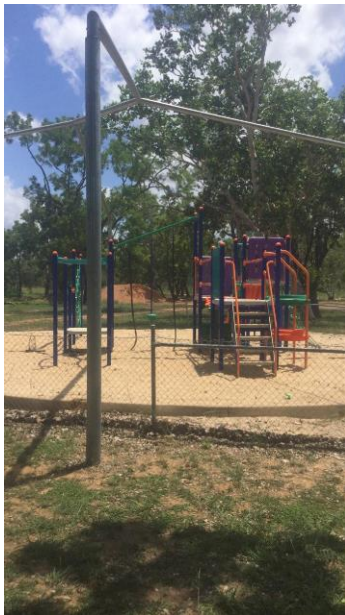
Inspection Type:	Shade Structure
Shade Structure Type:	Play ground
Shade Floor Type:	Sand
Roof Type:	Not Covered
Width (mm):	12
Length (mm):	20
Appearance:	3
Appearance Comment:	
Condition:	4 - Very Good
Comment:	Shade cloth poles installed

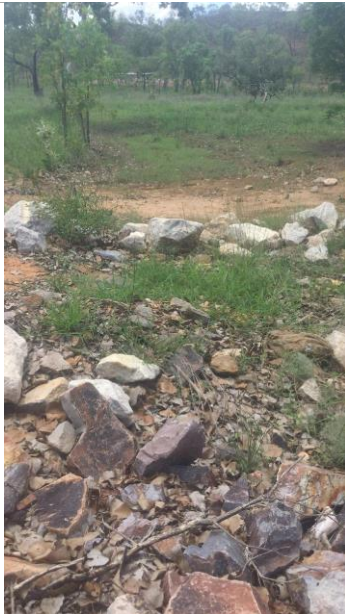
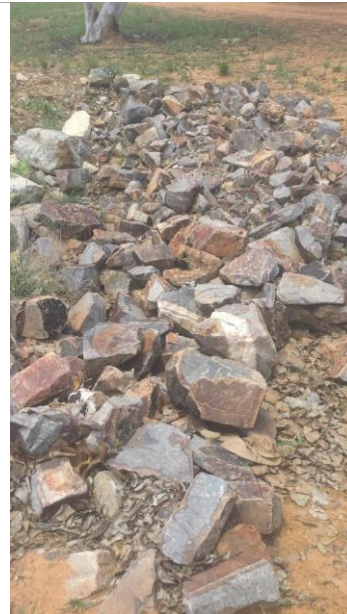
Rock structure to dissipate energy

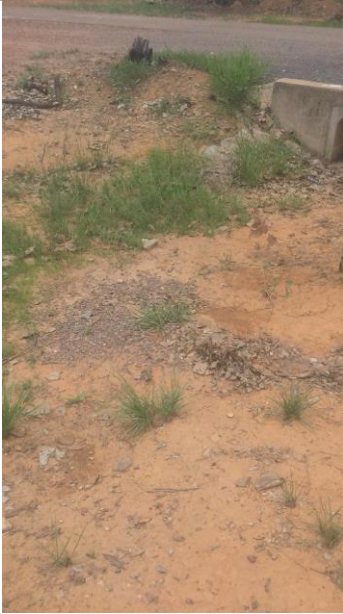
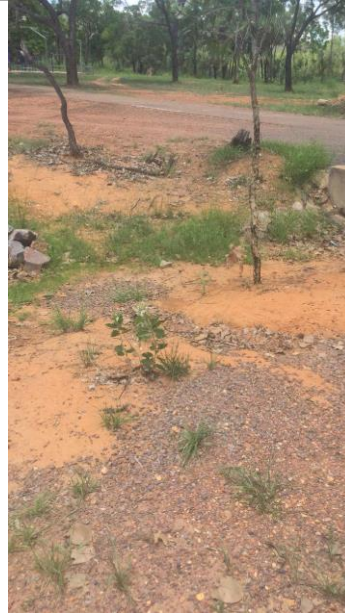
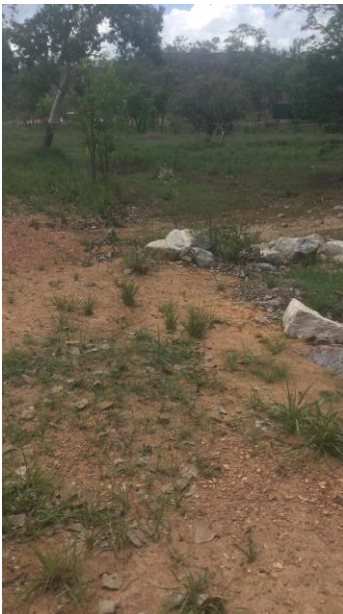
Stormwater Infrastructure:	Swales
Type of lining:	Natural Grasses
Are dimensions uniform along drain:	No
Base Width (m):	
Overall Width (m):	
Swale Depth (m):	2.5
Length of Batter 1 (m):	
Length of Batter 2 (m):	
Swale Condition:	1 - Very Poor
Swale Ponding:	No
Drain flooded at time of inspection:	No
Swale Comments:	Heavy erosion dimensions not indeterminable

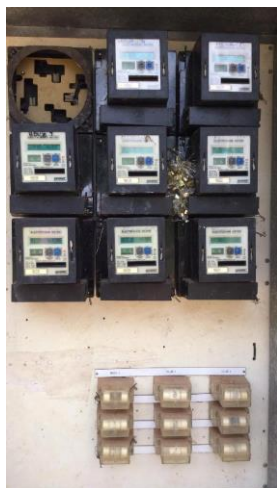
Meter Comment: Needs Cleaning. 8 Digital Meters. Indoor SB, Cond 3

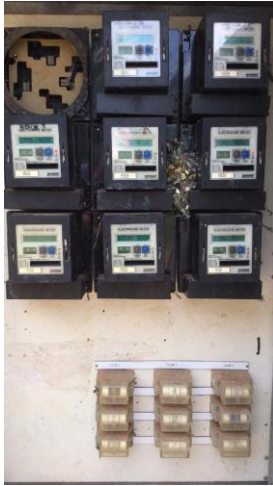
Meter Comment: Needs Cleaning. 8 Digital Meters.

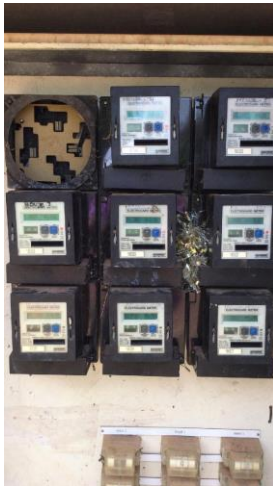
Meter Comment: Needs Cleaning. 8 Digital Meters.

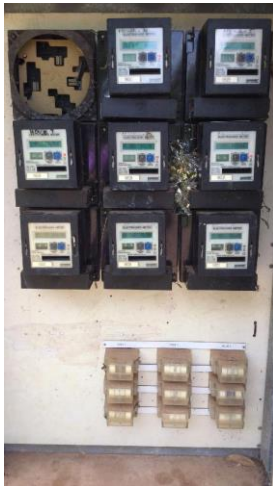
Meter Comment: Needs Cleaning. 8 Digital Meters.

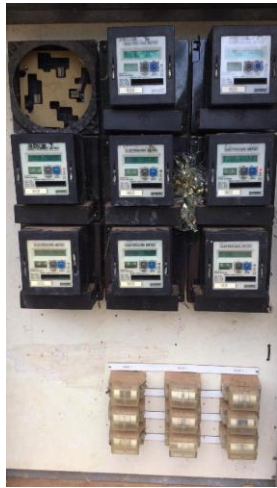
Meter Comment: Needs Cleaning. 8 Digital Meters. Indoor SB, Cond 3

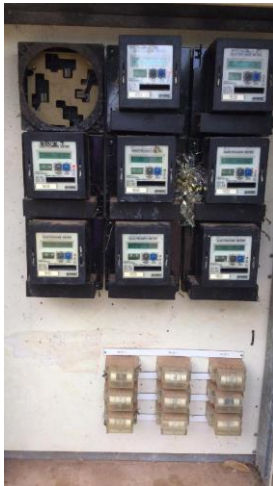
Meter Comment: Needs Cleaning. 8 Digital Maters

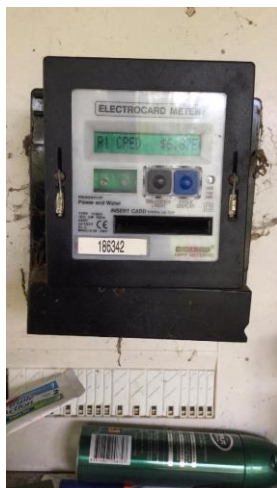
Meter Comment: Indoor SB, Cond 3

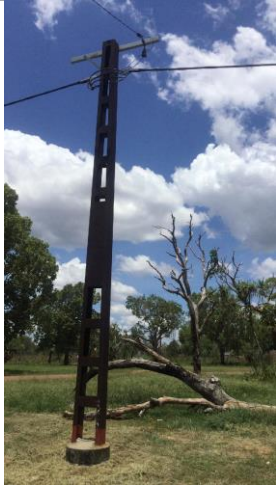
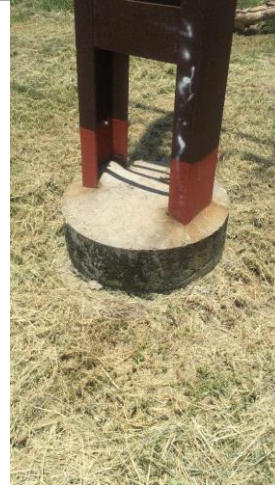
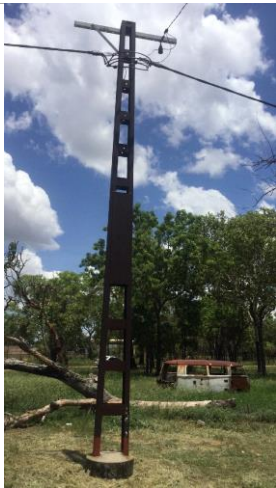
Inspection Date 9/12/2016 1:11:47 PM

What is Pole Material type:	Welded
What is the condition of pole:	3
How is the pole planted:	Concrete
What is the Condition of plant:	3
Is street light fitted:	No
Street Light Power Supply:	
Street Light Type	
Street Light Watts	
Street Light Condition	
Street Light Height	
What is the type of service:	Three
What is the HV voltage level:	
What is the arrangement of connected cables:	Twisted
Are there isolators on the pole:	No
What is the Condition:	
How many Lots are connected to this pole:	
Overhead Pole Comments:	No ID

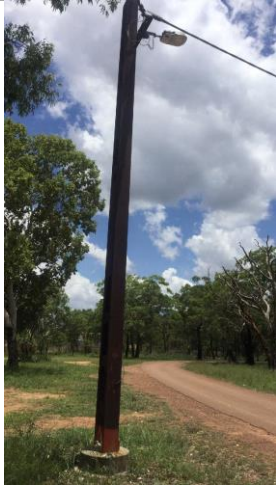
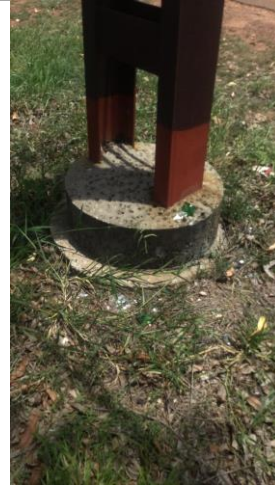
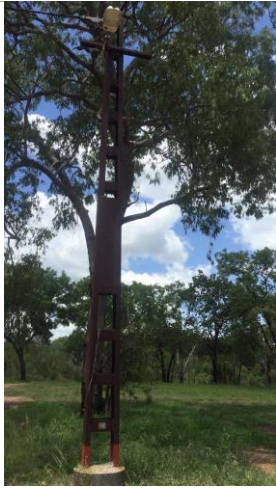
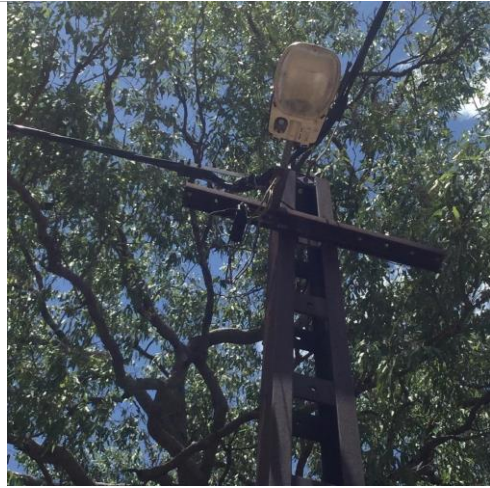
Inspection Date 9/12/2016 1:09:04 PM

What is Pole Material type:	Welded
What is the condition of pole:	3
How is the pole planted:	Concrete
What is the Condition of plant:	3
Is street light fitted:	Yes
Street Light Power Supply:	
Street Light Type	Unknown
Street Light Watts	
Street Light Condition	3
Street Light Height	
What is the type of service:	Three
What is the HV voltage level:	
What is the arrangement of connected cables:	Twisted
Are there isolators on the pole:	No
What is the Condition:	
How many Lots are connected to this pole:	
Overhead Pole Comments:	No ID

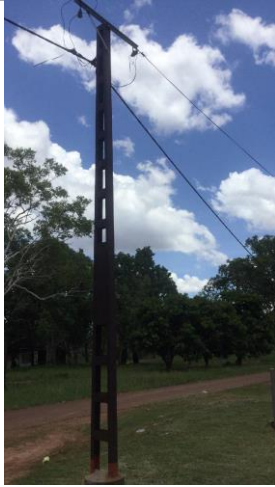
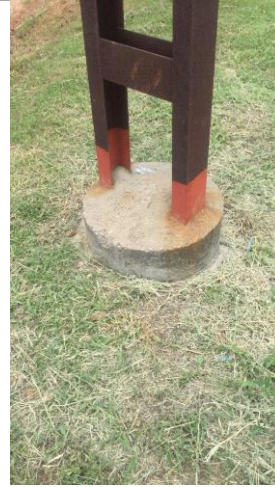
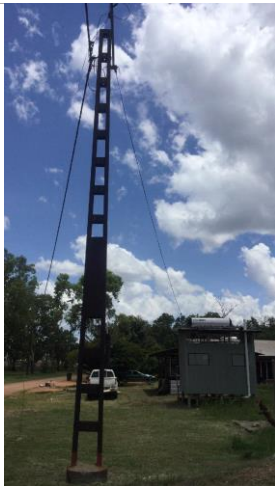
Inspection Date 9/12/2016 1:04:29 PM

What is Pole Material type:	Welded
What is the condition of pole:	3
How is the pole planted:	Concrete
What is the Condition of plant:	3
Is street light fitted:	No
Street Light Power Supply:	
Street Light Type	
Street Light Watts	
Street Light Condition	
Street Light Height	
What is the type of service:	Three
What is the HV voltage level:	
What is the arrangement of connected cables:	Twisted
Are there isolators on the pole:	No
What is the Condition:	
How many Lots are connected to this pole:	2
Overhead Pole Comments:	No ID

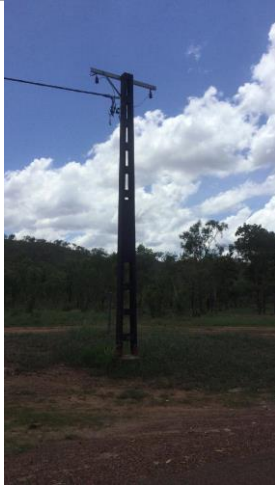
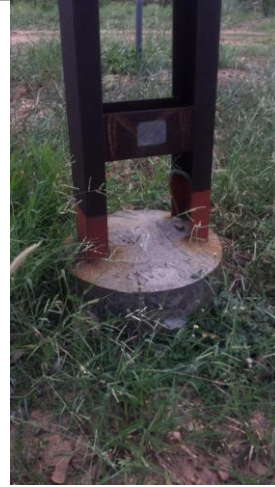
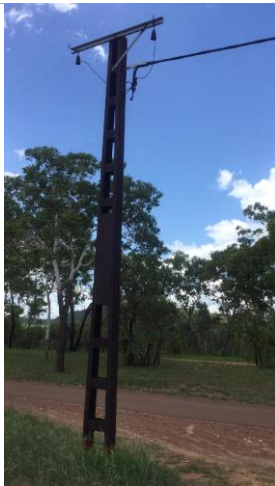
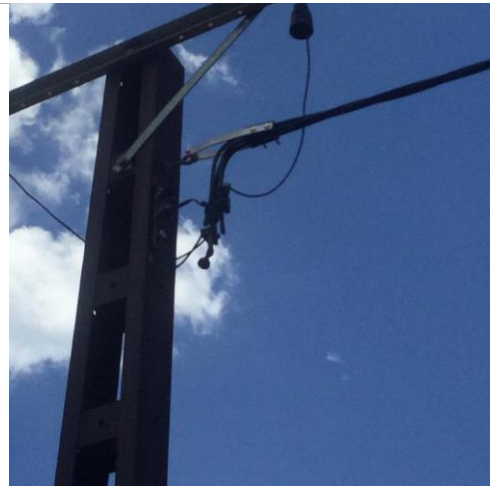
Inspection Date 9/12/2016 1:01:40 PM

What is Pole Material type:	Welded
What is the condition of pole:	3
How is the pole planted:	Concrete
What is the Condition of plant:	3
Is street light fitted:	No
Street Light Power Supply:	
Street Light Type	
Street Light Watts	
Street Light Condition	
Street Light Height	
What is the type of service:	Three
What is the HV voltage level:	
What is the arrangement of connected cables:	Twisted
Are there isolators on the pole:	No
What is the Condition:	
How many Lots are connected to this pole:	
Overhead Pole Comments:	No ID

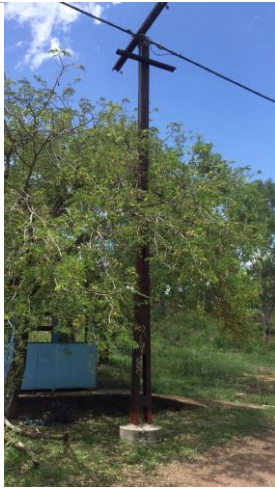
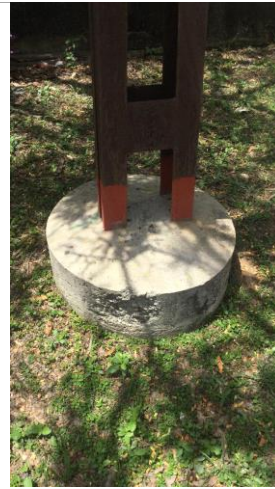
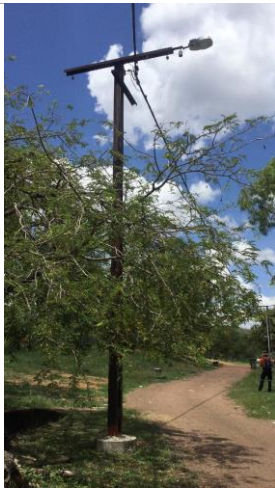
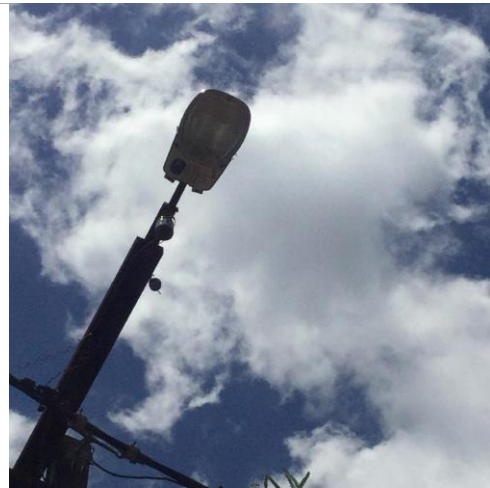
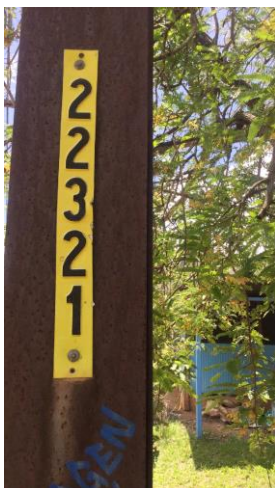
Inspection Date 9/12/2016 12:20:46 PM

What is Pole Material type:	Welded
What is the condition of pole:	3
How is the pole planted:	Concrete
What is the Condition of plant:	3
Is street light fitted:	Yes
Street Light Power Supply:	
Street Light Type	M80 D 04
Street Light Watts	
Street Light Condition	3
Street Light Height	
What is the type of service:	Three
What is the HV voltage level:	
What is the arrangement of connected cables:	Twisted
Are there isolators on the pole:	No
What is the Condition:	
How many Lots are connected to this pole:	
Overhead Pole Comments:	Vegetation needs clearing

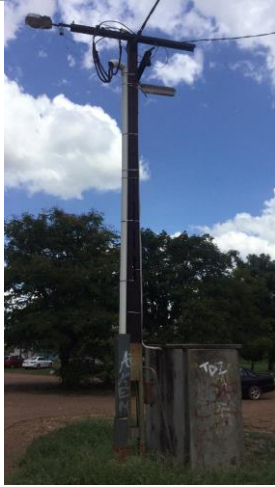
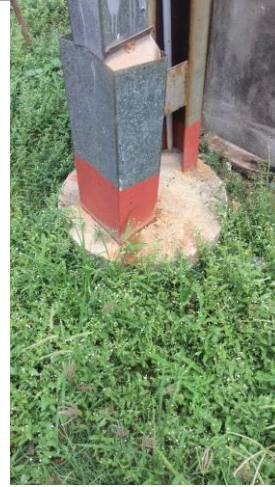
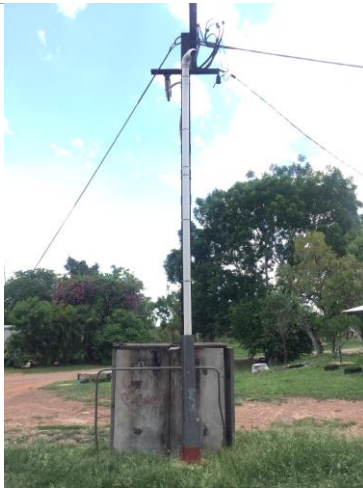
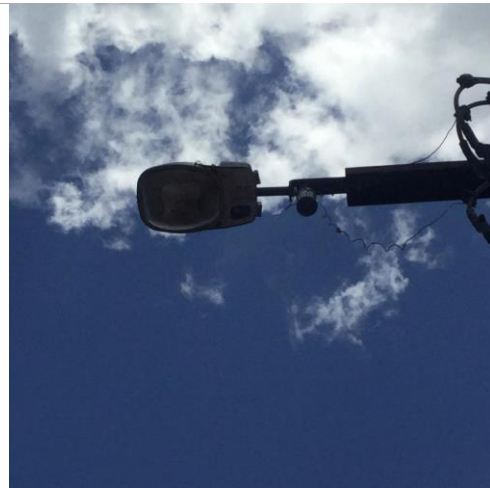
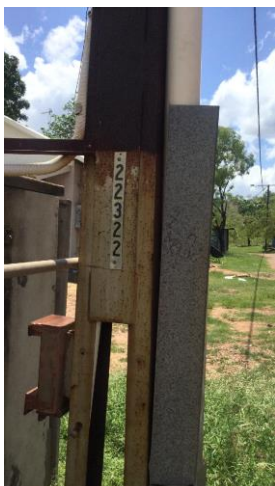
Inspection Date 9/12/2016 12:17:05 PM

What is Pole Material type:	Welded
What is the condition of pole:	3
How is the pole planted:	Concrete
What is the Condition of plant:	3
Is street light fitted:	Yes
Street Light Power Supply:	
Street Light Type	M80 D 04
Street Light Watts	
Street Light Condition	2
Street Light Height	
What is the type of service:	Three
What is the HV voltage level:	
What is the arrangement of connected cables:	Twisted
Are there isolators on the pole:	No
What is the Condition:	
How many Lots are connected to this pole:	
Overhead Pole Comments:

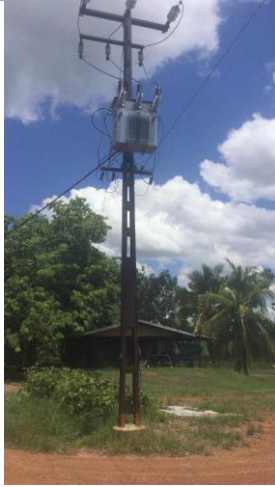
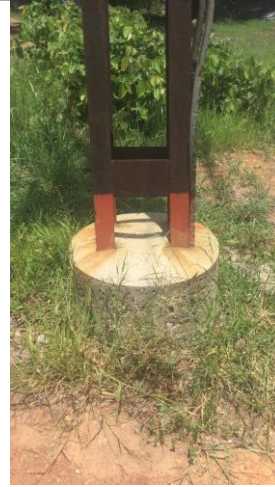
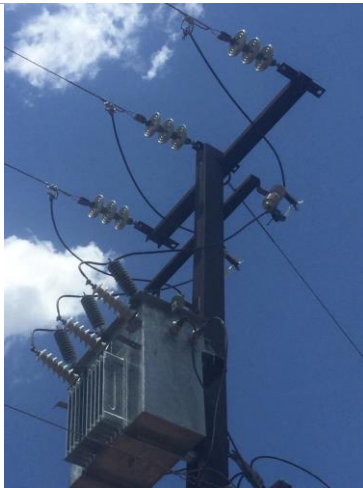
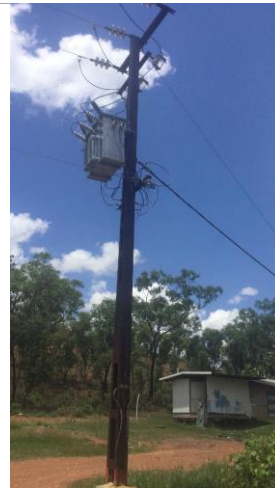
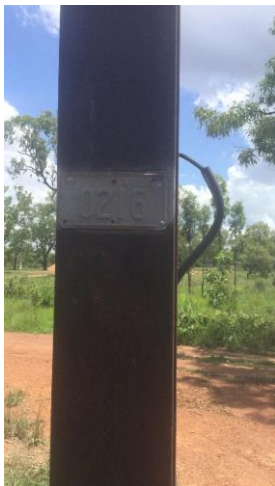
Inspection Date 9/12/2016 12:28:44 PM

What is Pole Material type: Welded  
What is the condition of pole: 3  
How is the pole planted: Concrete  
What is the Condition of plant: 3  
Is street light fitted: No  
Street Light Power Supply:  
Street Light Type  
Street Light Watts  
Street Light Condition  
Street Light Height  
What is the type of service: Combined  
What is the HV voltage level:  
What is the arrangement of connected cables: Parallel  
Are there isolators on the pole: Yes  
What is the Condition: 3  
How many Lots are connected to this pole:  
Overhead Pole Comments:

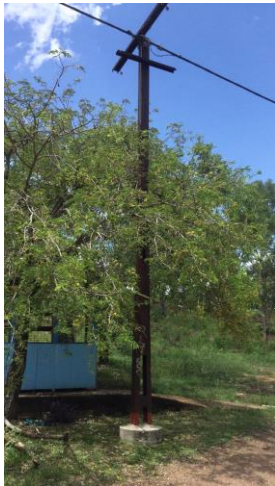
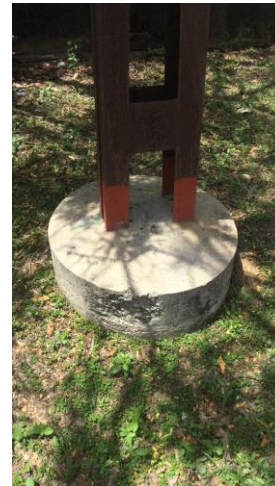
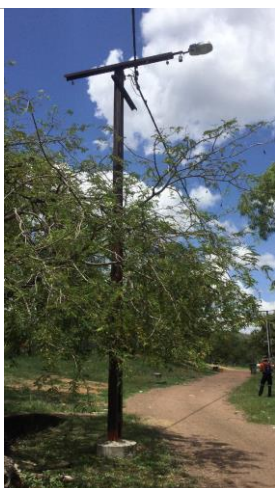
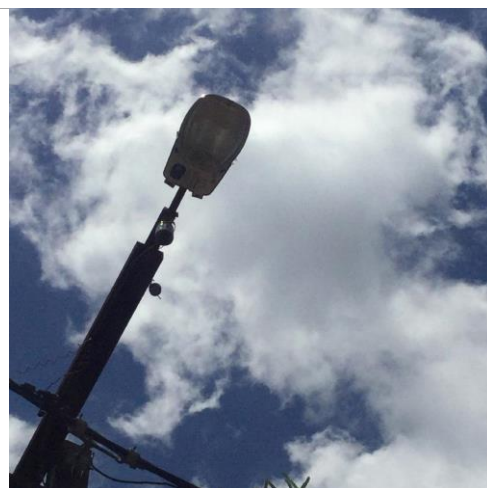
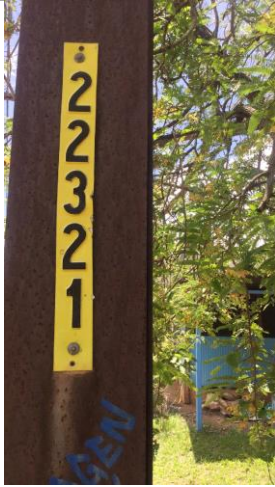
Street Light Condition 3
