### NT Town Camp Road Assessments

#### 403 - Palmerston Indigenous Village (Palmerston)

## Civil Infrastructure

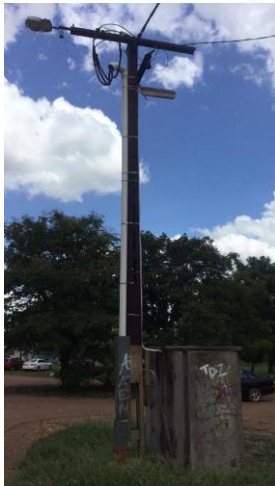
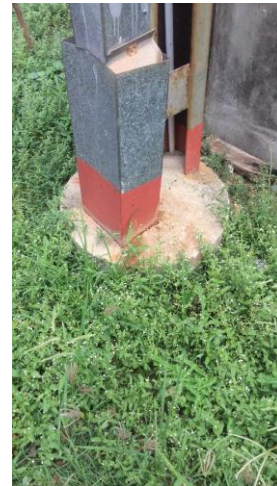
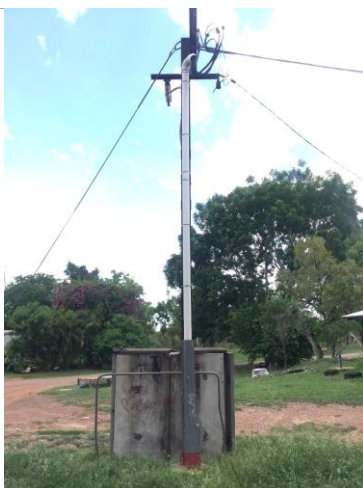
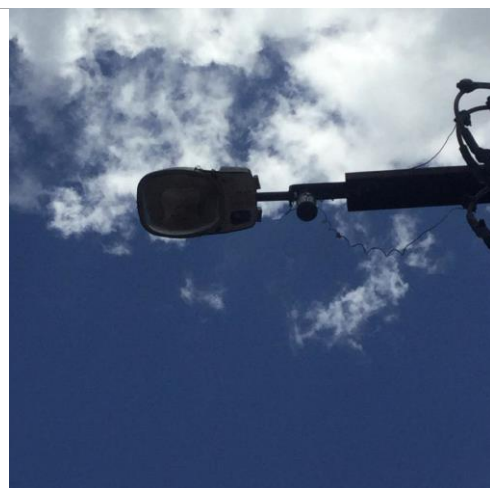
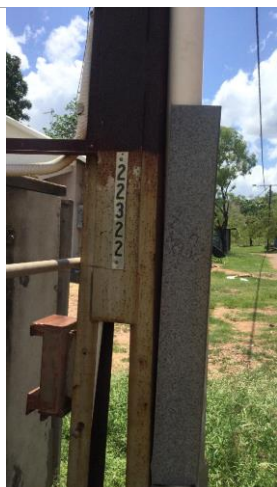
Street Light Condition 2

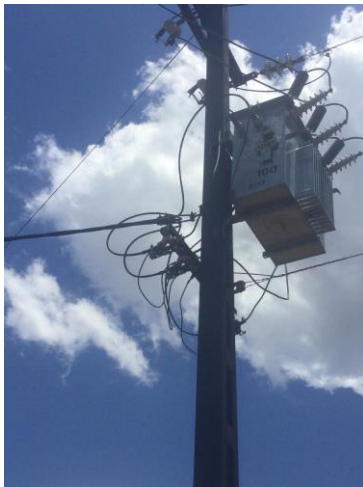
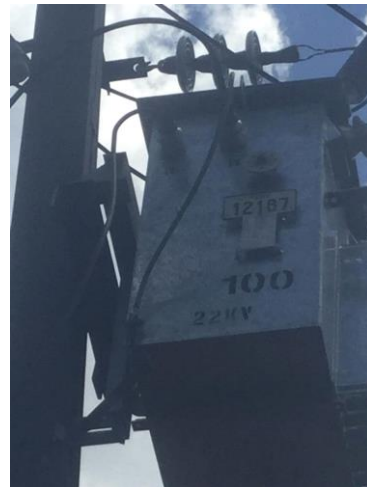
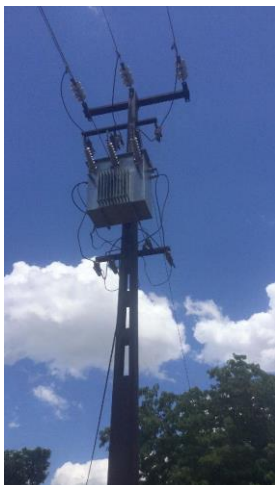
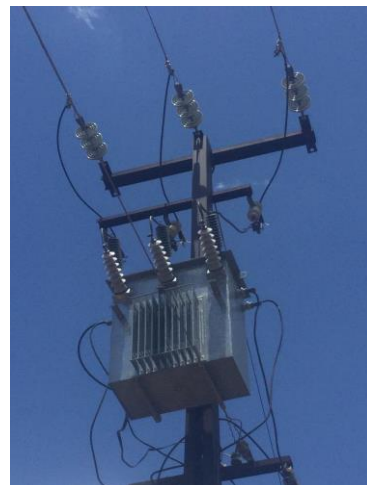
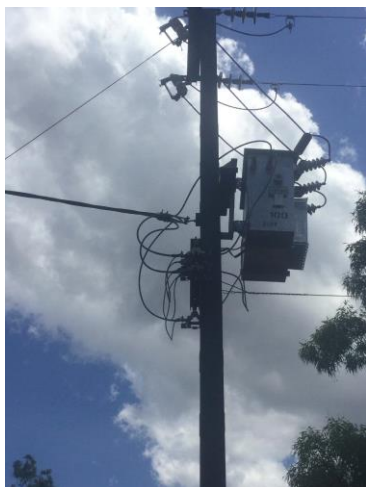
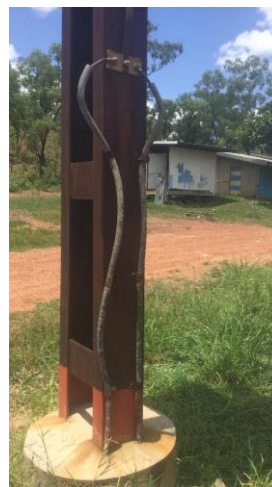
What is the condition of the mounting:

What is the condition of transformer:
