# Appendix B

## Municipal and essential infrastructure

# Elliott North & South Camp

# Elliott North Camp

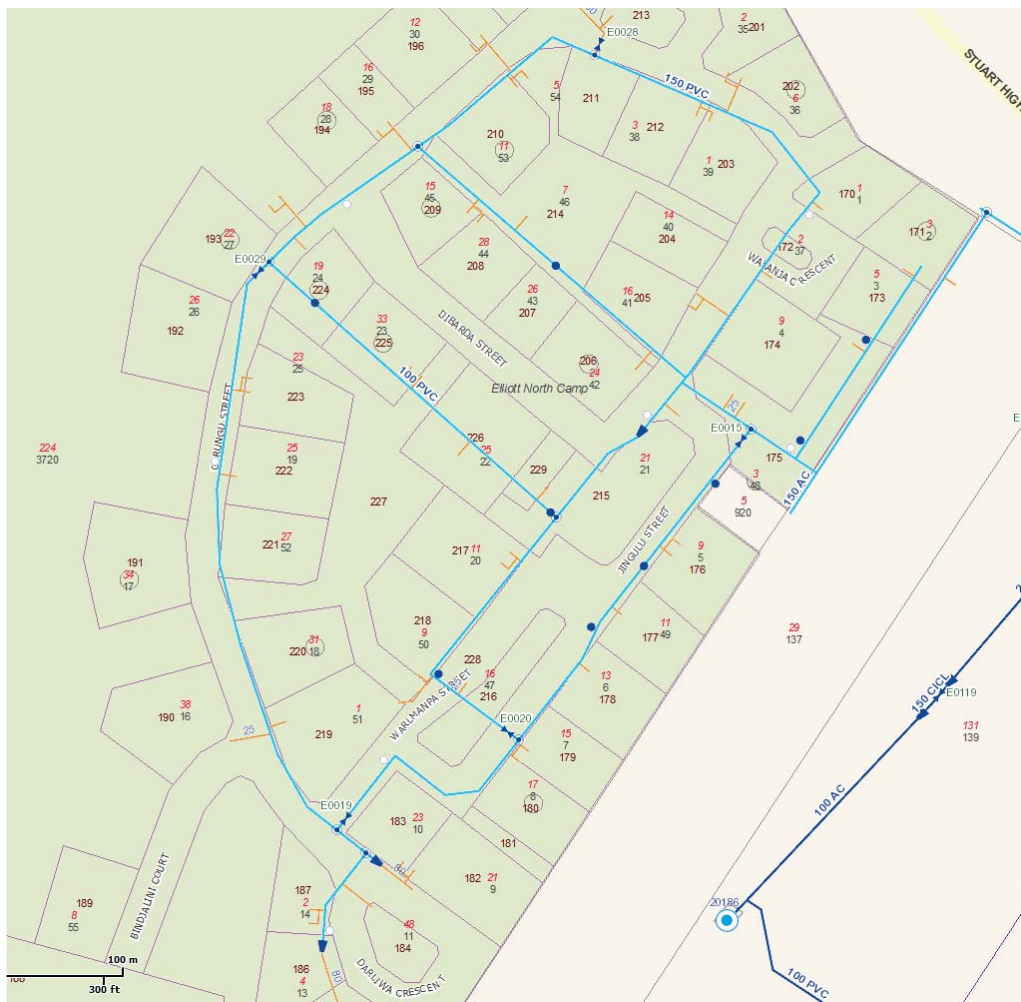
Figure 1 Elliott North Camp water supply

The water is supplied from PWC owned a water main outside of the community. Figure 1 shows the extent of the water reticulation network.

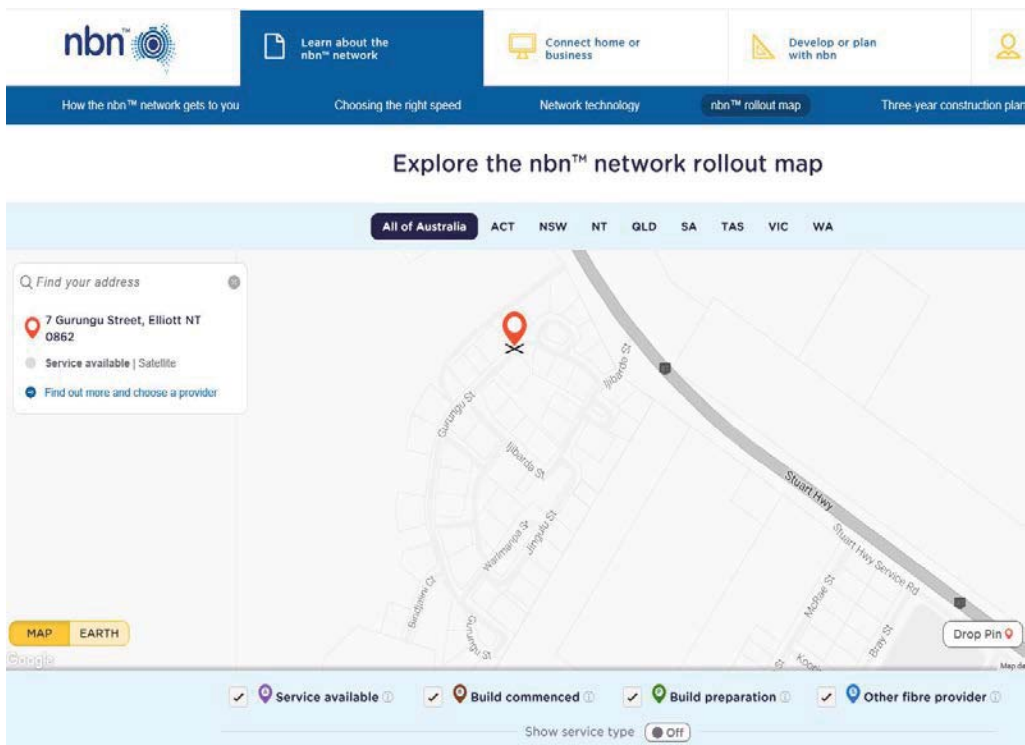
Figure 17 NBN network availability map

NBN is available to residents via satellite on application.

- No works are required because NBN is available to residents via satellite on application to an appropriate NBN access provider.

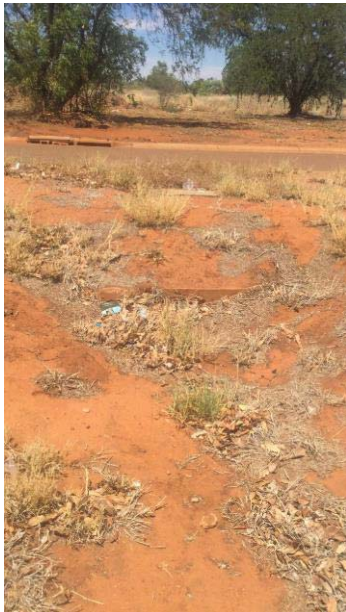
Couldn't see culvert dimensions

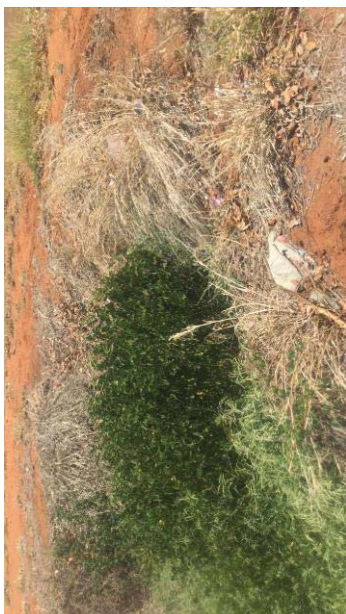
Stormwater Infrastructure: Culverts  
Culvert Type: RCP  
Diameter (mm): 300  
Width (mm):  
Culvert Depth (mm):  
Culvert Length (m):  
Culvert Condition: 2 - Poor  
Culvert Blockage (%): 50  
Culvert Comments:  
Culvert Head Wall: No  
Safety Grate:  
Headwall Blockage:  
Headwall Condition:  
Headwall Comment:  
End Wall: Yes  
End Wall condition: 3 - Good  
EW Comment:

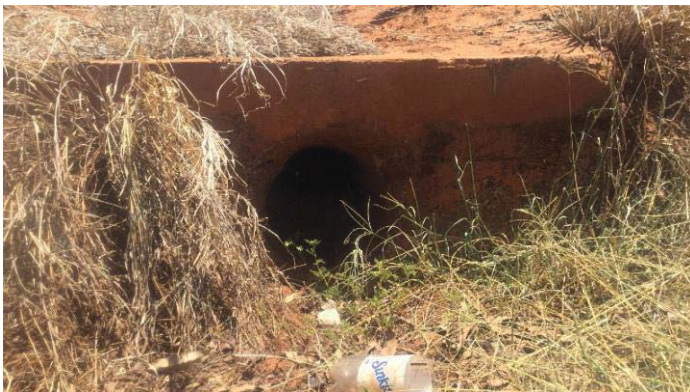
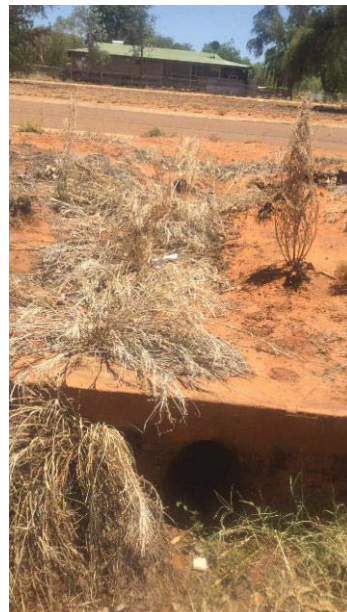
Insp ID: 1242      Group 3 - Tennant Creek, Elliott      Elliott North Camp

Stormwater Infrastructure:      Culverts  
Culvert Type:      RCP  
Diameter (mm):      450  
Width (mm):  
Culvert Depth (mm):  
Culvert Length (m):  
Culvert Condition:      2 - Poor  
Culvert Blockage (%):  
Culvert Comments:  
Culvert Head Wall:      No  
Safety Grate:  
Headwall Blockage:  
Headwall Condition:  
Headwall Comment:  
End Wall:      Yes  
End Wall condition:      2 - Poor  
EW Comment:

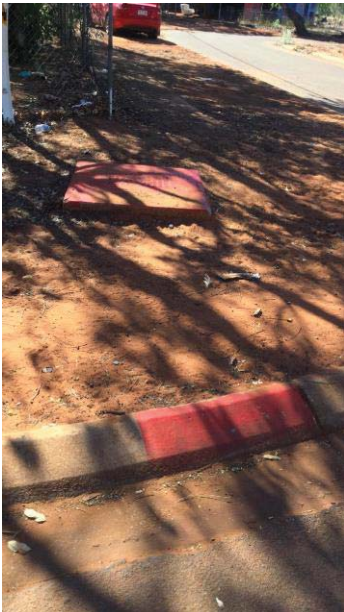
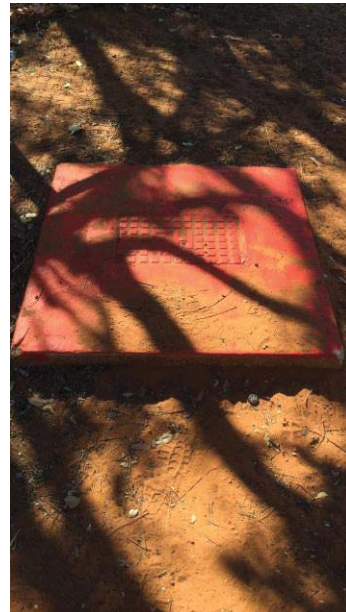
FH Condition: 1 - Very Poor

FH Comment: Cover not sitting properly, cover broken

- Restore fire hydrant pit
- Replace one tap
- Repair one tap
- Remove calcium build up from one residential lot water meter

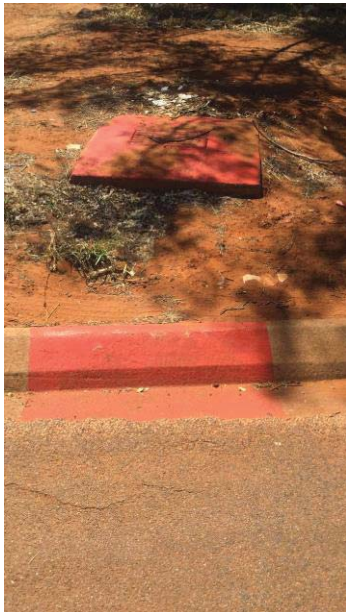
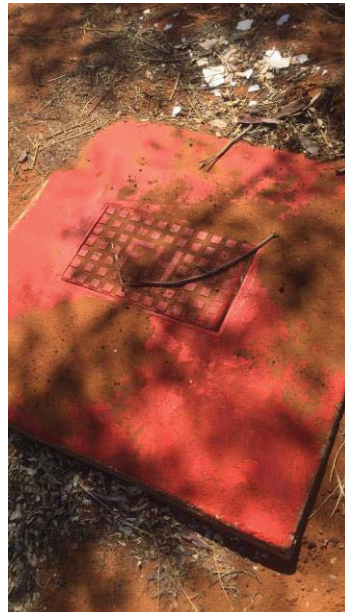
FH Condition: 3 - Good

FH Comment: Covered in leaves , next to fence

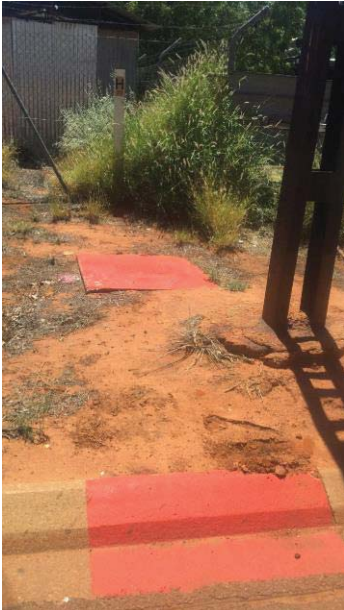
**FH Condition:** 3 - Good

**FH Comment:** Erosion around lid

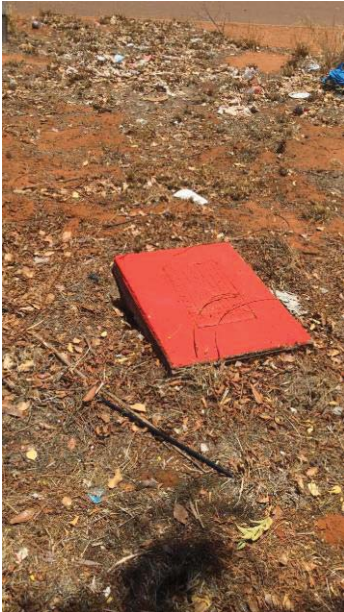
FH Condition: 3 - Good

FH Comment: Lid not flat on ground

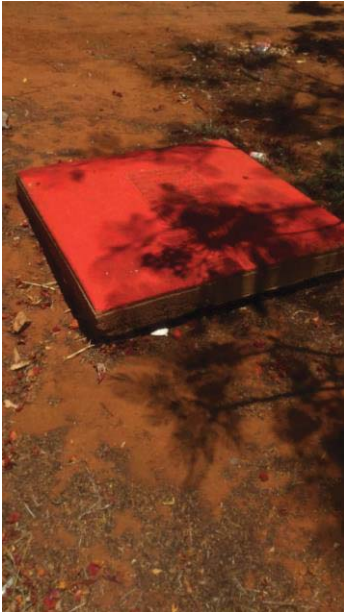
Comment: Covered in dirt

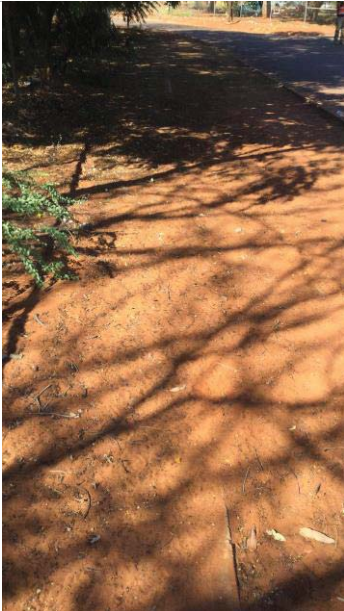
Comment: Broken sections and covered in dirt

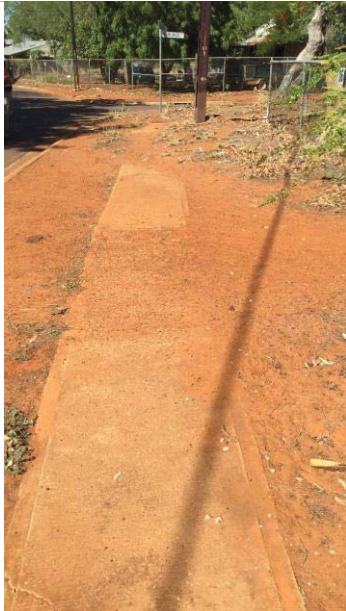
Comment: Overgrown, cracked sections, not maintained

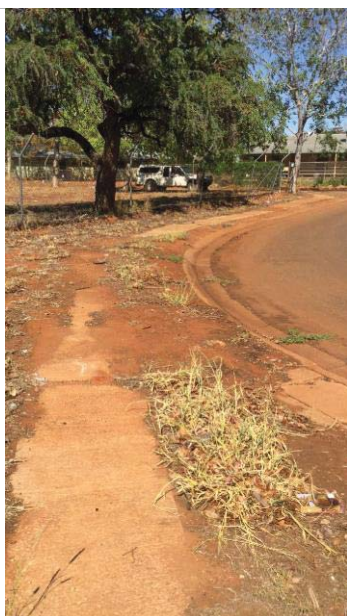
Comment: Broken, non existent sections

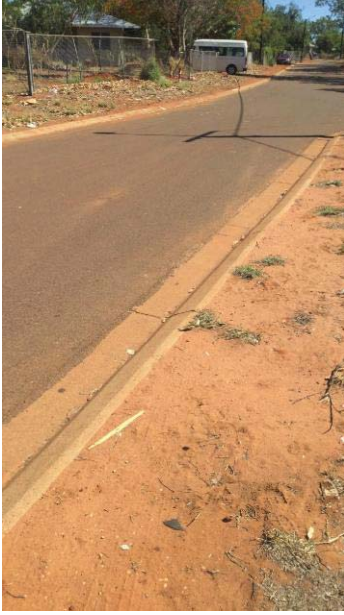
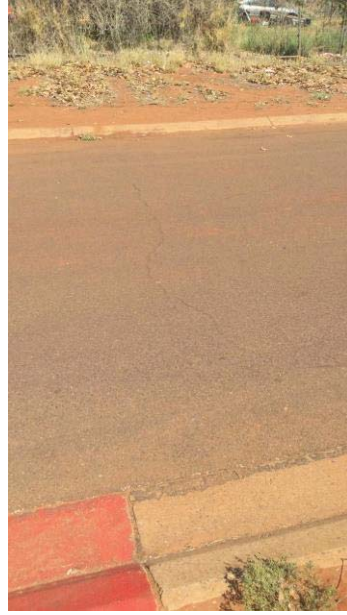
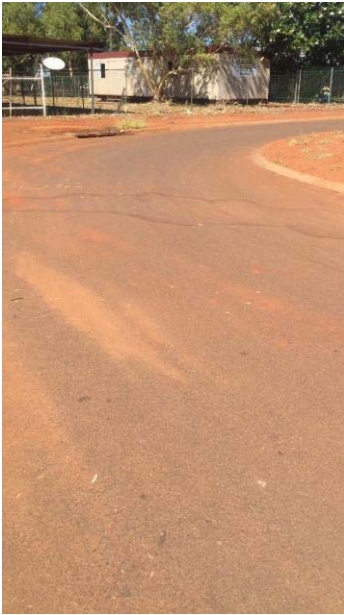
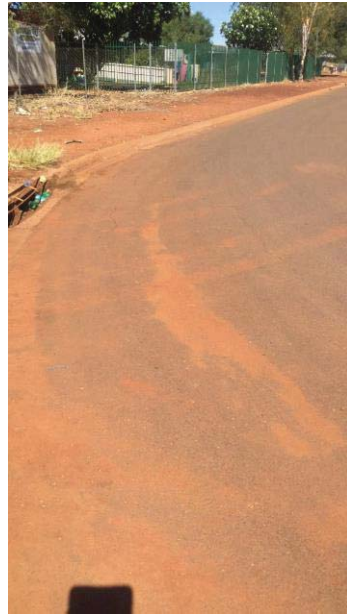
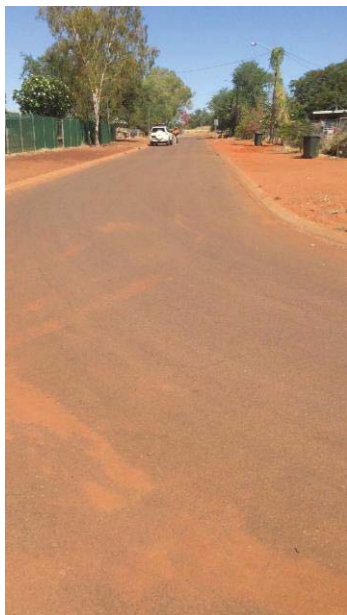
Defect Type	Defect QTY	Defect Condition	Defect Comments
Surfacing Cracks	5	3 - Good	5% of road has cracks

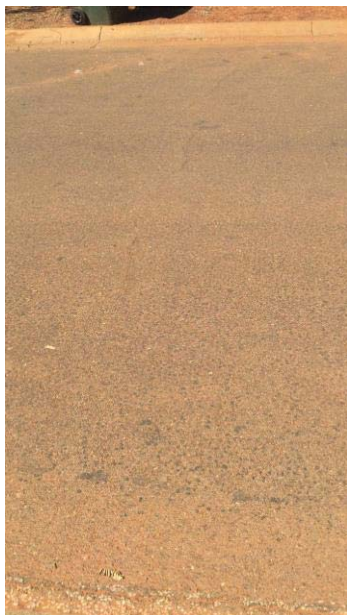
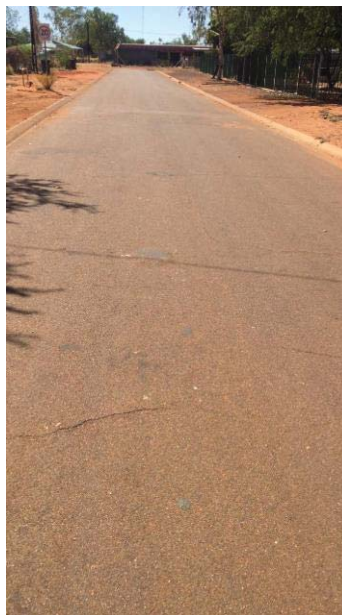
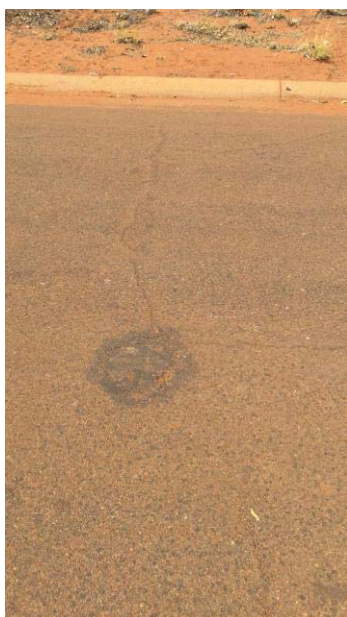
Defect Type	Defect QTY	Defect Condition	Defect Comments
Surfacing Cracks	5	2 - Poor	5% of road cracked

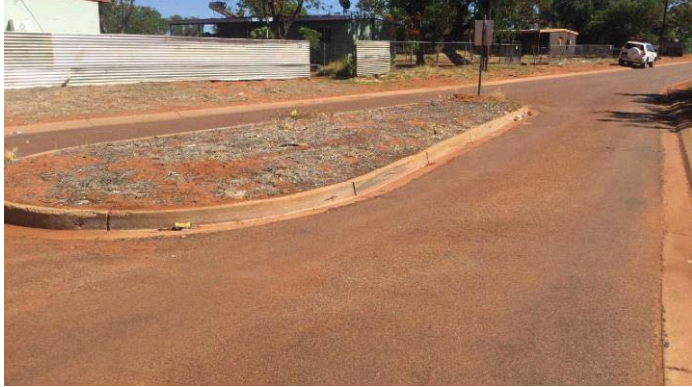
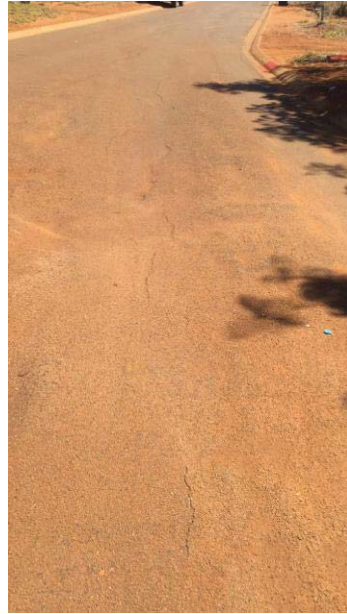
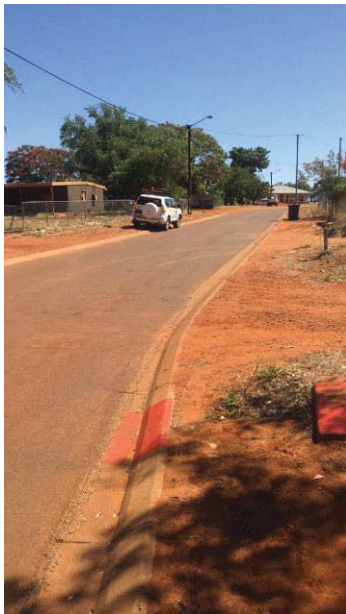
Defect Type	Defect QTY	Defect Condition	Defect Comments
Surfacing Cracks	5	3 - Good	% of road has cracked

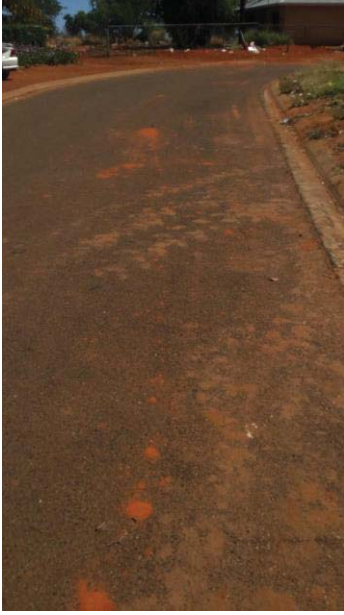
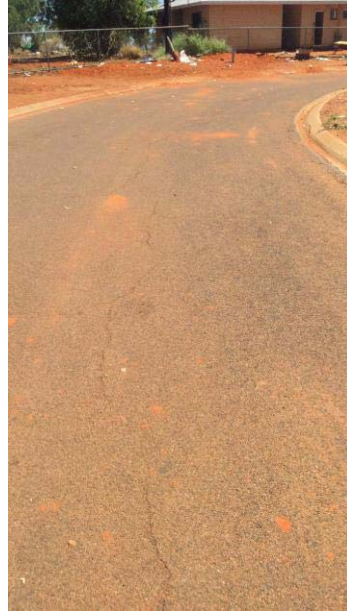
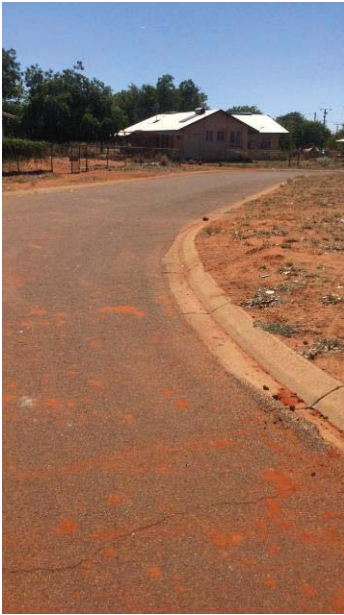
Defect Type	Defect QTY	Defect Condition	Defect Comments
Surfacing Cracks	10	3 - Good	10% of road has cracks

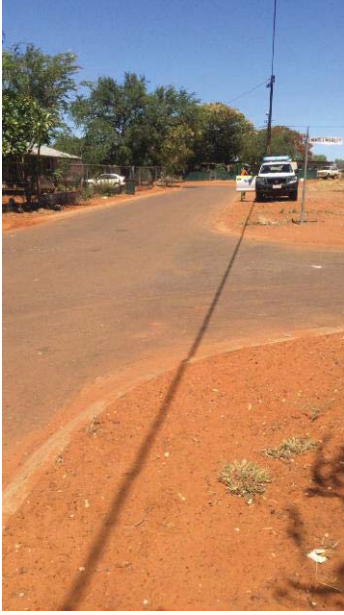
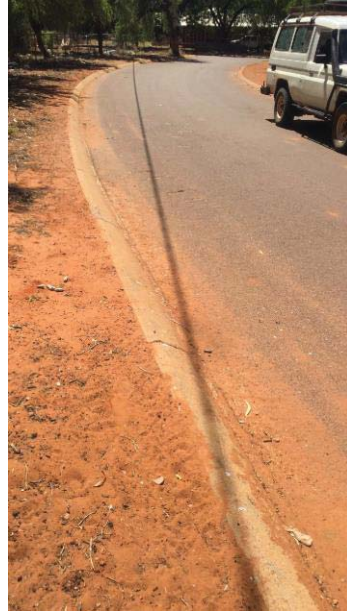
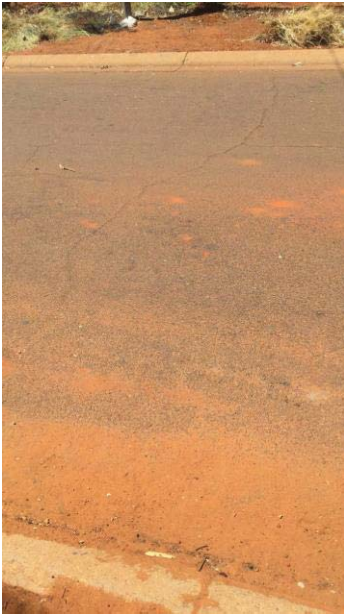
Defect Type	Defect QTY	Defect Condition	Defect Comments
Surfacing Cracks	10	3 - Good	10% of road has cracks , speed bumps

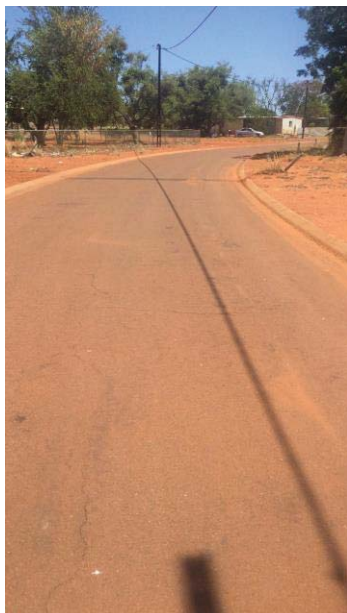
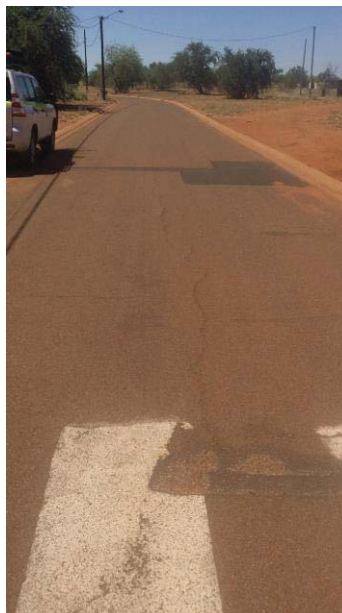
Defect Type	Defect QTY	Defect Condition	Defect Comments
Surfacing Cracks	5	3 - Good	5% of road cracked

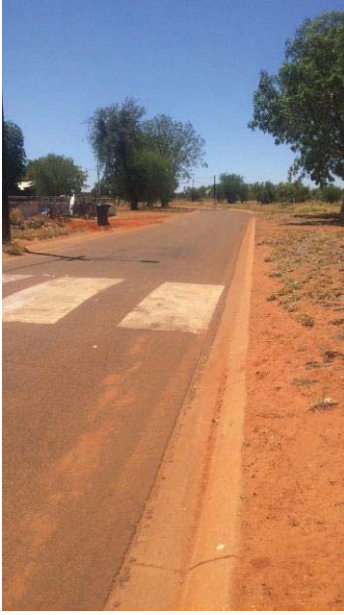
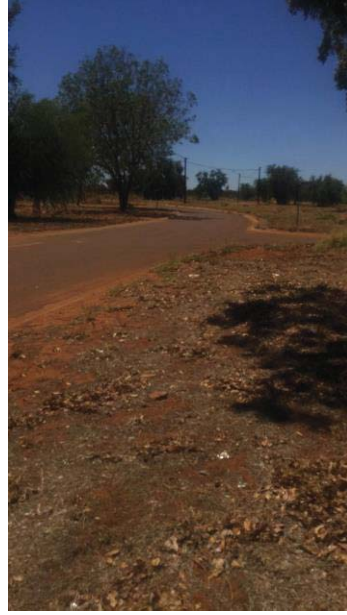
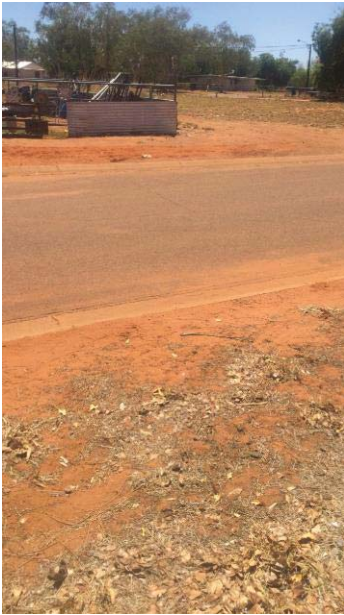
Defect Type	Defect QTY	Defect Condition	Defect Comments
Surfacing Cracks	10	3 - Good	10% road has cracks
Rutting	4	2 - Poor	Rita due to grader/heavy machinery drivin ove

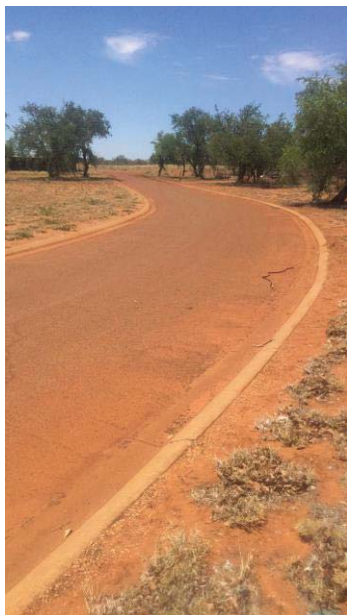
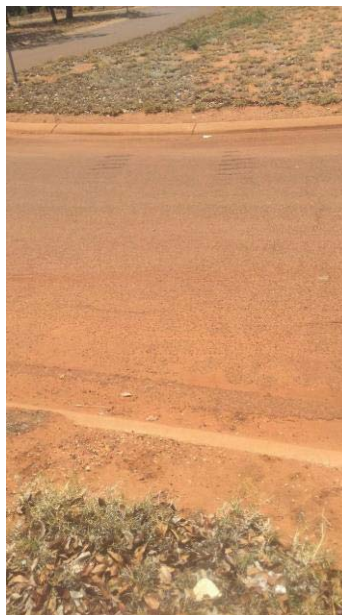
Defect Type	Defect QTY	Defect Condition	Defect Comments
Stone Loss	5	3 - Good	Some stone loss. Unused road
Surfacing Cracks	5	3 - Good	5% of road has cracks

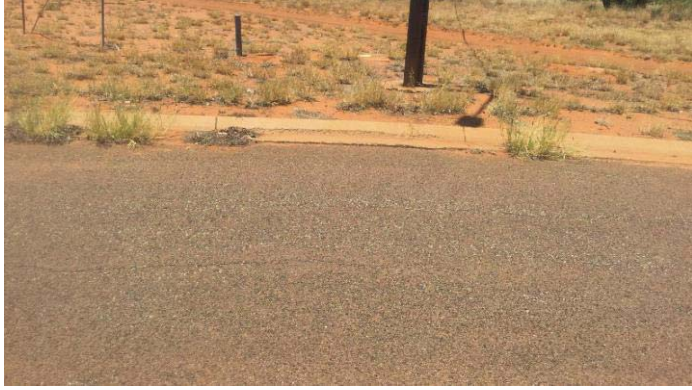
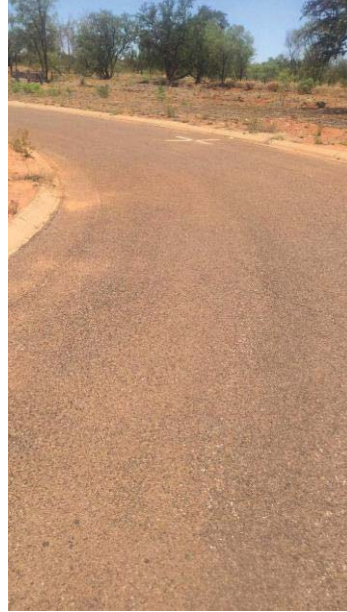
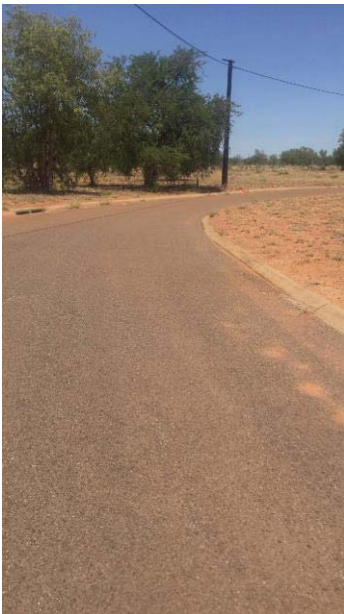
Defect Type	Defect QTY	Defect Condition	Defect Comments
Surfacing Cracks	5	3 - Good	5% of road

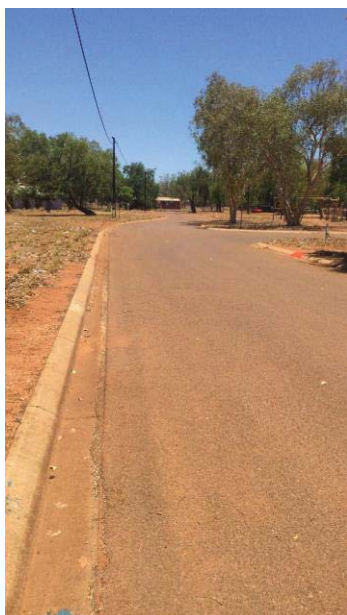
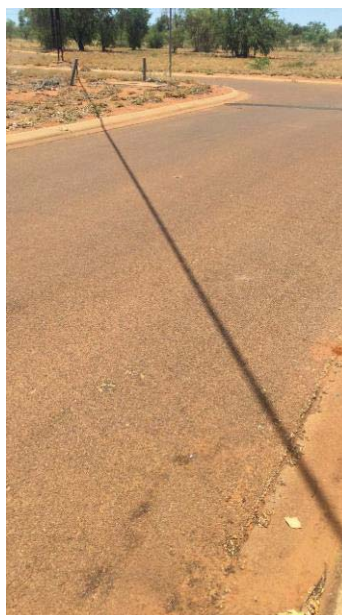
Defect Type	Defect QTY	Defect Condition	Defect Comments
Surfacing Cracks	5	3 - Good	5% of road

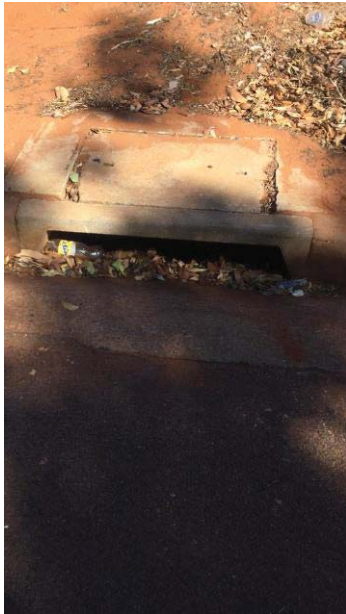
Stormwater Infrastructure: SEP  
Number of Bays: 1  
On grade or sag pit:  
Both sides of road: Right  
Condition: 3 - Good  
Blockage (%): 10  
Comment:

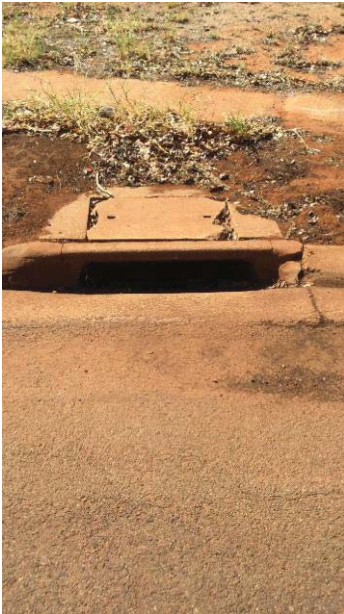
Stormwater Infrastructure: SEP  
Number of Bays: 1  
On grade or sag pit:  
Both sides of road: Left  
Condition: 2 - Poor  
Blockage (%): 10  
Comment:

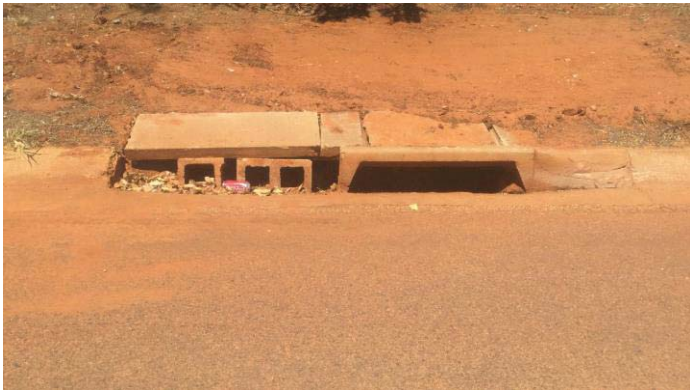
Stormwater Infrastructure: SEP  
Number of Bays: 2  
On grade or sag pit:  
Both sides of road: Left  
Condition: 2 - Poor  
Blockage (%): 50  
Comment:

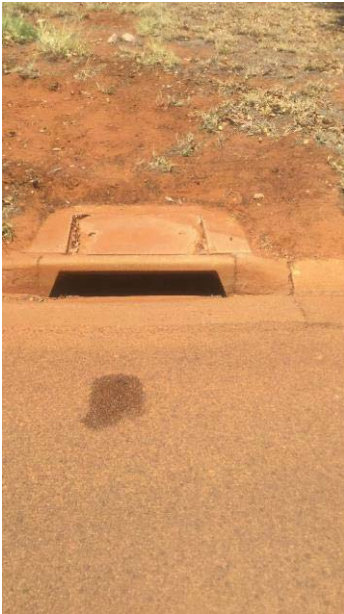
Stormwater Infrastructure: SEP  
Number of Bays: 1  
On grade or sag pit:  
Both sides of road: Right  
Condition: 2 - Poor  
Blockage (%):  
Comment:

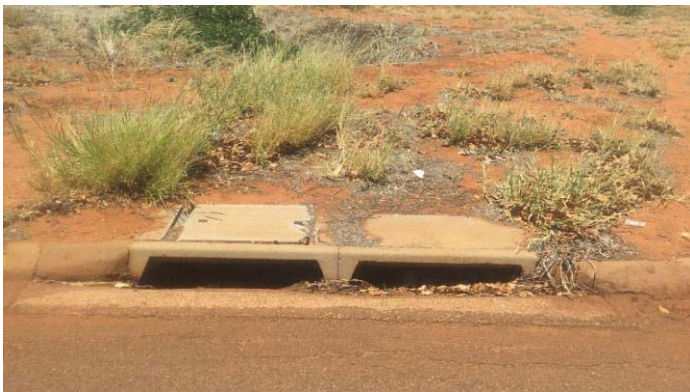
Stormwater Infrastructure:	SEP
Number of Bays:	2
On grade or sag pit:	
Both sides of road:	Right
Condition:	3 - Good
Blockage (%):	50
Comment:	Blocked inside

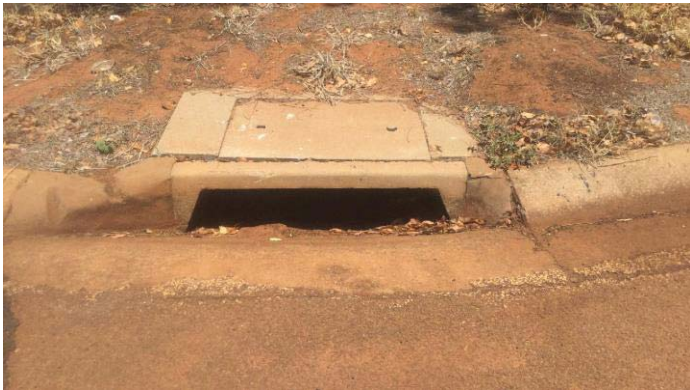
Stormwater Infrastructure: SEP  
Number of Bays: 1  
On grade or sag pit:  
Both sides of road: Left  
Condition: 3 - Good  
Blockage (%): 10  
Comment:

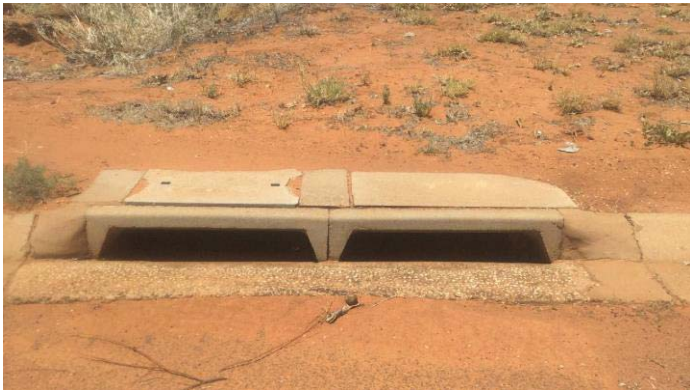
Stormwater Infrastructure: SEP  
Number of Bays: 2  
On grade or sag pit:  
Both sides of road: Right  
Condition: 3 - Good  
Blockage (%): 20  
Comment:

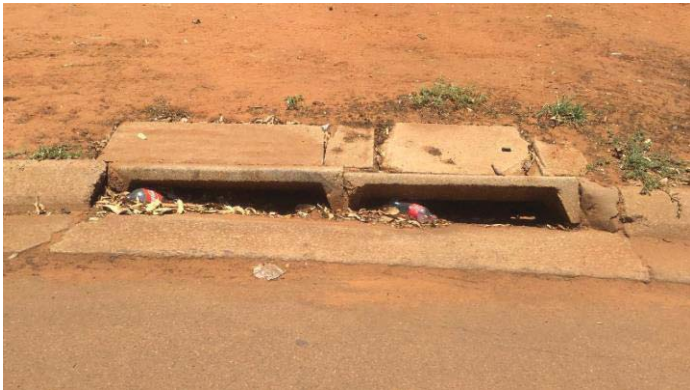
Stormwater Infrastructure: SEP  
Number of Bays: 2  
On grade or sag pit:  
Both sides of road: Right  
Condition: 2 - Poor  
Blockage (%): 30  
Comment:

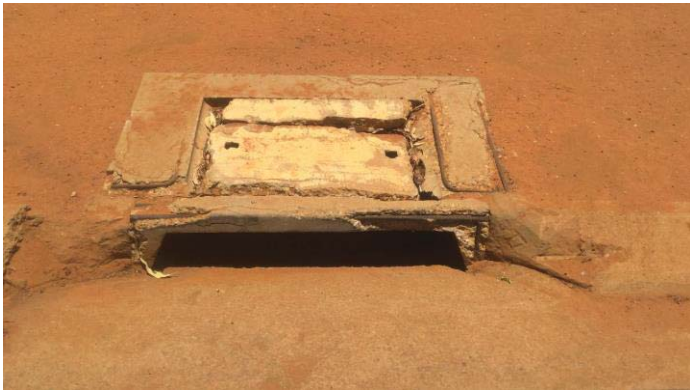
Stormwater Infrastructure: SEP  
Number of Bays: 1  
On grade or sag pit:  
Both sides of road:  
Condition: 2 - Poor  
Blockage (%): 10  
Comment:

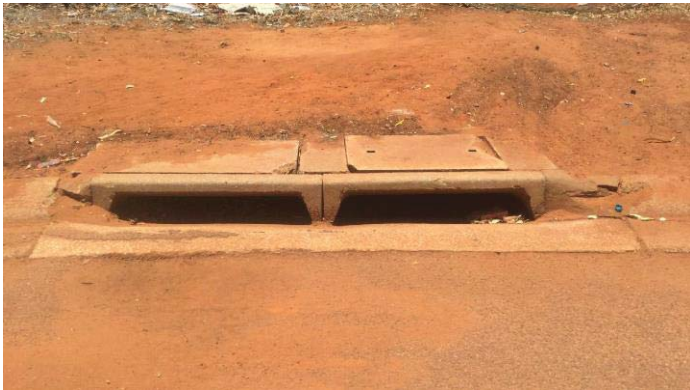
Stormwater Infrastructure: SEP  
Number of Bays: 2  
On grade or sag pit:  
Both sides of road:  
Condition: 2 - Poor  
Blockage (%): 40  
Comment:

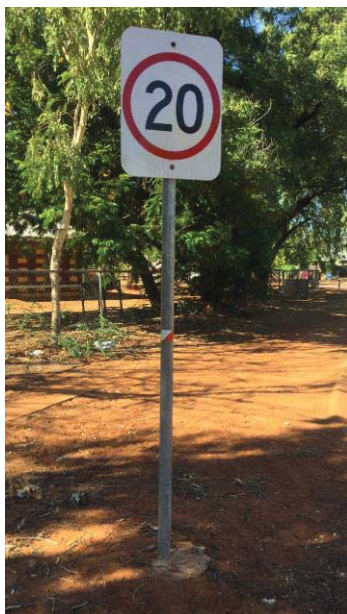
Sign Condition: 2 - Poor

Sign Comment: Sign bent

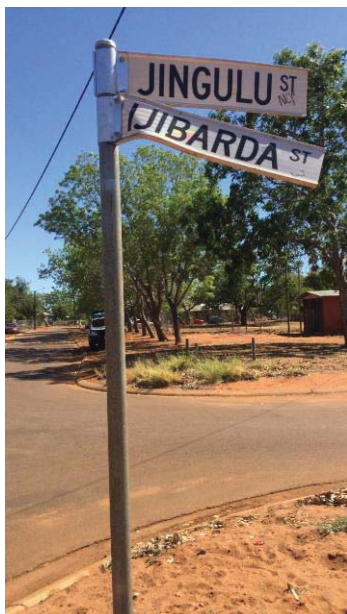
Sign Condition: 2 - Poor

Sign Comment: Faded, graffiti

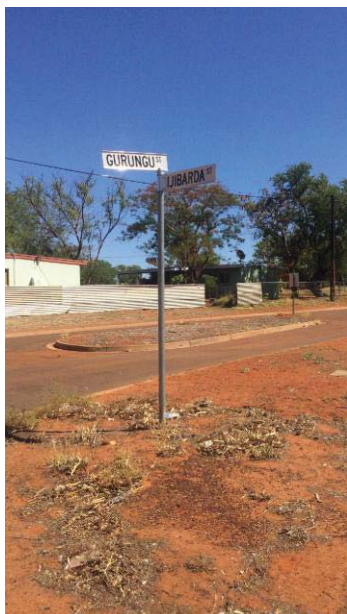
Sign Condition: 2 - Poor

Sign Comment: Faded, has graffiti

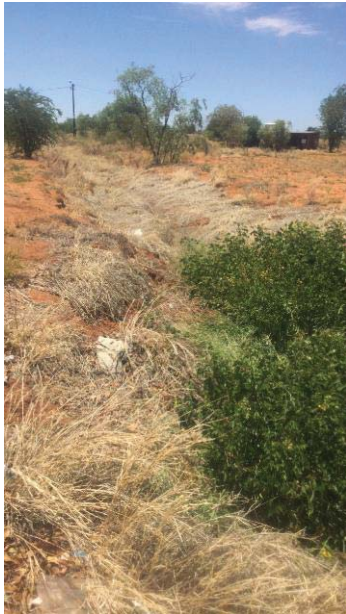
Stormwater Infrastructure:	Swales
Type of lining:	Natural Grasses
Are dimensions uniform along drain:	No
Base Width (m):	
Overall Width (m):	6
Swale Depth (m):	2
Length of Batter 1 (m):	
Length of Batter 2 (m):	
Swale Condition:	2 - Poor
Swale Ponding:	No
Drain flooded at time of inspection:	No
Swale Comments:	Dimensions estimated

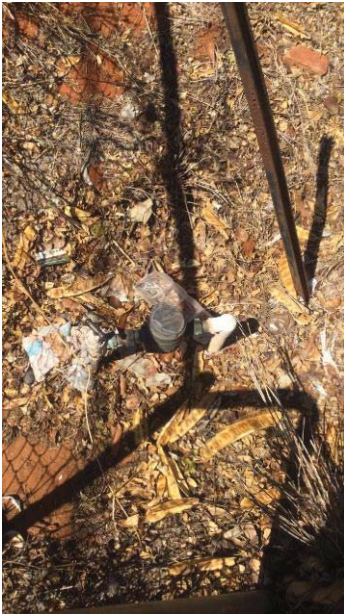
Lot Water Meter Condition: 2 - Poor

Lot Water Meter Comment: Calcium build up outside tap

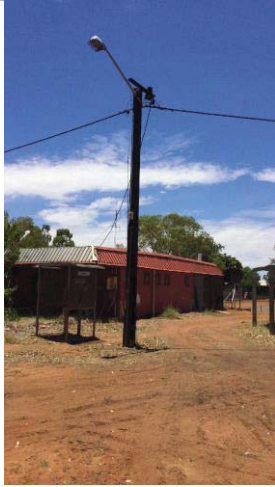
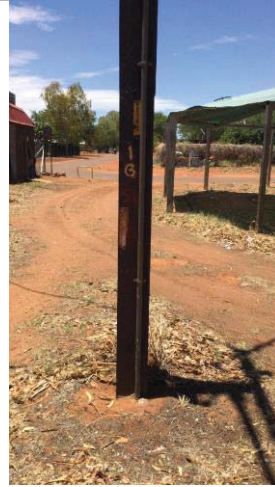
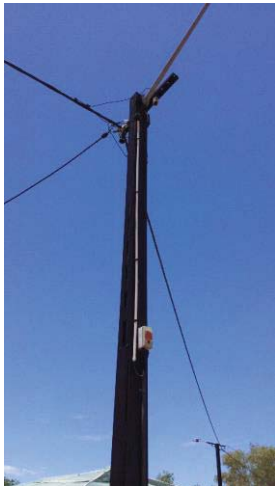
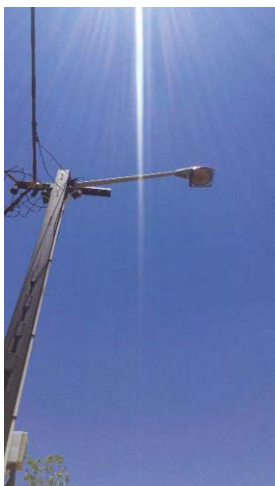
What is Pole Material type:	Welded
What is the condition of pole:	3
How is the pole planted:	Concrete
What is the Condition of plant:	3
Is street light fitted:	Yes
Street Light Power Supply:	
Street Light Type	S30D 93
Street Light Watts	30
Street Light Condition	1
Street Light Height	
What is the type of service:	Three
What is the HV voltage level:	400
What is the arrangement of connected cables:	Twisted
Are there isolators on the pole:	No
What is the Condition:	3
How many Lots are connected to this pole:	1
Overhead Pole Comments:	Surface rusted

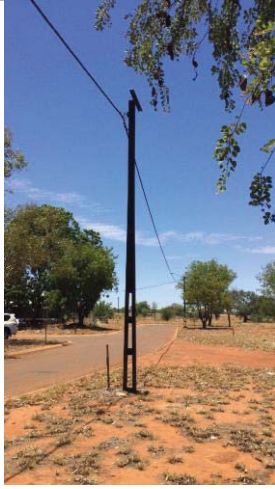
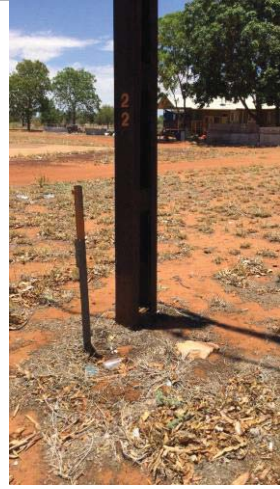
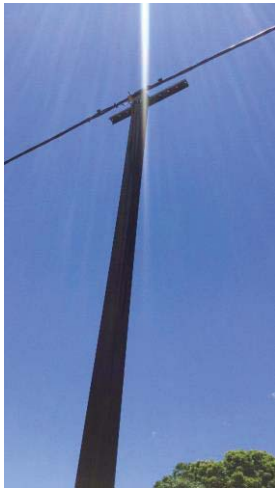
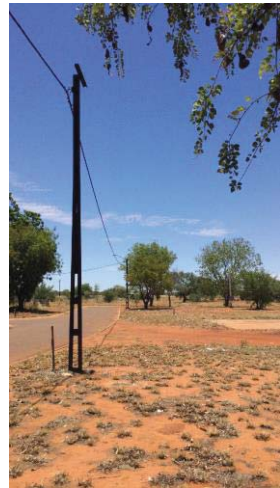
Overhead Pole Comments: Surface rusted

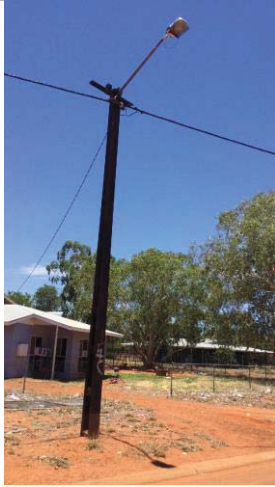
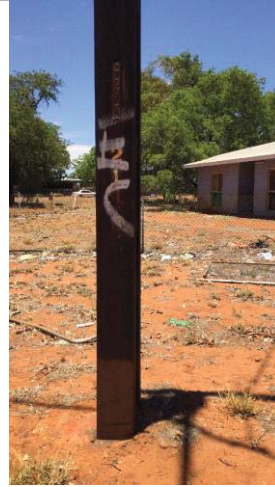
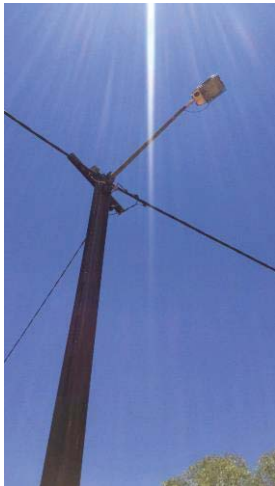
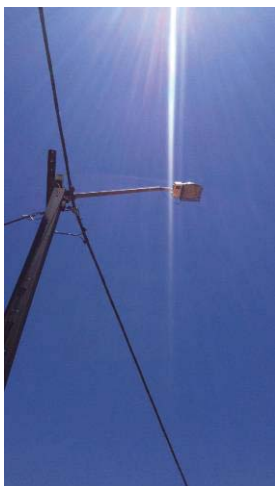
What is Pole Material type:	Welded
What is the condition of pole:	3
How is the pole planted:	Concrete
What is the Condition of plant:	3
Is street light fitted:	Yes
Street Light Power Supply:	
Street Light Type	Unknown
Street Light Watts	
Street Light Condition	3
Street Light Height	
What is the type of service:	Three
What is the HV voltage level:	400
What is the arrangement of connected cables:	Twisted
Are there isolators on the pole:	No
What is the Condition:	3
How many Lots are connected to this pole:	1
Overhead Pole Comments:	Surface rusted

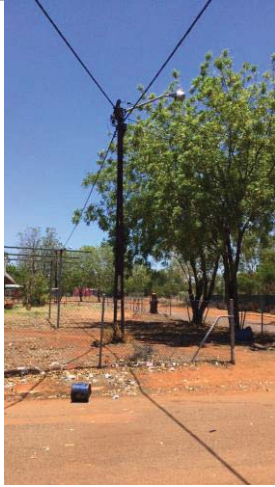
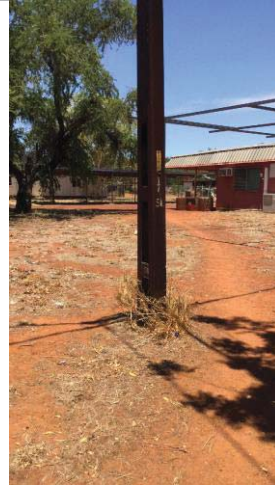
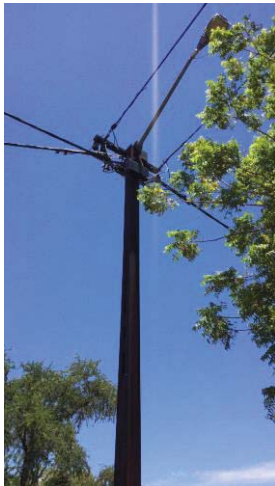
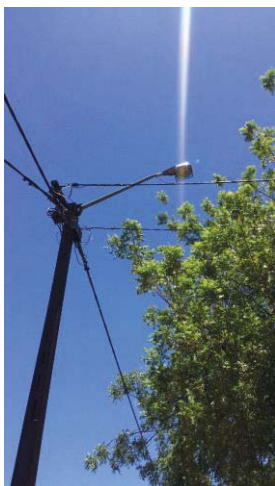
What is Pole Material type:	Welded
What is the condition of pole:	3
How is the pole planted:	Concrete
What is the Condition of plant:	3
Is street light fitted:	Yes
Street Light Power Supply:	
Street Light Type	S70D 90
Street Light Watts	
Street Light Condition	3
Street Light Height	
What is the type of service:	Three
What is the HV voltage level:	400
What is the arrangement of connected cables:	Twisted
Are there isolators on the pole:	No
What is the Condition:	3
How many Lots are connected to this pole:	2
Overhead Pole Comments:	Surface rusted

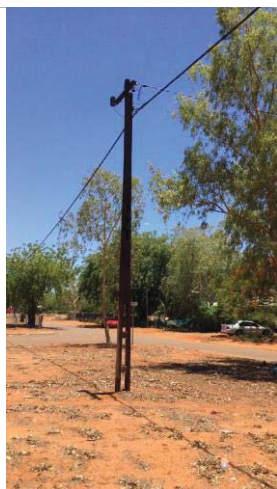
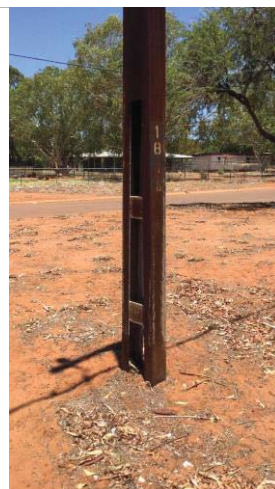
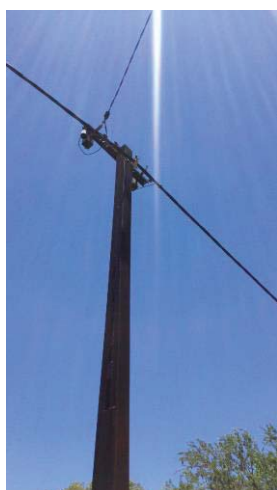
What is Pole Material type:	Welded
What is the condition of pole:	3
How is the pole planted:	Concrete
What is the Condition of plant:	3
Is street light fitted:	No
Street Light Power Supply:	
Street Light Type	
Street Light Watts	
Street Light Condition	
Street Light Height	
What is the type of service:	Three
What is the HV voltage level:	400
What is the arrangement of connected cables:	Twisted
Are there isolators on the pole:	No
What is the Condition:	3
How many Lots are connected to this pole:	1
Overhead Pole Comments:	Surface rusted

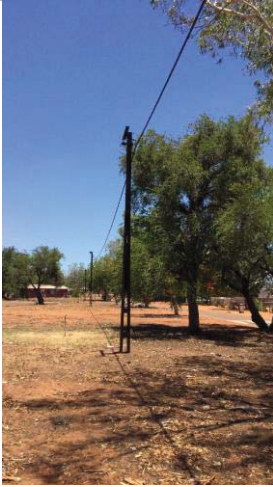
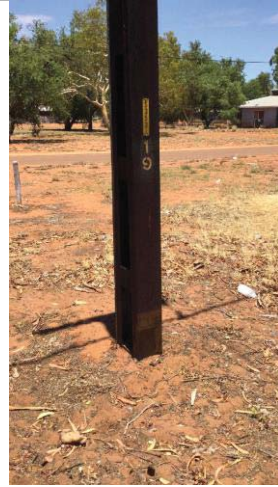
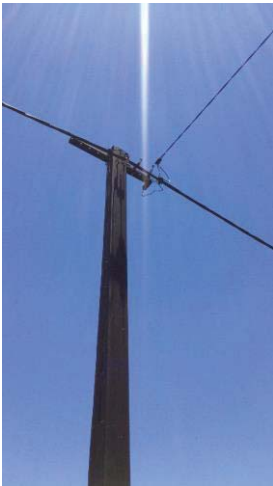
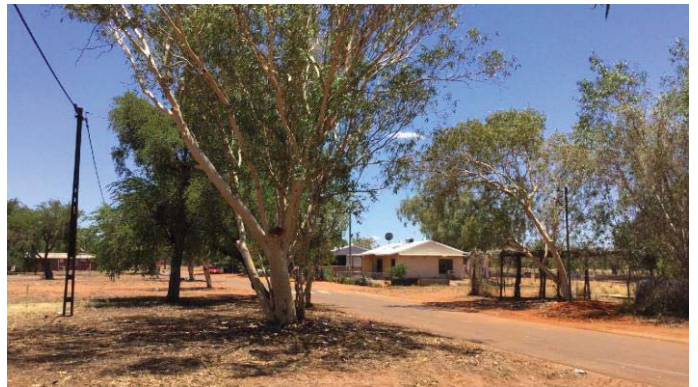
Inspection Date 29/11/2016 12:43:19 PM

What is Pole Material type:	Welded
What is the condition of pole:	3
How is the pole planted:	Concrete
What is the Condition of plant:	3
Is street light fitted:	Yes
Street Light Power Supply:	
Street Light Type	S70D 14
Street Light Watts	70
Street Light Condition	3
Street Light Height	
What is the type of service:	Three
What is the HV voltage level:	400
What is the arrangement of connected cables:	Twisted
Are there isolators on the pole:	No
What is the Condition:	3
How many Lots are connected to this pole:	1
Overhead Pole Comments:	Surface rusted

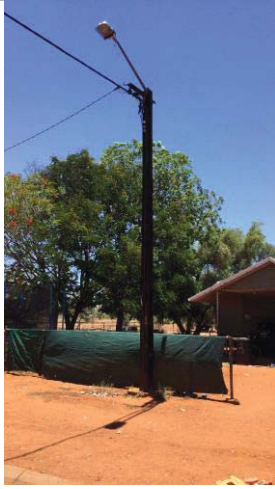
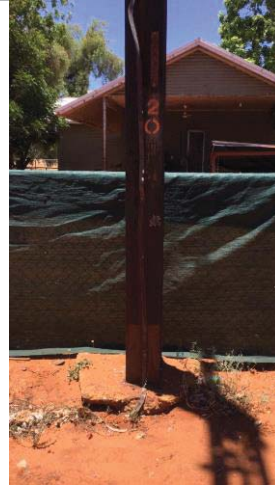
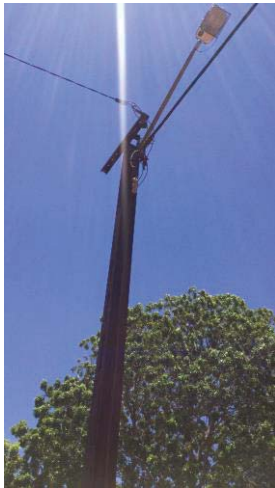
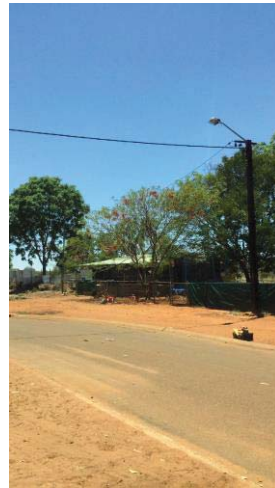
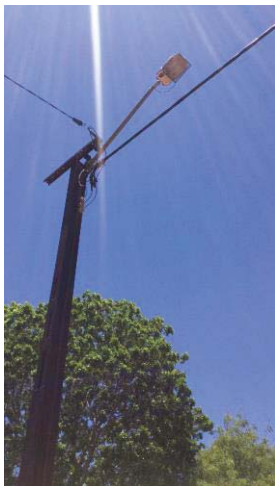
Inspection Date 29/11/2016 12:41:03 PM

What is Pole Material type:	Welded
What is the condition of pole:	3
How is the pole planted:	Concrete
What is the Condition of plant:	3
Is street light fitted:	Yes
Street Light Power Supply:	
Street Light Type	Unknown
Street Light Watts	
Street Light Condition	3
Street Light Height	
What is the type of service:	Three
What is the HV voltage level:	400
What is the arrangement of connected cables:	Twisted
Are there isolators on the pole:	No
What is the Condition:	3
How many Lots are connected to this pole:	1
Overhead Pole Comments:	Surface rusted

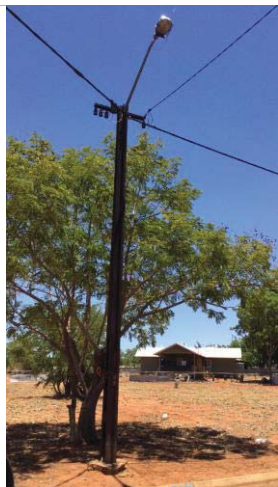
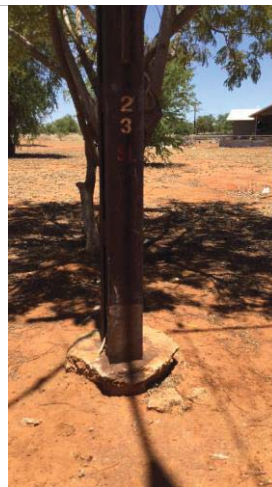
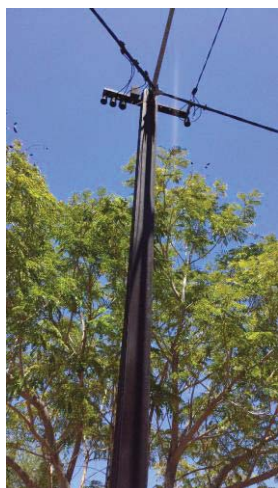
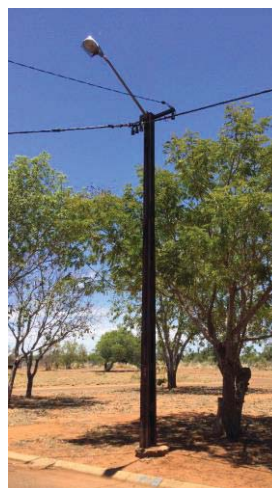
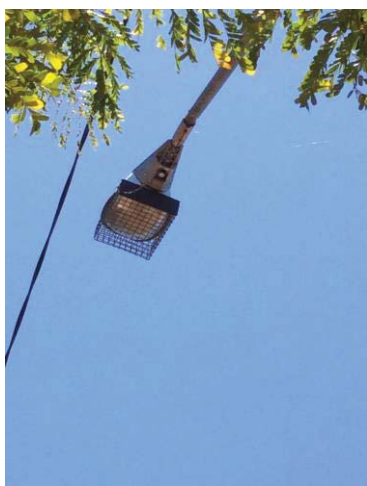
Inspection Date 29/11/2016 12:32:51 PM

What is the condition of pole: 3

Overhead Pole Comments: Surface rusted

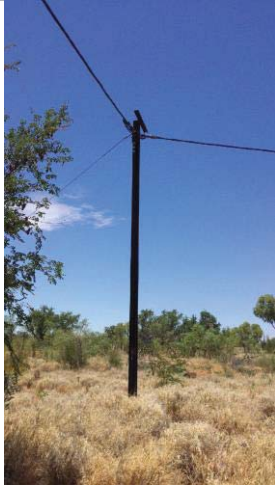
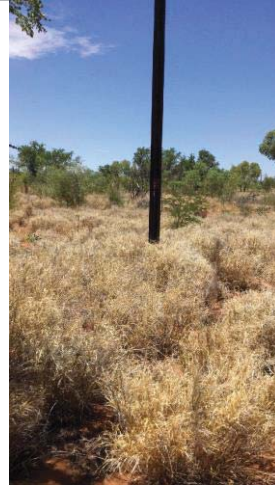
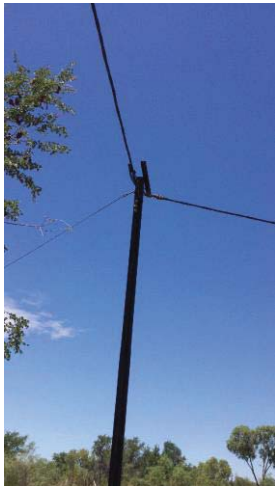
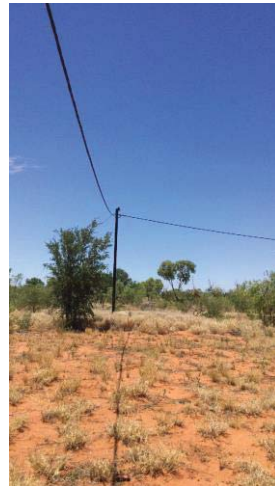
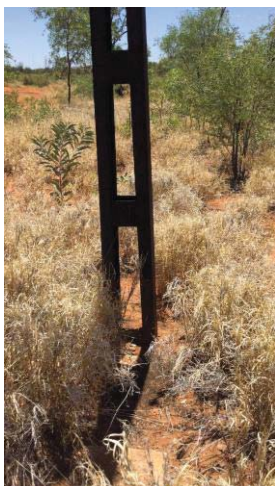
Inspection Date 29/11/2016 12:15:58 PM

What is Pole Material type:	Welded
What is the condition of pole:	3
How is the pole planted:	Concrete
What is the Condition of plant:	3
Is street light fitted:	Yes
Street Light Power Supply:	
Street Light Type	S70D 10
Street Light Watts	
Street Light Condition	3
Street Light Height	
What is the type of service:	Three
What is the HV voltage level:	400
What is the arrangement of connected cables:	Twisted
Are there isolators on the pole:	No
What is the Condition:	3
How many Lots are connected to this pole:	0
Overhead Pole Comments:	Surface rusted
