# Appendix B

## Municipal and essential infrastructure

# Elliott North & South Camp

# Elliott North Camp

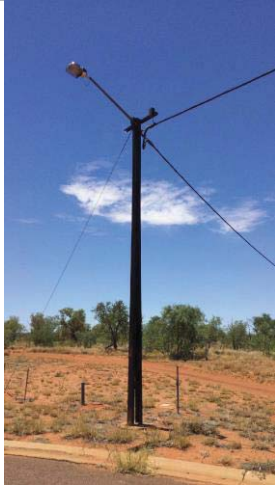
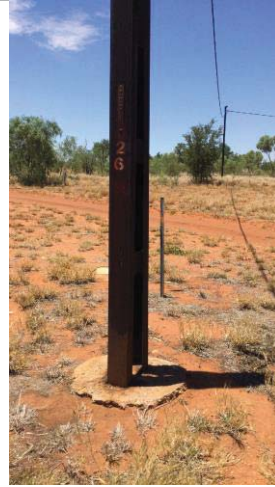
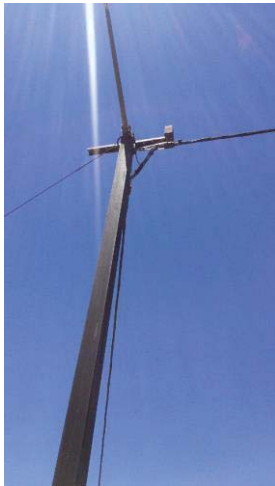
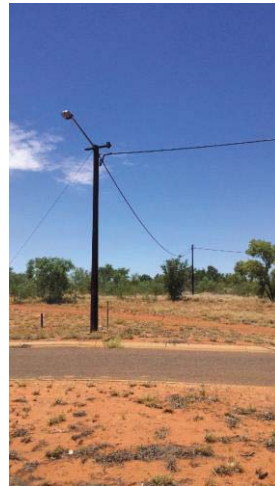
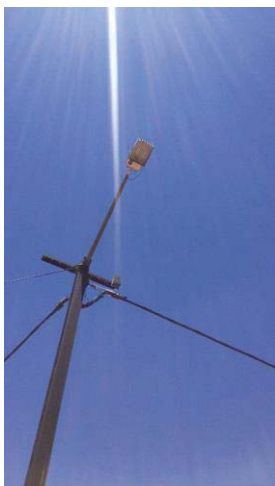
Inspection Date 29/11/2016 12:12:41 PM

What is the condition of pole: 3

Overhead Pole Comments: Surface rusted

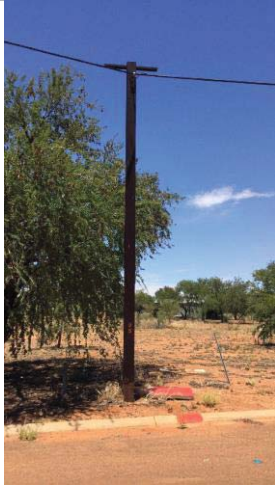
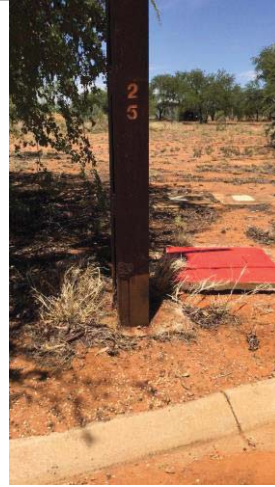
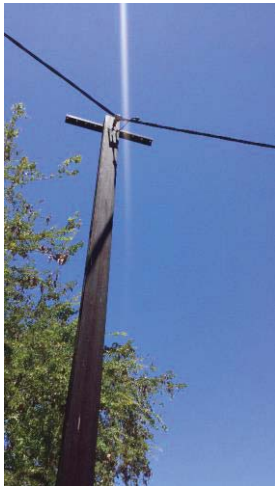
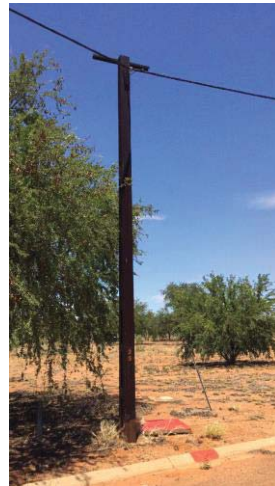
Inspection Date 29/11/2016 12:09:47 PM

What is Pole Material type:	Welded
What is the condition of pole:	3
How is the pole planted:	Concrete
What is the Condition of plant:	3
Is street light fitted:	Yes
Street Light Power Supply:	
Street Light Type	S70D 11
Street Light Watts	70
Street Light Condition	3
Street Light Height	
What is the type of service:	Three
What is the HV voltage level:	400
What is the arrangement of connected cables:	Twisted
Are there isolators on the pole:	No
What is the Condition:	3
How many Lots are connected to this pole:	0
Overhead Pole Comments:	Surface rusted

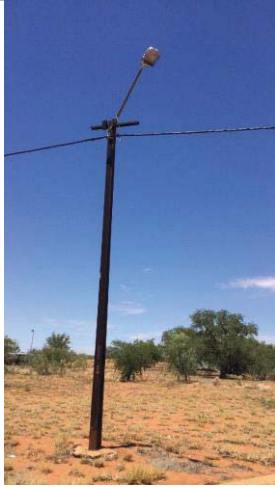
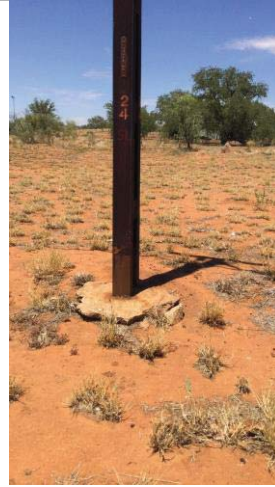
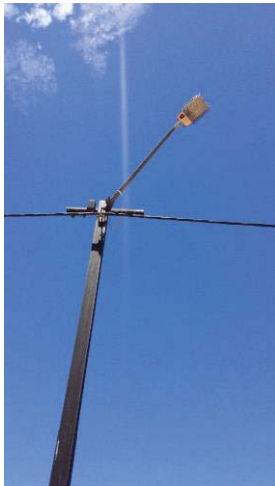
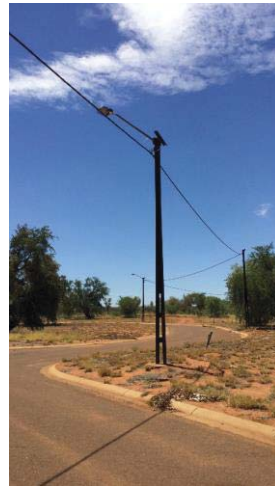
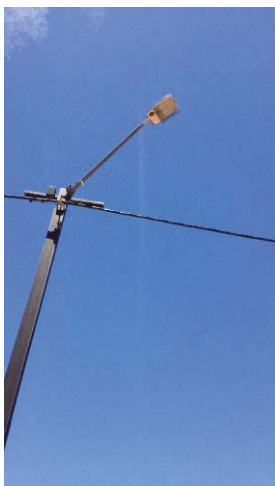
Inspection Date 29/11/2016 11:56:55 AM

What is Pole Material type:	Welded
What is the condition of pole:	3
How is the pole planted:	Concrete
What is the Condition of plant:	3
Is street light fitted:	No
Street Light Power Supply:	
Street Light Type	
Street Light Watts	
Street Light Condition	
Street Light Height	
What is the type of service:	Three
What is the HV voltage level:	400
What is the arrangement of connected cables:	Twisted
Are there isolators on the pole:	No
What is the Condition:	3
How many Lots are connected to this pole:	0
Overhead Pole Comments:	Surface rusted

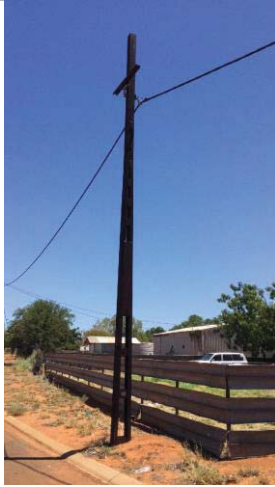
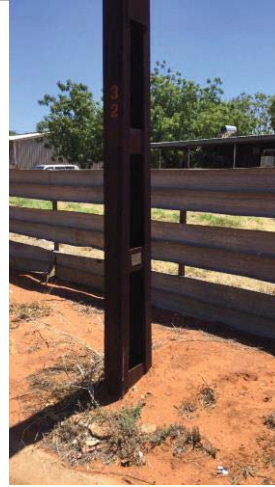
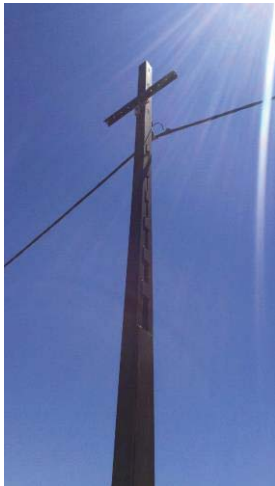
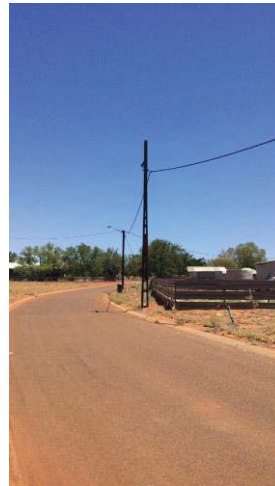
Inspection Date 29/11/2016 11:45:53 AM

What is Pole Material type:	Welded
What is the condition of pole:	3
How is the pole planted:	Concrete
What is the Condition of plant:	3
Is street light fitted:	Yes
Street Light Power Supply:	
Street Light Type	M80D 06
Street Light Watts	80
Street Light Condition	3
Street Light Height	
What is the type of service:	Three
What is the HV voltage level:	400
What is the arrangement of connected cables:	Twisted
Are there isolators on the pole:	No
What is the Condition:	3
How many Lots are connected to this pole:	1
Overhead Pole Comments:	Surface rusted

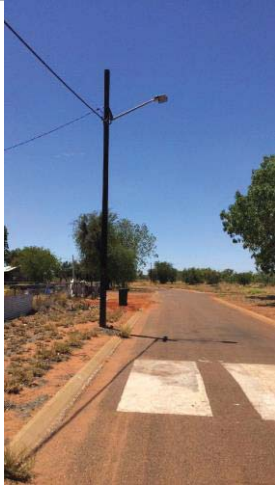
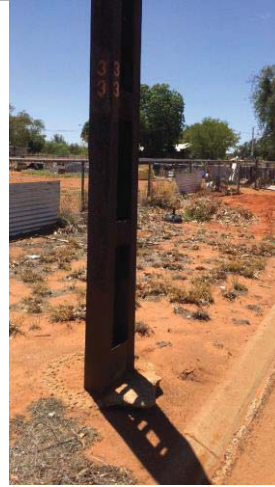
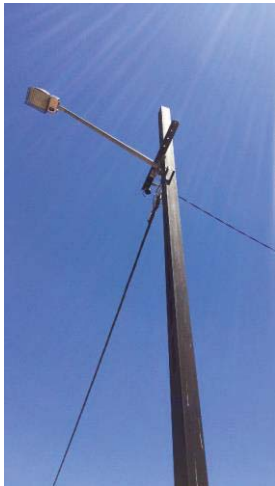
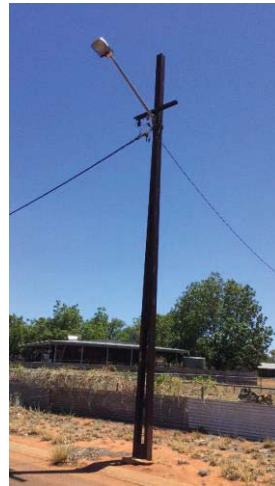
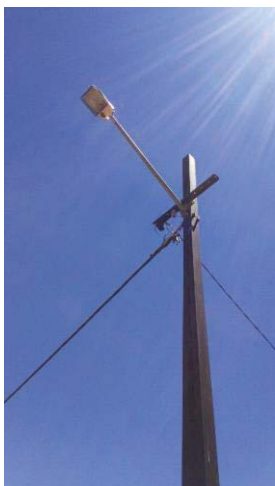
Inspection Date 29/11/2016 11:44:07 AM

What is the condition of pole: 3

What is the Condition of plant: 3

What is the Condition: 3

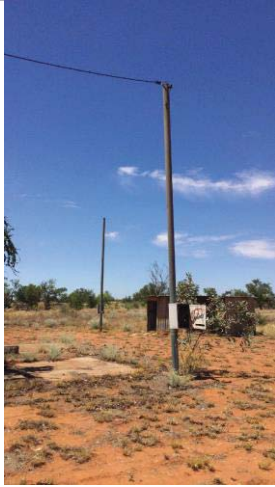
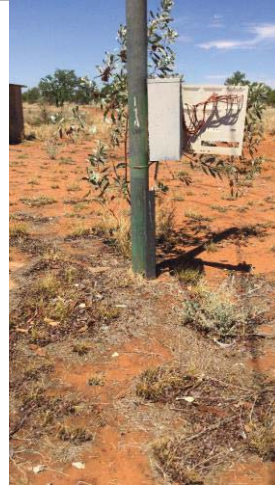
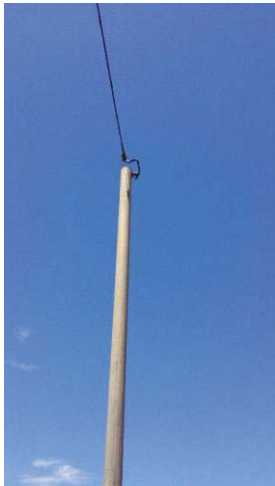
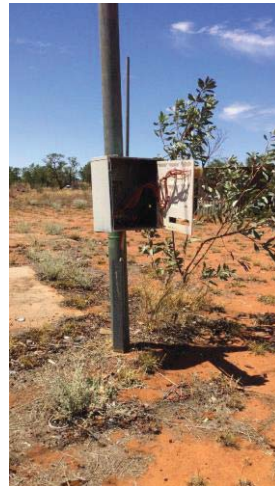
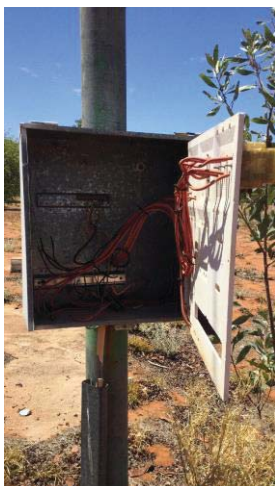
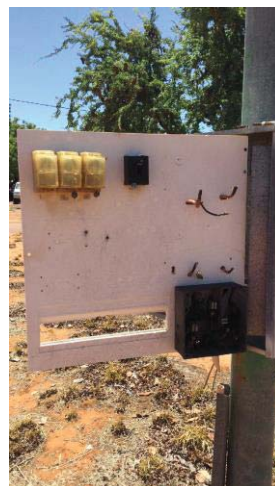
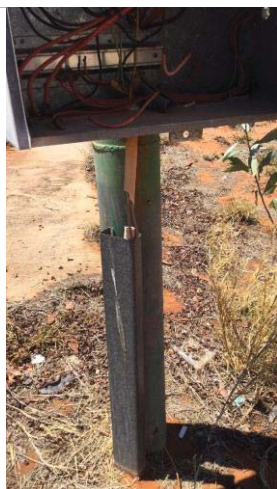
Inspection Date 29/11/2016 11:35:31 AM

What is Pole Material type:	Welded
What is the condition of pole:	3
How is the pole planted:	Concrete
What is the Condition of plant:	3
Is street light fitted:	Yes
Street Light Power Supply:	
Street Light Type	S70D 09
Street Light Watts	70
Street Light Condition	3
Street Light Height	
What is the type of service:	Three
What is the HV voltage level:	400
What is the arrangement of connected cables:	Twisted
Are there isolators on the pole:	No
What is the Condition:	3
How many Lots are connected to this pole:	3
Overhead Pole Comments:	Surface rusted

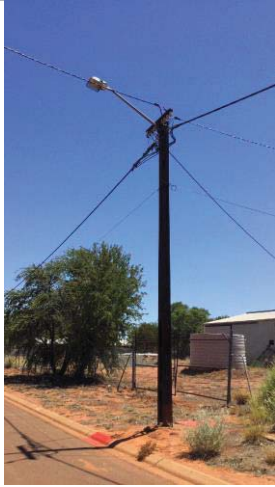
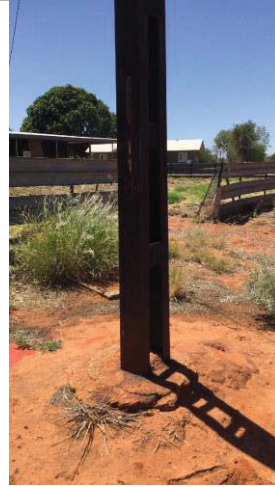
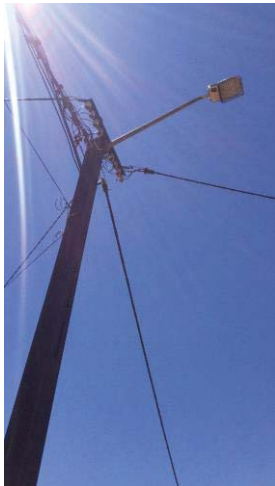
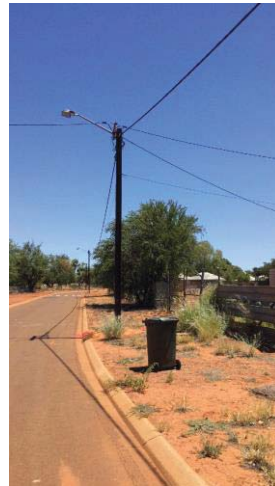
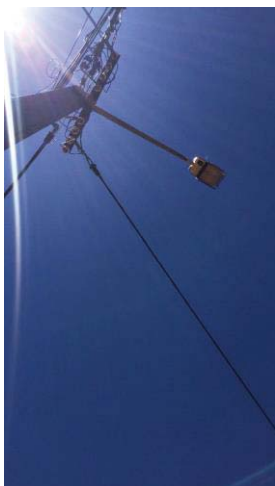
Inspection Date 29/11/2016 11:31:30 AM

What is the condition of pole: 3

What is the Condition of plant: 3

What is the Condition: 3

Overhead Pole Comments: Surface rusted

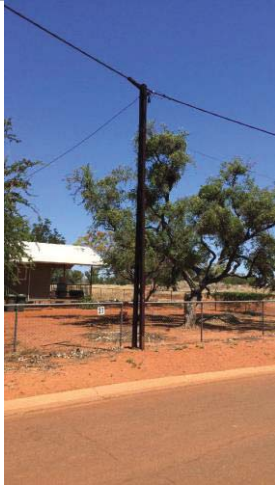
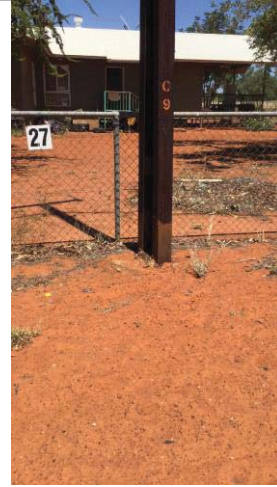
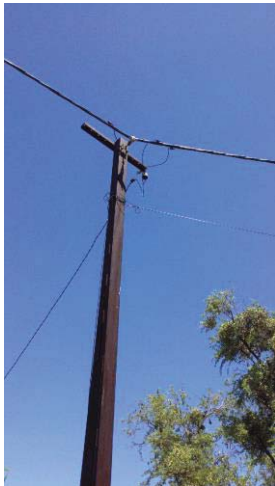
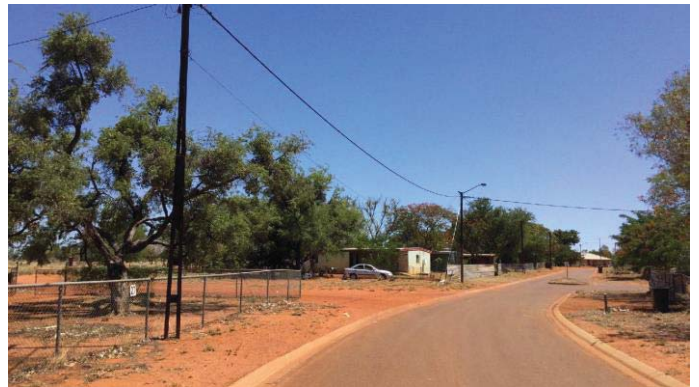
Inspection Date 29/11/2016 11:26:36 AM

What is Pole Material type:	Welded
What is the condition of pole:	3
How is the pole planted:	Concrete
What is the Condition of plant:	3
Is street light fitted:	Yes
Street Light Power Supply:	
Street Light Type	M80D 08
Street Light Watts	80
Street Light Condition	3
Street Light Height	
What is the type of service:	Three
What is the HV voltage level:	400
What is the arrangement of connected cables:	Twisted
Are there isolators on the pole:	No
What is the Condition:	3
How many Lots are connected to this pole:	1
Overhead Pole Comments:	Surface rusted

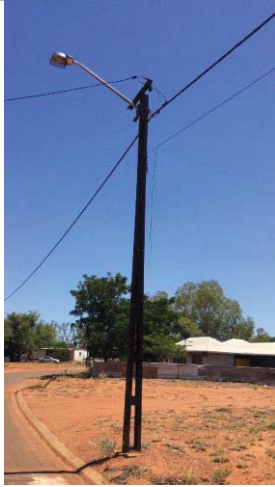
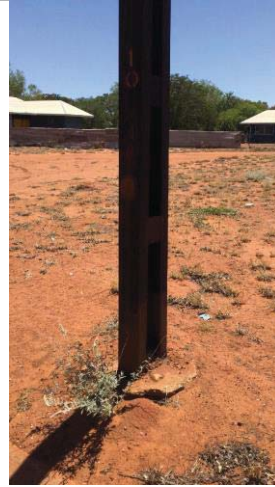
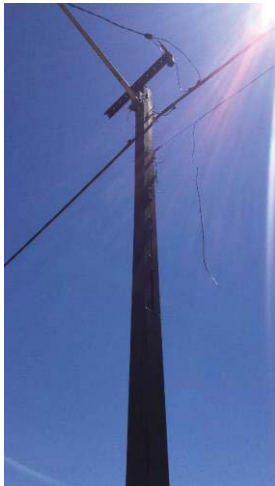
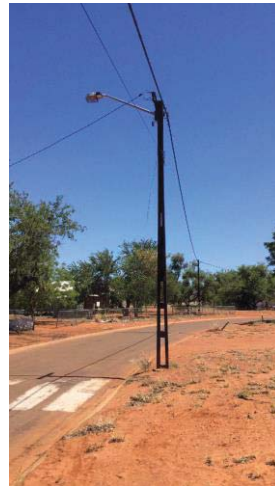
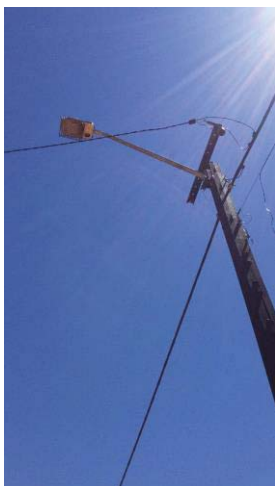
Inspection Date 29/11/2016 11:24:08 AM

What is Pole Material type:	Welded
What is the condition of pole:	3
How is the pole planted:	Concrete
What is the Condition of plant:	3
Is street light fitted:	Yes
Street Light Power Supply:	
Street Light Type	S70D 11
Street Light Watts	70
Street Light Condition	3
Street Light Height	
What is the type of service:	Three
What is the HV voltage level:	400
What is the arrangement of connected cables:	Twisted
Are there isolators on the pole:	No
What is the Condition:	3
How many Lots are connected to this pole:	2
Overhead Pole Comments:	Surface rusted

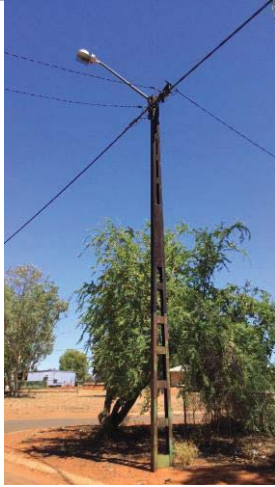
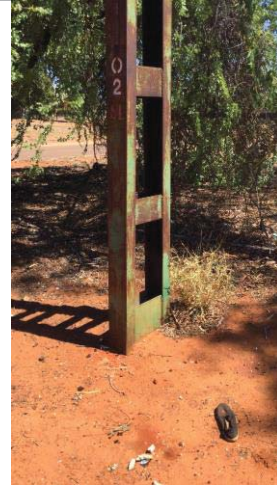
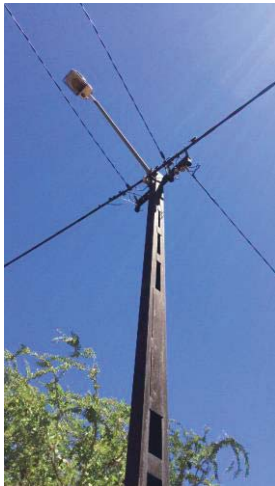
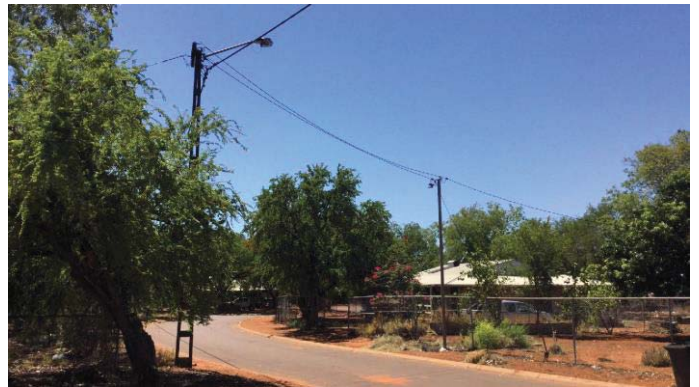
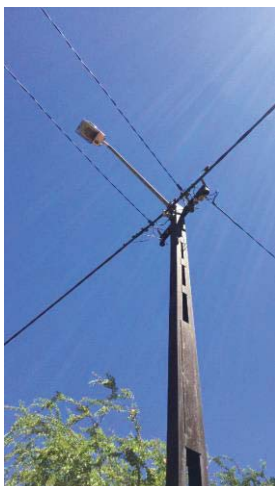
Inspection Date 29/11/2016 11:00:37 AM

What is Pole Material type:	Welded
What is the condition of pole:	3
How is the pole planted:	Concrete
What is the Condition of plant:	3
Is street light fitted:	Yes
Street Light Power Supply:	
Street Light Type	M80D 06
Street Light Watts	80
Street Light Condition	1
Street Light Height	
What is the type of service:	Three
What is the HV voltage level:	400
What is the arrangement of connected cables:	
Are there isolators on the pole:	No
What is the Condition:	3
How many Lots are connected to this pole:	3
Overhead Pole Comments:	Surface rusted

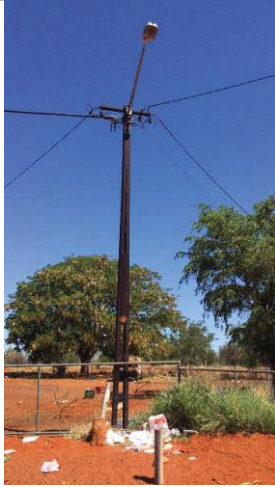
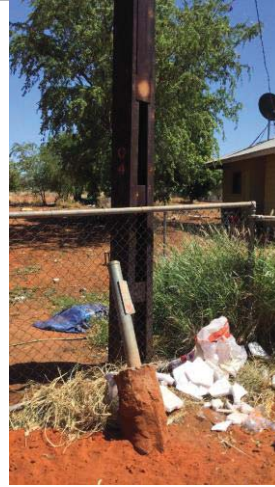
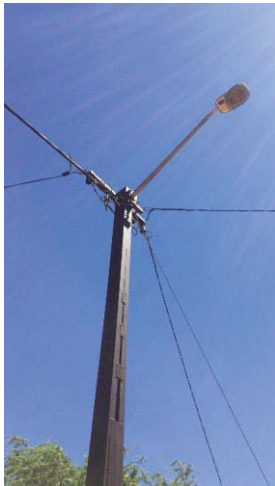
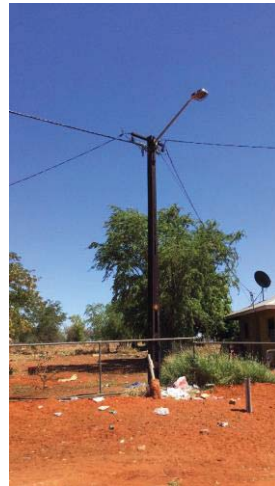
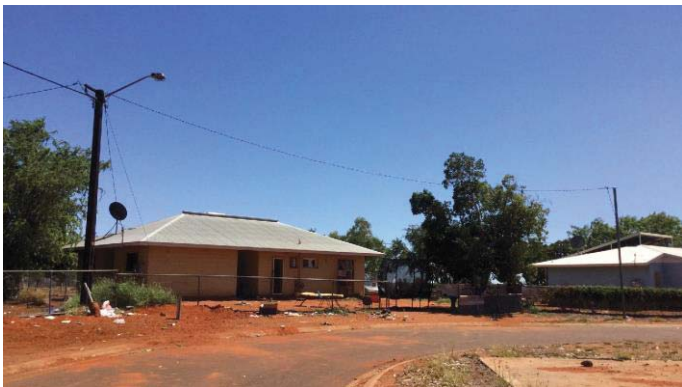
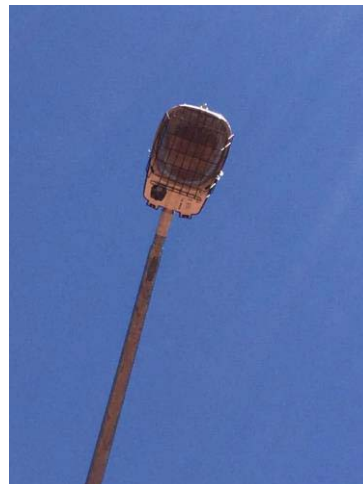
Inspection Date 29/11/2016 10:56:15 AM

What is Pole Material type:	Welded
What is the condition of pole:	3
How is the pole planted:	Concrete
What is the Condition of plant:	3
Is street light fitted:	No
Street Light Power Supply:	
Street Light Type	
Street Light Watts	
Street Light Condition	
Street Light Height	
What is the type of service:	Three
What is the HV voltage level:	400
What is the arrangement of connected cables:	Twisted
Are there isolators on the pole:	No
What is the Condition:	3
How many Lots are connected to this pole:	1
Overhead Pole Comments:	Surface rusted

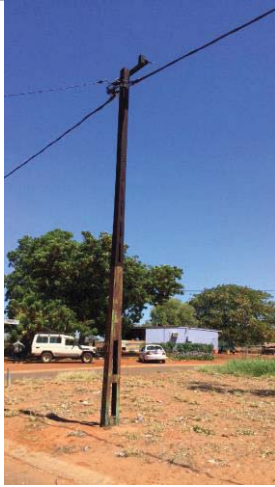
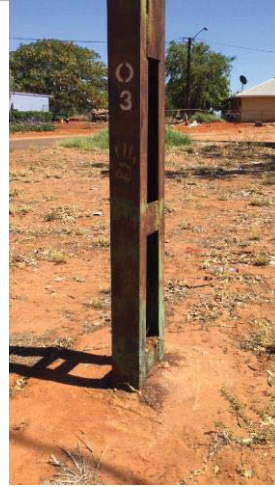
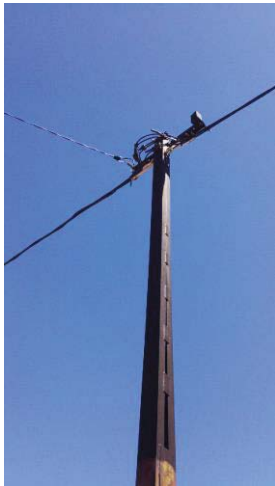
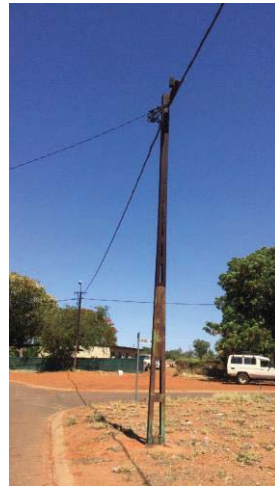
What is Pole Material type:	Welded
What is the condition of pole:	3
How is the pole planted:	Concrete
What is the Condition of plant:	3
Is street light fitted:	Yes
Street Light Power Supply:	
Street Light Type	SD55
Street Light Watts	55
Street Light Condition	3
Street Light Height	
What is the type of service:	Three
What is the HV voltage level:	400
What is the arrangement of connected cables:	Twisted
Are there isolators on the pole:	No
What is the Condition:	3
How many Lots are connected to this pole:	2
Overhead Pole Comments:	Surface rusted

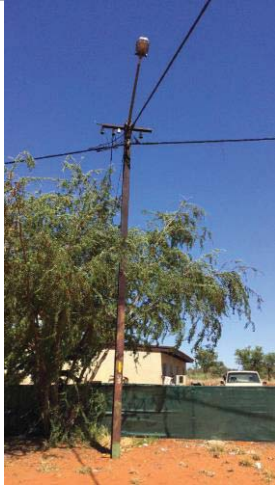
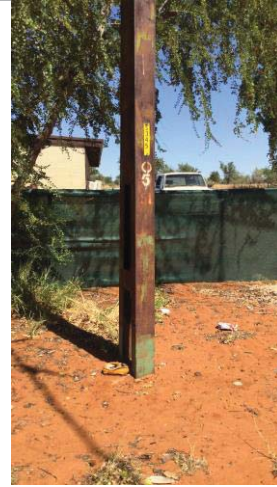
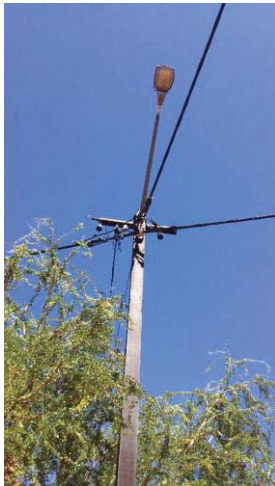
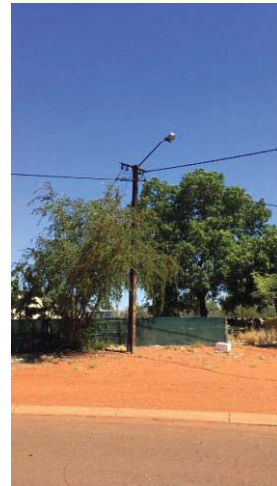
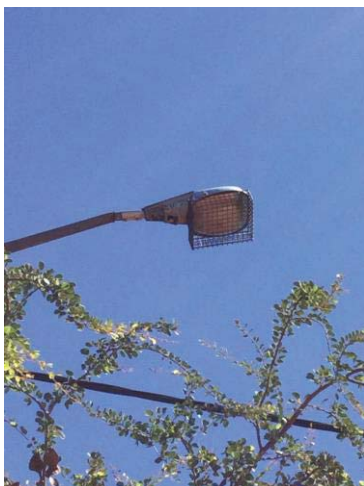
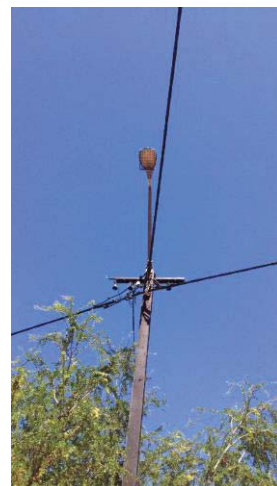
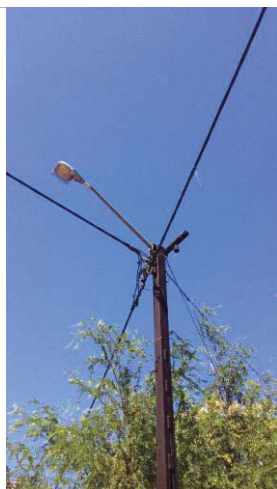
What is Pole Material type:	Welded
What is the condition of pole:	3
How is the pole planted:	Concrete
What is the Condition of plant:	3
Is street light fitted:	Yes
Street Light Power Supply:	
Street Light Type	M80D 07
Street Light Watts	80
Street Light Condition	3
Street Light Height	
What is the type of service:	Three
What is the HV voltage level:	400
What is the arrangement of connected cables:	Twisted
Are there isolators on the pole:	No
What is the Condition:	3
How many Lots are connected to this pole:	2
Overhead Pole Comments:	Surface rusted

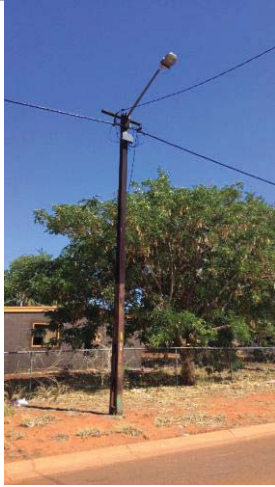
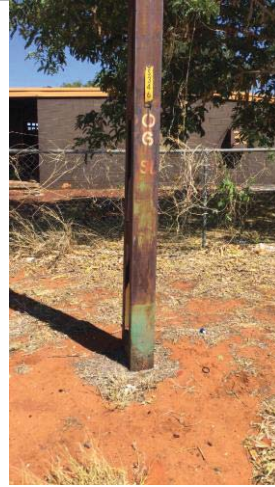
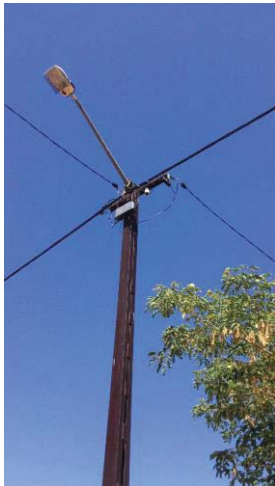
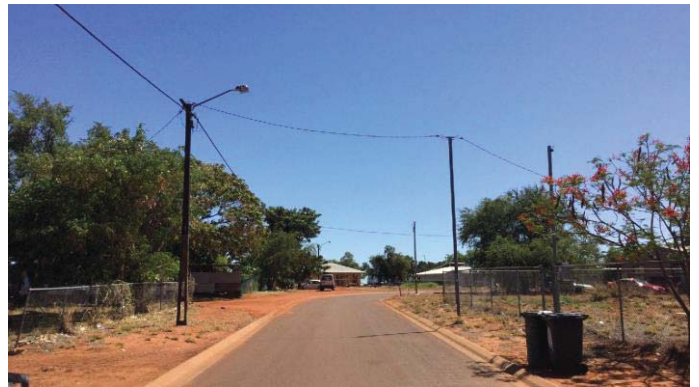
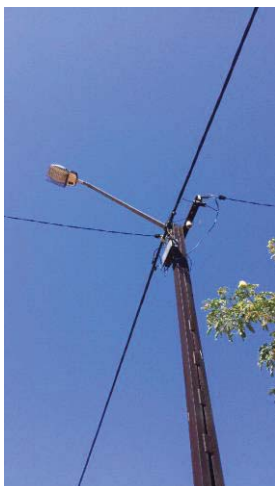
What is Pole Material type:	Welded
What is the condition of pole:	3
How is the pole planted:	Concrete
What is the Condition of plant:	3
Is street light fitted:	No
Street Light Power Supply:	
Street Light Type	
Street Light Watts	
Street Light Condition	
Street Light Height	
What is the type of service:	Three
What is the HV voltage level:	400
What is the arrangement of connected cables:	Twisted
Are there isolators on the pole:	No
What is the Condition:	3
How many Lots are connected to this pole:	2
Overhead Pole Comments:	Surface rusted

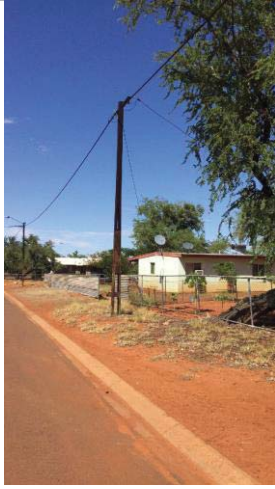
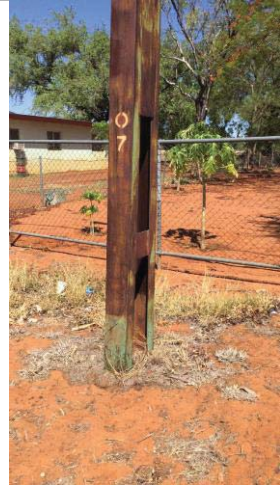
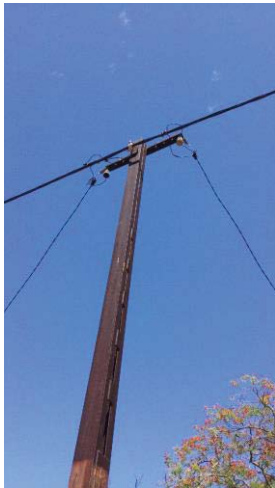
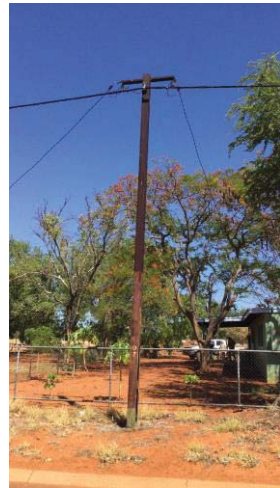
What is Pole Material type:	Welded
What is the condition of pole:	3
How is the pole planted:	Concrete
What is the Condition of plant:	3
Is street light fitted:	Yes
Street Light Power Supply:	
Street Light Type	S70D 08
Street Light Watts	80
Street Light Condition	3
Street Light Height	
What is the type of service:	Three
What is the HV voltage level:	400
What is the arrangement of connected cables:	Twisted
Are there isolators on the pole:	No
What is the Condition:	3
How many Lots are connected to this pole:	0
Overhead Pole Comments:	Surface rusted

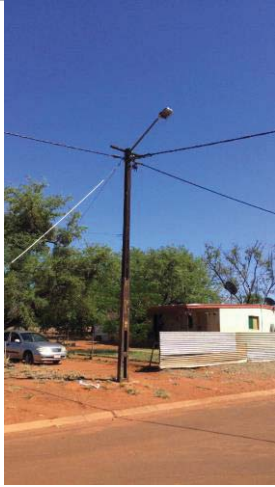
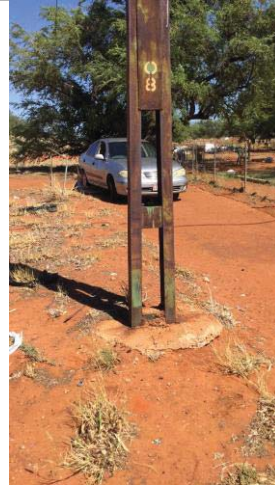
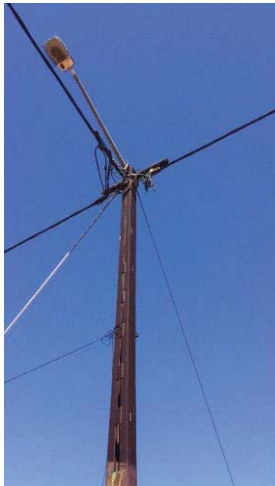
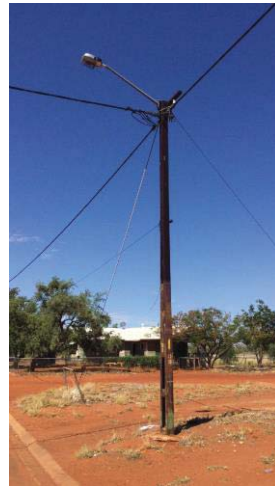
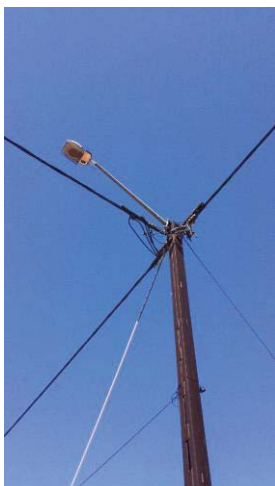
What is Pole Material type:	Welded
What is the condition of pole:	3
How is the pole planted:	Concrete
What is the Condition of plant:	3
Is street light fitted:	No
Street Light Power Supply:	
Street Light Type	
Street Light Watts	
Street Light Condition	
Street Light Height	
What is the type of service:	Three
What is the HV voltage level:	400
What is the arrangement of connected cables:	Twisted
Are there isolators on the pole:	No
What is the Condition:	3
How many Lots are connected to this pole:	2
Overhead Pole Comments:	Surface rusted

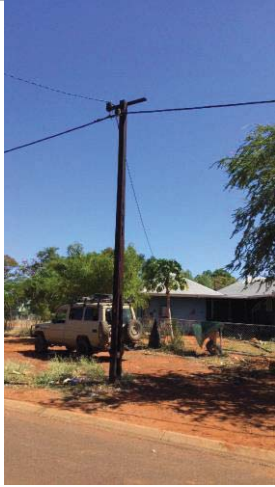
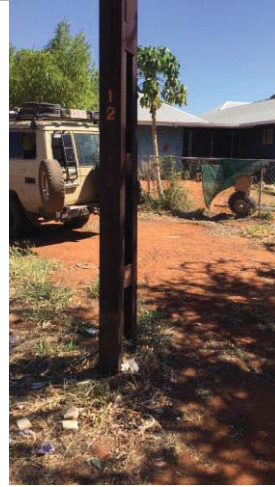
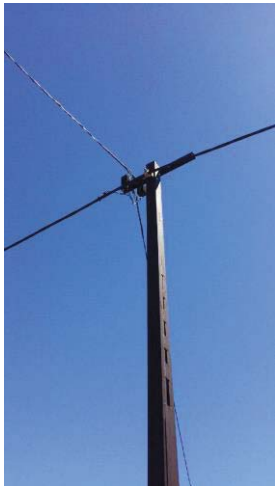
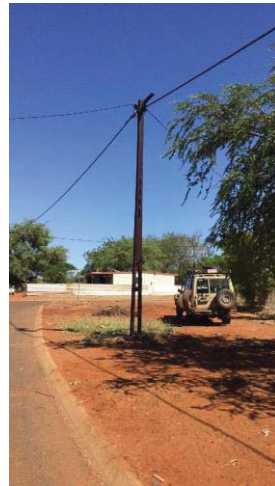
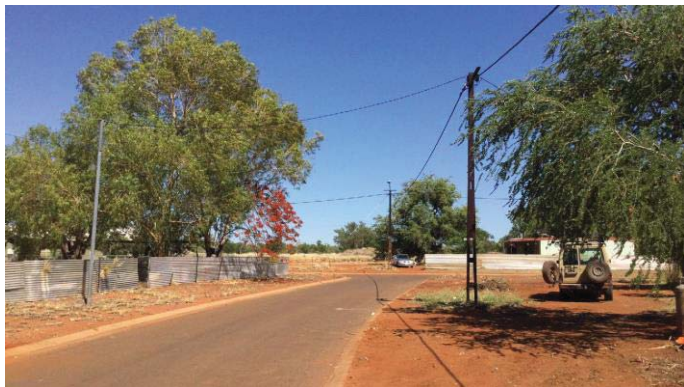
What is Pole Material type:	Welded
What is the condition of pole:	3
How is the pole planted:	Concrete
What is the Condition of plant:	3
Is street light fitted:	Yes
Street Light Power Supply:	
Street Light Type	S70D 08
Street Light Watts	70
Street Light Condition	3
Street Light Height	
What is the type of service:	Three
What is the HV voltage level:	400
What is the arrangement of connected cables:	Twisted
Are there isolators on the pole:	No
What is the Condition:	3
How many Lots are connected to this pole:	2
Overhead Pole Comments:	Surface rusted

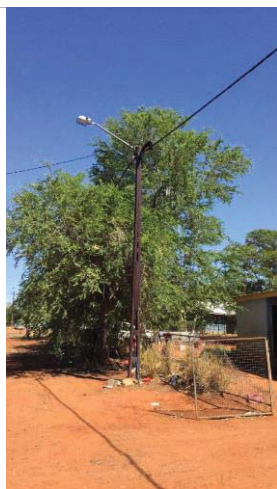
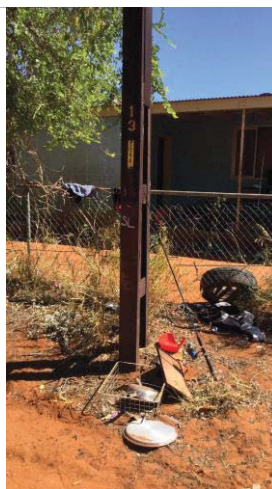
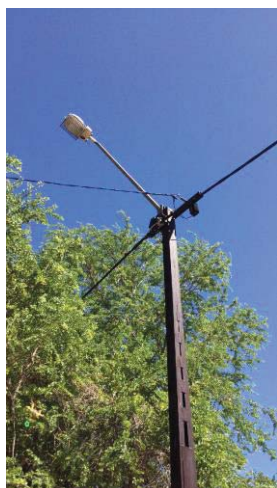
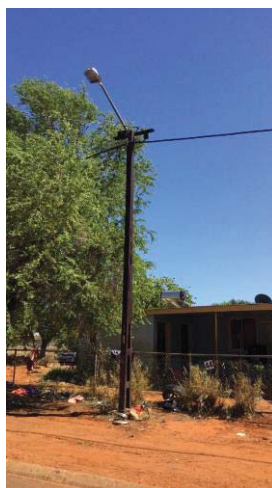
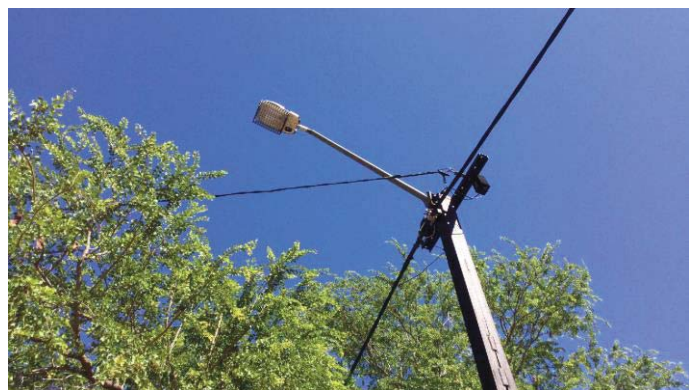
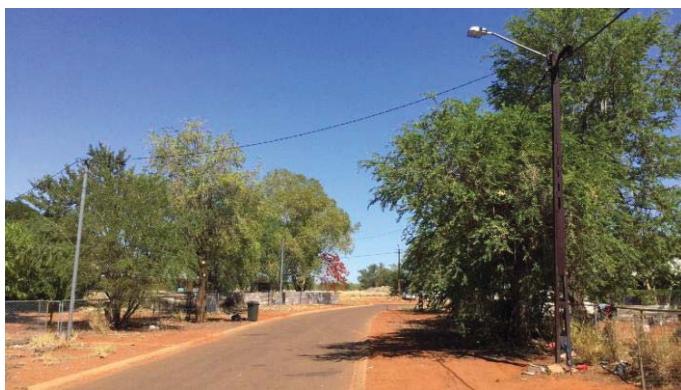
What is Pole Material type:	Welded
What is the condition of pole:	3
How is the pole planted:	Concrete
What is the Condition of plant:	3
Is street light fitted:	Yes
Street Light Power Supply:	
Street Light Type	M80D 16
Street Light Watts	80
Street Light Condition	3
Street Light Height	
What is the type of service:	Three
What is the HV voltage level:	400
What is the arrangement of connected cables:	Twisted
Are there isolators on the pole:	No
What is the Condition:	3
How many Lots are connected to this pole:	3
Overhead Pole Comments:	Surface rusted

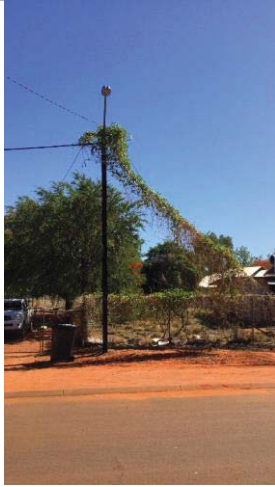
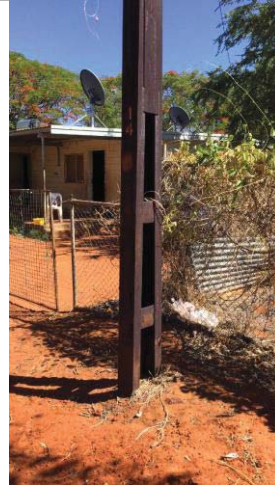
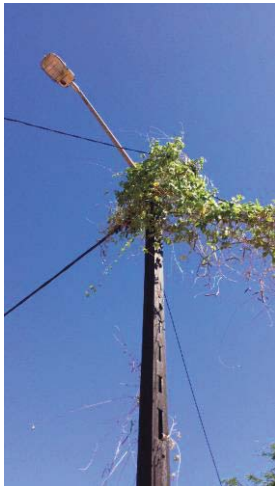
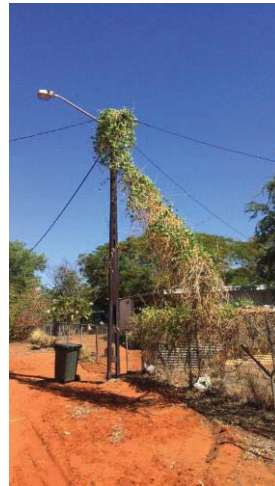
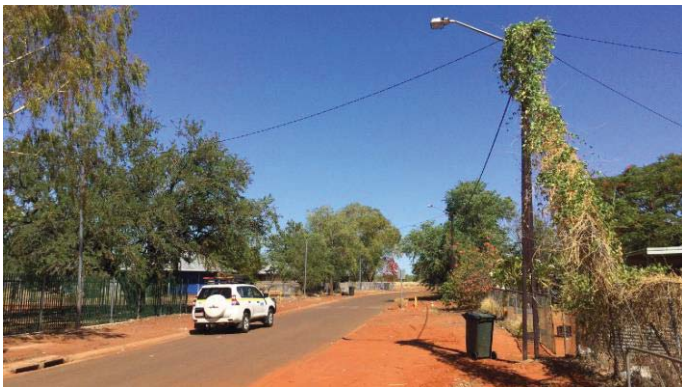
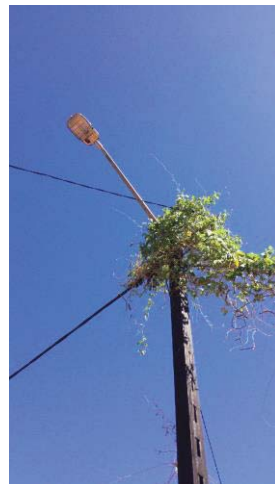
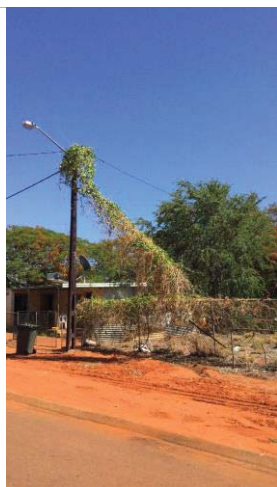
What is Pole Material type:	Welded
What is the condition of pole:	3
How is the pole planted:	Concrete
What is the Condition of plant:	3
Is street light fitted:	Yes
Street Light Power Supply:	
Street Light Type	Unknown
Street Light Watts	
Street Light Condition	3
Street Light Height	
What is the type of service:	Three
What is the HV voltage level:	400
What is the arrangement of connected cables:	
Are there isolators on the pole:	No
What is the Condition:	3
How many Lots are connected to this pole:	1
Overhead Pole Comments:	Surface rusted

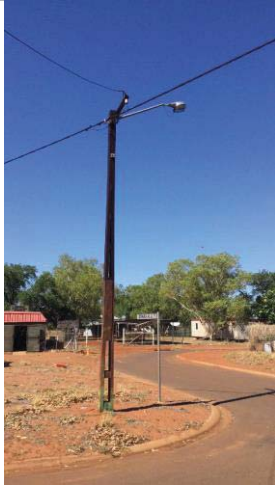
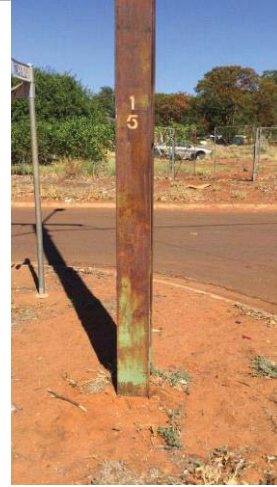
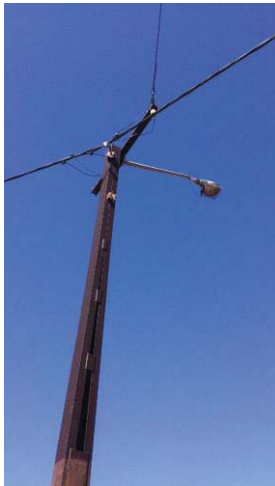
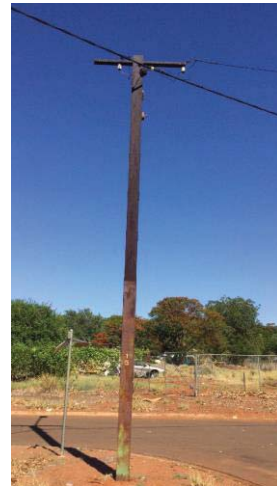
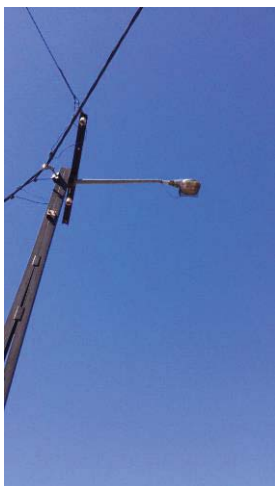
What is Pole Material type:	Welded
What is the condition of pole:	3
How is the pole planted:	Concrete
What is the Condition of plant:	3
Is street light fitted:	Yes
Street Light Power Supply:	
Street Light Type	M80D 06
Street Light Watts	80
Street Light Condition	3
Street Light Height	
What is the type of service:	Three
What is the HV voltage level:	400
What is the arrangement of connected cables:	Twisted
Are there isolators on the pole:	No
What is the Condition:	3
How many Lots are connected to this pole:	2
Overhead Pole Comments:	Surface rusted

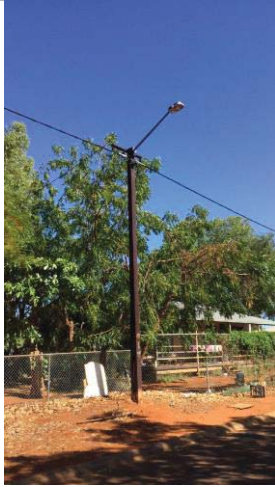
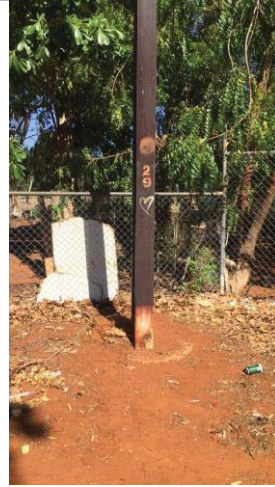
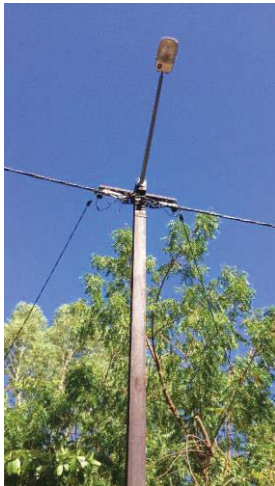
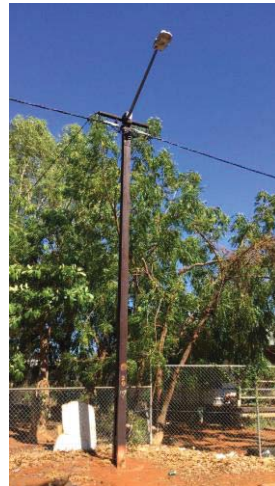
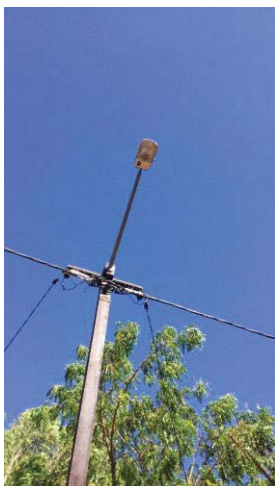
What is Pole Material type:	Welded
What is the condition of pole:	3
How is the pole planted:	Concrete
What is the Condition of plant:	3
Is street light fitted:	Yes
Street Light Power Supply:	
Street Light Type	M80D 06
Street Light Watts	80
Street Light Condition	3
Street Light Height	
What is the type of service:	Three
What is the HV voltage level:	400
What is the arrangement of connected cables:	Twisted
Are there isolators on the pole:	No
What is the Condition:	3
How many Lots are connected to this pole:	3
Overhead Pole Comments:	Surface rusted

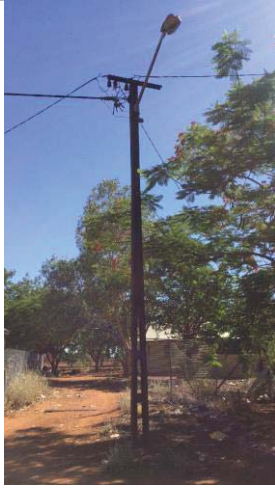
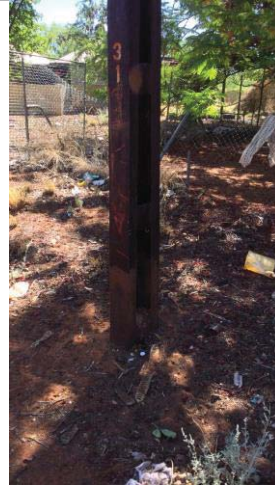
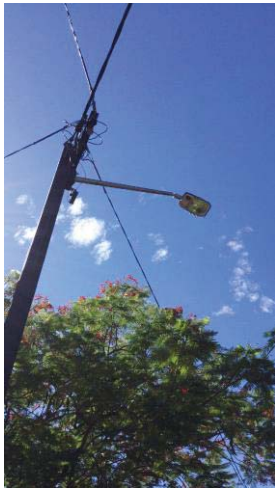
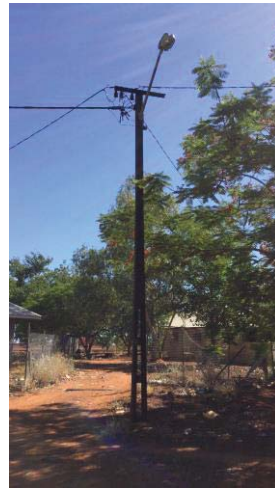
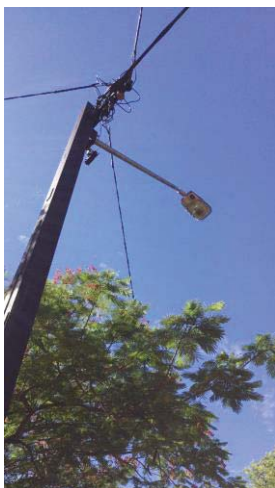
What is the condition of pole: 3

What is the Condition of plant: 3

What is the Condition: 3

Overhead Pole Comments: Surface rusted

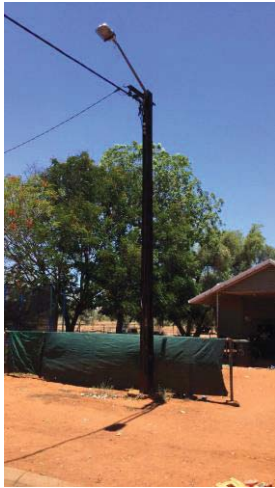
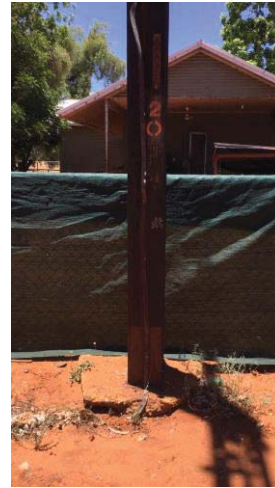
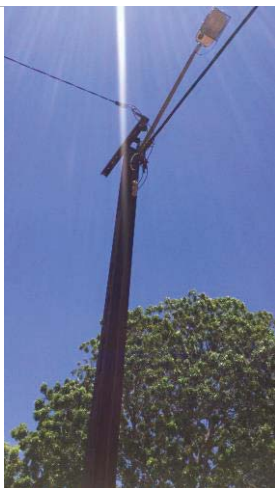
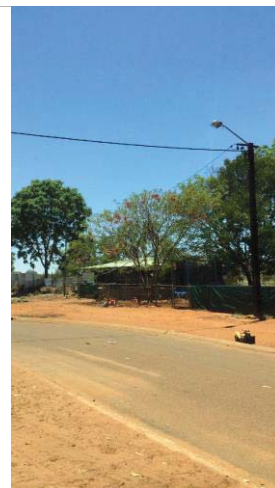
Is street light fitted: Yes  
Street Light Power Supply:  
Street Light Type S70D 14  
Street Light Watts 70  
Street Light Condition 3  
Street Light Height

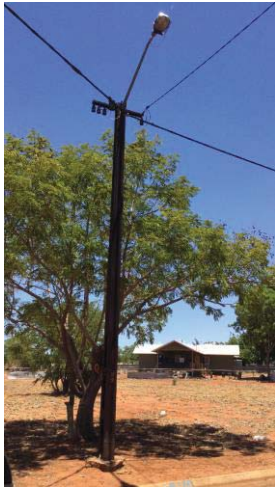
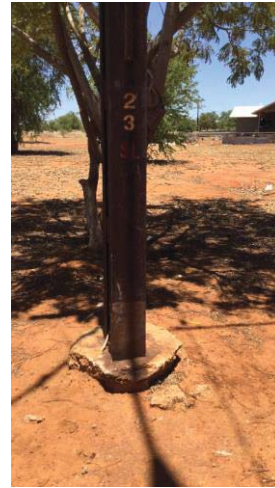
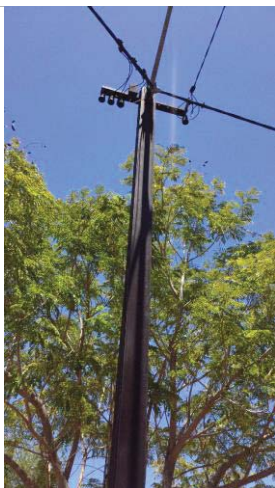
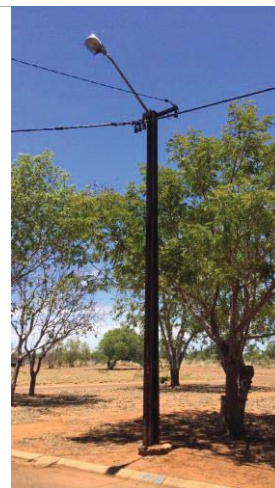
Street Light Condition 3

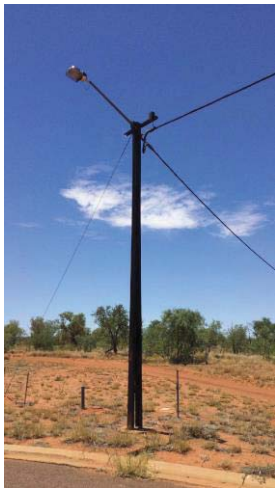
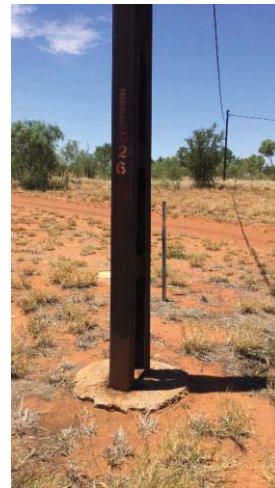
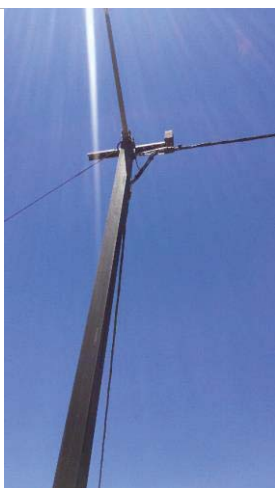
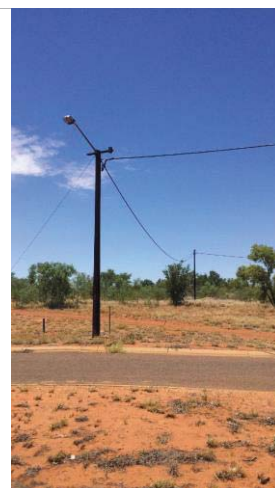
Street Light Condition 3

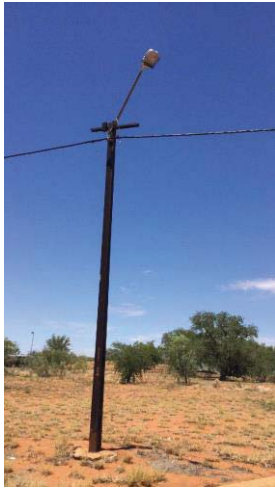
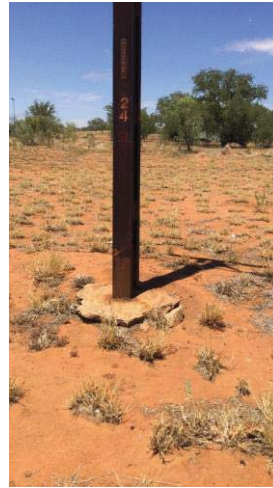
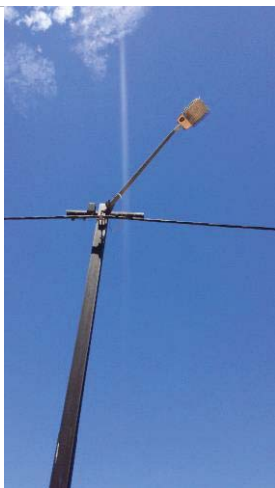
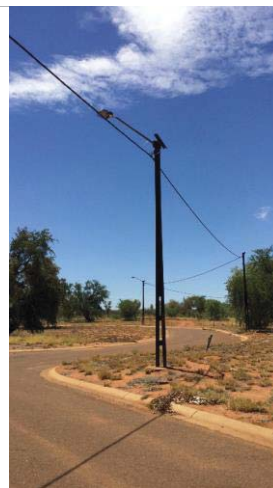
Is street light fitted: Yes  
Street Light Power Supply:  
Street Light Type S70D 11  
Street Light Watts 70  
Street Light Condition 3  
Street Light Height

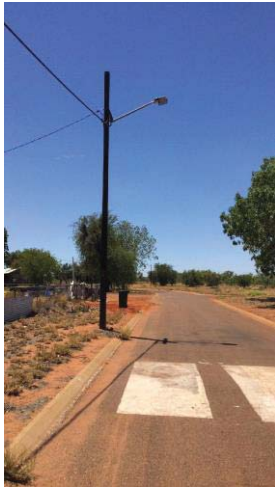
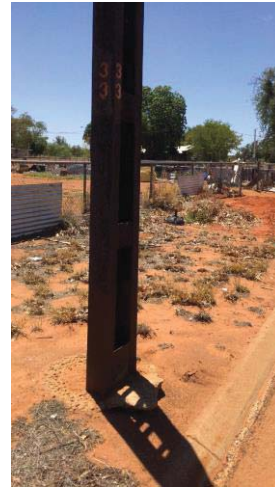
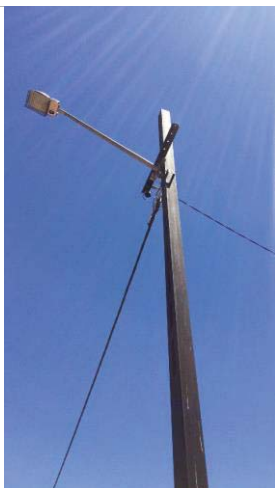
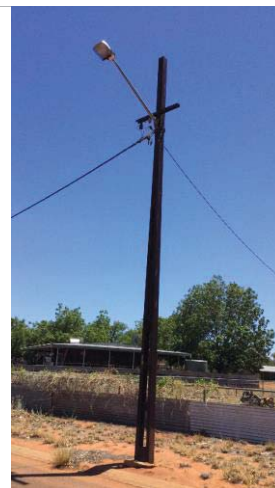
Street Light Condition 3

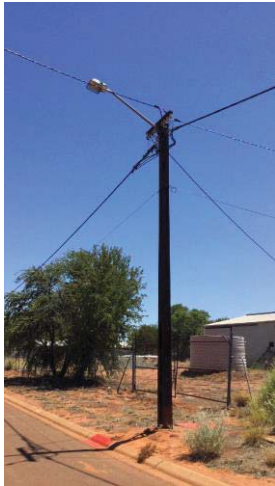
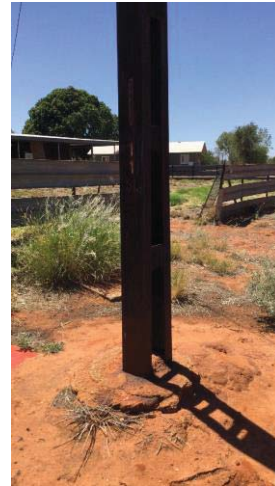
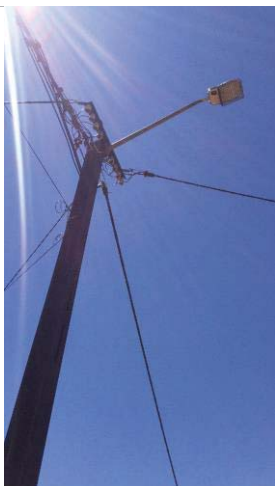
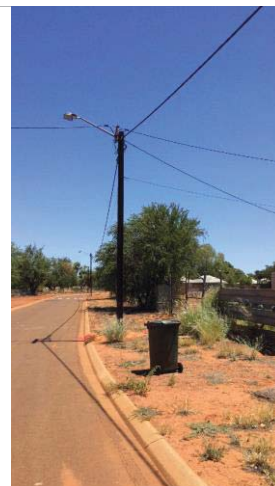
Is street light fitted: Yes  
Street Light Power Supply:  
Street Light Type S70D 09  
Street Light Watts 70  
Street Light Condition 3  
Street Light Height
