# Appendix B

## Municipal and essential infrastructure

# Elliott North & South Camp

# Elliott North Camp

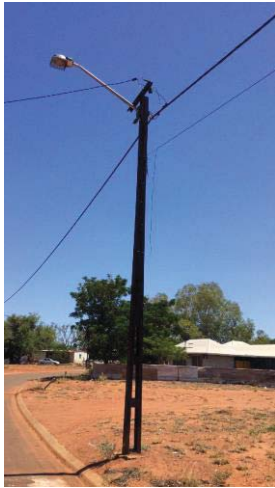
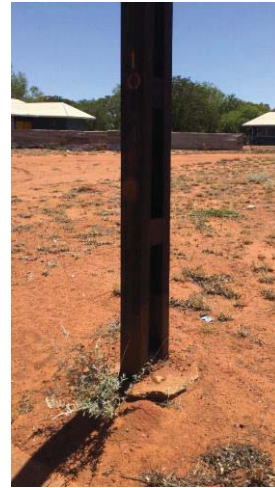
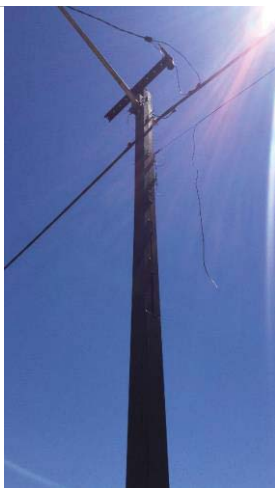
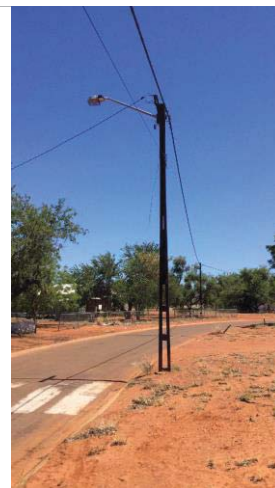
Street Light Condition 3

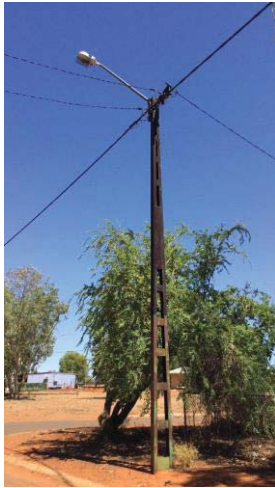
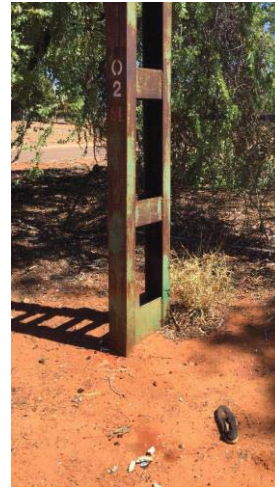
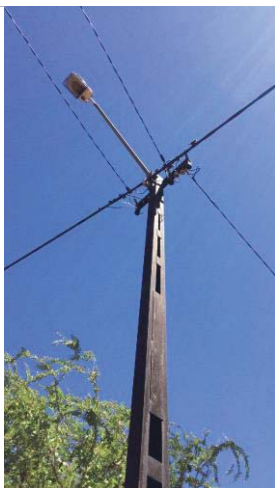
Is street light fitted: Yes  
Street Light Power Supply:  
Street Light Type S70D 11  
Street Light Watts 70  
Street Light Condition 3  
Street Light Height

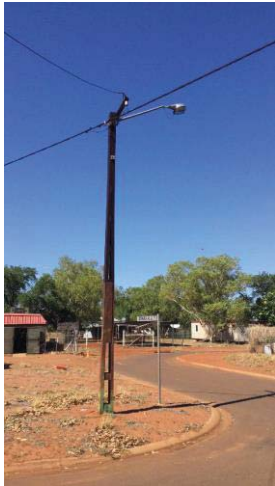
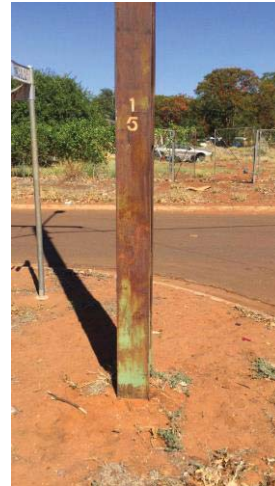
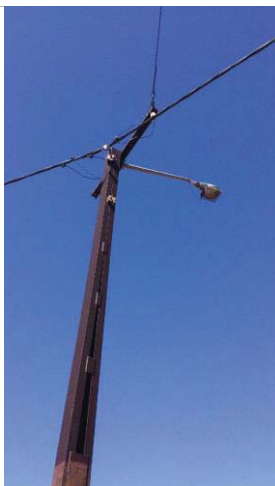
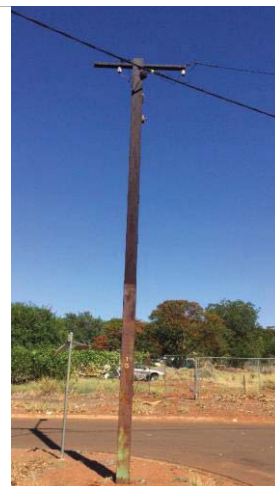
Street Light Condition 3

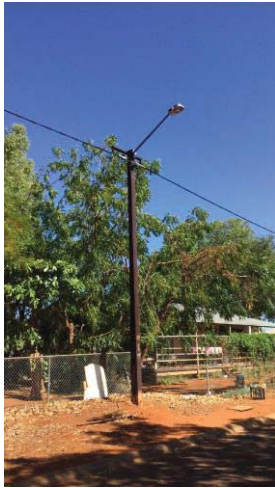
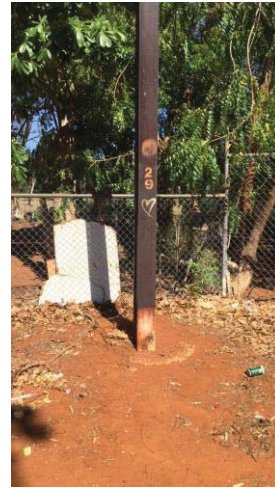
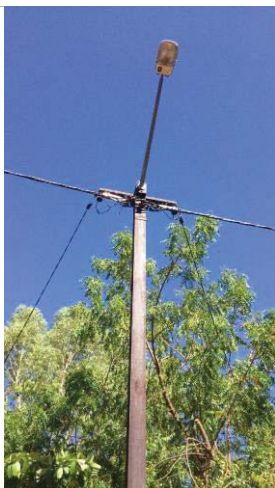
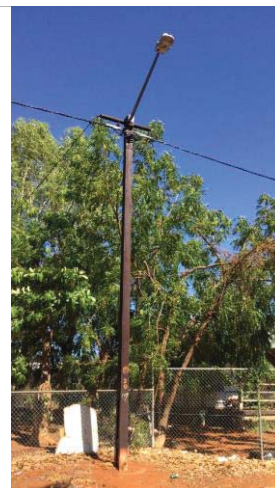
Street Light Condition 3

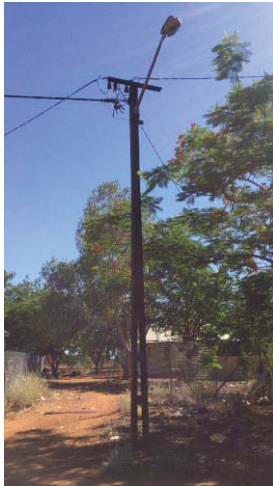
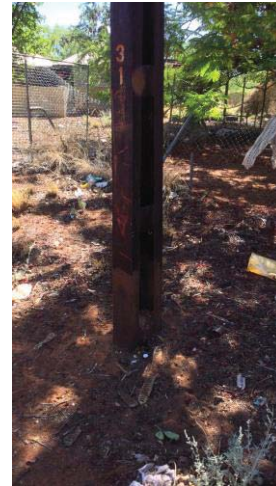
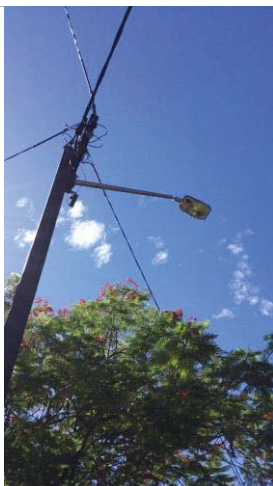
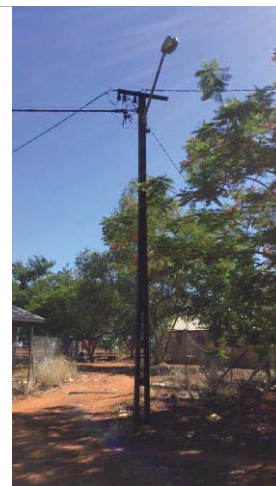
Street Light Condition 3

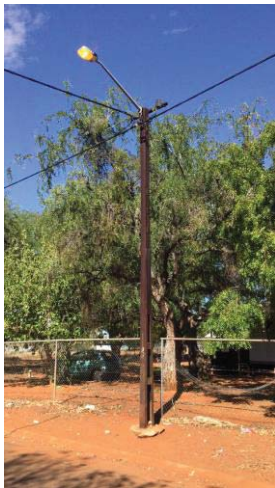
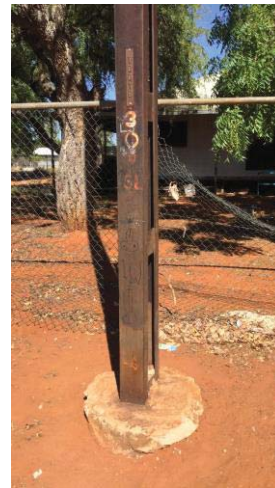
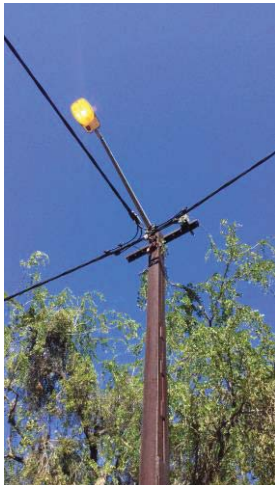
What is the condition of street lights:

3

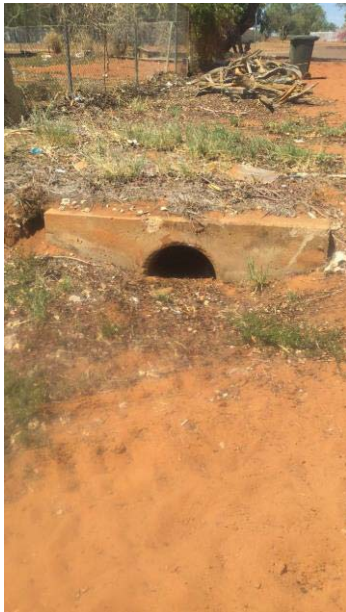
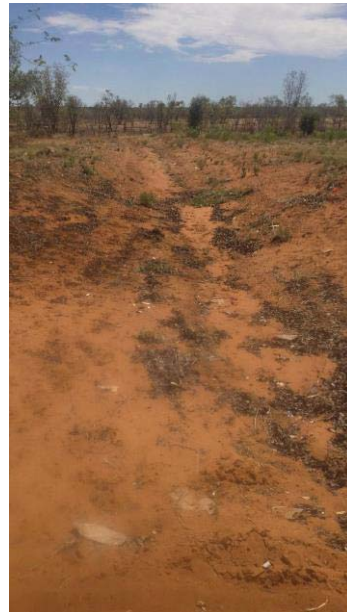
Stormwater Infrastructure:	Culverts
Culvert Type:	RCP
Diameter (mm):	600
Width (mm):	
Culvert Depth (mm):	
Culvert Length (m):	
Culvert Condition:	2 - Poor
Culvert Blockage (%):	50
Culvert Comments:	
Culvert Head Wall:	No
Safety Grate:	
Headwall Blockage:	
Headwall Condition:	
Headwall Comment:	
End Wall:	Yes
End Wall condition:	3 - Good
EW Comment:

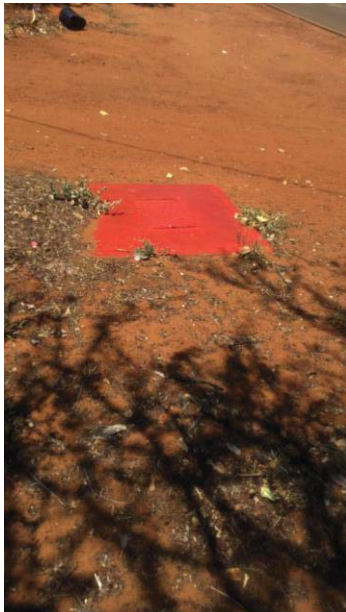
FH Condition: 4 - Very Good

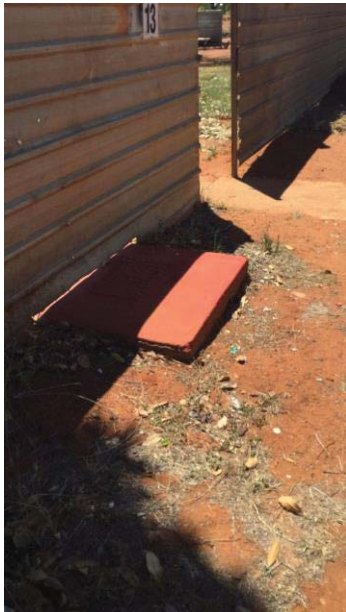
FH Condition: 3 - Good

FH Comment: Fence over lid

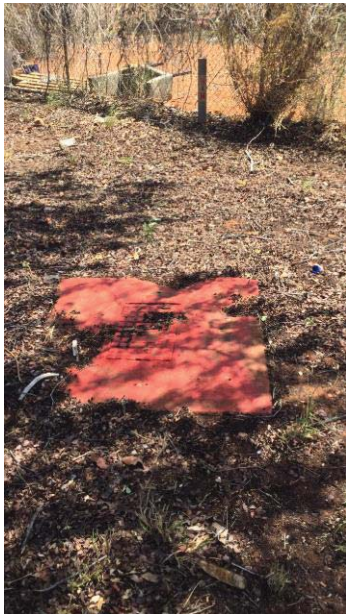
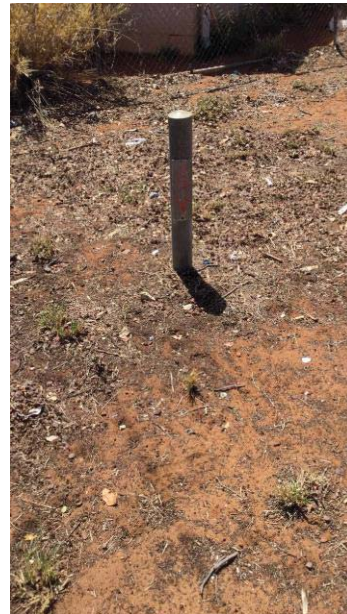
FH Condition: 4 - Very Good

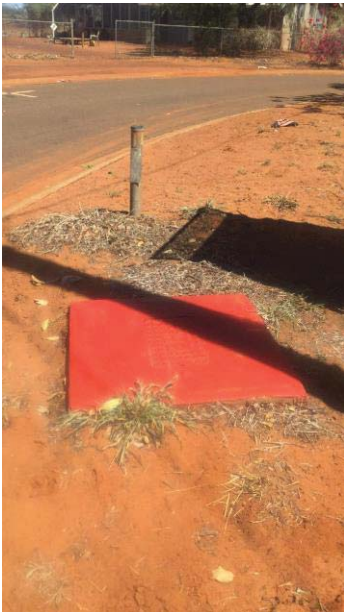
FH Condition: 4 - Very Good

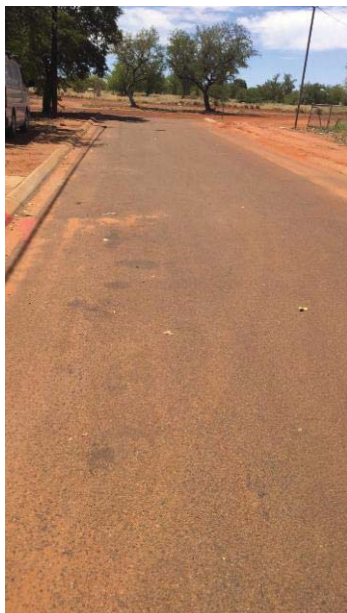
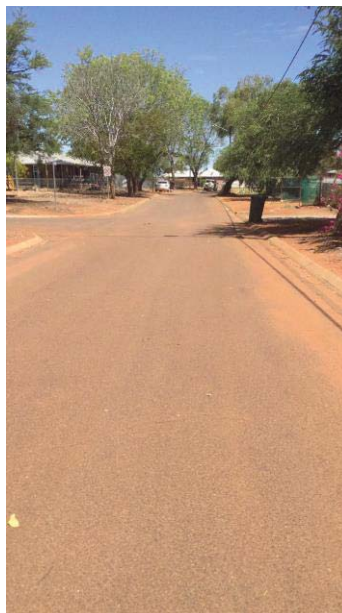
Inspection Date 29/11/2016 2:06:48 PM

Defect Type	Defect QTY	Defect Condition	Defect Comments
Surfacing Cracks	5	3 - Good	5 % of road cracked

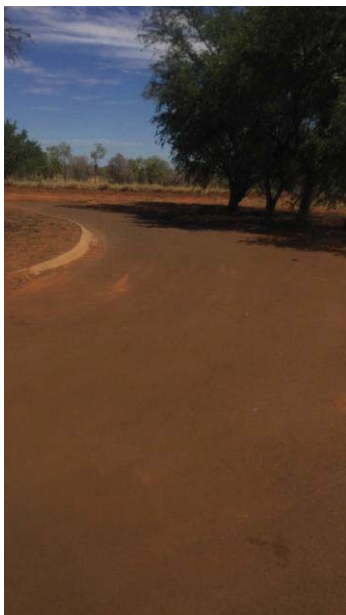
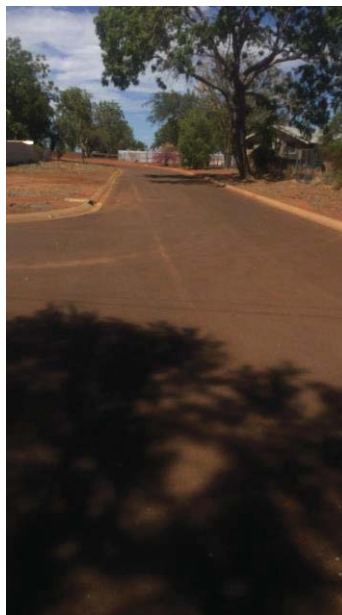
Inspection Date 29/11/2016 2:28:14 PM

Defect Type	Defect QTY	Defect Condition	Defect Comments
Surfacing Cracks	5	3 - Good	% of road

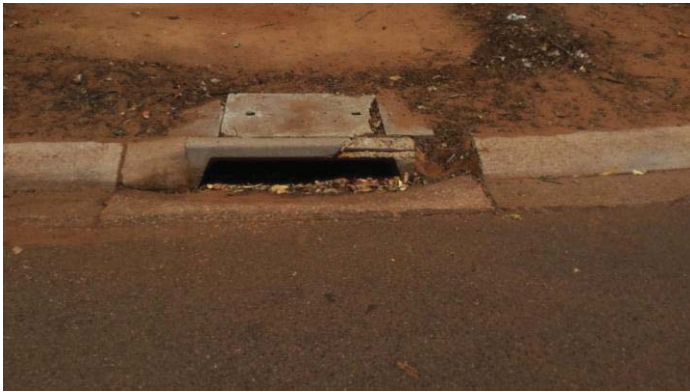
Stormwater Infrastructure: SEP  
Number of Bays: 1  
On grade or sag pit:  
Both sides of road: Left  
Condition: 2 - Poor  
Blockage (%): 20  
Comment:

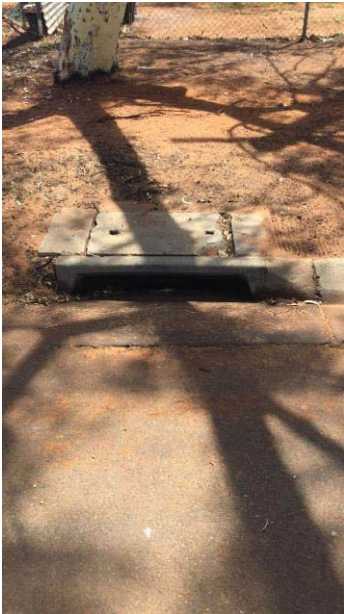
Stormwater Infrastructure: SEP  
Number of Bays: 1  
On grade or sag pit:  
Both sides of road: Right  
Condition: 3 - Good  
Blockage (%): 10  
Comment:

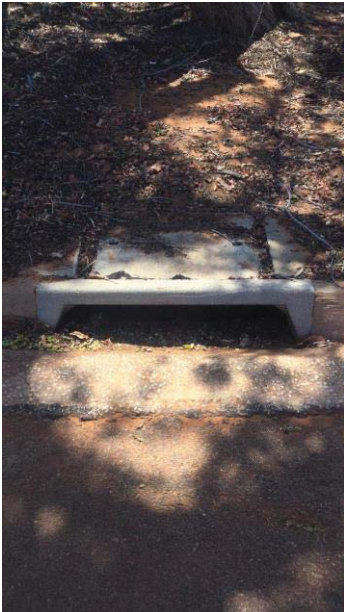
Stormwater Infrastructure:	SEP
Number of Bays:	1
On grade or sag pit:	
Both sides of road:	Left
Condition:	2 - Poor
Blockage (%):	10
Comment:	Broken lid

- Replace two side entry pit lids
- Clear blockages from all five pits
- Clear blockages from culvert
- Reshape swale downstream of endwall

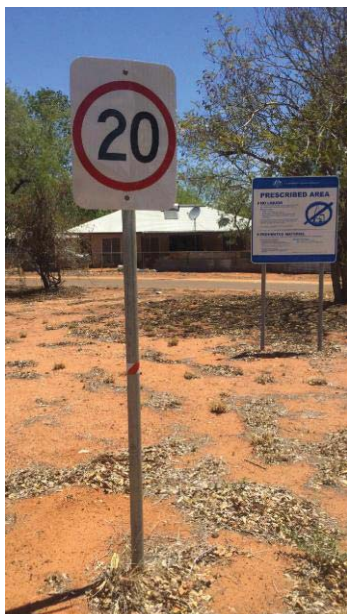
Sign Condition: 3 - Good

Sign Comment: Sign is slightly bent

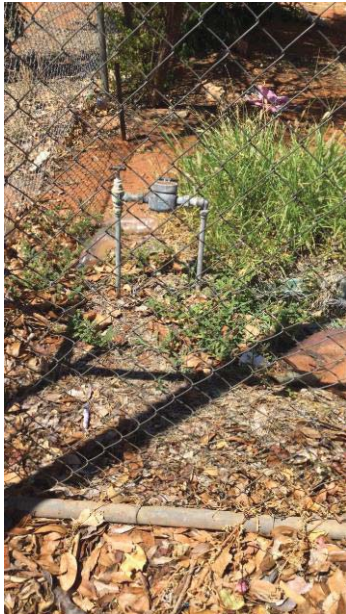
Lot Water Meter Condition: 2 - Poor

- Replace one tap
- Repair two residential lot water meters
- Install nine new residential lot water meters

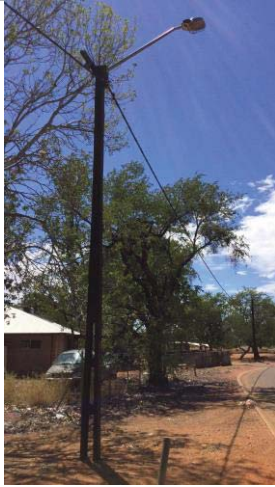
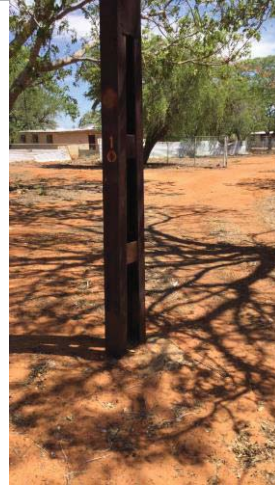
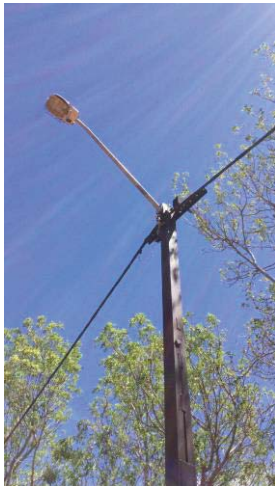
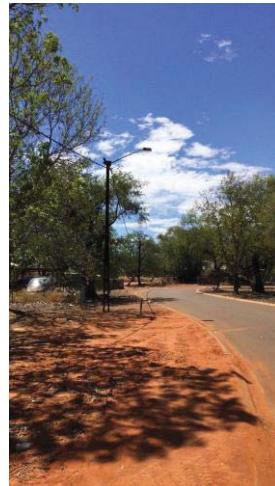
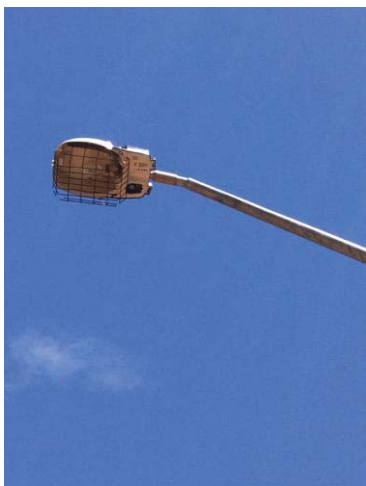
Inspection Date 29/11/2016 2:55:18 PM

What is Pole Material type:	Welded
What is the condition of pole:	3
How is the pole planted:	Concrete
What is the Condition of plant:	3
Is street light fitted:	Yes
Street Light Power Supply:	
Street Light Type	M80d 06
Street Light Watts	80
Street Light Condition	2
Street Light Height	
What is the type of service:	Three
What is the HV voltage level:	400
What is the arrangement of connected cables:	Twisted
Are there isolators on the pole:	No
What is the Condition:	3
How many Lots are connected to this pole:	0
Overhead Pole Comments:	Surface rusted

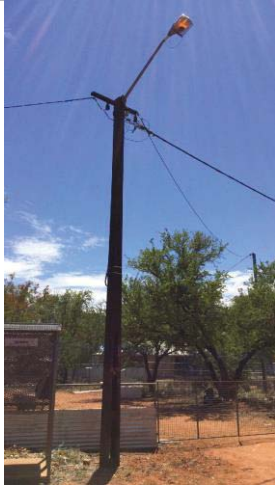
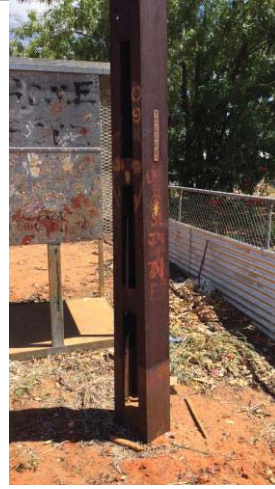
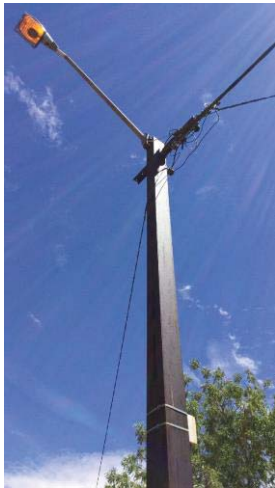
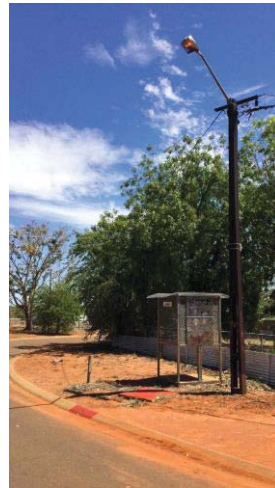
Inspection Date 29/11/2016 2:51:12 PM

What is Pole Material type:	Welded
What is the condition of pole:	3
How is the pole planted:	Concrete
What is the Condition of plant:	3
Is street light fitted:	Yes
Street Light Power Supply:	
Street Light Type	S50D 08
Street Light Watts	50
Street Light Condition	3
Street Light Height	
What is the type of service:	Three
What is the HV voltage level:	400
What is the arrangement of connected cables:	
Are there isolators on the pole:	No
What is the Condition:	3
How many Lots are connected to this pole:	2
Overhead Pole Comments:	Surface rusted

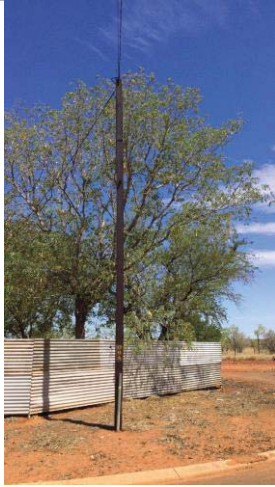
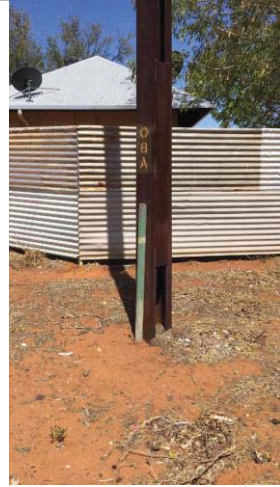
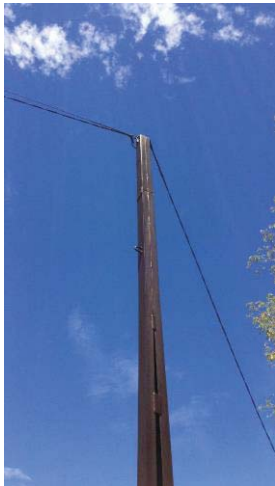
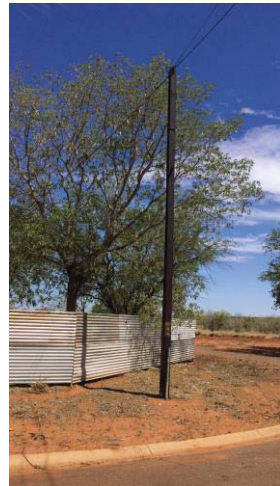
Inspection Date 29/11/2016 2:46:46 PM

What is Pole Material type:	Welded
What is the condition of pole:	3
How is the pole planted:	Concrete
What is the Condition of plant:	3
Is street light fitted:	No
Street Light Power Supply:	
Street Light Type	
Street Light Watts	
Street Light Condition	
Street Light Height	
What is the type of service:	Single
What is the HV voltage level:	230
What is the arrangement of connected cables:	Twisted
Are there isolators on the pole:	No
What is the Condition:	3
How many Lots are connected to this pole:	1
Overhead Pole Comments:	Surface rusted

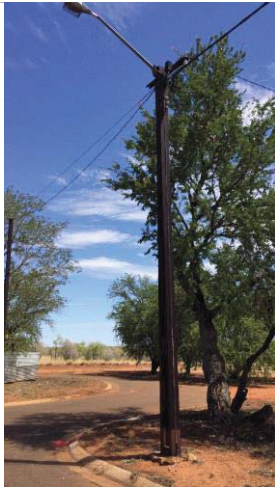
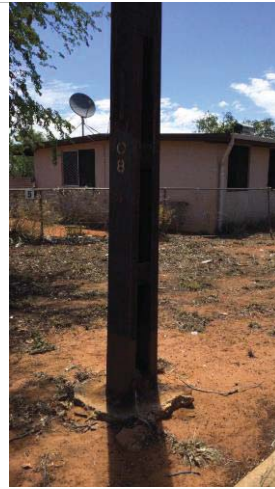
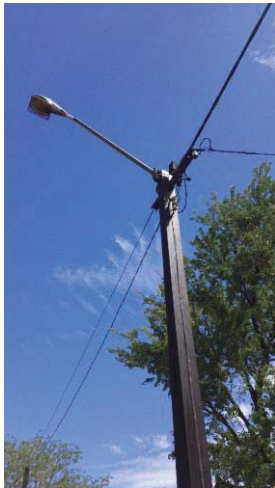
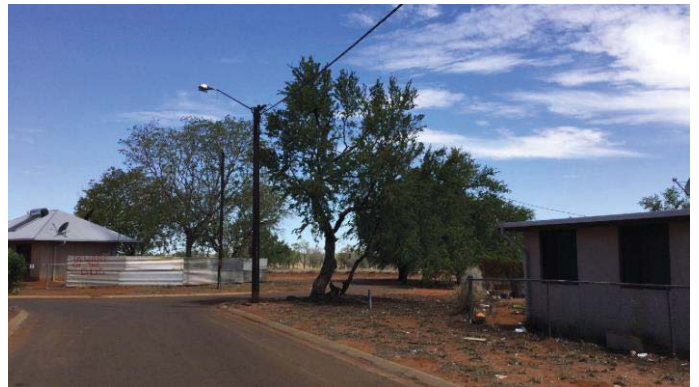
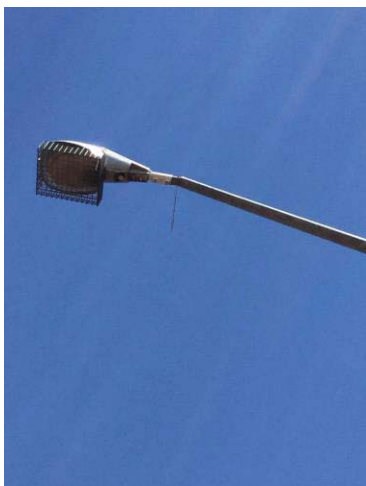
Inspection Date 29/11/2016 2:44:05 PM

What is Pole Material type:	Welded
What is the condition of pole:	3
How is the pole planted:	Concrete
What is the Condition of plant:	3
Is street light fitted:	Yes
Street Light Power Supply:	
Street Light Type	Unknown
Street Light Watts	
Street Light Condition	3
Street Light Height	
What is the type of service:	Three
What is the HV voltage level:	400
What is the arrangement of connected cables:	Twisted
Are there isolators on the pole:	No
What is the Condition:	3
How many Lots are connected to this pole:	2
Overhead Pole Comments:	Surface rusted
