Northern Territory Camps

Civil Infrastructure

Group 5 - Borroloola

Yanyula

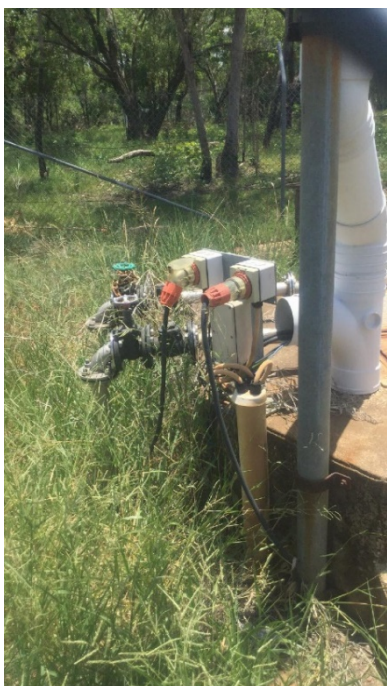
Figure 2 Sewer pump station (electrical)

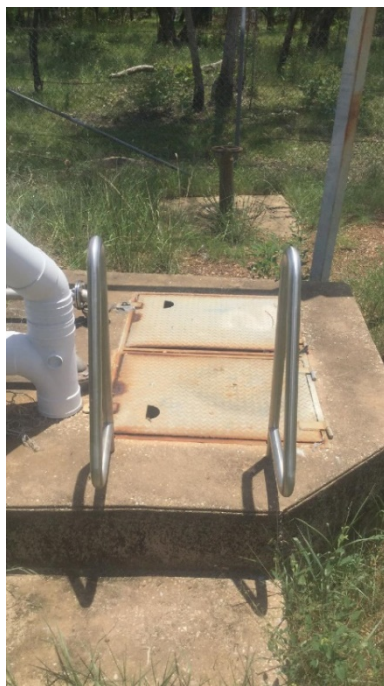
Figure 3 Sewer pump station (access chamber)

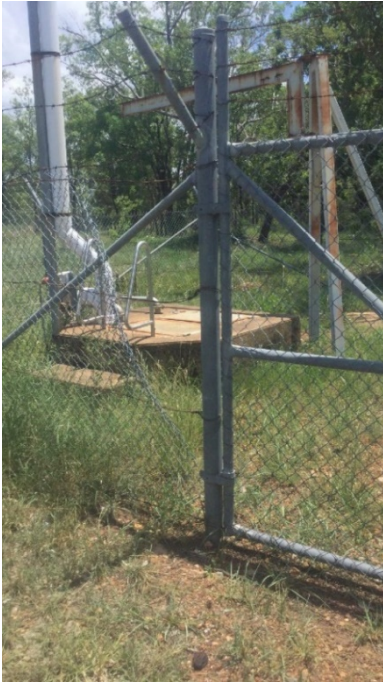
Figure 4 Sewer pump station (davit arm)
