Completion Report

Langarra Outstation – Houses 5 & 6 Agreement HHIPN00005

Project Overview

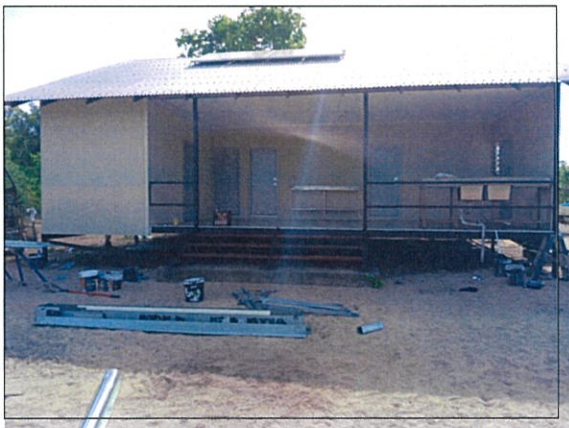
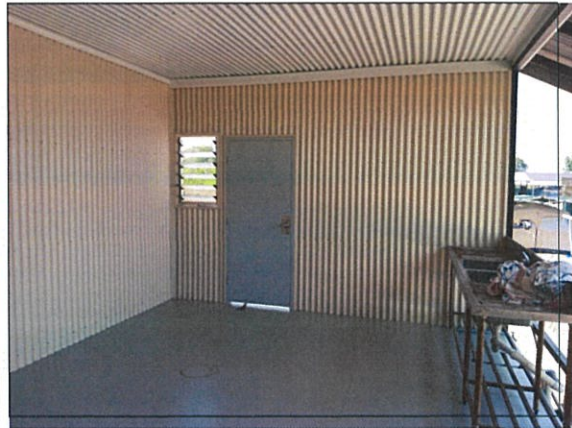
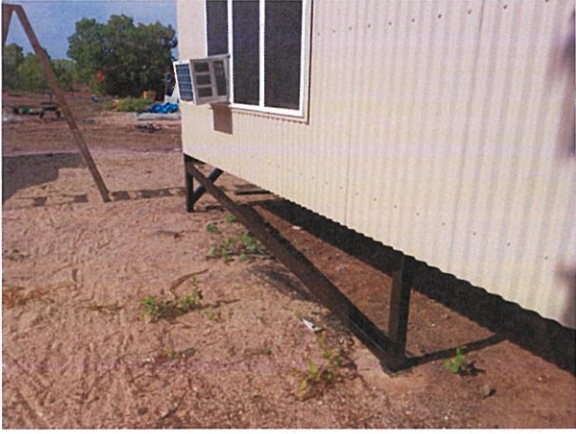
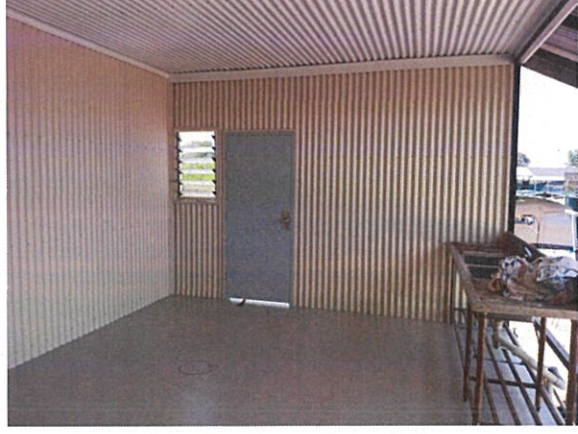
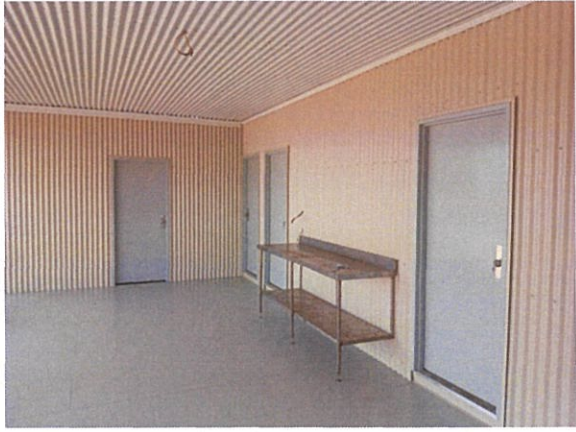
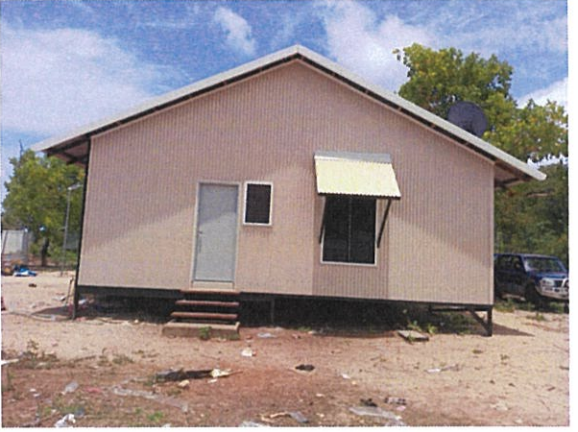
House 6

- Repaired and replaced all rusted out stumps / columns.
- Attached new columns to concrete footings with chemset.
- Lifted house structure and placed new floor bearers where structural integrity was compromised by rust.

- Lifted house structure and placed new floor joists using box steel.
- Placed new cleats and bolts.
- Removed and rebuilt complete front deck.
 - removed all existing rusted out purlins and replaced with box steel.

- replaced subfloor and decking with 19mm cement sheet.
 - rebuilt stairs and adjusted handrails to suit.
 - painted new decking and rails.
- Removed and replaced verandah beam.

- Removed and replaced front wall top plate that was badly rusted out and replaced all cleats.
- Removed front cladding and inspect, then remove and replace rusted wall studs.

- Removed and replaced all external wall cladding showing signs of rust.
- Removed and replaced verandah ceiling cladding.
- replaced ceiling joist as necessary after inspection and rust treated as appropriate.

- Rust treated, primed and painted all steel work new and old.

- Removed and replaced window awnings x 3.
- Removed and replaced all door jambs, doors, security plates and locks x 4.
- Removed and repaired damaged window galleries 3 x 5 blade gallery set, 3 x 7 blade gallery set.
- Replaced fly screens with crimsafe security screens.
