Completion Report

Homelands Housing and Infrastructure Program

HHIP2500001 Rockhole Community

House No14

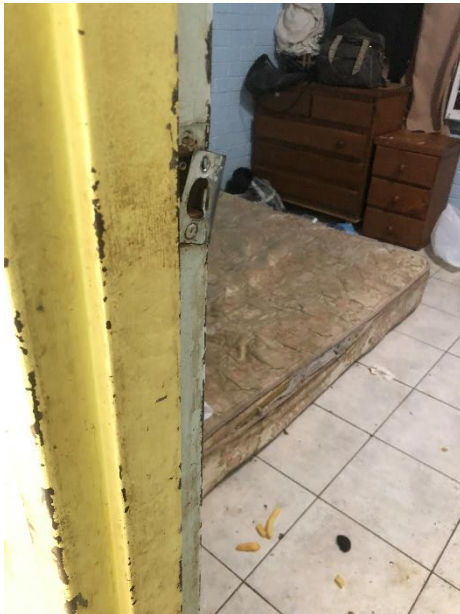
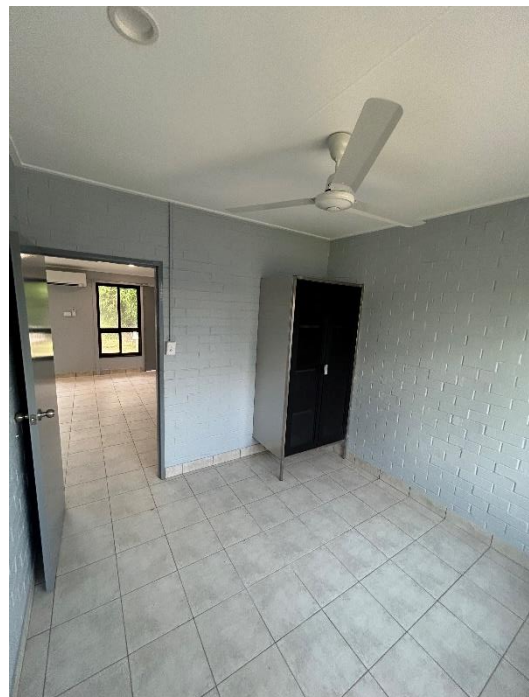
Bedroom 2

No internal photo to show as access was restricted during the initial scoping of works.
