Completion Report

Homelands Housing and Infrastructure Program

HHIP2500001 Rockhole Community

House No11

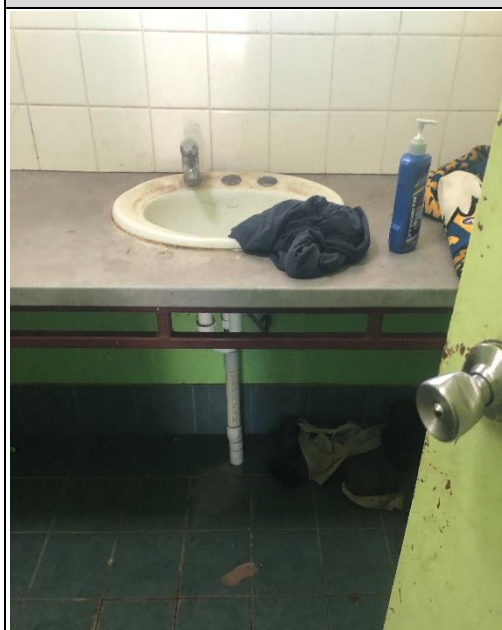
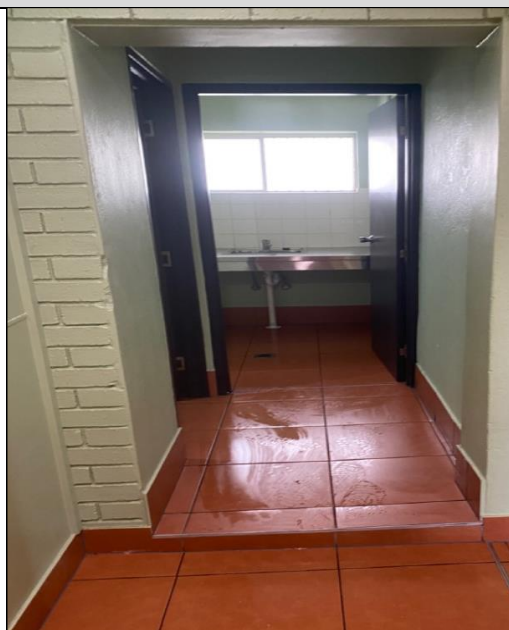
Sanitation

- Replace tiles – stained and rusty.
- Leaking water – inspect for any plumbing issues and repair.
- Replace Toilet bowl.

- Shower head, shower taps, and sink taps to be removed and replace with quarter turn hand levers.
- Replace tiles – stained and rusty.

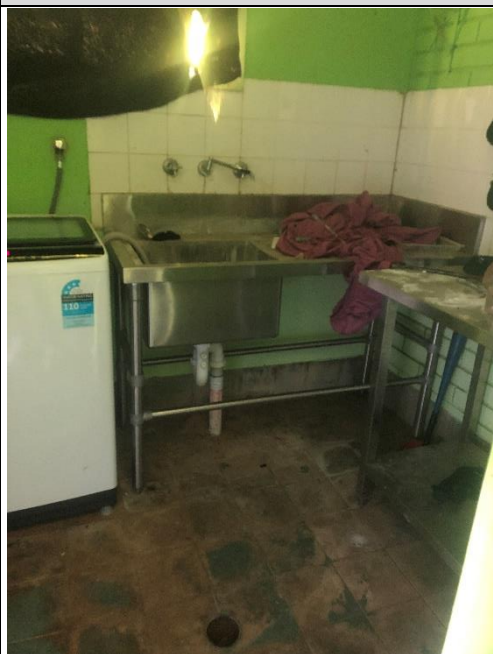
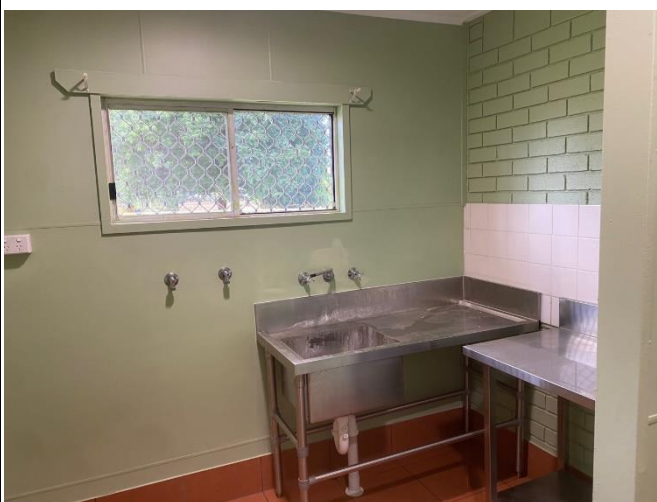
Laundry

- Fix wall panel for the cupboard.
- Change taps to levers.
