Completion Report

Homelands Housing and Infrastructure Program

HHIP2500001 Rockhole Community

Civil & Housing Refurbishment

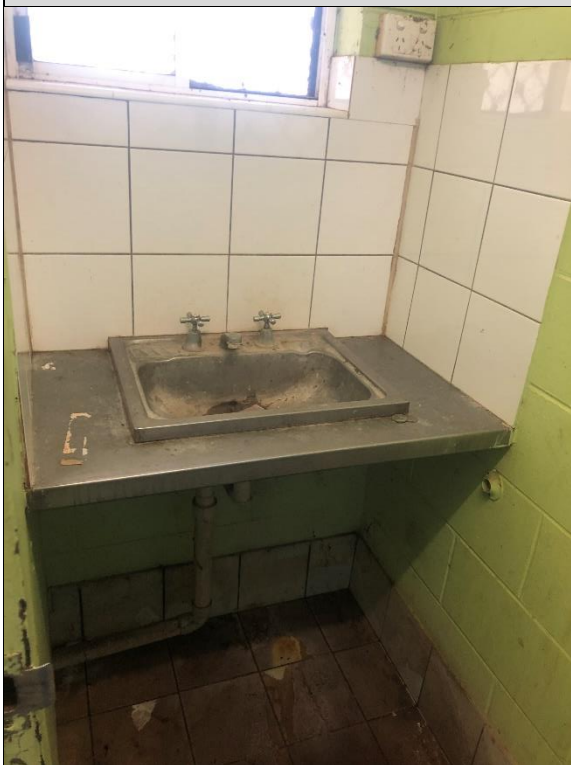
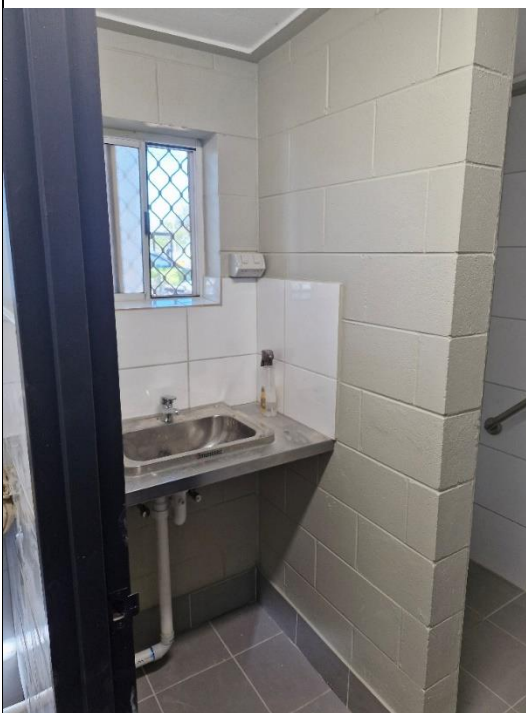
Sanitation

Bathroom
<p>Toilet</p> <ul style="list-style-type: none"> • Replace tiles – stained and rusty. • Leaking water – inspect for any plumbing issues and repair. • Replace Toilet bowl. <p>Shower</p> <ul style="list-style-type: none"> • Shower head, shower taps, and sink taps to be removed and replace with quarter turn hand levers. • Replace tiles – stained and rusty.
Laundry
<ul style="list-style-type: none"> • Fix wall panel for the cupboard. • Change taps to levers.
Bedroom 1
<ul style="list-style-type: none"> • Reinstate fly screen. • Reinstate fan to the ceiling, hanging loose. • No air conditioning unit in this room – install. • Install night latch on door.
Bedroom 2
<ul style="list-style-type: none"> • Reinstate fly screen. • Door handle missing – reinstate; install night latch. • Reattach fan switch to the wall. • Replace air conditioning unit.

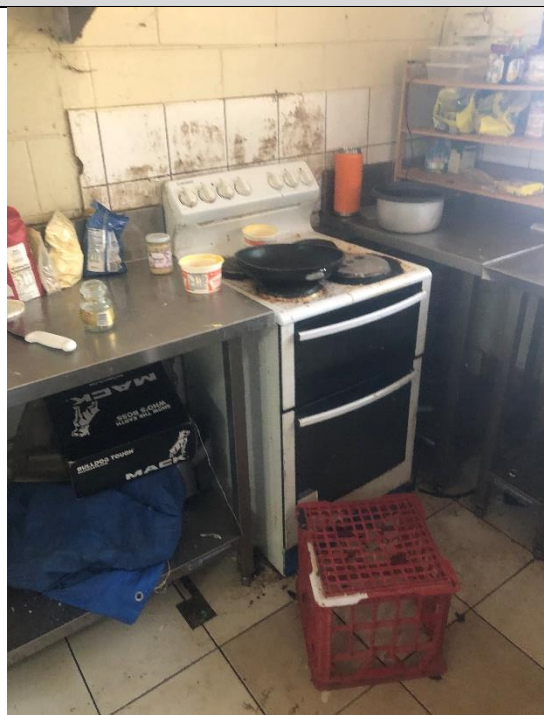
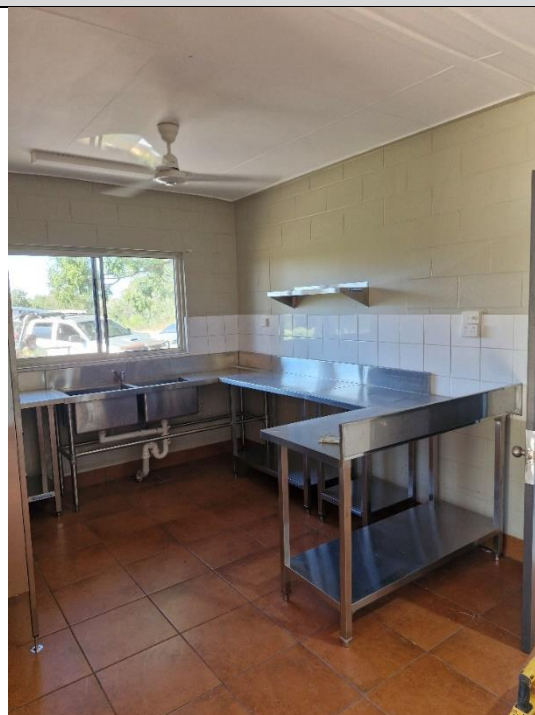
Homeland:	Rockhole Community, Florina Road, Katherine
House/Asset No:	House 6
Scoping Date:	15/07/2023
Throughout the Dwelling	
Required Maintenance Works <ul style="list-style-type: none"> • Environmental Clean • Repaint all internal walls, ceiling, door, door frames and window frames. • Repaint external walls and roof. • Multiple lights (internal and external) not working – inspect and repair. • Inspect Fire Alarms and install where missing. • Install night latch on all doors. • Install curtain hooks in all windows. • Install Crim safe to all windows and door flyscreen to match where missing. 	
Exterior	
<ul style="list-style-type: none"> • Tighten existing clothes line and add extra lines where missing. • 1 X room to be added at the back of the house unless other suitable options available. 	
Lounge/Kitchen	
<ul style="list-style-type: none"> • Flyscreen is bent and off the window - needs replacement to Crim safe. • No electrical supply, inspect and repair. • Replace light – missing bulb and cover. • Flooring requires cleaning. • Inspect smoke alarm and repair/replace as required. • No air conditioning unit in this room – install. Kitchen <ul style="list-style-type: none"> • Reinstate fly screen. • Replace kitchen shelves with stainless steel shelves. • Cooktop /Oven – doesn't work – only two hot plates are operational – Replace. • Replace existing damaged flooring with tiles.
