Completion Report

Homelands Housing and Infrastructure Program

HHIP2500001 Rockhole Community

House No8

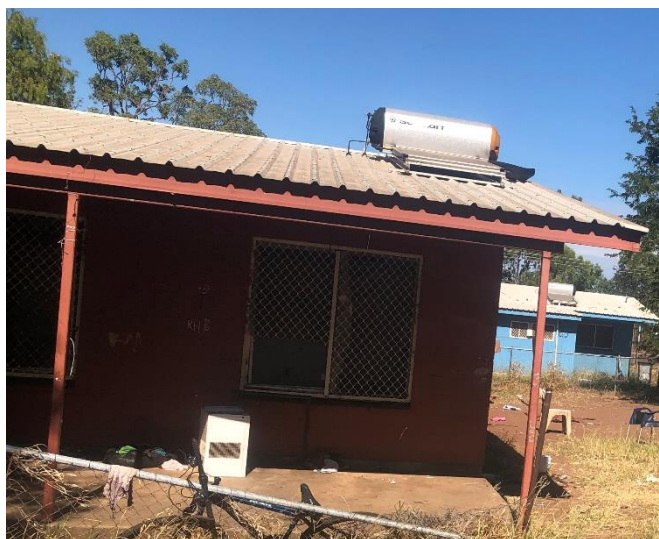
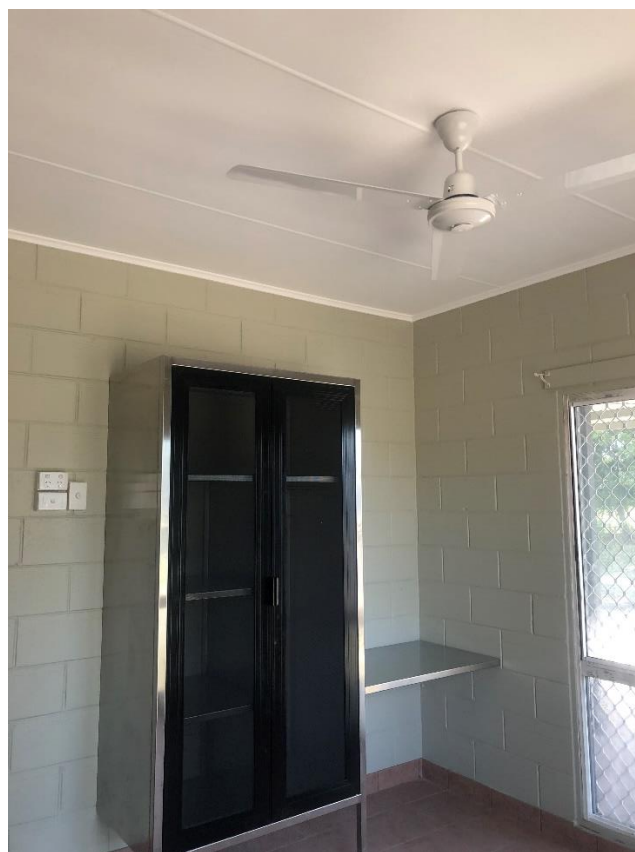
Bedroom 2

No internal photo to show as access was restricted during the initial scoping of works.
