# Completion Report

## Homelands Housing and Infrastructure Program

**\*HHIP2500001 Rockhole Community\***

**\*Civil & Housing Refurbishment\***

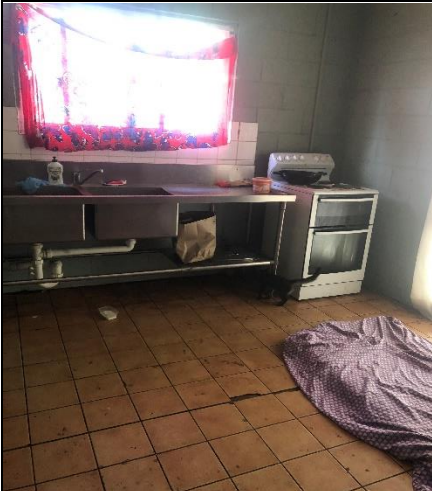
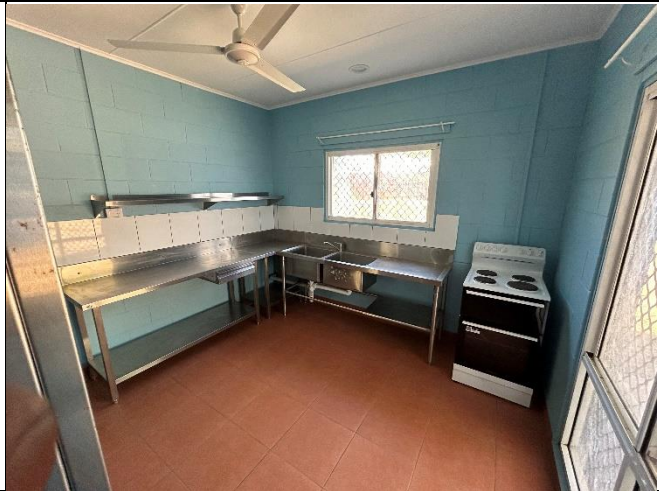
**Kitchen**

<b>Lounge/Kitchen</b>	
<ul style="list-style-type: none"> <li>• Flyscreen is bent and off the window - needs replacement to Crim safe.</li> <li>• No electrical supply, inspect and repair.</li> <li>• Replace light – missing bulb and cover.</li> <li>• Flooring requires cleaning.</li> <li>• Inspect smoke alarm and repair/replace as required.</li> <li>• No air conditioning unit in this room – install.</li> </ul> <p><b>Kitchen</b></p> <ul style="list-style-type: none"> <li>• Reinstate fly screen.</li> <li>• Replace kitchen shelves with stainless steel shelves.</li> <li>• Cooktop /Oven – doesn't work – only two hot plates are operational – Replace.</li> <li>• Replace existing damaged flooring with tiles.</li> </ul>

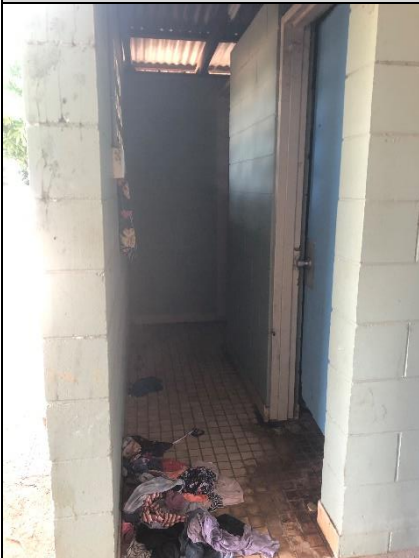
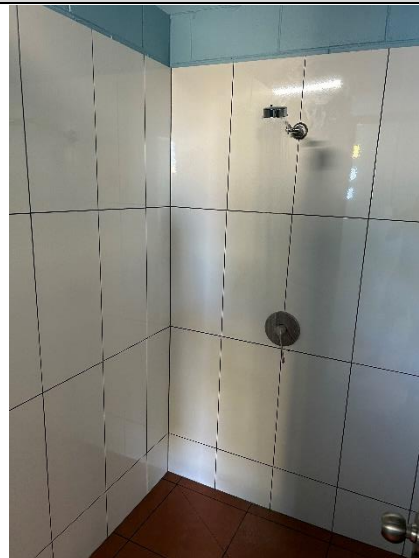
**Bathroom**

<b>Bathroom</b>
<p><b>Toilet</b></p> <ul style="list-style-type: none"><li>• Replace tiles – stained and rusty.</li><li>• Leaking water – inspect for any plumbing issues and repair.</li><li>• Replace Toilet bowl.</li></ul> <p><b>Shower</b></p> <ul style="list-style-type: none"><li>• Shower head, shower taps, and sink taps to be removed and replace with quarter turn hand levers.</li><li>• Replace tiles – stained and rusty.</li></ul>
<b>Laundry</b>
<ul style="list-style-type: none"><li>• Fix wall panel for the cupboard.</li><li>• Change taps to levers.</li></ul>
<b>Bedroom 1</b>
<ul style="list-style-type: none"><li>• Reinstate fly screen.</li><li>• Reinstate fan to the ceiling, hanging loose.</li><li>• No air conditioning unit in this room – install.</li><li>• Install night latch on door.</li></ul>
<b>Bedroom 2</b>
<ul style="list-style-type: none"><li>• Reinstate fly screen.</li><li>• Door handle missing – reinstate; install night latch.</li><li>• Reattach fan switch to the wall.</li><li>• Replace air conditioning unit.</li></ul>
