Completion Report for Houses 1 through 4 1st October 2024

Langarra Outstation – Agreement HHIPN00005

House 2

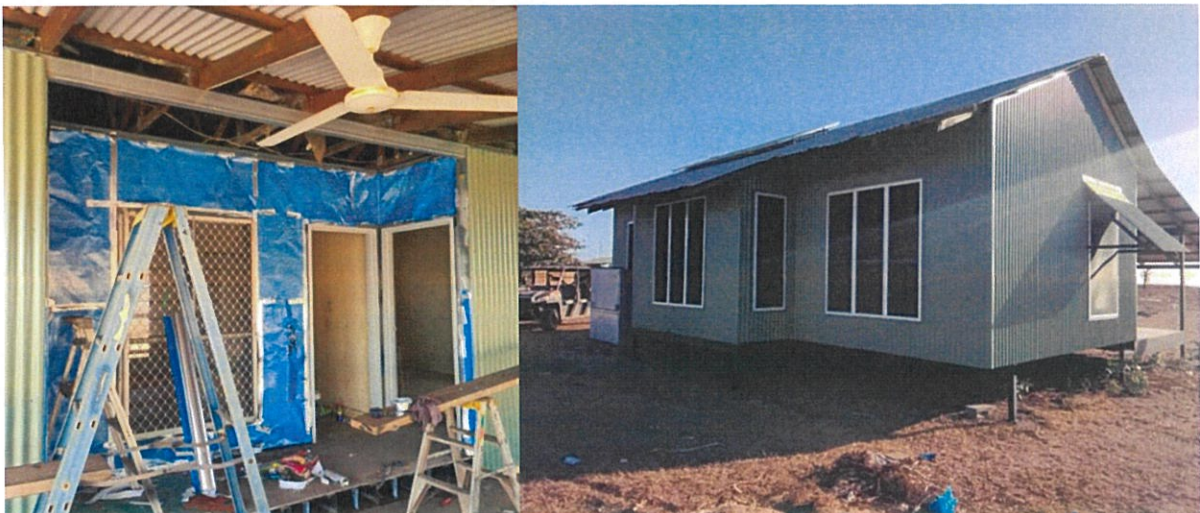
- Repair and replace rusted-out stumps and columns.
- Attach new columns to concrete footings.
- Lift house structure, install new bearers, joists, cleats, and bolts.
- Rebuild stairs and adjust handrails.
- Paint new decking and rails.
- Remove and replace veranda beam.
- Replace the front wall top plate and external cladding showing any rust or deterioration.
- Expose steel frame and replace all rusted sections
- Rust treat, prime, and paint all framing and steel work.
- Replace window awnings and rusted deck roof areas.
- Stain rafters and purlins of the front veranda.

- Remove and replace all door jambs, doors, security plates and locks.
- Repair or replace damaged window galleries and louvres
- Replace fly screens with Crimsafe security screens.
