Completion Report for Houses 1 through 4 1st October 2024

Langarra Outstation – Agreement HHIPN00005

House 4 (Transitional)

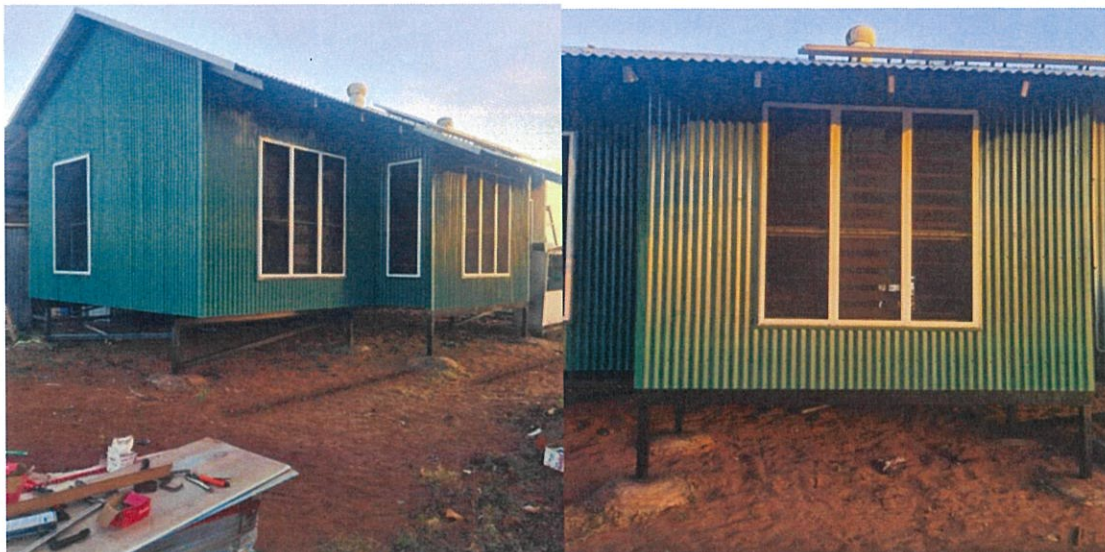
- Repair and replace all rusted-out stumps/columns.
- Attach new columns to concrete footings.
- Lift house structure and place new floor bearers, joists, cleats, and bolts.
- Remove and rebuild complete front deck
- remove all existing rusted out purlins and replace with box
- replace subfloor and decking with 19mm cement sheet
- rebuild stairs and adjust handrails to suit
- paint new decking and rails
- Remove and replace veranda beam.
- Replace front wall top plate.
- Remove and replace all external cladding showing signs of deterioration.
- Expose framing and replace all rusted studs and framing
- Rust treat, prime, and paint all framing and other steel work.
- Replace rusted vermin mesh.
- Replace window awnings and the back edge of the deck roof.
- Stain rafters and purlins of the front veranda.
- Remove and replace window awnings
- Replace back edge of deck roof

- Remove and replace all door jambs, doors, security plates and locks
- Repair or replace all damaged window galleries and louvres
- Replace fly screens with Crimsafe security screens.
