Kulaluk

2 Condition assessment

5.2 Existing infrastructure condition assessment

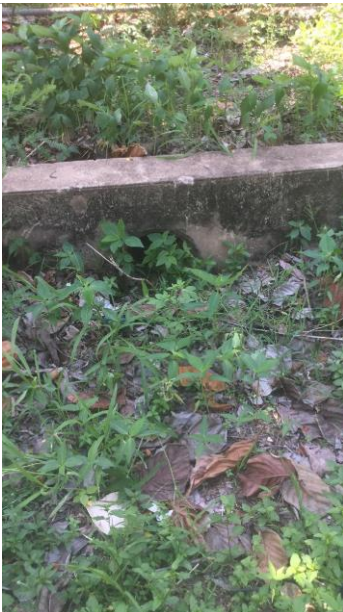
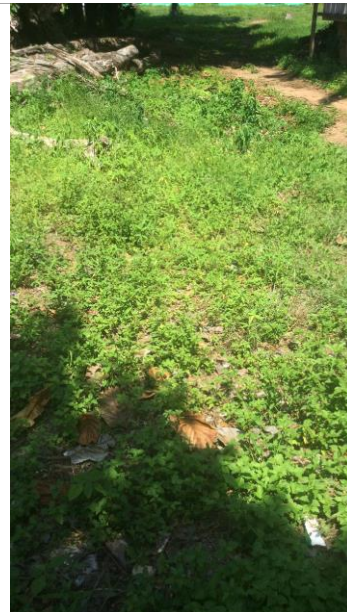
Stormwater Infrastructure:	Culverts
Culvert Type:	RCP
Diameter (mm):	270
Width (mm):	
Culvert Depth (mm):	
Culvert Length (m):	11
Culvert Condition:	2 - Poor
Culvert Blockage (%):	50
Culvert Comments:	
Culvert Head Wall:	Yes
Safety Grate:	
Headwall Blockage:	10
Headwall Condition:	3 - Good
Headwall Comment:	Overgrown around headwall
End Wall:	Yes
End Wall condition:	3 - Good
EW Comment:

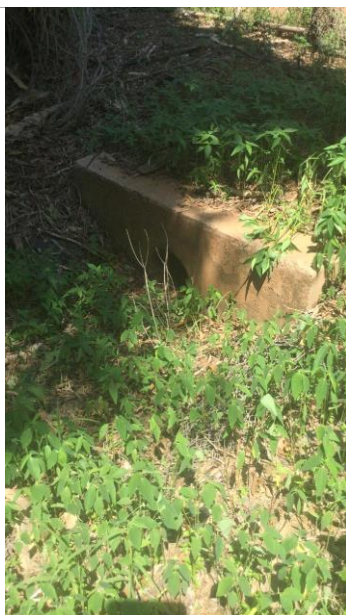
Some concrete damage on lid

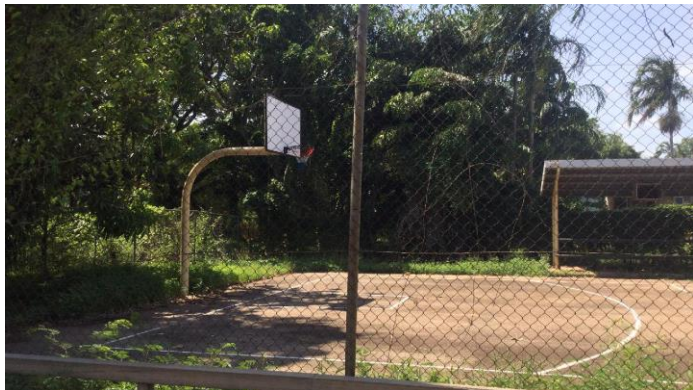
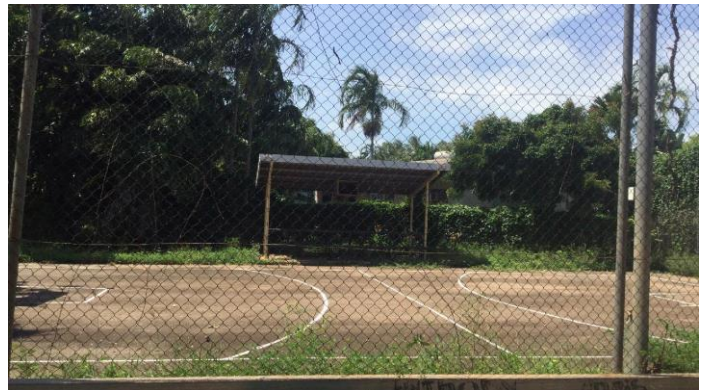
Inspection Type:	Shade Structure
Shade Structure Type:	Basket Ball Court
Shade Floor Type:	Spray seal
Roof Type:	Not Covered
Width (mm):	
Length (mm):	
Appearance:	3
Appearance Comment:	New linemarking
Condition:	3 - Good
Comment:

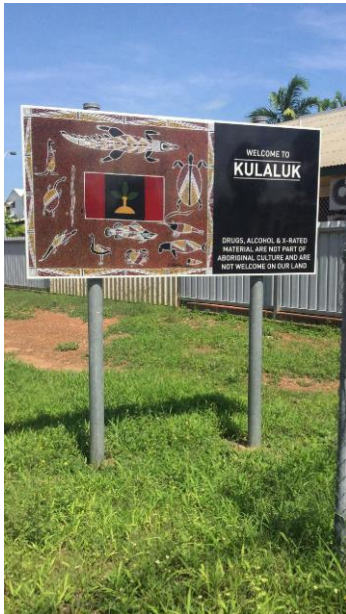
Sign Condition: 3 - Good

Sign Comment: Starting to fade

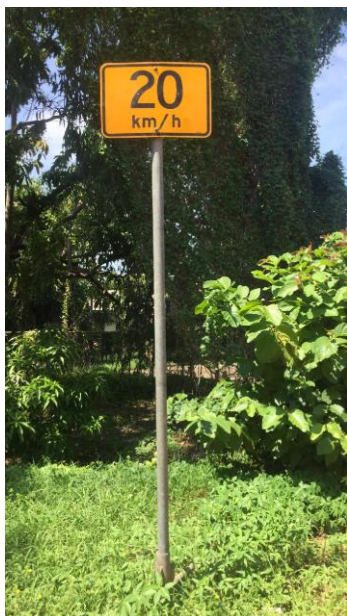
Sign Condition: 2 - Poor

Sign Comment: Post in private porperty

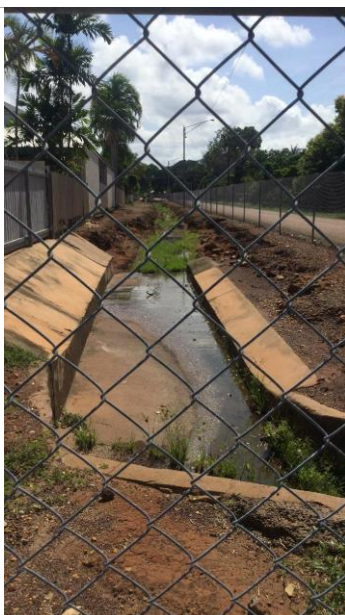
Need guard rails at culvert outlet

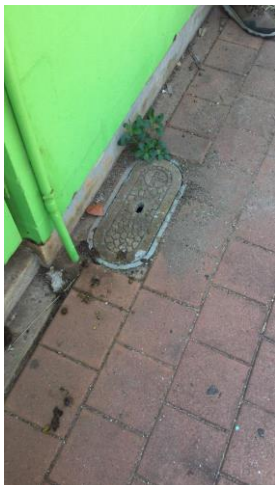
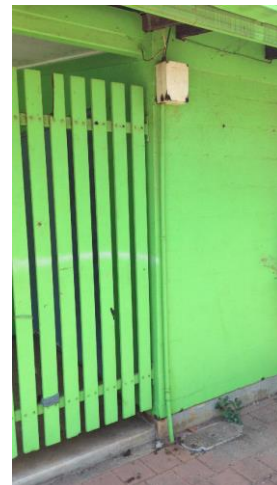
Meter Condition: 3

Meter Comment: Blank plates are missing on CB slot.

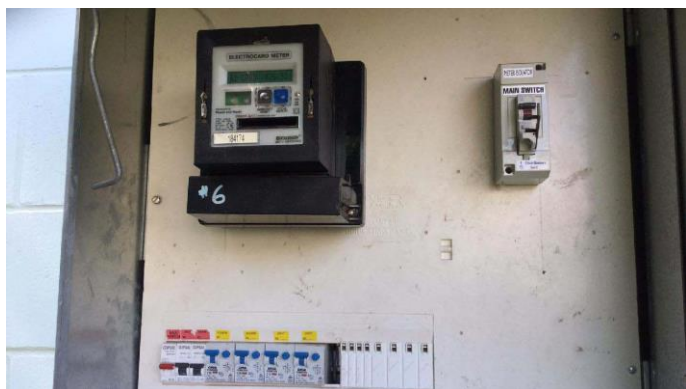
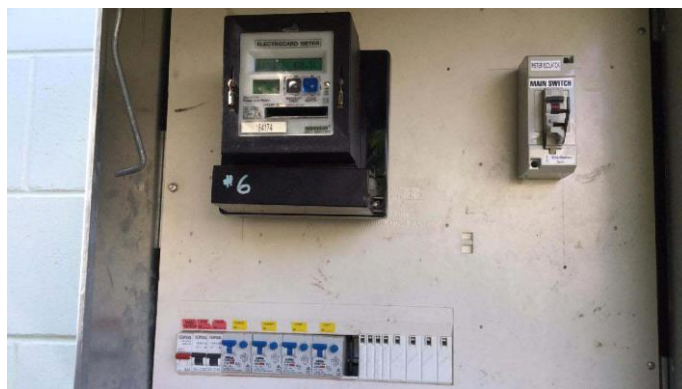
Meter Comment: Blank plates are missing on CB slot.

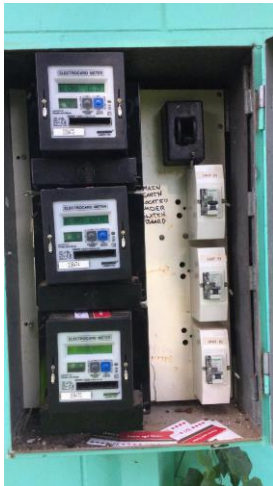
Meter Comment: 3 Digital Meters

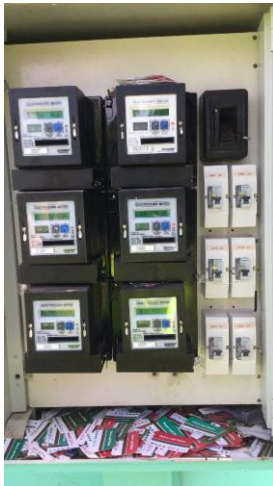
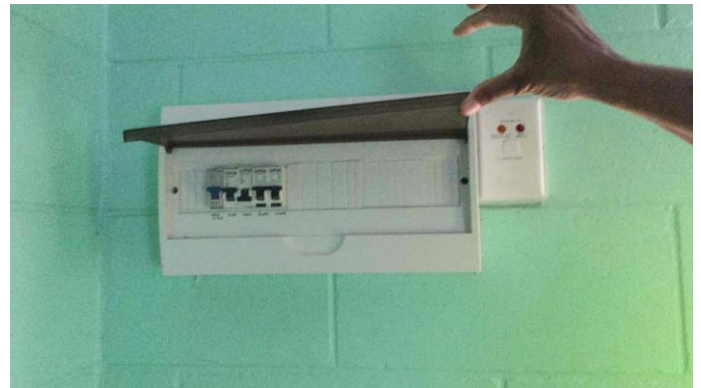
Meter Comment: 6 Digital Meters. Indoor SB, Cond 3

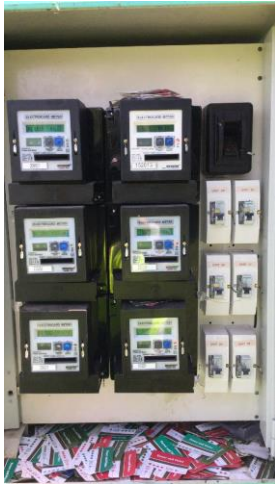
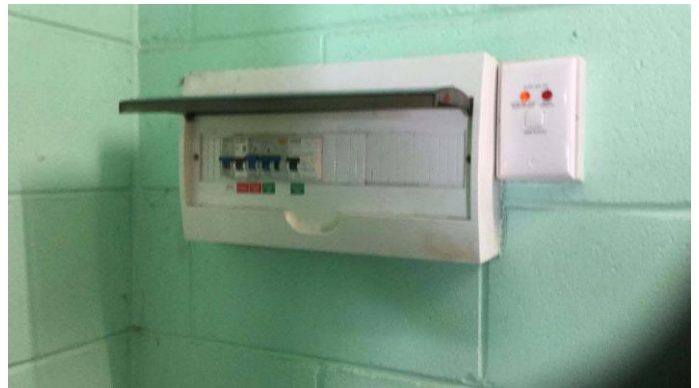
Meter Comment: 6 Digital Meters. Indoor SB, Cond 3

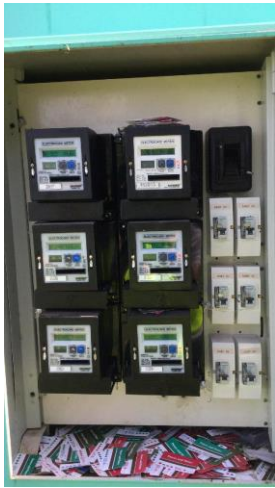
Meter Comment: 6 Digital Meters.

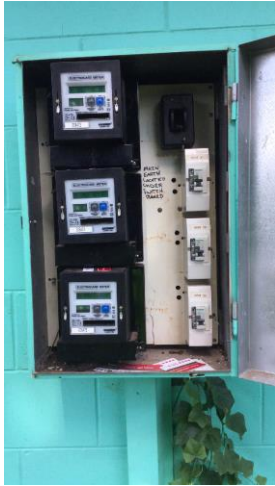
Meter Comment: 3 Digital Meters

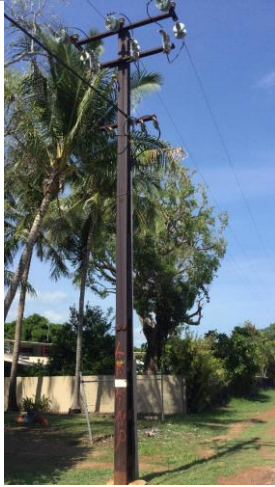
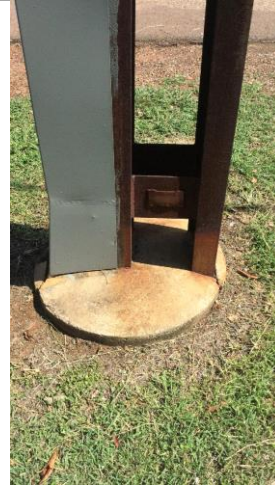
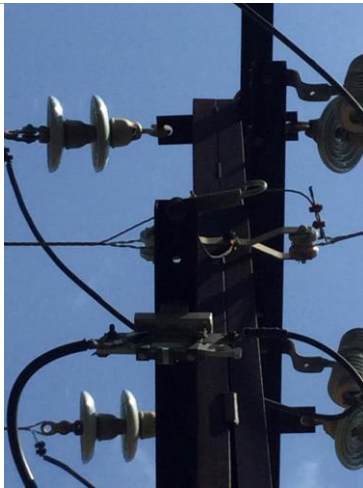
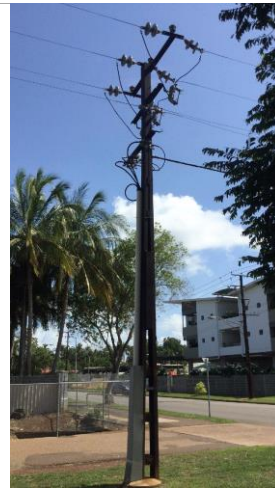
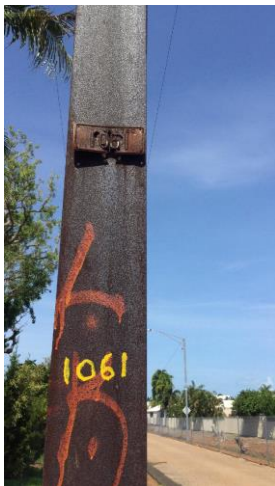
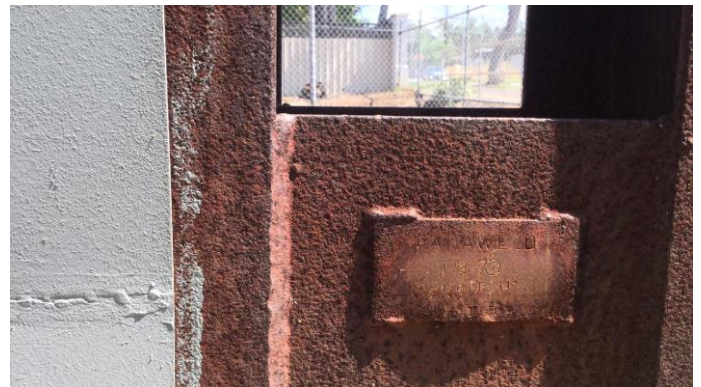
What is Pole Material type:	Welded
What is the condition of pole:	3
How is the pole planted:	Concrete
What is the Condition of plant:	3
Is street light fitted:	No
Street Light Power Supply:	
Street Light Type	
Street Light Watts	
Street Light Condition	
Street Light Height	
What is the type of service:	Three
What is the HV voltage level:	11000
What is the arrangement of connected cables:	Parallel
Are there isolators on the pole:	Yes
What is the Condition:	3
How many Lots are connected to this pole:	
Overhead Pole Comments:	Surface rust

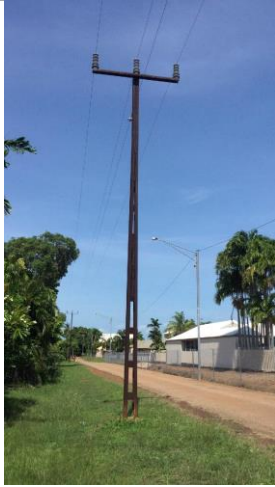
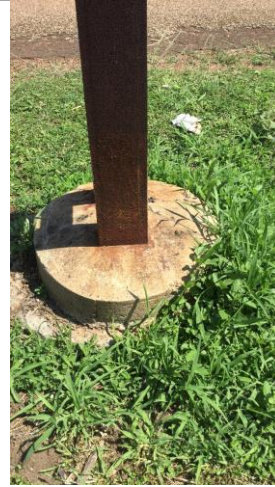
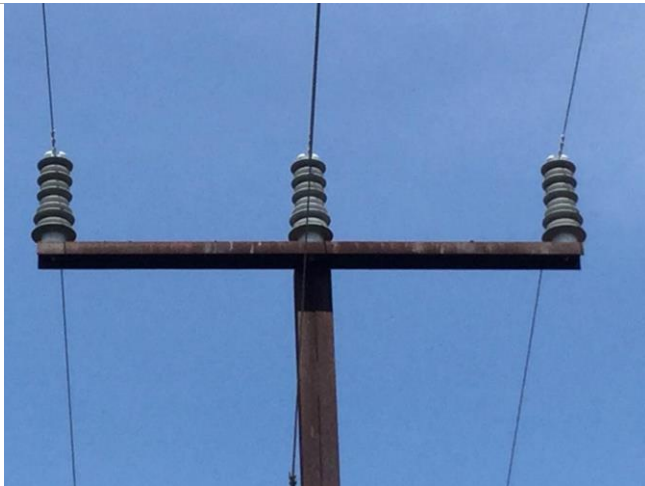
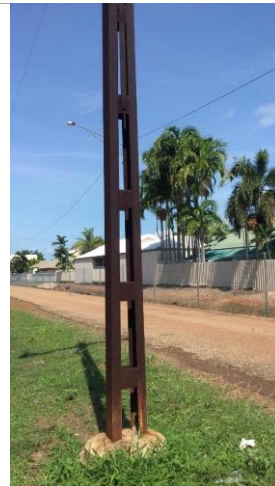
Overhead Pole Comments: Surface rust ,minor pitting on isolator

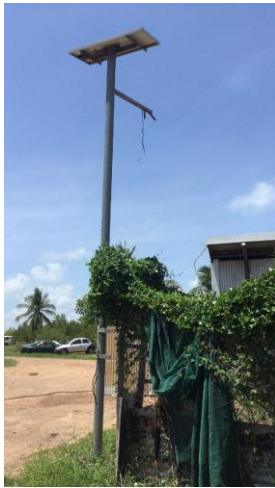
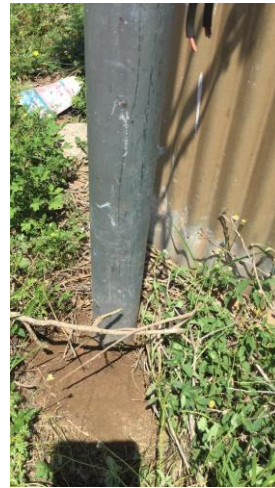
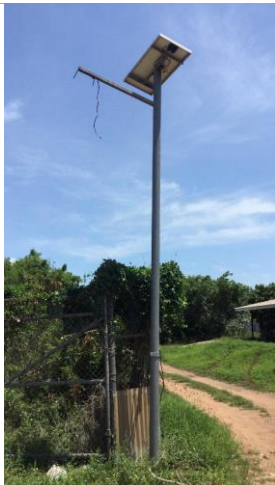
What is the condition of street lights: 1

What is Street Lighting pole installation height (approximate): 6

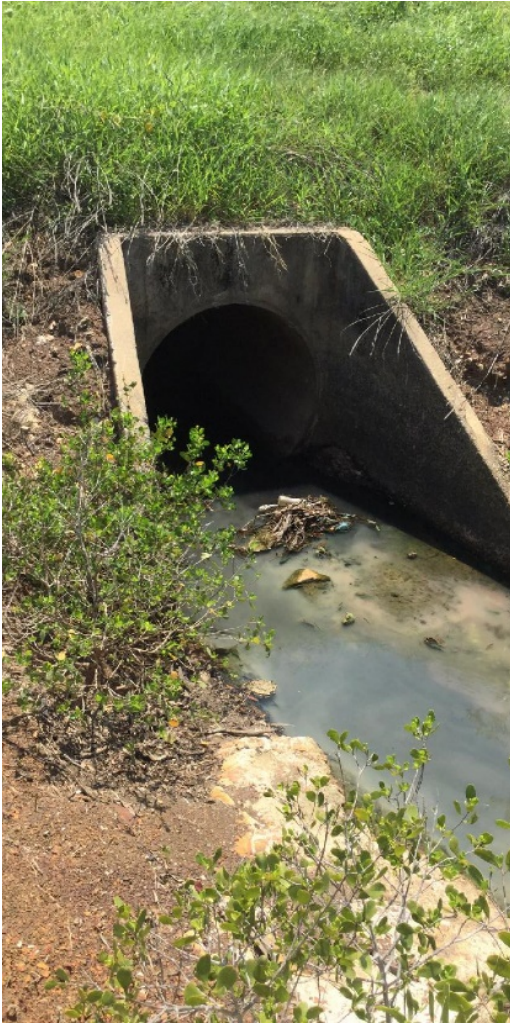
Figure 12 Headwall

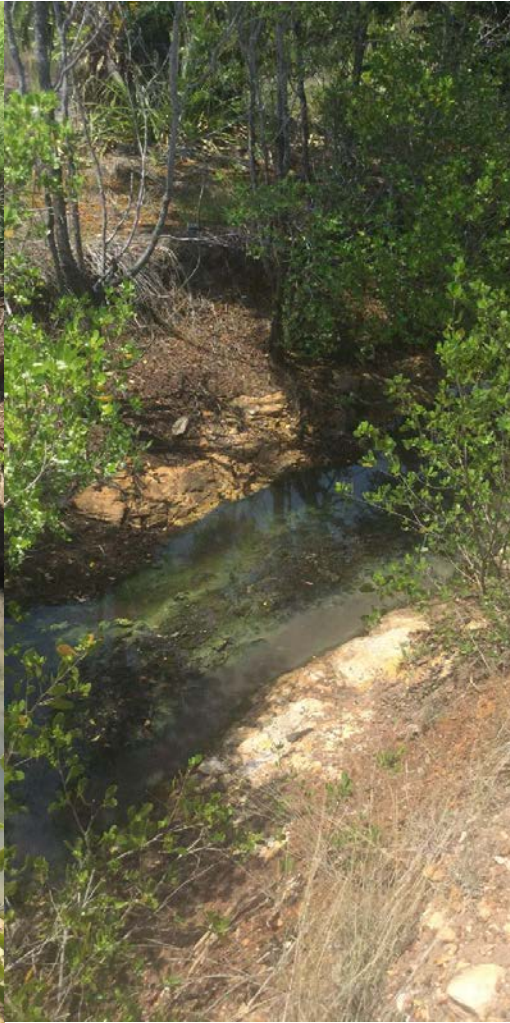
Figure 13 Swale

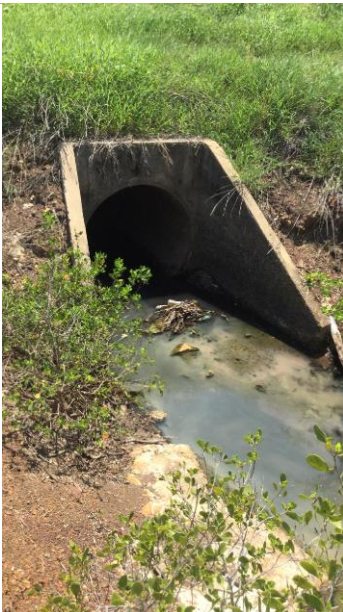
Stormwater Infrastructure:	Culverts
Culvert Type:	RCP
Diameter (mm):	1200
Width (mm):	
Culvert Depth (mm):	
Culvert Length (m):	
Culvert Condition:	3 - Good
Culvert Blockage (%):	10
Culvert Comments:	
Culvert Head Wall:	No Access
Safety Grate:	No Access
Headwall Blockage:	
Headwall Condition:	
Headwall Comment:	
End Wall:	Yes
End Wall condition:	3 - Good
EW Comment:	Some scour around end wall, Ponding in culvert

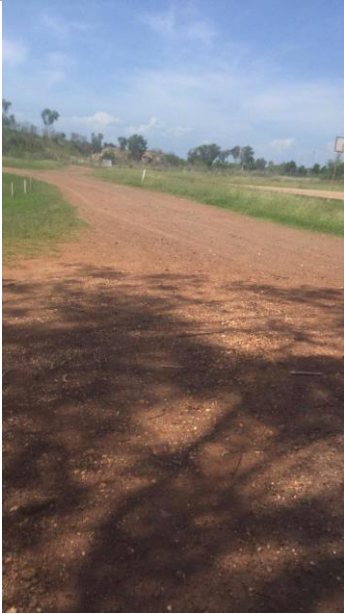
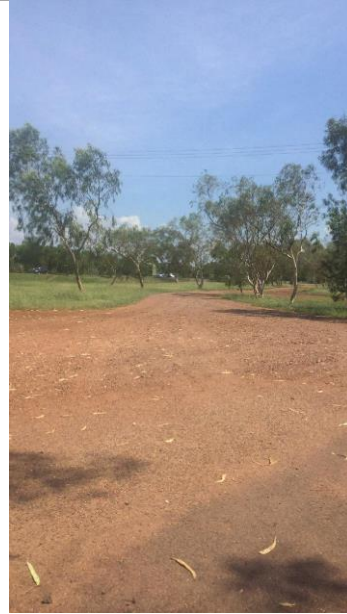
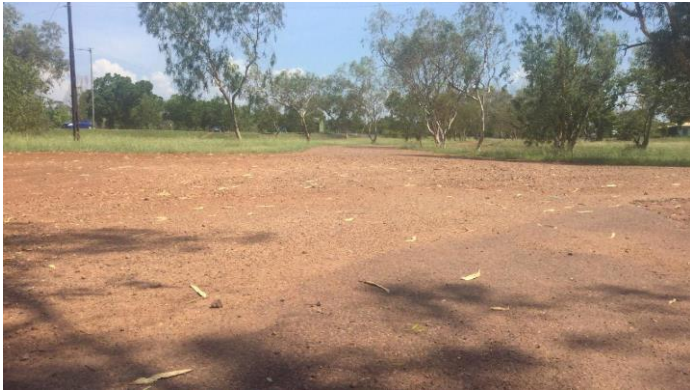
Road Name: 825_3
What are you inspecting: Pavements
Ch From (km): 0.15
Ch To (km): 0.25
Road Type: Unsealed
Section Width (m): 4
Road Condition: 2 - Poor

Defect Type	Defect QTY	Defect Condition	Defect Comments
Potholes	1	2 - Poor	
Edge Breaks		3 - Good	
Undulation/Settlement		3 - Good

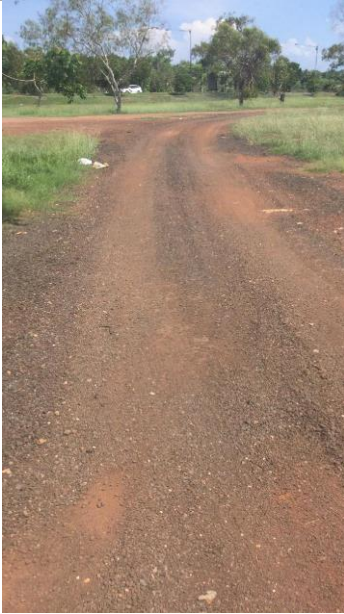
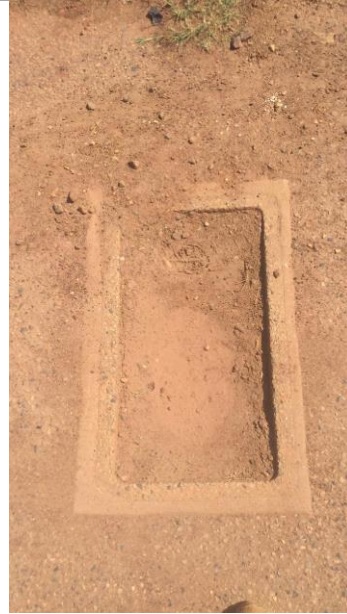
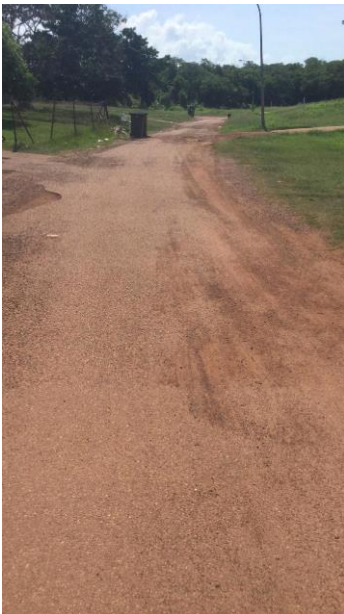
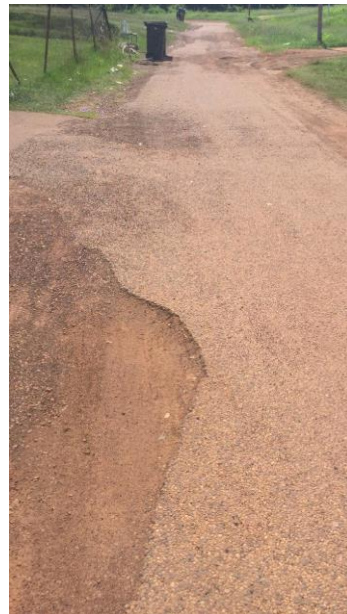
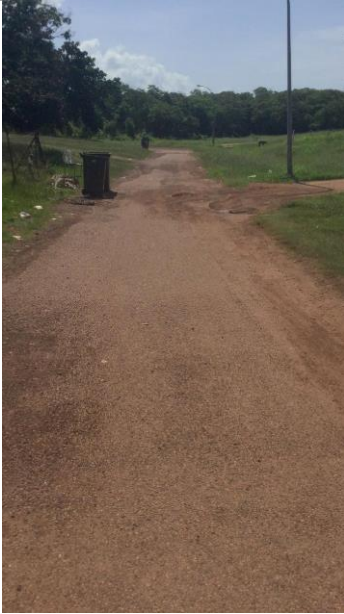
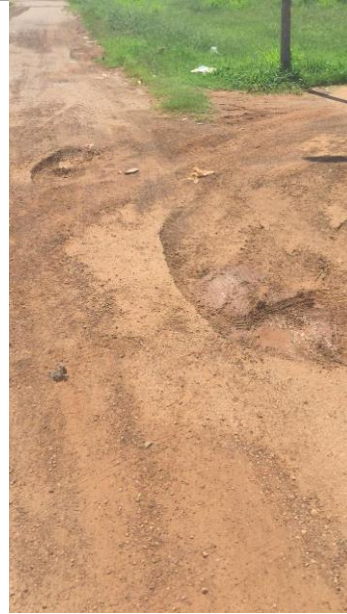
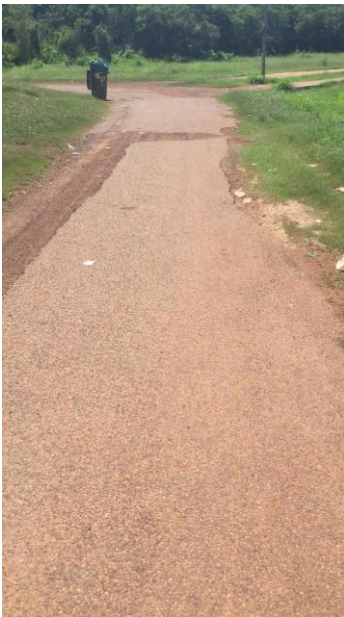
Road Name: 825_2
What are you inspecting: Pavements
Ch From (km): 0.4
Ch To (km): 0.52
Road Type: Sealed - spray seal
Section Width (m): 4
Road Condition: 1 - Very Poor
General Comment: Last 50 m is unsealed

Defect Type	Defect QTY	Defect Condition	Defect Comments
Edge Breaks		1 - Very Poor	
Potholes	10

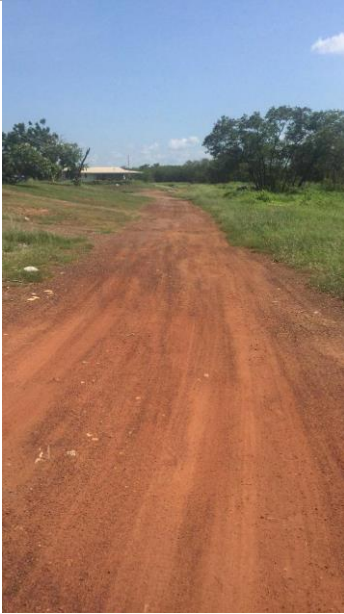
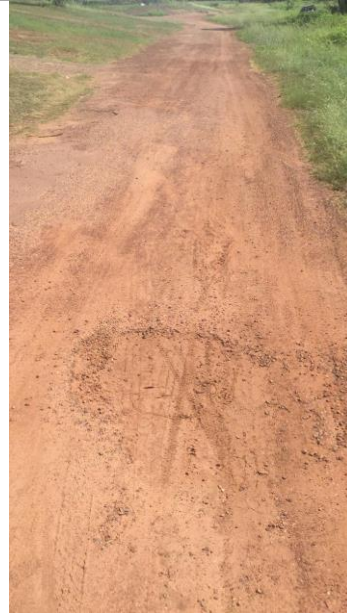
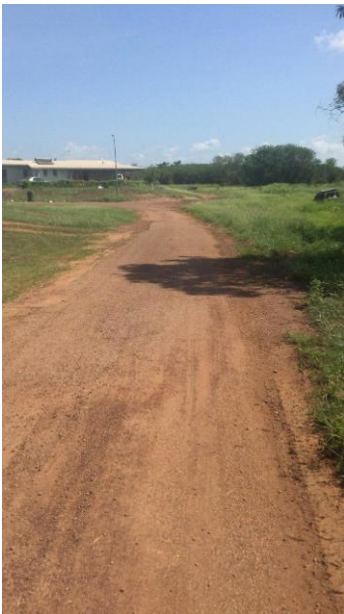
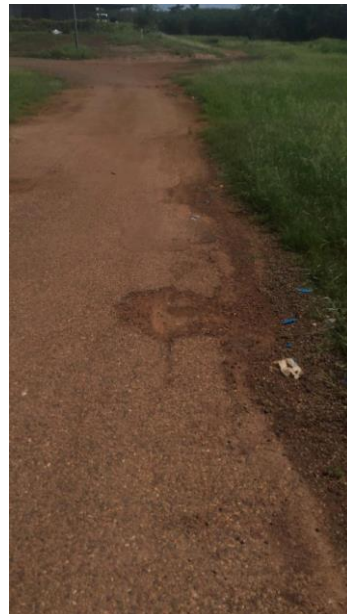
Road Name: 825_2
What are you inspecting: Pavements
Ch From (km): 0.3
Ch To (km): 0.4
Road Type: Sealed - spray seal
Section Width (m): 4
Road Condition: 2 - Poor

Defect Type	Defect QTY	Defect Condition	Defect Comments
Surfacing Failure		2 - Poor	
Potholes	6	2 - Poor	
Undulation/Settlement		2 - Poor	
Edge Breaks		2 - Poor

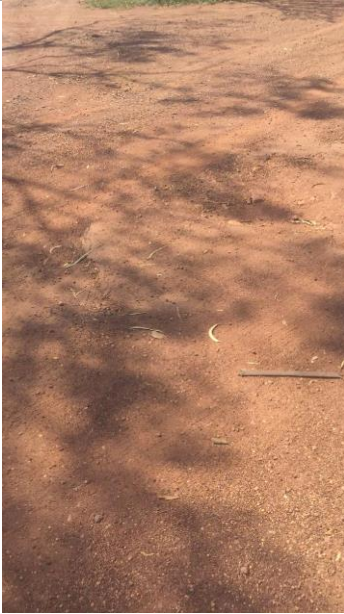
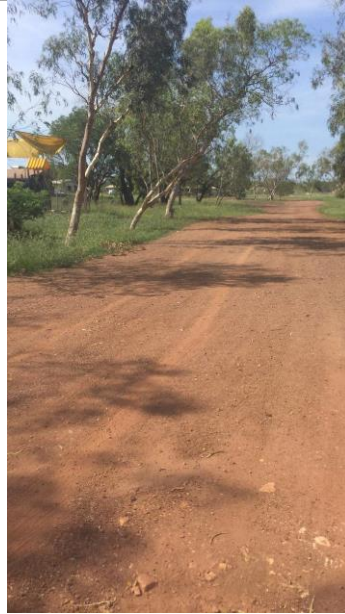
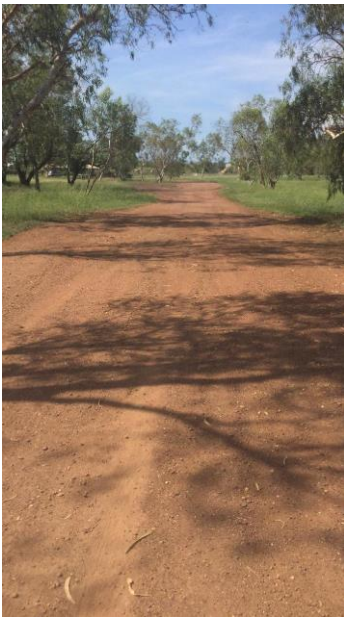
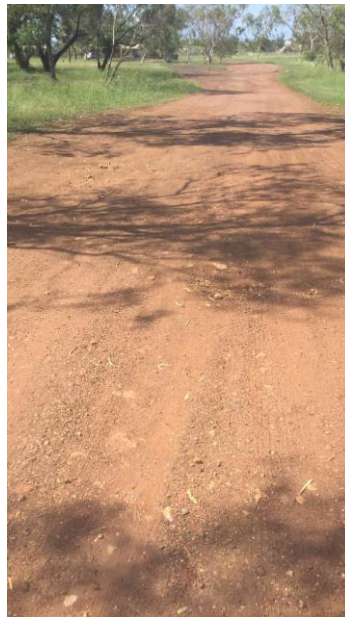
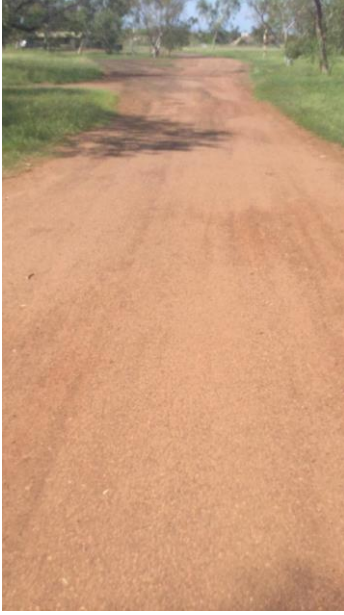
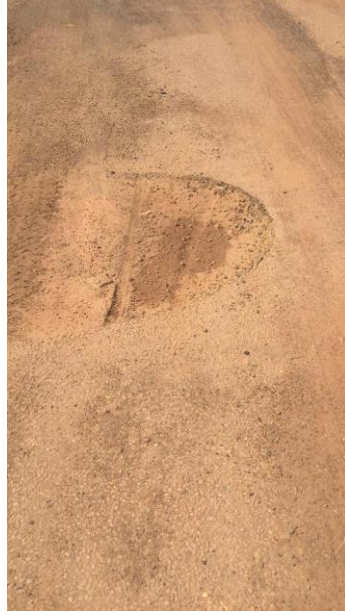
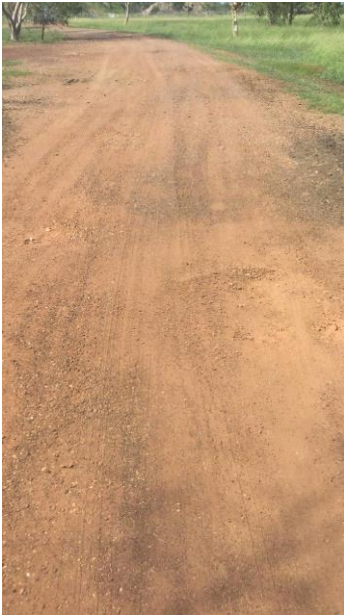
Road Condition: 2 - Poor

Defect Type	Defect QTY	Defect Condition	Defect Comments
Potholes	12	2 - Poor	
Undulation/Settlement	10

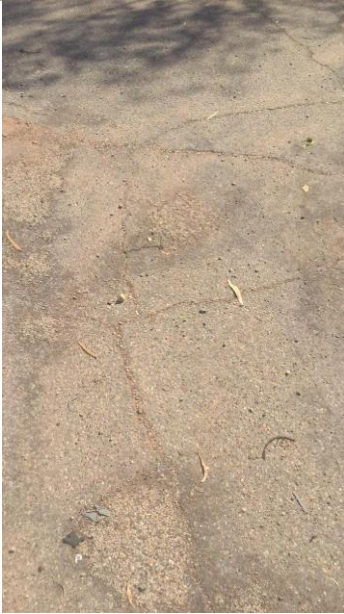
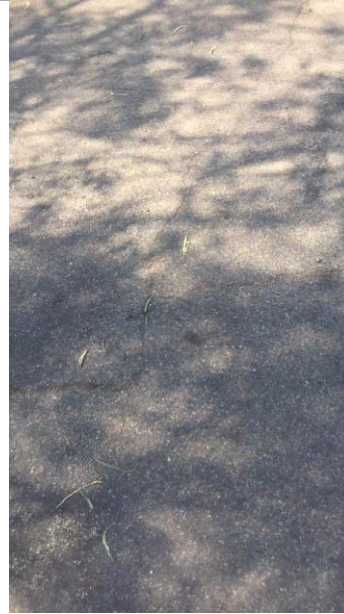
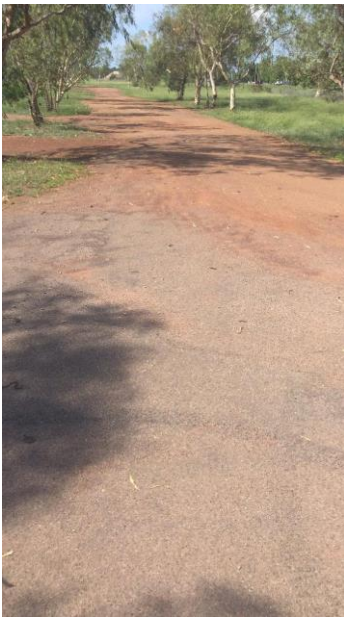
Road Name: 825_3
What are you inspecting: Pavements
Ch From (km): 0
Ch To (km): 0.05
Road Type: Sealed - spray seal
Section Width (m): 8
Road Condition: 2 - Poor
General Comment:

Defect Type	Defect QTY	Defect Condition	Defect Comments
Crocodile Cracks	5	4 - Very Good	5 % of sealed section
Edge Breaks		3 - Good

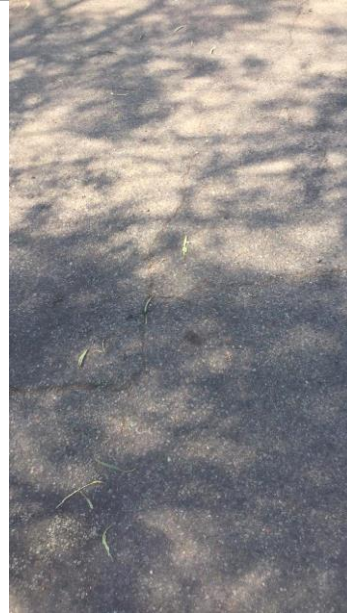
Road Condition: 2 - Poor

Defect Type	Defect QTY	Defect Condition	Defect Comments
Crocodile Cracks	5	4 - Very Good	5 % of sealed section
Edge Breaks		3 - Good

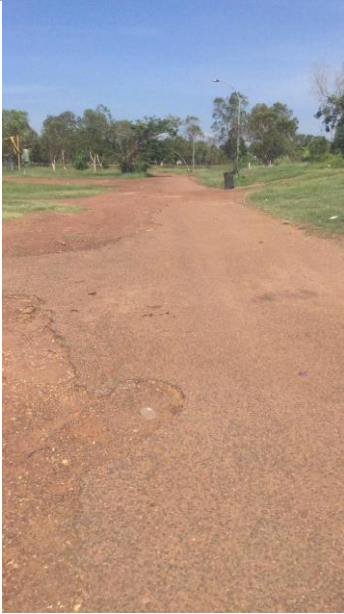
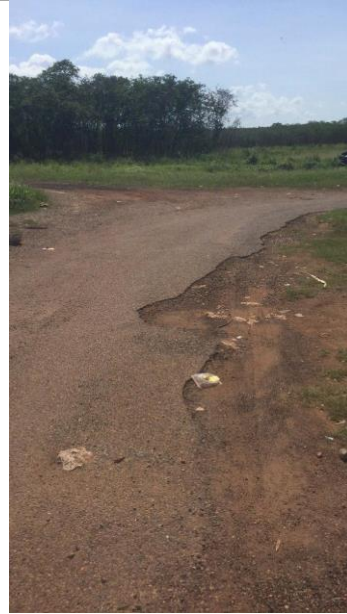
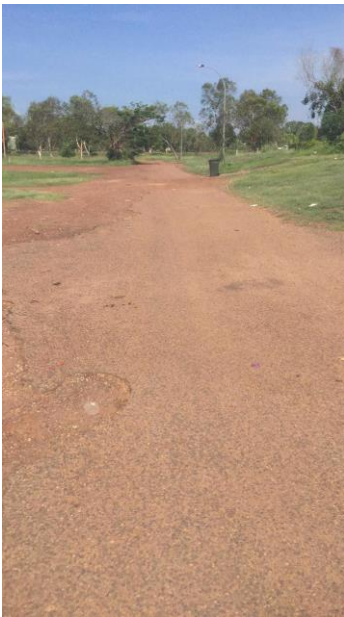
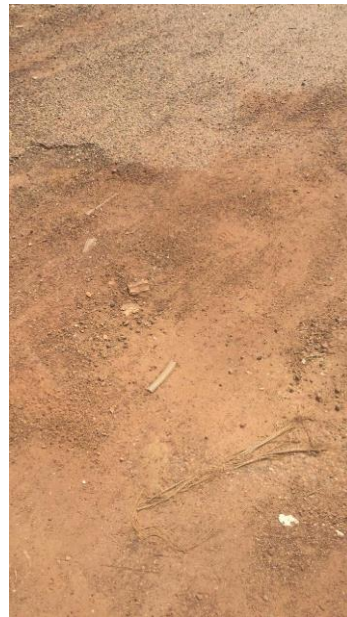
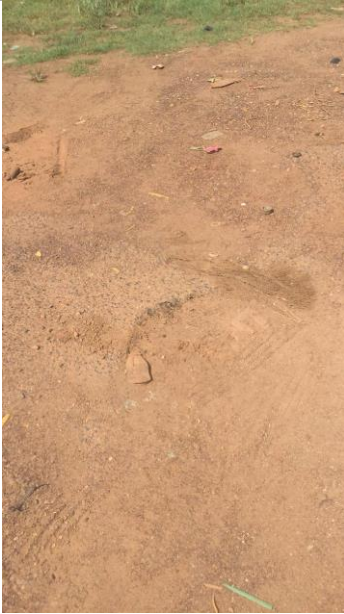
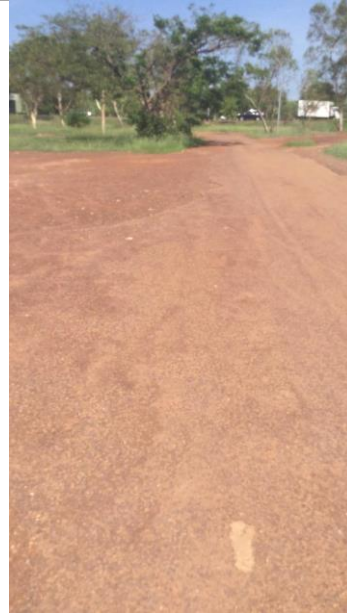
Road Condition: 2 - Poor

Defect Type	Defect QTY	Defect Condition	Defect Comments
Edge Breaks		1 - Very Poor	
Potholes	3	3 - Good

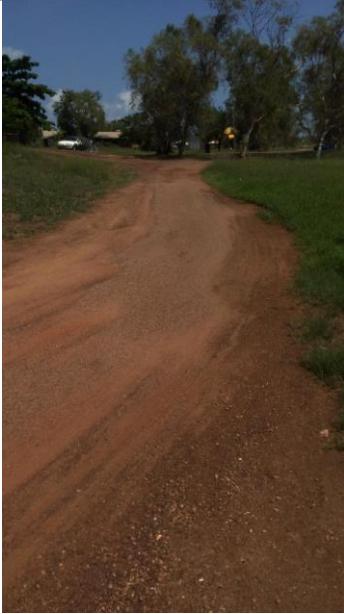
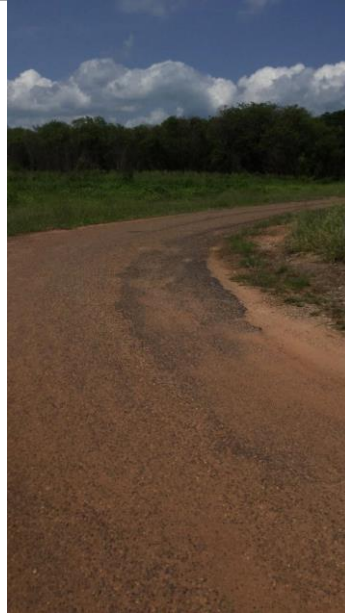
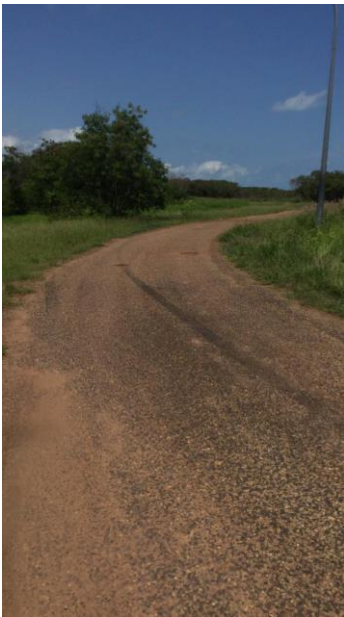
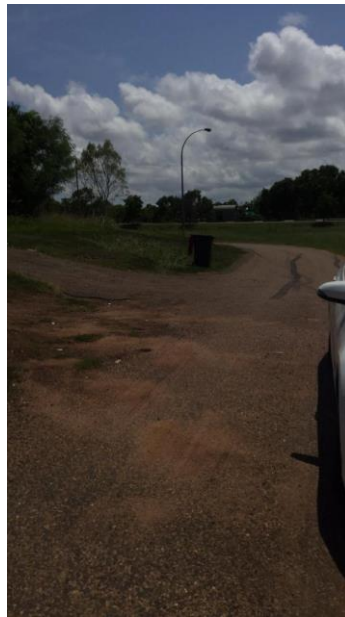
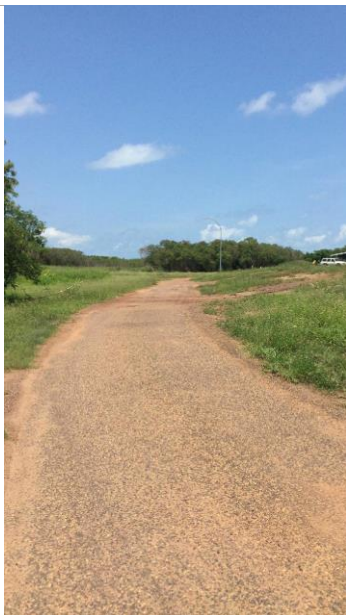
Road Name: 825_2
What are you inspecting: Pavements
Ch From (km): 0
Ch To (km): 0.15
Road Type: Sealed - spray seal
Section Width (m): 4
Road Condition: 2 - Poor

General Comment: First 50m of road in poor condition, last 100m in good condition

Defect Type	Defect QTY	Defect Condition	Defect Comments
Potholes	5	3 - Good	5% of road has potholes , varying size

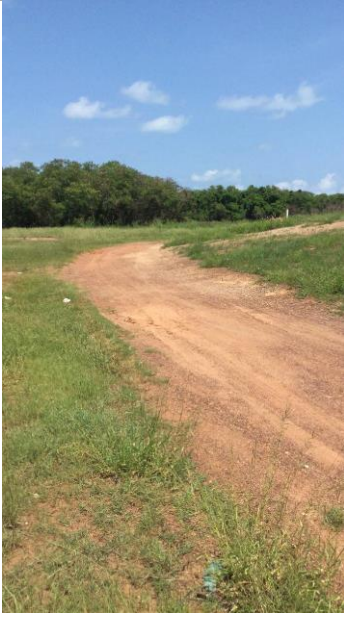
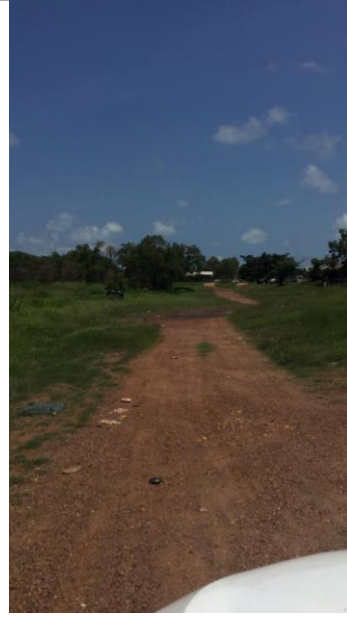
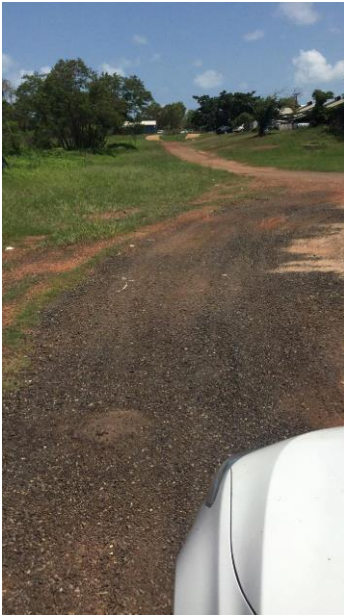
Road Name: 825_2
What are you inspecting: Pavements
Ch From (km): 0.15
Ch To (km): 0.3
Road Type: Sealed - spray seal
Section Width (m): 4
Road Condition: 2 - Poor
General Comment:

Defect Type	Defect QTY	Defect Condition	Defect Comments
Undulation/Settlement	50		50% of road has undulations
Potholes	10	2 - Poor	10 % of road has potholes

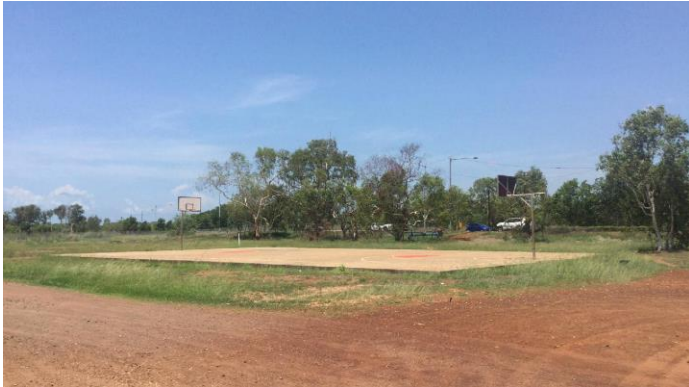
Minmarama Park

Inspection Type:	Shade Structure
Shade Structure Type:	Basket Ball Court
Shade Floor Type:	Concrete
Roof Type:	Not Covered
Width (mm):	
Length (mm):	
Appearance:	3
Appearance Comment:	No nets on basketball ring
Condition:	3 - Good
Comment:

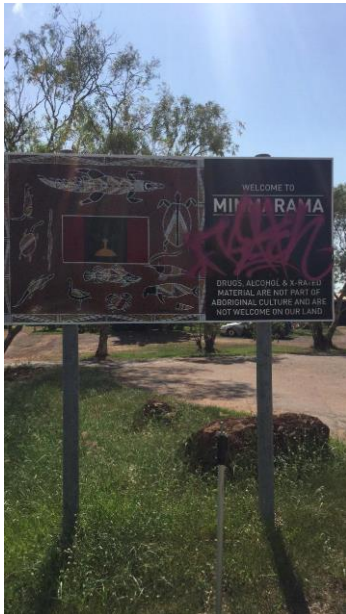
Sign Condition: 2 - Poor

Sign Comment: Graffitied

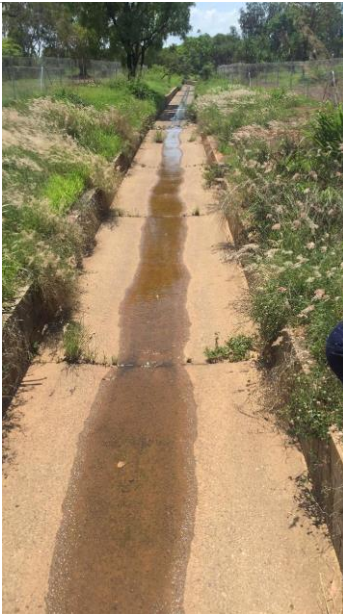
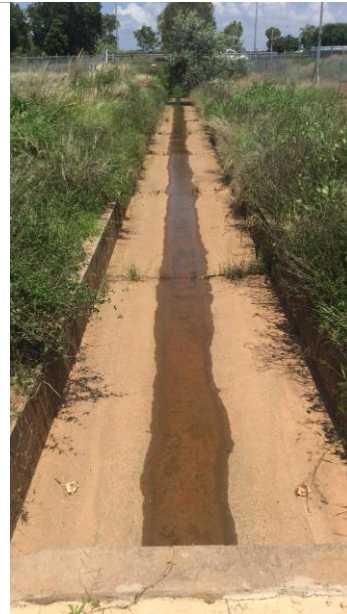
Minmarama Park

Stormwater Infrastructure:	Swales
Type of lining:	Concrete
Are dimensions uniform along drain:	Yes
Base Width (m):	2.4
Overall Width (m):	2.4
Swale Depth (m):	600
Length of Batter 1 (m):	0
Length of Batter 2 (m):	0
Swale Condition:	4 - Very Good
Swale Ponding:	No
Drain flooded at time of inspection:	No
Swale Comments:	Halikos private property

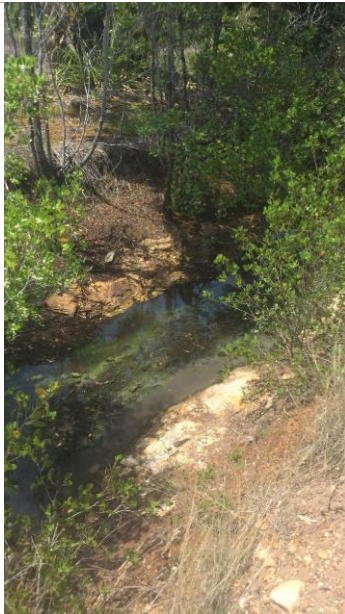
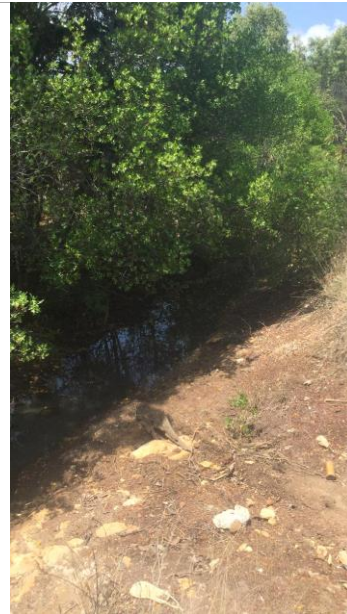
Minmarama Park

Stormwater Infrastructure:	Swales
Type of lining:	No Lining
Are dimensions uniform along drain:	Yes
Base Width (m):	1.5
Overall Width (m):	4.5
Swale Depth (m):	1.2
Length of Batter 1 (m):	1.5
Length of Batter 2 (m):	1.5
Swale Condition:	2 - Poor
Swale Ponding:	Yes
Drain flooded at time of inspection:	Yes
Swale Comments:

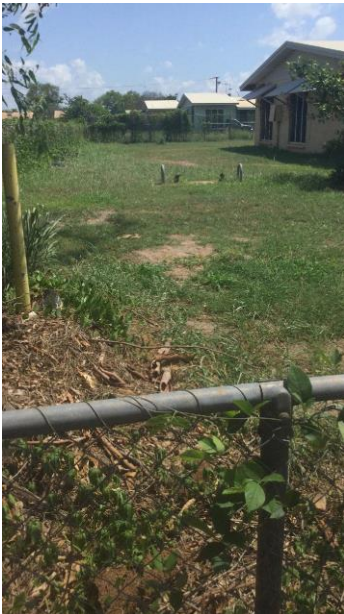
Lot Water Meter Condition: 3 - Good

Lot Water Meter Comment: 2 side by side, within property boundary

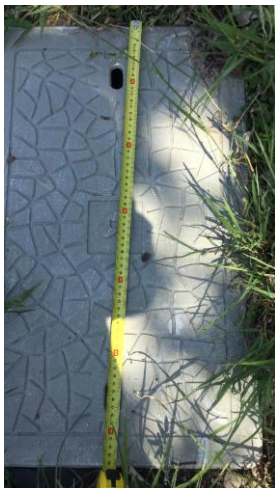
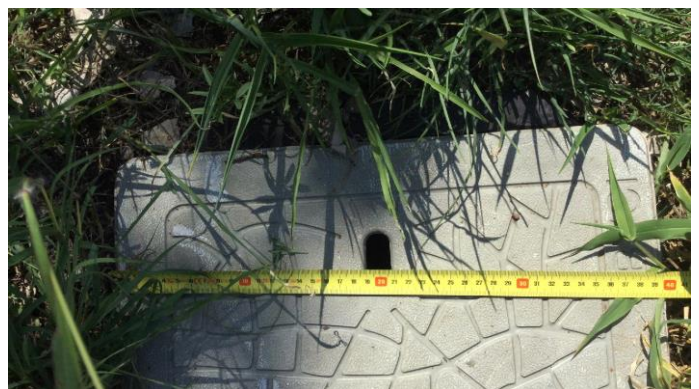
What is Pit Condition: 3

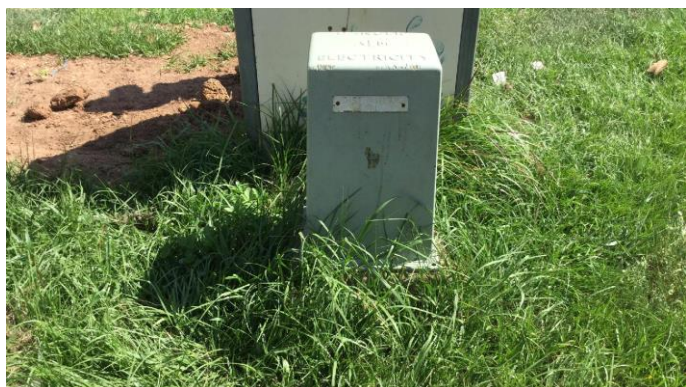
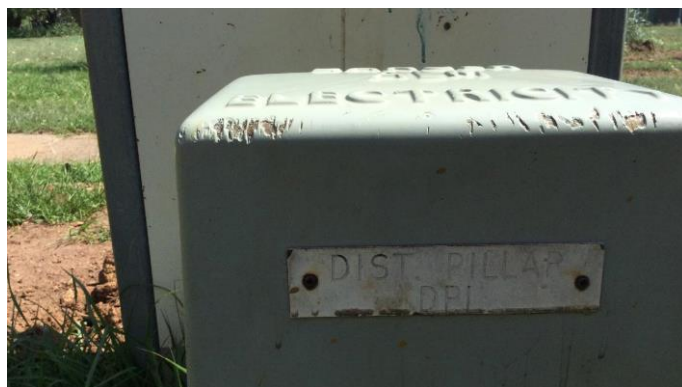
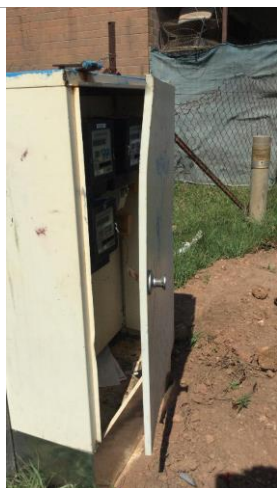
What is the condition of switchboard: 3

Condition Comments: Door bent and corroded

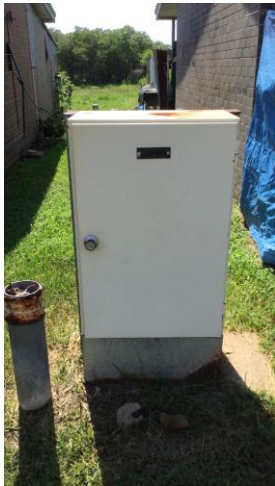
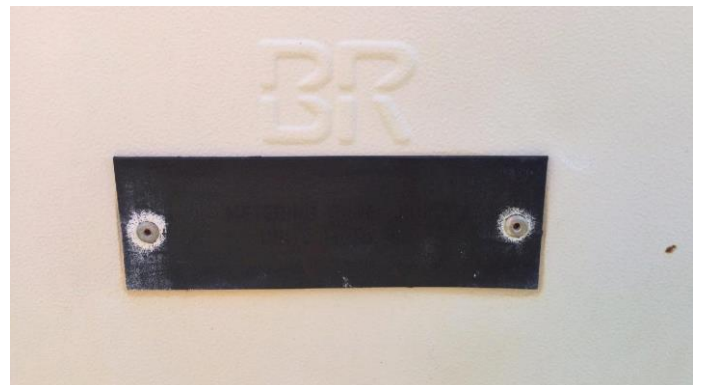
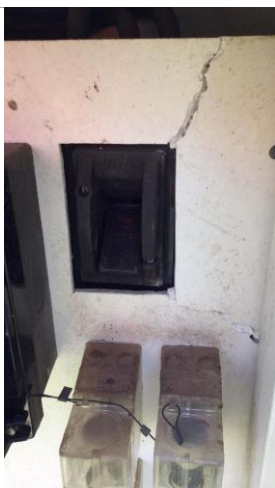
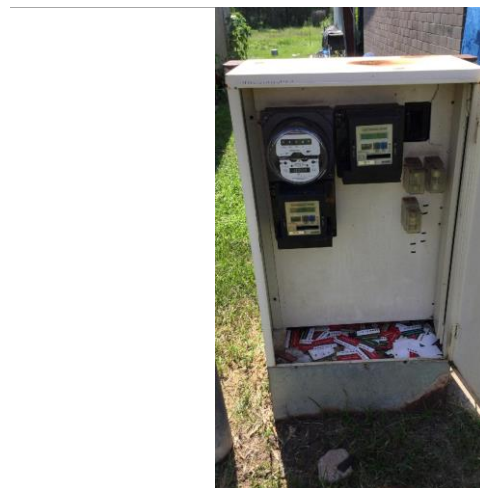
Rusted points on body .

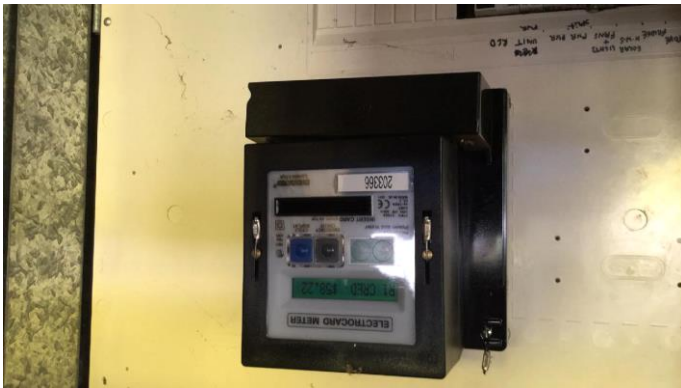
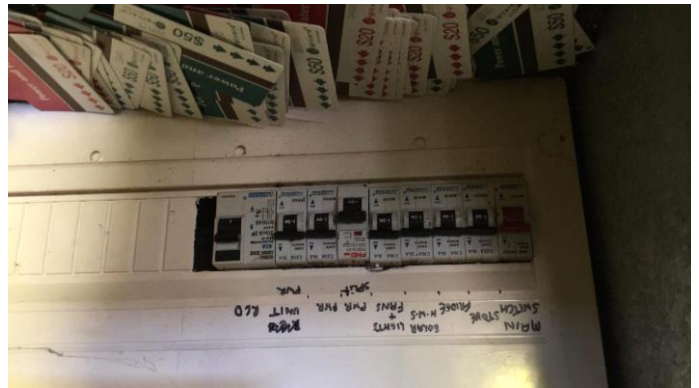
Meter Condition: 3

Meter Comment: Blank plates are missing on CB slot.

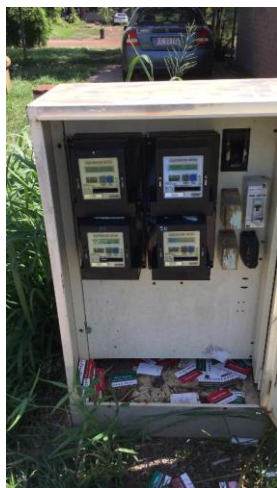
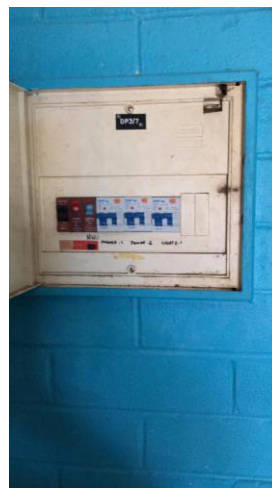
Meter Condition: 3

Meter Comment: 4 digital meters. Indoor SB, Cond 3

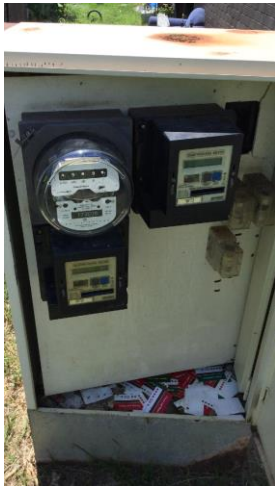
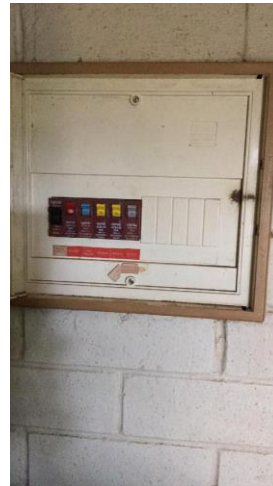
Meter Condition: 3

Meter Comment: One Analogue Meter + 2 Digital Meters. Indoor SB, Cond 3

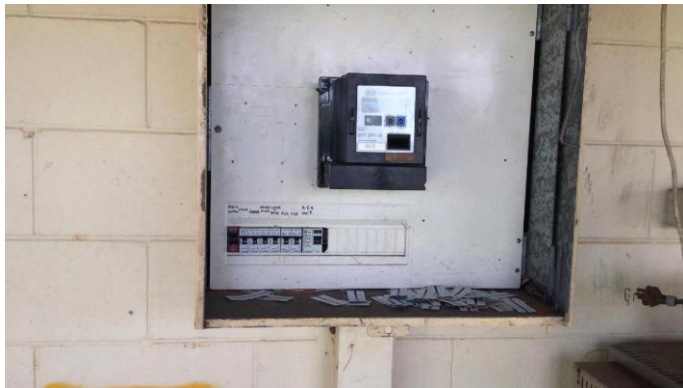
Meter Type: Prepaid
Meter Switchboard Cond: 2
Meter Condition: 3
Meter Comment: Blank plates are missing on CB slot.
Comments:

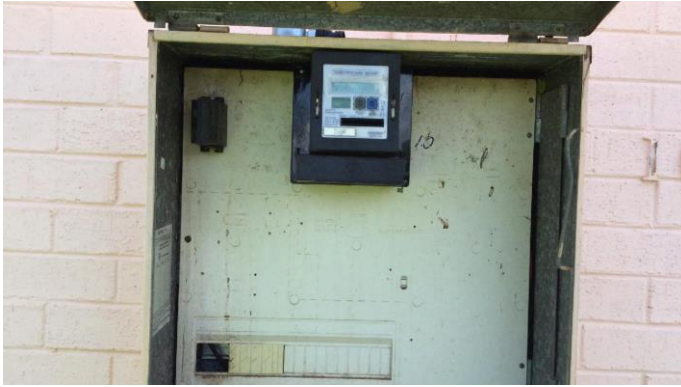
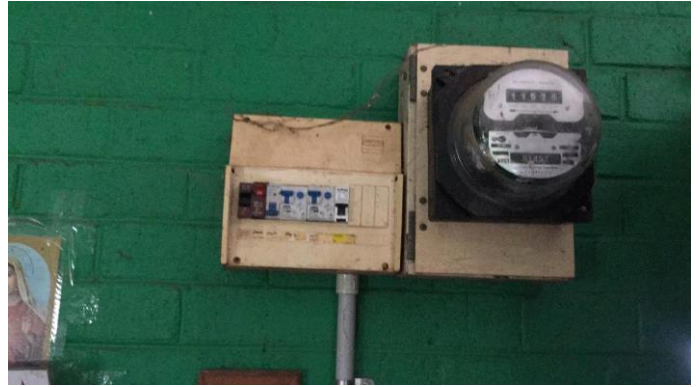
Meter Condition: 3

Meter Comment: Assumed prepaid meter is servicing, and analogue is out of service. To be confirmed. Ind

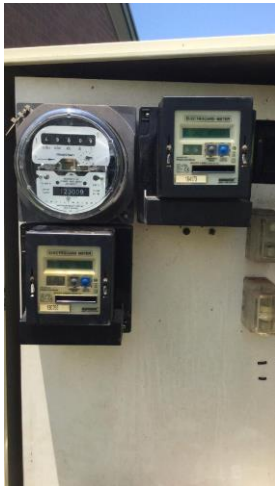
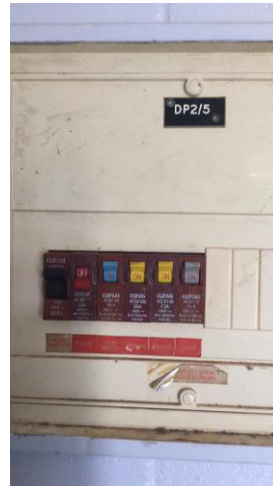
Meter Condition: 3

Meter Comment: One Analogue Meter + Two Digital Meters. Indoor SB, Cond 3

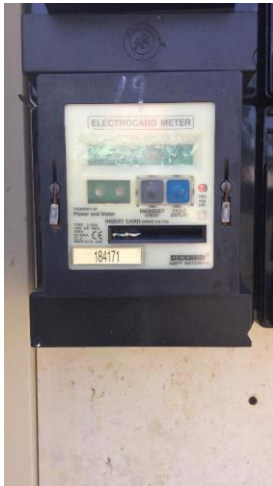
Meter Condition: 3

Meter Comment: Condition of CB not assessed.
