Kulaluk

2 Condition assessment

5.2 Existing infrastructure condition assessment

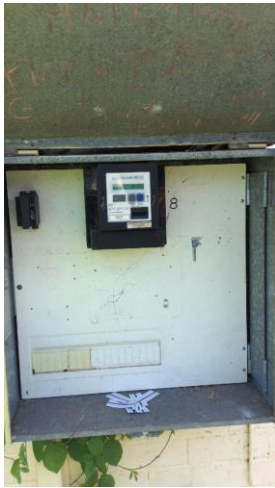
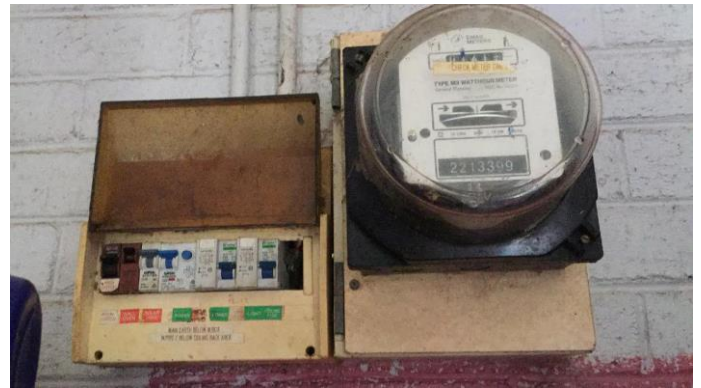
Meter Condition: 3

Meter Comment: Assumed prepaid meter is servicing, and analogue is out of service. To be confirmed. In

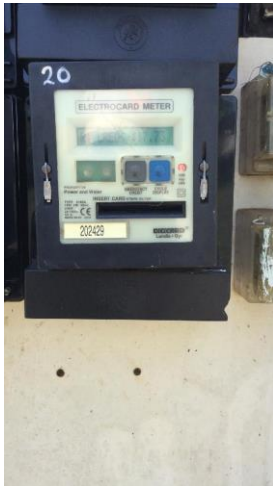
Meter Condition: 3

Meter Comment: Condition of CB not assessed.

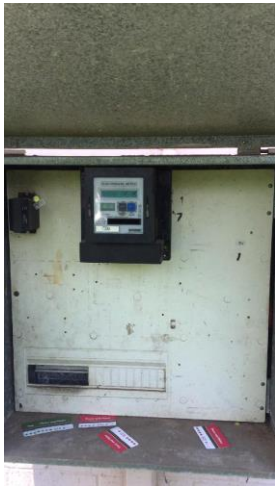
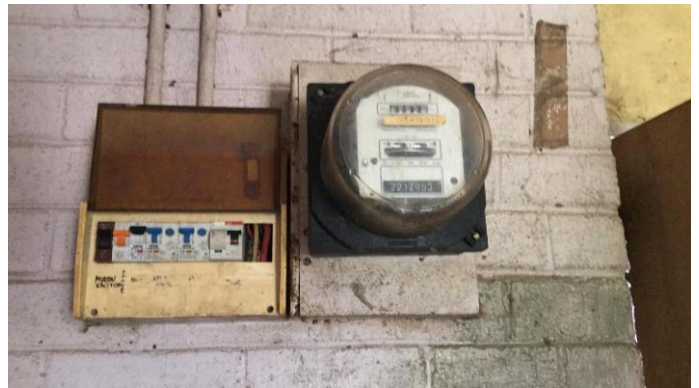
Meter Condition: 3

Meter Comment: Assumed prepaid meter is servicing, and analogue is out of service. To be confirmed. Blan

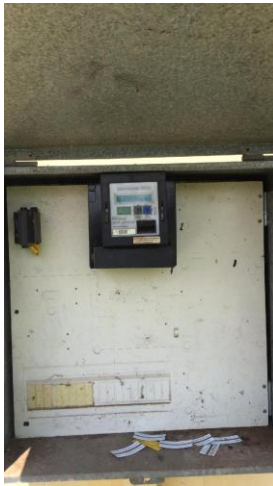
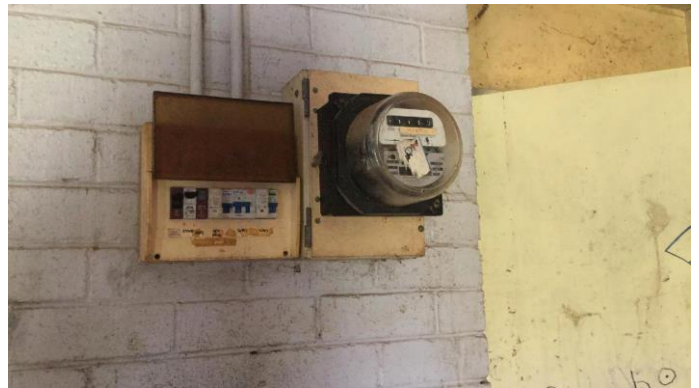
Meter Condition: 3

Meter Comment: Assumed prepaid meter is servicing, and analogue is out of service. To be confirmed. Ind

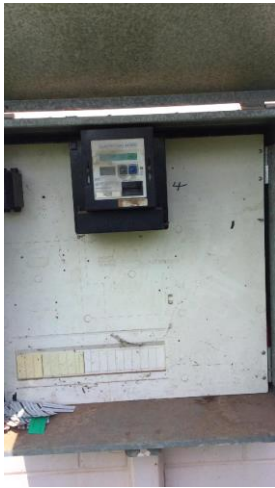
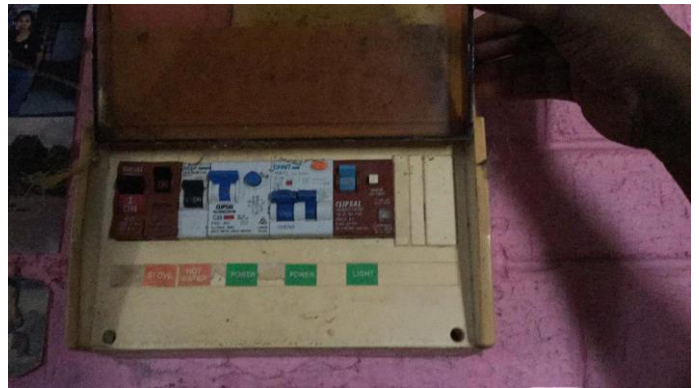
Meter Condition: 3

Meter Comment: Indoor SB, Cond 3

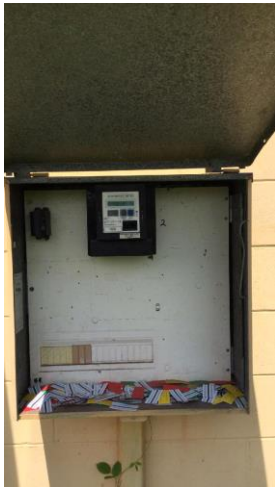
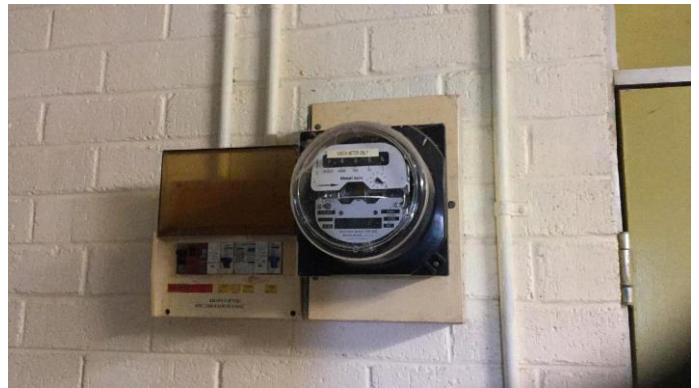
Meter Condition: 3

Meter Comment: Assumed prepaid meter is servicing, and analogue is out of service. To be confirmed. Ind

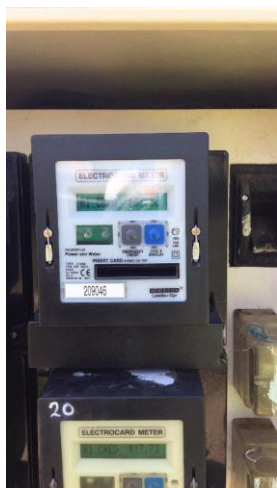
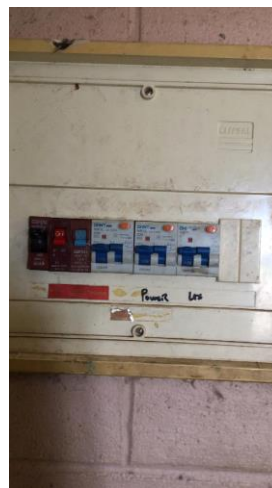
Meter Condition: 3

Meter Comment: Indoor SB, Cond 3

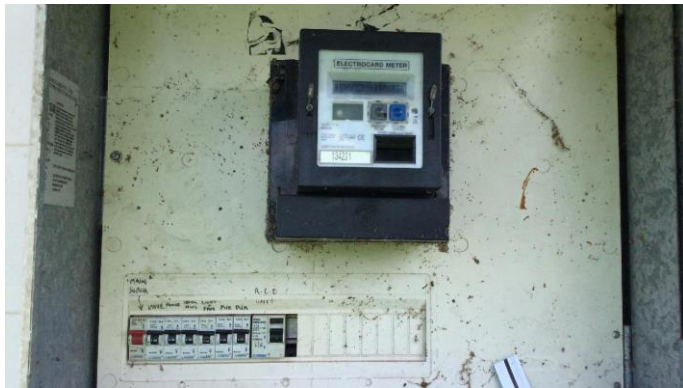
Meter Condition: 3

Meter Comment: Blank plates are missing on CB slot.

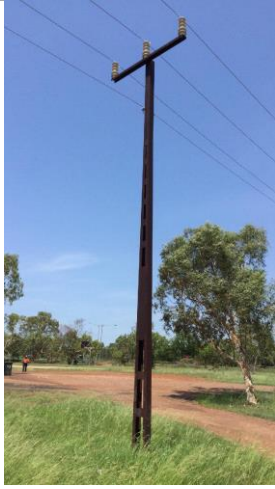
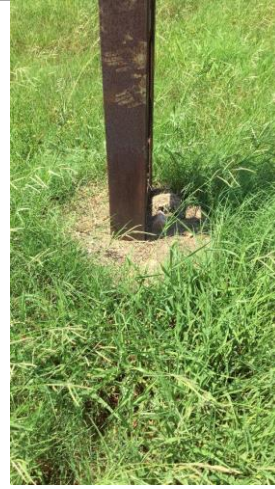
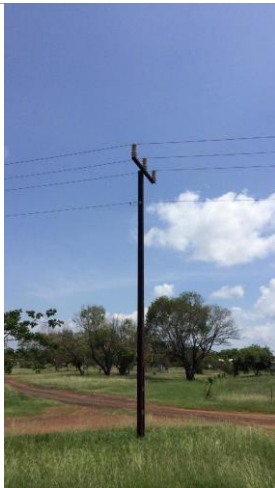
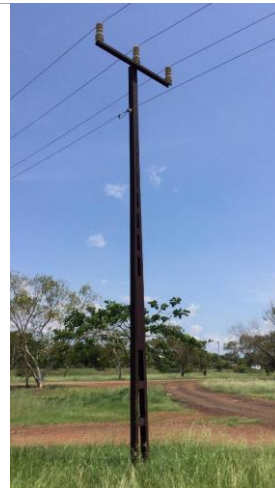
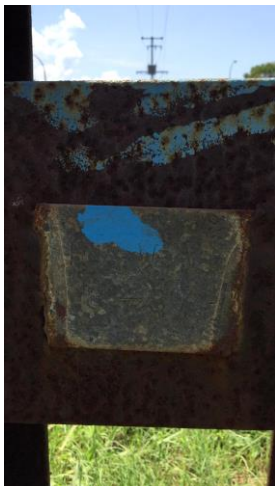
What is the condition of pole: 3

Overhead Pole Comments: Surface rusted.

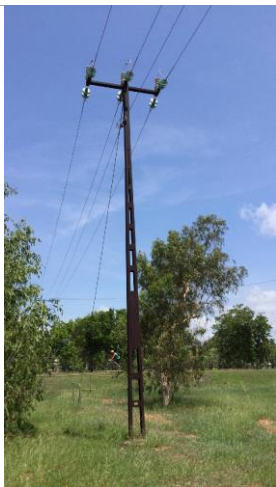
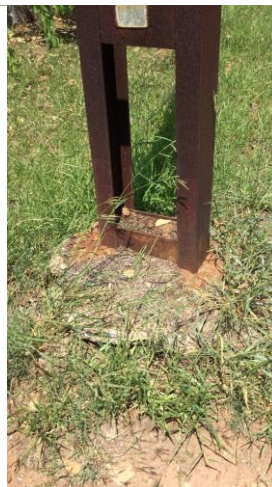
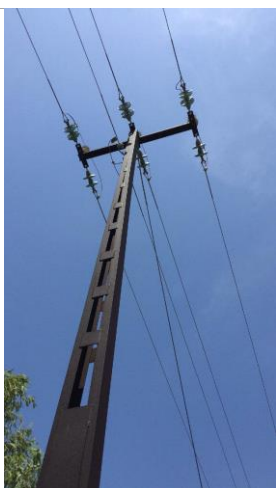
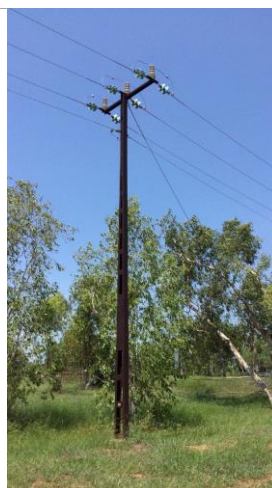
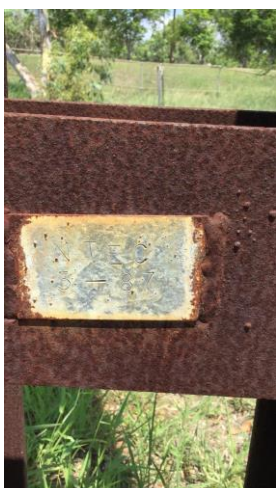
What is the condition of pole: 3

Overhead Pole Comments: Surface rusted
