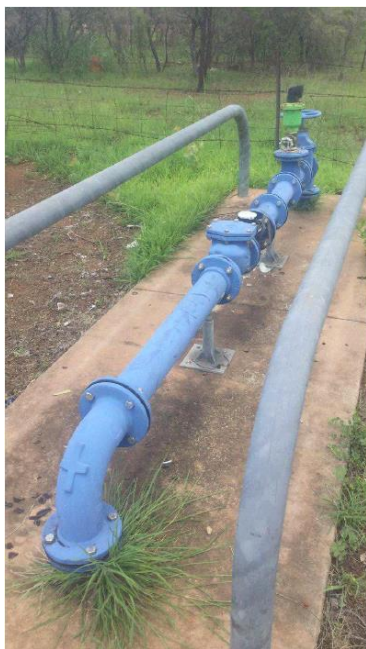
Figure 4 Sign, condition: *very good*

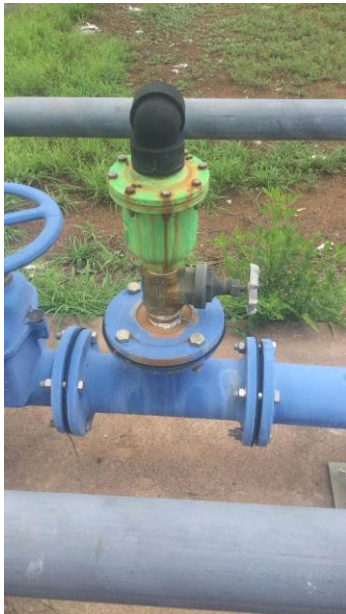
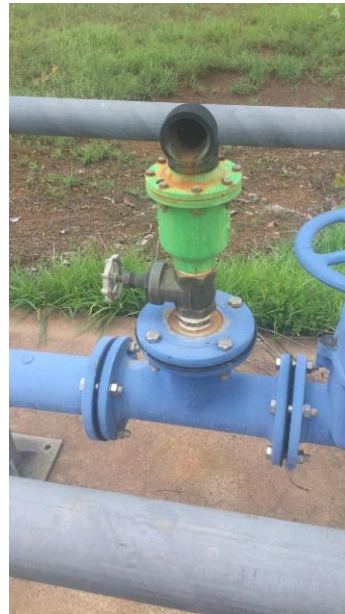
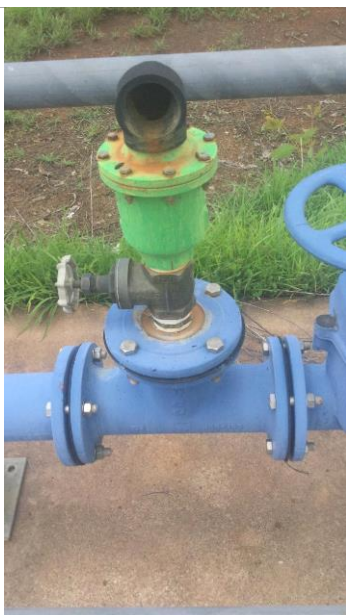
Air Valve Condition: 3 - Good

Air Valve Comments: Sings of light surfacerust from previous leak

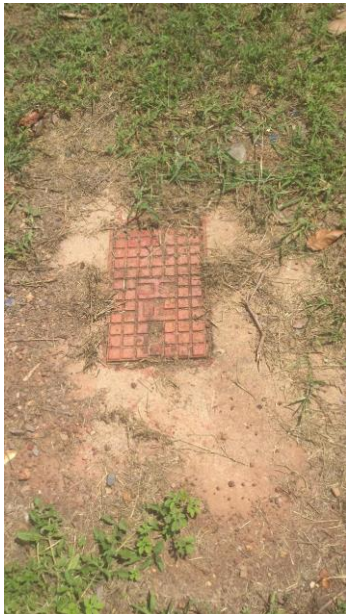
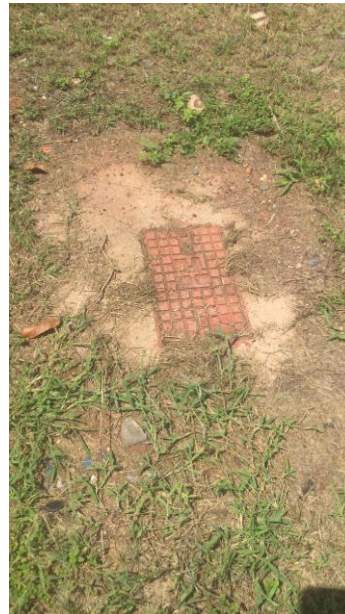
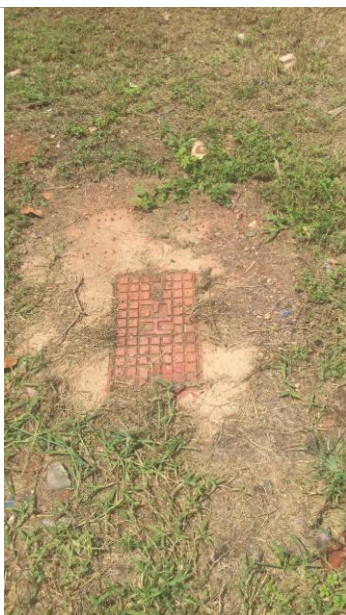
FH Condition: 2 - Poor

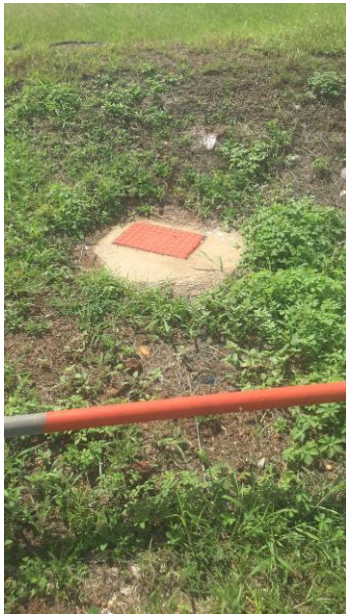
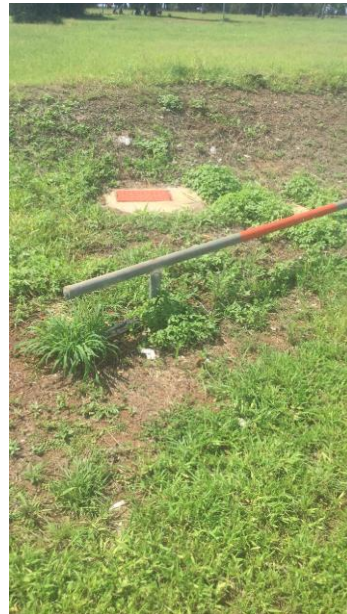
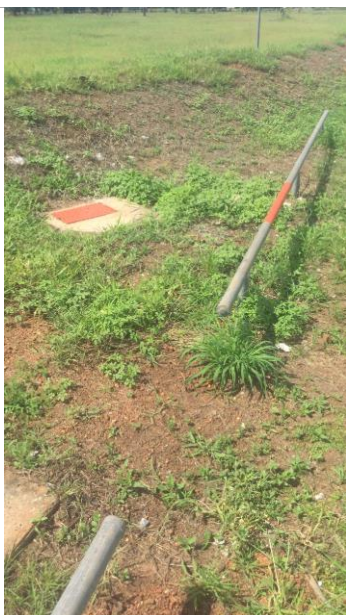
Single or Double: Single
Sluice Valve: No
Above or Below ground: Below ground
FH Leakage: No Access
Bollards around hydrant: Yes
FH Condition: 3 - Good
FH Comment:

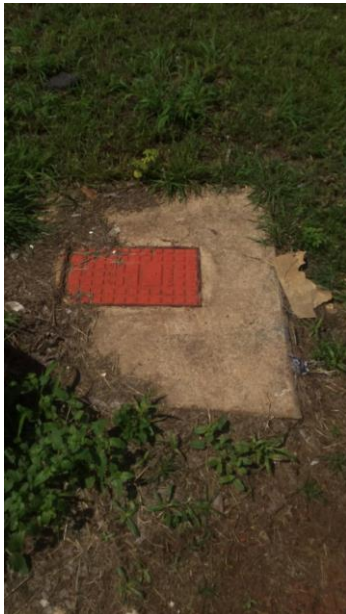
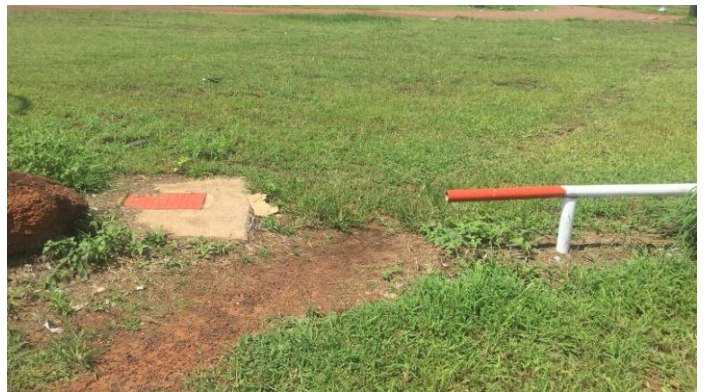
FH Condition: 3 - Good

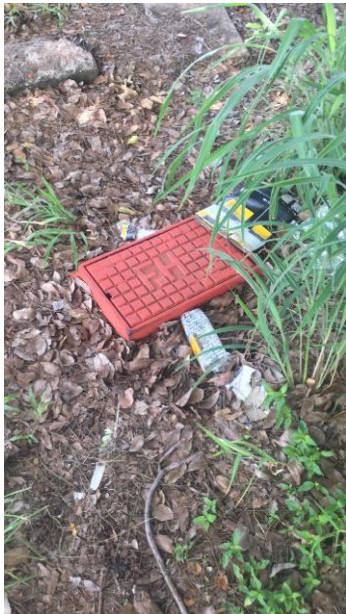
FH Condition: 3 - Good

FH Comment: Post near hydrant

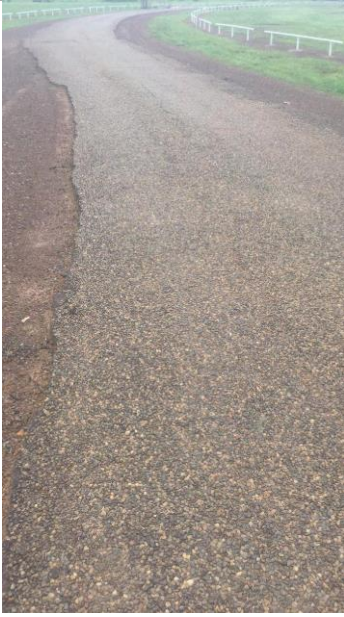
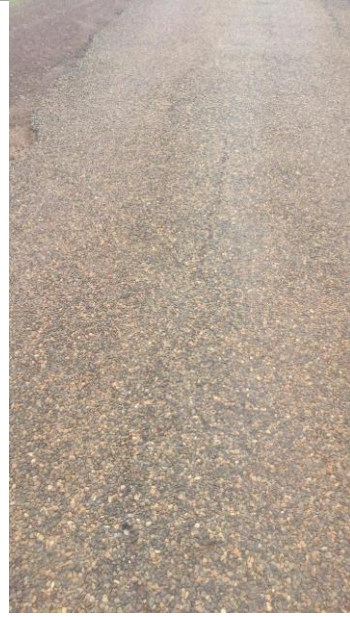
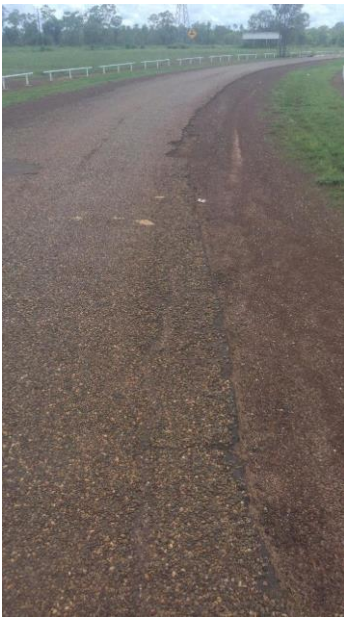
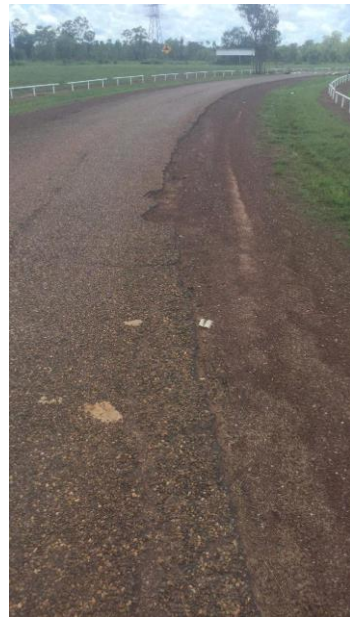
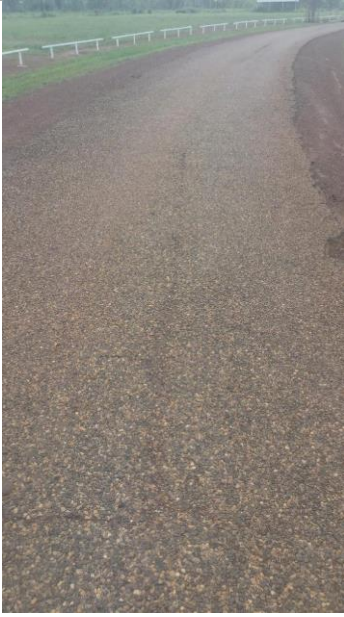
Road Condition: 2 - Poor

Defect Type	Defect QTY	Defect Condition	Defect Comments
Edge Breaks	60	2 - Poor	Percent
Surfacing Cracks	5	2 - Poor	Percent
Stone Loss	10	2 - Poor	Percent

Shoulder Type	Width	Dropoff(mm)	Erosion	Condition	Shoulder Comments
Unsealed		70

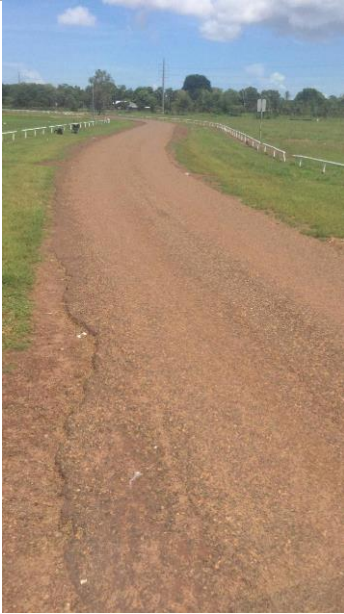
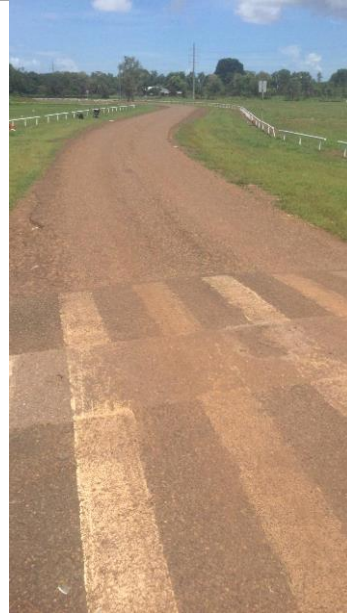
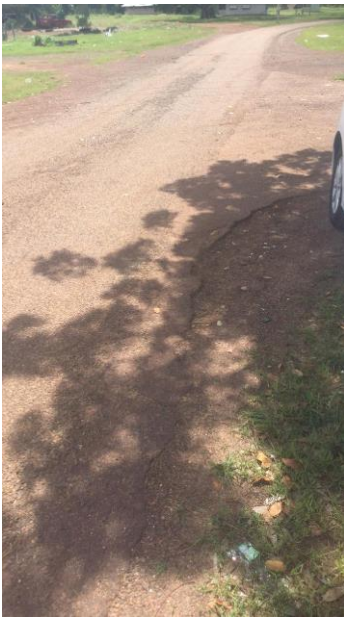
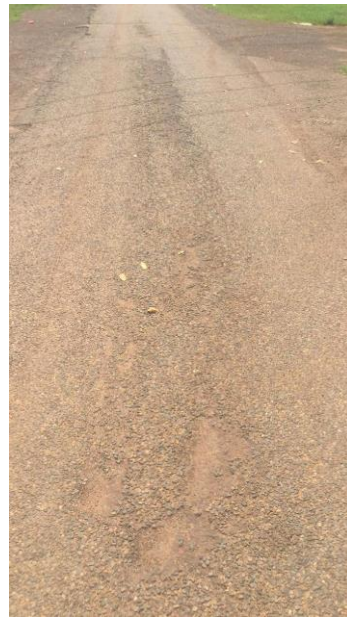
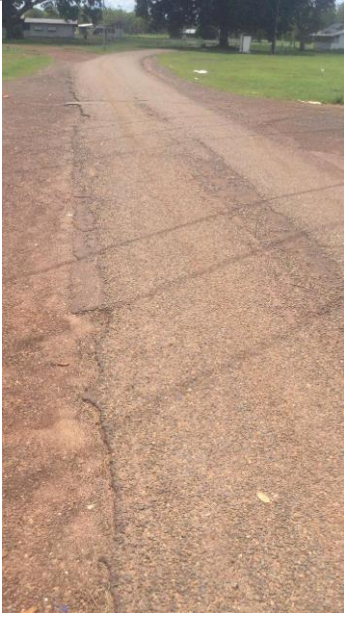
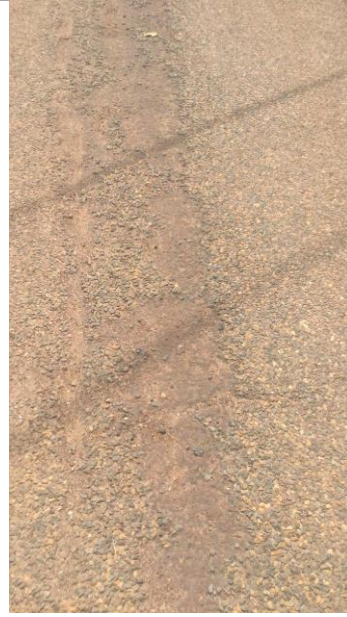
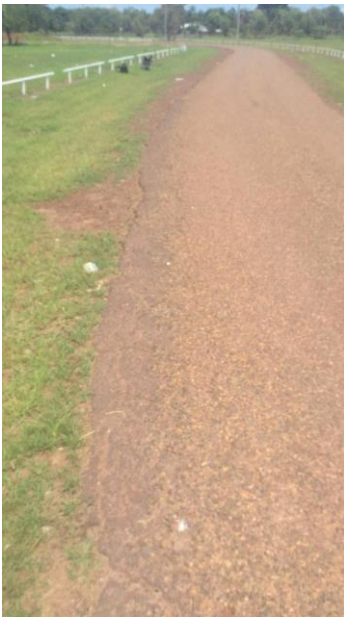
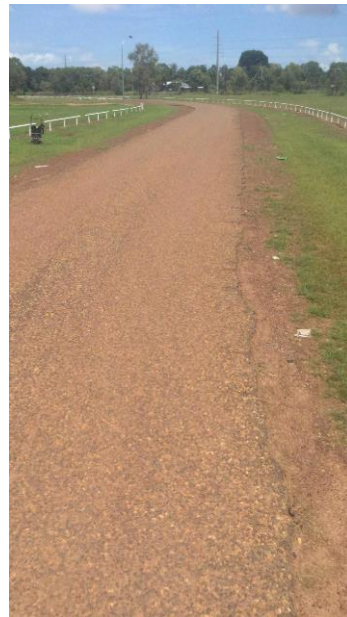
Road Condition: 2 - Poor

Defect Type	Defect QTY	Defect Condition	Defect Comments
Stone Loss	20	2 - Poor	Percent
Edge Breaks	30	2 - Poor	Percent
Surfacing Cracks	5	2 - Poor	Percent

Shoulder Type	Width	Dropoff(mm)	Erosion	Condition	Shoulder Comments
Unsealed		70		2

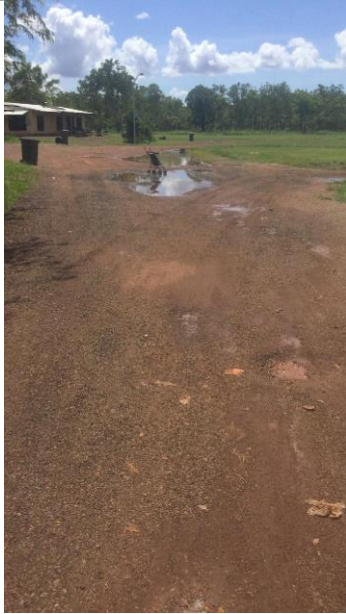
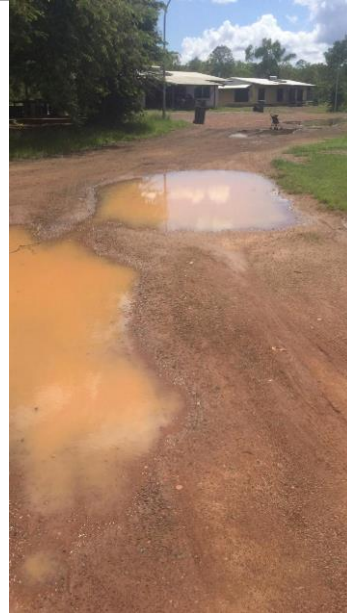
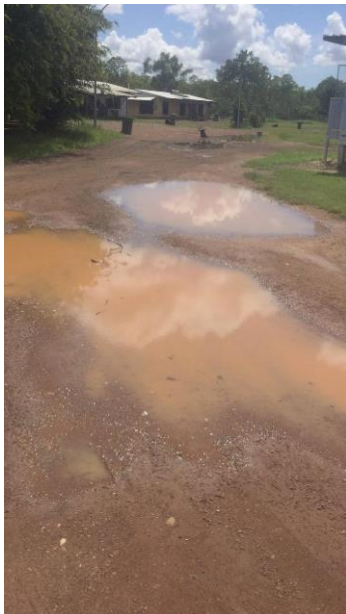
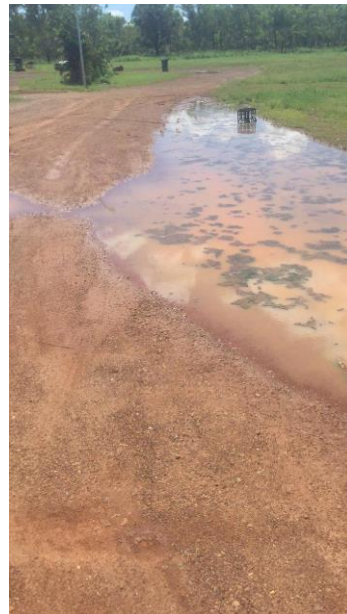
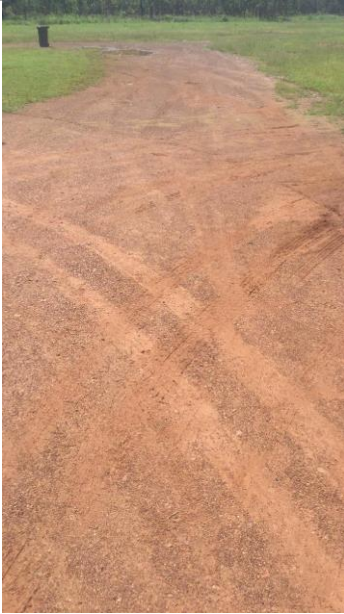
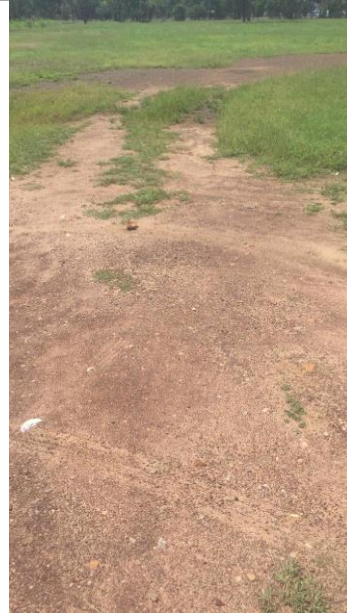
Road Condition: 1 - Very Poor

Defect Type	Defect QTY	Defect Condition	Defect Comments
Undulation/Settlement	40	1 - Very Poor	Percent

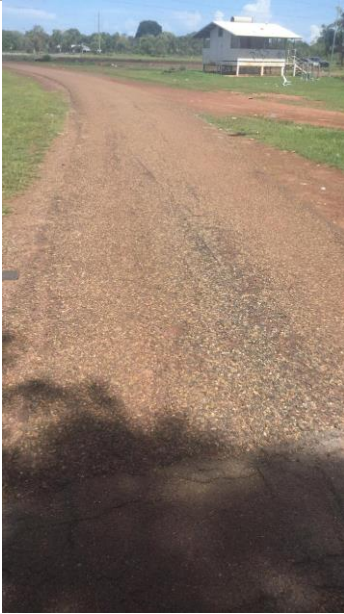
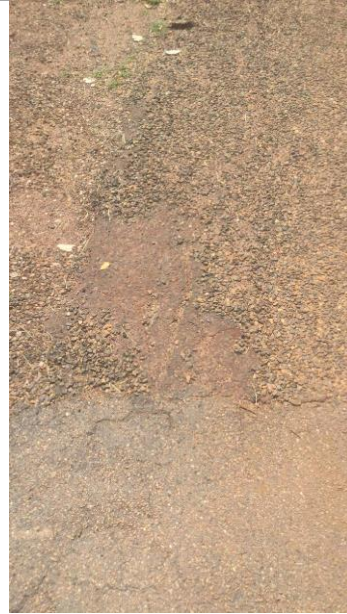
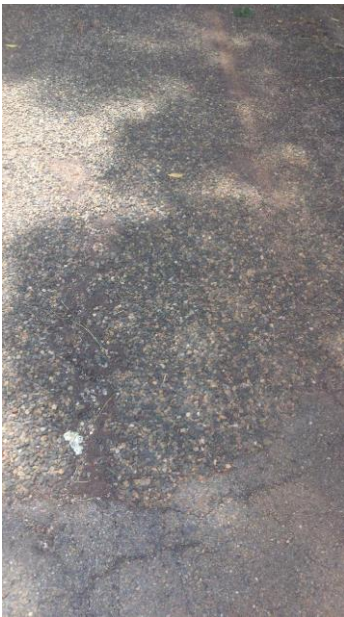
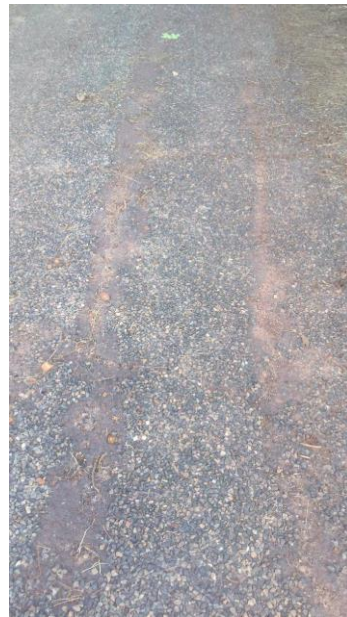
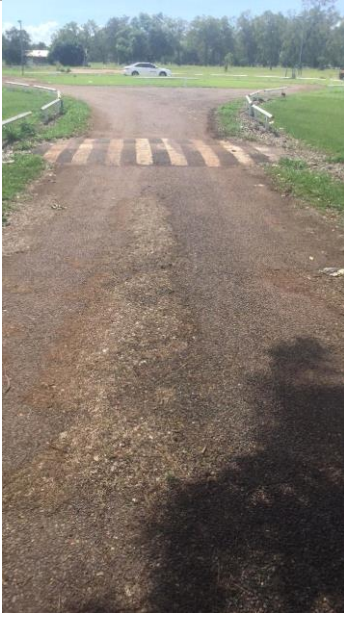
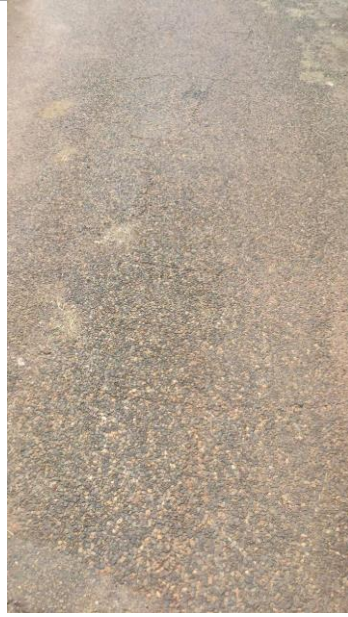
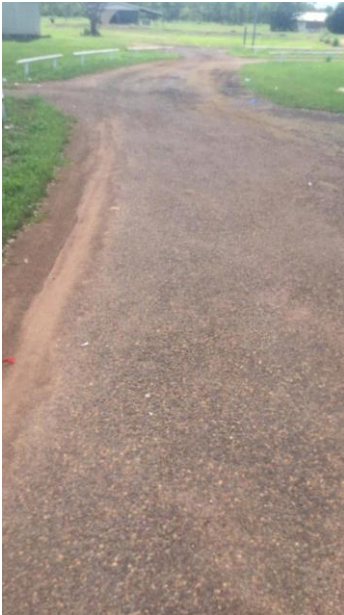
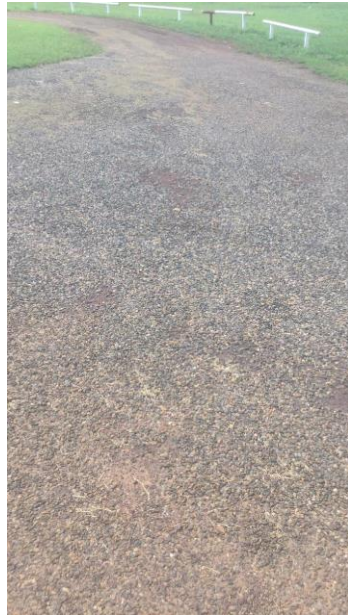
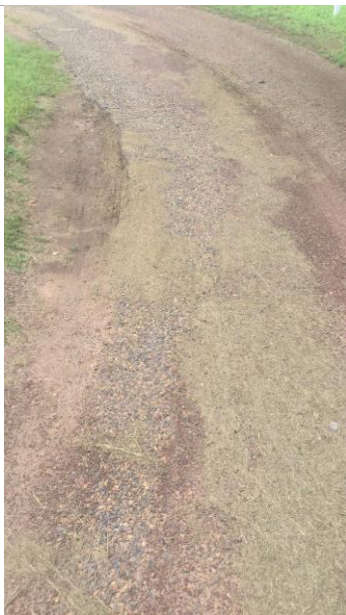
Road Condition: 1 - Very Poor

Defect Type	Defect QTY	Defect Condition	Defect Comments
Stone Loss	10	1 - Very Poor	Percent
Surfacing Cracks	5	2 - Poor	Percent
Edge Breaks	20	2 - Poor	Percent

Shoulder Type	Width	Dropoff(mm)	Erosion	Condition	Shoulder Comments
Unsealed		30

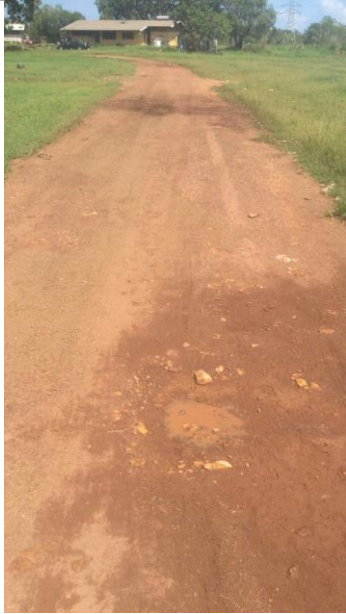
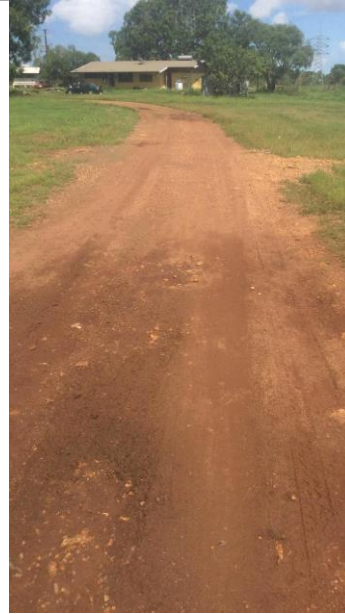
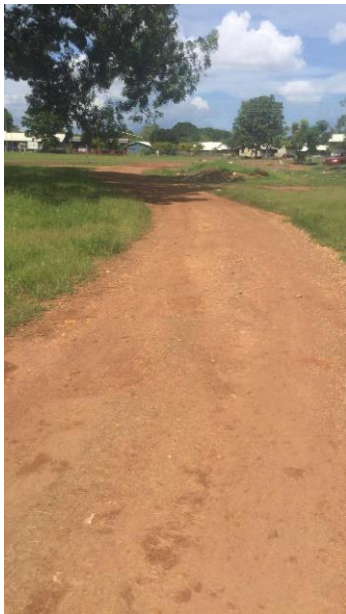
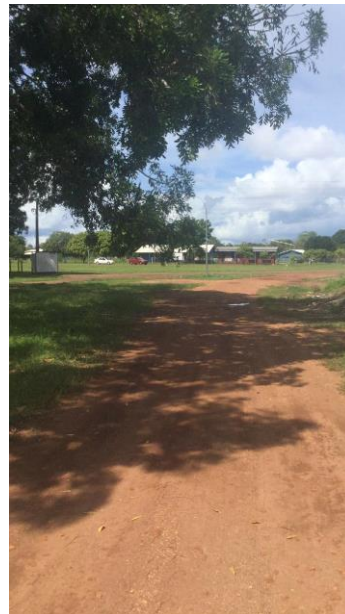
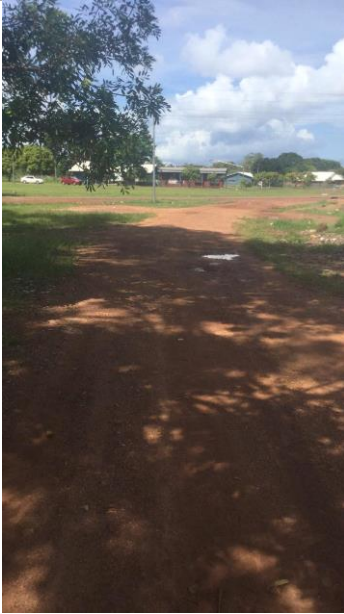
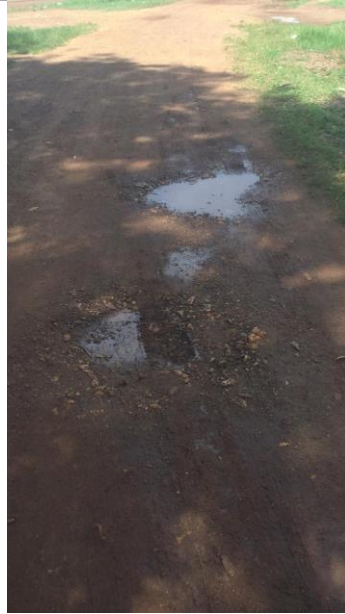
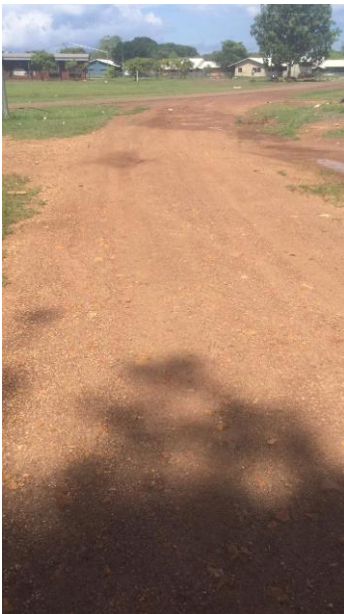
Road Condition: 2 - Poor

Defect Type	Defect QTY	Defect Condition	Defect Comments
Undulation/Settlement	5	2 - Poor	Percent

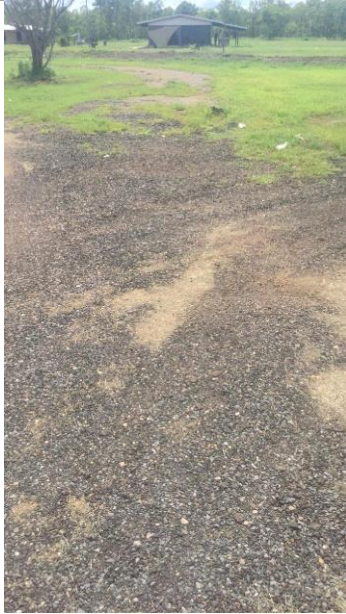
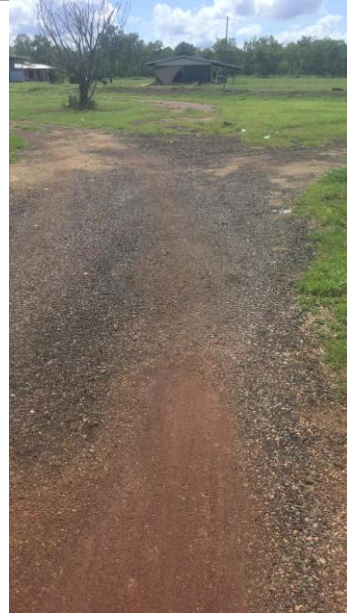
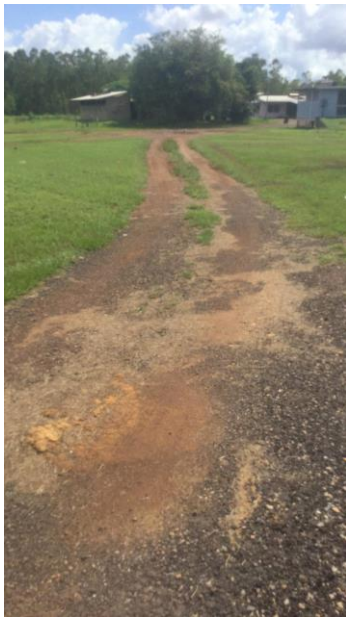
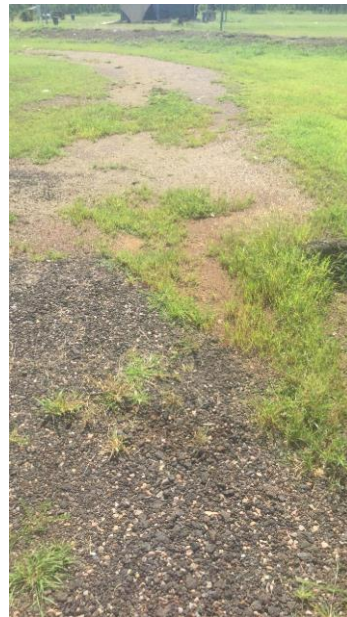
Road Condition: 1 - Very Poor

Defect Type	Defect QTY	Defect Condition	Defect Comments
Surfacing Failure	30	1 - Very Poor	Percent

Shoulder Type	Width	Dropoff(mm)	Erosion	Condition	Shoulder Comments
Unsealed				2

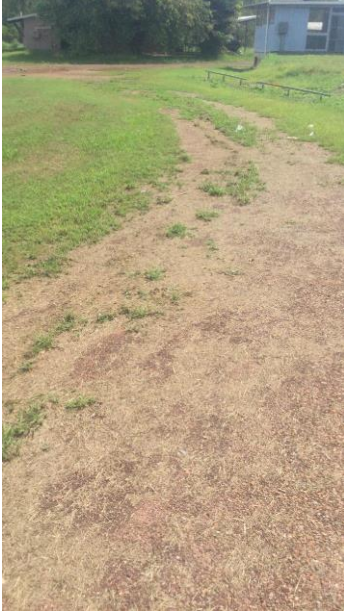
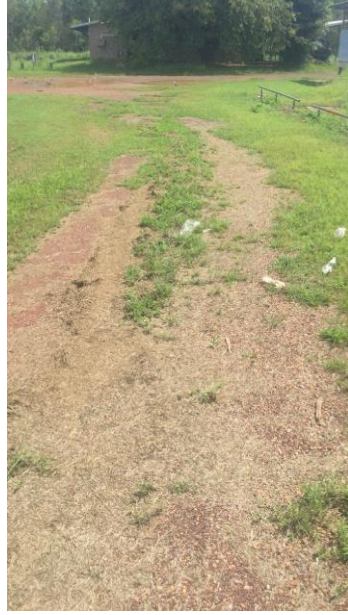
Road Name: 344_1
What are you inspecting: Pavements
Ch From (km): 0
Ch To (km): 0.07
Road Type: Sealed - spray seal
Section Width (m): 4
Road Condition: 3 - Good
General Comment:

Defect Type	Defect QTY	Defect Condition	Defect Comments
Edge Breaks	20	2 - Poor	% of road

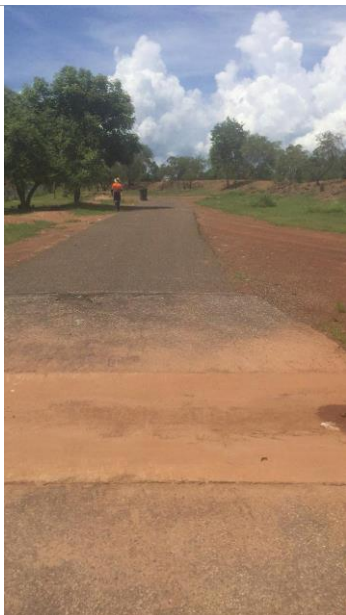
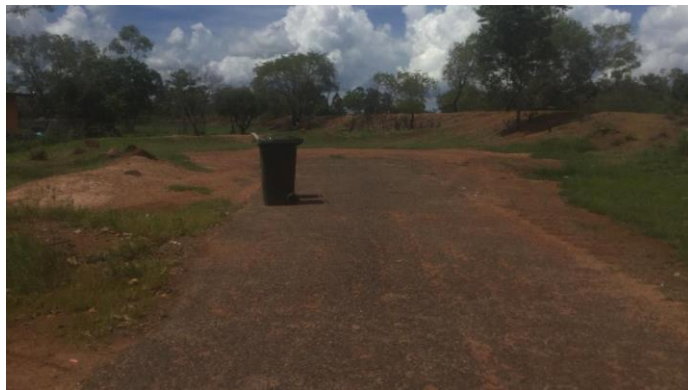
Road Condition: 2 - Poor

Defect Type	Defect QTY	Defect Condition	Defect Comments
Potholes	5	2 - Poor	5% of road
Stone Loss	20	2 - Poor	% of road
General Appearance	50	2 - Poor	Graffiti, rubbish, wheelie bin on road

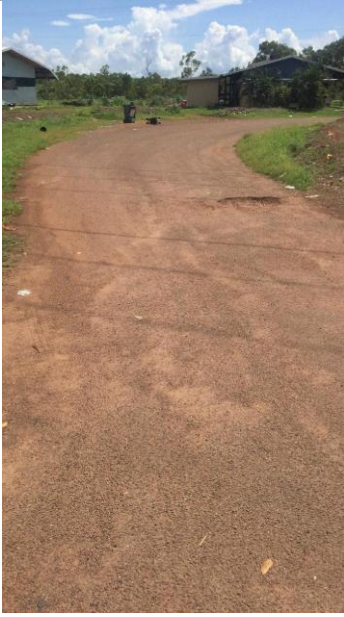
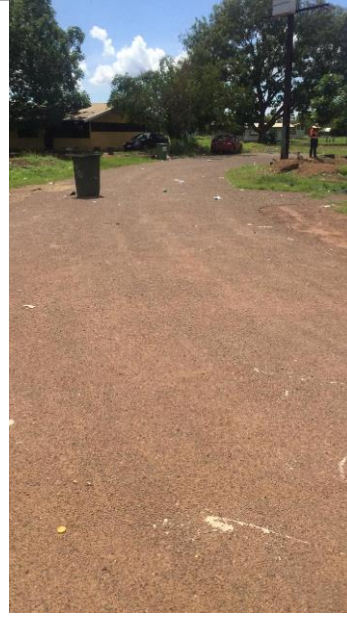
Road Condition: 2 - Poor

Defect Type	Defect QTY	Defect Condition	Defect Comments
Potholes	10	2 - Poor	5% of road has potholes
Stone Loss	30	3 - Good	30% of road
Edge Breaks	20	2 - Poor	20% of road

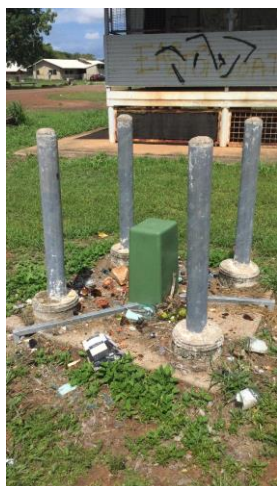
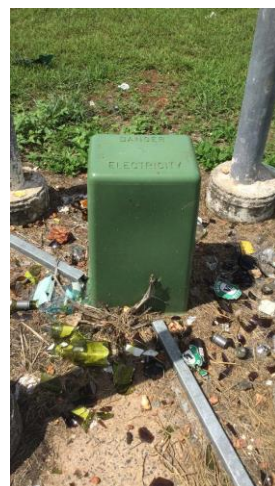
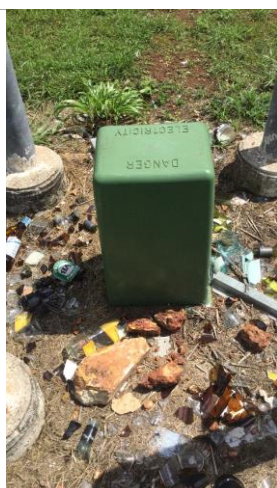
What is the condition of switchboard: 3

What is the condition of cables/glands into switchboard: 3

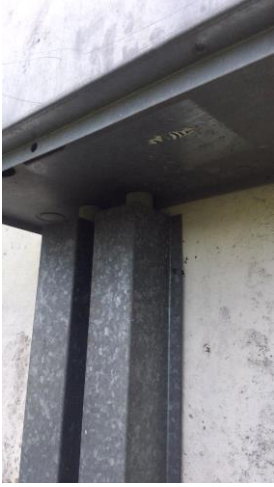
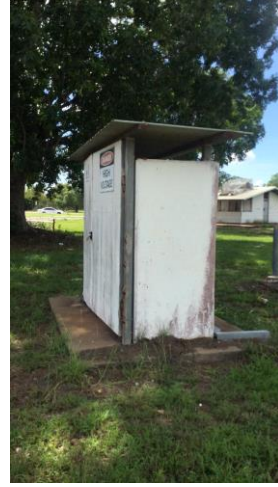
Meter Condition: 3

Meter Comment: Blank plates are missing on CB slot. Indoor SB, Cond 2, Blank plates are missing on CB sl

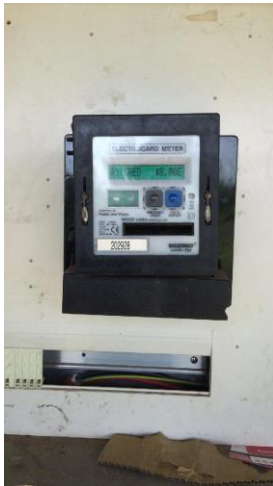
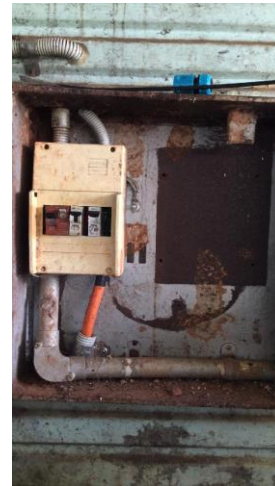
Meter Condition: 3

Meter Comment: Blank plates are missing on CB slot. Indoor SB, Cond 3

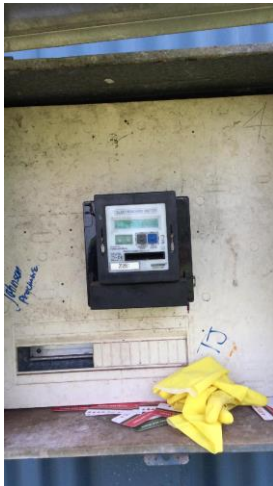
Meter Condition: 3

Meter Comment: Blank plates are missing on CB slot. Indoor SB, Cond 3

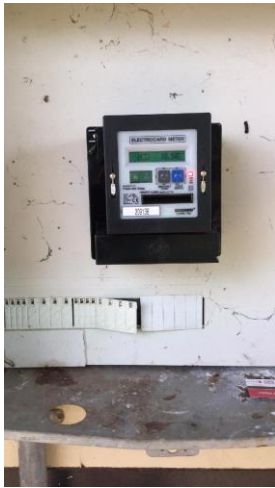
Meter Condition: 3

Meter Comment: Blank plates are missing on CB slot. Indoor SB, Cond 3

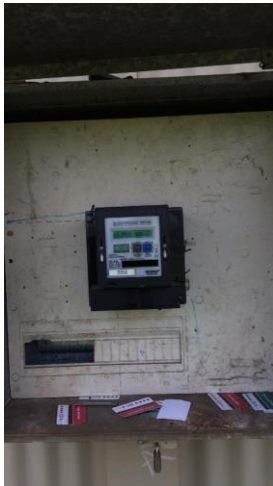
Meter Condition: 3

Meter Comment: CBs are in poor condition.

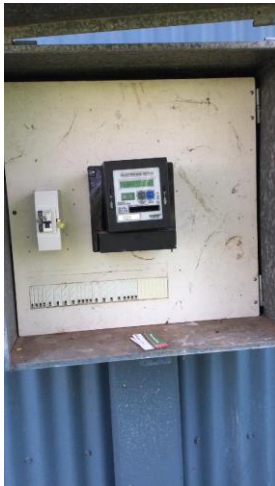
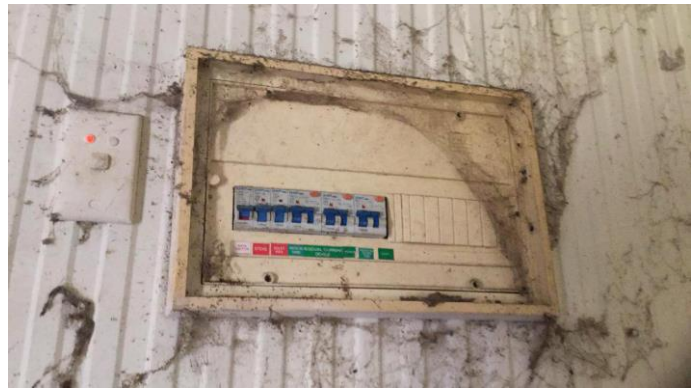
Meter Condition: 2

Meter Comment: Meter box is damaged. Indoor SB, Cond 3

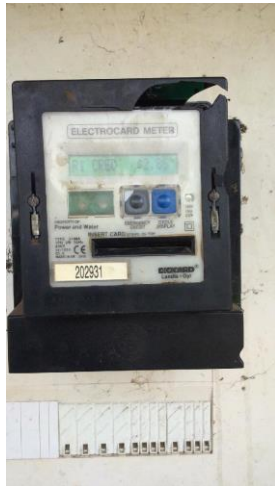
Meter Condition: 3

Meter Comment: Blank plates are missing on CB slot. Indoor SB, Cond 3

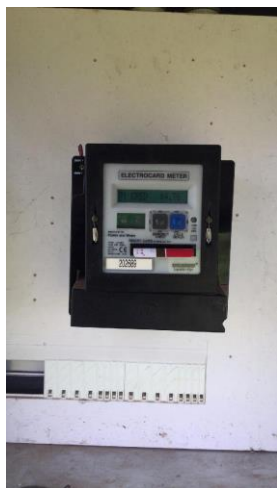
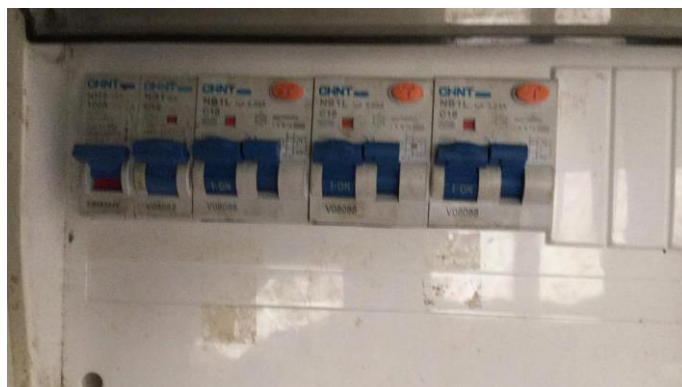
Meter Condition: 3

Meter Comment: Blank plates are missing on CB slot. Indoor SB, Cond 3

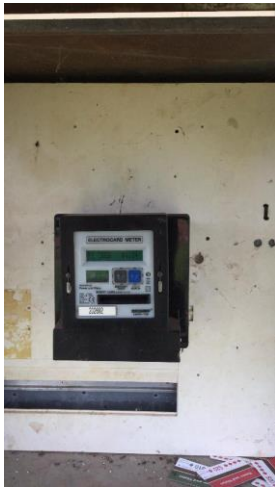
Meter Condition: 3

Meter Comment: Blank plates are missing on CB slot. Indoor SB, Cond 3

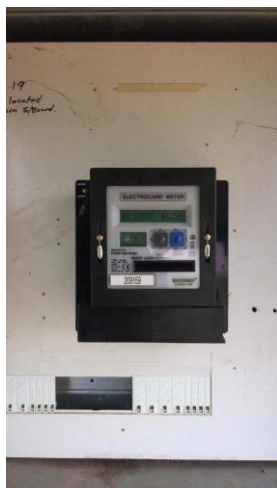
Meter Condition: 3

Meter Comment: Blank plates are missing on CB slot. Indoor SB, Cond 2, Blank plates are missing on CB slot

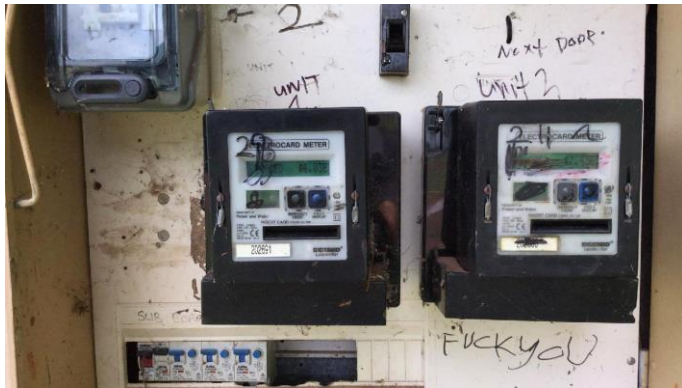
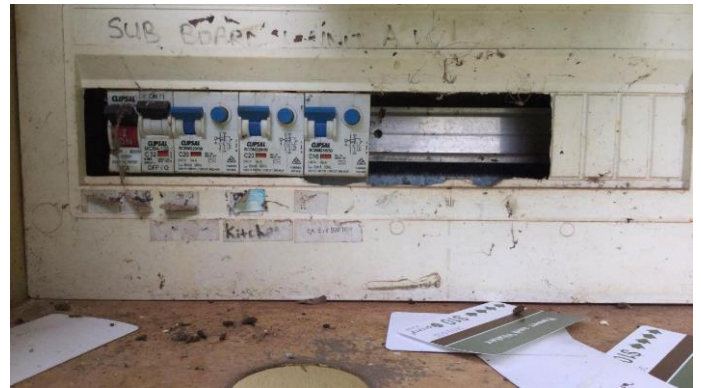
Meter Comment: Condition of CB not assessed.

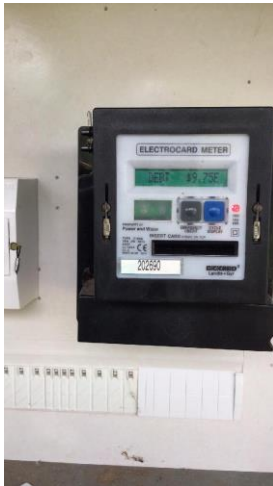
Meter Condition: 3

Meter Comment: Blank plates are missing on CB slot. Indoor SB, Cond 2, Blank plates are missing on CB slot.

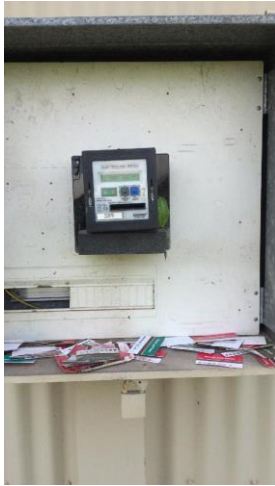
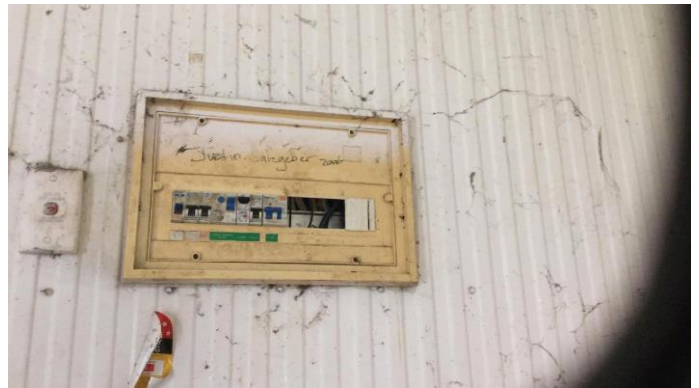
Meter Condition: 3

Meter Comment: Blank plates are missing on CB slot. Indoor SB, Cond 2, Blank plates are missing on CB slot

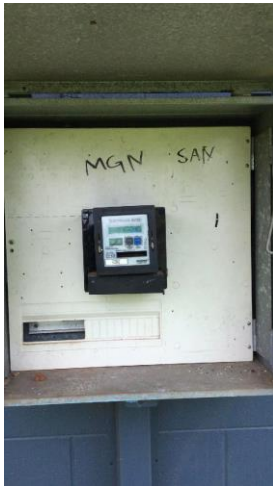
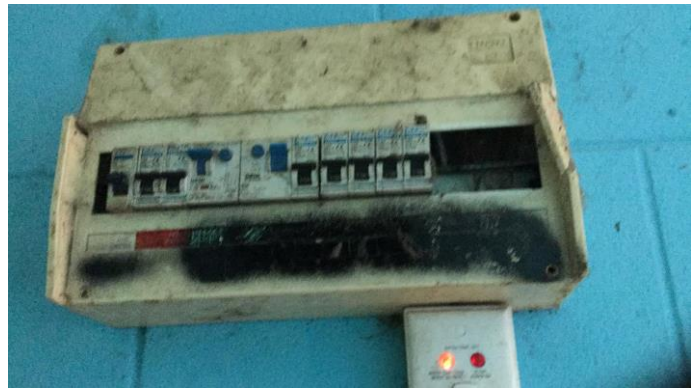
Meter Condition: 3

Meter Comment: Blank plates are missing on CB slot.

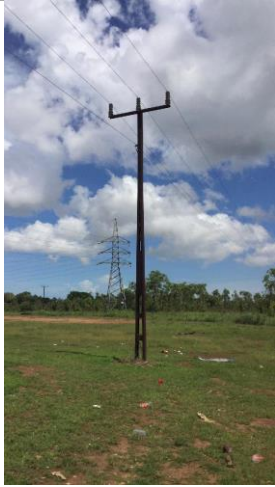
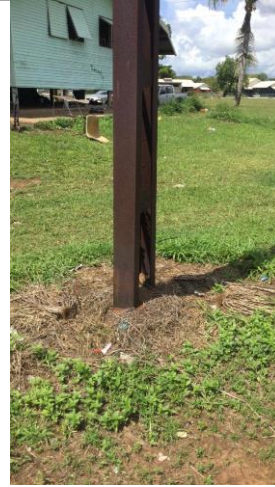
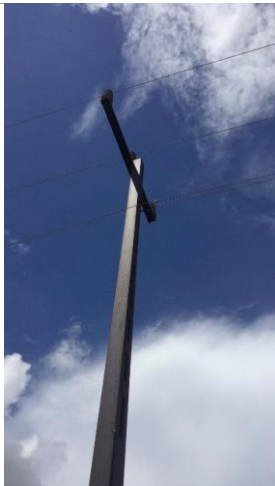
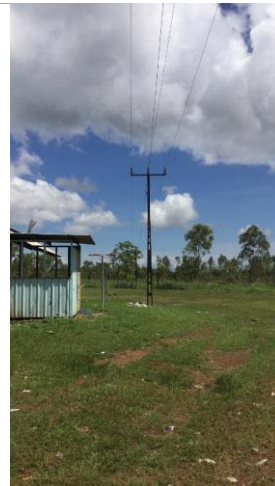
Inspection Date 16/12/2016 11:21:29 AM

Overhead Pole Comments: Surface rusted

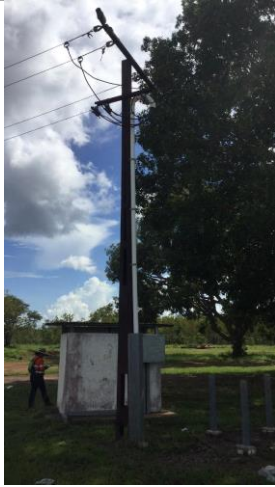
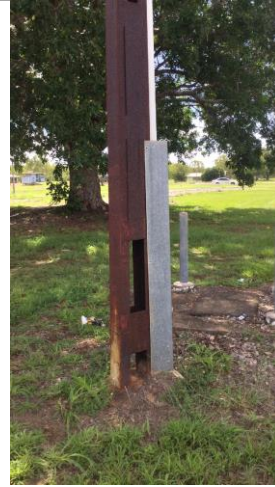
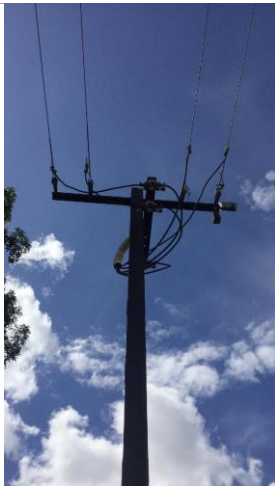
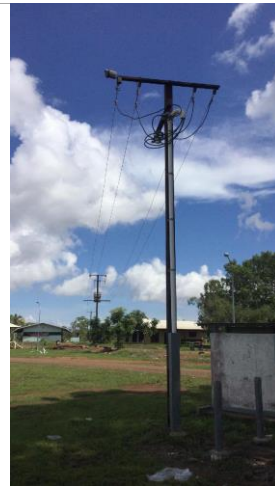
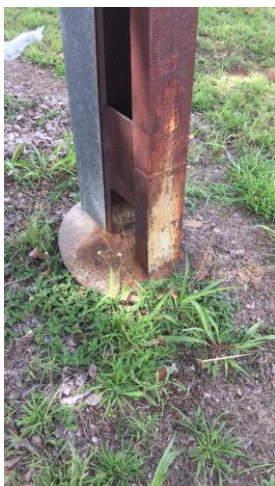
Inspection Date 16/12/2016 10:50:40 AM

What is Pole Material type:	Welded
What is the condition of pole:	3
How is the pole planted:	Concrete
What is the Condition of plant:	3
Is street light fitted:	No
Street Light Power Supply:	
Street Light Type	
Street Light Watts	
Street Light Condition	
Street Light Height	
What is the type of service:	Three
What is the HV voltage level:	400
What is the arrangement of connected cables:	Parallel
Are there isolators on the pole:	No
What is the Condition:	3
How many Lots are connected to this pole:	0
Overhead Pole Comments:	Surface rusted

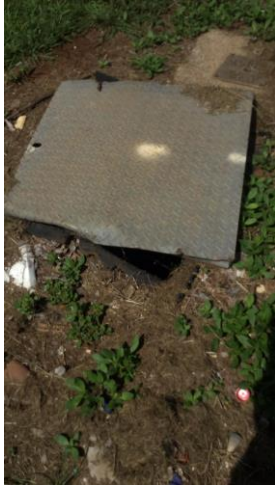
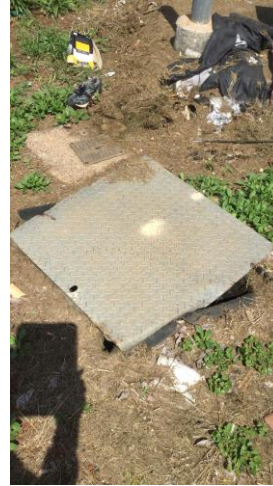
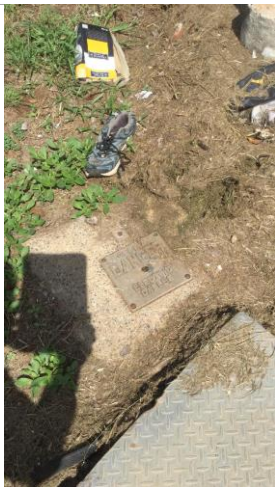
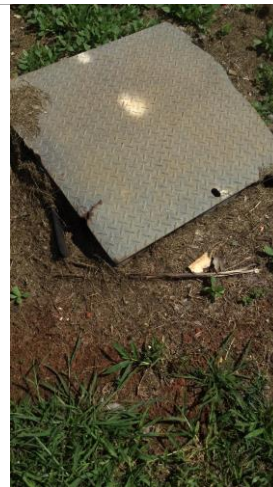
Comments: Poor condition

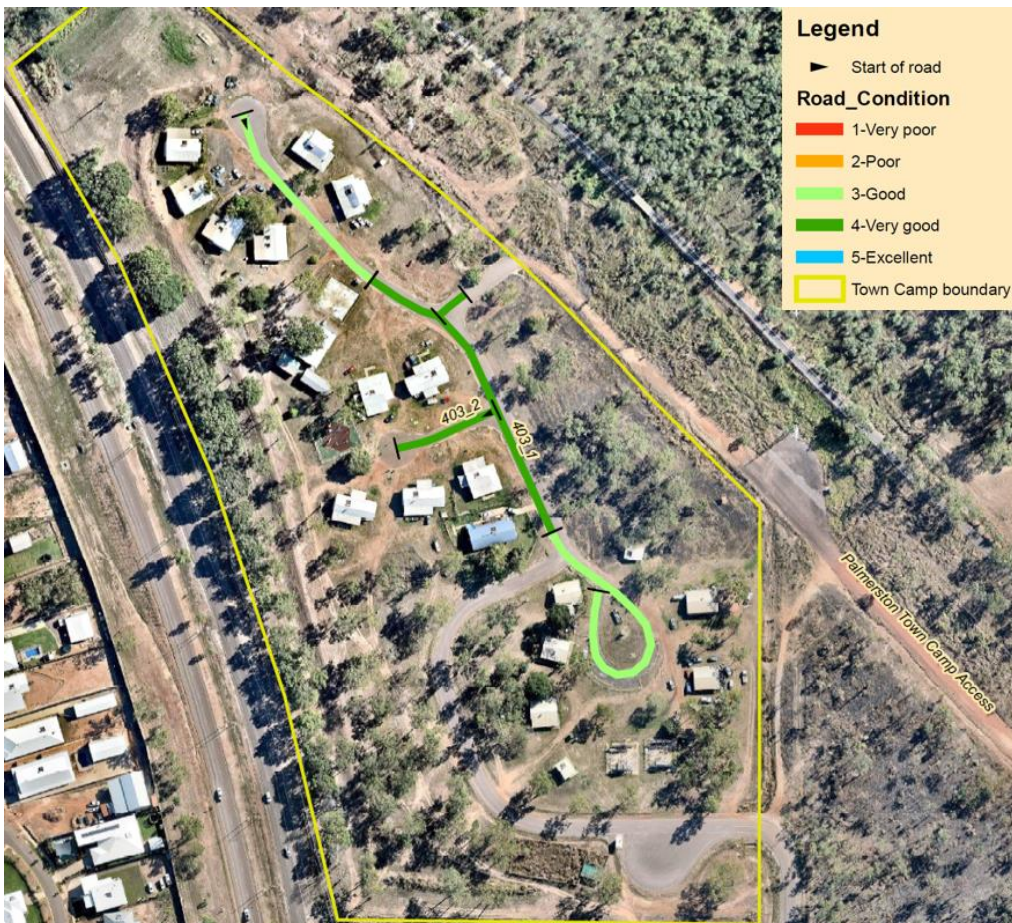
Figure 10 Road condition map

Table 7 below details the condition of the roads within Palmerston Town Camp for specific segments. Figure 10 shows a map of the road network with the road number and chainage direction with relation to Table 7.

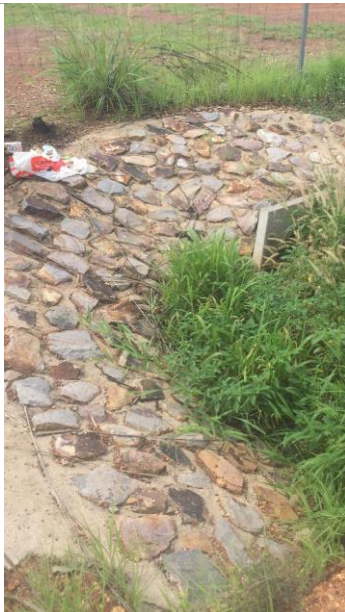
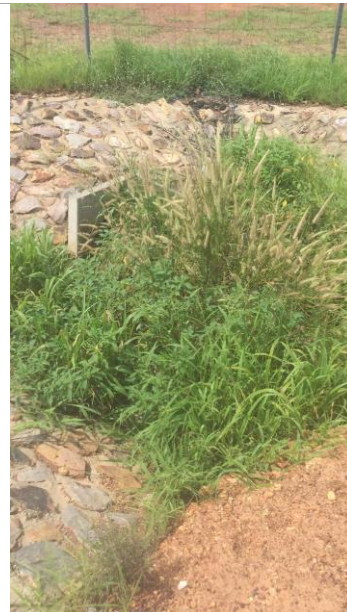
Stormwater Infrastructure:	Culverts
Culvert Type:	RCP
Diameter (mm):	600
Width (mm):	
Culvert Depth (mm):	
Culvert Length (m):	
Culvert Condition:	3 - Good
Culvert Blockage (%):	
Culvert Comments:	Upstream side not accessible, length unknown
Culvert Head Wall:	No Access
Safety Grate:	No Access
Headwall Blockage:	
Headwall Condition:	
Headwall Comment:	
End Wall:	Yes
End Wall condition:	3 - Good
EW Comment:	Overgrown and fenced off

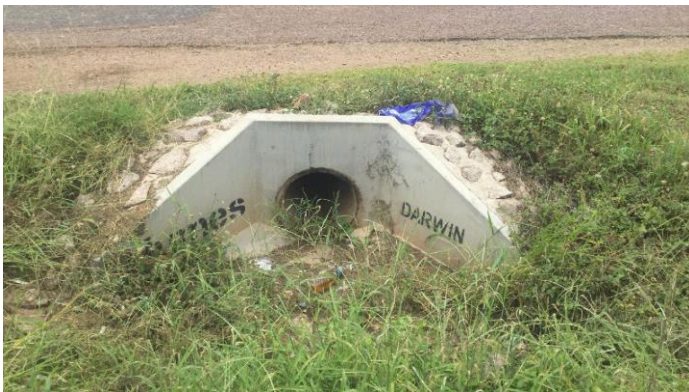
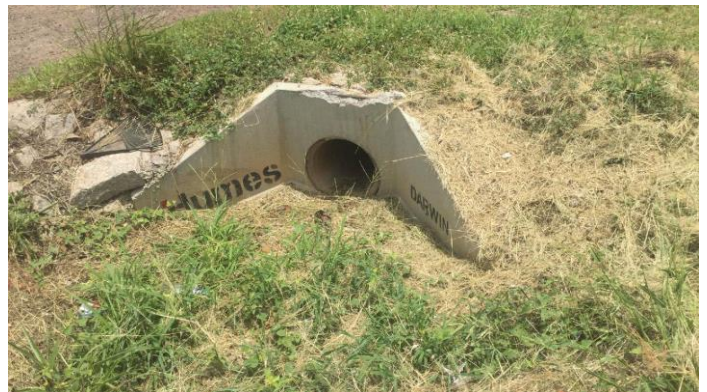
Stormwater Infrastructure:	Culverts
Culvert Type:	RCP
Diameter (mm):	375
Width (mm):	
Culvert Depth (mm):	
Culvert Length (m):	12
Culvert Condition:	4 - Very Good
Culvert Blockage (%):	
Culvert Comments:	
Culvert Head Wall:	Yes
Safety Grate:	No
Headwall Blockage:	
Headwall Condition:	4 - Very Good
Headwall Comment:	Some concrete damage
End Wall:	Yes
End Wall condition:	4 - Very Good
EW Comment:

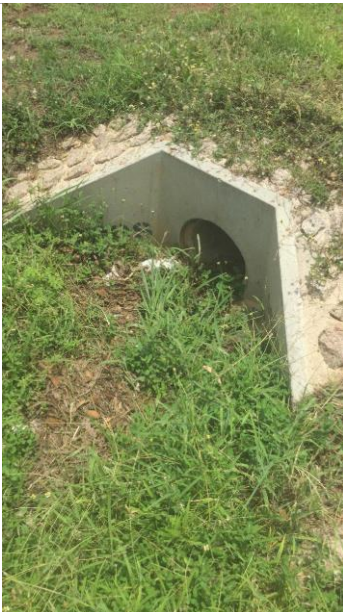
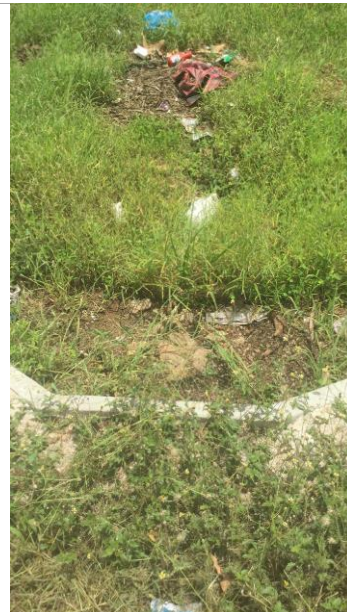
Stormwater Infrastructure:	Culverts
Culvert Type:	RCP
Diameter (mm):	375
Width (mm):	
Culvert Depth (mm):	
Culvert Length (m):	18
Culvert Condition:	3 - Good
Culvert Blockage (%):	10
Culvert Comments:	
Culvert Head Wall:	Yes
Safety Grate:	No
Headwall Blockage:	20
Headwall Condition:	4 - Very Good
Headwall Comment:	
End Wall:	Yes
End Wall condition:	4 - Very Good
EW Comment:

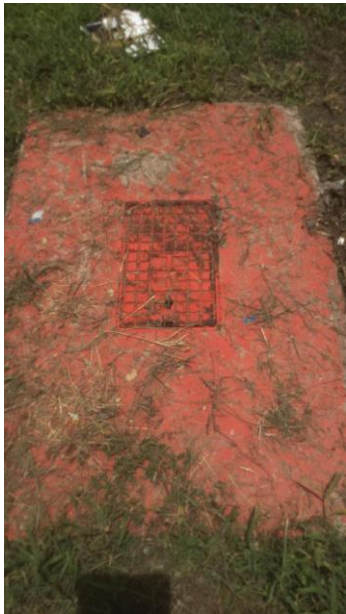
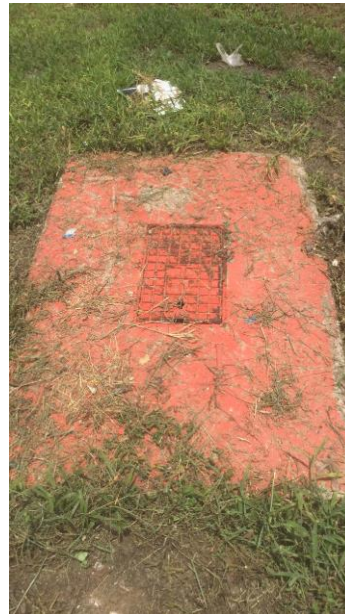
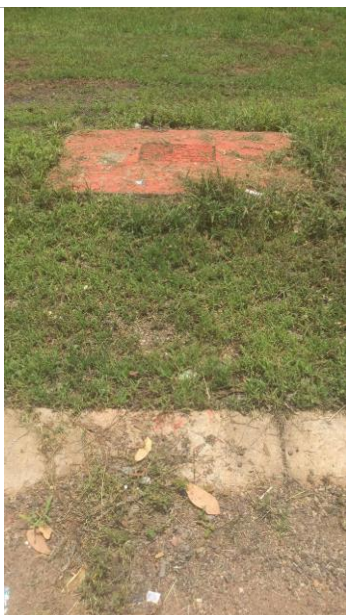
Single or Double: Single
Sluice Valve: No
Above or Below ground: Below ground
FH Leakage: No Access
Bollards around hydrant: No
FH Condition: 3 - Good
FH Comment:
