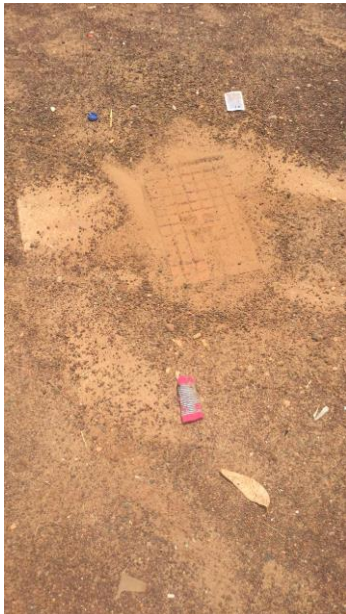
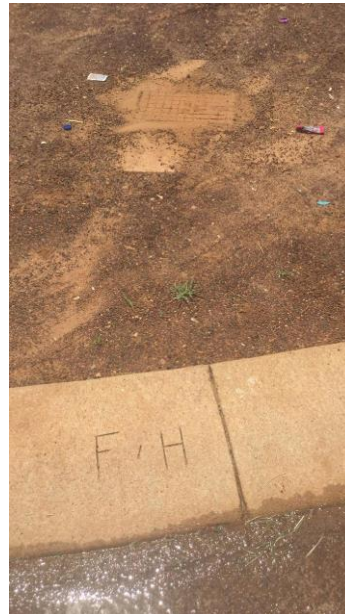
FH Condition: 3 - Good

FH Comment: Covered in dirty, not clearly visabl

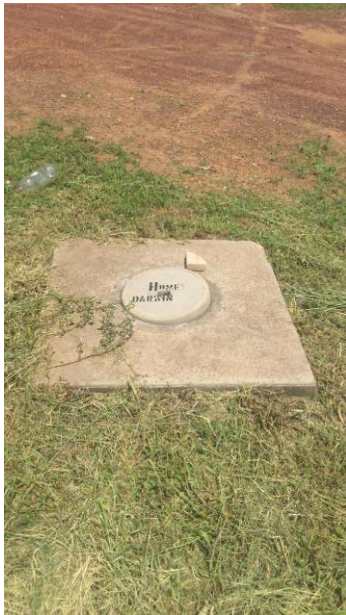
Manhole Condition: 3 - Good

Comments: Lid is not sitting properly

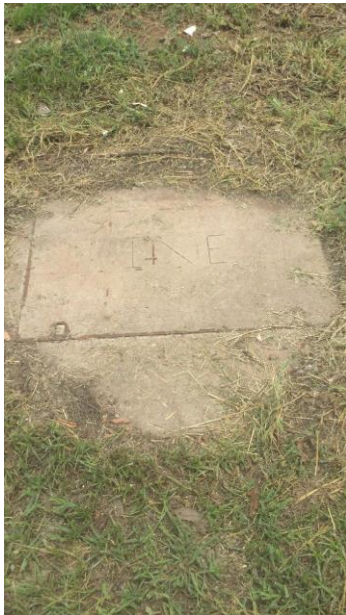
Manhole Condition: 4 - Very Good

Comments: Partially covered by grass

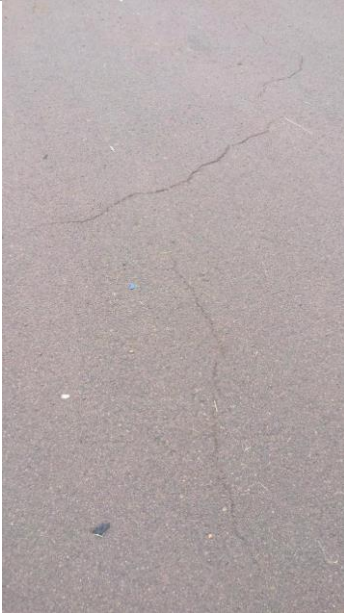
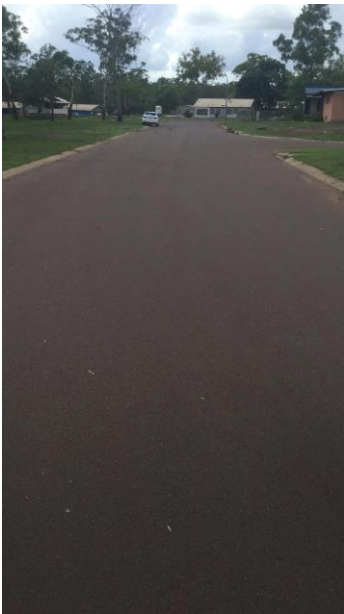
Road Name: 403_1
What are you inspecting: Pavements
Ch From (km): 0.1
Ch To (km): 0.25
Road Type: Sealed - asphalt
Section Width (m): 6
Road Condition: 4 - Very Good
General Comment:

Defect Type	Defect QTY	Defect Condition	Defect Comments
Surfacing Cracks	2	3 - Good	2%

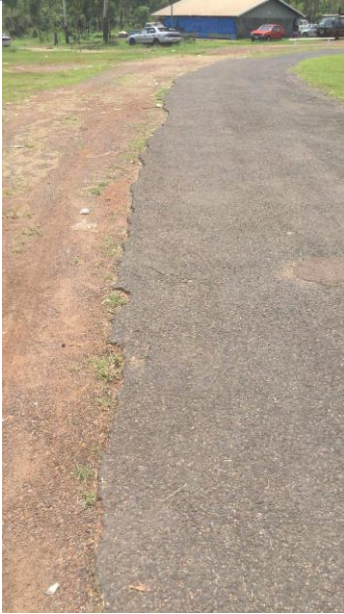
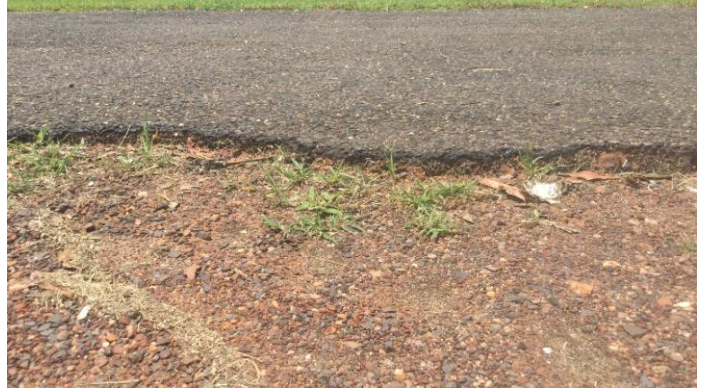
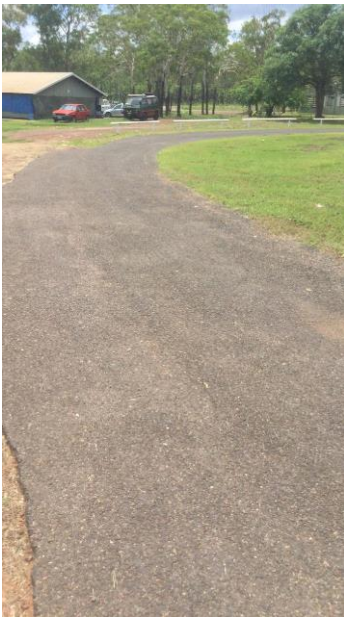
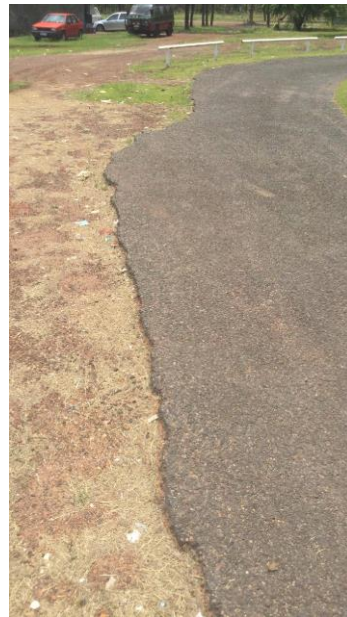
Road Name: 403_1
What are you inspecting: Pavements
Ch From (km): 0.25
Ch To (km): 0.39
Road Type: Sealed - asphalt
Section Width (m): 3.5
Road Condition: 3 - Good
General Comment:

Road Defects Section

Defect Type	Defect QTY	Defect Condition	Defect Comments
Edge Breaks	10	2 - Poor	20%

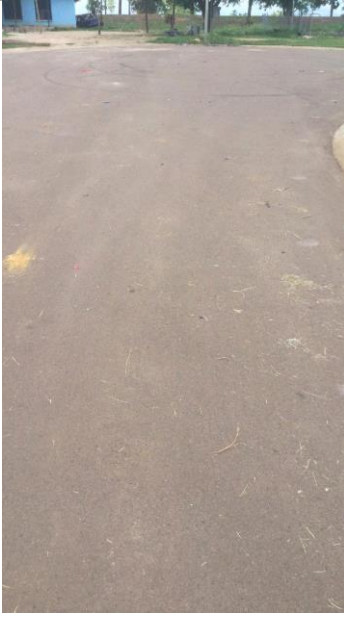
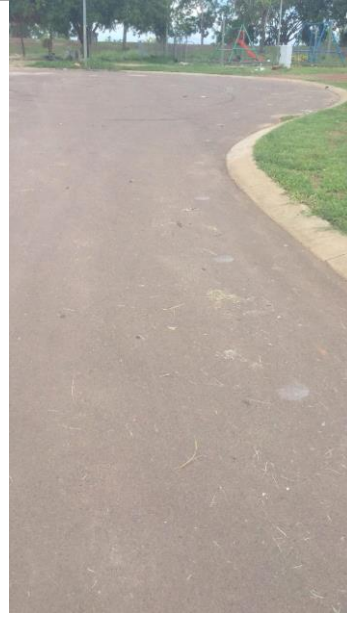
Road Name: 403_2
What are you inspecting: Pavements
Ch From (km): 0
Ch To (km): 0.05
Road Type: Sealed - asphalt
Section Width (m): 6
Road Condition: 4 - Very Good

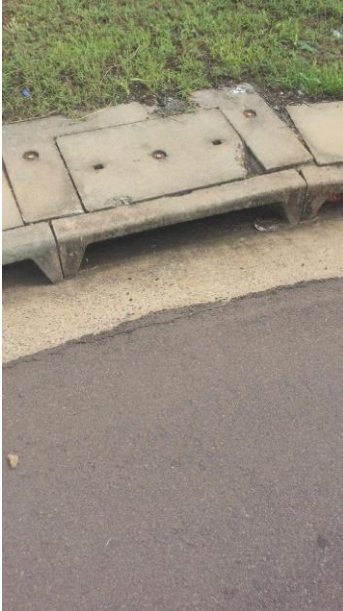
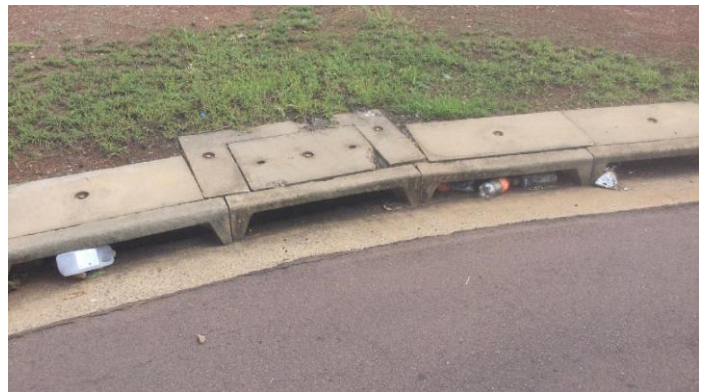
Stormwater Infrastructure: SEP
Number of Bays: 4
On grade or sag pit:
Both sides of road: Left
Condition: 4 - Very Good
Blockage (%): 10
Comment:

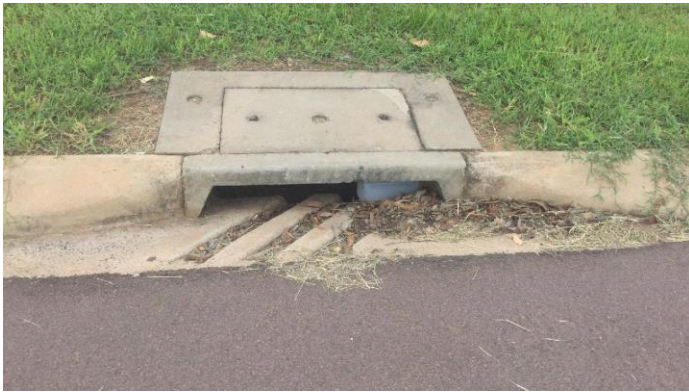
Stormwater Infrastructure: SEP
Number of Bays: 1
On grade or sag pit:
Both sides of road:
Condition: 4 - Very Good
Blockage (%): 10
Comment:

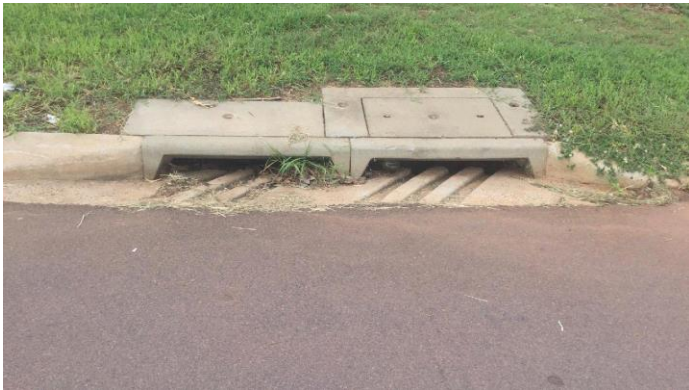
Stormwater Infrastructure: SEP
Number of Bays: 2
On grade or sag pit:
Both sides of road:
Condition: 4 - Very Good
Blockage (%): 30
Comment:

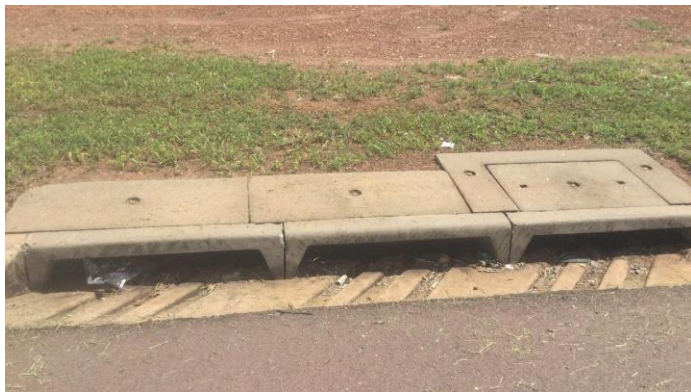
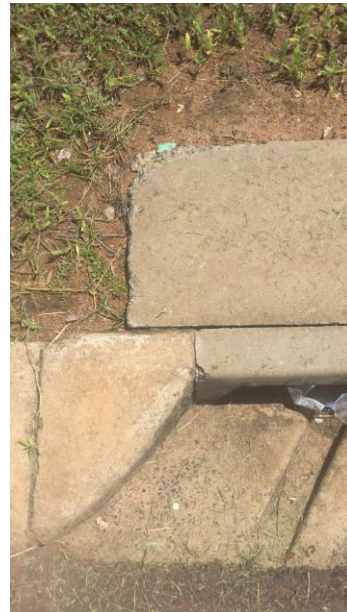
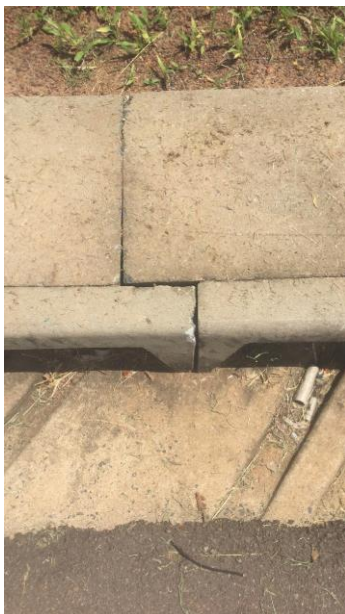
Stormwater Infrastructure: SEP
Number of Bays: 3
On grade or sag pit:
Both sides of road: Left
Condition: 4 - Very Good
Blockage (%): 0
Comment:

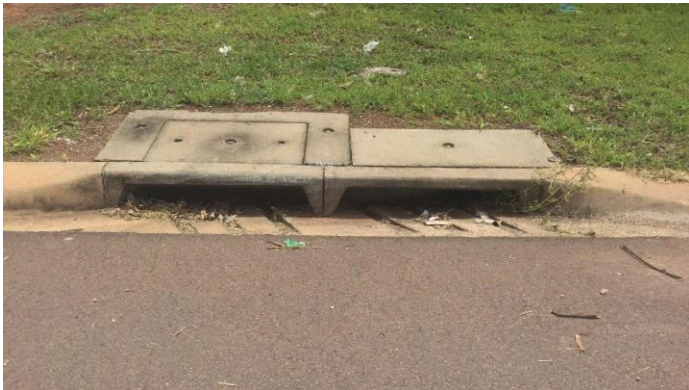
Stormwater Infrastructure: SEP
Number of Bays: 2
On grade or sag pit:
Both sides of road: Left
Condition: 4 - Very Good
Blockage (%): 10
Comment:

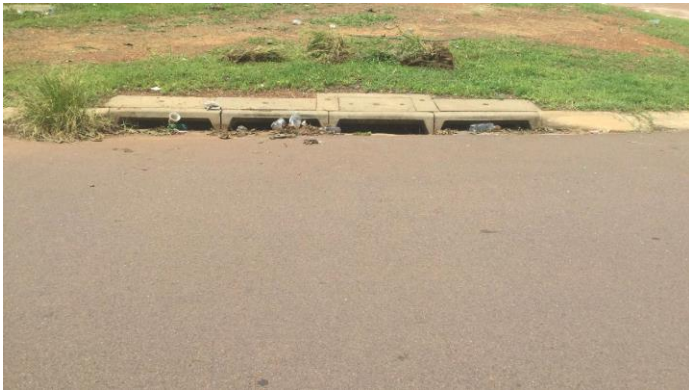
Stormwater Infrastructure: SEP
Number of Bays: 4
On grade or sag pit:
Both sides of road: Right
Condition: 4 - Very Good
Blockage (%): 20
Comment:

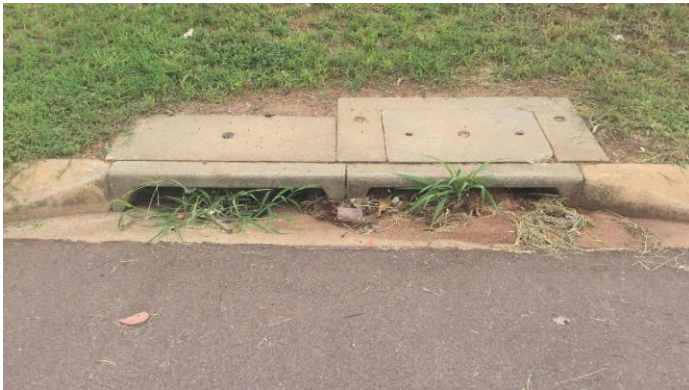
Stormwater Infrastructure:	SEP
Number of Bays:	2
On grade or sag pit:	
Both sides of road:	Right
Condition:	4 - Very Good
Blockage (%):	40
Comment:

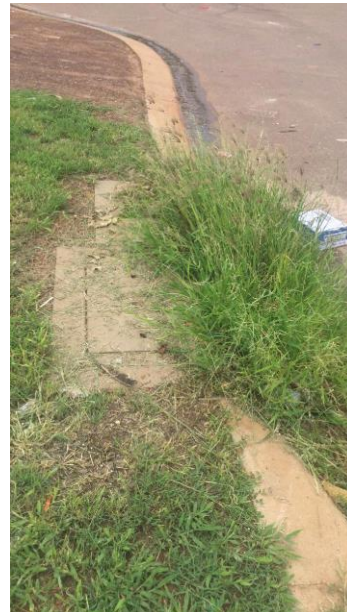
Stormwater Infrastructure: SEP
Number of Bays: 2
On grade or sag pit:
Both sides of road:
Condition: 3 - Good
Blockage (%): 100
Comment:

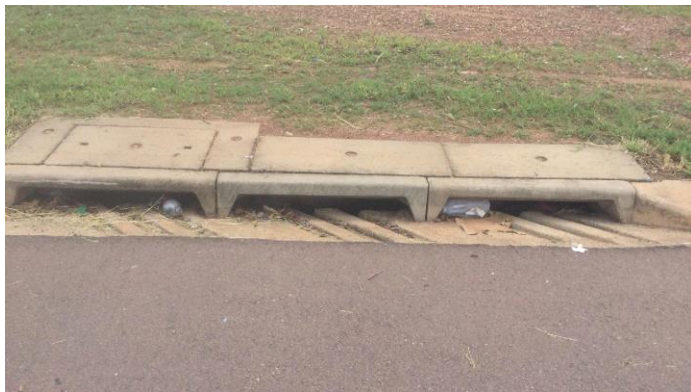
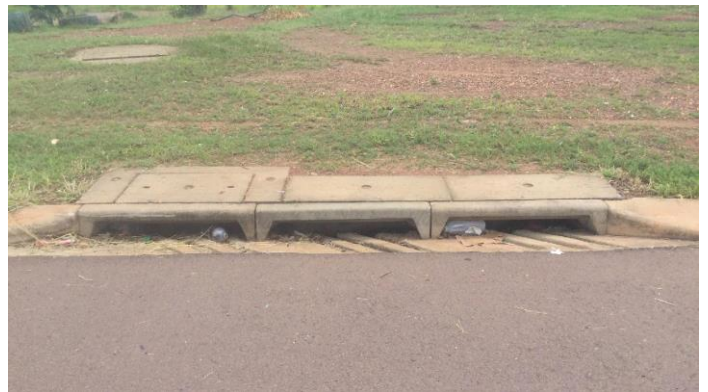
Stormwater Infrastructure: SEP
Number of Bays: 3
On grade or sag pit:
Both sides of road: Left
Condition: 4 - Very Good
Blockage (%): 10
Comment:

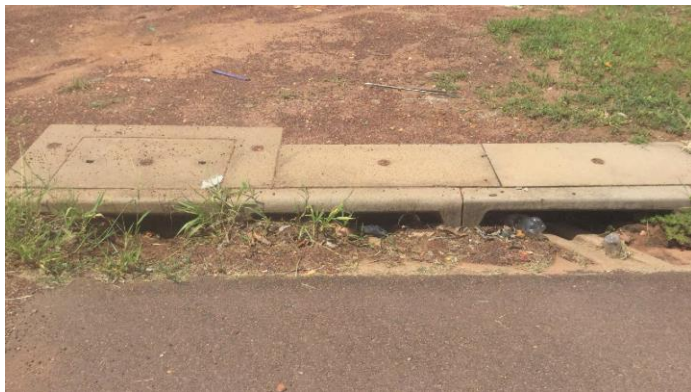
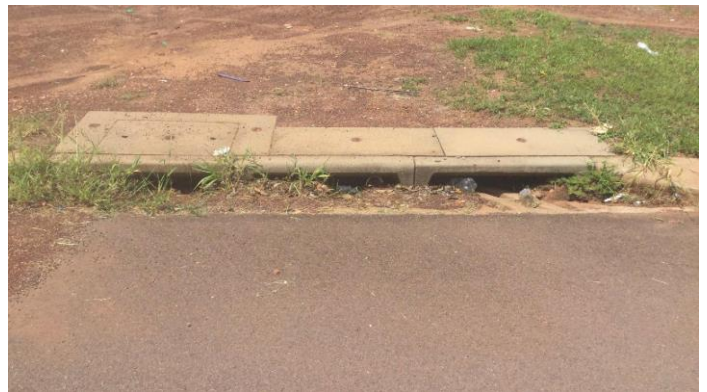
Stormwater Infrastructure: SEP
Number of Bays: 3
On grade or sag pit:
Both sides of road: Right
Condition: 3 - Good
Blockage (%): 40
Comment:

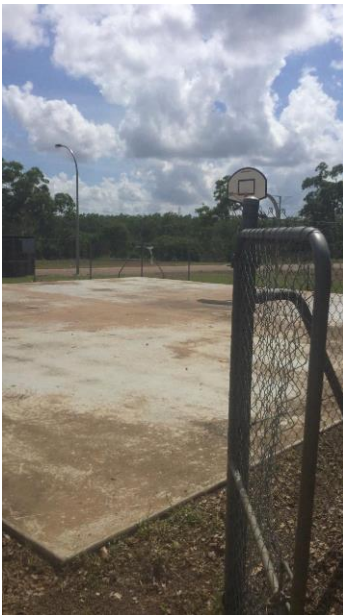
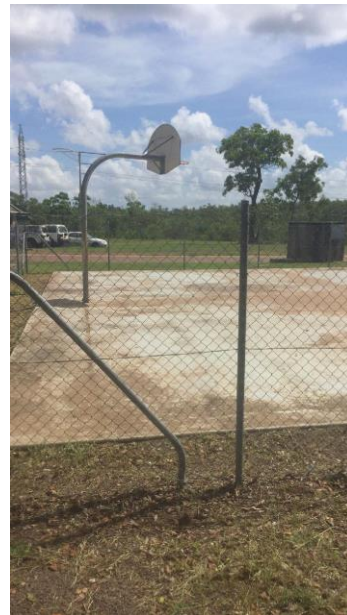
Inspection Type:	Shade Structure
Shade Structure Type:	Basket Ball Court
Shade Floor Type:	Concrete
Roof Type:	Not Covered
Width (mm):	18
Length (mm):	8
Appearance:	3
Appearance Comment:	
Condition:	3 - Good
Comment:

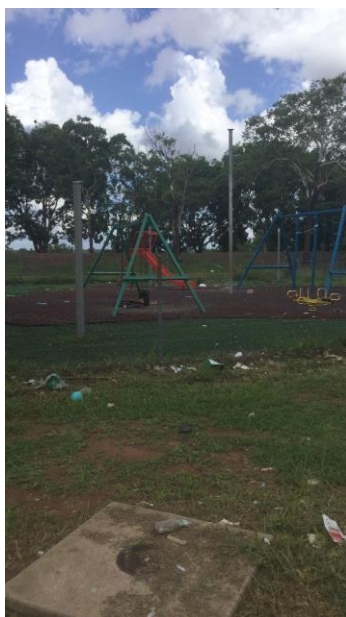
Inspection Type:	Shade Structure
Shade Structure Type:	Play ground
Shade Floor Type:	Rubber Mats
Roof Type:	Not Covered
Width (mm):	20
Length (mm):	20
Appearance:	2
Appearance Comment:	Rubbish, paint peeling
Condition:	2 - Poor
Comment:

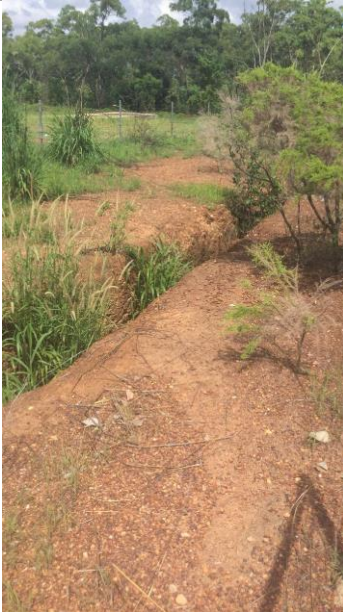
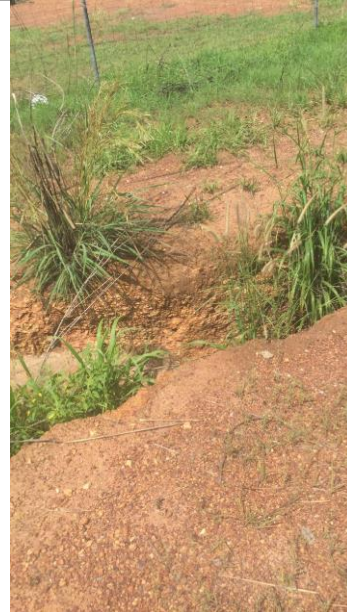
Stormwater Infrastructure:	Swales
Type of lining:	No Lining
Are dimensions uniform along drain:	Yes
Base Width (m):	0.7
Overall Width (m):	0.7
Swale Depth (m):	1
Length of Batter 1 (m):	0
Length of Batter 2 (m):	0
Swale Condition:	3 - Good
Swale Ponding:	No
Drain flooded at time of inspection:	No
Swale Comments:	Overgrown, fenced off

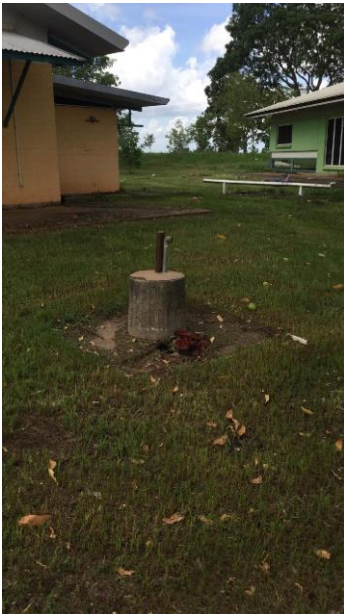
Tap Condition: 1 - Very Poor

Tap Comment: No tap handle

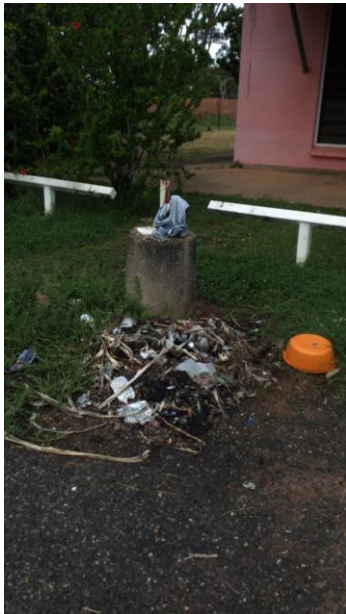
Tap Condition: 1 - Very Poor

Tap Comment: Broken tap

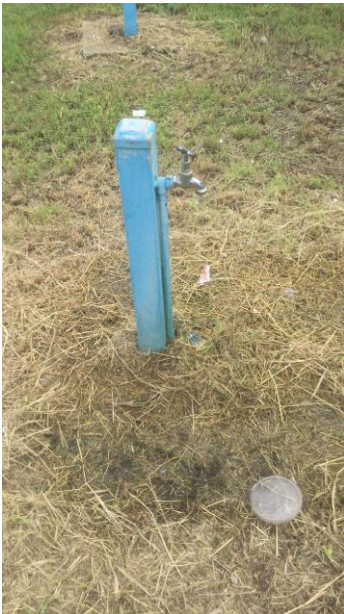
Tap Leakage: Yes

Tap Condition: 2 - Poor

Tap Comment: Good condition other than constant leaking

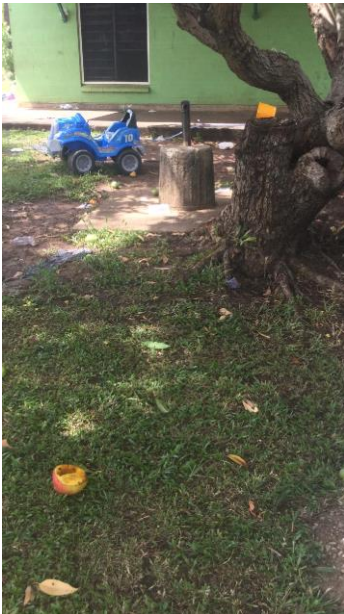
Tap Condition: 1 - Very Poor

Tap Comment: No tap connected

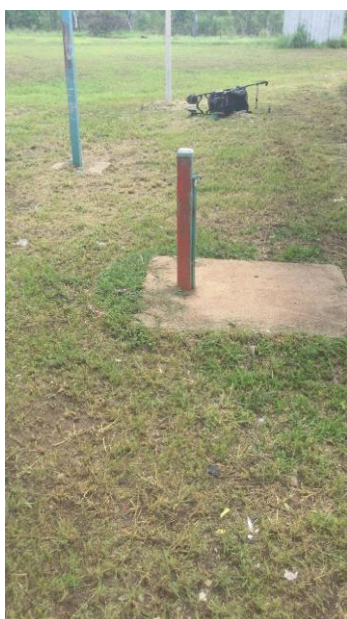
Tap Condition: 1 - Very Poor

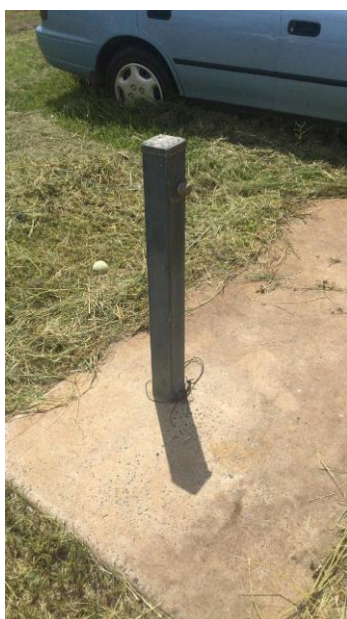
Tap Leakage: No

Tap Condition: 1 - Very Poor

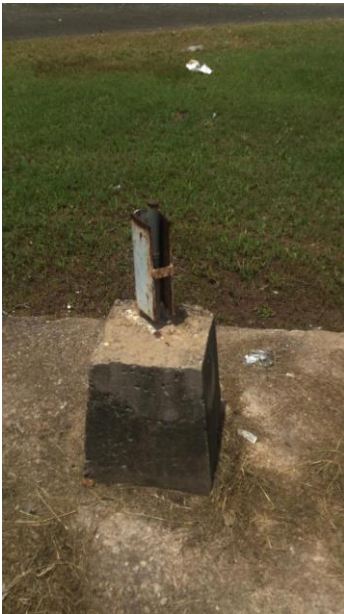
Tap Leakage: No

Tap Condition: 1 - Very Poor

Tap Comment: No tap

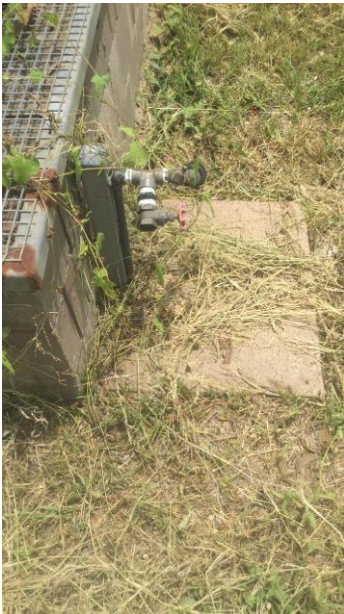
Tap Leakage: No

Tap Condition: 3 - Good

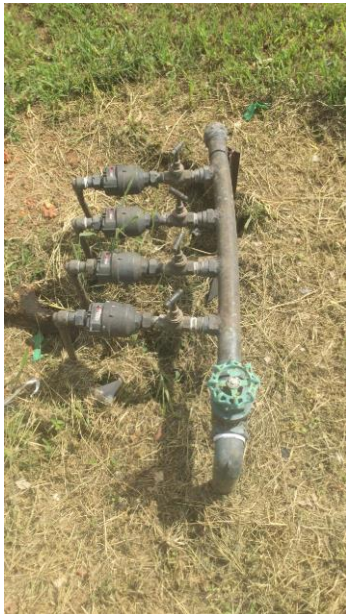
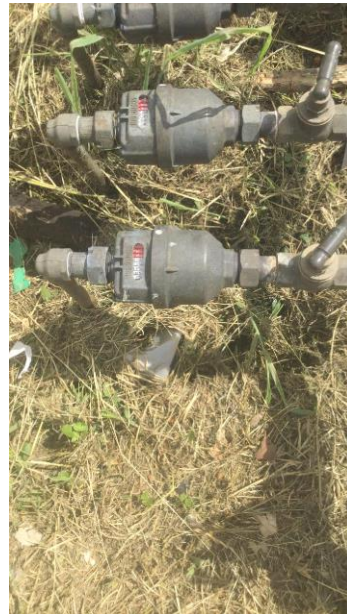
Lot Water Meter Condition: 3 - Good

Lot Water Meter Comment: 4 lot water meters

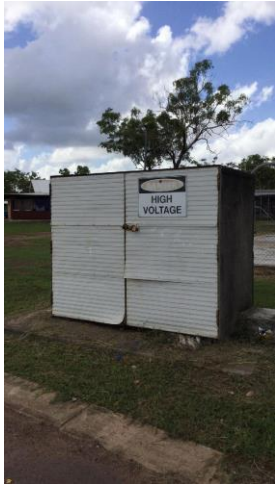
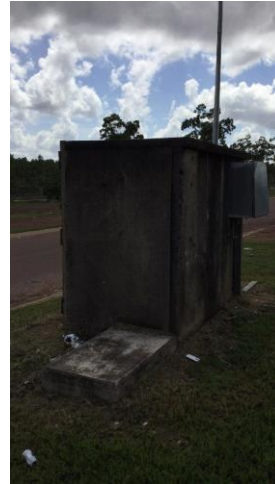
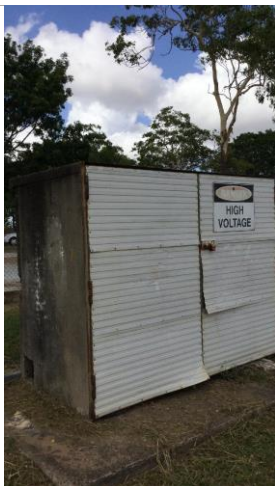
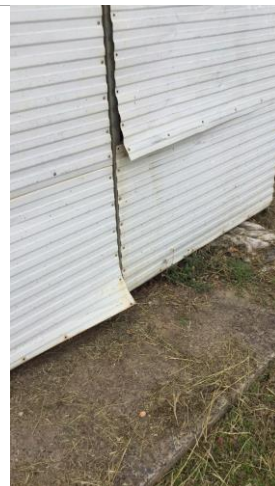
Condition Comments:

Door needs repairs

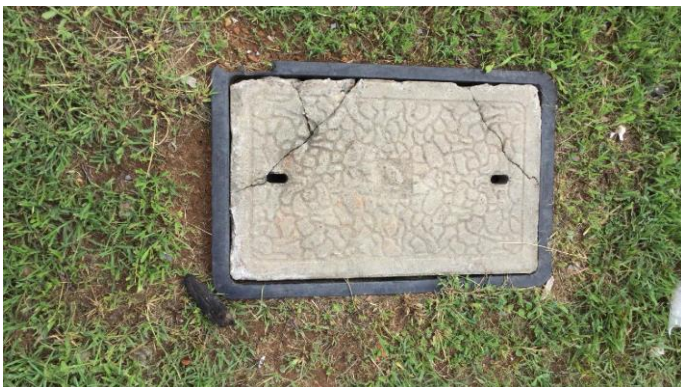
What is Pit Condition: 3

Underground Comments: Cover cracked.

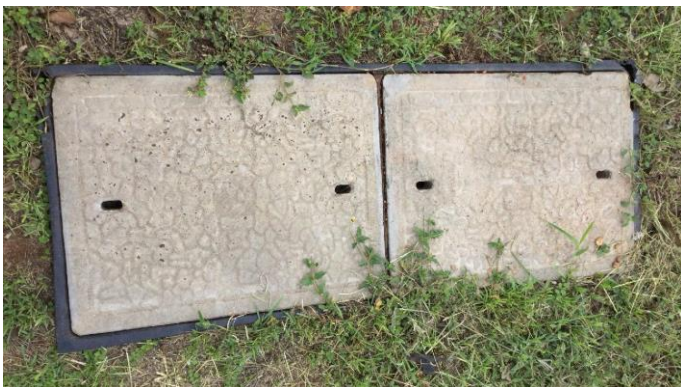
What is Pit Condition: 3

Underground Comments: Two pits.

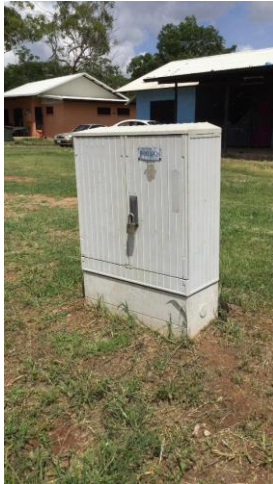
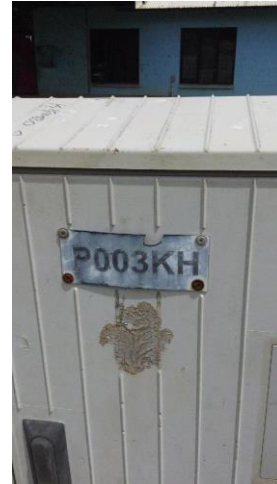
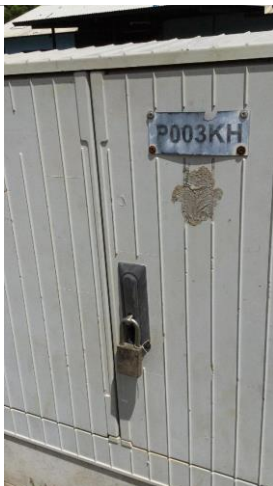
Damage on body

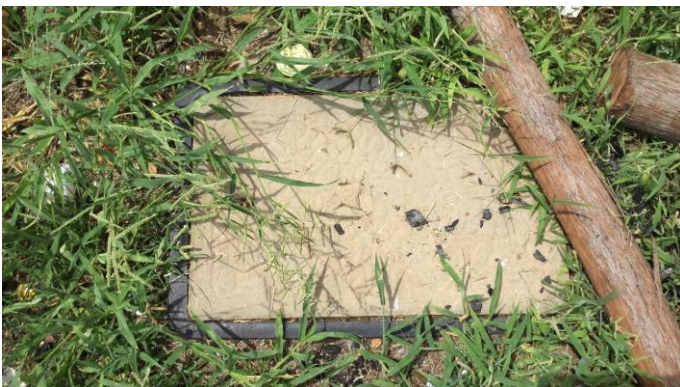
Underground Comments: Needs cleaning around.

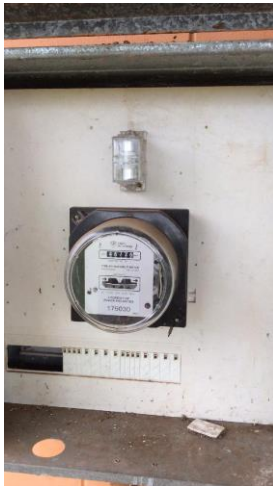
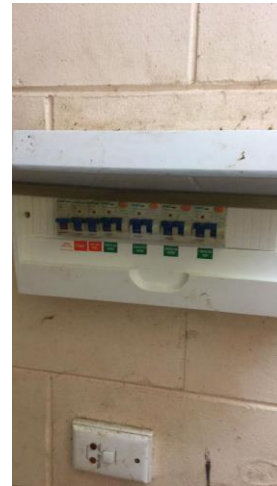
Meter Comment: Blank plates are missing on CB slot. Analogue Meter. Indoor SB, Cond 3

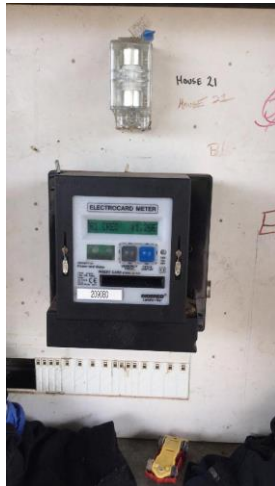
Meter Comment: Blank plates are missing on CB slot. Indoor SB, Cond 3

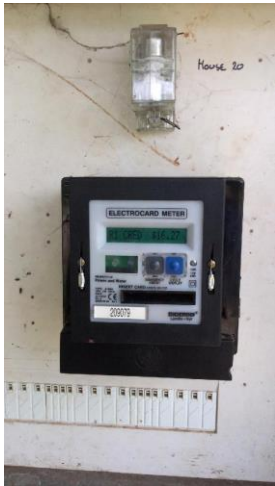
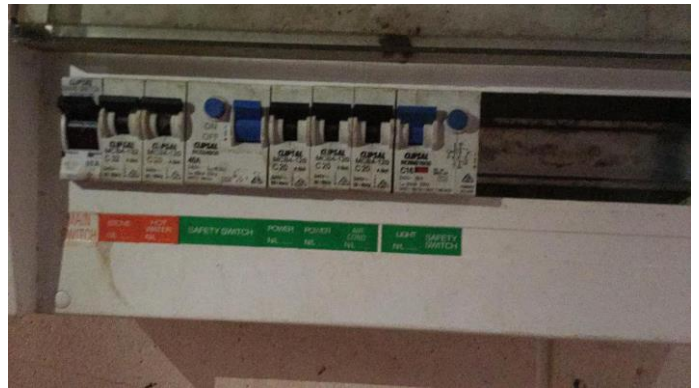
Meter Comment: Indoor SB, Cond 2, Blank plates are missing on CB slot.

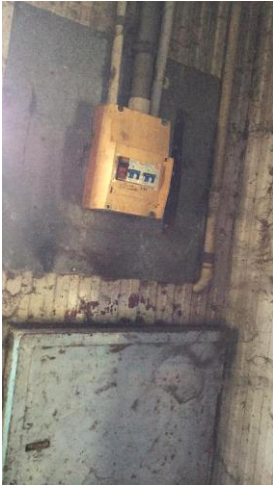
Meter Comment: Indoor SB, Cond 3

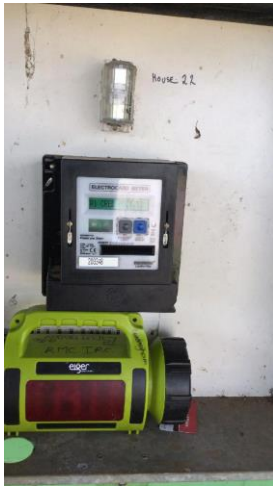
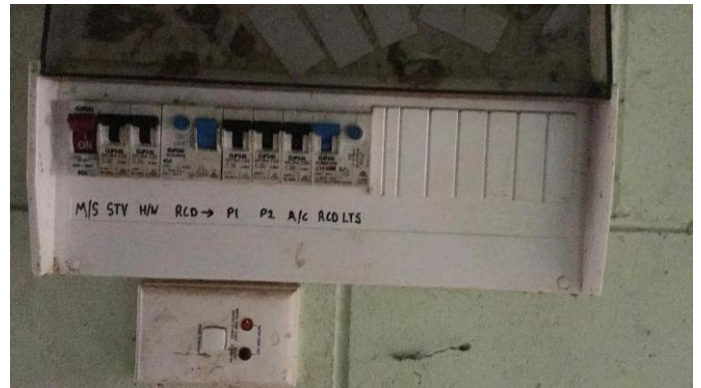
Meter Comment: Condition of CB not assessed. Indoor SB, Cond 3

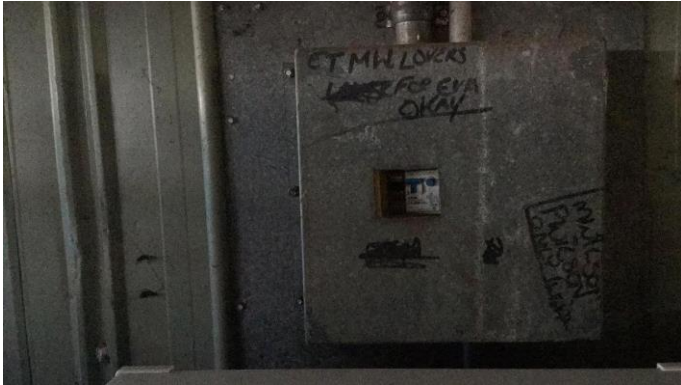
Meter Comment: Indoor SB, Cond 2, Blank plates are missing on CB slot.

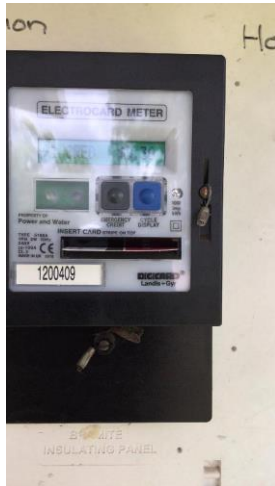
Meter Comment: Condition of CB not assessed. Indoor SB, Cond 3

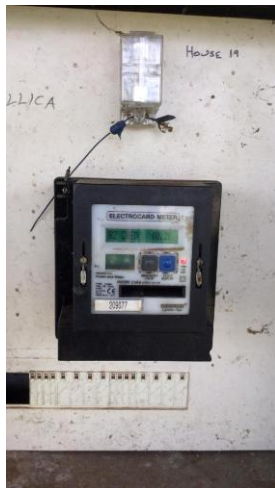
Meter Comment: Blank plates are missing on CB slot.

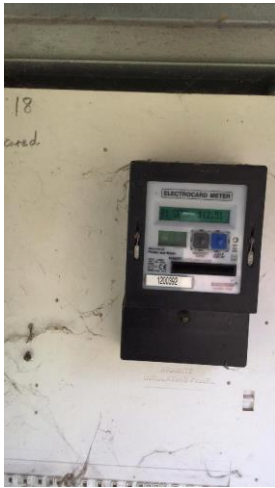
Meter Comment: Condition of CB not assessed. Indoor SB, Cond 3

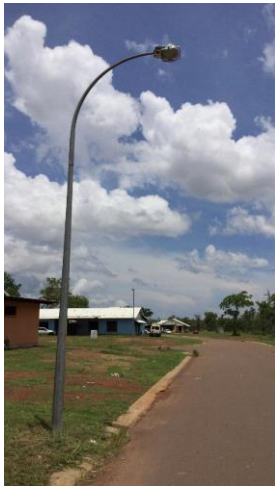
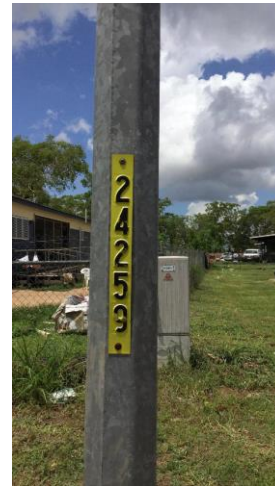
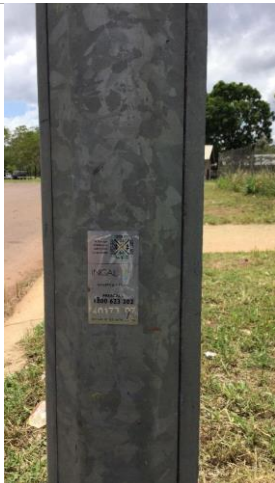
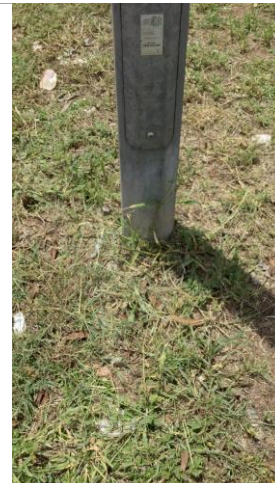
What is the condition of street lights:

What is Street Lighting pole installation height (approximate):

7

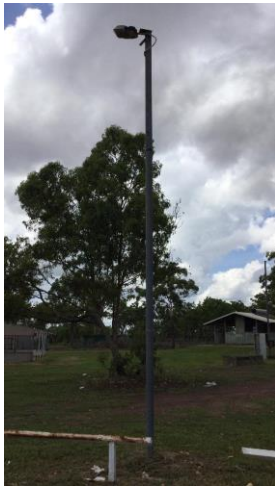
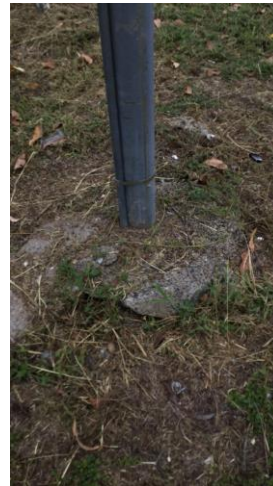
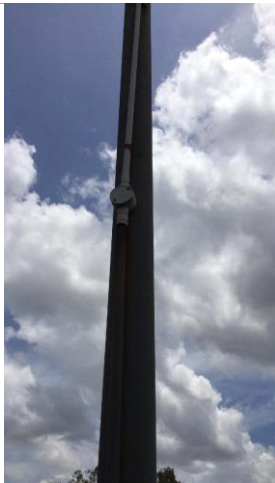
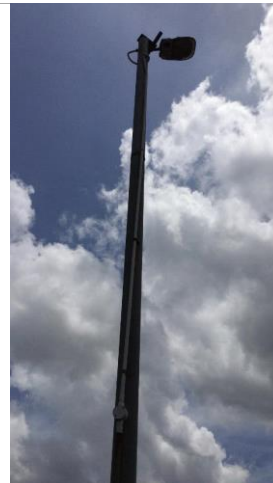
What is the condition of street lights:

What is Street Lighting pole installation height (approximate):

7
