# Northern Territory Town Camps

## Civil Infrastructure

Kargaru (East Side Camp)

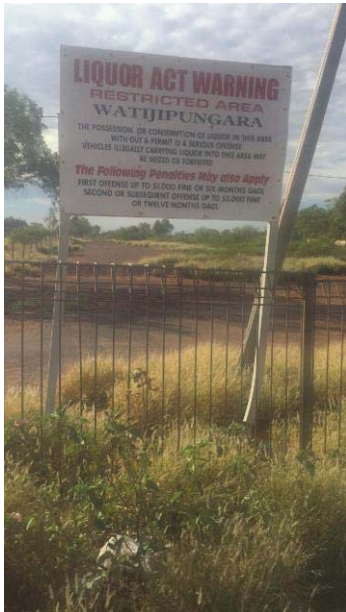
Insp ID: 1441

Type of Sign: Liquor act warning

Sign Condition: 2 - Poor

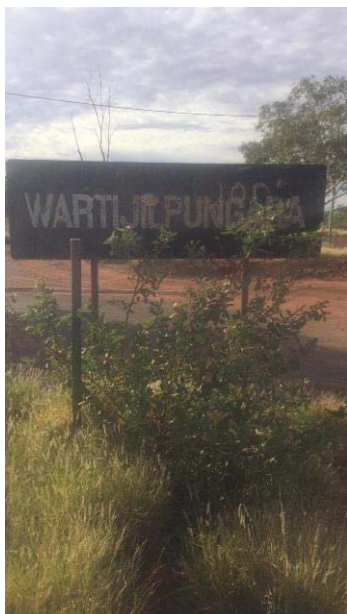
Insp ID: 1442

Type of Sign: Camp name sign

Sign Condition: 2 - Poor

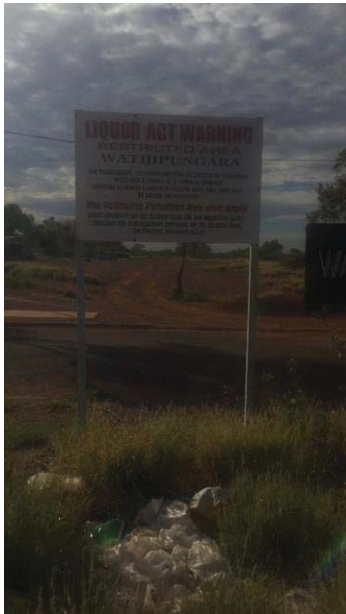
Insp ID: 1443

Sign Condition: 2 - Poor

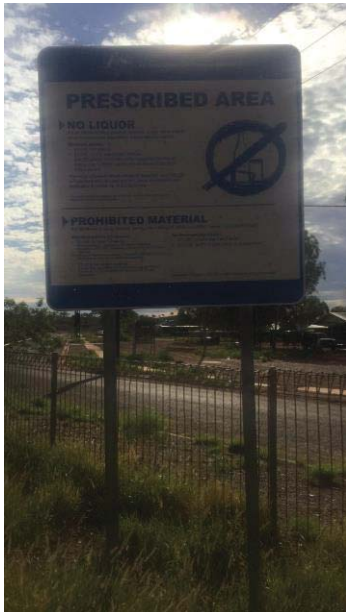
Sign Condition: 3 - Good

Sign Comment: Sign is old

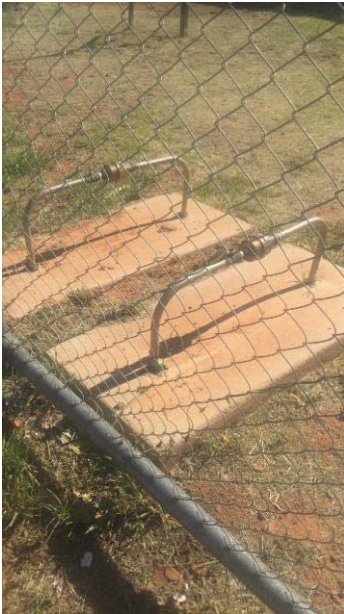
Lot Water Meter Condition: 4 - Very Good

Lot Water Meter Comment: Two water meters, in one lot

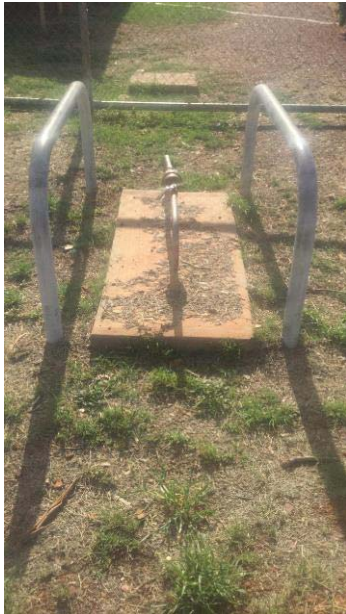
Lot Water Meter Condition: 3 - Good

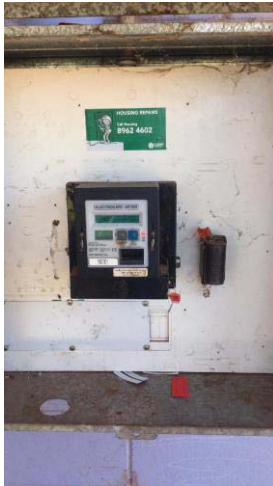
Meter Condition: 3

Meter Comment: Indoor SB, Cond 3

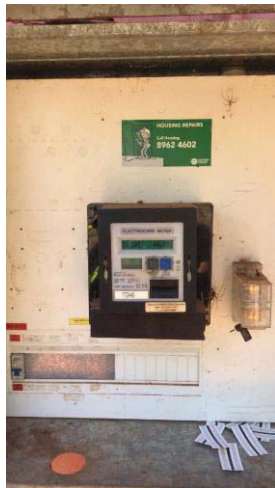
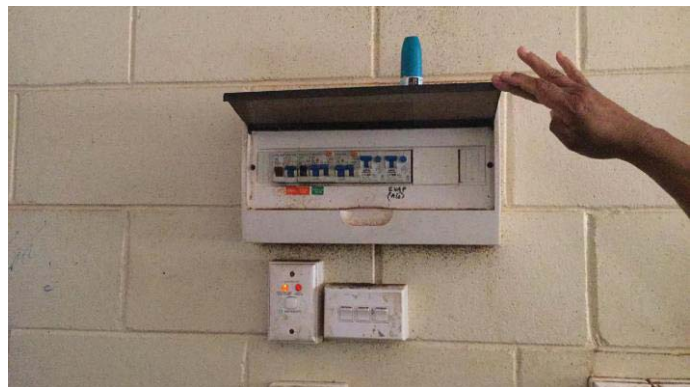
Meter Type: Prepaid  
Meter Switchboard Cond: 3  
Meter Condition: 3  
Meter Comment: Indoor SB, Cond 3  
Comments:

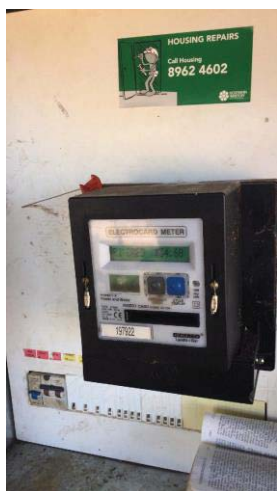
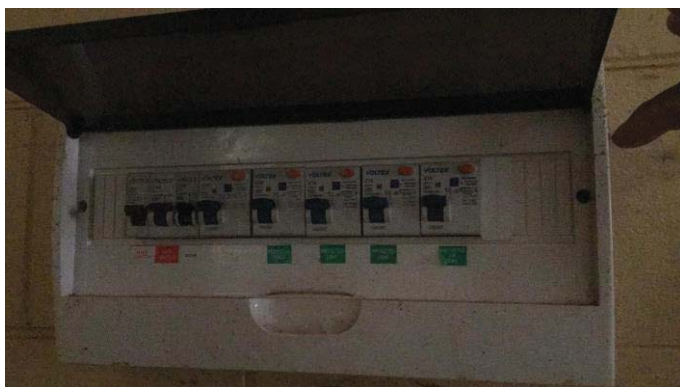
Meter Condition: 3

Meter Comment: Indoor SB, Cond 3

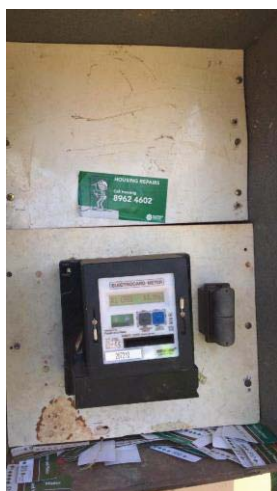
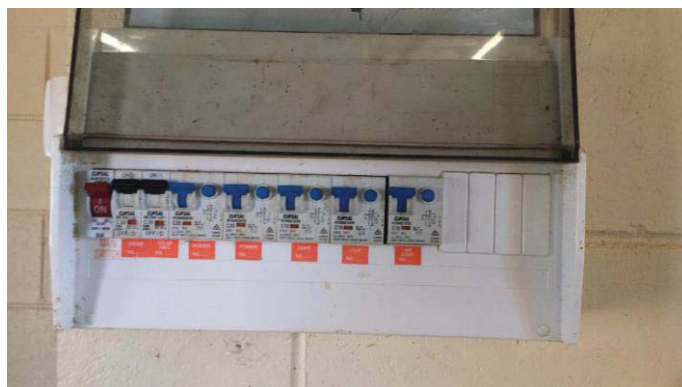
Meter Condition: 3

Meter Comment: Indoor SB, Cond 3

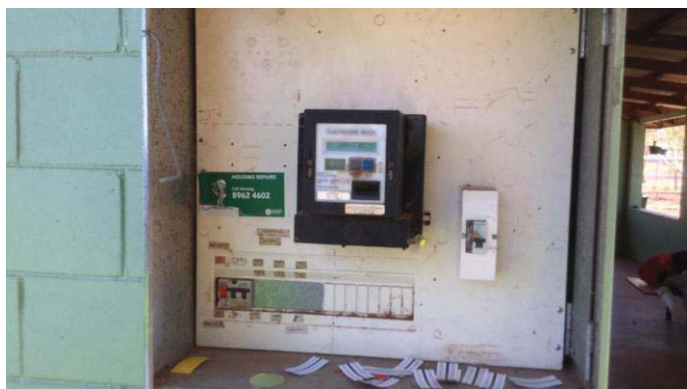
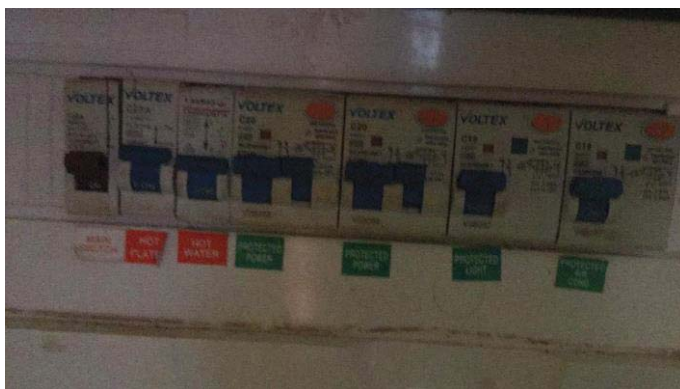
Meter Condition: 3

Meter Comment: Indoor SB, Cond 3

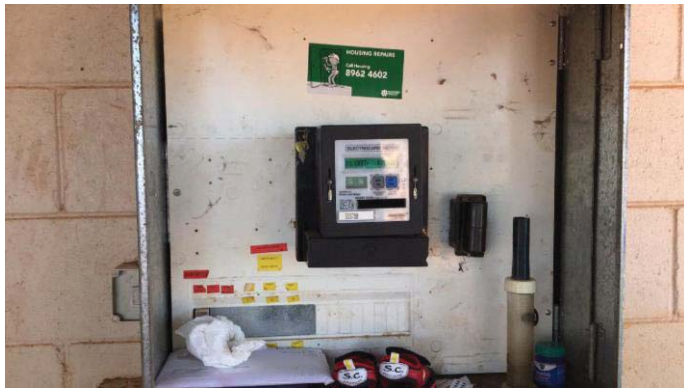
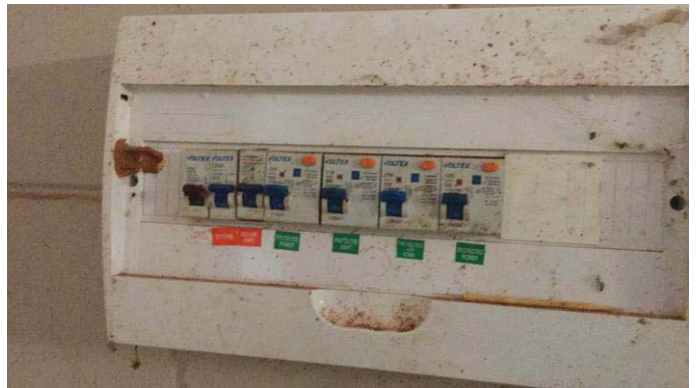
Meter Type: Prepaid  
Meter Switchboard Cond: 3  
Meter Condition: 3  
Meter Comment: Indoor SB, Cond 3  
Comments:

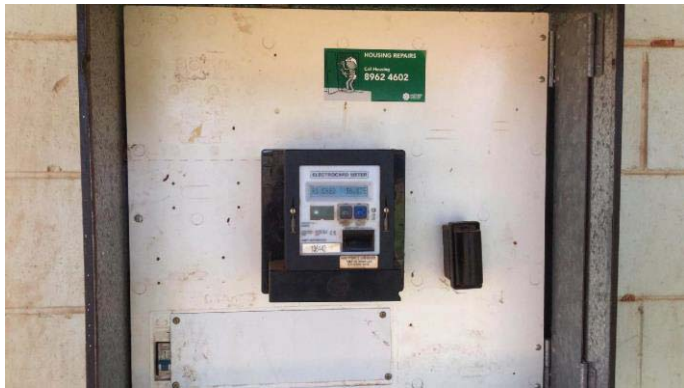
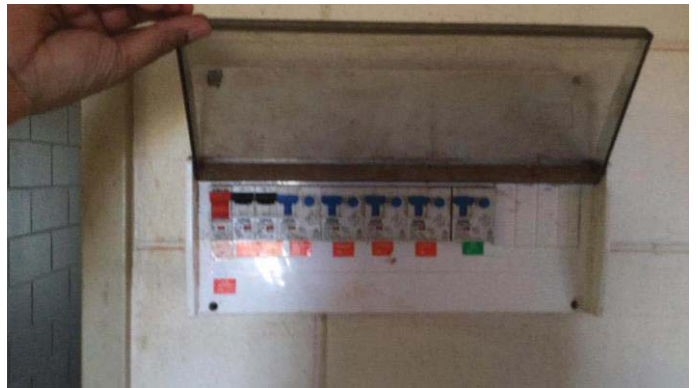
Meter Type: Prepaid  
Meter Switchboard Cond: 3  
Meter Condition: 3  
Meter Comment: Indoor SB, Cond 3  
Comments:

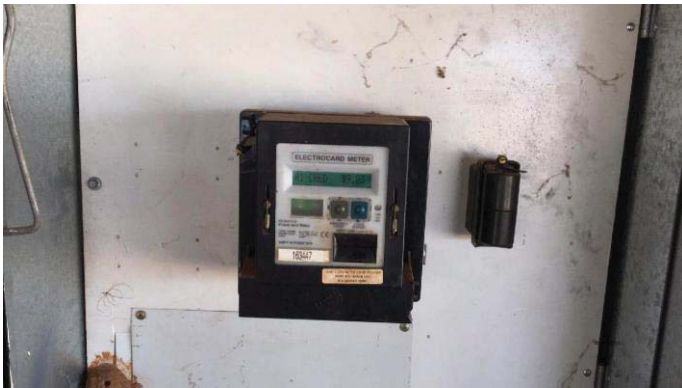
Meter Condition: 3

Meter Comment: Indoor SB, Cond 3

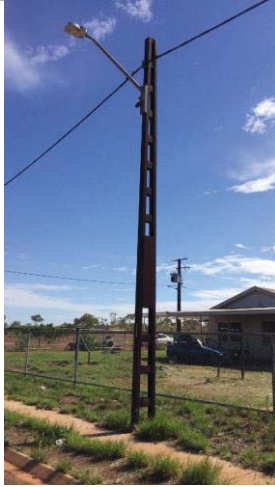
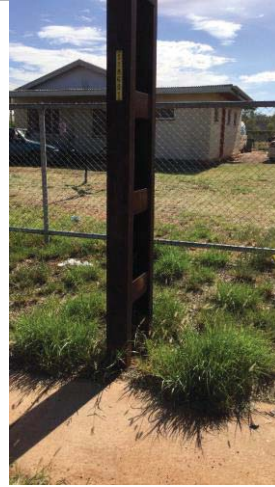
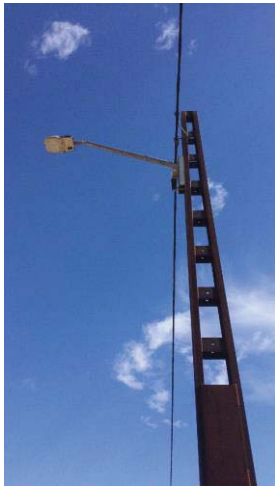
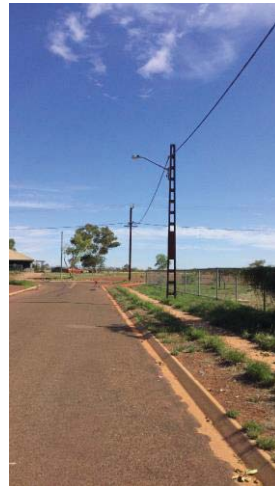
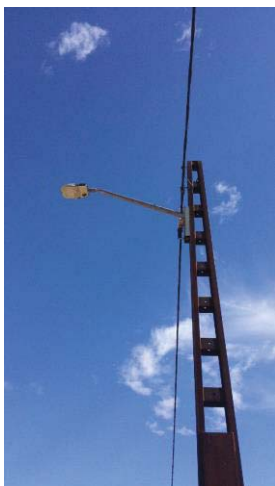
What is Pole Material type:	Welded
What is the condition of pole:	3
How is the pole planted:	Concrete
What is the Condition of plant:	3
Is street light fitted:	Yes
Street Light Power Supply:	
Street Light Type	M125D 10
Street Light Watts	125
Street Light Condition	3
Street Light Height	
What is the type of service:	Three
What is the HV voltage level:	400
What is the arrangement of connected cables:	Twisted
Are there isolators on the pole:	No
What is the Condition:	3
How many Lots are connected to this pole:	0
Overhead Pole Comments:	Surface rusted

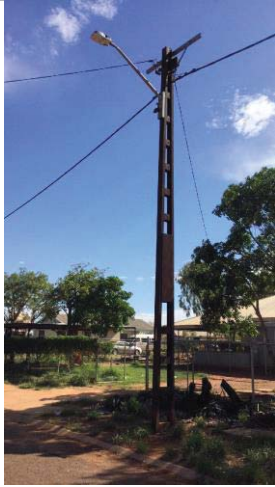
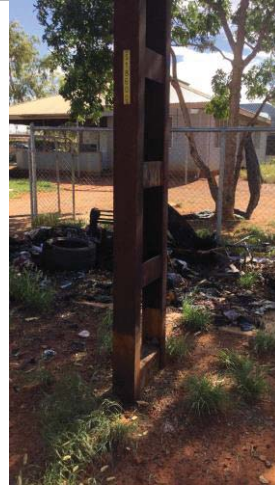
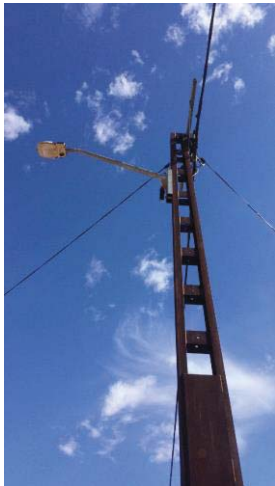
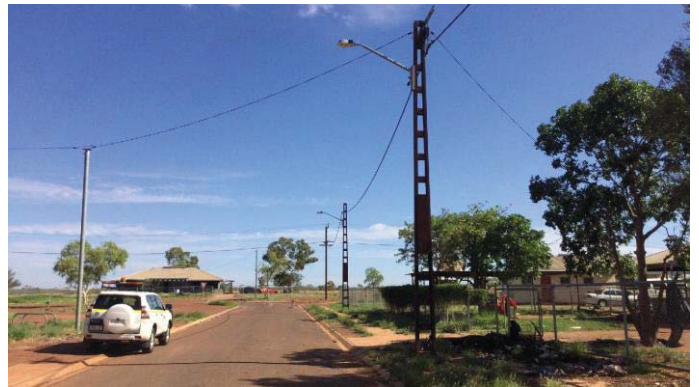
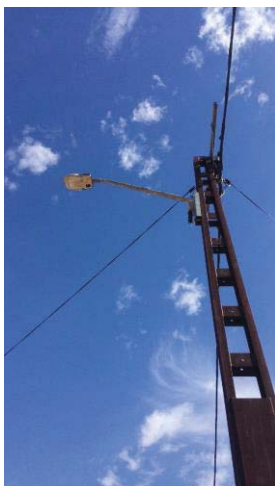
What is Pole Material type:	Welded
What is the condition of pole:	3
How is the pole planted:	Concrete
What is the Condition of plant:	3
Is street light fitted:	Yes
Street Light Power Supply:	
Street Light Type	M125D 10
Street Light Watts	125
Street Light Condition	3
Street Light Height	
What is the type of service:	Three
What is the HV voltage level:	400
What is the arrangement of connected cables:	Twisted
Are there isolators on the pole:	No
What is the Condition:	3
How many Lots are connected to this pole:	2
Overhead Pole Comments:	Surface rusted

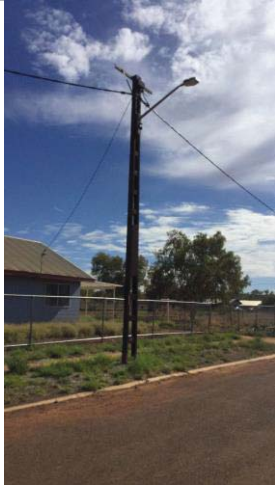
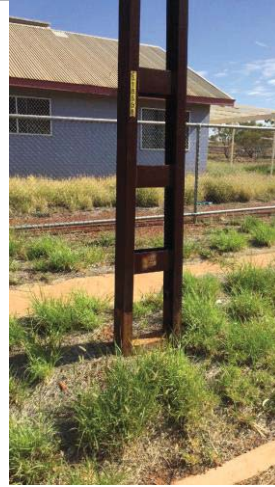
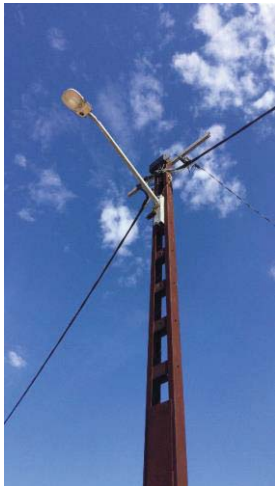
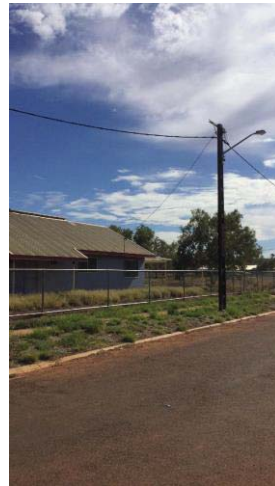
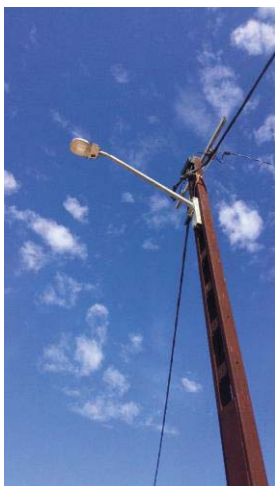
What is Pole Material type:	Welded
What is the condition of pole:	3
How is the pole planted:	Concrete
What is the Condition of plant:	3
Is street light fitted:	Yes
Street Light Power Supply:	
Street Light Type	M125D 10
Street Light Watts	125
Street Light Condition	3
Street Light Height	
What is the type of service:	Three
What is the HV voltage level:	400
What is the arrangement of connected cables:	Twisted
Are there isolators on the pole:	No
What is the Condition:	3
How many Lots are connected to this pole:	1
Overhead Pole Comments:	Surface rusted

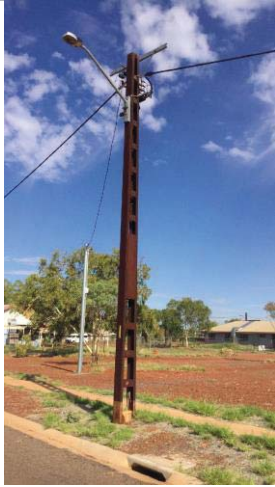
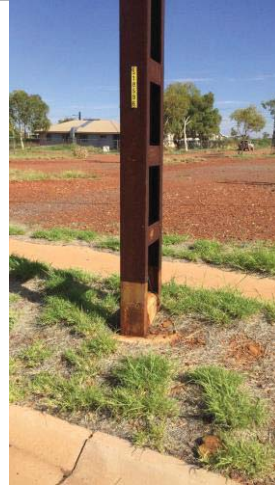
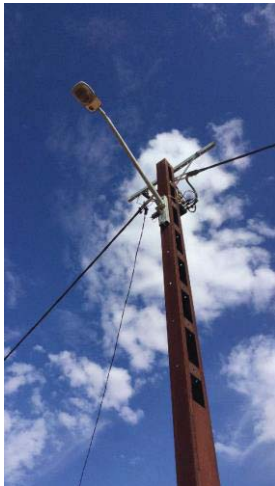
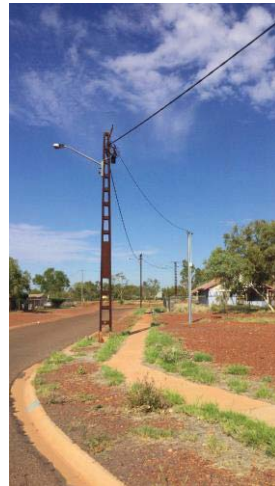
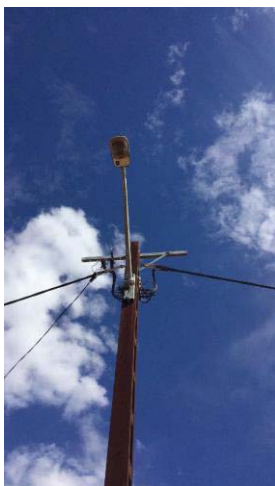
What is Pole Material type:	Welded
What is the condition of pole:	3
How is the pole planted:	Concrete
What is the Condition of plant:	3
Is street light fitted:	Yes
Street Light Power Supply:	
Street Light Type	M125D 10
Street Light Watts	125
Street Light Condition	2
Street Light Height	
What is the type of service:	Three
What is the HV voltage level:	400
What is the arrangement of connected cables:	Twisted
Are there isolators on the pole:	No
What is the Condition:	3
How many Lots are connected to this pole:	1
Overhead Pole Comments:	Surface rusted

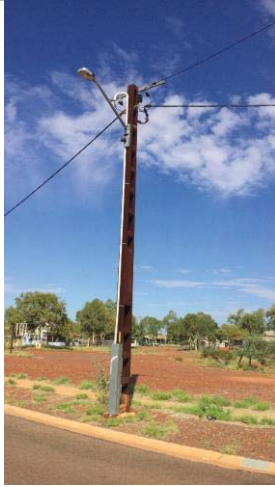
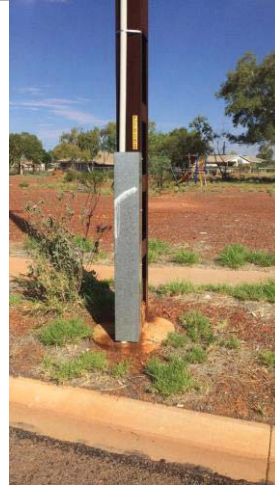
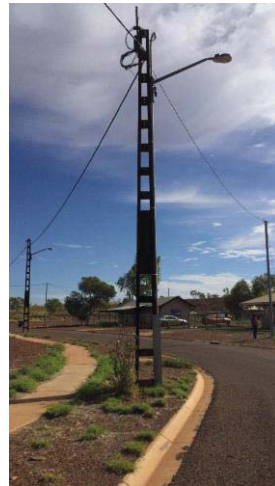
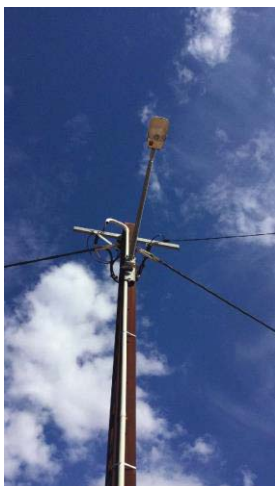
What is Pole Material type:	Welded
What is the condition of pole:	3
How is the pole planted:	Concrete
What is the Condition of plant:	3
Is street light fitted:	Yes
Street Light Power Supply:	
Street Light Type	M125D 09
Street Light Watts	125
Street Light Condition	2
Street Light Height	
What is the type of service:	Three
What is the HV voltage level:	400
What is the arrangement of connected cables:	Twisted
Are there isolators on the pole:	No
What is the Condition:	3
How many Lots are connected to this pole:	1
Overhead Pole Comments:	Surface rusted

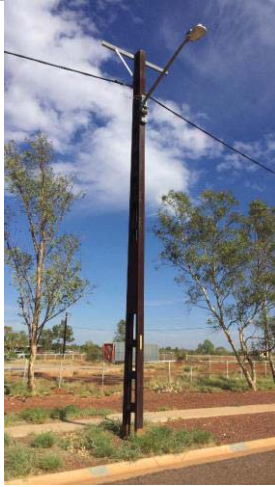
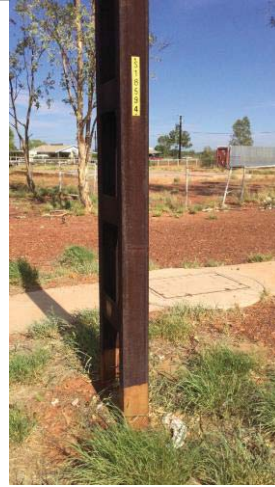
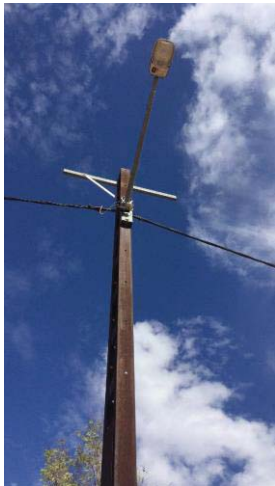
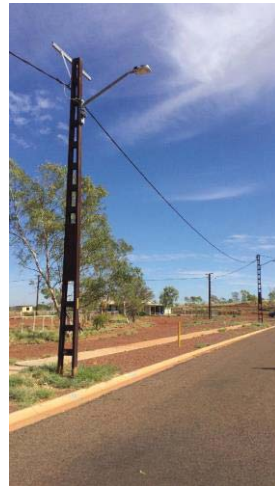
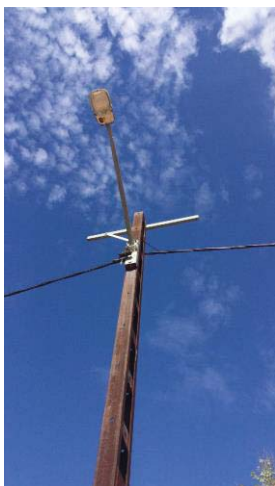
What is Pole Material type:	Welded
What is the condition of pole:	3
How is the pole planted:	Concrete
What is the Condition of plant:	3
Is street light fitted:	Yes
Street Light Power Supply:	
Street Light Type	M125D 10
Street Light Watts	125
Street Light Condition	3
Street Light Height	
What is the type of service:	Three
What is the HV voltage level:	400
What is the arrangement of connected cables:	Twisted
Are there isolators on the pole:	No
What is the Condition:	3
How many Lots are connected to this pole:	0
Overhead Pole Comments:	Surface rusted

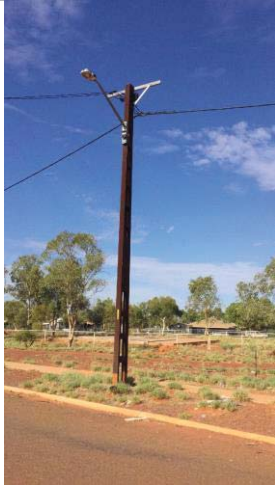
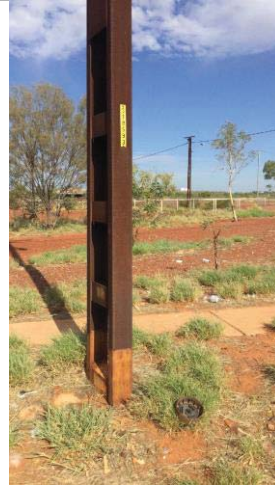
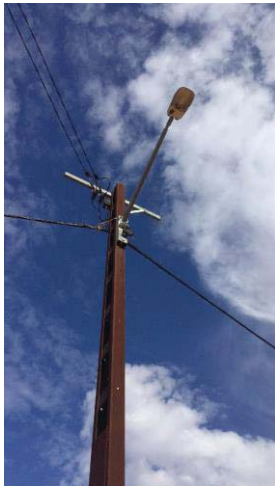
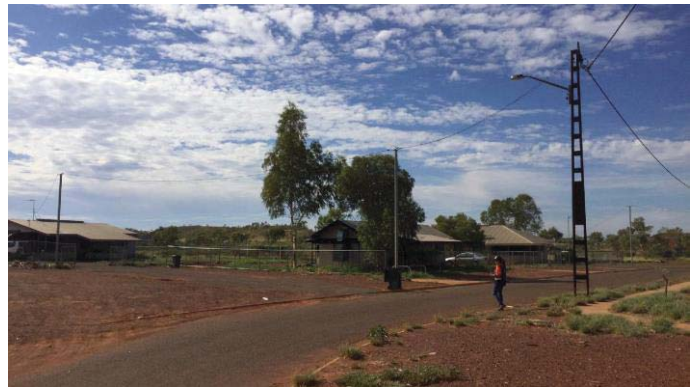
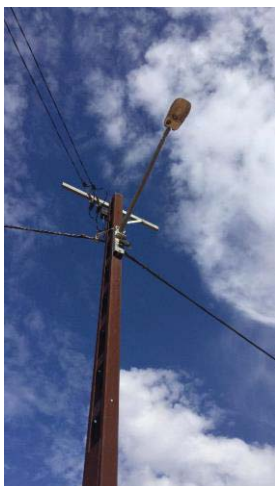
Inspection Date 1/12/2016 8:50:44 AM

What is Pole Material type:	Welded
What is the condition of pole:	3
How is the pole planted:	Concrete
What is the Condition of plant:	3
Is street light fitted:	Yes
Street Light Power Supply:	
Street Light Type	M125D 09
Street Light Watts	125
Street Light Condition	2
Street Light Height	
What is the type of service:	Three
What is the HV voltage level:	400
What is the arrangement of connected cables:	Twisted
Are there isolators on the pole:	No
What is the Condition:	3
How many Lots are connected to this pole:	0
Overhead Pole Comments:	Surface rusted

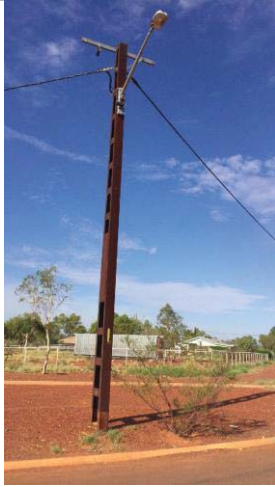
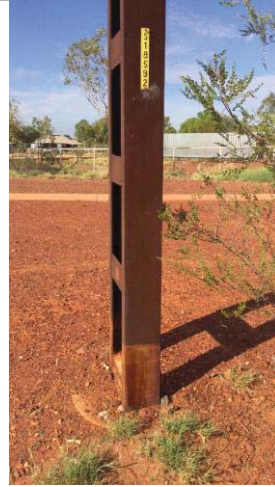
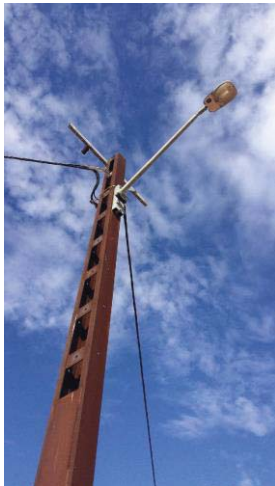
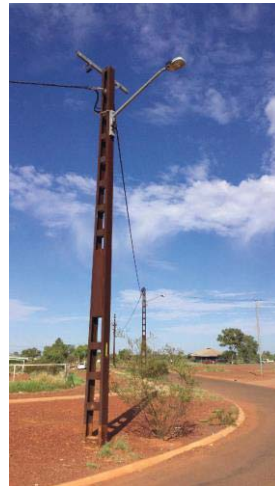
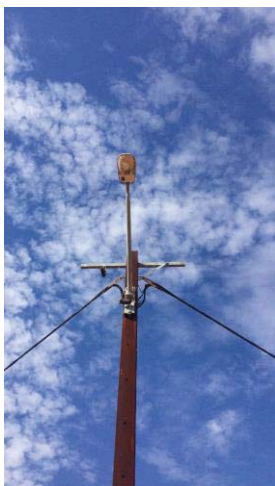
Inspection Date 1/12/2016 8:47:39 AM

What is Pole Material type:	Welded
What is the condition of pole:	3
How is the pole planted:	Concrete
What is the Condition of plant:	3
Is street light fitted:	Yes
Street Light Power Supply:	
Street Light Type	M125D 10
Street Light Watts	125
Street Light Condition	2
Street Light Height	
What is the type of service:	Three
What is the HV voltage level:	400
What is the arrangement of connected cables:	Twisted
Are there isolators on the pole:	No
What is the Condition:	3
How many Lots are connected to this pole:	1
Overhead Pole Comments:	Surface rusted

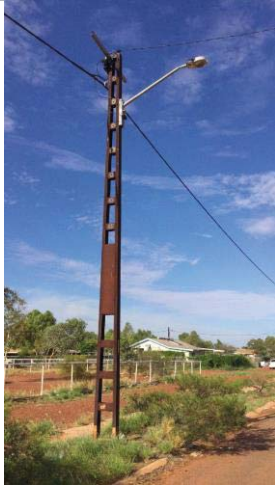
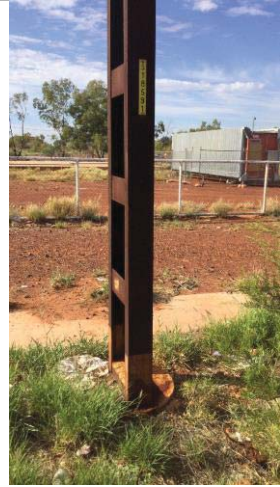
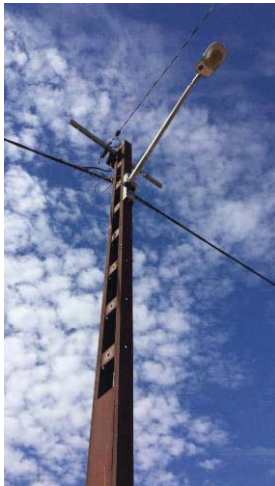
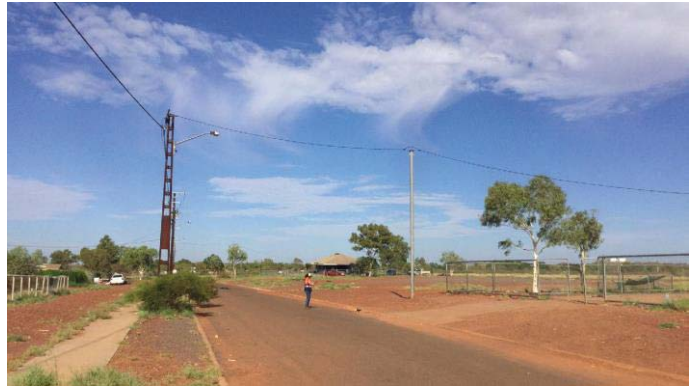
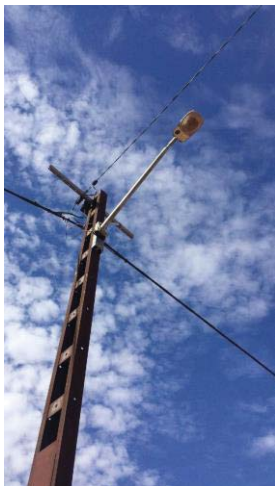
Inspection Date 1/12/2016 8:43:52 AM

What is Pole Material type:	Welded
What is the condition of pole:	3
How is the pole planted:	Concrete
What is the Condition of plant:	3
Is street light fitted:	Yes
Street Light Power Supply:	
Street Light Type	S70D 13
Street Light Watts	70
Street Light Condition	2
Street Light Height	
What is the type of service:	Combined
What is the HV voltage level:	11000
What is the arrangement of connected cables:	Parallel
Are there isolators on the pole:	No
What is the Condition:	3
How many Lots are connected to this pole:	1
Overhead Pole Comments:	Surface rusted

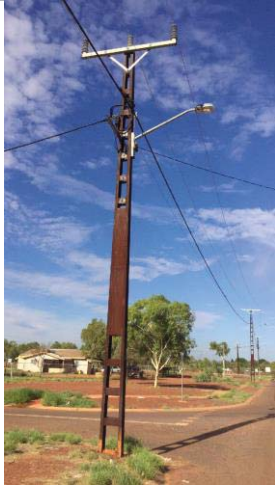
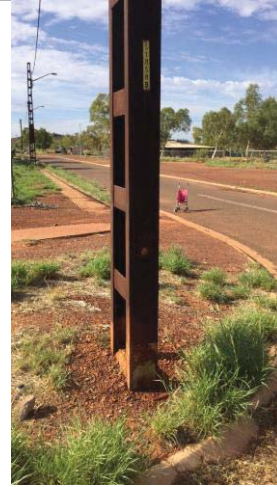
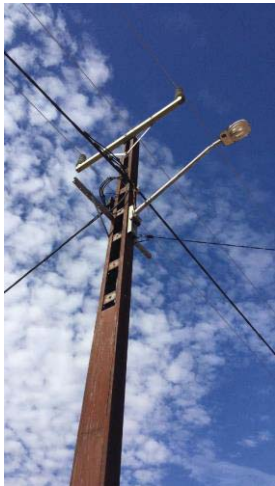
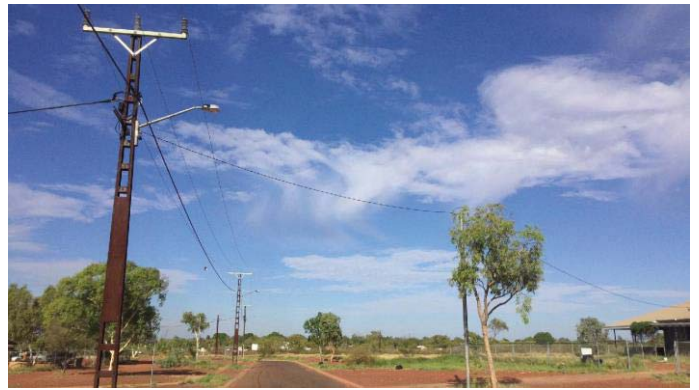
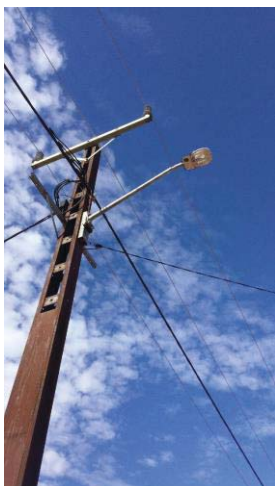
Inspection Date 1/12/2016 8:36:34 AM

What is Pole Material type:	Welded
What is the condition of pole:	3
How is the pole planted:	Concrete
What is the Condition of plant:	3
Is street light fitted:	Yes
Street Light Power Supply:	
Street Light Type	M125D 10
Street Light Watts	125
Street Light Condition	2
Street Light Height	
What is the type of service:	Combined
What is the HV voltage level:	1100
What is the arrangement of connected cables:	Parallel
Are there isolators on the pole:	Yes
What is the Condition:	3
How many Lots are connected to this pole:	1
Overhead Pole Comments:	Surface rusted

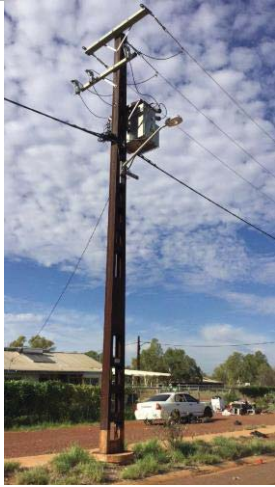
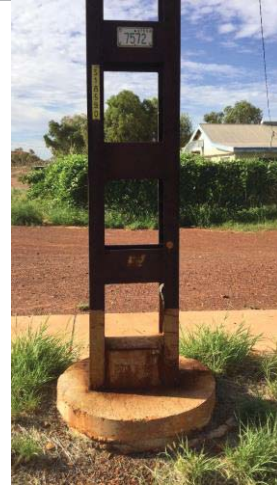
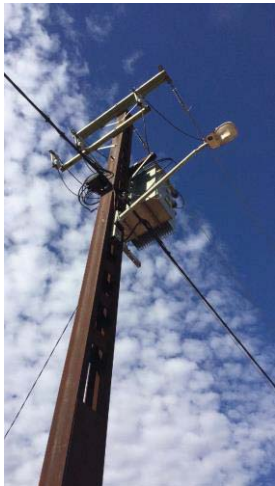
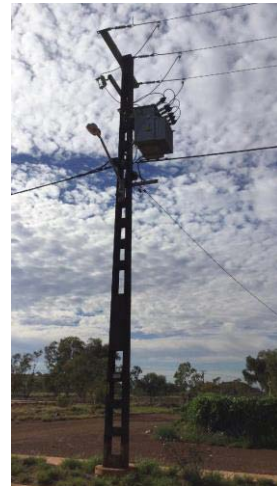
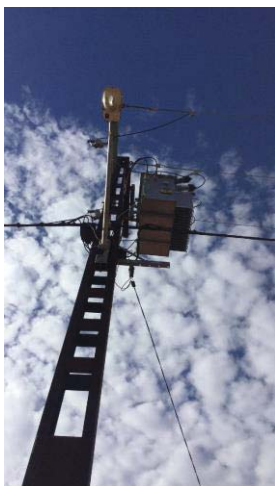
Inspection Date 1/12/2016 8:30:10 AM

What is Pole Material type:	Welded
What is the condition of pole:	3
How is the pole planted:	Concrete
What is the Condition of plant:	3
Is street light fitted:	Yes
Street Light Power Supply:	
Street Light Type	M125D 08
Street Light Watts	125
Street Light Condition	2
Street Light Height	
What is the type of service:	Combined
What is the HV voltage level:	11000
What is the arrangement of connected cables:	Parallel
Are there isolators on the pole:	No
What is the Condition:	3
How many Lots are connected to this pole:	0
Overhead Pole Comments:	Surface rusted

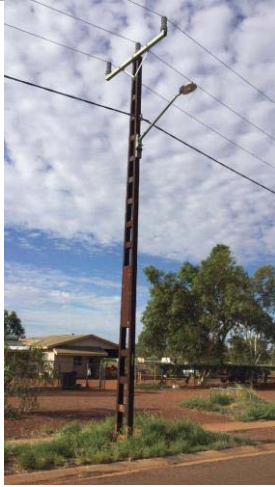
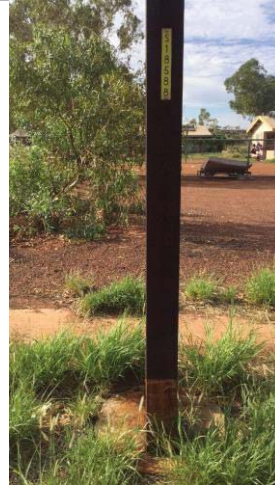
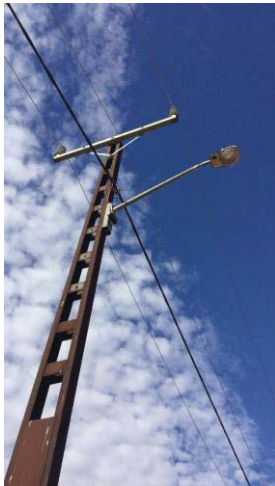
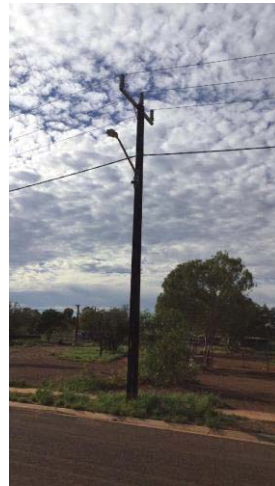
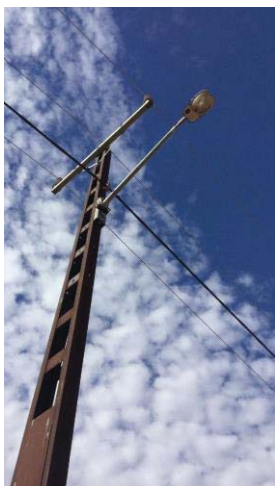
Inspection Date 1/12/2016 8:24:42 AM

What is Pole Material type:	Welded
What is the condition of pole:	3
How is the pole planted:	Concrete
What is the Condition of plant:	
Is street light fitted:	Yes
Street Light Power Supply:	
Street Light Type	M125D 10
Street Light Watts	125
Street Light Condition	2
Street Light Height	
What is the type of service:	Combined
What is the HV voltage level:	11000
What is the arrangement of connected cables:	Parallel
Are there isolators on the pole:	No
What is the Condition:	3
How many Lots are connected to this pole:	1
Overhead Pole Comments:	Surface rusted

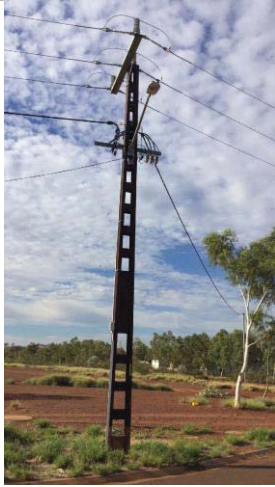
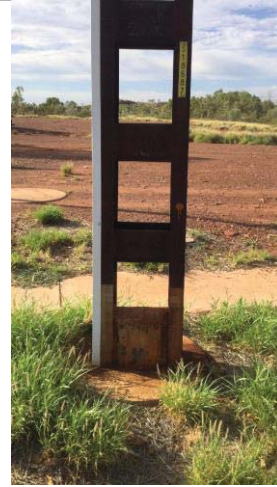
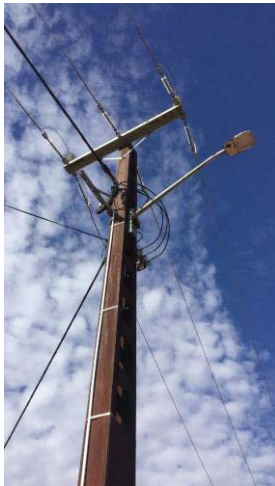
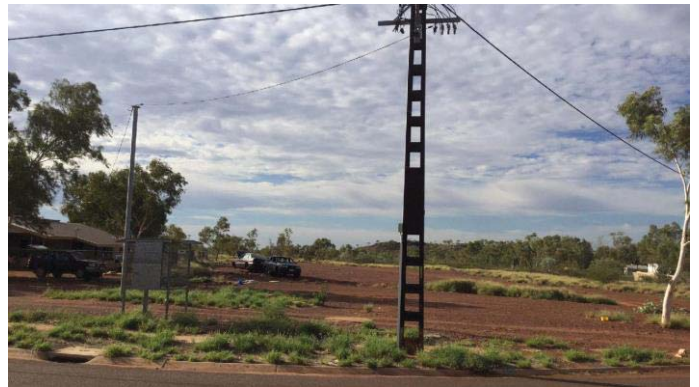
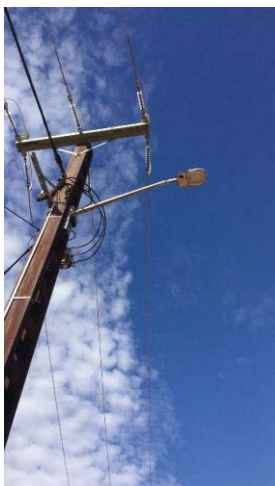
Inspection Date 1/12/2016 8:19:13 AM

What is the condition of pole: 3

Overhead Pole Comments: Surface rusted

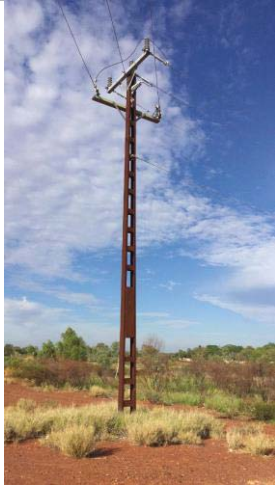
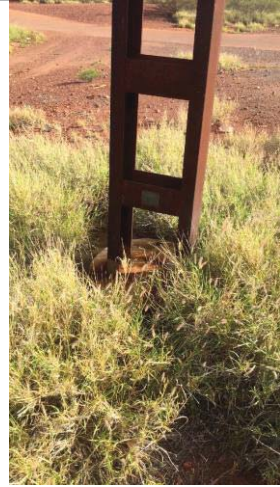
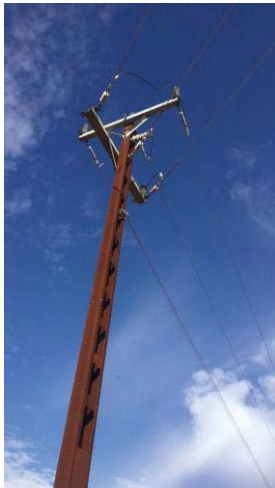
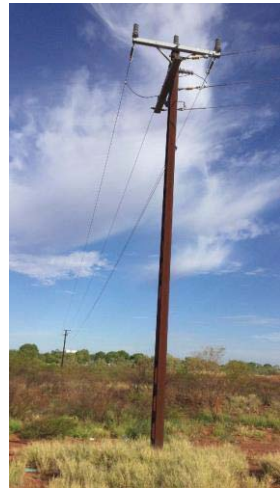
Inspection Date 1/12/2016 8:14:53 AM

What is Pole Material type:	Welded
What is the condition of pole:	3
How is the pole planted:	Concrete
What is the Condition of plant:	3
Is street light fitted:	Yes
Street Light Power Supply:	
Street Light Type	M125D 10
Street Light Watts	125
Street Light Condition	3
Street Light Height	
What is the type of service:	Three
What is the HV voltage level:	400
What is the arrangement of connected cables:	Twisted
Are there isolators on the pole:	No
What is the Condition:	3
How many Lots are connected to this pole:	2
Overhead Pole Comments:	Surface rusted

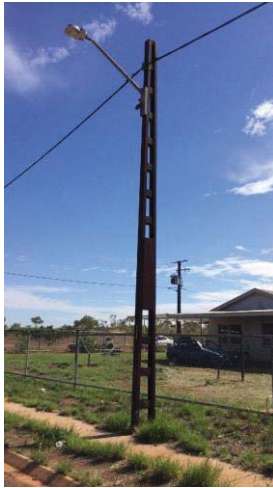
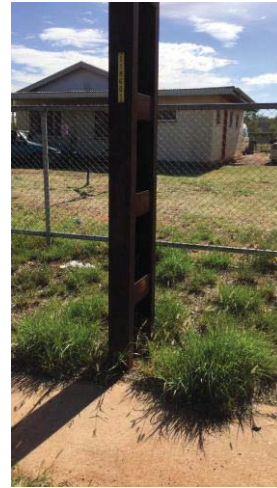
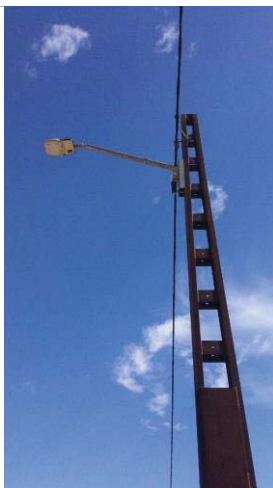
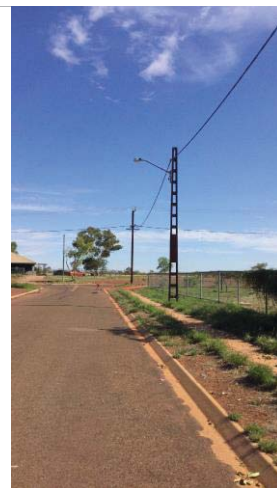
Street Light Condition 3

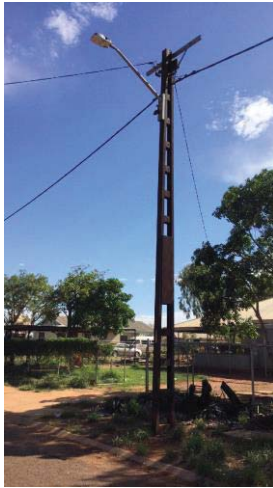
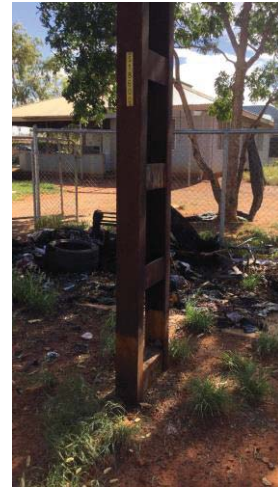
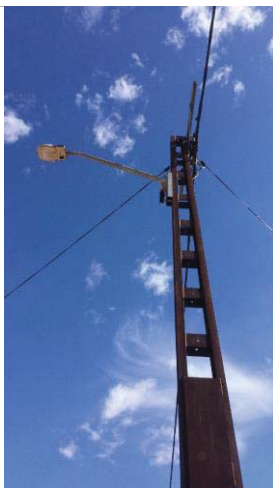
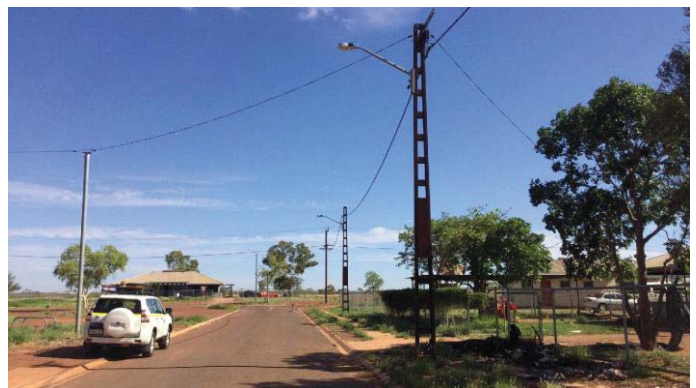
Street Light Condition 3

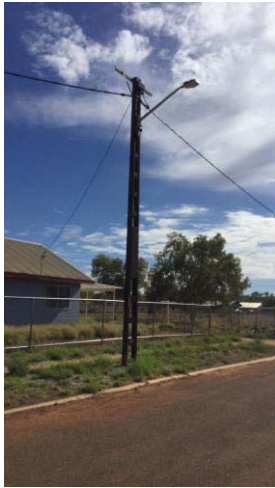
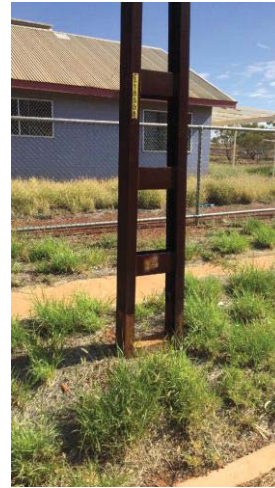
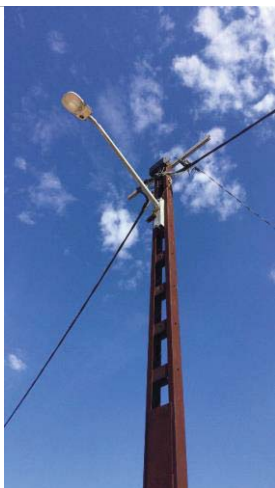
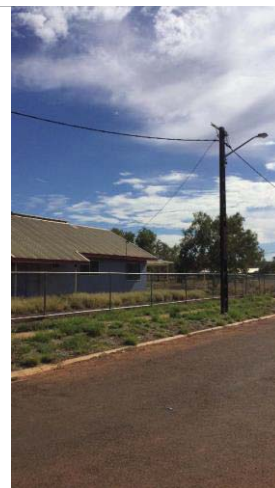
Street Light Condition 3

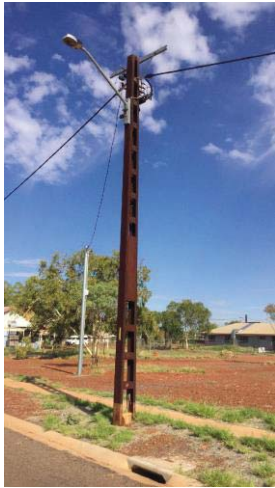
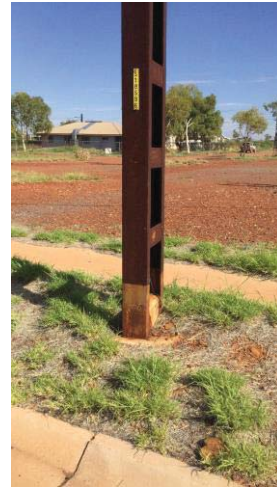
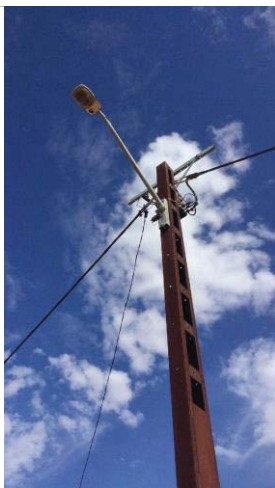
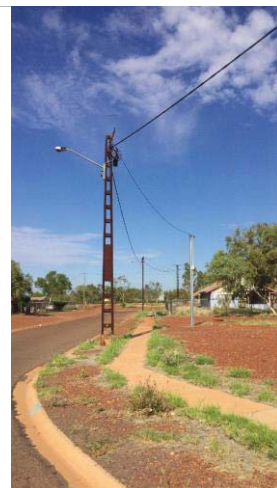
Street Light Condition 2

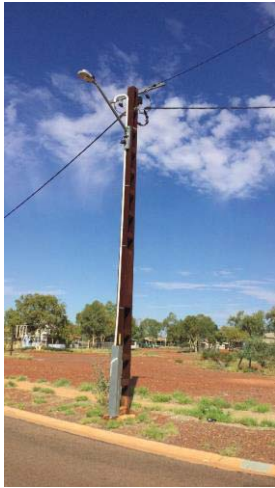
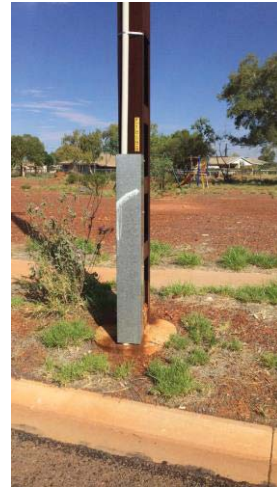
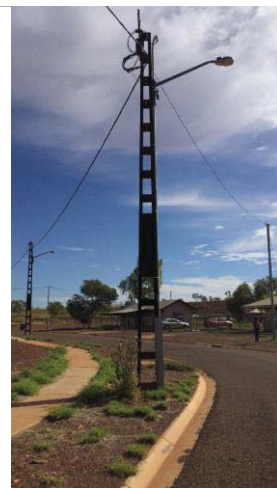
Street Light Condition 2

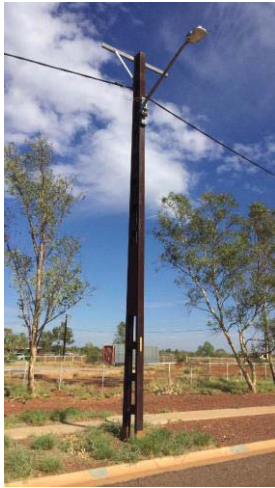
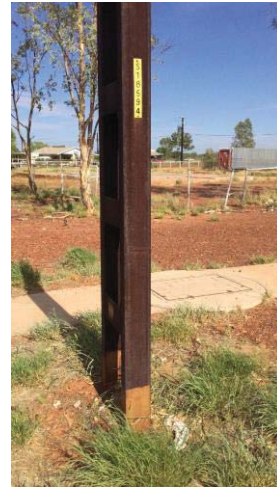
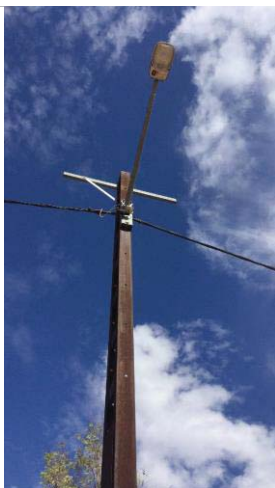
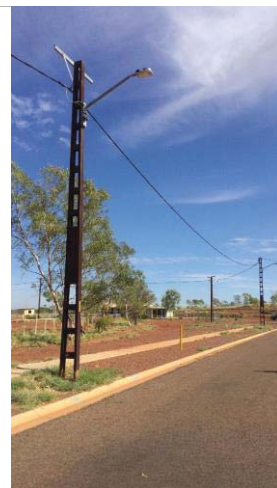
Street Light Condition 3

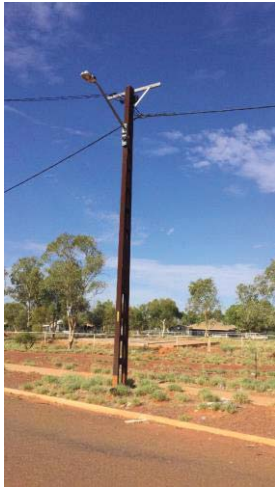
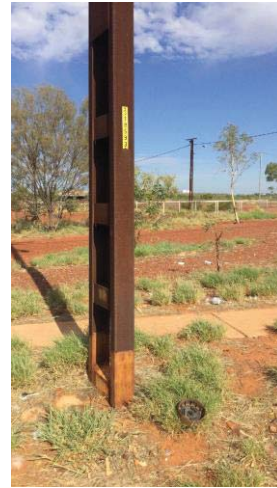
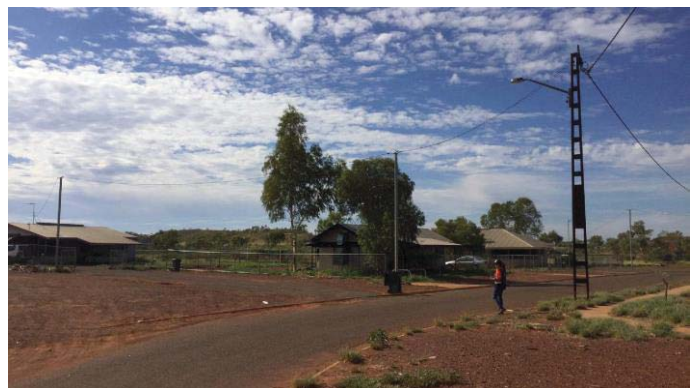
Street Light Condition 2

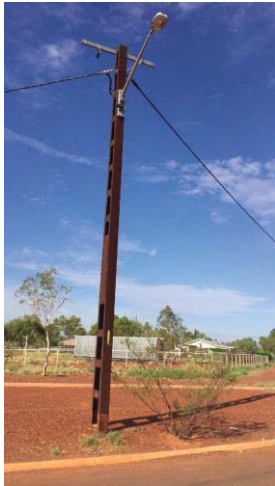
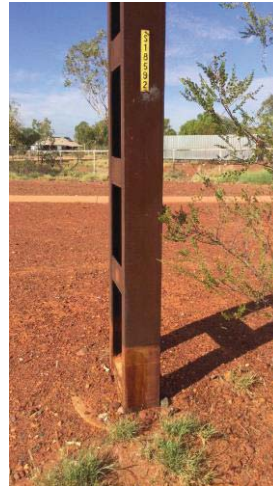
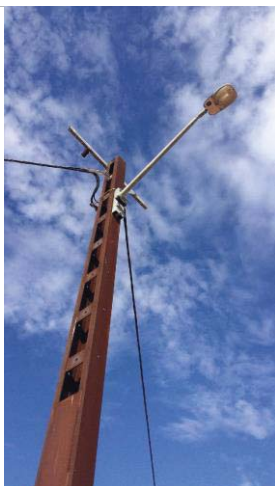
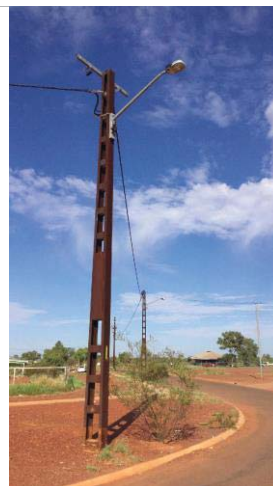
Street Light Condition 2

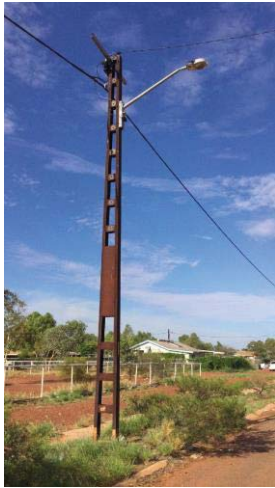
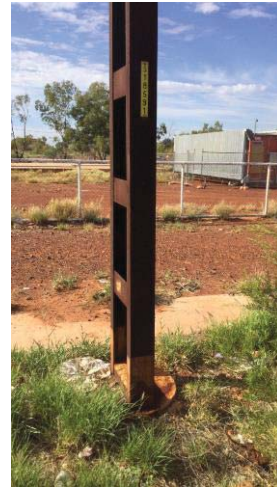
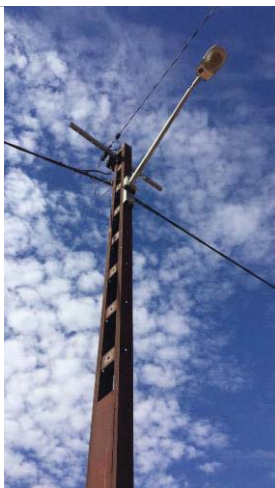
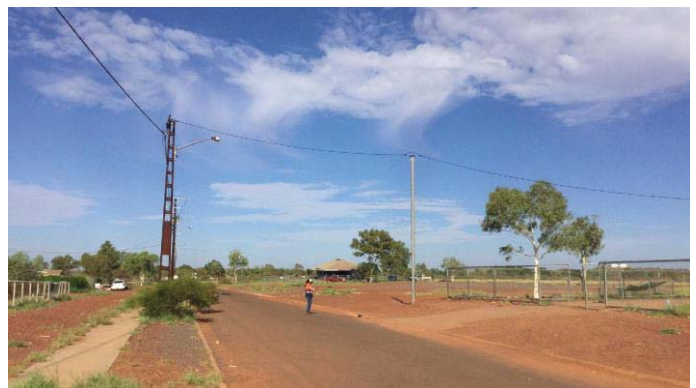
Street Light Condition 2

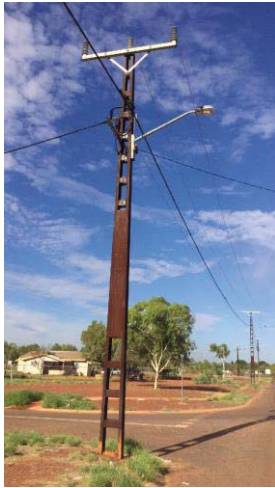
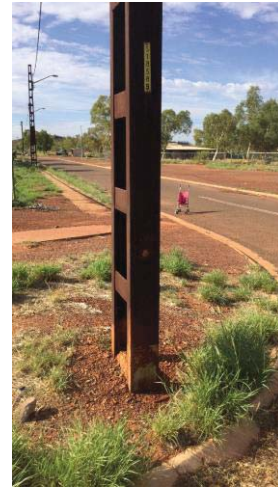
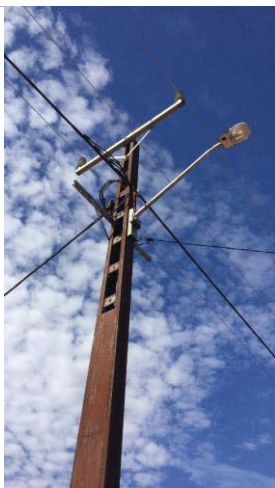
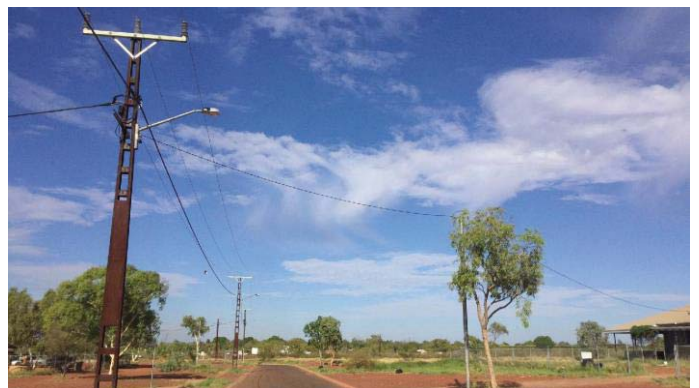
Street Light Condition 2

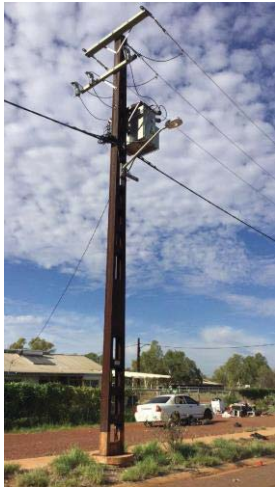
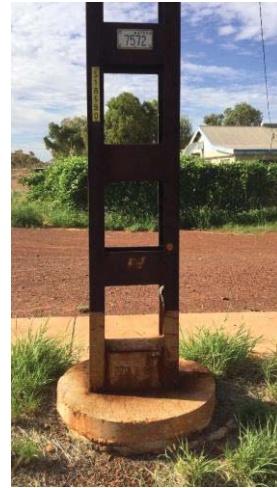
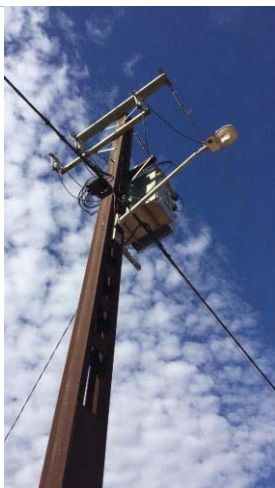
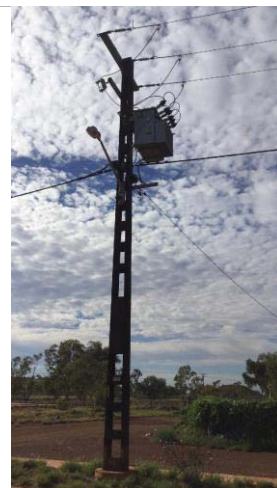
Street Light Condition 2
