# Northern Territory Town Camps

## Civil Infrastructure

Kargaru (East Side Camp)

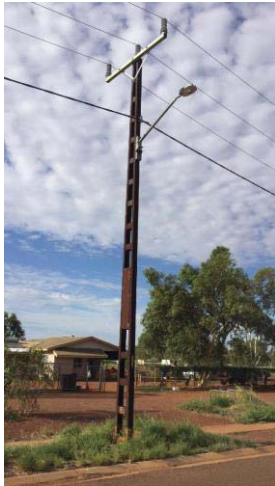
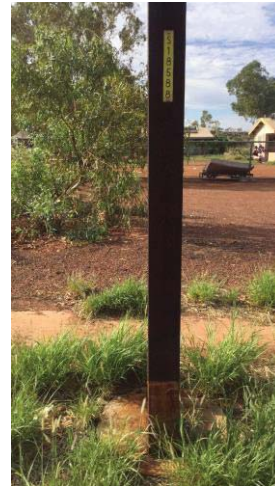
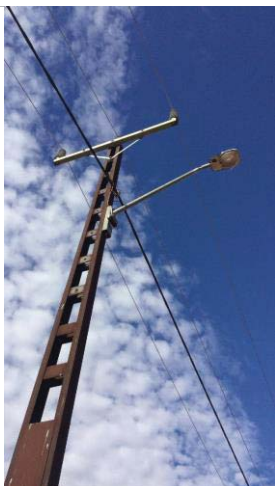
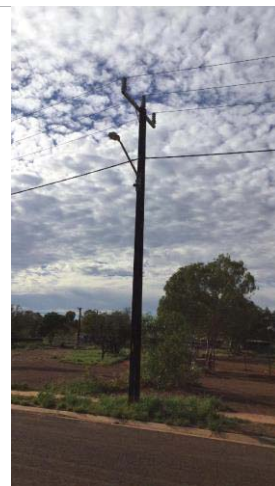
Street Light Condition 2

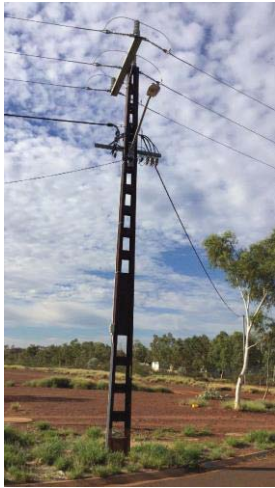
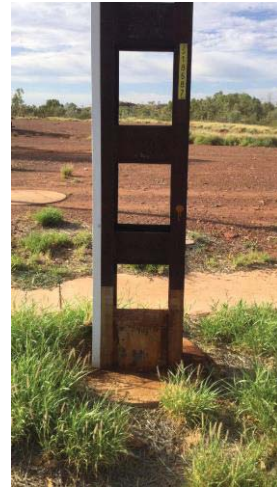
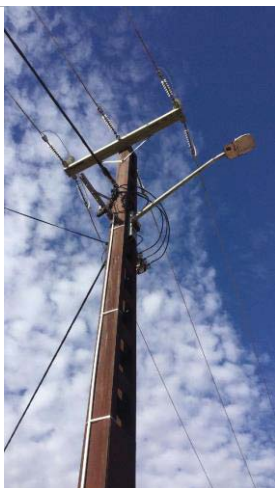
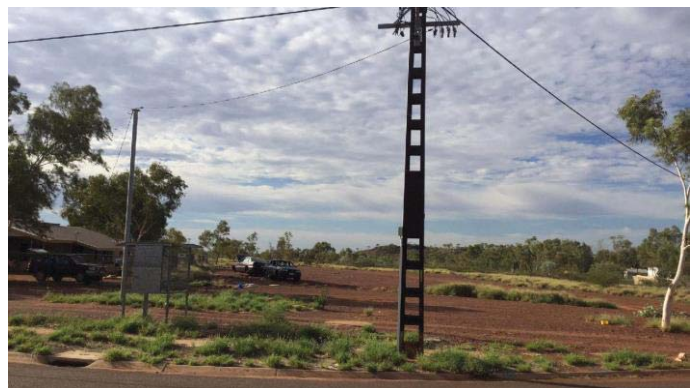
Street Light Condition 2

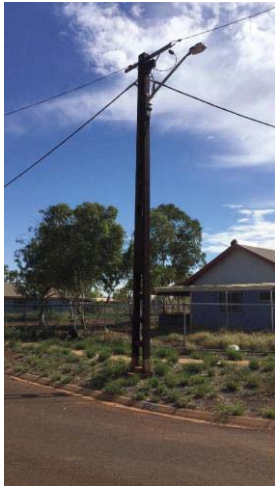
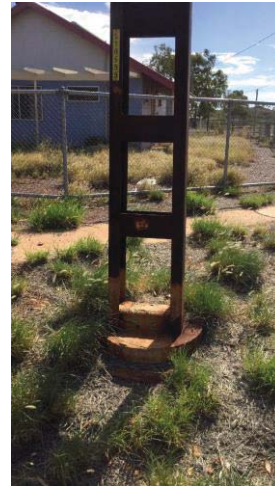
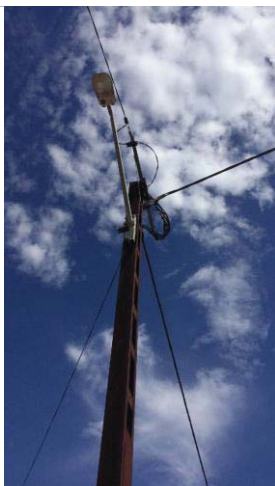
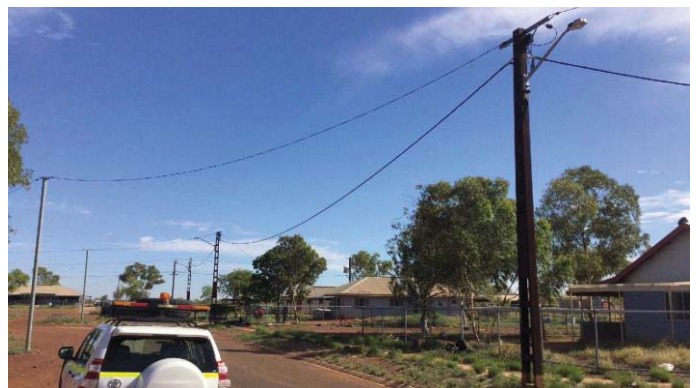
Street Light Condition 3

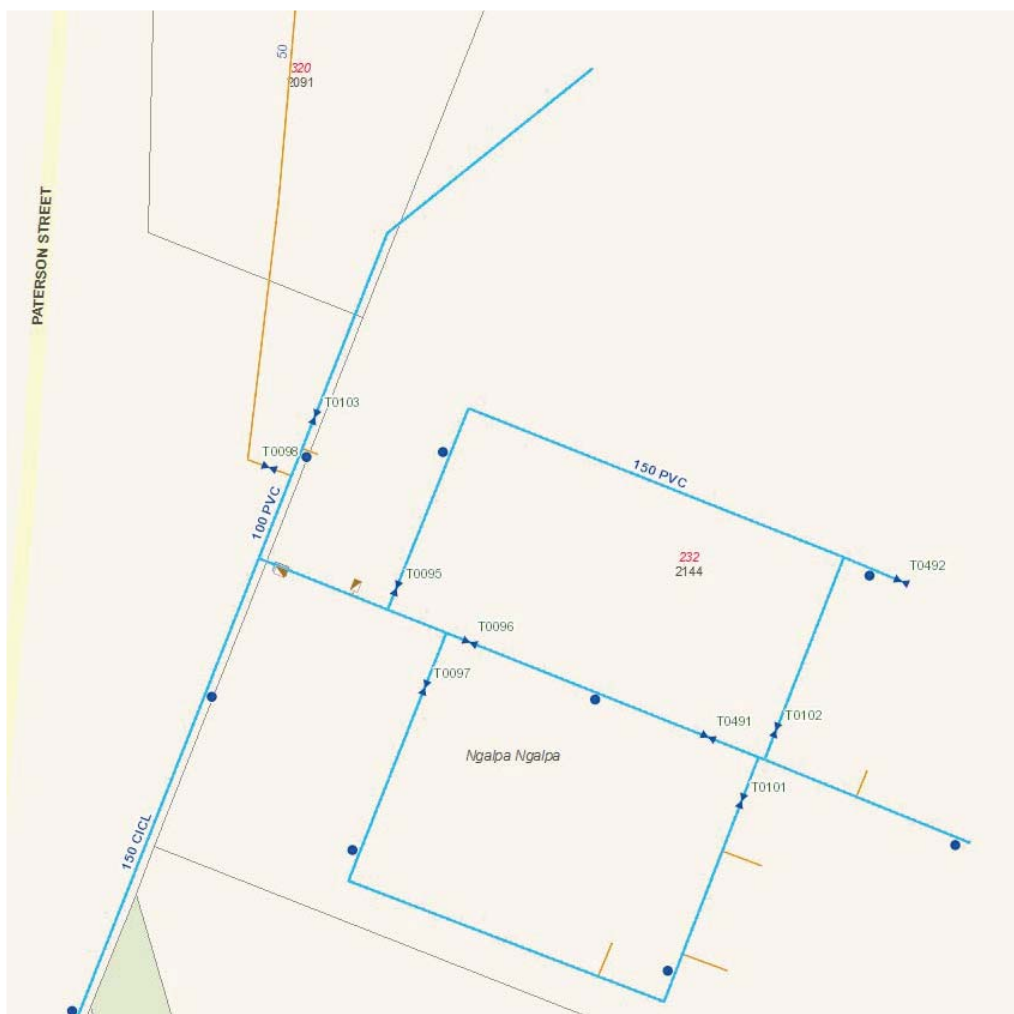
Figure 4 Ngalpa Ngalpa water main network

The water supply assets within Ngalpa Ngalpa are believed to be owned by Julalikari Housing Incorporated, but are the responsibility of Far North – T&J Contractors to maintain. The water is supplied from a DN150 PVC water main outside of the community, which is the responsibility of PWC. Figure 4 shows the extent of the water reticulation network

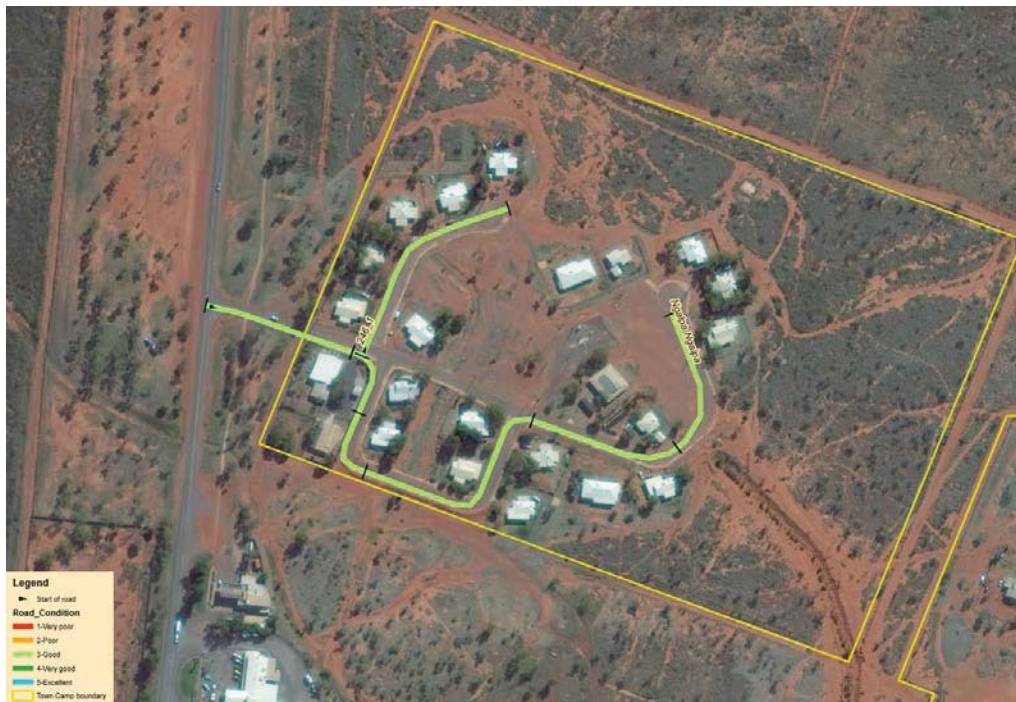
Figure 9 Ngalpa Ngalpa road network

Table 9 below details the condition of the roads within Ngalpa Ngalpa for specific segments. Figure 9 shows a map of the road network with the condition ratings, road name, and chainage direction. Note, the percentage refers to the percentage of that particular road segment which experiences the defect.

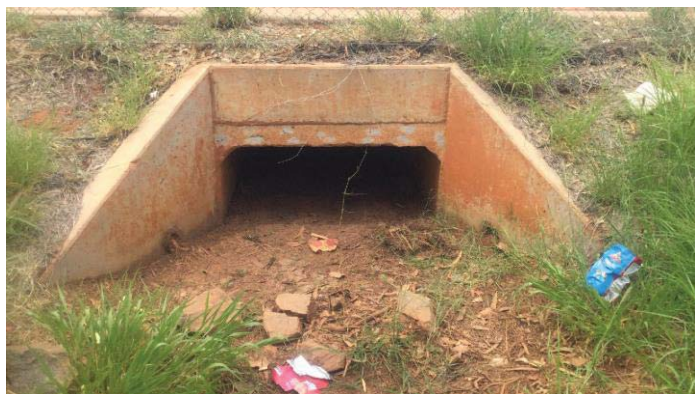
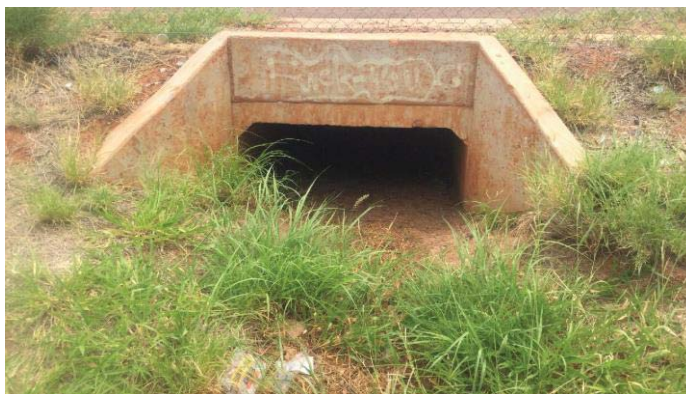
Stormwater Infrastructure:	Culverts
Culvert Type:	RCBC
Diameter (mm):	
Width (mm):	1200
Culvert Depth (mm):	600
Culvert Length (m):	13
Culvert Condition:	3 - Good
Culvert Blockage (%):	30
Culvert Comments:	
Culvert Head Wall:	Yes
Safety Grate:	No
Headwall Blockage:	
Headwall Condition:	3 - Good
Headwall Comment:	
End Wall:	Yes
End Wall condition:	3 - Good
EW Comment:

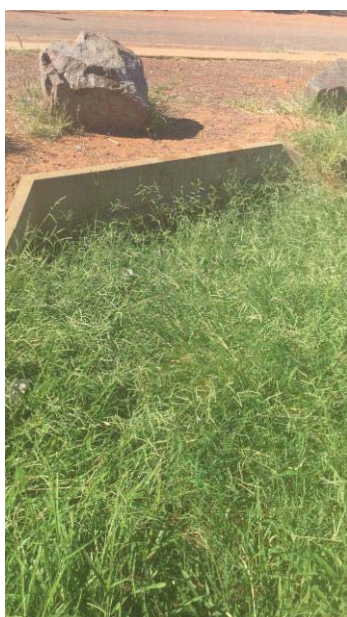
Stormwater Infrastructure:	Culverts
Culvert Type:	RCBC
Diameter (mm):	
Width (mm):	1200
Culvert Depth (mm):	600
Culvert Length (m):	
Culvert Condition:	3 - Good
Culvert Blockage (%):	
Culvert Comments:	Couldn't confirm size
Culvert Head Wall:	Yes
Safety Grate:	Yes
Headwall Blockage:	50
Headwall Condition:	3 - Good
Headwall Comment:	
End Wall:	No Access
End Wall condition:	
EW Comment:

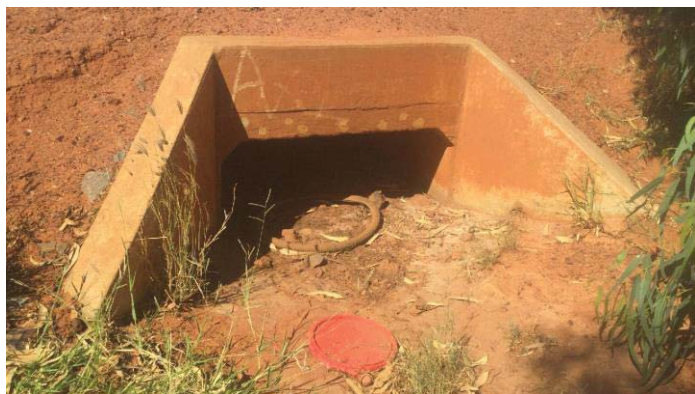
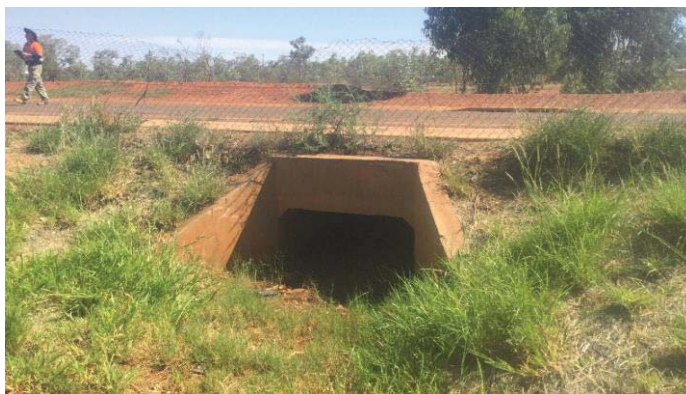
Stormwater Infrastructure:	Culverts
Culvert Type:	RCBC
Diameter (mm):	
Width (mm):	1200
Culvert Depth (mm):	600
Culvert Length (m):	14
Culvert Condition:	3 - Good
Culvert Blockage (%):	20
Culvert Comments:	
Culvert Head Wall:	Yes
Safety Grate:	No
Headwall Blockage:	
Headwall Condition:	3 - Good
Headwall Comment:	
End Wall:	Yes
End Wall condition:	3 - Good
EW Comment:

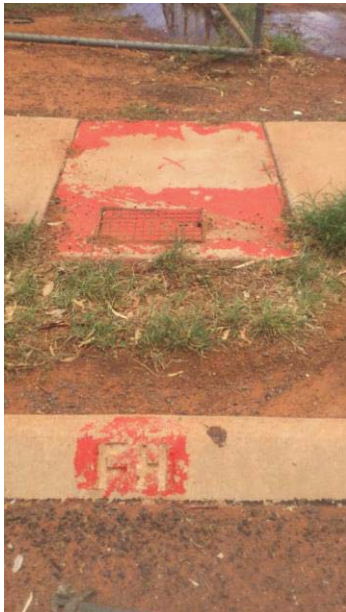
FH Condition: 2 - Poor

FH Comment: Paint peeling

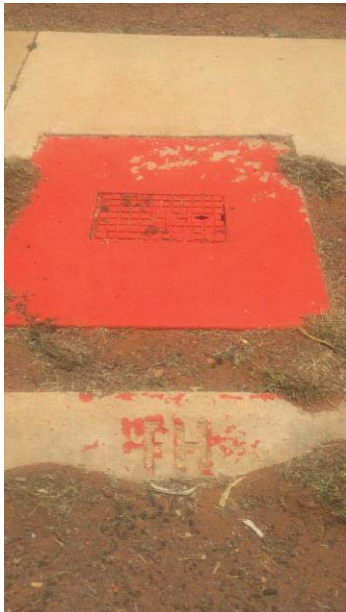
FH Condition: 3 - Good

FH Comment: Paint peeling

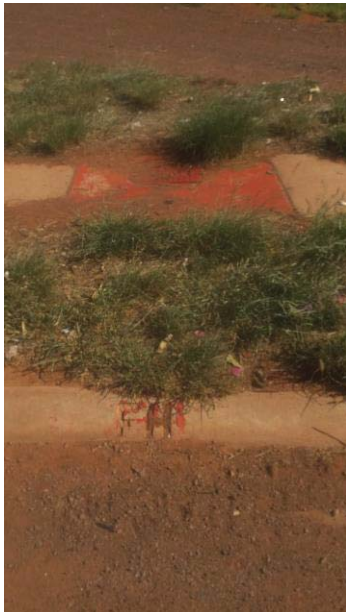
**FH Condition:** 3 - Good

**FH Comment:** Paint fading

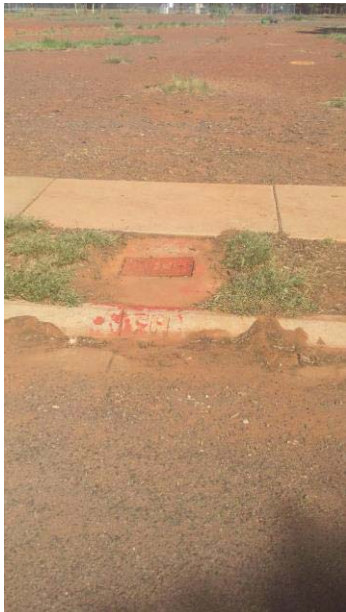
FH Condition: 2 - Poor

FH Comment: Paint faded, lid not sitting properly

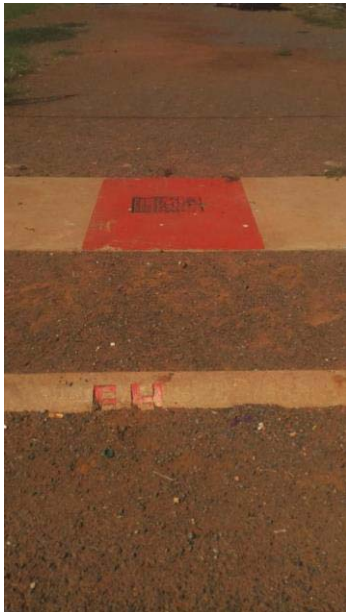
FH Condition: 3 - Good

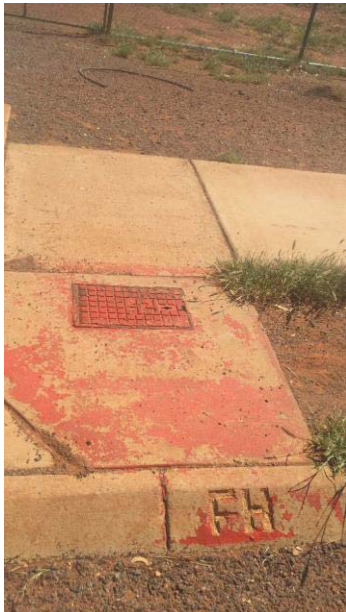
FH Condition: 3 - Good

FH Comment: Paint faded

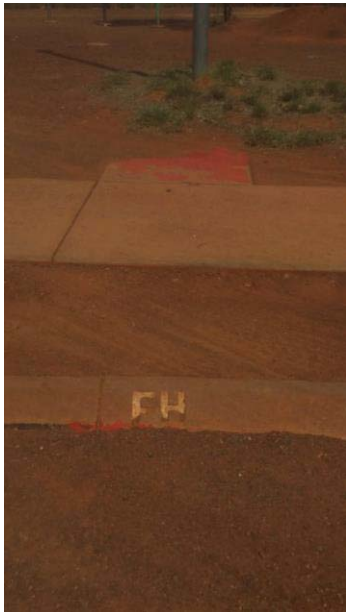
FH Condition: 3 - Good

FH Comment: Paint peeling. Covered with dirt

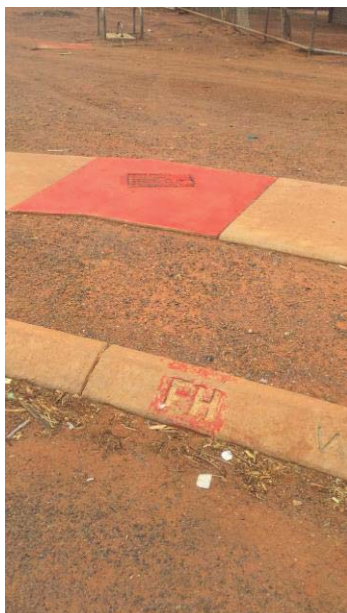
**FH Condition:** 4 - Very Good

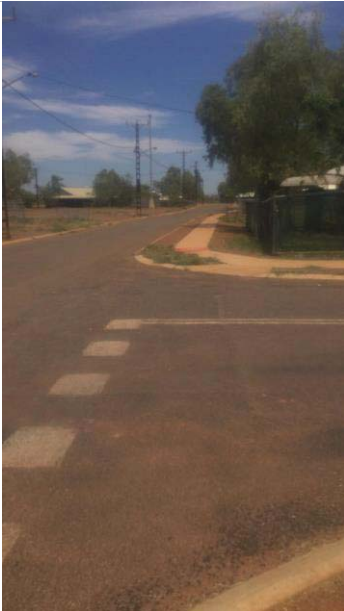
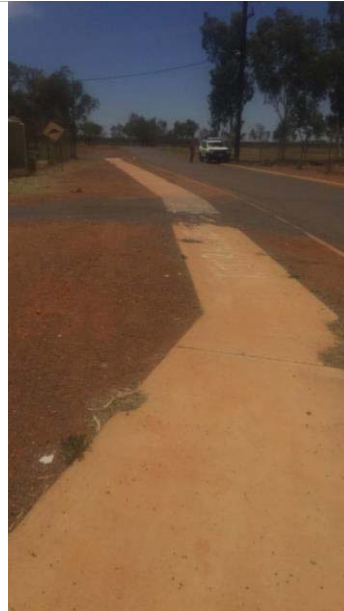
Footpath Condition: 4 - Very Good

Comment: Needs tidy up

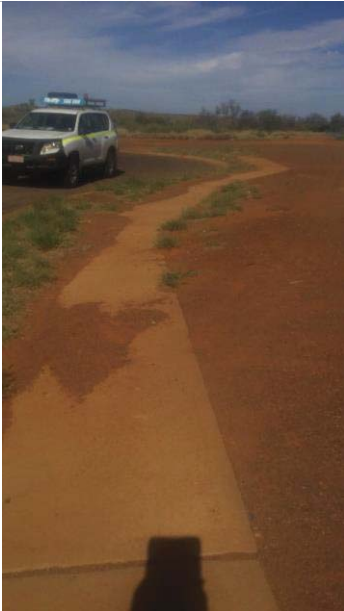
Footpath Condition: 3 - Good

Comment: Needs tidy up

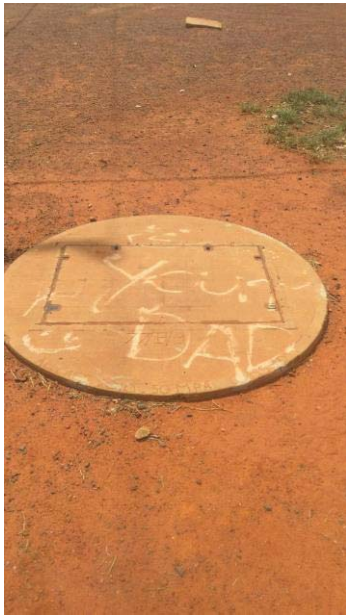
Notes on Lid: 77/B/3

Manhole Condition: 3 - Good

Comments: Graffiti

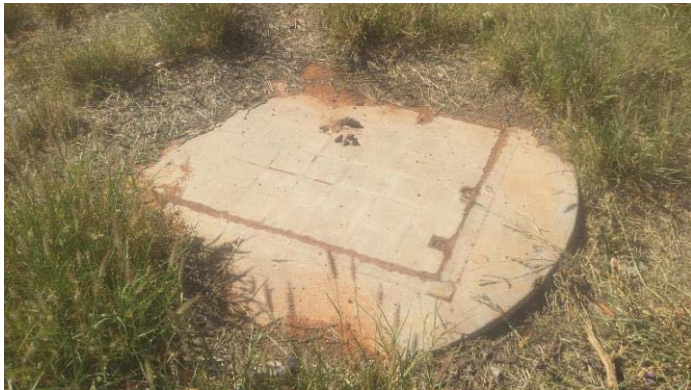
Manhole Condition: 3 - Good

Comments: Overgrown

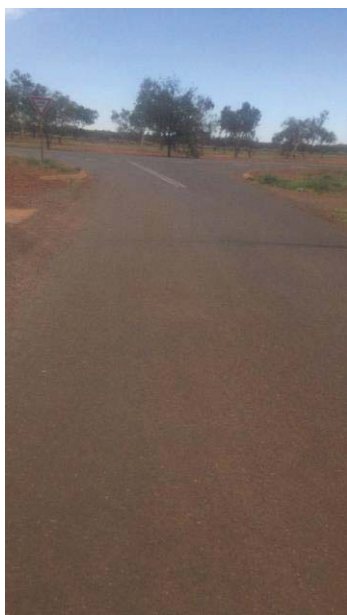
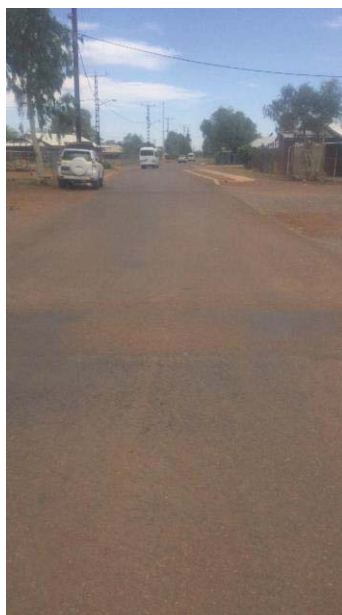
Road Condition: 3 - Good

Defect Type	Defect QTY	Defect Condition	Defect Comments
General Appearance		2 - Poor	Road looks old, no major defects

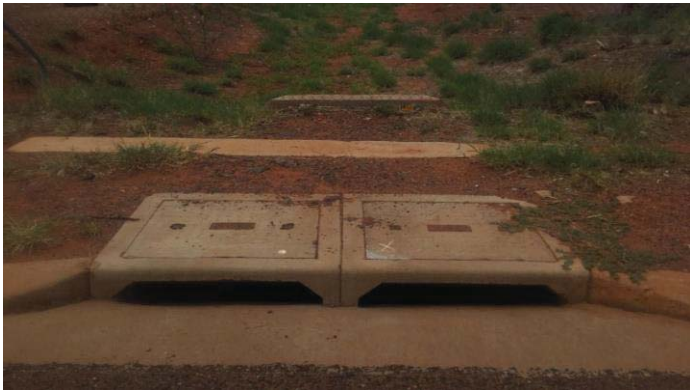
Stormwater Infrastructure: SEP  
Number of Bays: 2  
On grade or sag pit:  
Both sides of road: Left  
Condition: 4 - Very Good  
Blockage (%): 0  
Comment:

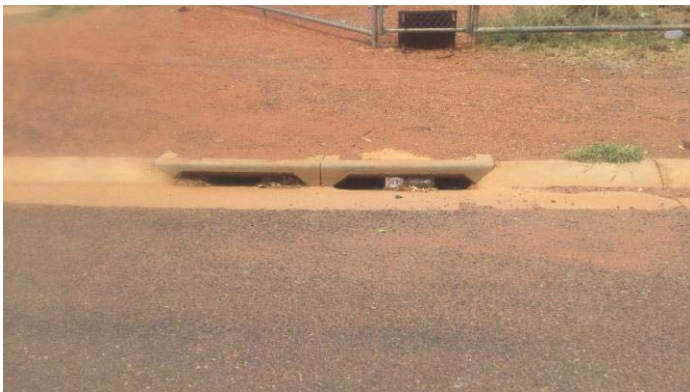
Stormwater Infrastructure: SEP  
Number of Bays: 2  
On grade or sag pit:  
Both sides of road: Left  
Condition: 3 - Good  
Blockage (%): 20  
Comment:

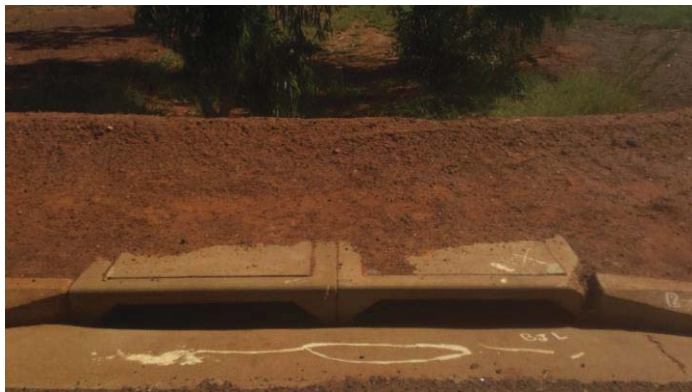
Stormwater Infrastructure: SEP  
Number of Bays: 2  
On grade or sag pit:  
Both sides of road: Right  
Condition: 3 - Good  
Blockage (%):  
Comment:

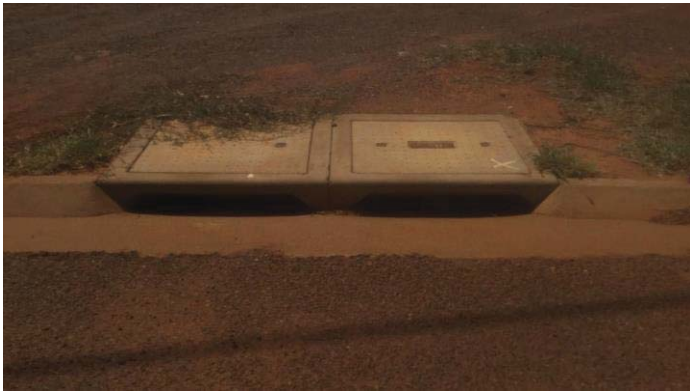
Stormwater Infrastructure: SEP  
Number of Bays: 2  
On grade or sag pit:  
Both sides of road: Left  
Condition: 4 - Very Good  
Blockage (%): 5  
Comment:

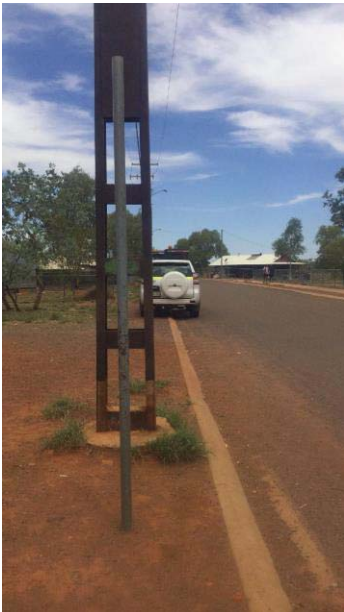
Sign Condition: 1 - Very Poor

Sign Comment: No sign

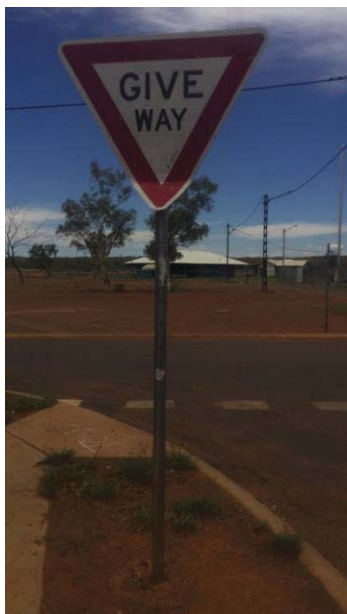
Sign Condition: 2 - Poor

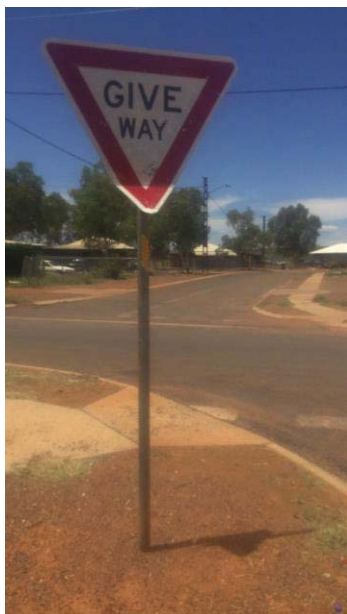
Sign Condition: 2 - Poor

Sign Comment: Bent & has graffiti

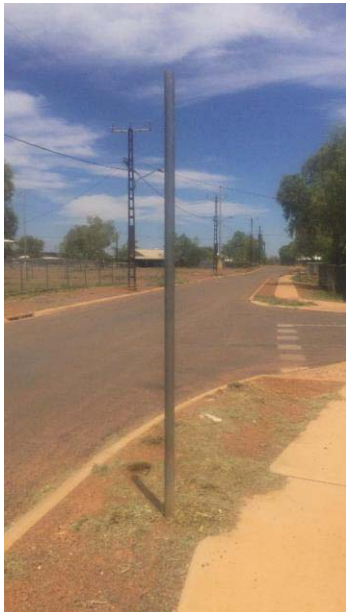
Sign Condition: 1 - Very Poor

Sign Comment: No sign

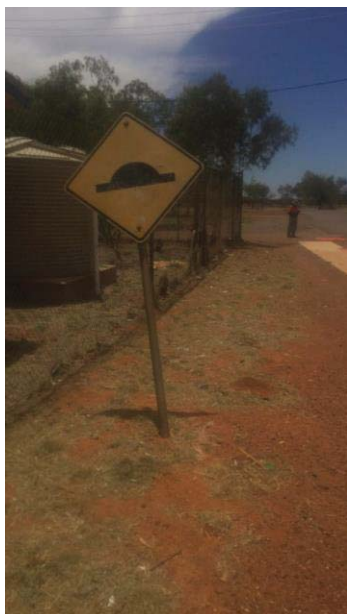
Sign Condition: 2 - Poor

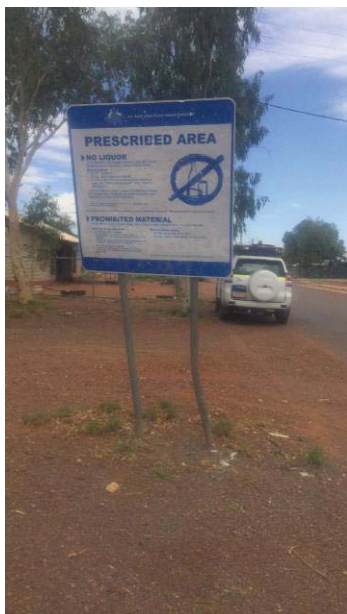
Sign Condition: 2 - Poor

Sign Comment: Graffiti, on a lean , old

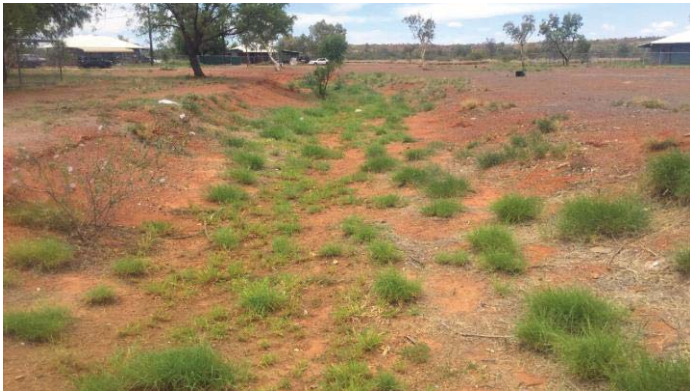
Stormwater Infrastructure:	Swales
Type of lining:	Natural Grasses
Are dimensions uniform along drain:	No
Base Width (m):	3
Overall Width (m):	12
Swale Depth (m):	1.5
Length of Batter 1 (m):	
Length of Batter 2 (m):	
Swale Condition:	3 - Good
Swale Ponding:	No
Drain flooded at time of inspection:	No
Swale Comments:	Approximate dimensions

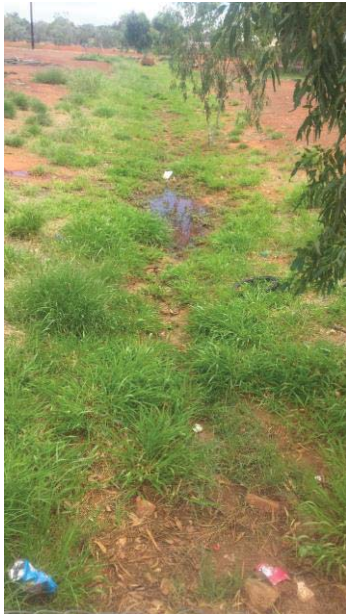
Stormwater Infrastructure:	Swales
Type of lining:	Natural Grasses
Are dimensions uniform along drain:	No
Base Width (m):	1
Overall Width (m):	15
Swale Depth (m):	1.5
Length of Batter 1 (m):	
Length of Batter 2 (m):	
Swale Condition:	3 - Good
Swale Ponding:	Yes
Drain flooded at time of inspection:	No
Swale Comments:	Approximate dimensions

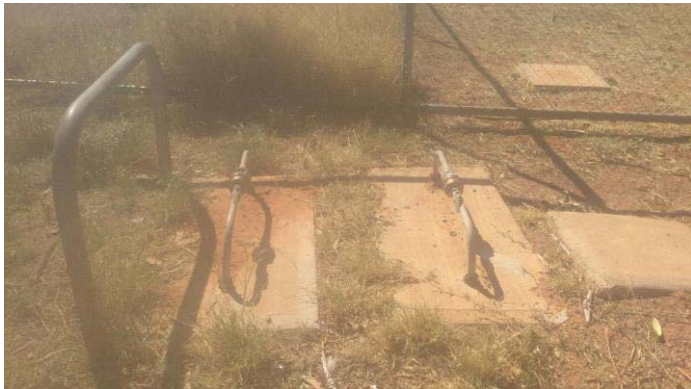
Lot Water Meter Condition: 3 - Good

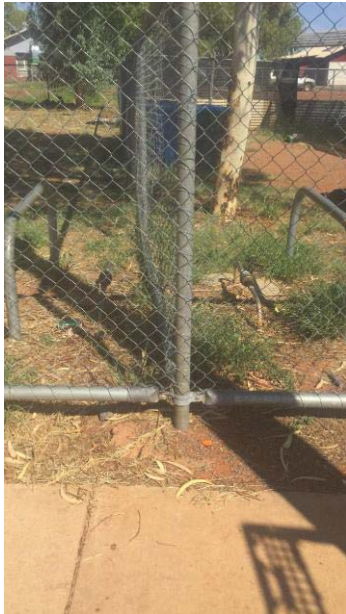
Lot Water Meter Condition: 3 - Good

Lot Water Meter Comment: Two water meters, one in each lot

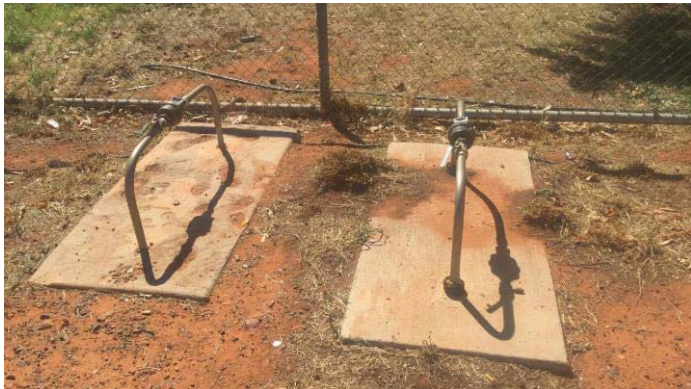
Lot Water Meter Condition: 3 - Good

Lot Water Meter Comment: Two water meters, in road verge

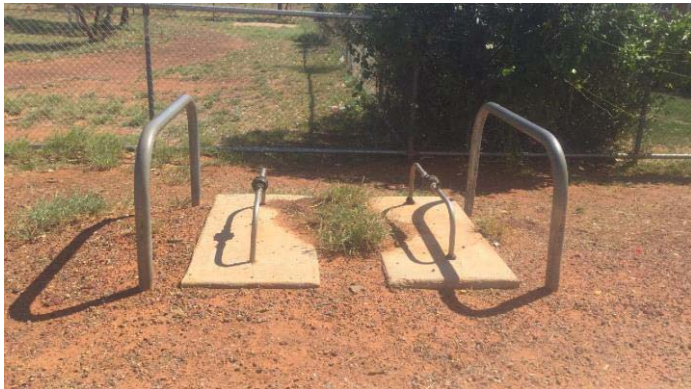
Lot Water Meter Condition: 3 - Good

Lot Water Meter Comment: In road verge , two meters

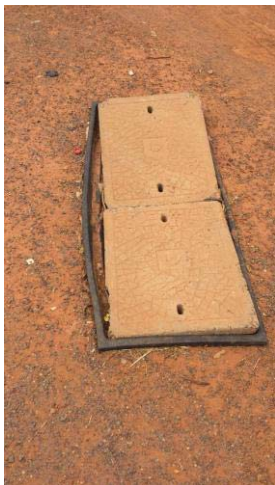
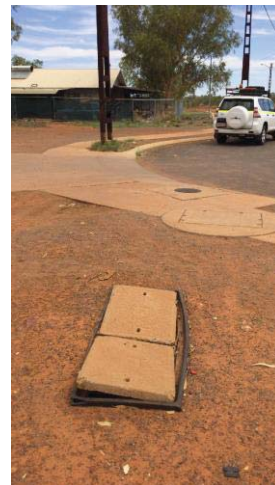
What is Pit Condition: 2

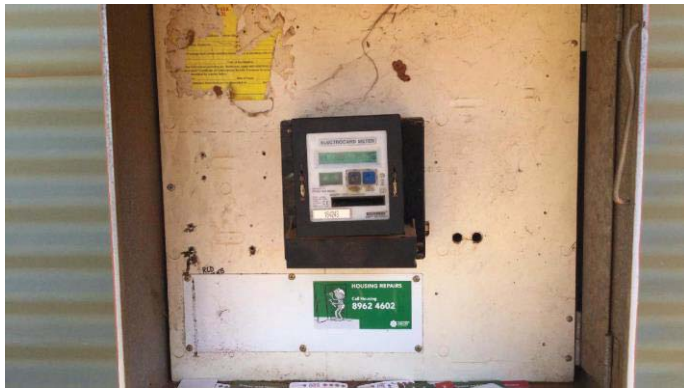
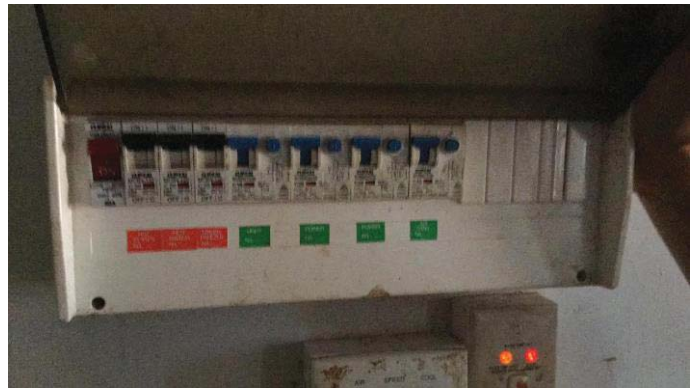
Meter Condition: 3

Meter Comment: Condition of CB not assessed. Indoor SB, Cond 3

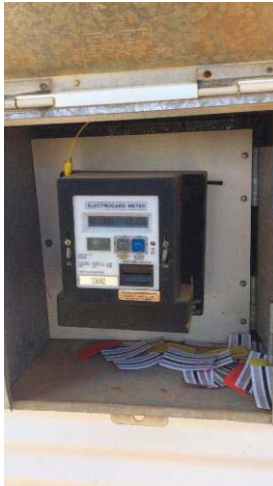
Meter Condition: 4

Meter Comment: Condition of CB not assessed.

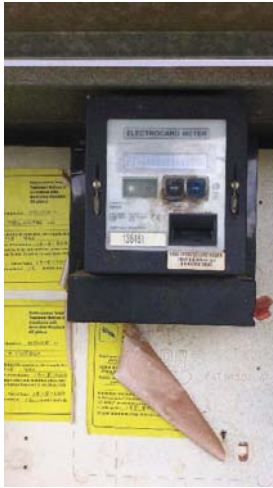
Meter Condition: 3

Meter Comment: Condition of CB not assessed. Indoor SB, Cond 2, Blank plates are missing on CB slot.

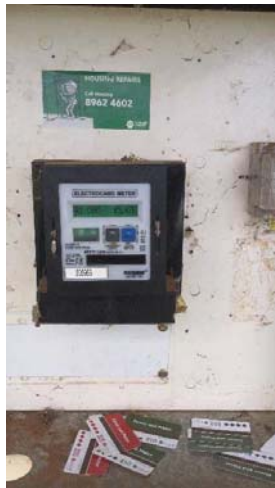
Meter Condition: 3

Meter Comment: Indoor SB, Cond 3

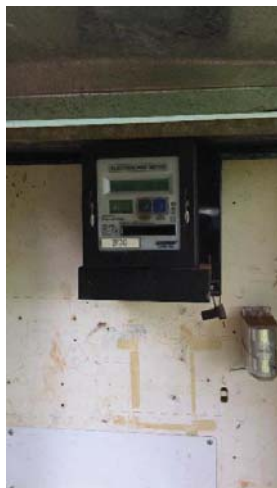
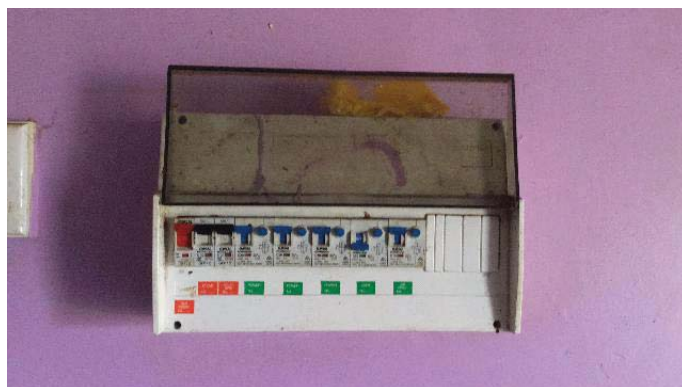
Meter Condition: 3

Meter Comment: Indoor SB, Cond 3

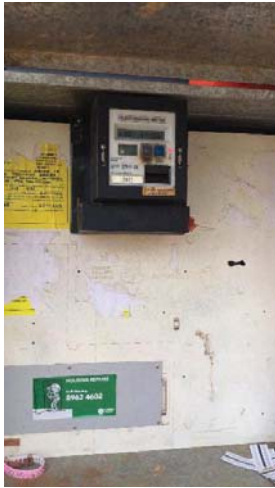
Meter Condition: 3

Meter Comment: Indoor SB, Cond 3

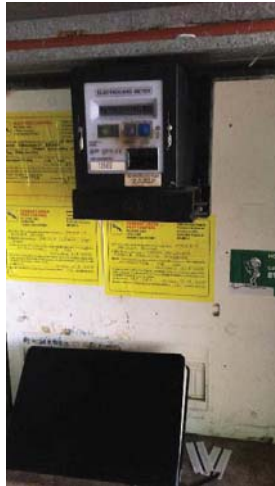
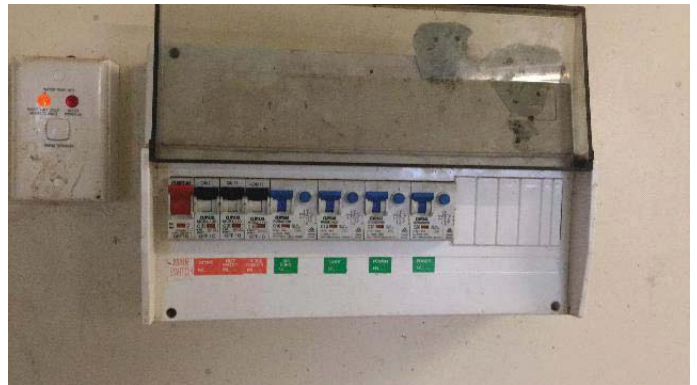
Meter Condition: 3

Meter Comment: Condition of CB not assessed. Indoor SB, Cond 3

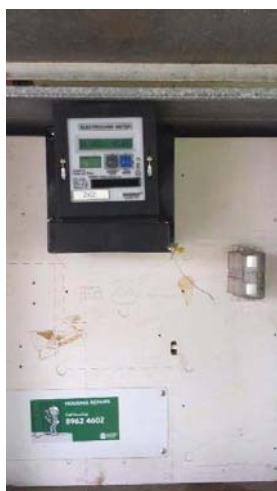
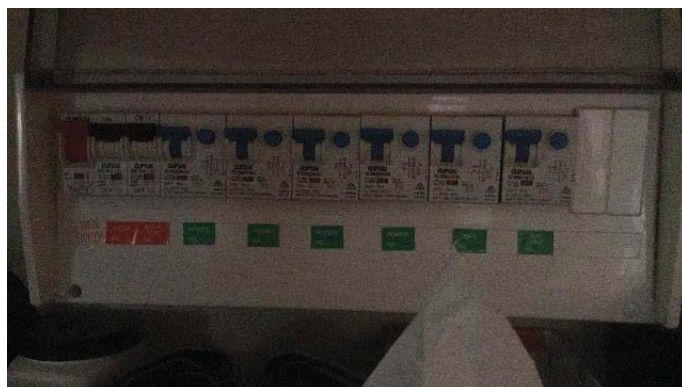
Meter Condition: 3

Meter Comment: Indoor SB, Cond 3

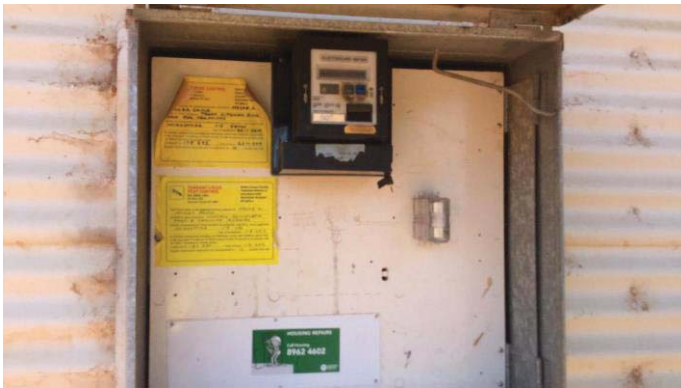
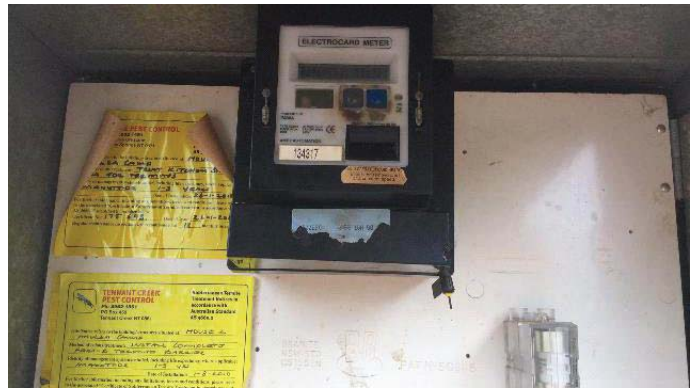
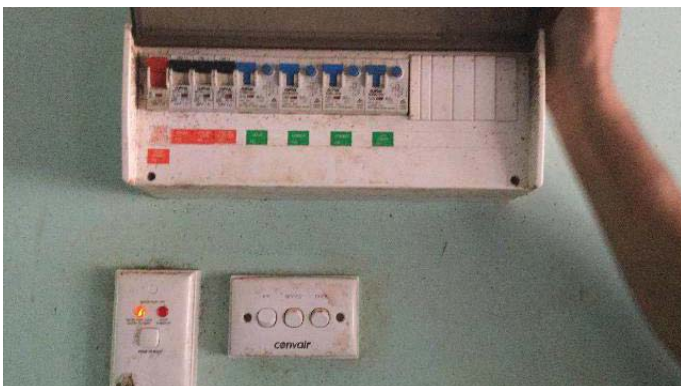
Meter Condition: 3

Meter Comment: Indoor SB, Cond 3

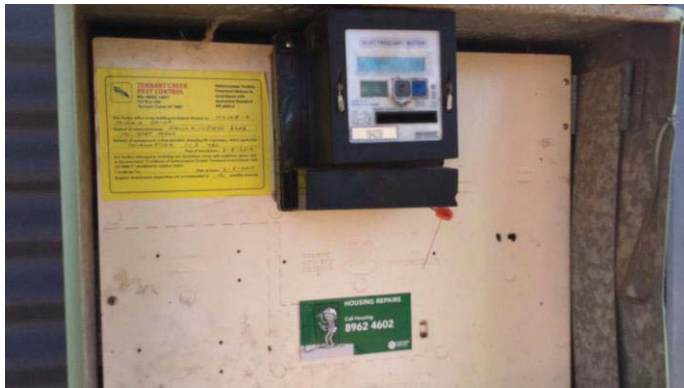
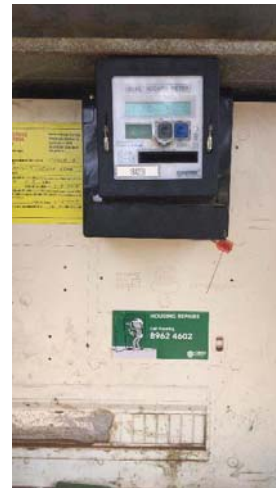
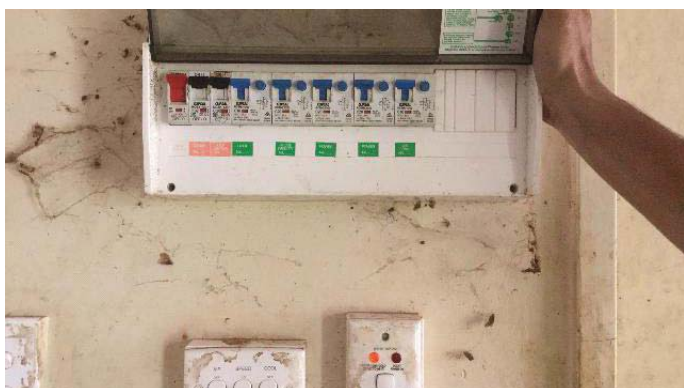
Meter Type: Prepaid  
Meter Switchboard Cond: 3  
Meter Condition: 3  
Meter Comment: Indoor SB, Cond 3  
Comments:

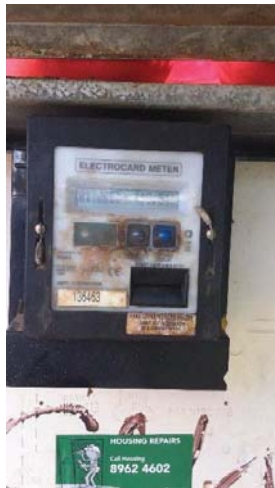
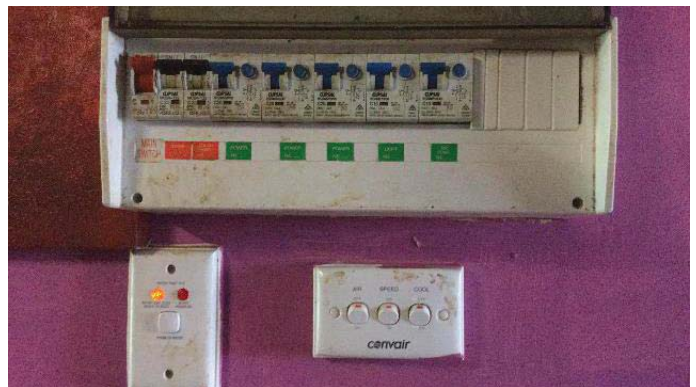
Meter Condition: 3

Meter Comment: Condition of CB not assessed. Indoor SB, Cond 3

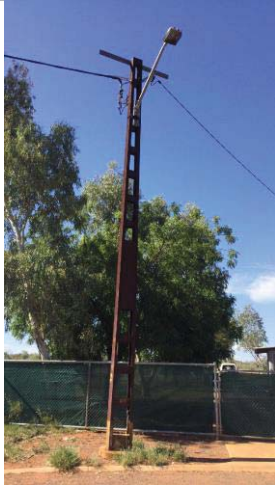
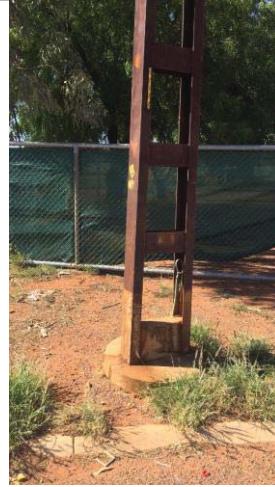
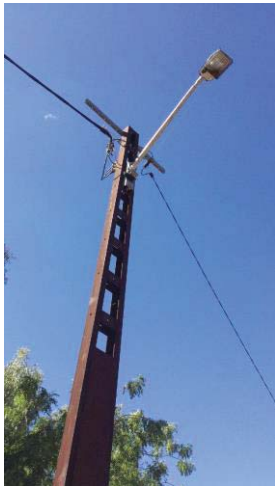
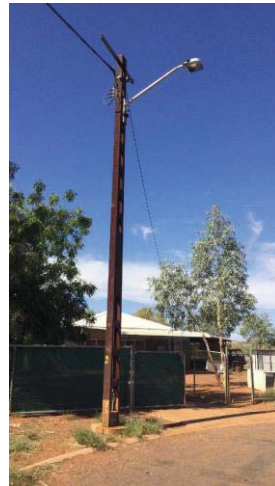
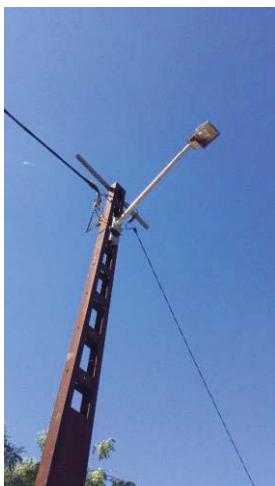
What is Pole Material type:	Welded
What is the condition of pole:	3
How is the pole planted:	Concrete
What is the Condition of plant:	3
Is street light fitted:	Yes
Street Light Power Supply:	
Street Light Type	M125D 10
Street Light Watts	125
Street Light Condition	2
Street Light Height	
What is the type of service:	Three
What is the HV voltage level:	400
What is the arrangement of connected cables:	Twisted
Are there isolators on the pole:	No
What is the Condition:	3
How many Lots are connected to this pole:	1
Overhead Pole Comments:	Surface rusted

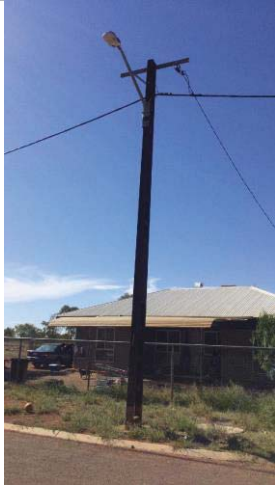
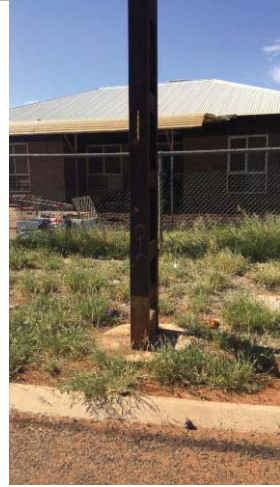
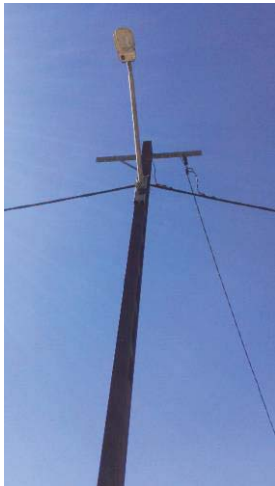
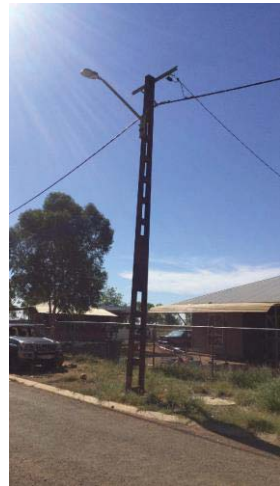
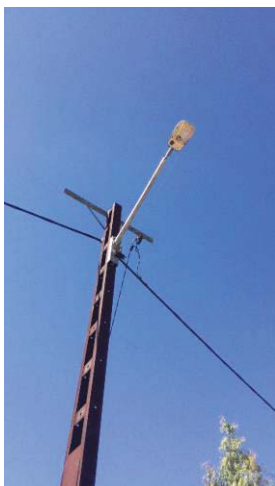
What is Pole Material type:	Welded
What is the condition of pole:	3
How is the pole planted:	Concrete
What is the Condition of plant:	3
Is street light fitted:	Yes
Street Light Power Supply:	
Street Light Type	M125D 10
Street Light Watts	125
Street Light Condition	2
Street Light Height	
What is the type of service:	Three
What is the HV voltage level:	400
What is the arrangement of connected cables:	Twisted
Are there isolators on the pole:	No
What is the Condition:	3
How many Lots are connected to this pole:	1
Overhead Pole Comments:	Surface rusted

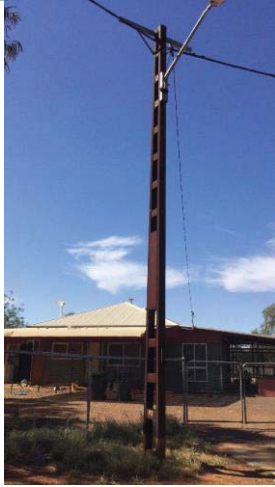
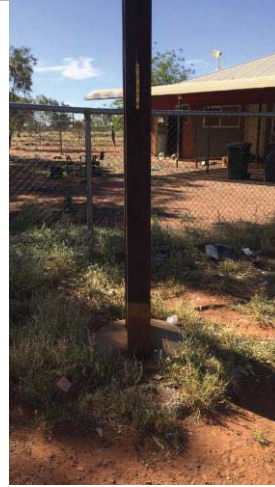
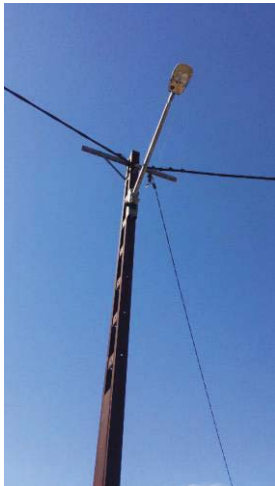
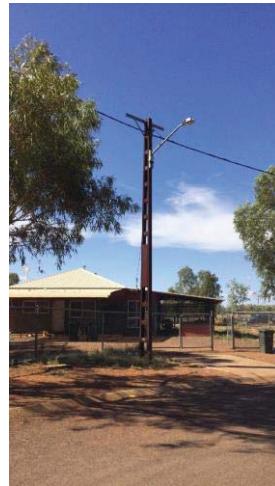
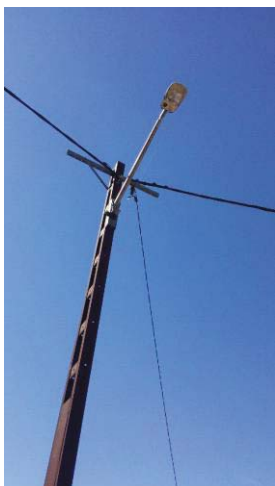
What is Pole Material type:	Welded
What is the condition of pole:	3
How is the pole planted:	Concrete
What is the Condition of plant:	3
Is street light fitted:	Yes
Street Light Power Supply:	
Street Light Type	M125D 10
Street Light Watts	125
Street Light Condition	3
Street Light Height	
What is the type of service:	Three
What is the HV voltage level:	400
What is the arrangement of connected cables:	Twisted
Are there isolators on the pole:	No
What is the Condition:	3
How many Lots are connected to this pole:	1
Overhead Pole Comments:	Surface rusted

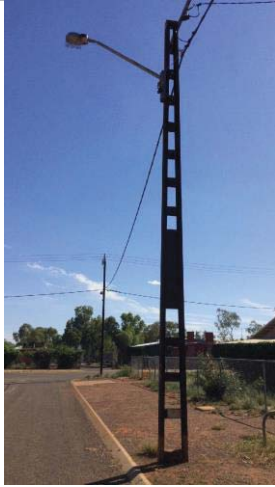
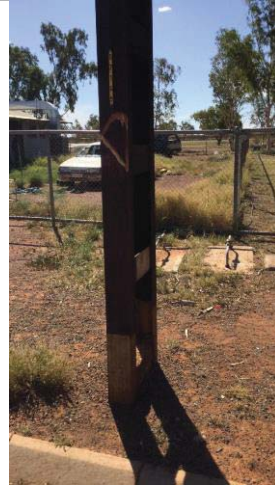
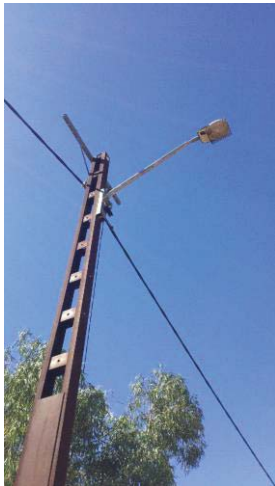
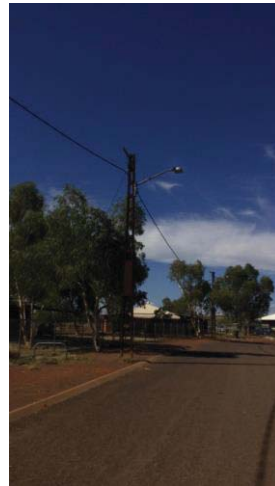
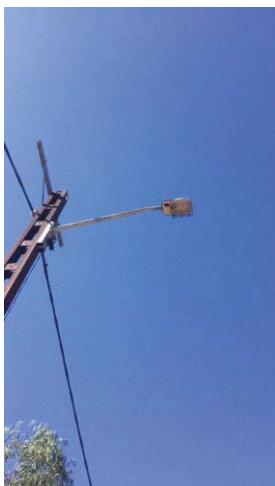
What is Pole Material type:	Welded
What is the condition of pole:	3
How is the pole planted:	Concrete
What is the Condition of plant:	3
Is street light fitted:	Yes
Street Light Power Supply:	
Street Light Type	M125D 10
Street Light Watts	125
Street Light Condition	3
Street Light Height	
What is the type of service:	Three
What is the HV voltage level:	400
What is the arrangement of connected cables:	Twisted
Are there isolators on the pole:	No
What is the Condition:	3
How many Lots are connected to this pole:	1
Overhead Pole Comments:	Surface rusted

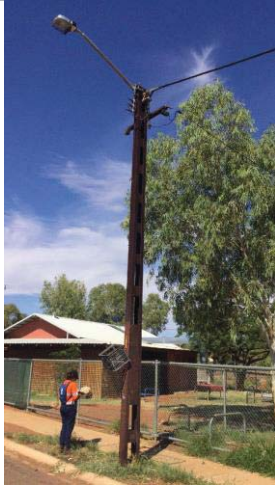
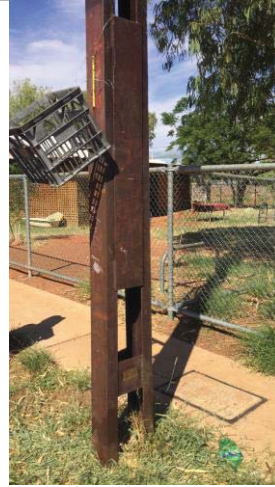
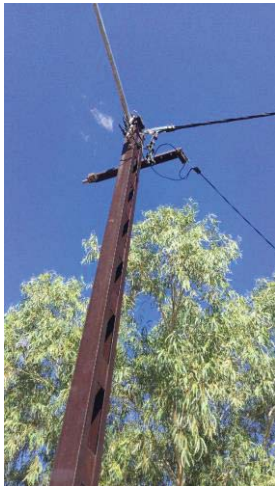
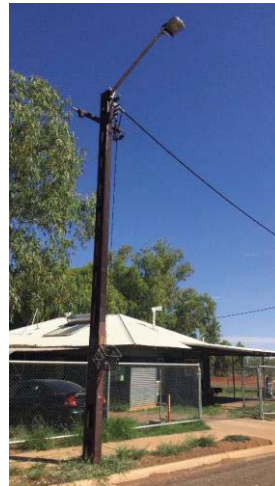
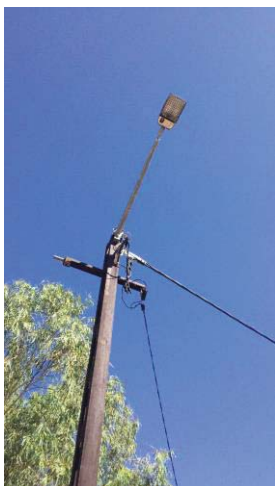
What is Pole Material type:	Welded
What is the condition of pole:	3
How is the pole planted:	Concrete
What is the Condition of plant:	3
Is street light fitted:	Yes
Street Light Power Supply:	
Street Light Type	S70D 14
Street Light Watts	70
Street Light Condition	3
Street Light Height	
What is the type of service:	Three
What is the HV voltage level:	400
What is the arrangement of connected cables:	Twisted
Are there isolators on the pole:	No
What is the Condition:	3
How many Lots are connected to this pole:	1
Overhead Pole Comments:	Surface rusted

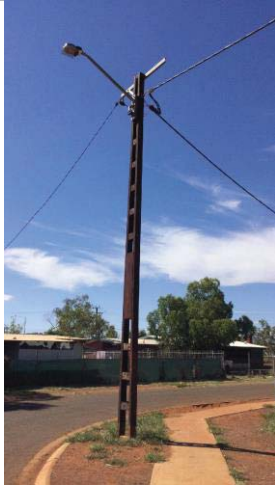
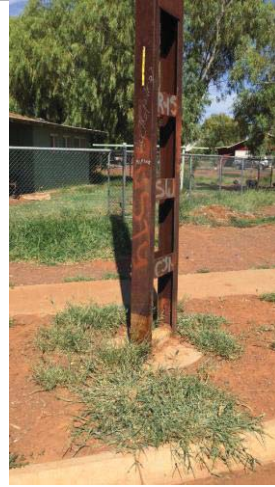
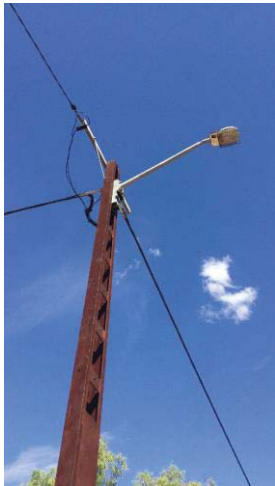
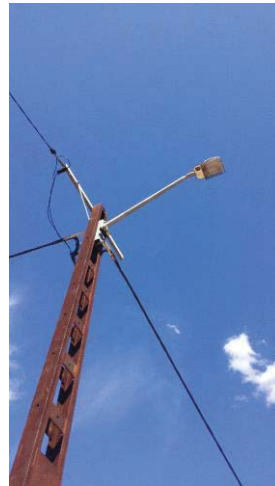
What is Pole Material type:	Welded
What is the condition of pole:	3
How is the pole planted:	Concrete
What is the Condition of plant:	3
Is street light fitted:	Yes
Street Light Power Supply:	
Street Light Type	S70D 13
Street Light Watts	70
Street Light Condition	2
Street Light Height	
What is the type of service:	Three
What is the HV voltage level:	400
What is the arrangement of connected cables:	Twisted
Are there isolators on the pole:	No
What is the Condition:	3
How many Lots are connected to this pole:	1
Overhead Pole Comments:	Surface rusted
