# Northern Territory Town Camps

## Civil Infrastructure

Kargaru (East Side Camp)

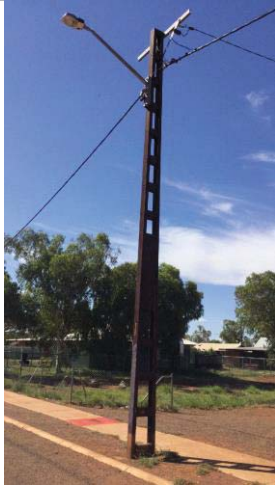
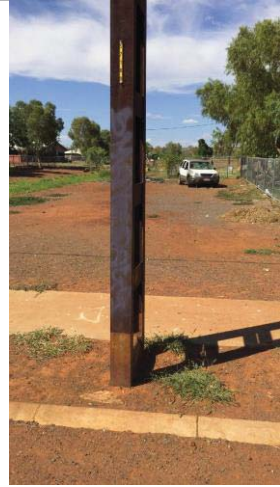
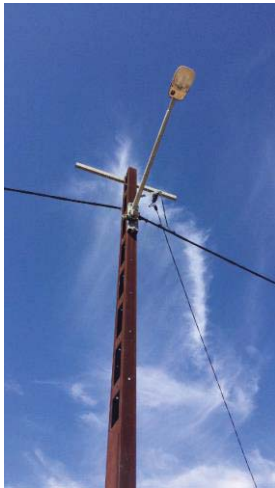
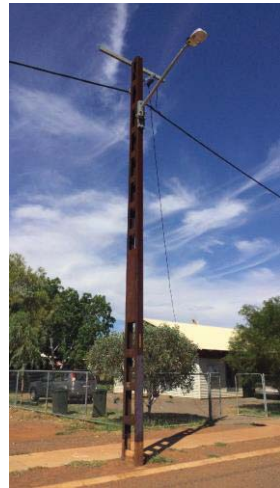
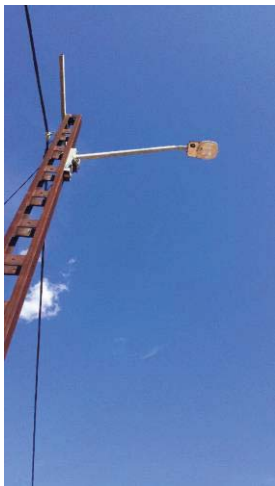
What is Pole Material type:	Welded
What is the condition of pole:	3
How is the pole planted:	Concrete
What is the Condition of plant:	3
Is street light fitted:	Yes
Street Light Power Supply:	
Street Light Type	S70D 14
Street Light Watts	70
Street Light Condition	2
Street Light Height	
What is the type of service:	Three
What is the HV voltage level:	400
What is the arrangement of connected cables:	Twisted
Are there isolators on the pole:	No
What is the Condition:	3
How many Lots are connected to this pole:	1
Overhead Pole Comments:	Surface rusted

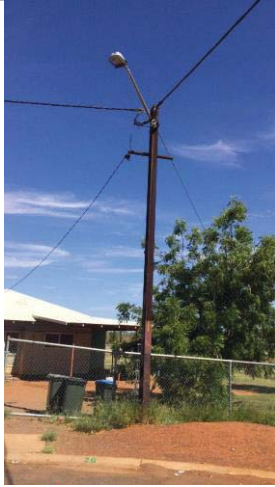
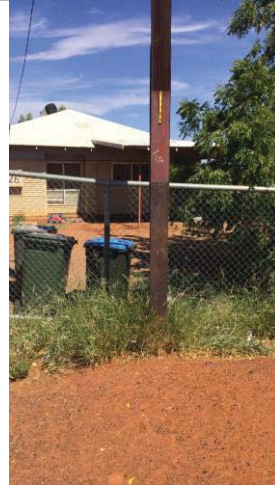
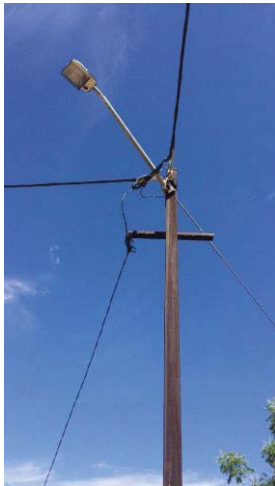
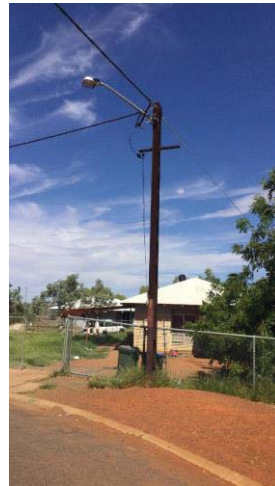
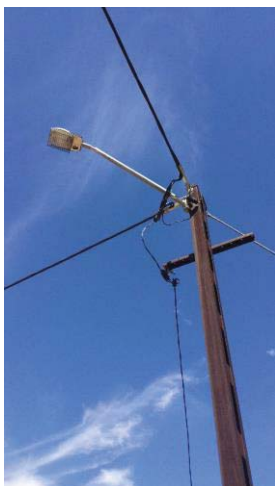
What is Pole Material type:	Welded
What is the condition of pole:	3
How is the pole planted:	Concrete
What is the Condition of plant:	3
Is street light fitted:	Yes
Street Light Power Supply:	
Street Light Type	S70D 12
Street Light Watts	70
Street Light Condition	3
Street Light Height	
What is the type of service:	Three
What is the HV voltage level:	400
What is the arrangement of connected cables:	Twisted
Are there isolators on the pole:	
What is the Condition:	3
How many Lots are connected to this pole:	1
Overhead Pole Comments:	Surface rusted

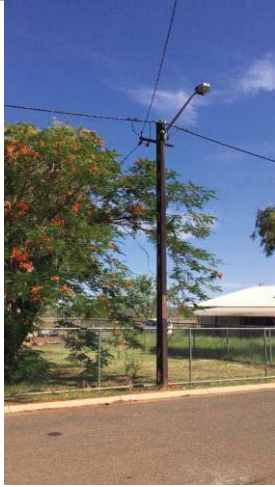
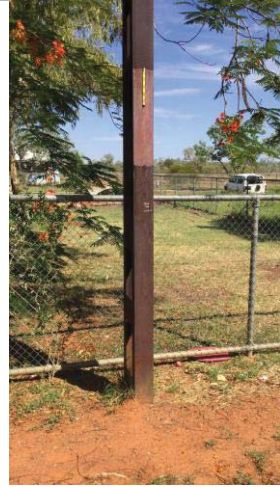
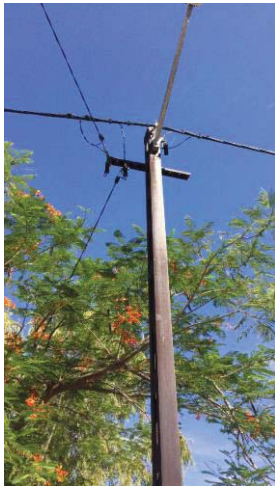
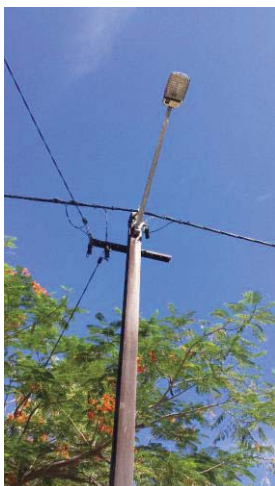
What is Pole Material type:	Welded
What is the condition of pole:	3
How is the pole planted:	Concrete
What is the Condition of plant:	3
Is street light fitted:	Yes
Street Light Power Supply:	
Street Light Type	S70D 13
Street Light Watts	70
Street Light Condition	3
Street Light Height	
What is the type of service:	Three
What is the HV voltage level:	400
What is the arrangement of connected cables:	Twisted
Are there isolators on the pole:	No
What is the Condition:	3
How many Lots are connected to this pole:	2
Overhead Pole Comments:	Surface rusted

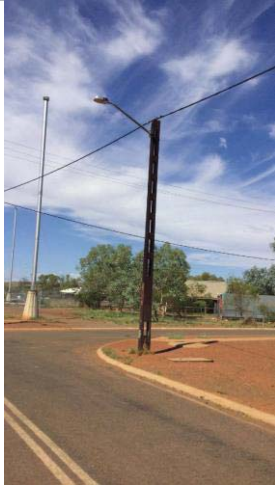
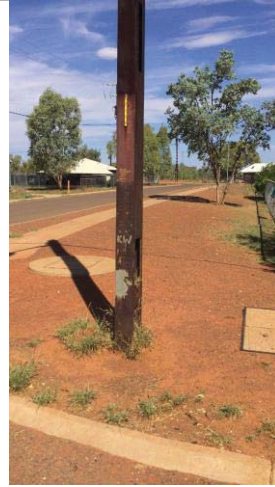
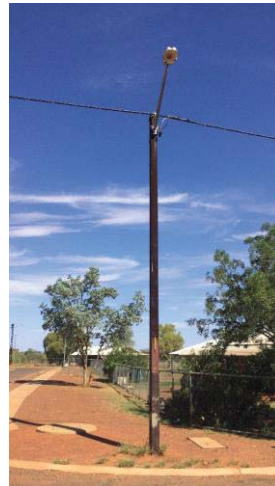
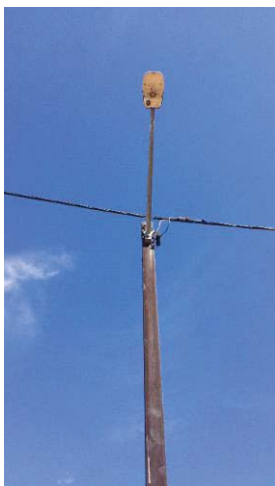
What is Pole Material type:	Welded
What is the condition of pole:	3
How is the pole planted:	Concrete
What is the Condition of plant:	3
Is street light fitted:	Yes
Street Light Power Supply:	
Street Light Type	M125D 10
Street Light Watts	125
Street Light Condition	2
Street Light Height	
What is the type of service:	Three
What is the HV voltage level:	400
What is the arrangement of connected cables:	Twisted
Are there isolators on the pole:	No
What is the Condition:	3
How many Lots are connected to this pole:	
Overhead Pole Comments:	Surface rusted

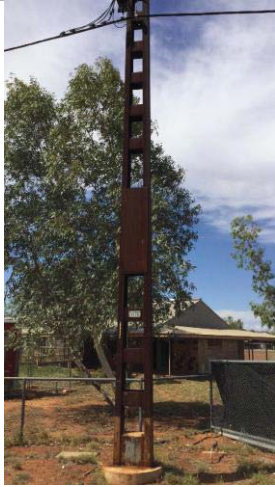
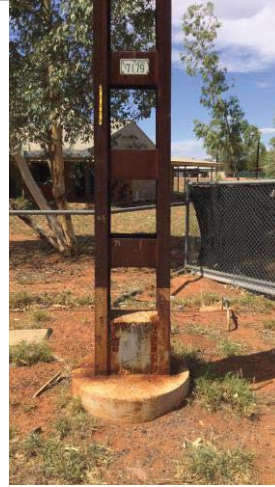
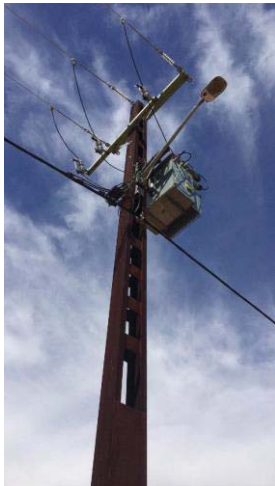
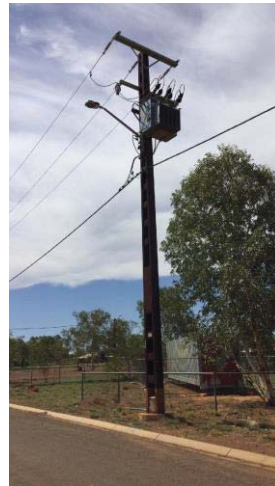
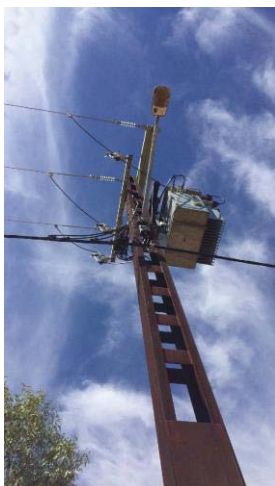
What is Pole Material type:	Welded
What is the condition of pole:	3
How is the pole planted:	Concrete
What is the Condition of plant:	3
Is street light fitted:	Yes
Street Light Power Supply:	
Street Light Type	M125D 10
Street Light Watts	125
Street Light Condition	3
Street Light Height	
What is the type of service:	Three
What is the HV voltage level:	400
What is the arrangement of connected cables:	Twisted
Are there isolators on the pole:	No
What is the Condition:	3
How many Lots are connected to this pole:	3
Overhead Pole Comments:	Surface rusted

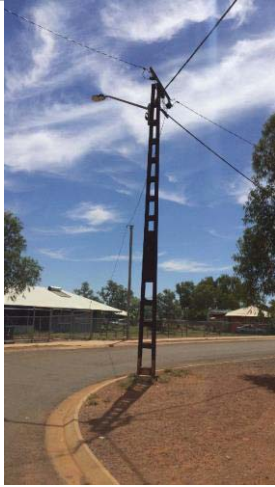
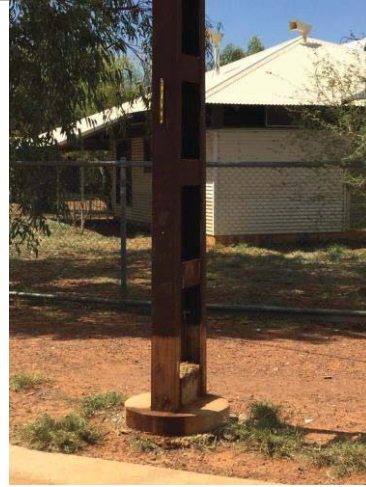
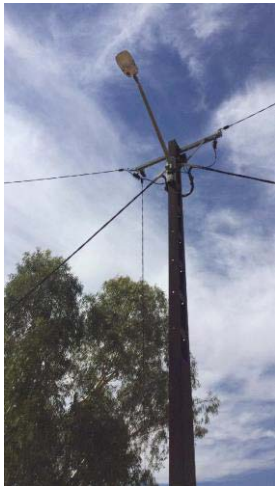
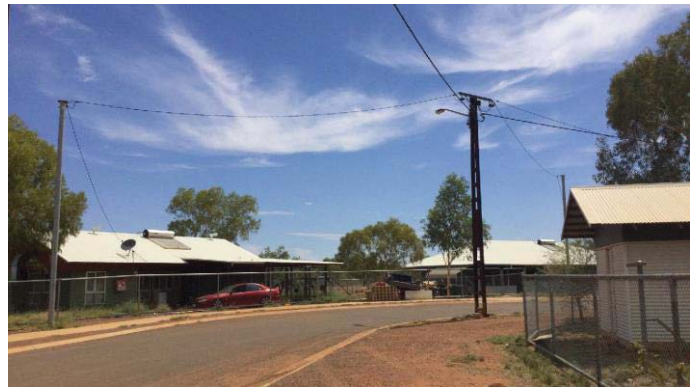
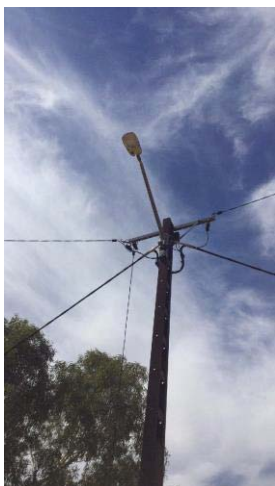
What is Pole Material type:	Welded
What is the condition of pole:	3
How is the pole planted:	Concrete
What is the Condition of plant:	3
Is street light fitted:	Yes
Street Light Power Supply:	
Street Light Type	S70D 14
Street Light Watts	70
Street Light Condition	2
Street Light Height	
What is the type of service:	Three
What is the HV voltage level:	400
What is the arrangement of connected cables:	Twisted
Are there isolators on the pole:	No
What is the Condition:	3
How many Lots are connected to this pole:	0
Overhead Pole Comments:	Surface rusted

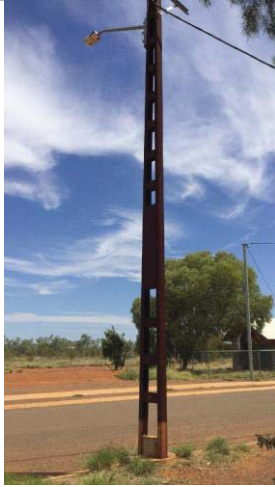
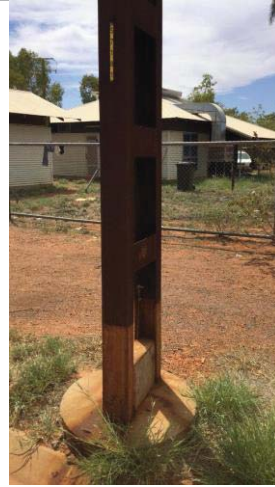
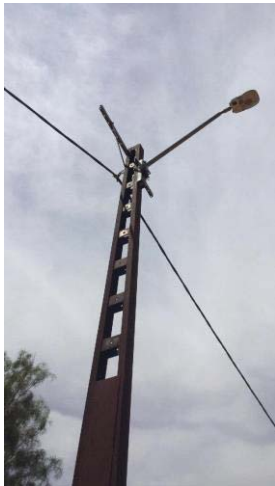
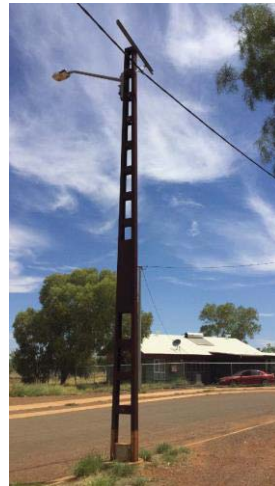
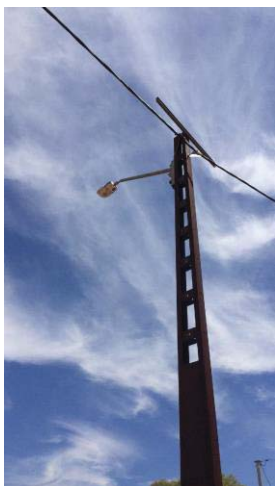
What is Pole Material type:	Welded
What is the condition of pole:	3
How is the pole planted:	Concrete
What is the Condition of plant:	3
Is street light fitted:	Yes
Street Light Power Supply:	
Street Light Type	M125D 10
Street Light Watts	125
Street Light Condition	2
Street Light Height	
What is the type of service:	Three
What is the HV voltage level:	400
What is the arrangement of connected cables:	Twisted
Are there isolators on the pole:	No
What is the Condition:	3
How many Lots are connected to this pole:	0
Overhead Pole Comments:	Surface rusted

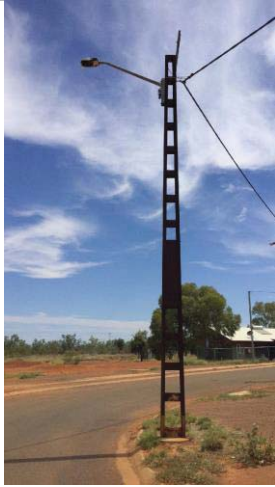
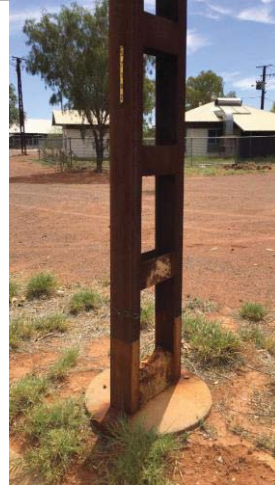
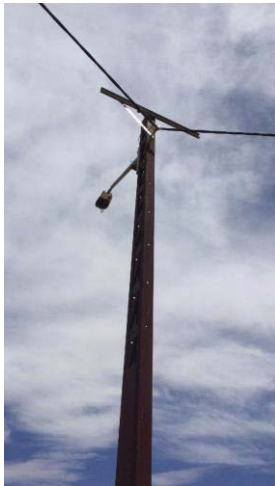
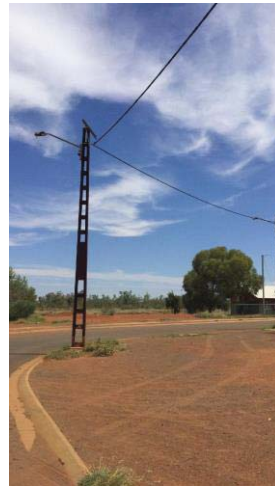
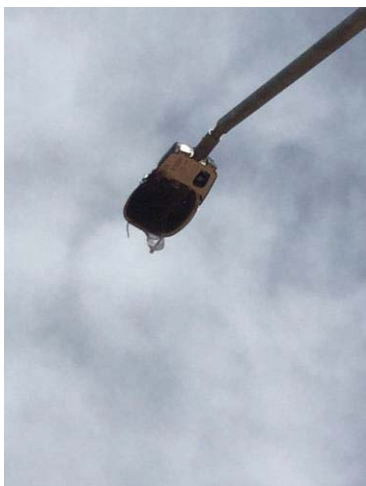
What is Pole Material type:	Welded
What is the condition of pole:	3
How is the pole planted:	Concrete
What is the Condition of plant:	3
Is street light fitted:	Yes
Street Light Power Supply:	
Street Light Type	M125D 10
Street Light Watts	125
Street Light Condition	3
Street Light Height	
What is the type of service:	Three
What is the HV voltage level:	400
What is the arrangement of connected cables:	Twisted
Are there isolators on the pole:	No
What is the Condition:	3
How many Lots are connected to this pole:	1
Overhead Pole Comments:	Surface rusted

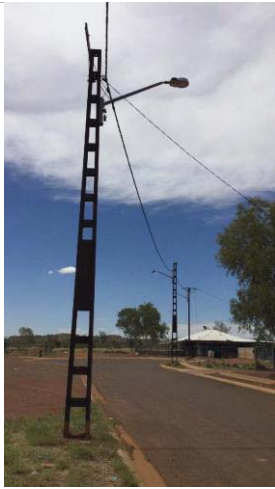
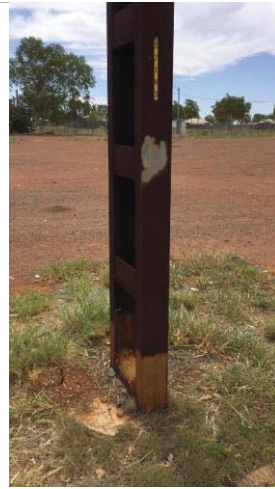
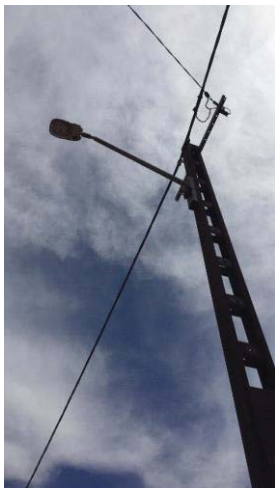
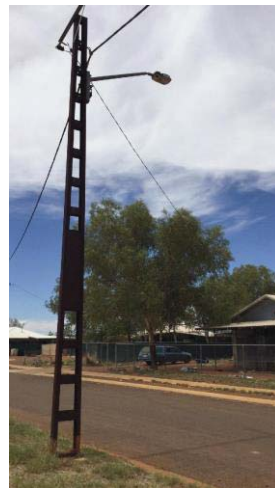
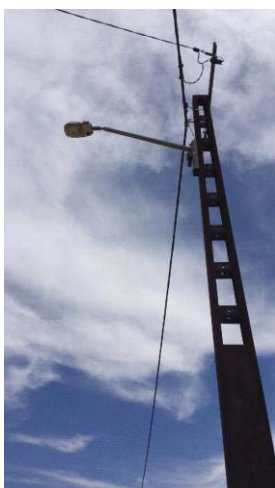
What is Pole Material type:	Welded
What is the condition of pole:	3
How is the pole planted:	Concrete
What is the Condition of plant:	3
Is street light fitted:	Yes
Street Light Power Supply:	
Street Light Type	S70D 11
Street Light Watts	70
Street Light Condition	2
Street Light Height	
What is the type of service:	Three
What is the HV voltage level:	400
What is the arrangement of connected cables:	Twisted
Are there isolators on the pole:	No
What is the Condition:	3
How many Lots are connected to this pole:	0
Overhead Pole Comments:	Surface rusted

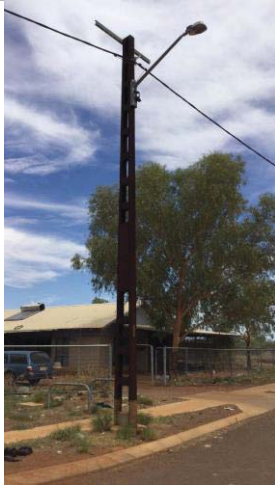
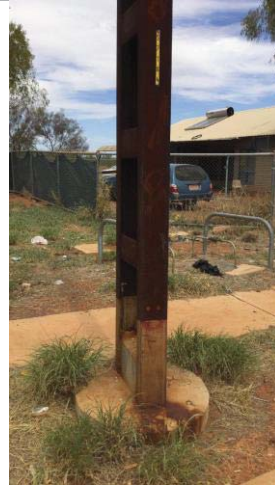
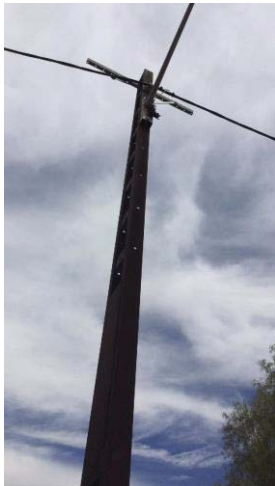
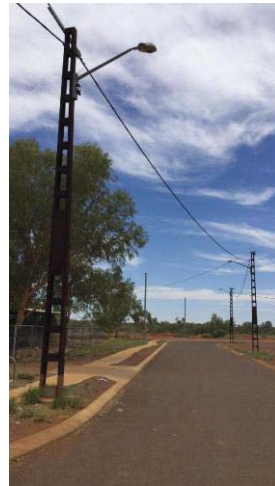
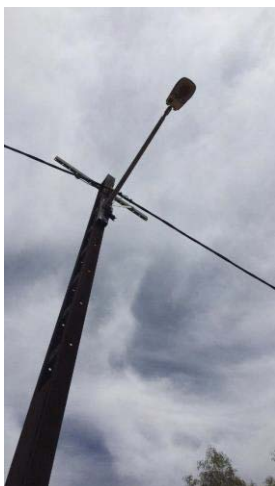
What is Pole Material type:	Welded
What is the condition of pole:	3
How is the pole planted:	Concrete
What is the Condition of plant:	3
Is street light fitted:	Yes
Street Light Power Supply:	
Street Light Type	S70D 11
Street Light Watts	70
Street Light Condition	3
Street Light Height	
What is the type of service:	Three
What is the HV voltage level:	
What is the arrangement of connected cables:	Twisted
Are there isolators on the pole:	No
What is the Condition:	3
How many Lots are connected to this pole:	
Overhead Pole Comments:	Surface rusted

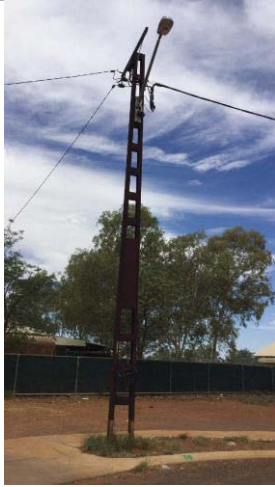
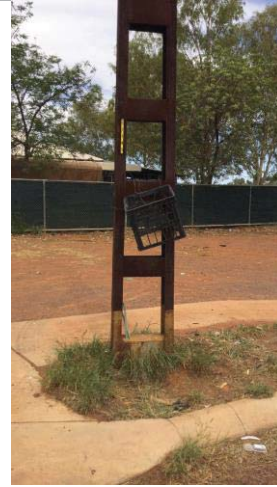
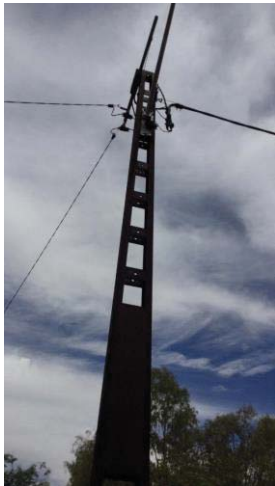
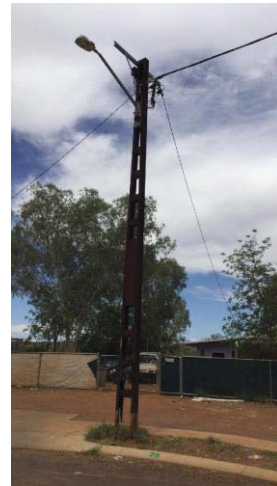
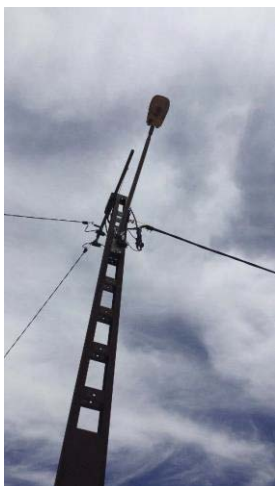
What is Pole Material type:	Welded
What is the condition of pole:	3
How is the pole planted:	Concrete
What is the Condition of plant:	3
Is street light fitted:	Yes
Street Light Power Supply:	
Street Light Type	M125D 10
Street Light Watts	125
Street Light Condition	2
Street Light Height	
What is the type of service:	Three
What is the HV voltage level:	400
What is the arrangement of connected cables:	Twisted
Are there isolators on the pole:	No
What is the Condition:	3
How many Lots are connected to this pole:	2
Overhead Pole Comments:	Surface rusted

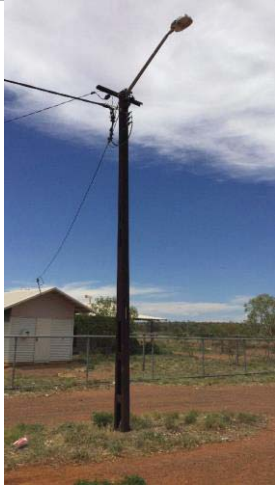
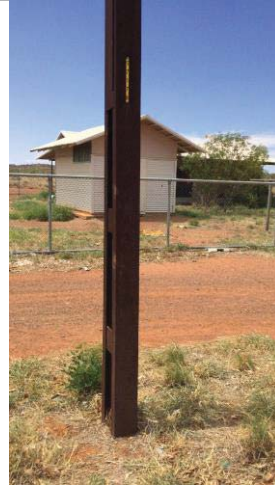
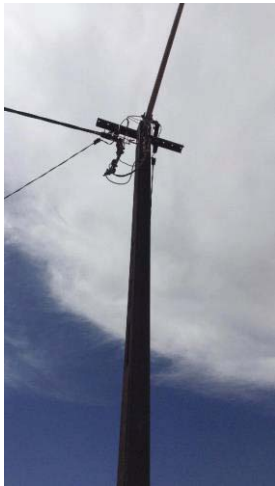
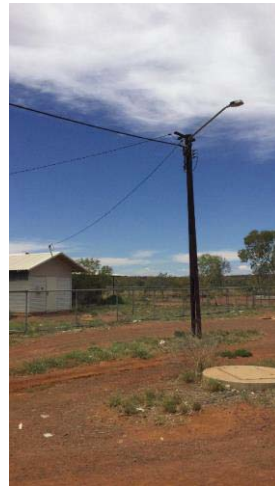
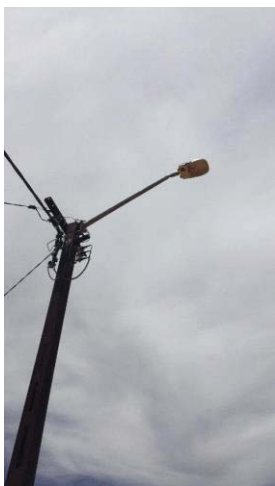
What is Pole Material type:	Welded
What is the condition of pole:	3
How is the pole planted:	Concrete
What is the Condition of plant:	3
Is street light fitted:	Yes
Street Light Power Supply:	
Street Light Type	S70D 10
Street Light Watts	70
Street Light Condition	3
Street Light Height	
What is the type of service:	Three
What is the HV voltage level:	400
What is the arrangement of connected cables:	Twisted
Are there isolators on the pole:	No
What is the Condition:	3
How many Lots are connected to this pole:	1
Overhead Pole Comments:	Surface rusted

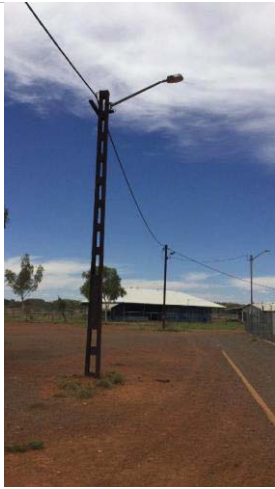
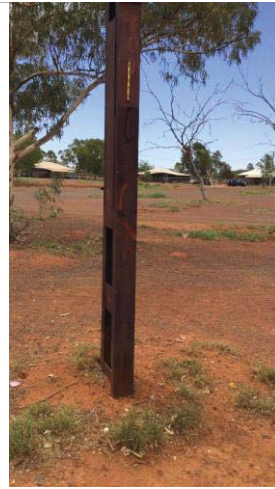
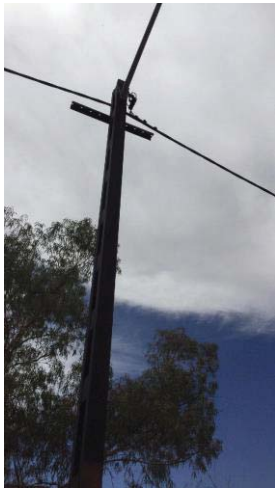
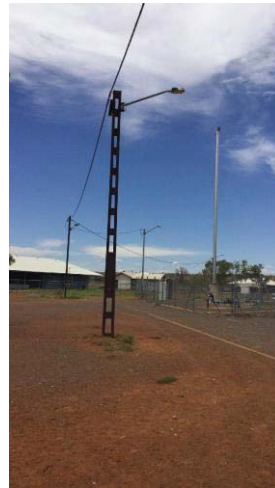
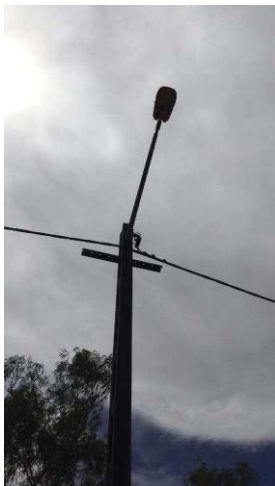
What is Pole Material type:	Welded
What is the condition of pole:	3
How is the pole planted:	Concrete
What is the Condition of plant:	3
Is street light fitted:	Yes
Street Light Power Supply:	
Street Light Type	S70D 13
Street Light Watts	70
Street Light Condition	2
Street Light Height	
What is the type of service:	Three
What is the HV voltage level:	400
What is the arrangement of connected cables:	Twisted
Are there isolators on the pole:	No
What is the Condition:	3
How many Lots are connected to this pole:	0
Overhead Pole Comments:	Surface rusted

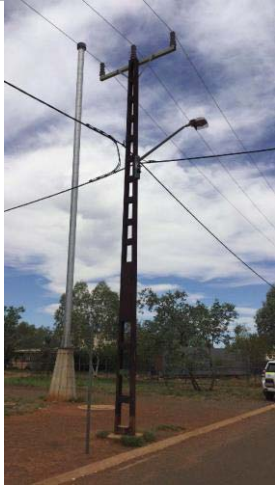
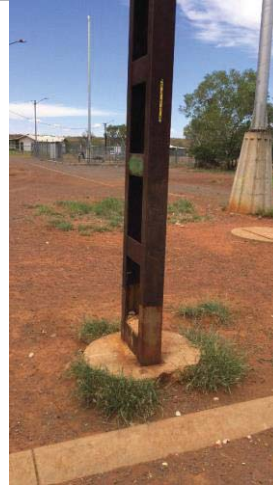
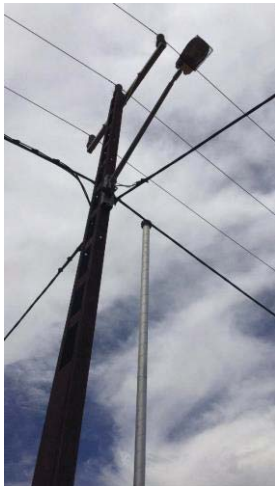
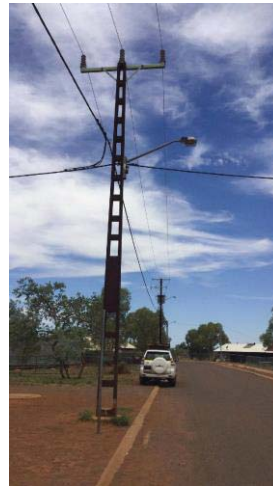
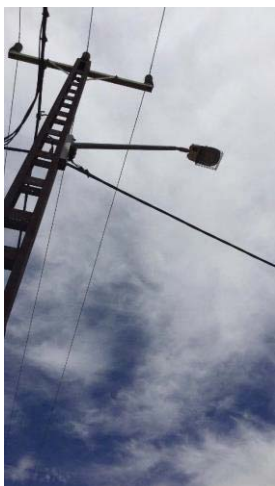
What is Pole Material type:	Welded
What is the condition of pole:	3
How is the pole planted:	Concrete
What is the Condition of plant:	3
Is street light fitted:	Yes
Street Light Power Supply:	
Street Light Type	M125D 10
Street Light Watts	125
Street Light Condition	3
Street Light Height	
What is the type of service:	Combined
What is the HV voltage level:	11000
What is the arrangement of connected cables:	Parallel
Are there isolators on the pole:	No
What is the Condition:	3
How many Lots are connected to this pole:	0
Overhead Pole Comments:	Surface rusted

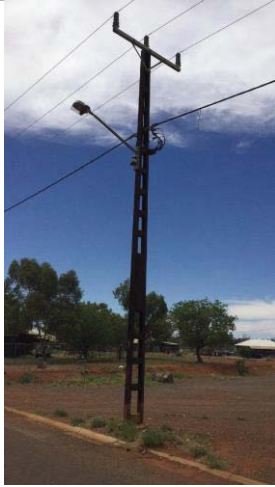
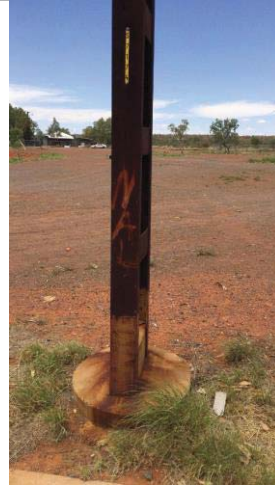
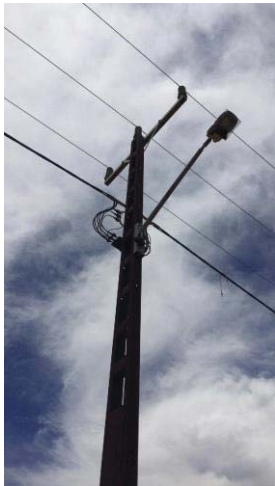
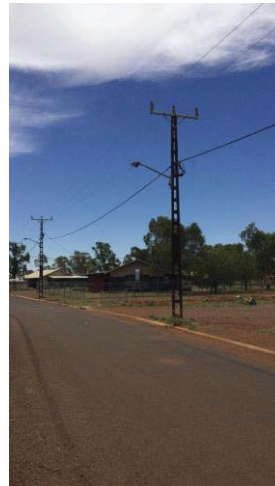
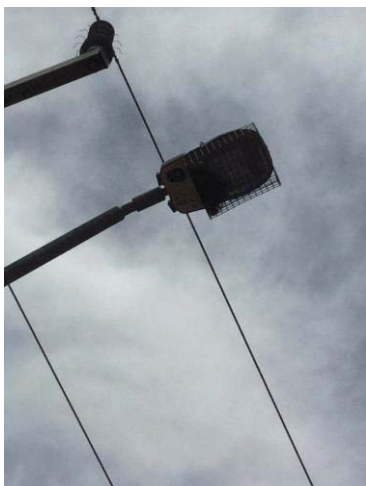
What is Pole Material type:	Welded
What is the condition of pole:	3
How is the pole planted:	Concrete
What is the Condition of plant:	3
Is street light fitted:	Yes
Street Light Power Supply:	
Street Light Type	M125D 10
Street Light Watts	125
Street Light Condition	2
Street Light Height	
What is the type of service:	Combined
What is the HV voltage level:	11000
What is the arrangement of connected cables:	Parallel
Are there isolators on the pole:	No
What is the Condition:	3
How many Lots are connected to this pole:	0
Overhead Pole Comments:	Surface rusted

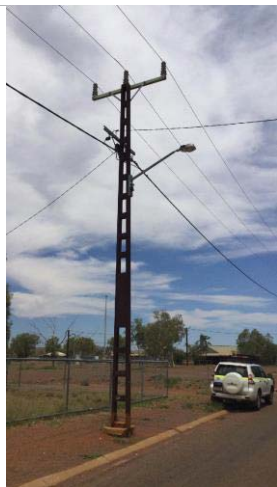
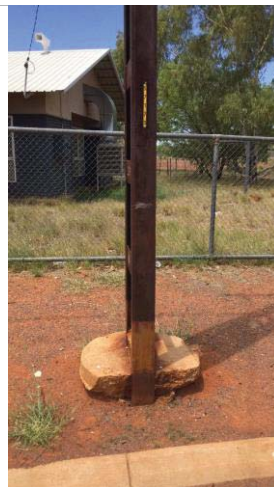
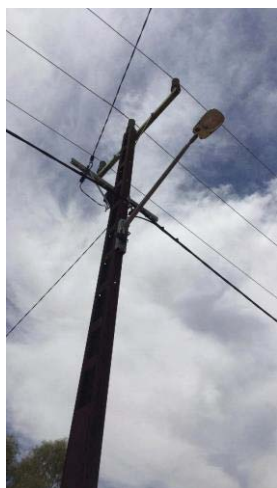
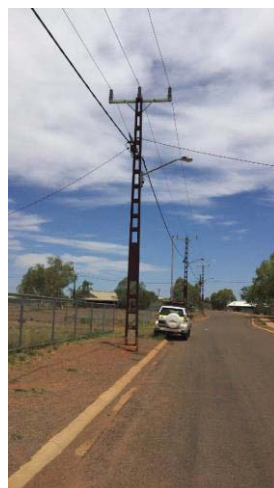
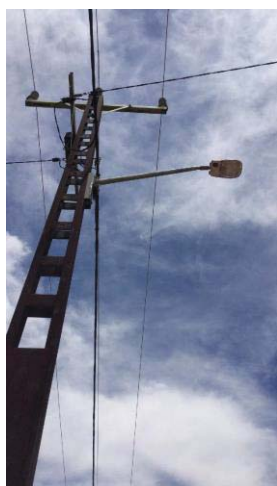
What is Pole Material type:	Welded
What is the condition of pole:	3
How is the pole planted:	Concrete
What is the Condition of plant:	3
Is street light fitted:	Yes
Street Light Power Supply:	
Street Light Type	M125D 10
Street Light Watts	125
Street Light Condition	3
Street Light Height	
What is the type of service:	Combined
What is the HV voltage level:	11000
What is the arrangement of connected cables:	Parallel
Are there isolators on the pole:	No
What is the Condition:	3
How many Lots are connected to this pole:	2
Overhead Pole Comments:	Surface rusted

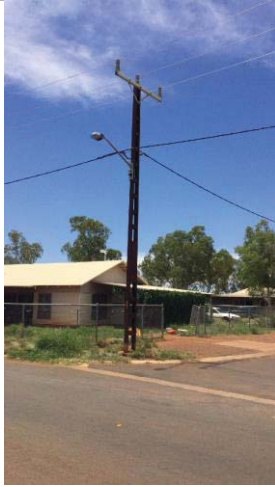
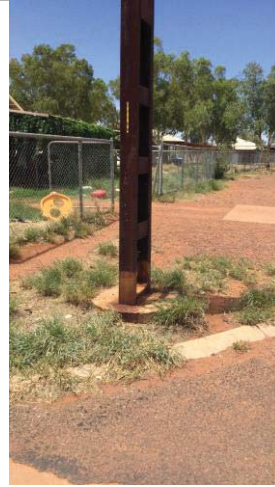
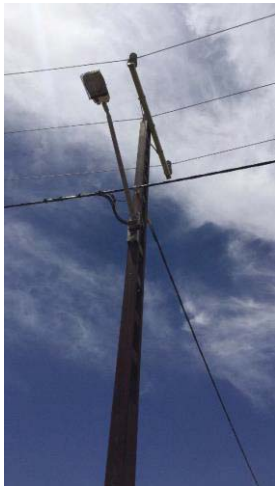
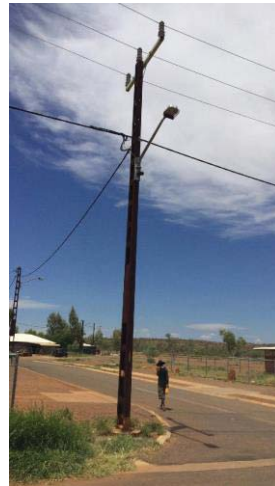
What is Pole Material type:	Welded
What is the condition of pole:	3
How is the pole planted:	Concrete
What is the Condition of plant:	3
Is street light fitted:	Yes
Street Light Power Supply:	
Street Light Type	S70D 15
Street Light Watts	70
Street Light Condition	3
Street Light Height	
What is the type of service:	Combined
What is the HV voltage level:	11000
What is the arrangement of connected cables:	Parallel
Are there isolators on the pole:	No
What is the Condition:	3
How many Lots are connected to this pole:	0
Overhead Pole Comments:	Surface rusted

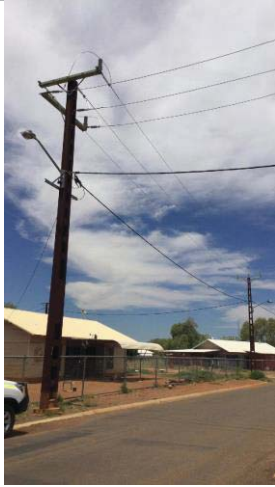
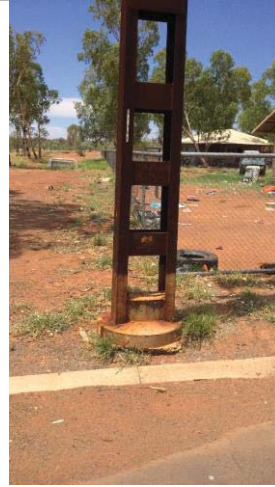
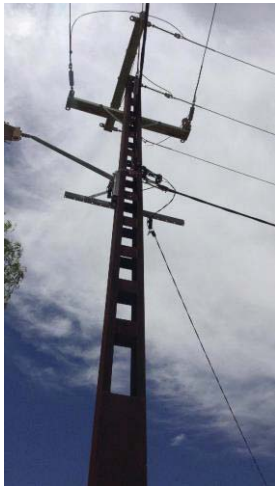
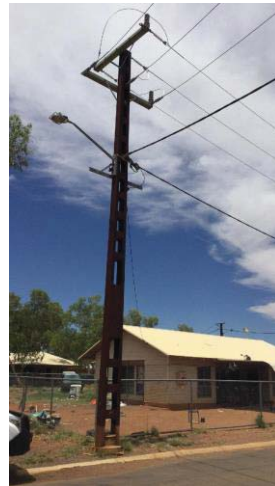
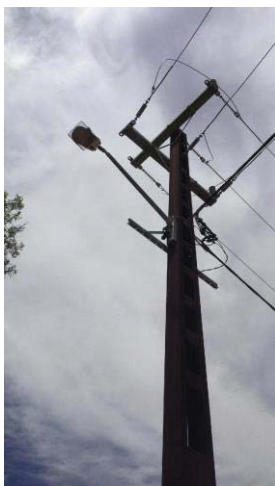
What is Pole Material type:	Welded
What is the condition of pole:	3
How is the pole planted:	Concrete
What is the Condition of plant:	3
Is street light fitted:	Yes
Street Light Power Supply:	
Street Light Type	M125D 10
Street Light Watts	125
Street Light Condition	3
Street Light Height	
What is the type of service:	Combined
What is the HV voltage level:	11000
What is the arrangement of connected cables:	Parallel
Are there isolators on the pole:	No
What is the Condition:	3
How many Lots are connected to this pole:	1
Overhead Pole Comments:	Surface rusted

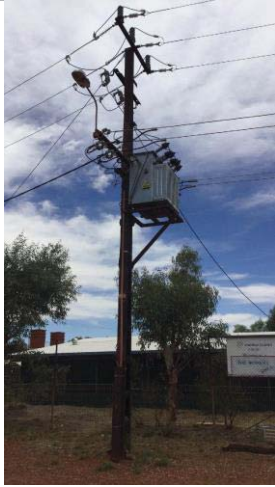
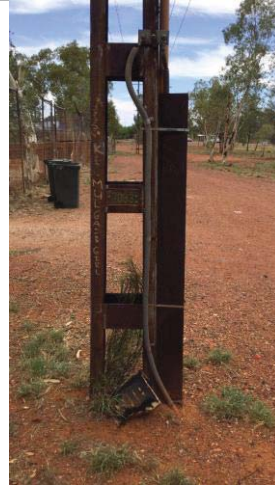
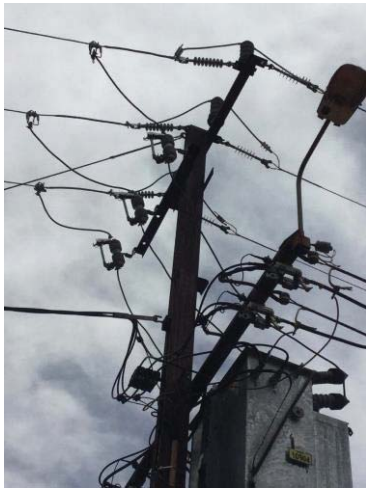
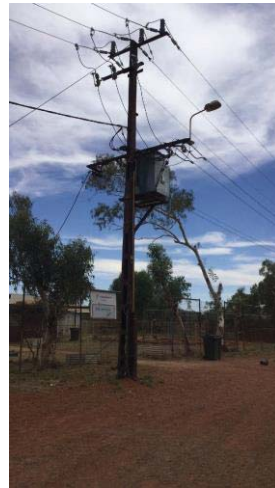
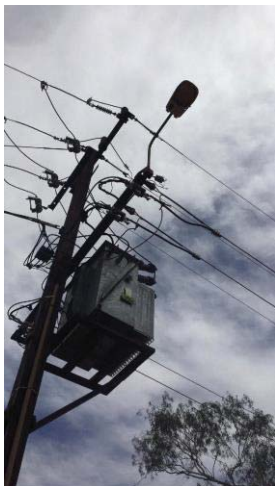
What is Pole Material type:	Welded
What is the condition of pole:	3
How is the pole planted:	Concrete
What is the Condition of plant:	3
Is street light fitted:	Yes
Street Light Power Supply:	
Street Light Type	S70D 11
Street Light Watts	70
Street Light Condition	2
Street Light Height	
What is the type of service:	Combined
What is the HV voltage level:	11000
What is the arrangement of connected cables:	Parallel
Are there isolators on the pole:	Yes
What is the Condition:	3
How many Lots are connected to this pole:	1
Overhead Pole Comments:	Surface rusted

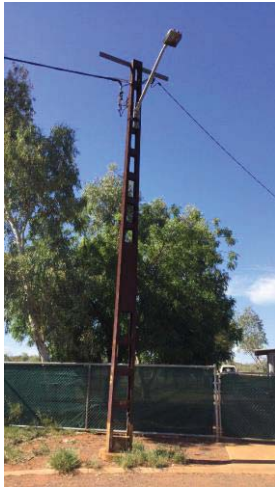
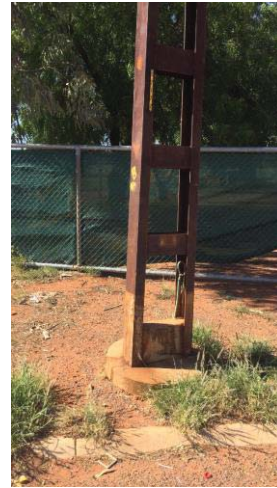
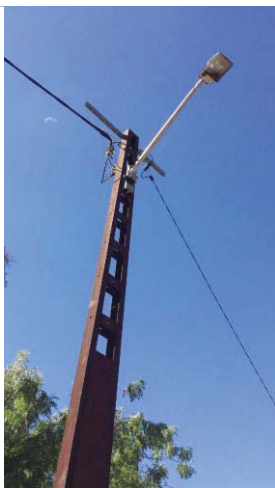
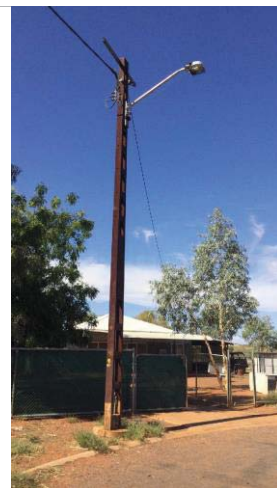
Street Light Condition 2

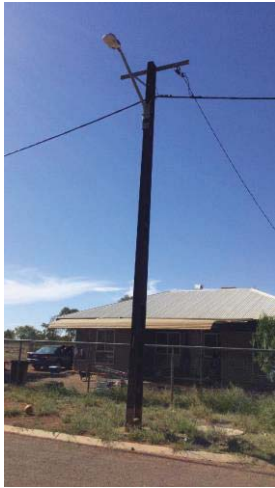
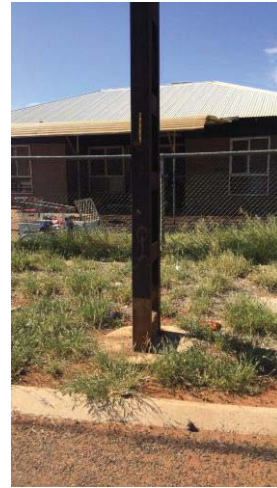
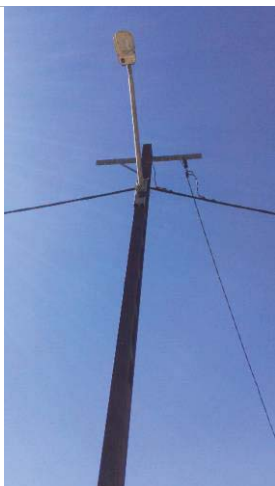
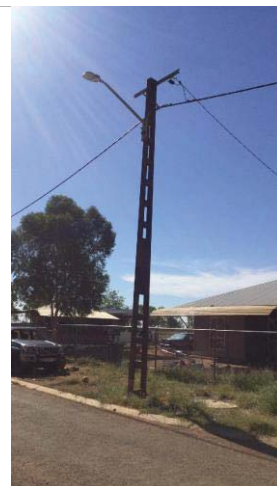
Street Light Condition 2

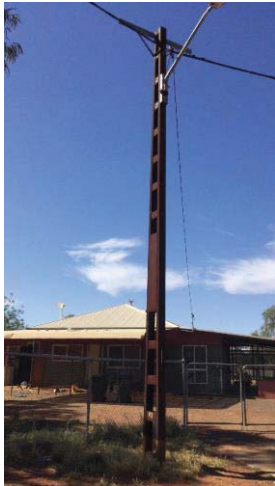
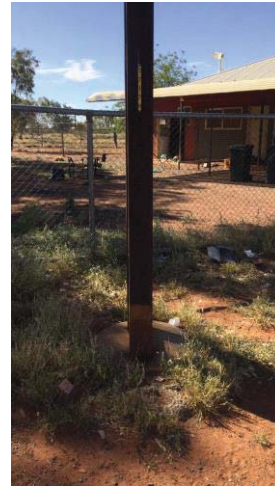
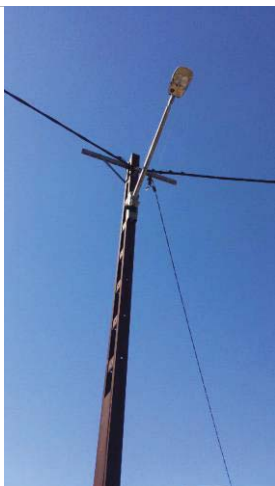
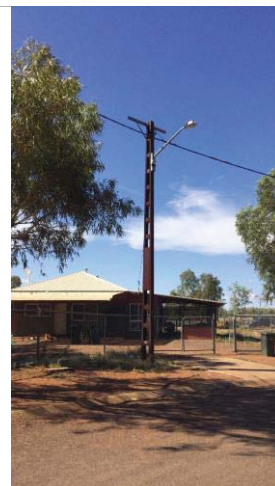
Street Light Condition 3

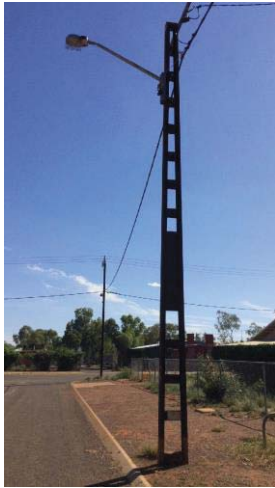
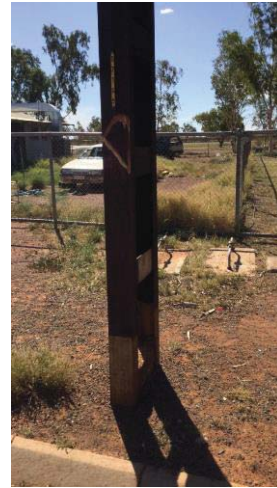
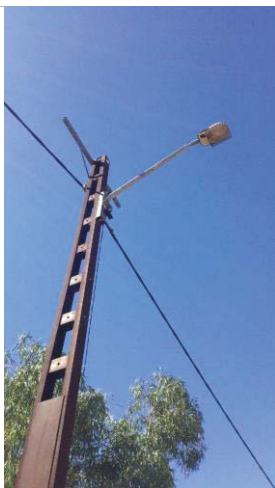
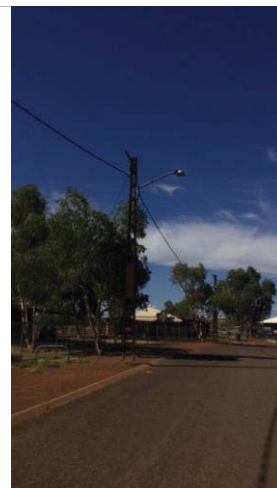
Street Light Condition 3

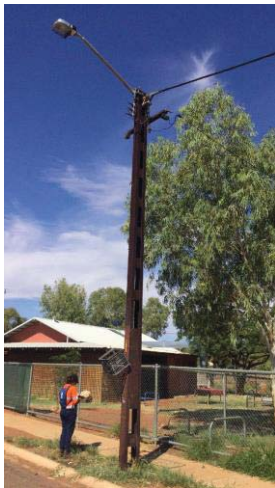
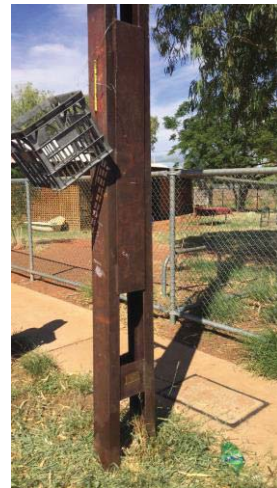
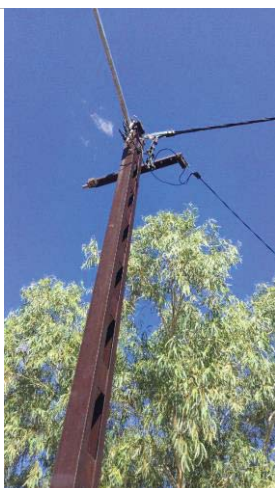
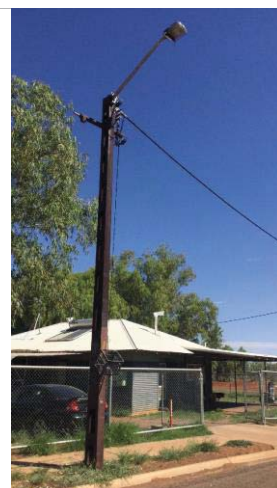
Street Light Condition 3

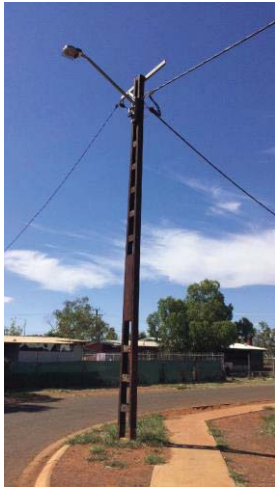
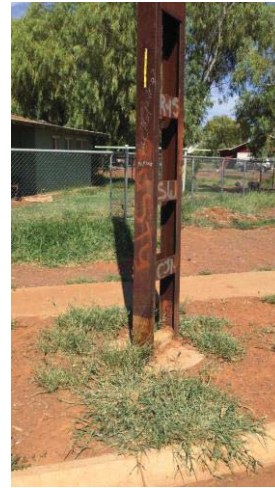
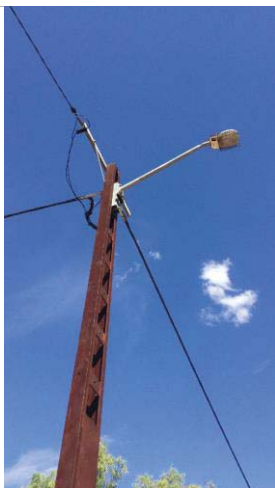
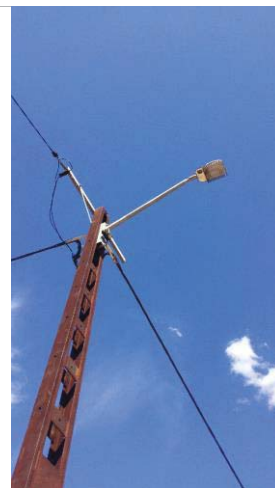
Is street light fitted: Yes  
Street Light Power Supply:  
Street Light Type S70D 13  
Street Light Watts 70  
Street Light Condition 2  
Street Light Height

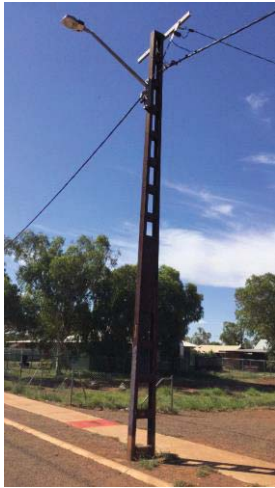
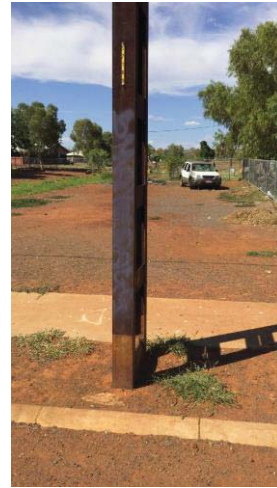
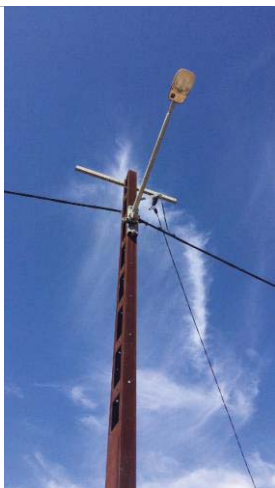
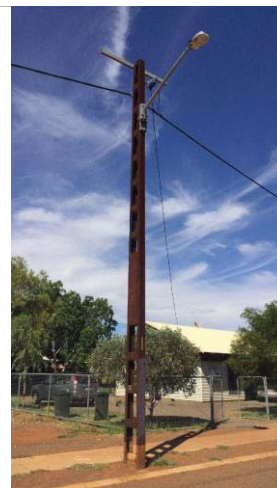
Street Light Condition 2

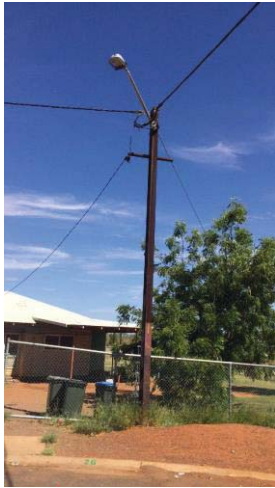
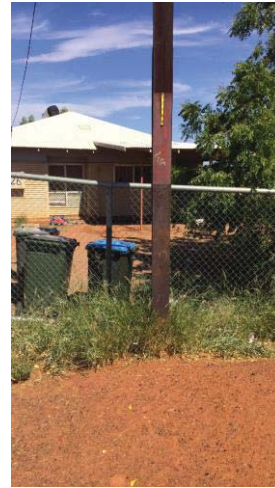
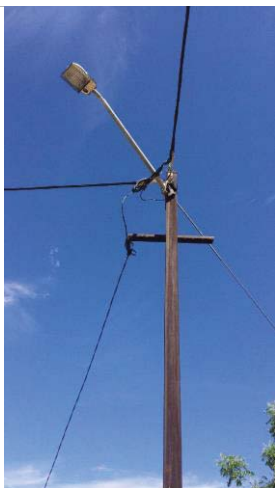
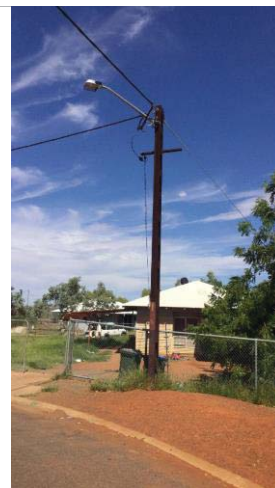
Is street light fitted: Yes  
Street Light Power Supply:  
Street Light Type S70D 12  
Street Light Watts 70  
Street Light Condition 3  
Street Light Height

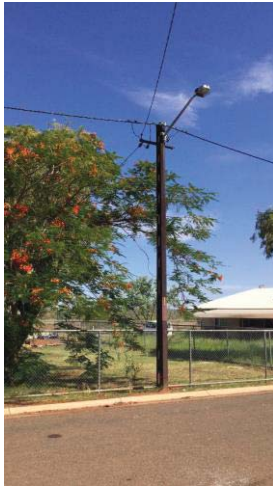
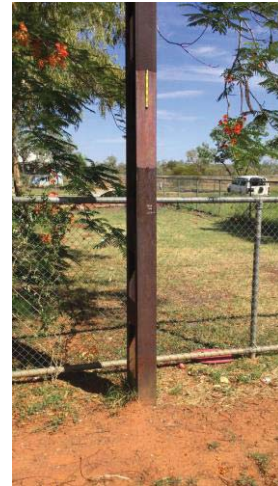
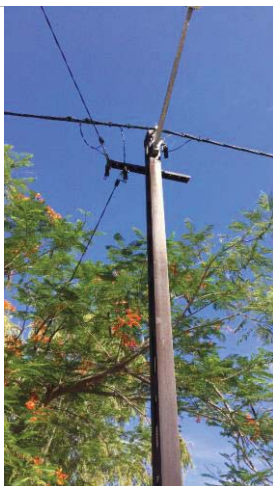
Street Light Condition 3

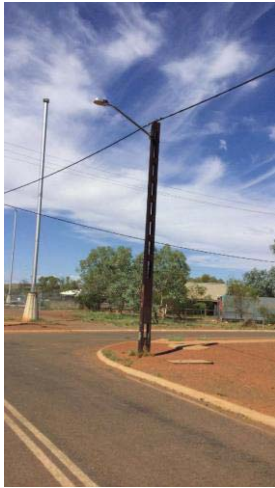
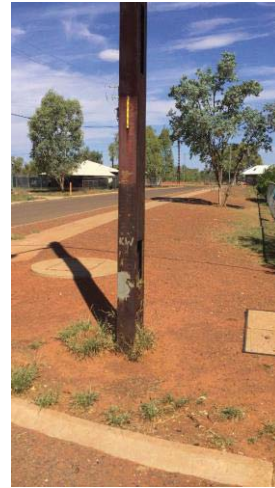
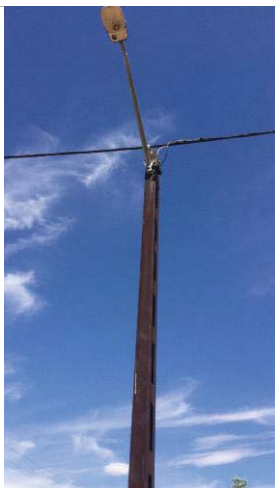
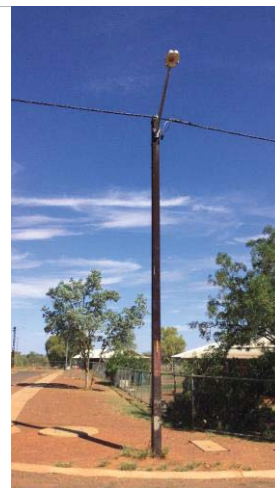
Street Light Condition 2

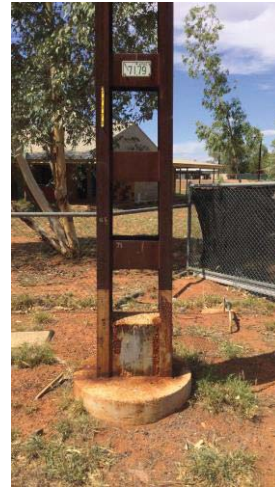
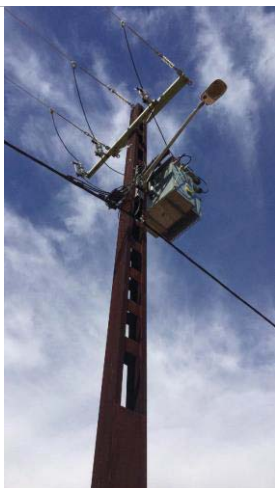
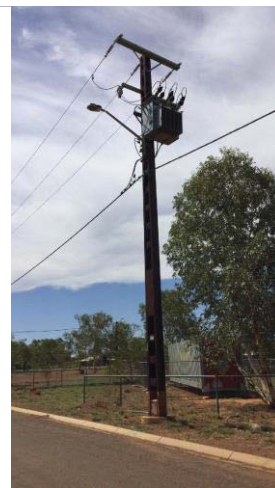
Street Light Condition 2

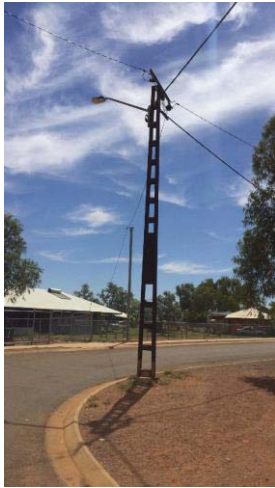
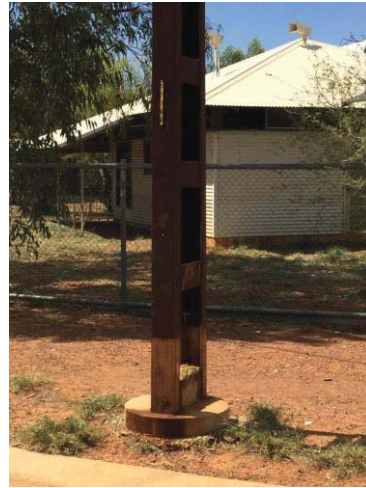
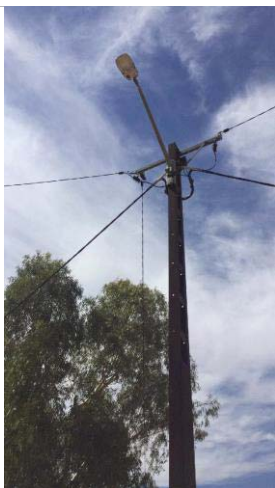
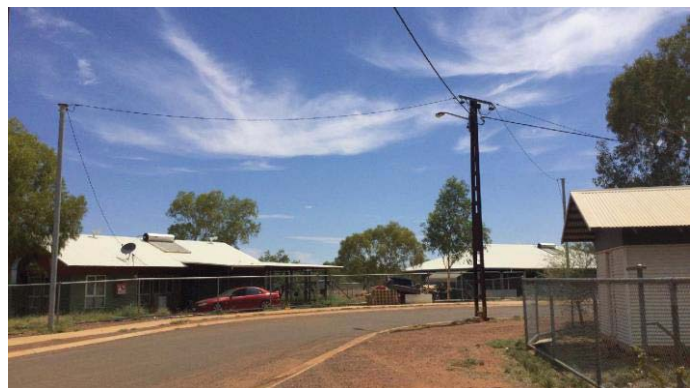
Street Light Condition 3

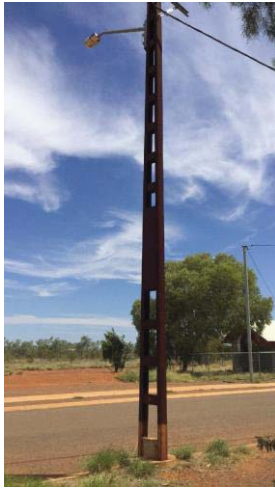
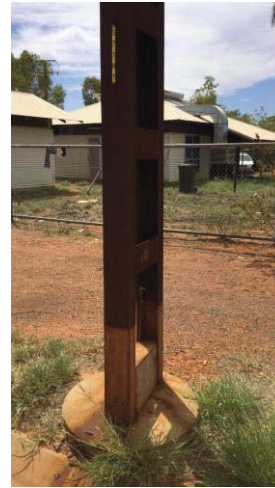
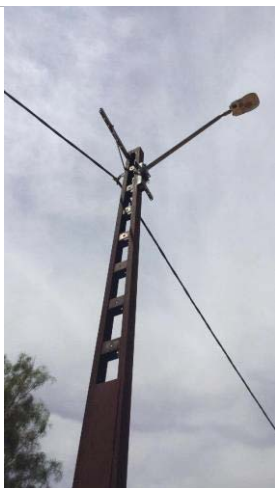
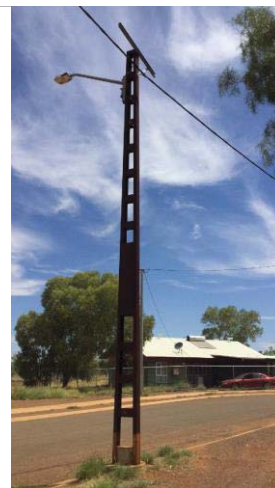
Street Light Condition 2
