# Northern Territory Town Camps

## Civil Infrastructure

Kargaru (East Side Camp)

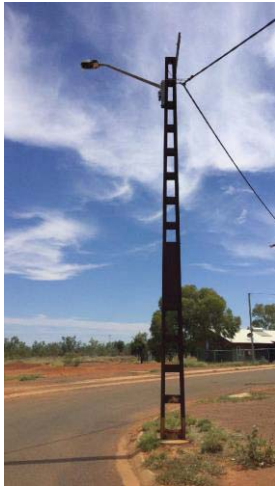
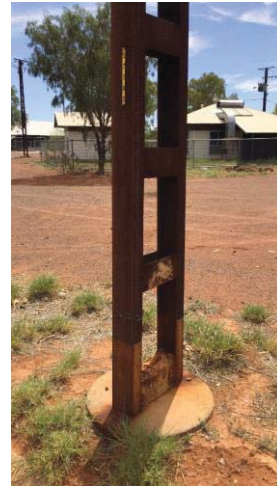
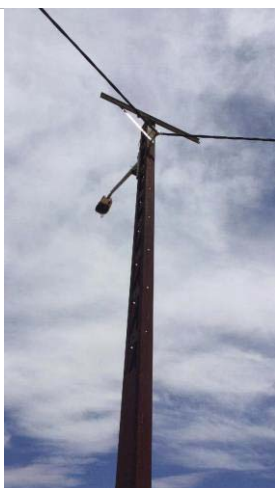
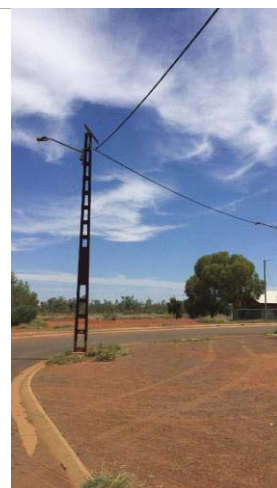
Street Light Condition 2

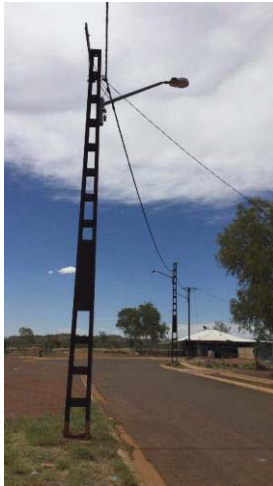
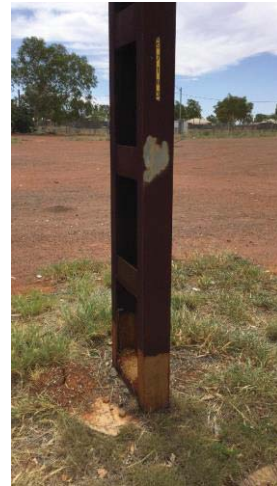
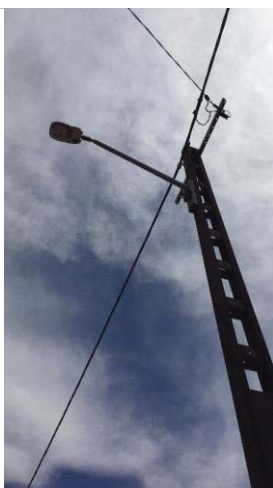
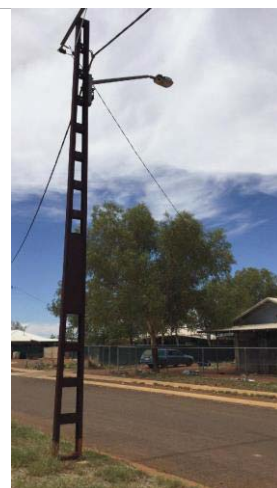
Street Light Condition 3

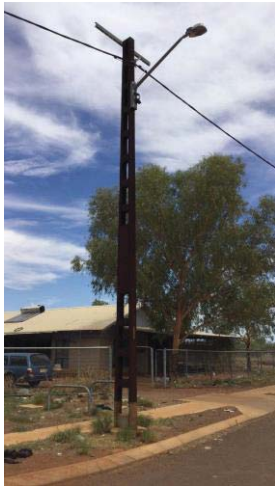
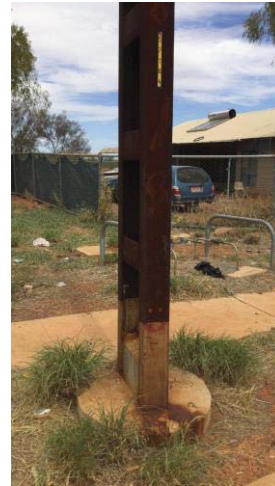
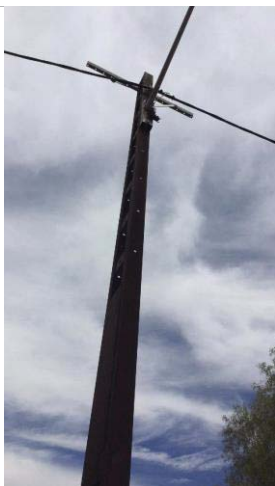
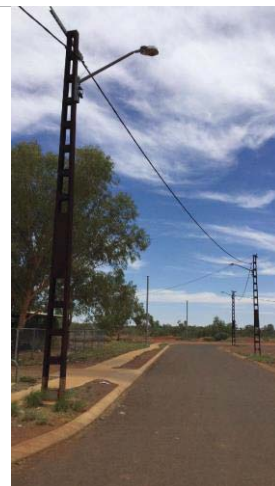
Is street light fitted: Yes  
Street Light Power Supply:  
Street Light Type S70D 11  
Street Light Watts 70  
Street Light Condition 2  
Street Light Height

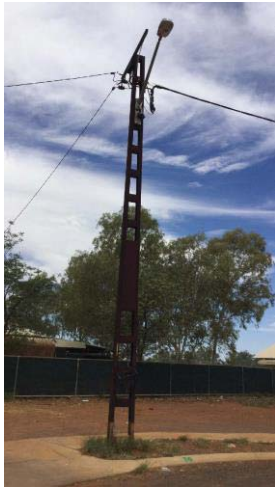
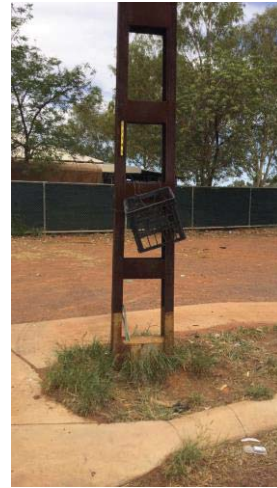
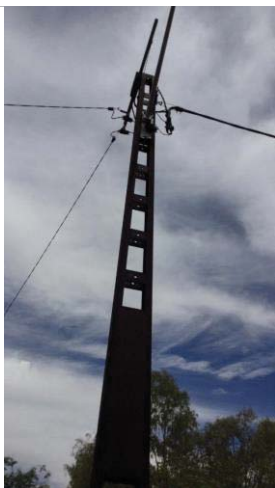
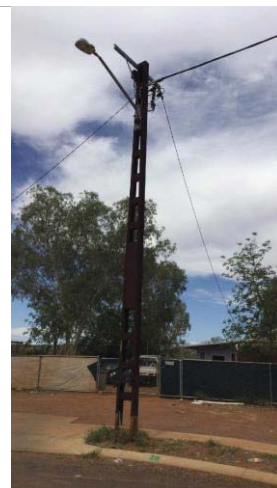
Street Light Condition 3

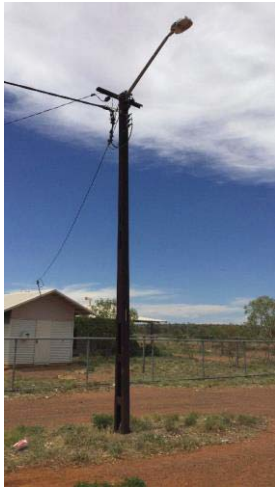
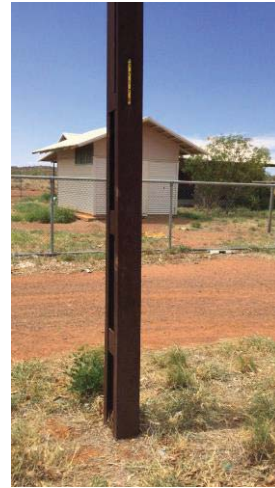
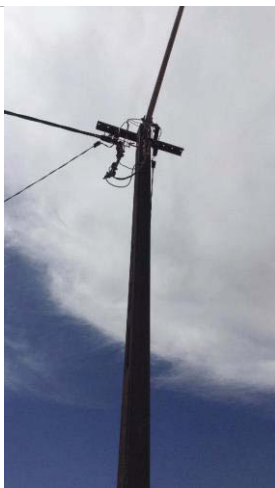
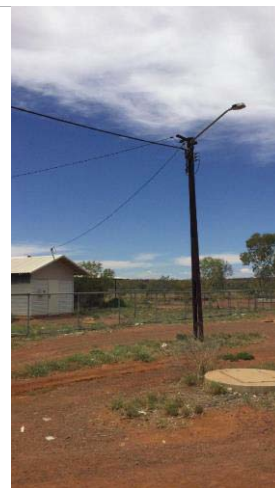
Street Light Condition 2

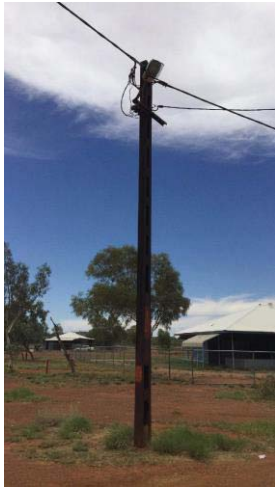
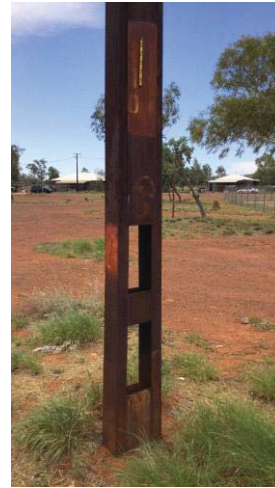
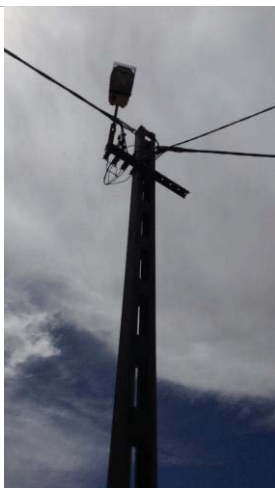
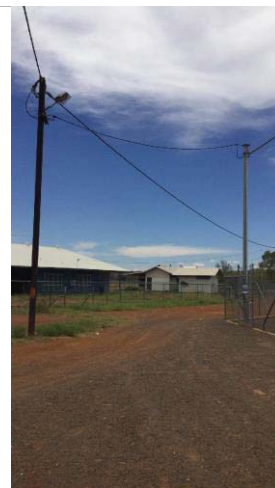
Is street light fitted: Yes  
Street Light Power Supply:  
Street Light Type S70D 10  
Street Light Watts 70  
Street Light Condition 3  
Street Light Height

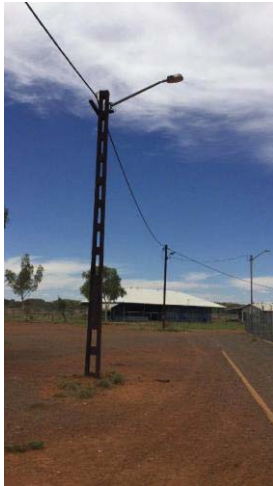
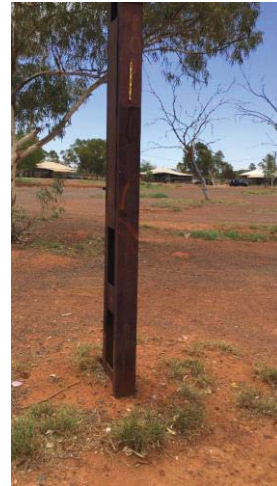
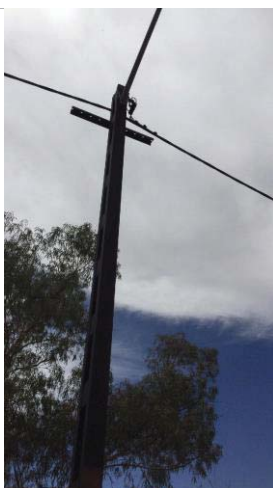
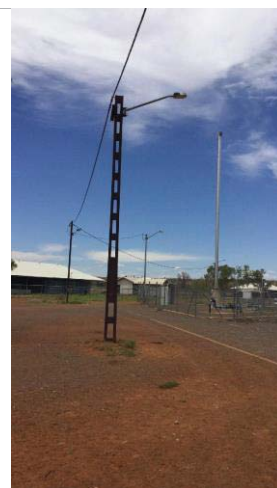
Street Light Condition 2
