## Northern Territory Town Camps

### Electrical Infrastructure

## 2 Condition assessment

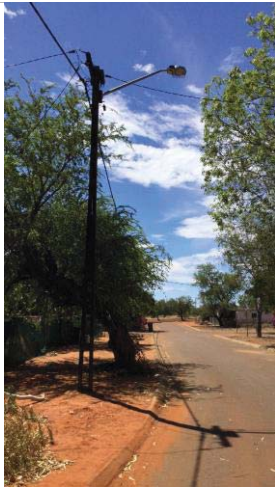
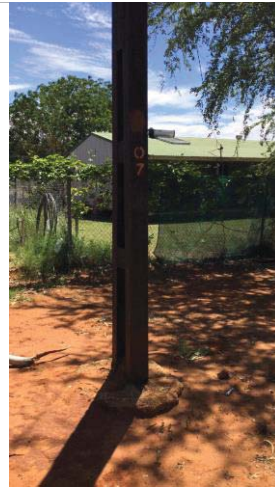
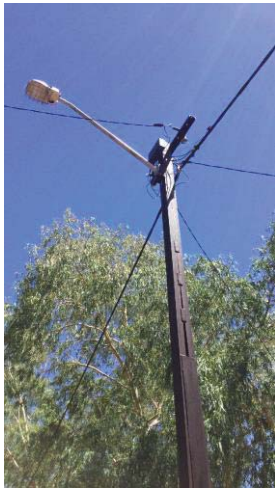
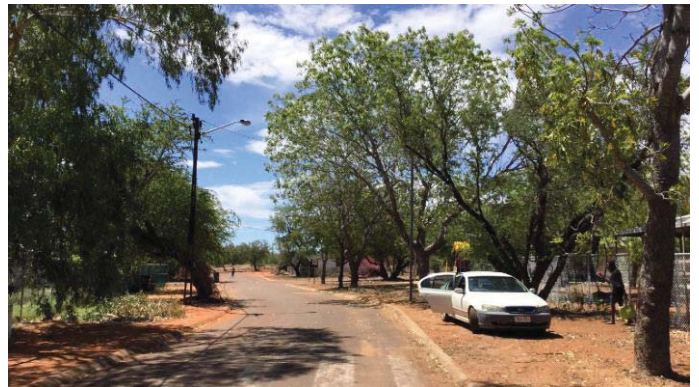
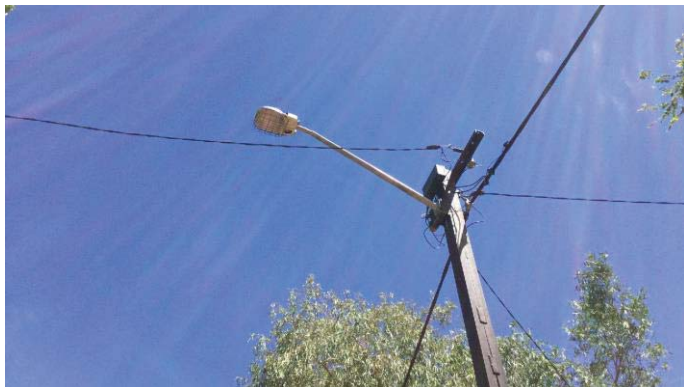
Surface rusted. Not connected.

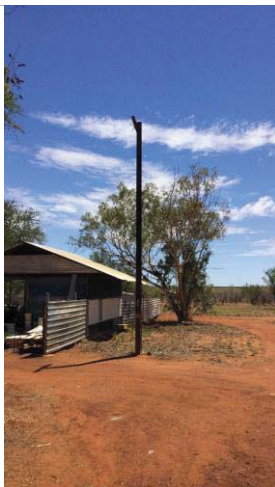
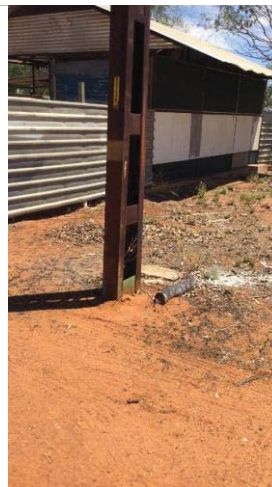
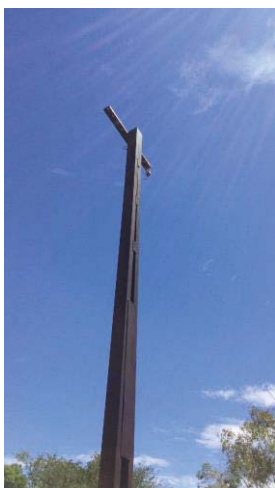
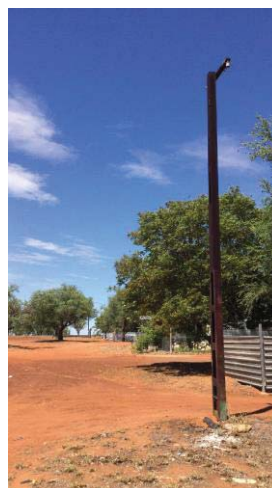
What is the condition of pole: 3

Overhead Pole Comments: Surface rusted

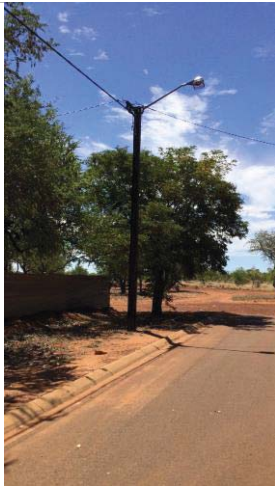
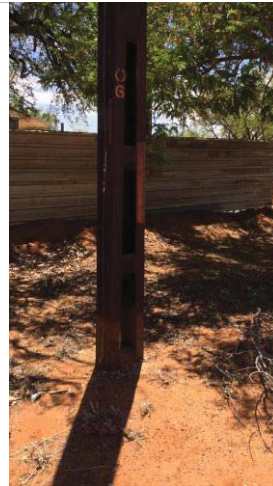
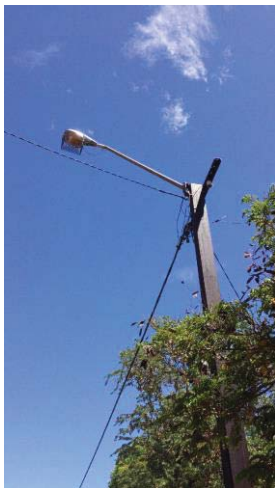
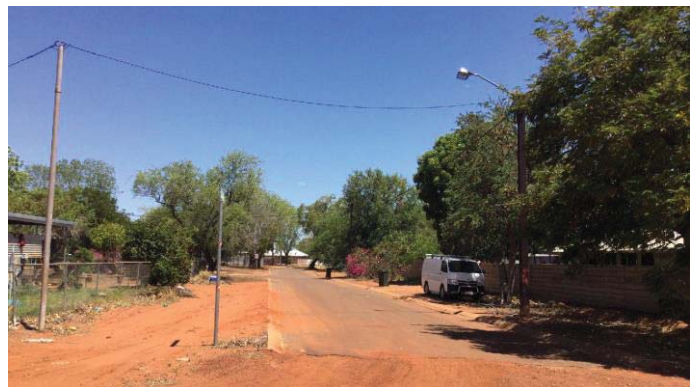
What is the condition of pole: 3

Overhead Pole Comments: Surface rusted

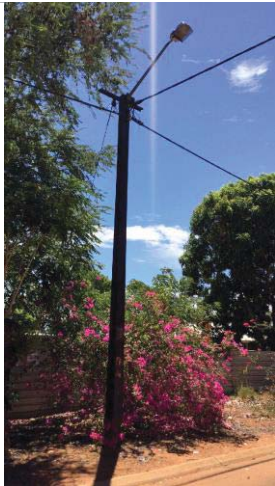
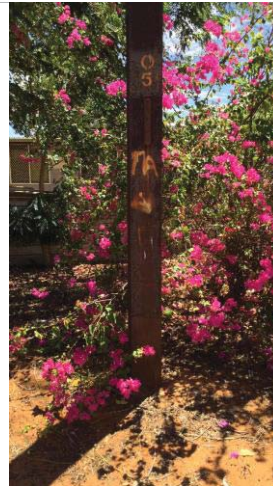
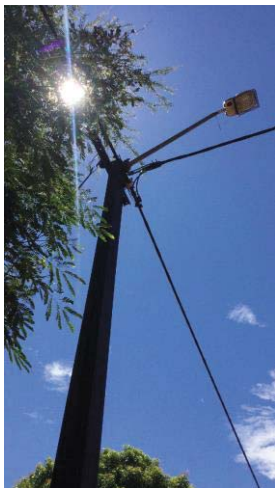
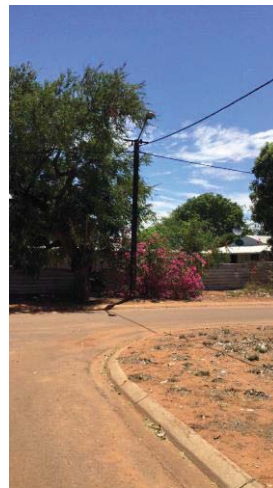
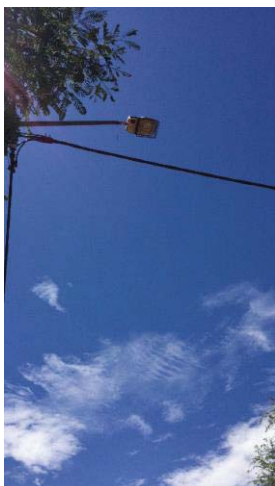
What is the condition of pole: 3

Overhead Pole Comments: Surface rusted

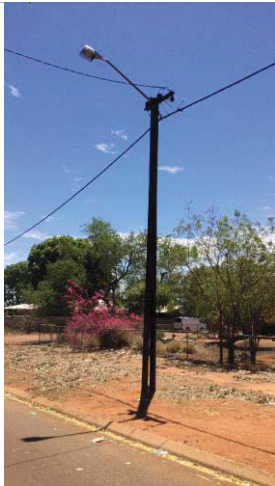
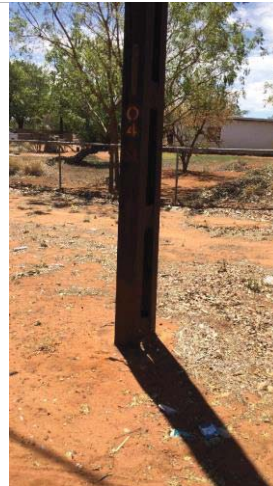
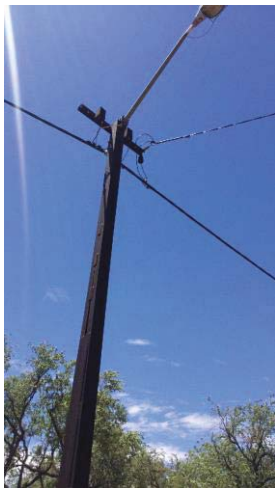
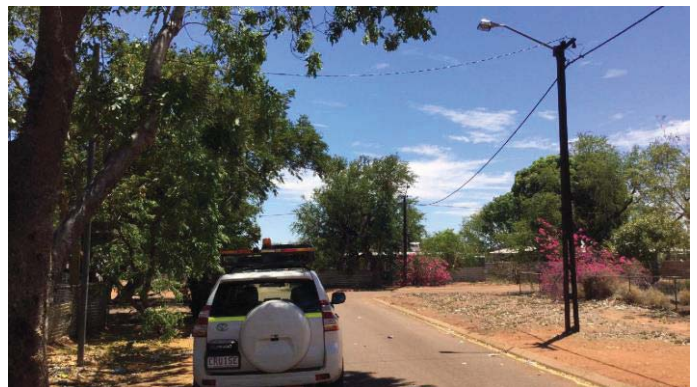
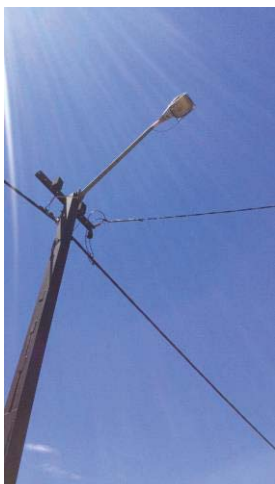
What is the condition of pole: 3

Overhead Pole Comments: Surface rusted

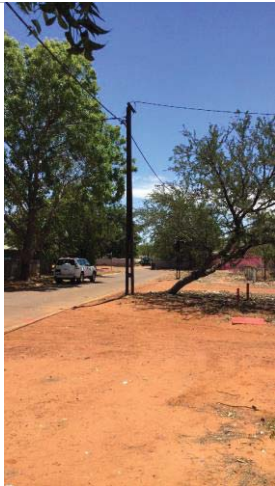
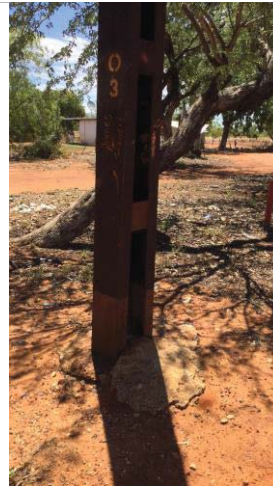
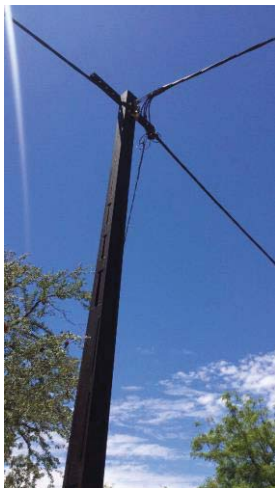
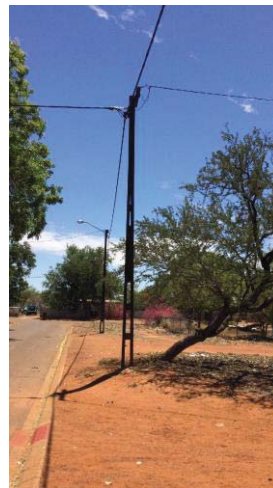
What is the condition of pole: 3

Overhead Pole Comments: Surface rusted

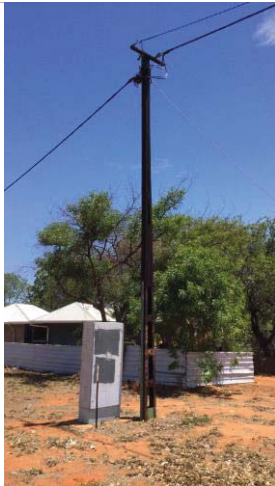
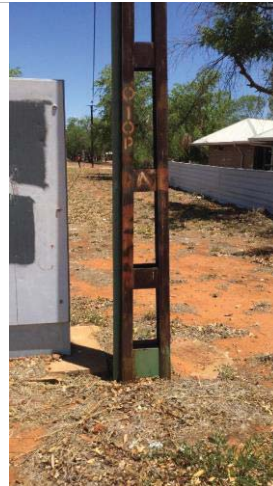
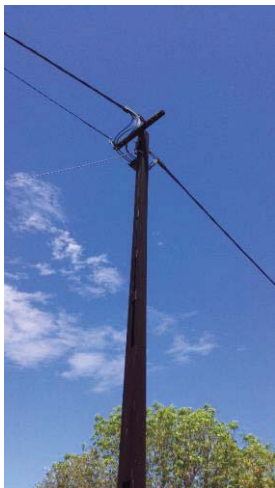
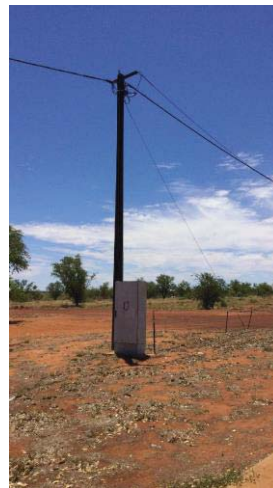
What is the condition of pole: 3

Overhead Pole Comments: Surface rusted

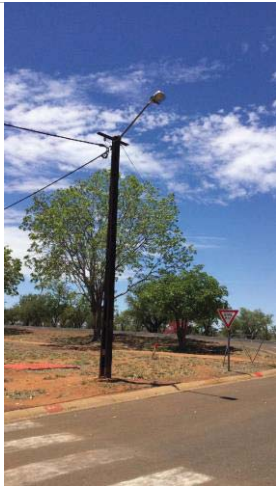
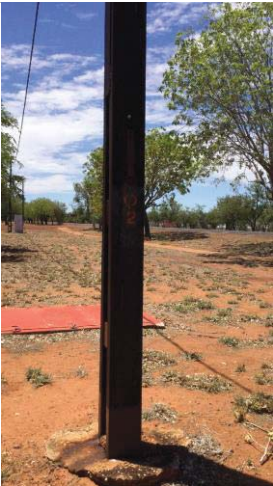
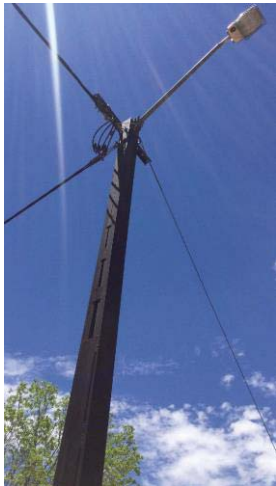
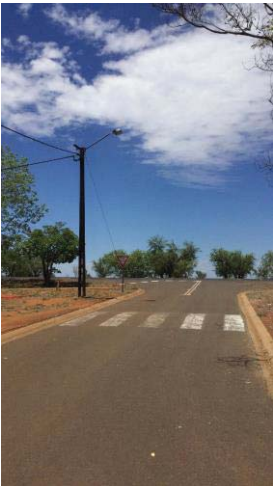
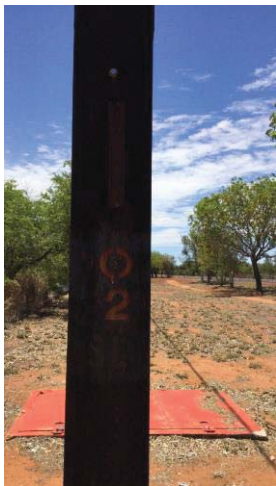
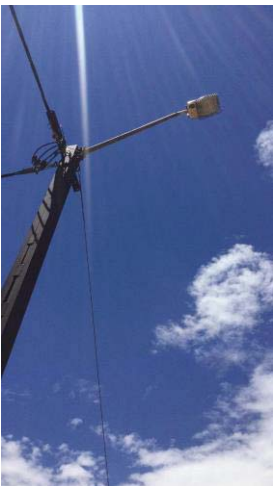
What is the condition of pole: 3

Overhead Pole Comments: Surface rusted

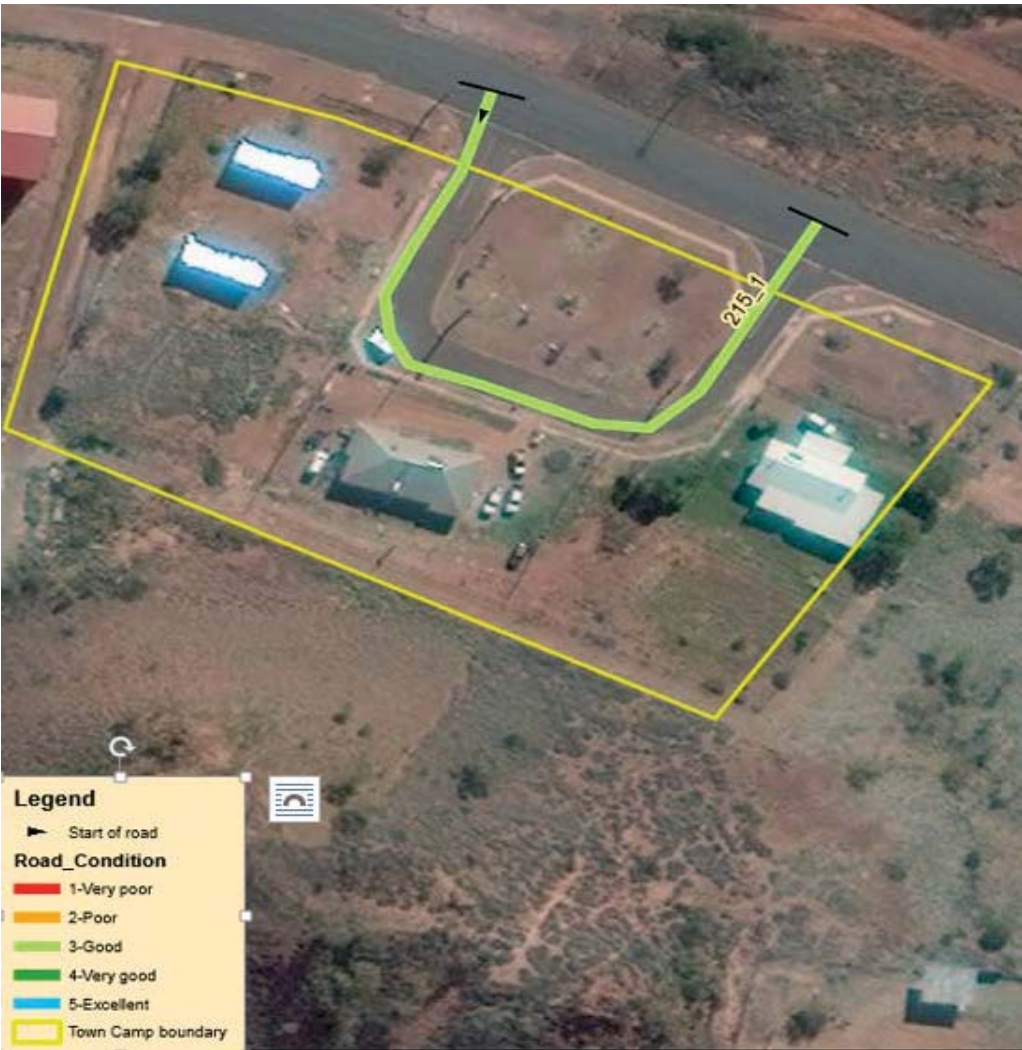
Figure 8 Blueberry Hill community road network

Table 9 below details the condition of the roads within Blueberry Hill community for specific segments. Figure 8 shows a map of the road network with the condition ratings, road name, and chainage direction. Note, the percentage refers to the percentage of that particular road segment which experiences the defect.

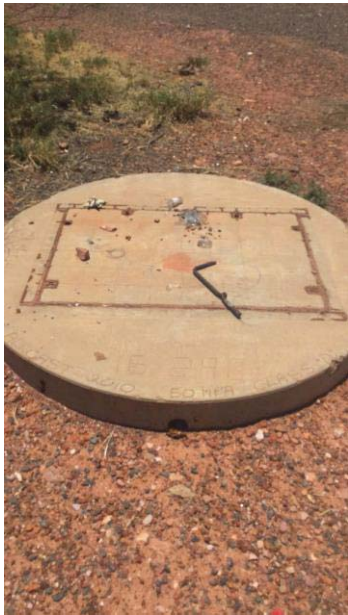
Notes on Lid: 16/29C

Comments: In property

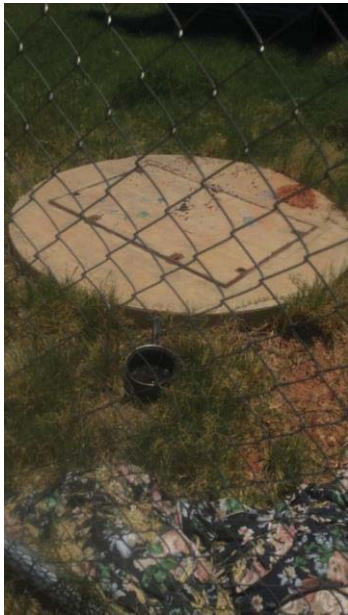
Notes on Lid: 16/29D

Comments: Paint on lid

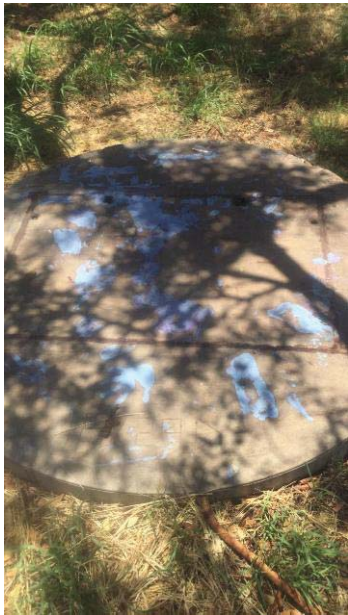
Notes on Lid: 16/29E

Comments: Within property

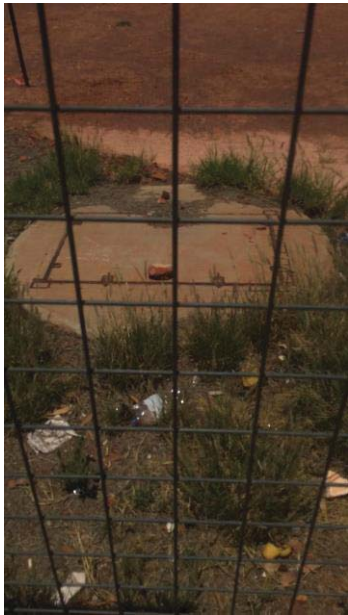
Comments: Covered with grass

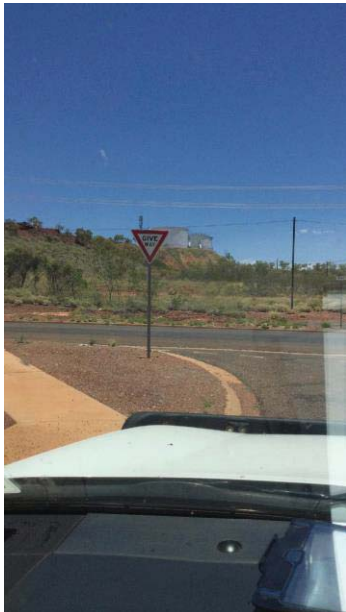
**Sign Comment:** On slight angle

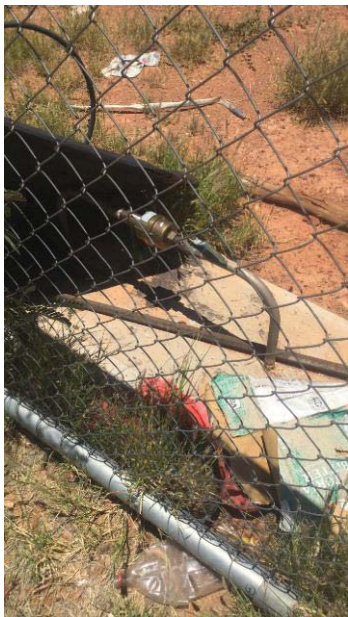
Lot Water Meter Condition: 4 - Very Good

Lot Water Meter Comment: Two meters

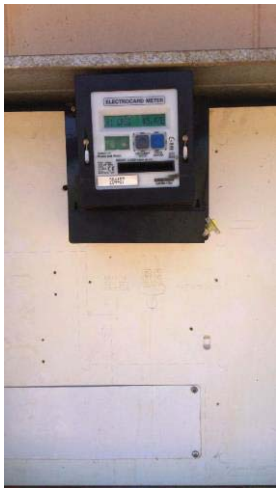
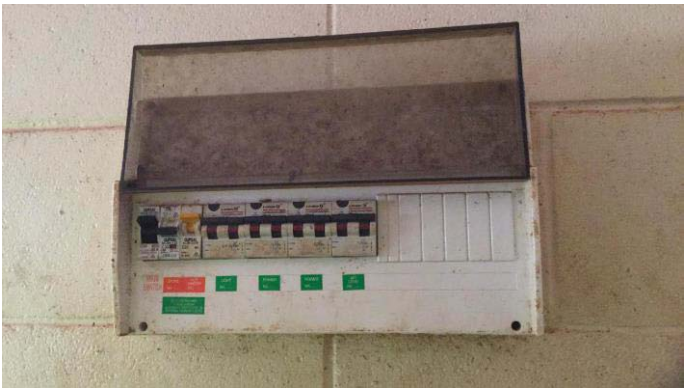
Meter Condition: 3

Meter Comment: Indoor SB, Cond 3

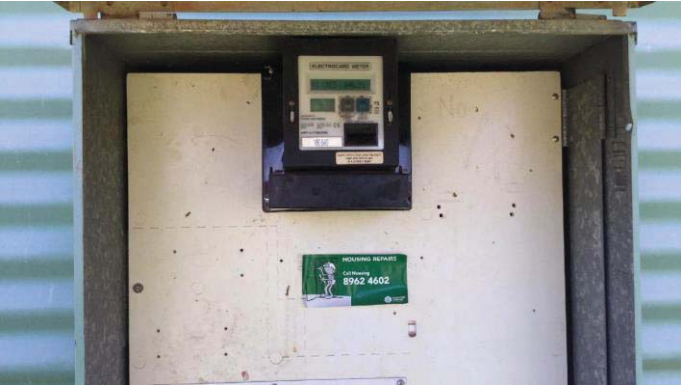
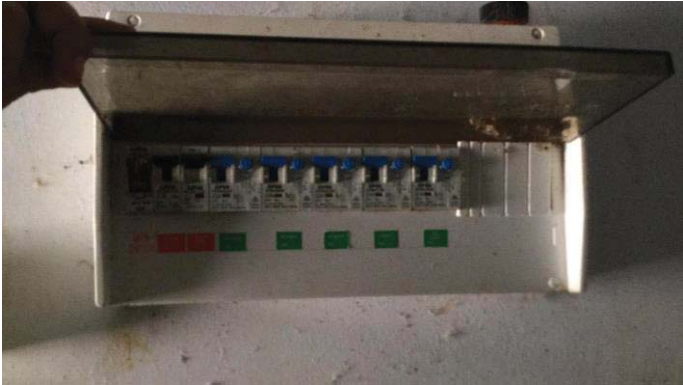
Meter Condition: 3

Meter Comment: Condition of CB not assessed. Indoor SB, Cond 3

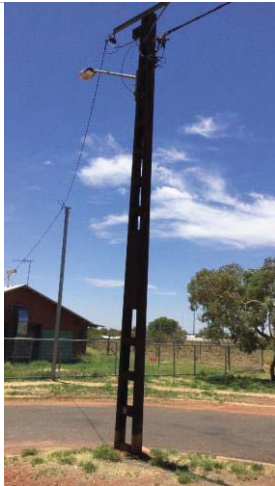
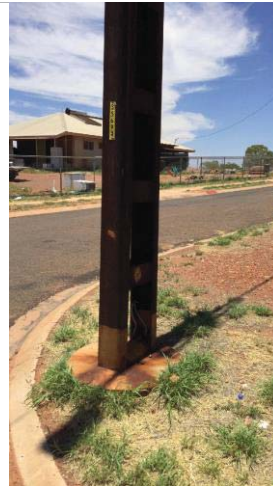
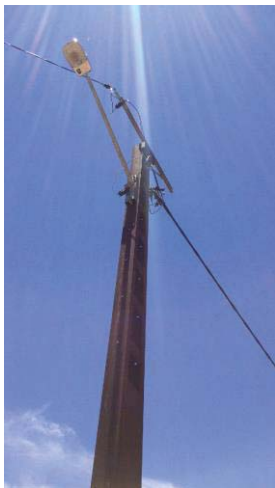
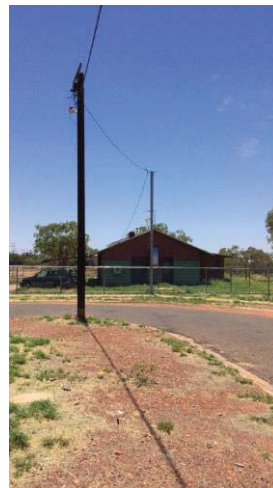
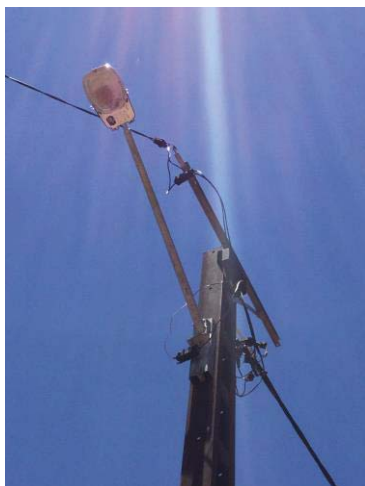
What is the condition of pole: 3

What is the Condition of plant: 3

Street Light Condition 2

What is the Condition: 3

Overhead Pole Comments: Surface rusted

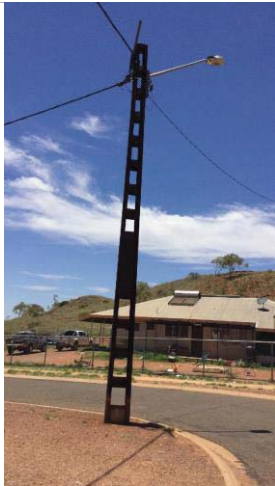
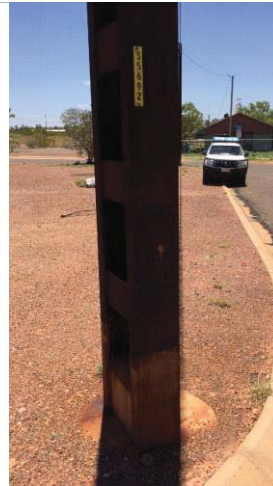
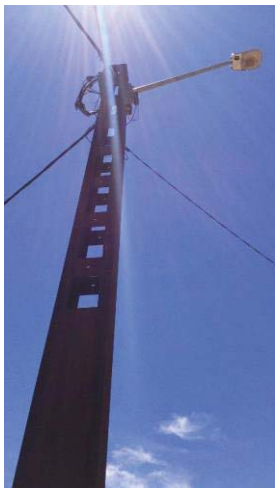
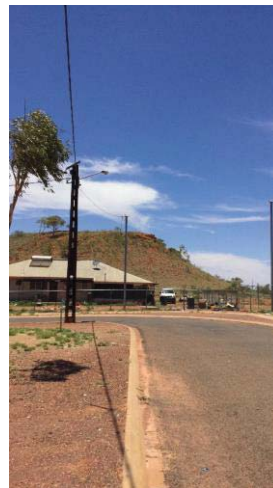
**What is the condition of pole:** 3

**What is the Condition of plant:** 3

**Street Light Condition** 2

**What is the Condition:** 3

**Overhead Pole Comments:** Surface rusted

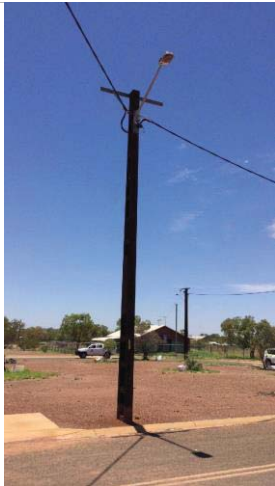
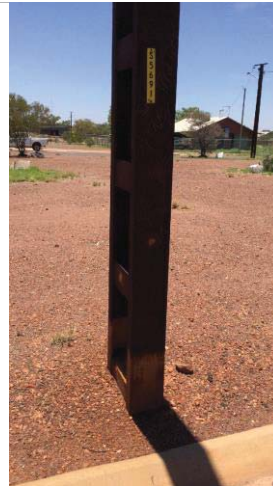
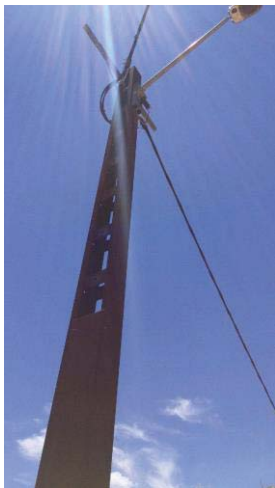
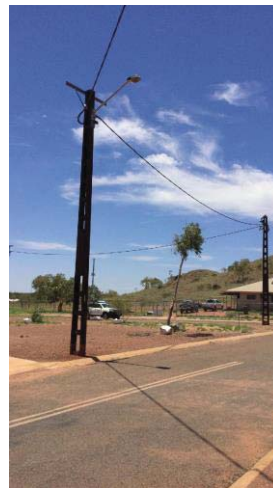
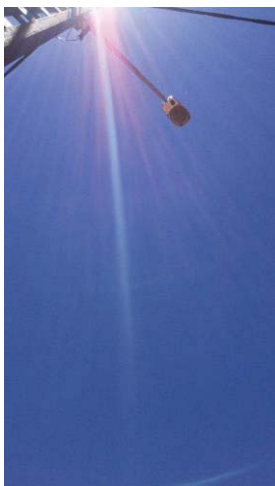
What is the condition of pole: 3

What is the Condition of plant: 3

Street Light Condition 2

What is the Condition: 3

Overhead Pole Comments: Surface rusted

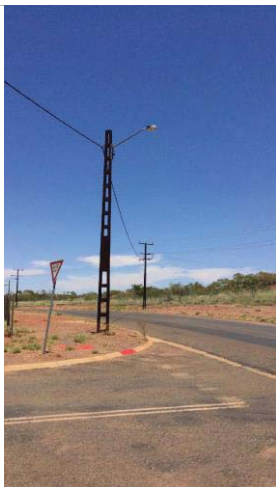
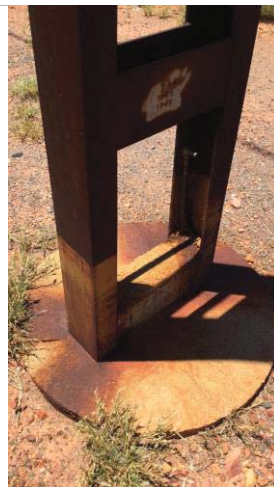
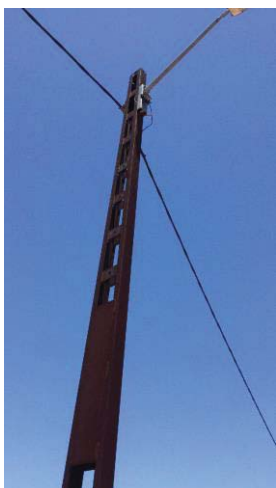
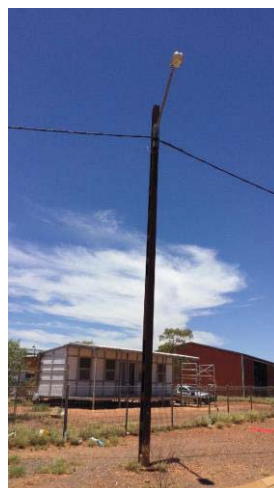
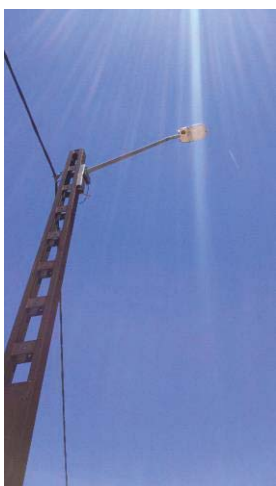
What is the condition of pole: 3

What is the Condition of plant: 3

Street Light Condition 3

What is the Condition: 3

Overhead Pole Comments: Surface rusted

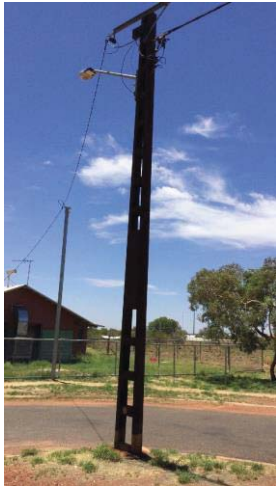
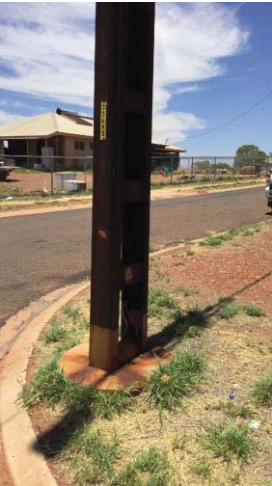
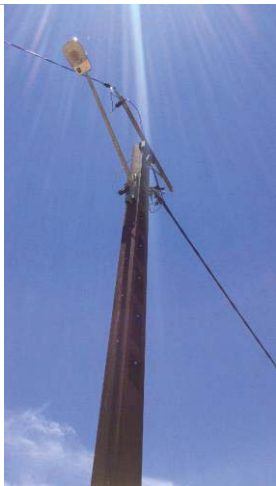
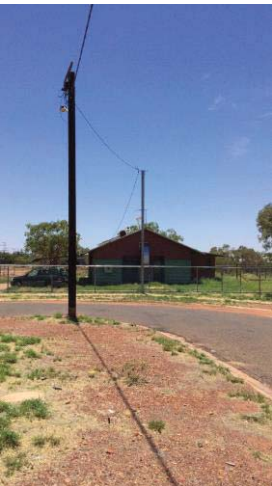
Street Light Condition 2

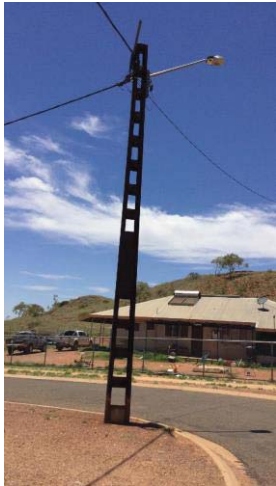
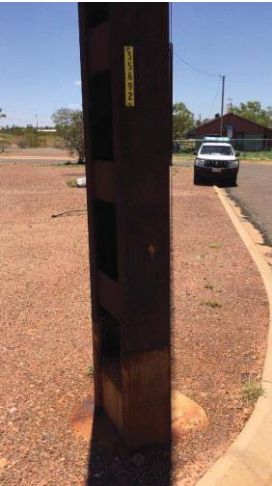
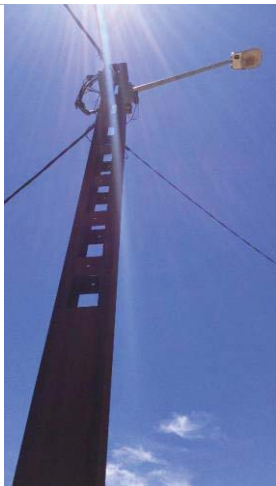
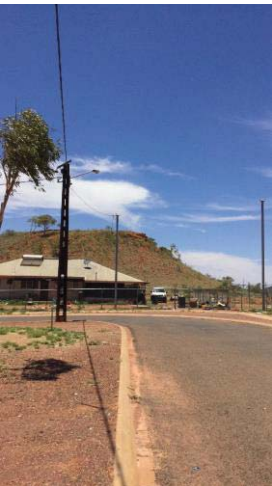
Street Light Condition 2

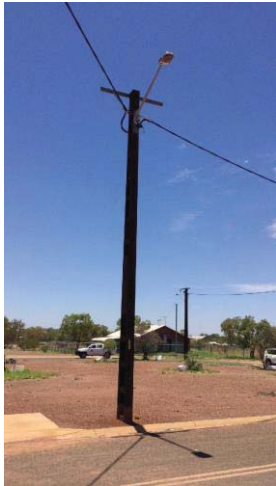
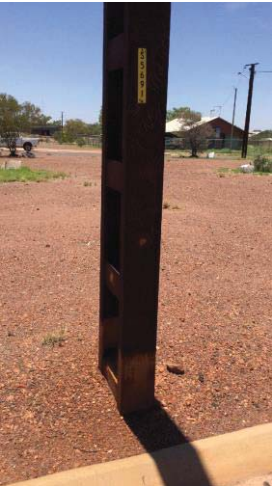
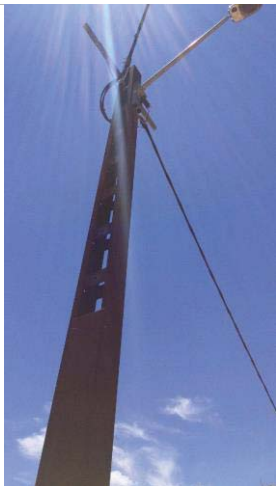
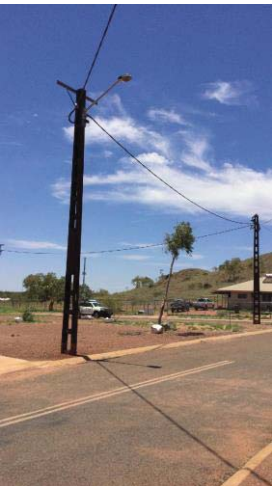
Street Light Condition 2

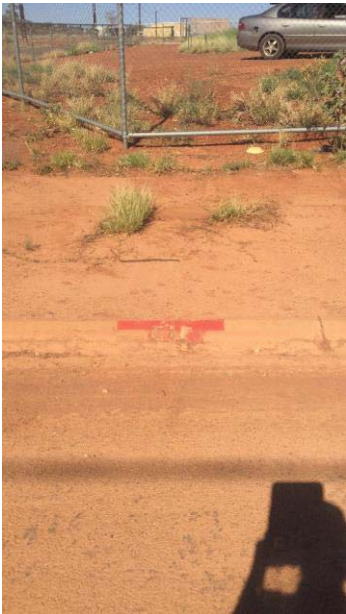
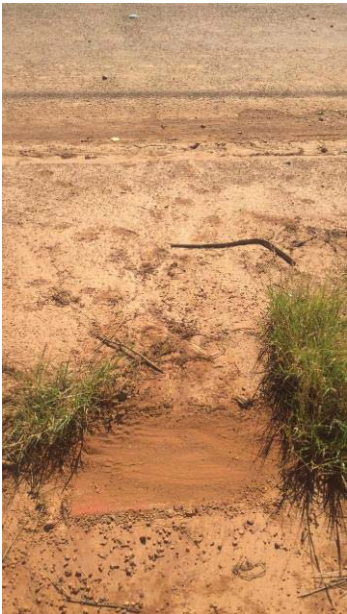
FH Condition: 3 - Good

FH Comment: Covered in dirt

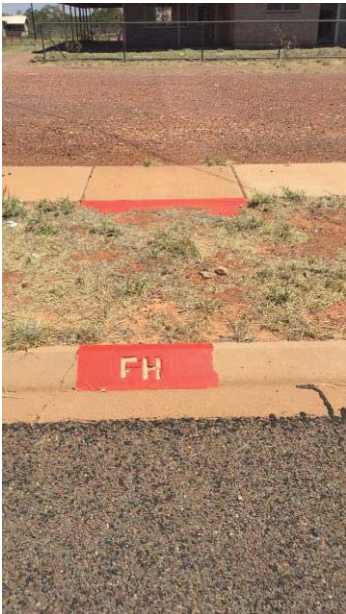
FH Condition: 4 - Very Good

FH Comment: Covered in dirt

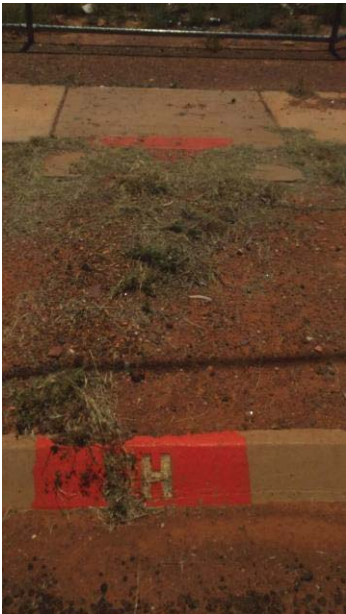
FH Condition: 4 - Very Good

FH Comment: Overgrown

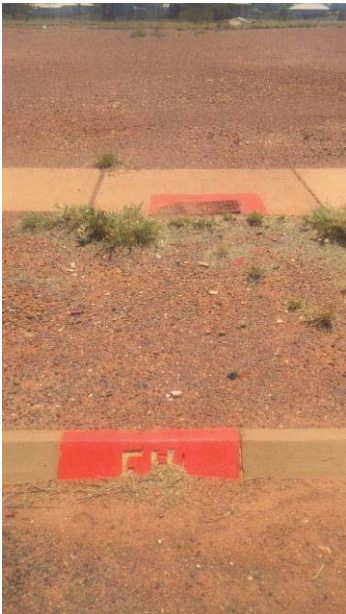
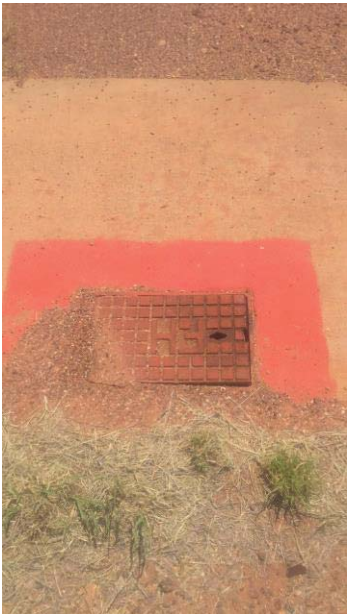
FH Condition: 3 - Good

FH Comment: Lid not on properly

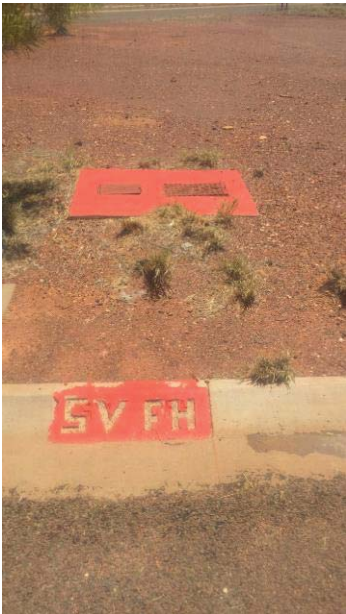
FH Condition: 3 - Good

FH Comment: Paint on kerb starting to peel

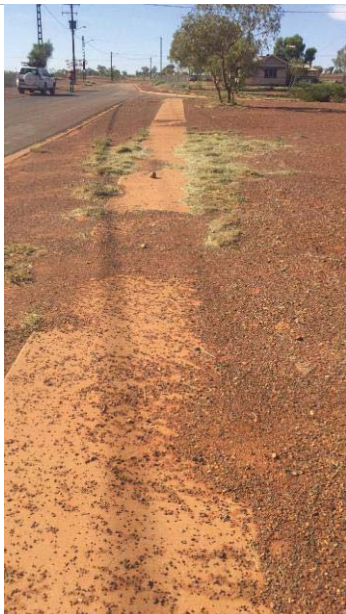
**General Comment:** Needs maintenance, rocks and dirt on footpath

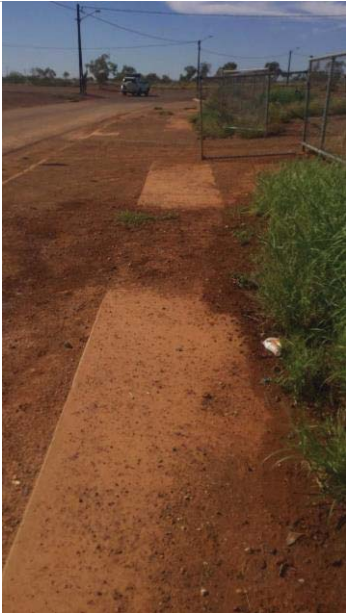
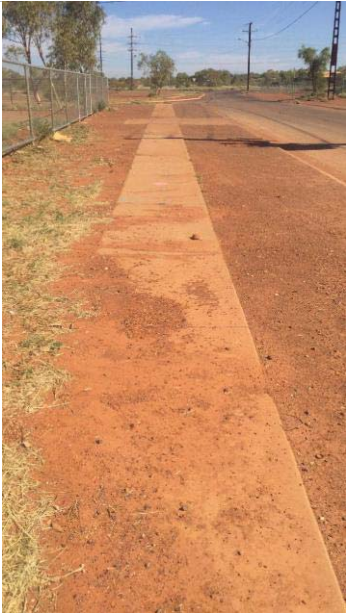
Comment: Needs a clean

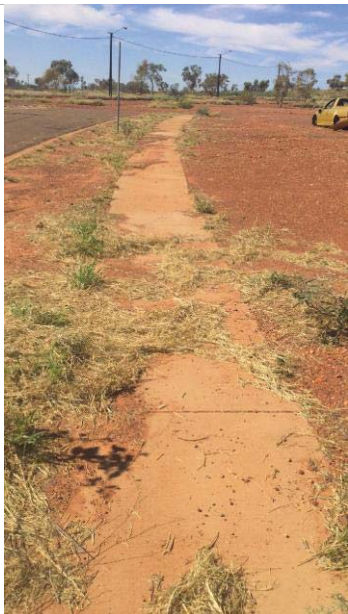
General Comment: Structurally fine, but needs a tidy up

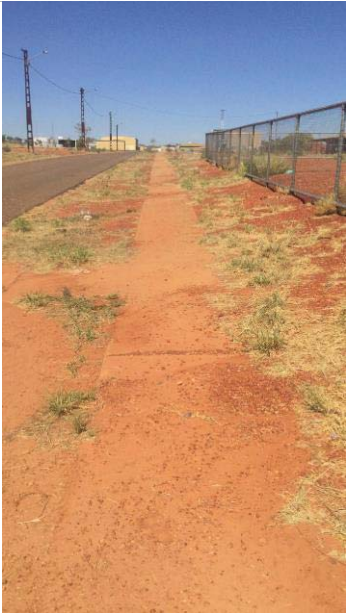
General Comment: Needs tidy up

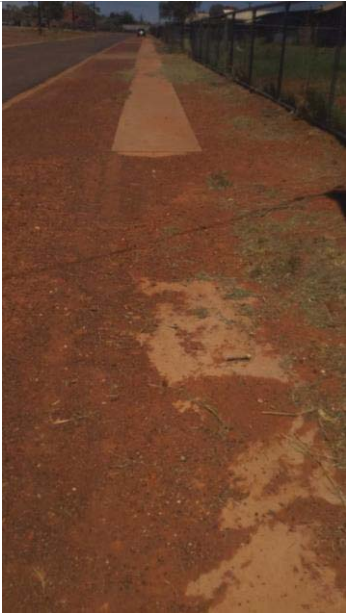
Comment: Needs tidy up

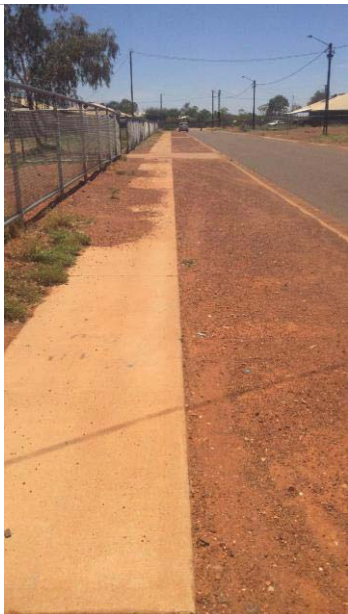
Comment: Needs tidy up

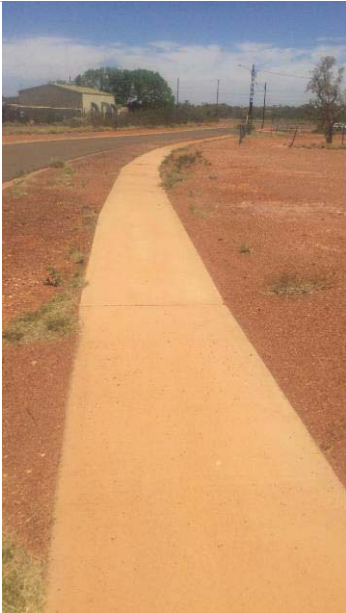
Comment: Needs general tidy up

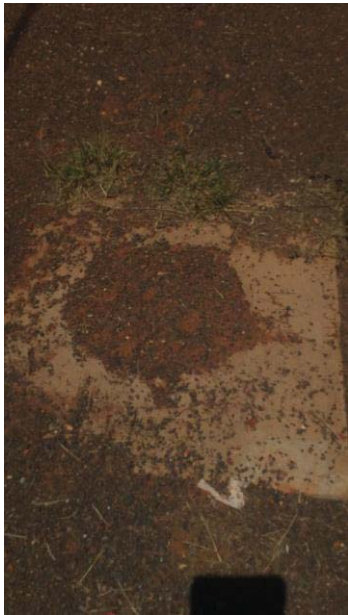
The sewer infrastructure that was assessed is in good to very good condition. There was one manhole that was covered in graffiti, and another that was covered in gravel. It is recommended that these manholes are cleaned and tidied up.

Comments: Covered in gravel

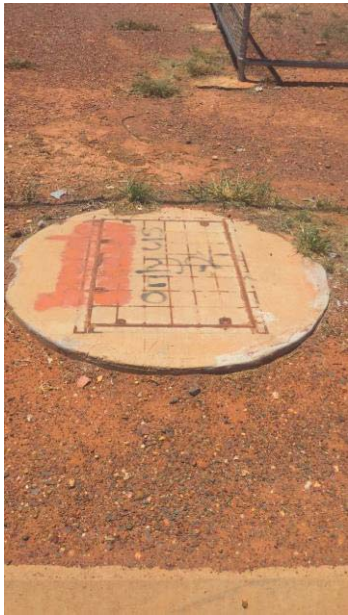
Manhole Condition: 3 - Good

Notes on Lid: 1/4

Comments: Graffiti

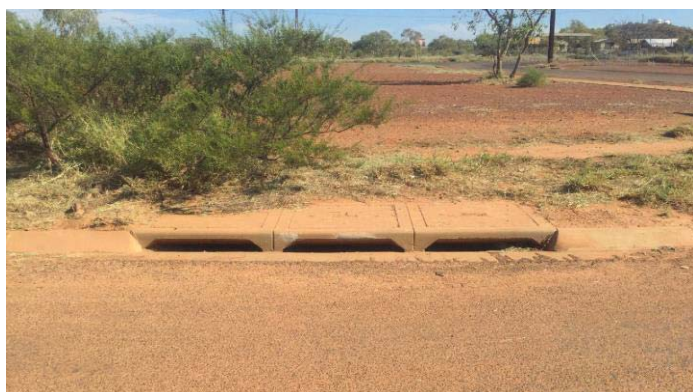
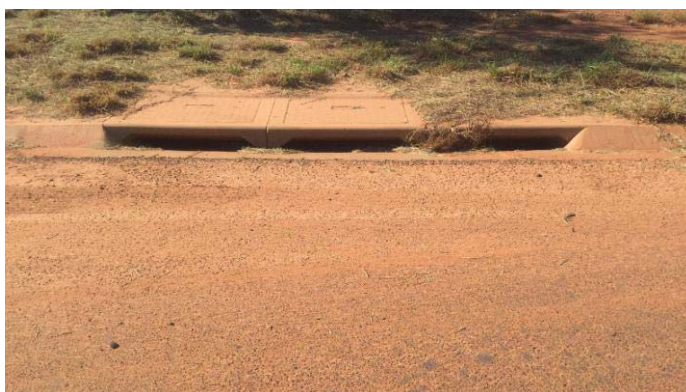
Condition:2 - Poor

Comment:Broken concrete

- Repair one side entry pit (one bay)
- Clear blockages from four side entry pits (20 - 40% blocked)
- Clear blockages from culvert headwall and swale, including removing trees and debris.
- Replace lid on one side entry pit

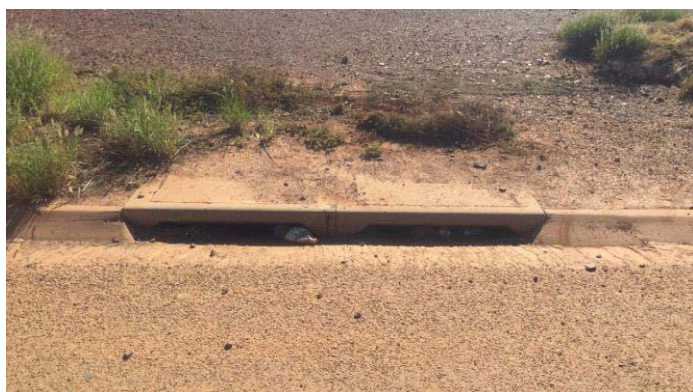
Stormwater Infrastructure: SEP  
Number of Bays: 2  
On grade or sag pit:  
Both sides of road: Left  
Condition: 3 - Good  
Blockage (%): 40  
Comment:

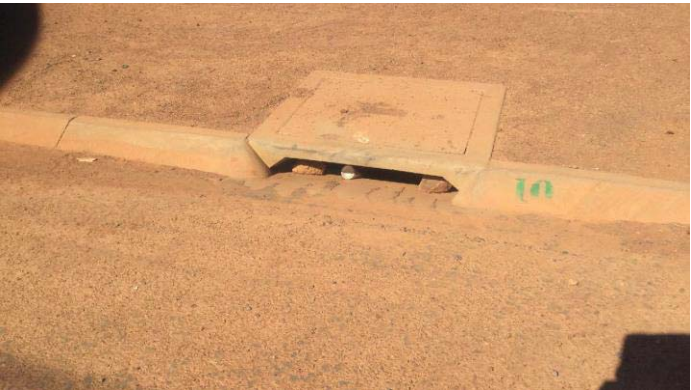
| Condition: | 3 - Good |
| Blockage (%): | 20 |
| Comment: | Blocked with concrete |

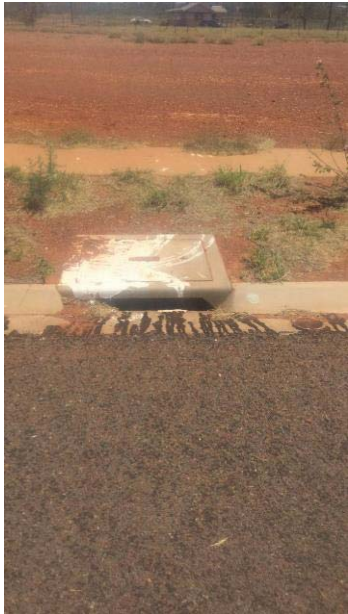
| Condition: | 3 - Good |
| Blockage (%): | 20 |
| Comment: | Covered in white paint |

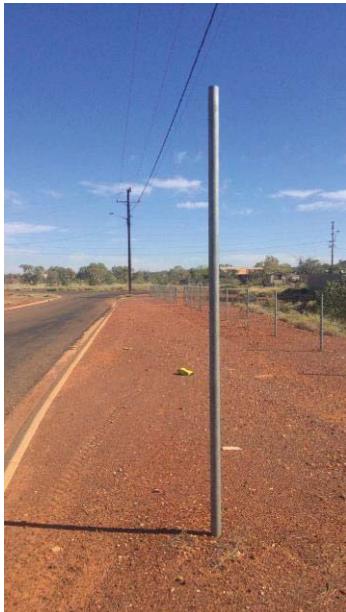
**Sign Condition:** 1 - Very Poor

**Sign Comment:** No street name sign. Post only

- Install street name signs on post (four)
- Remove graffiti from one sign (or replace sign)
- Replace one sign and post
- General tidy up of foot paths – approximately 500 m
- Clean out kerbs and gutters

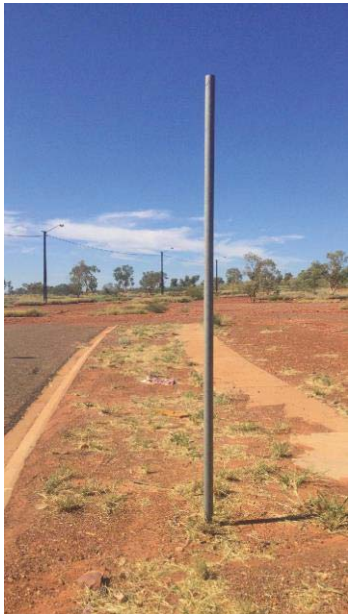
Sign Condition: 2 - Poor

Sign Comment: No sign

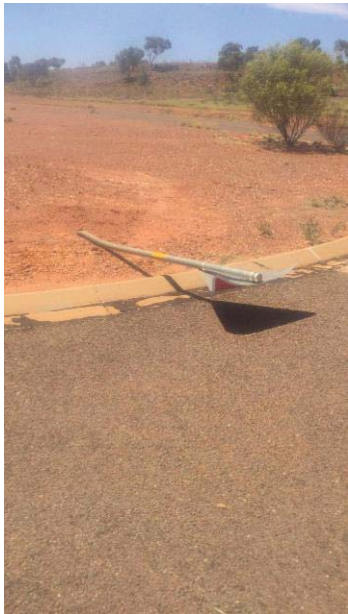
Sign Condition: 1 - Very Poor

Sign Comment: Sign bent, leaning over road

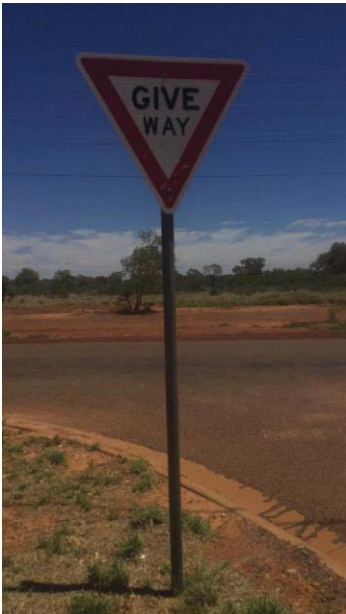
Sign Condition: 3 - Good

Sign Comment: Some graffiti

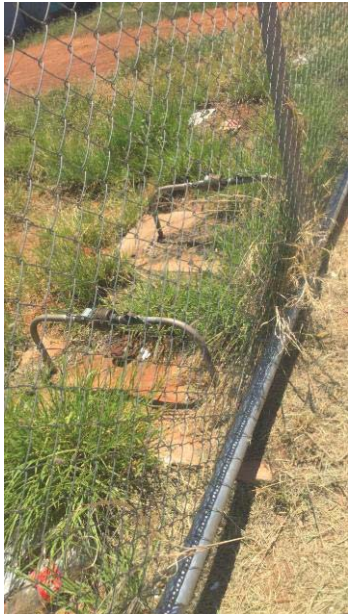
Lot Water Meter Condition: 4 - Very Good

Lot Water Meter Comment: Two meters in one lot

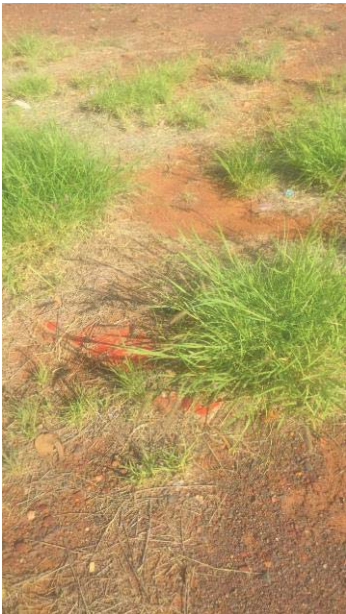
FH Condition: 2 - Poor

FH Comment: Paint fading and covered in dirt and grass

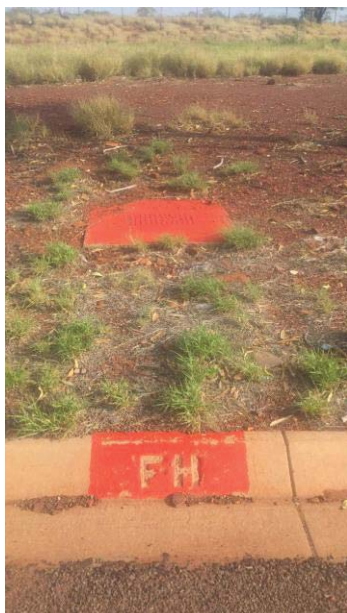
**FH Condition:** 4 - Very Good

**FH Comment:** Paint on kerb starting to peel

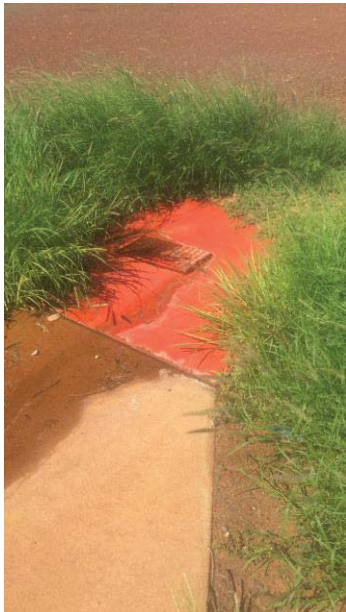
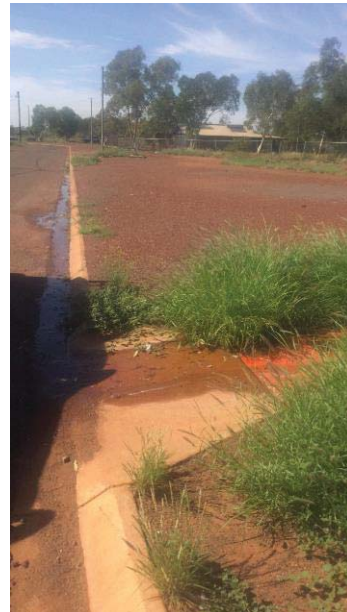
**FH Condition:** 2 - Poor

**FH Comment:** Leaking

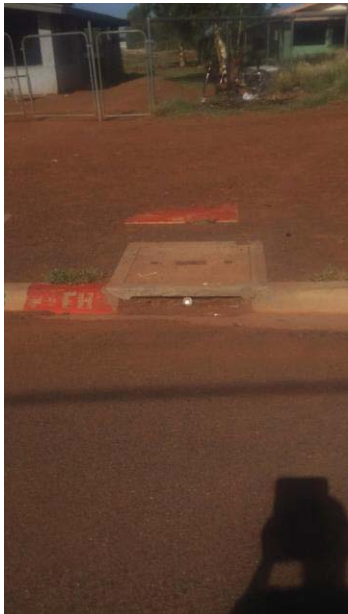
FH Condition: 3 - Good

FH Comment: Paint fading, covered in dirt

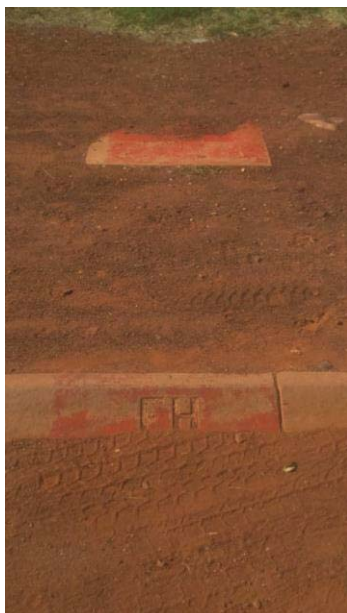
**FH Condition:** 2 - Poor

**FH Comment:** Paint fading , covered in dirt

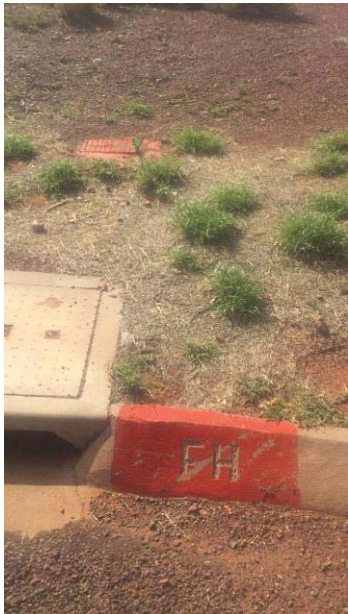
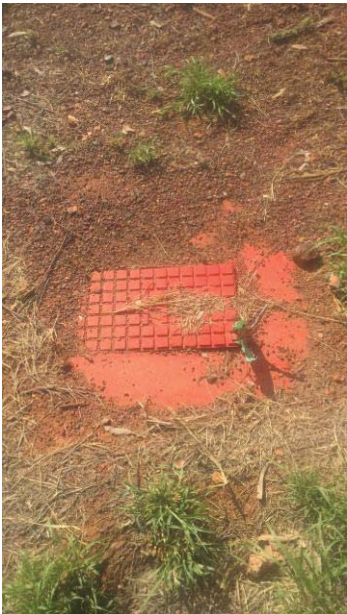
FH Condition: 3 - Good

FH Comment: Paint fading, covered in dirt

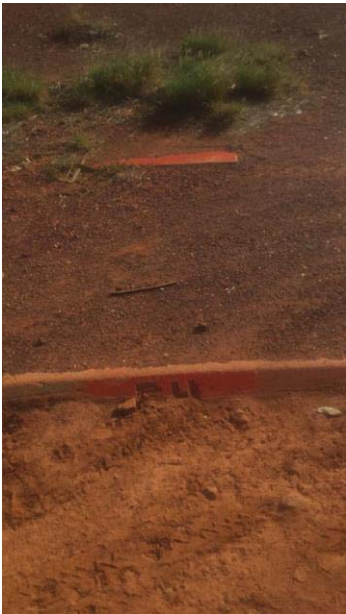
FH Condition: 3 - Good

FH Comment: Covered in dirt

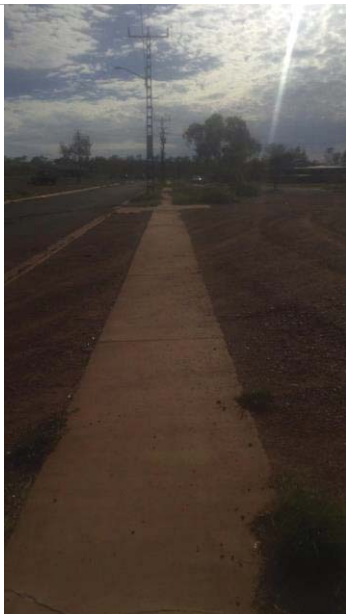
**Comment:** Needs tidy up. Grass over growing and dirt on footpath

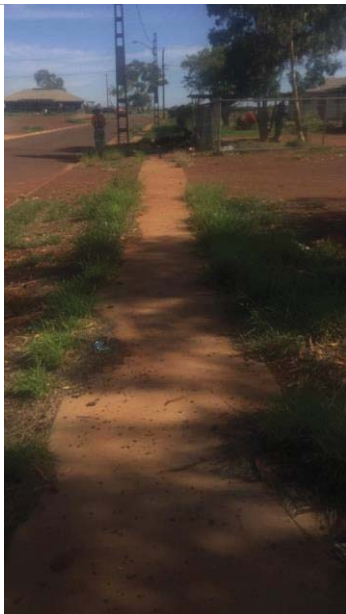
**Footpath Condition:** 3 - Good

**Comment:** Needs tidy up, rubbish removed

- General tidy up of the footpaths – approximately 650 m
- Replace three custom signs
- General tidy up of one road – approximately 140 m
- Clean out gutters – approximately 300 m

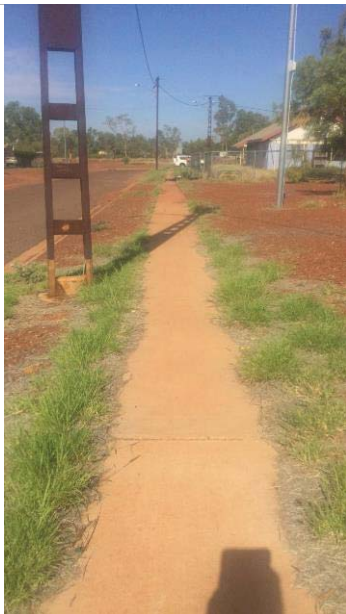
**Footpath Condition:** 3 - Good

**Comment:** Needs tidy up

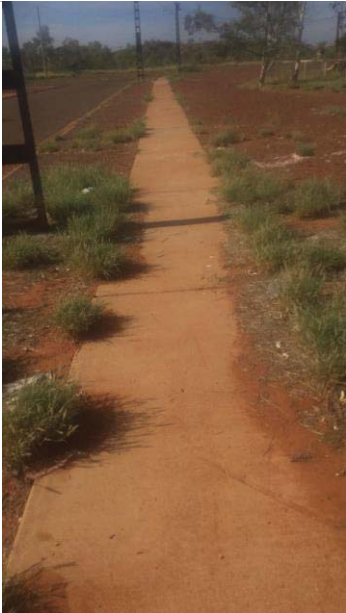
Footpath Condition: 3 - Good

Comment: Needs tidy up
