## Northern Territory Town Camps

### Electrical Infrastructure

## 2 Condition assessment

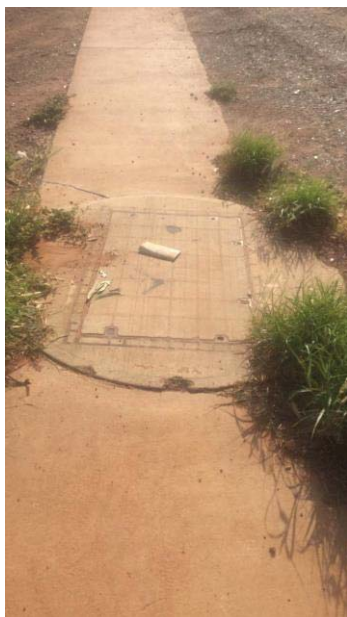
**Notes on Lid:** B1

**Manhole Condition:** 3 - Good

**Comments:** In footpath

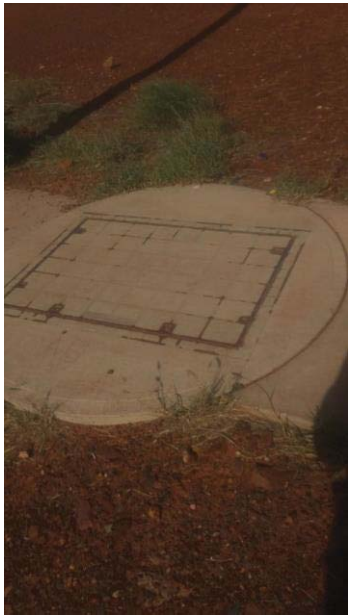
Notes on Lid: A8

Manhole Condition: 3 - Good

Comments: In footpath

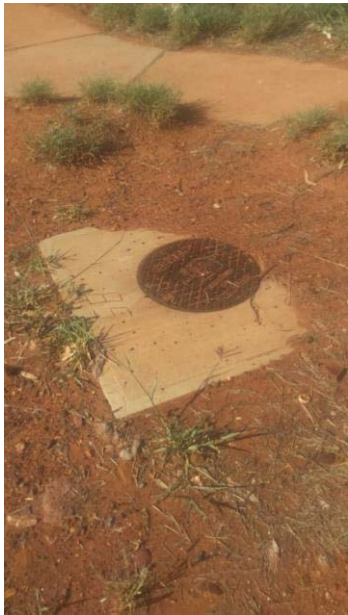
Notes on Lid: B5

Manhole Condition: 3 - Good

Comments: Covered in dirt

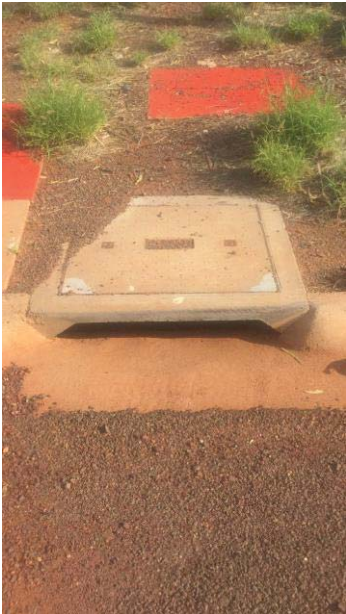
Gravel at sep entrance, could be blocked in side

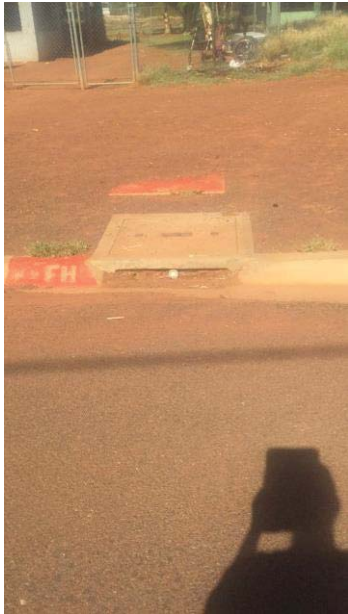
Condition:2 - Poor

Blockage (%):100

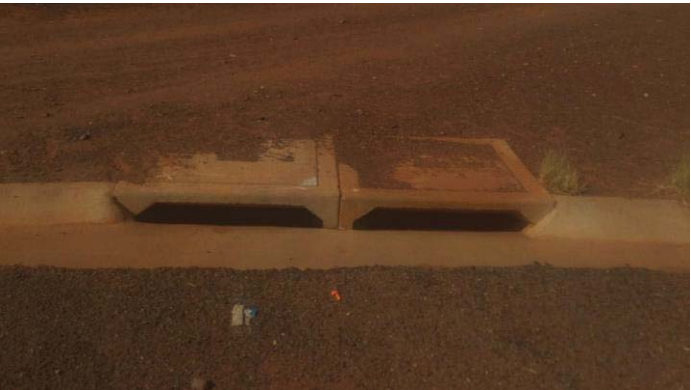
Condition:3 - Good

Blockage (%):0

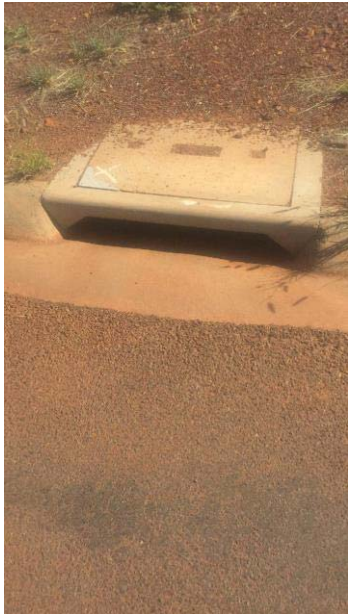
Condition:3 - Good

Blockage (%):0

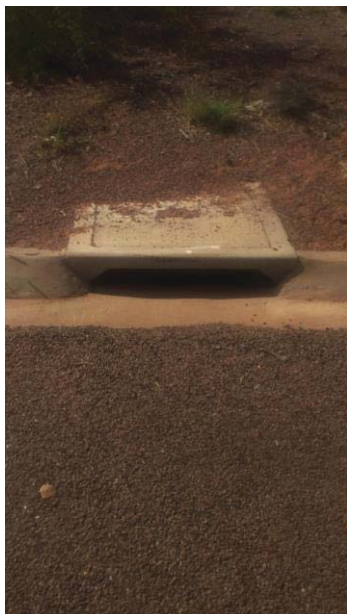
**Condition:** 4 - Very Good

**Blockage (%):** 0

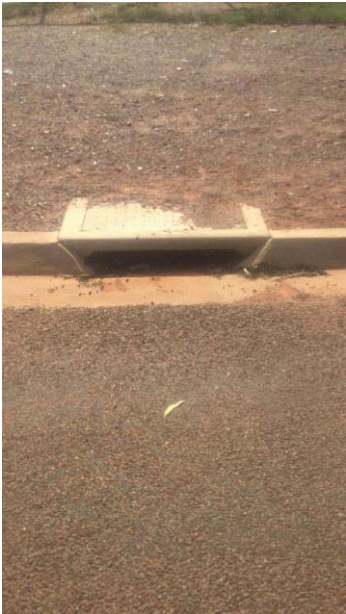
Condition:3 - Good

Blockage (%):30

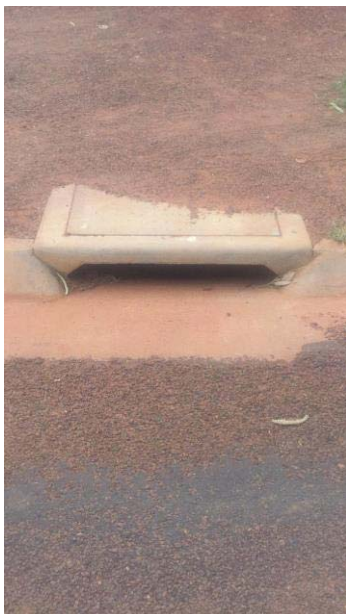
Stormwater Infrastructure: SEP  
Number of Bays: 1  
On grade or sag pit:  
Both sides of road: Left  
Condition: 3 - Good  
Blockage (%): 0  
Comment:

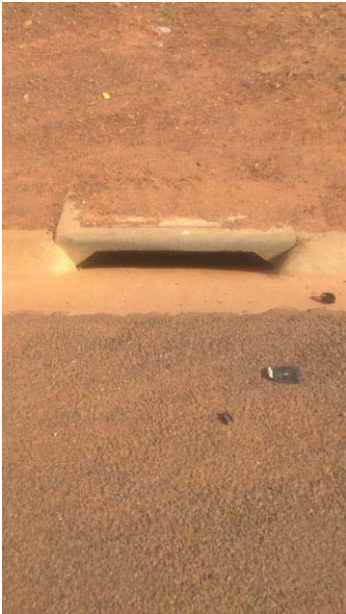
Condition:3 - Good

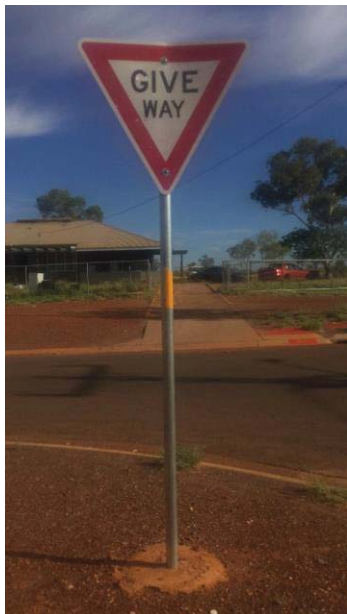
**Sign Condition:** 3 - Good

**Sign Comment:** Some paint chipping
