Northern Territory Camps

Civil Infrastructure

Group 5 - Borroloola

Yanyula

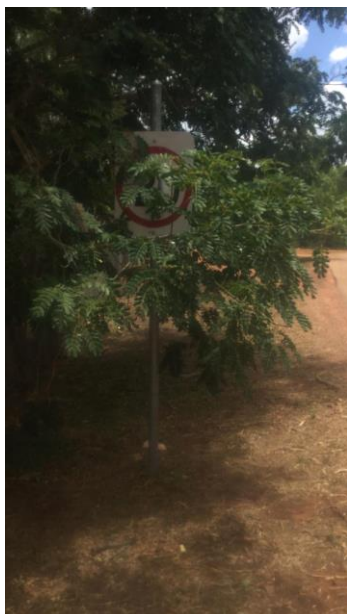
Sign Condition: 2 - Poor

Sign Comment: Tree growing in front , sign graffitied

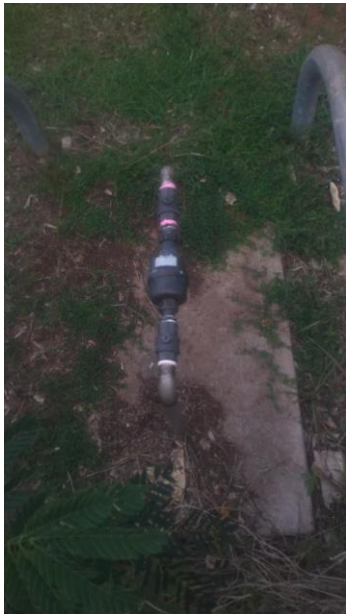
Lot Water Meter Condition: 2 - Poor

Lot Water Meter Comment: No tap handles

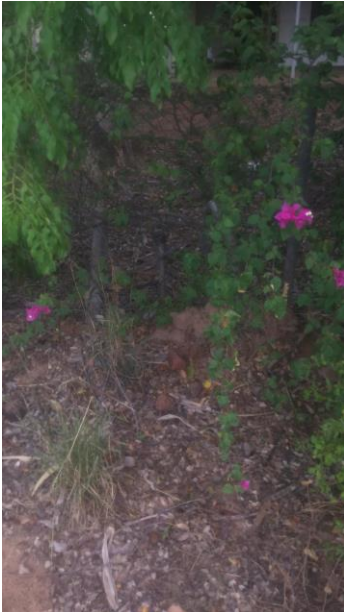
Lot Water Meter Condition: 2 - Poor

Lot Water Meter Comment: No tap handles

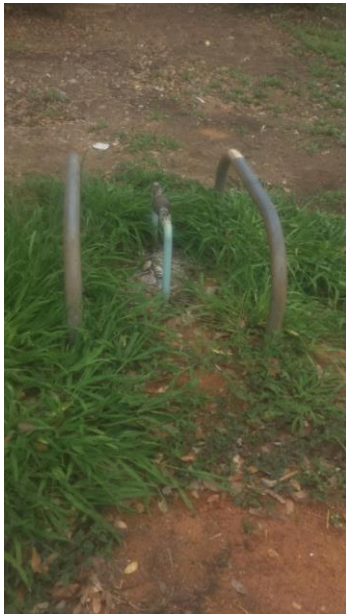
Lot Water Meter Condition: 2 - Poor

Lot Water Meter Comment: No tap handles

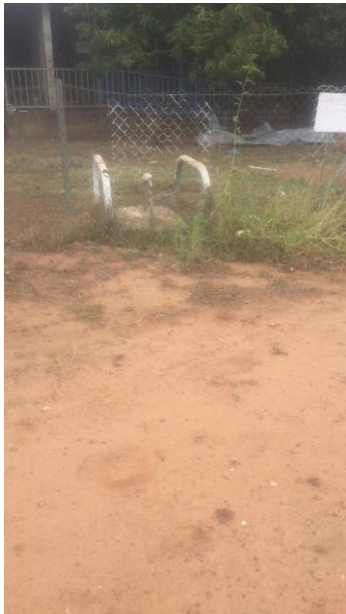
Lot Water Meter Condition: 2 - Poor

Lot Water Meter Comment: No tap handles , all painted white

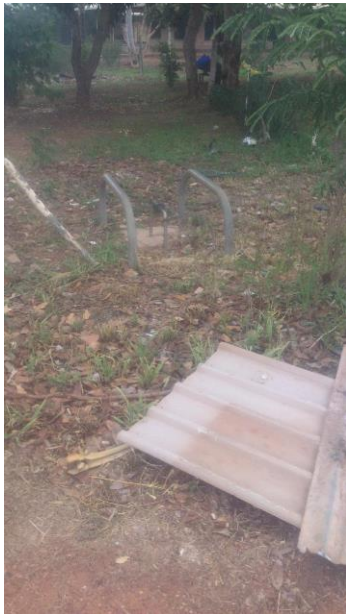
Lot Water Meter Condition: 2 - Poor

Lot Water Meter Comment: No tap handles

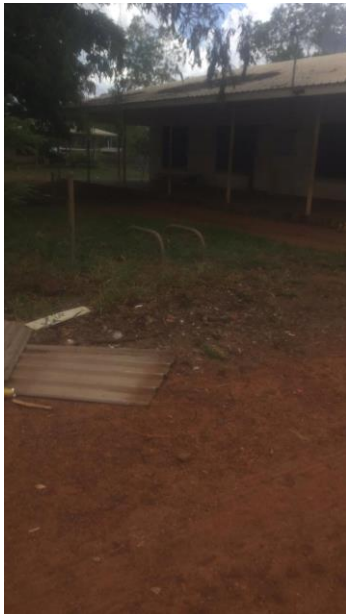
Lot Water Meter Condition: 2 - Poor

Lot Water Meter Comment: No tap handles

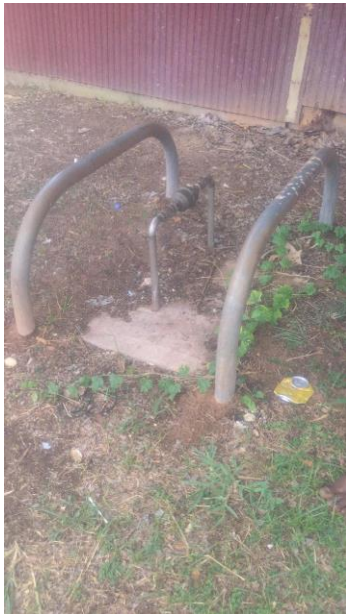
Lot Water Meter Condition: 2 - Poor

Lot Water Meter Comment: No tap handles

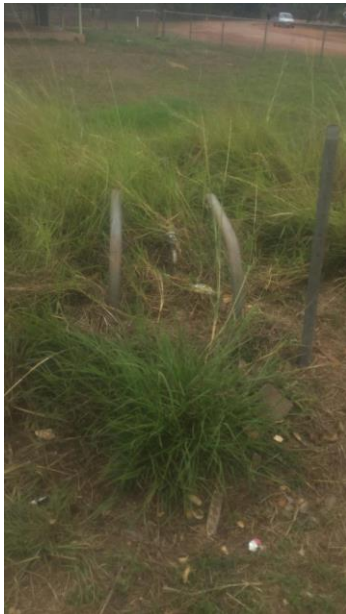
Lot Water Meter Condition: 2 - Poor

Lot Water Meter Comment: No tap handles , bent bollard, covered in grass

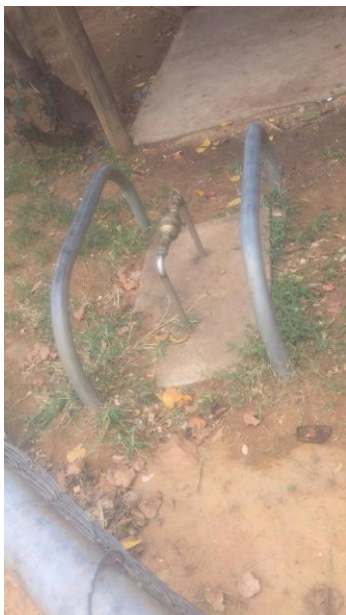
Lot Water Meter Condition: 2 - Poor

Lot Water Meter Comment: No tap handles

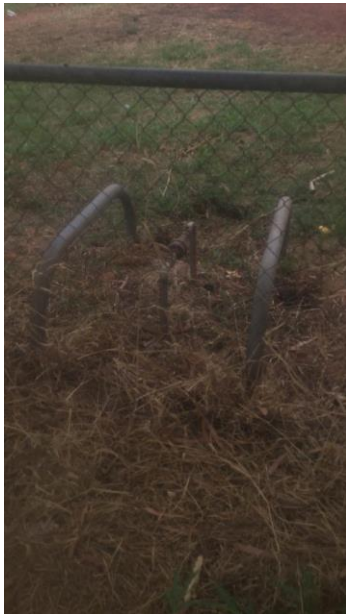
Lot Water Meter Condition: 2 - Poor

Lot Water Meter Comment: No tap handles

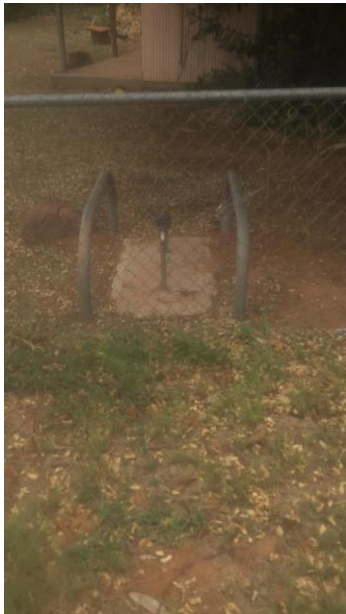
Lot Water Meter Condition: 2 - Poor

Lot Water Meter Comment: No tap handles

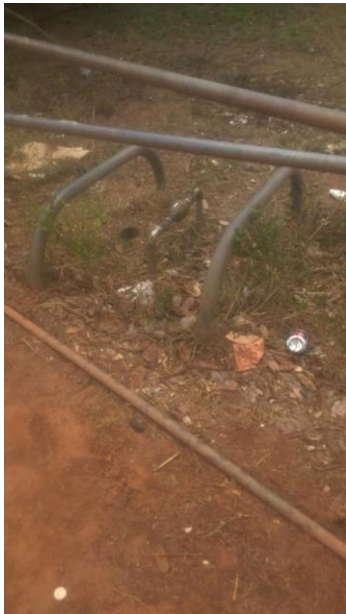
Lot Water Meter Condition: 2 - Poor

Lot Water Meter Comment: No tap handles

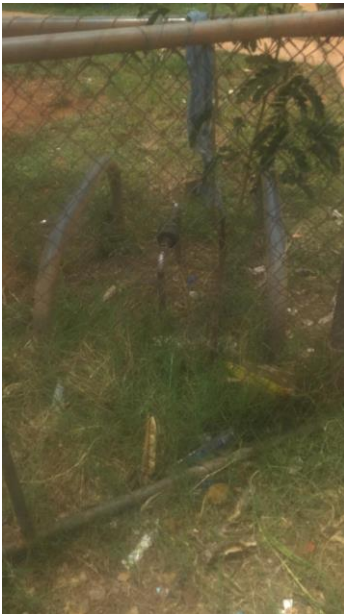
Lot Water Meter Condition: 2 - Poor

Lot Water Meter Comment: No tap handles

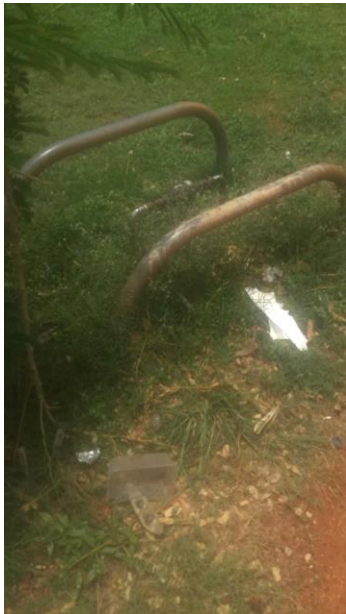
Lot Water Meter Condition: 2 - Poor

Lot Water Meter Comment: No tap handles

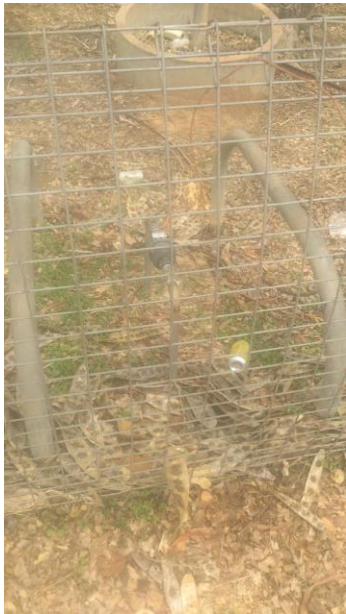
Lot Water Meter Condition: 2 - Poor

Lot Water Meter Comment: No tap handles

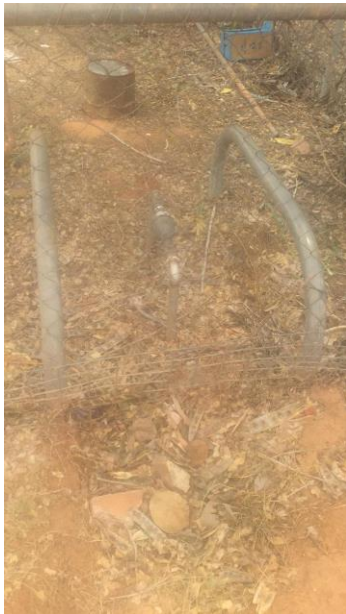
Lot Water Meter Condition: 2 - Poor

Lot Water Meter Comment: No tap handles

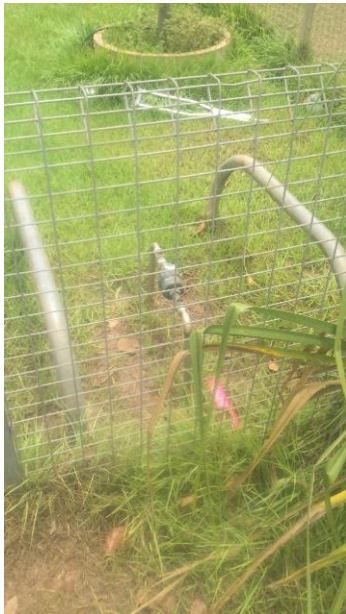
Lot Water Meter Condition: 2 - Poor

Lot Water Meter Comment: No tap handles

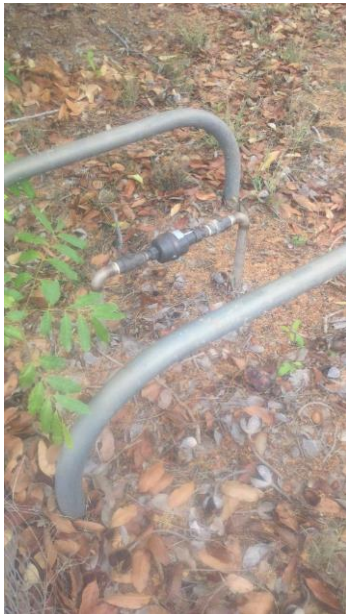
Lot Water Meter Condition: 2 - Poor

Lot Water Meter Comment: No tap handles

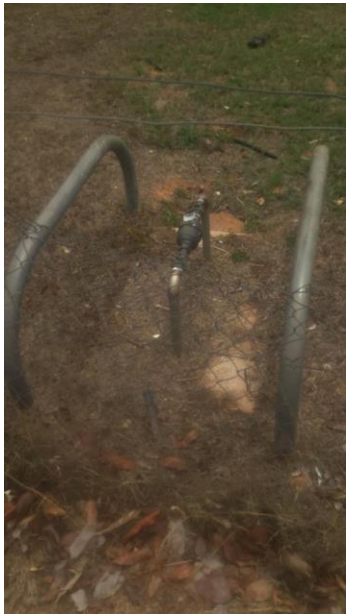
Lot Water Meter Condition: 2 - Poor

Lot Water Meter Comment: No tap handles

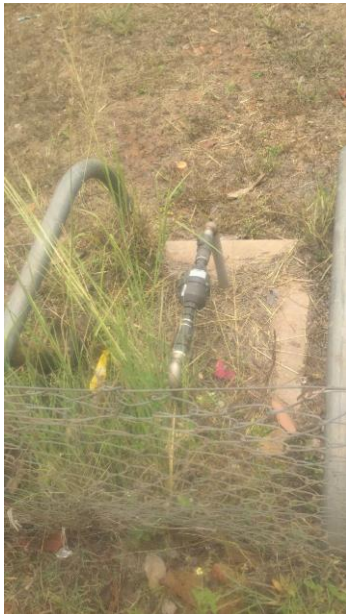
Lot Water Meter Condition: 2 - Poor

Lot Water Meter Comment: No tap handles

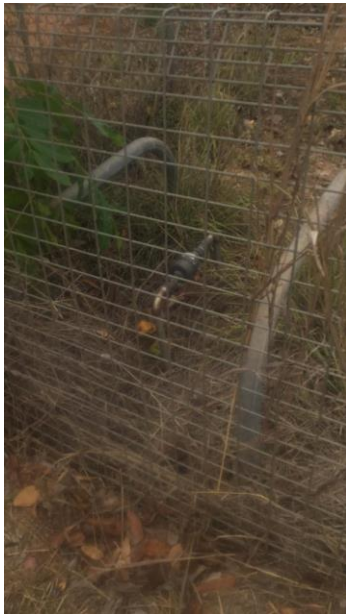
Lot Water Meter Condition: 2 - Poor

Lot Water Meter Comment: No tap handles

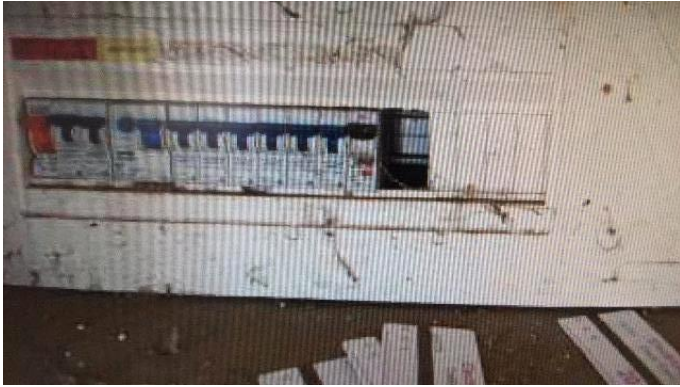
Meter Comment: Type & Condition of meter to be confirmed as meter photo not captured. Blank plates a

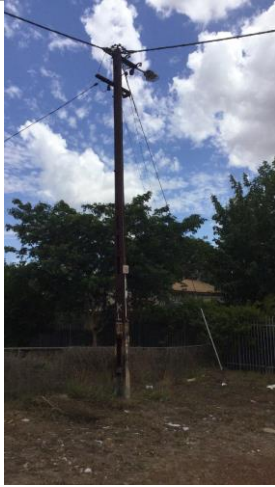
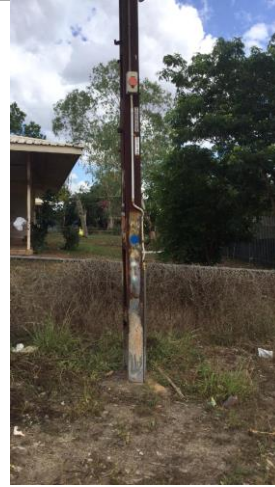
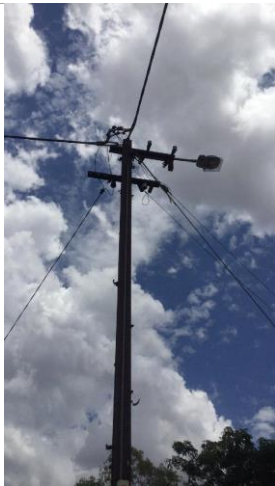
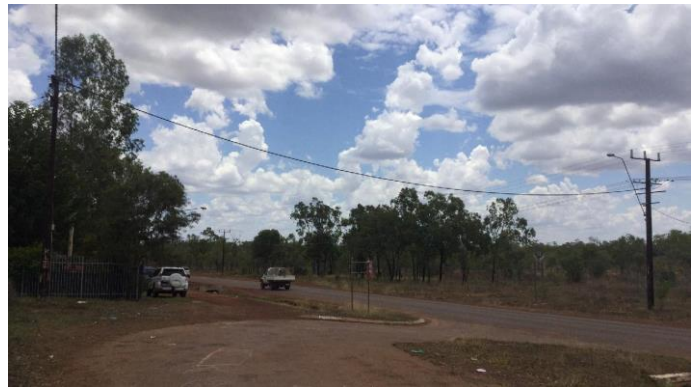
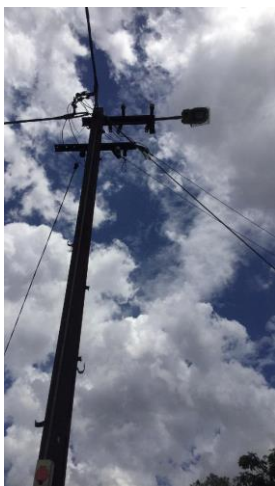
What is Pole Material type:	Welded
What is the condition of pole:	3
How is the pole planted:	Concrete
What is the Condition of plant:	3
Is street light fitted:	Yes
Street Light Power Supply:	
Street Light Type	M80d 02
Street Light Watts	
Street Light Condition	3
Street Light Height	
What is the type of service:	Three
What is the HV voltage level:	400
What is the arrangement of connected cables:	Twisted
Are there isolators on the pole:	No
What is the Condition:	3
How many Lots are connected to this pole:	3
Overhead Pole Comments:	Surface rusted

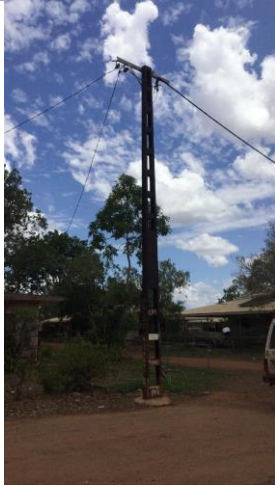
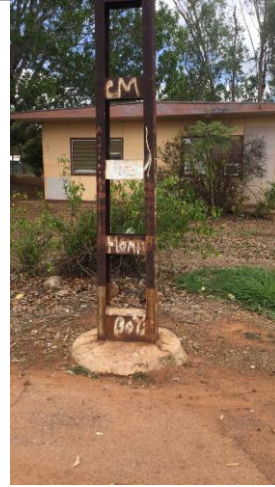
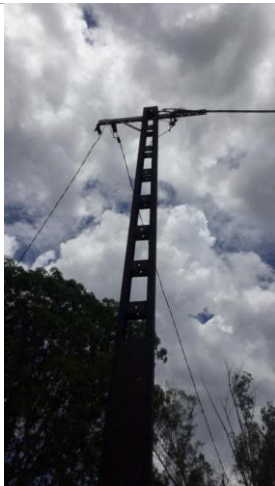
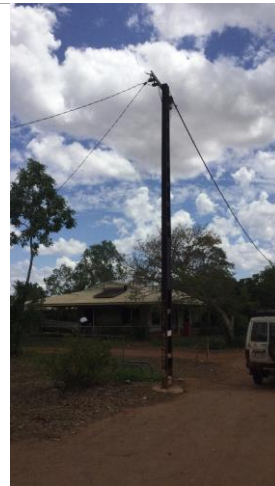
What is Pole Material type:	Welded
What is the condition of pole:	3
How is the pole planted:	Concrete
What is the Condition of plant:	3
Is street light fitted:	No
Street Light Power Supply:	
Street Light Type	
Street Light Watts	
Street Light Condition	
Street Light Height	
What is the type of service:	Three
What is the HV voltage level:	400
What is the arrangement of connected cables:	Twisted
Are there isolators on the pole:	No
What is the Condition:	3
How many Lots are connected to this pole:	2
Overhead Pole Comments:	Surface rusted

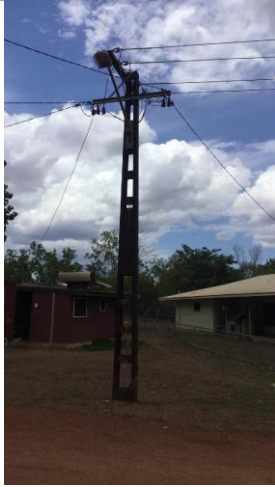
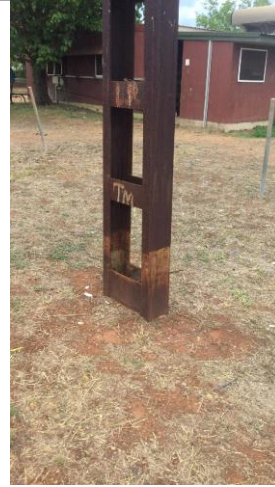
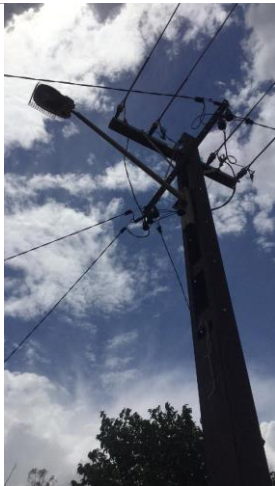
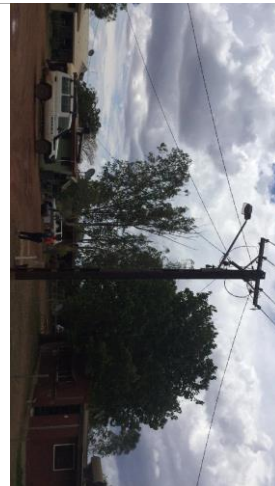
What is Pole Material type:	Welded
What is the condition of pole:	3
How is the pole planted:	Concrete
What is the Condition of plant:	3
Is street light fitted:	Yes
Street Light Power Supply:	
Street Light Type	M80d 02
Street Light Watts	
Street Light Condition	2
Street Light Height	
What is the type of service:	Three
What is the HV voltage level:	400
What is the arrangement of connected cables:	Parallel
Are there isolators on the pole:	No
What is the Condition:	3
How many Lots are connected to this pole:	4
Overhead Pole Comments:	Surface rusted

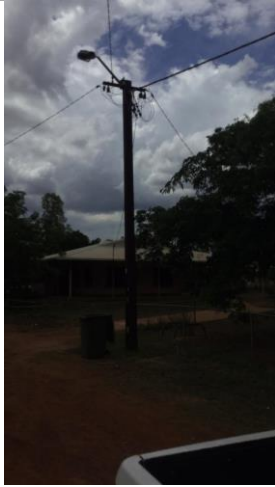
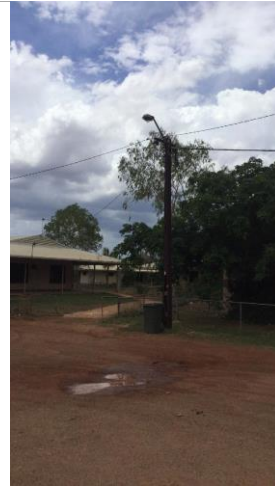
What is Pole Material type:	Welded
What is the condition of pole:	3
How is the pole planted:	Concrete
What is the Condition of plant:	3
Is street light fitted:	Yes
Street Light Power Supply:	
Street Light Type	Unknown
Street Light Watts	
Street Light Condition	3
Street Light Height	
What is the type of service:	Three
What is the HV voltage level:	11000
What is the arrangement of connected cables:	Twisted
Are there isolators on the pole:	No
What is the Condition:	3
How many Lots are connected to this pole:	4
Overhead Pole Comments:	Surface rusted

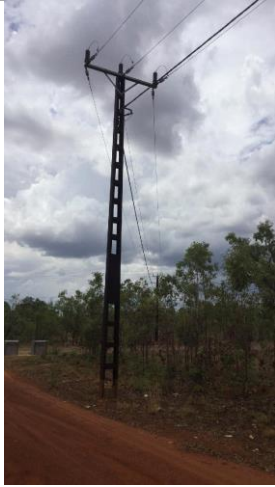
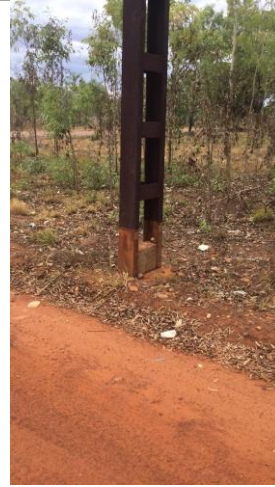
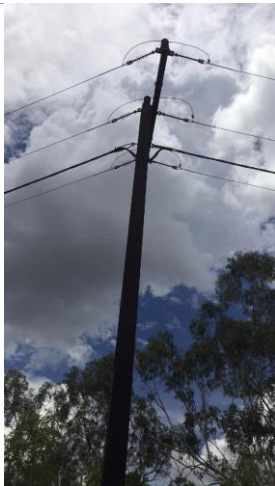
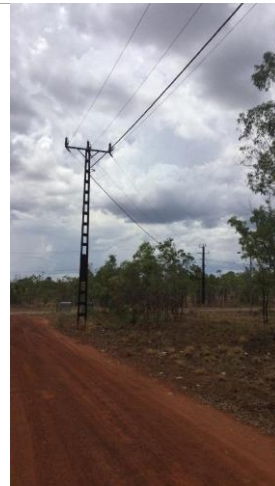
Overhead Pole Comments: Surface rusted

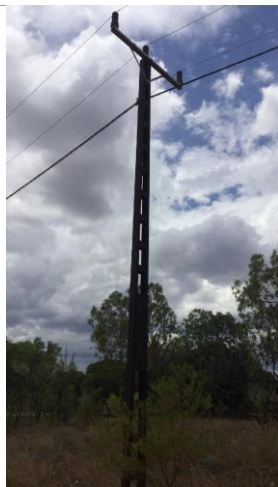
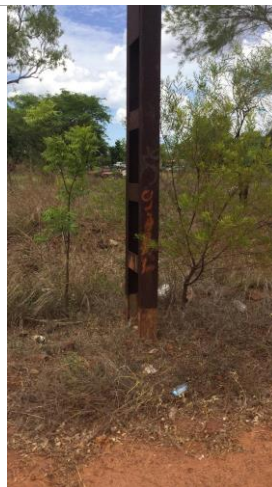
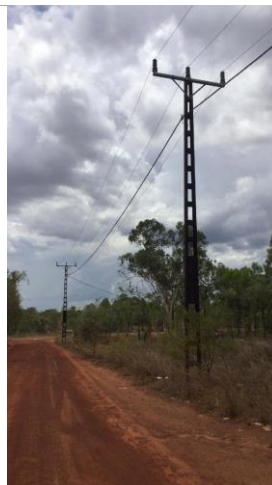
Overhead Pole Comments: Surface rusted

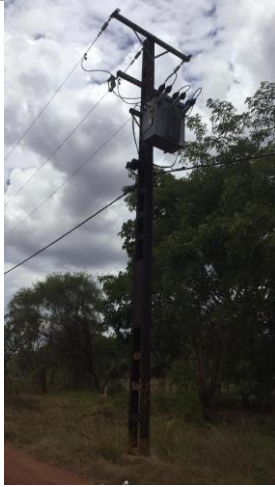
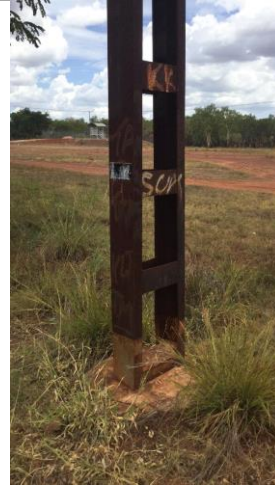
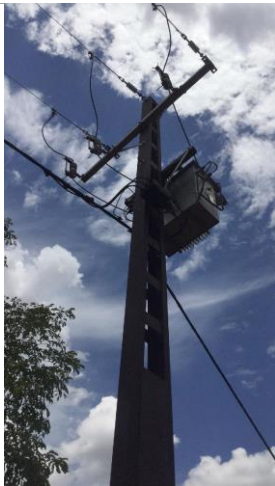
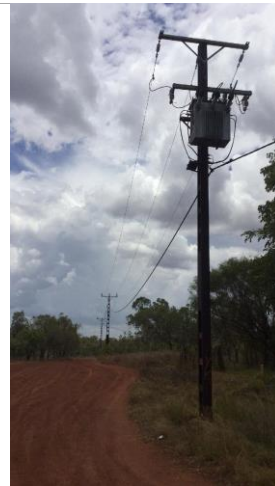
Overhead Pole Comments: Surface rusted

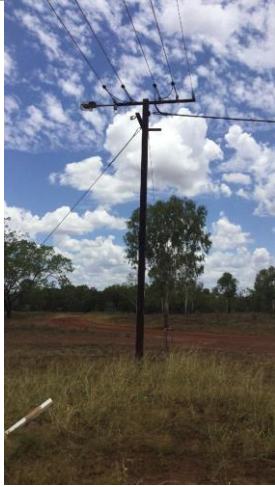
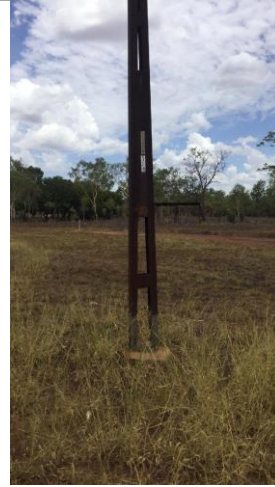
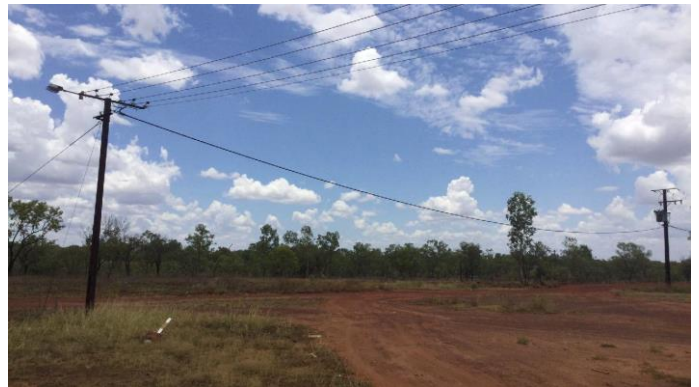
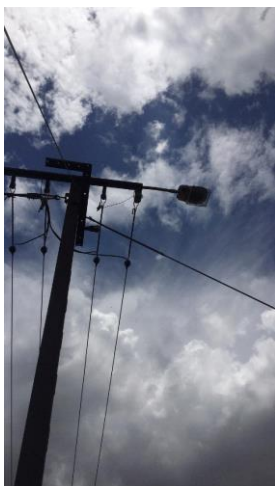
What is Pole Material type:	Welded
What is the condition of pole:	3
How is the pole planted:	Concrete
What is the Condition of plant:	3
Is street light fitted:	Yes
Street Light Power Supply:	
Street Light Type	M80d 06
Street Light Watts	
Street Light Condition	2
Street Light Height	
What is the type of service:	Three
What is the HV voltage level:	400
What is the arrangement of connected cables:	Parallel
Are there isolators on the pole:	No
What is the Condition:	3
How many Lots are connected to this pole:	0
Overhead Pole Comments:	Surface rusted

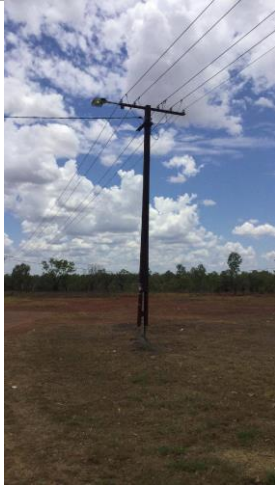
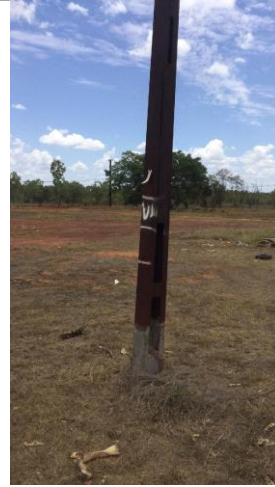
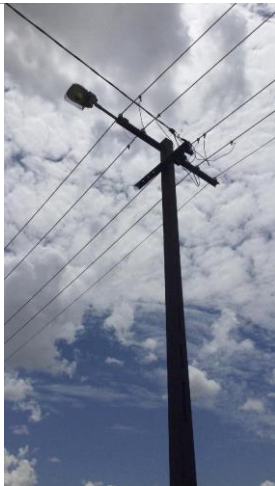
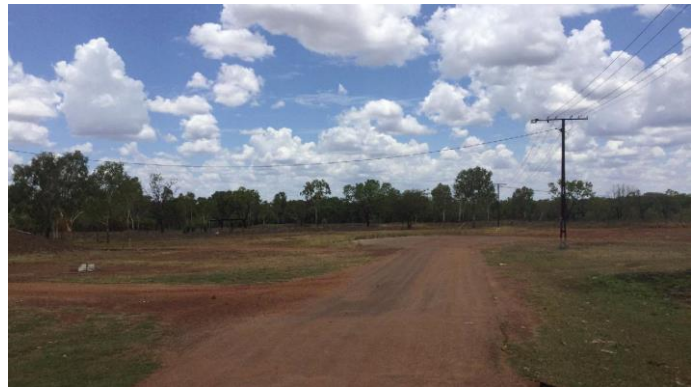
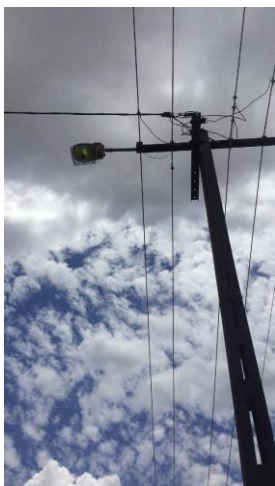
What is Pole Material type:	Welded
What is the condition of pole:	3
How is the pole planted:	Concrete
What is the Condition of plant:	3
Is street light fitted:	Yes
Street Light Power Supply:	
Street Light Type	Unknown
Street Light Watts	
Street Light Condition	3
Street Light Height	
What is the type of service:	Three
What is the HV voltage level:	400
What is the arrangement of connected cables:	Parallel
Are there isolators on the pole:	No
What is the Condition:	3
How many Lots are connected to this pole:	1
Overhead Pole Comments:	Surface rusted . Feeds pump station

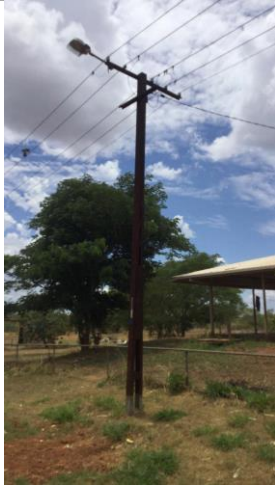
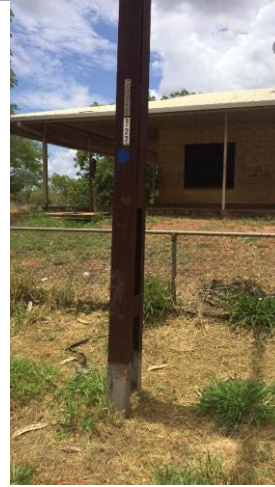
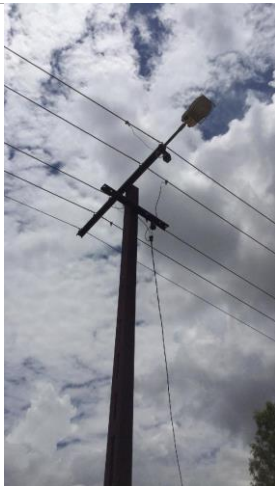
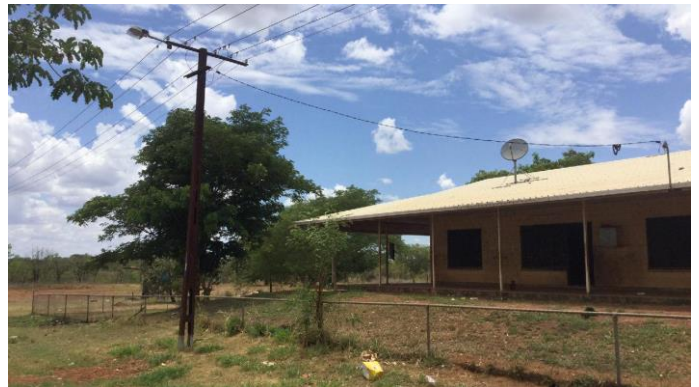
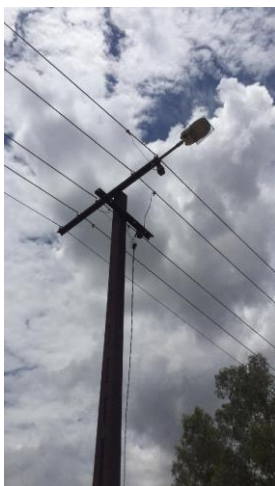
What is Pole Material type:	Welded
What is the condition of pole:	3
How is the pole planted:	Concrete
What is the Condition of plant:	3
Is street light fitted:	Yes
Street Light Power Supply:	
Street Light Type	M80d 02
Street Light Watts	
Street Light Condition	2
Street Light Height	
What is the type of service:	Three
What is the HV voltage level:	400
What is the arrangement of connected cables:	Parallel
Are there isolators on the pole:	No
What is the Condition:	3
How many Lots are connected to this pole:	1
Overhead Pole Comments:	Surface rusted

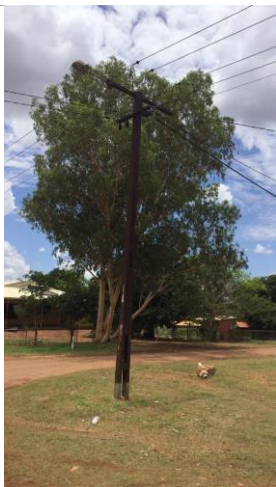
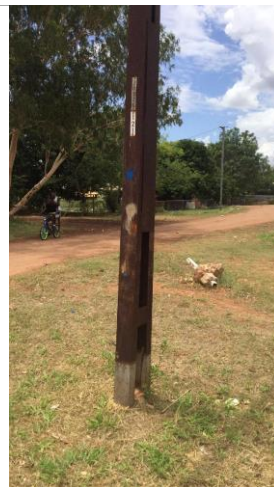
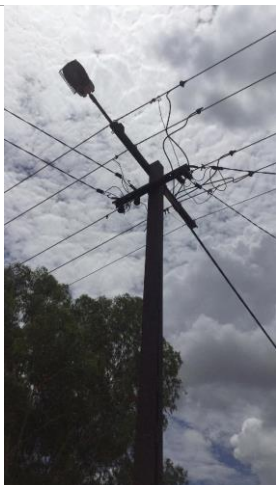
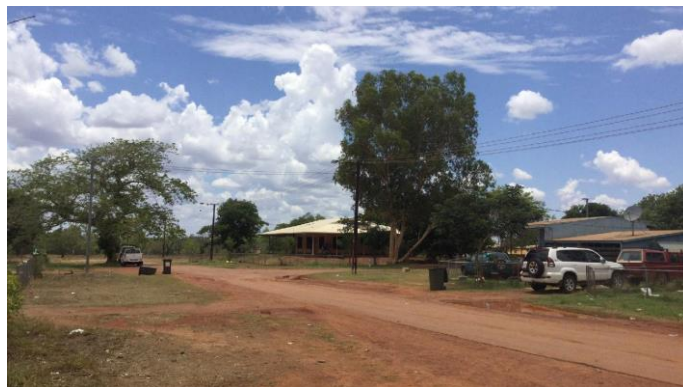
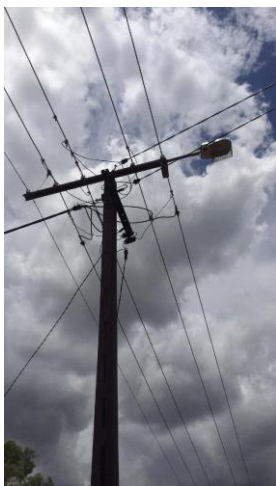
What is Pole Material type:	Welded
What is the condition of pole:	3
How is the pole planted:	Concrete
What is the Condition of plant:	3
Is street light fitted:	Yes
Street Light Power Supply:	
Street Light Type	M80d 02
Street Light Watts	
Street Light Condition	2
Street Light Height	
What is the type of service:	Three
What is the HV voltage level:	400
What is the arrangement of connected cables:	Parallel
Are there isolators on the pole:	No
What is the Condition:	3
How many Lots are connected to this pole:	4
Overhead Pole Comments:	Surface rusted

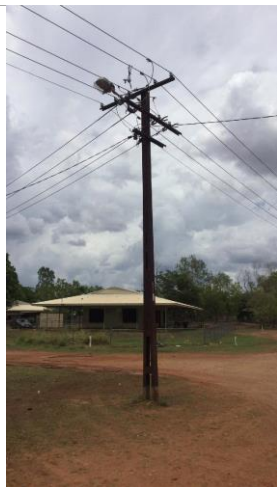
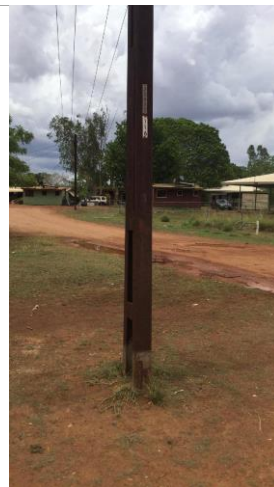
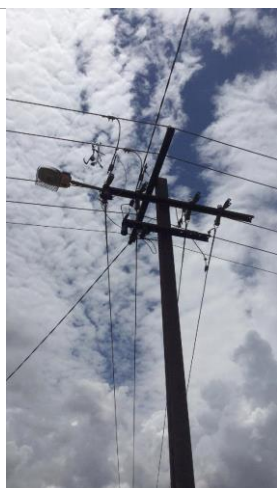
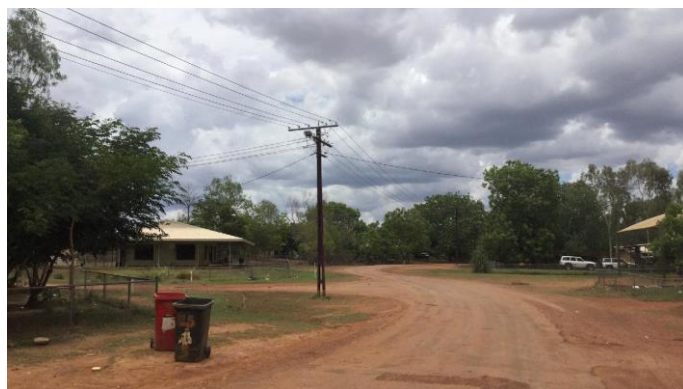
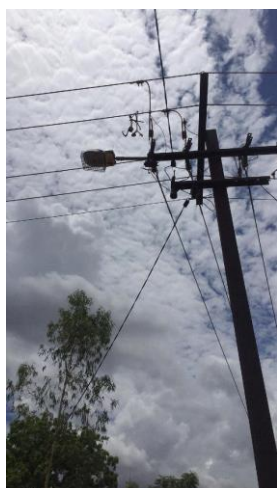
What is Pole Material type:	Welded
What is the condition of pole:	3
How is the pole planted:	Concrete
What is the Condition of plant:	3
Is street light fitted:	Yes
Street Light Power Supply:	
Street Light Type	M80d 02
Street Light Watts	
Street Light Condition	2
Street Light Height	
What is the type of service:	Three
What is the HV voltage level:	400
What is the arrangement of connected cables:	Parallel
Are there isolators on the pole:	No
What is the Condition:	3
How many Lots are connected to this pole:	2
Overhead Pole Comments:	Surface rusted

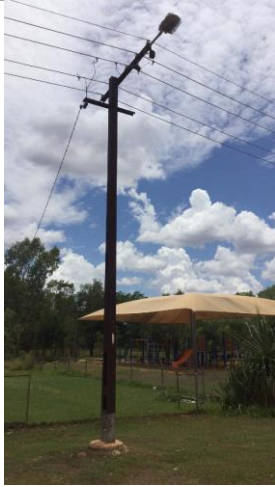
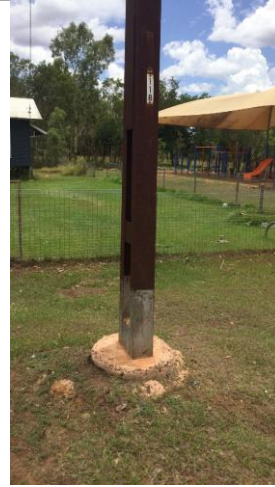
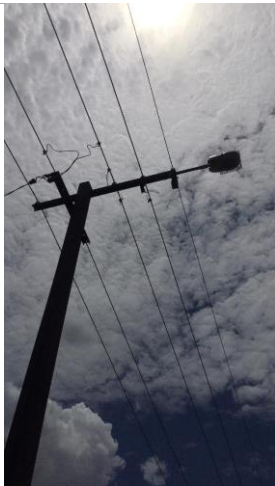
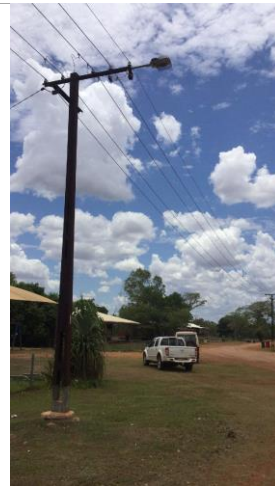
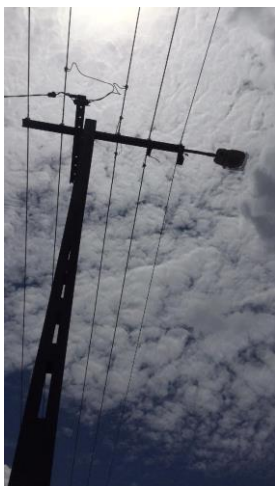
What is Pole Material type:	Welded
What is the condition of pole:	3
How is the pole planted:	Concrete
What is the Condition of plant:	3
Is street light fitted:	Yes
Street Light Power Supply:	
Street Light Type	M80d 02
Street Light Watts	
Street Light Condition	2
Street Light Height	
What is the type of service:	Three
What is the HV voltage level:	400
What is the arrangement of connected cables:	Parallel
Are there isolators on the pole:	No
What is the Condition:	3
How many Lots are connected to this pole:	1
Overhead Pole Comments:	Surface rusted

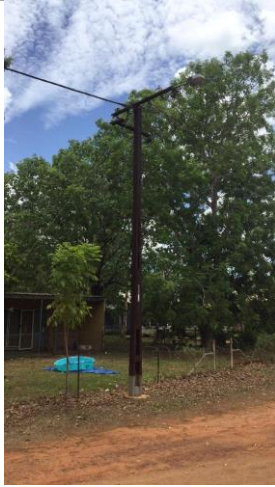
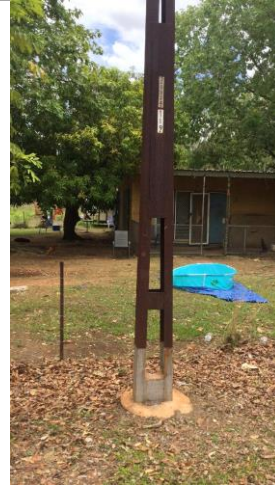
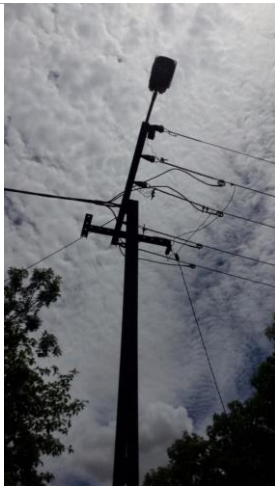
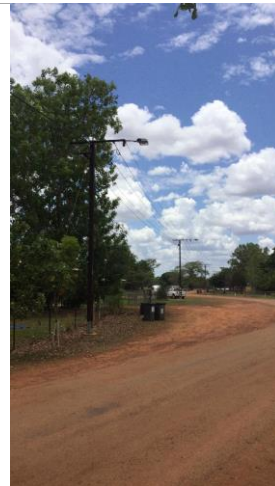
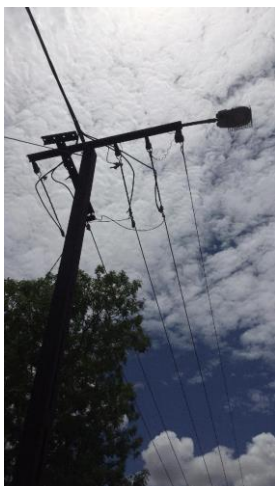
What is Pole Material type:	Welded
What is the condition of pole:	3
How is the pole planted:	Concrete
What is the Condition of plant:	3
Is street light fitted:	Yes
Street Light Power Supply:	
Street Light Type	M80d 05
Street Light Watts	
Street Light Condition	2
Street Light Height	
What is the type of service:	Three
What is the HV voltage level:	400
What is the arrangement of connected cables:	Twisted
Are there isolators on the pole:	No
What is the Condition:	3
How many Lots are connected to this pole:	1
Overhead Pole Comments:	Surface rusted

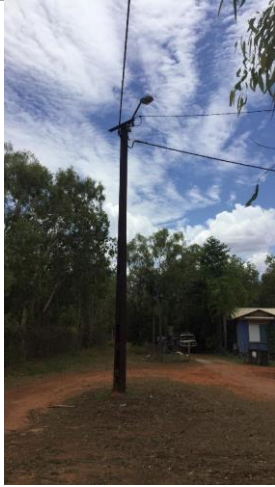
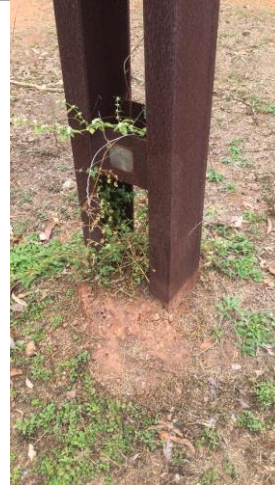
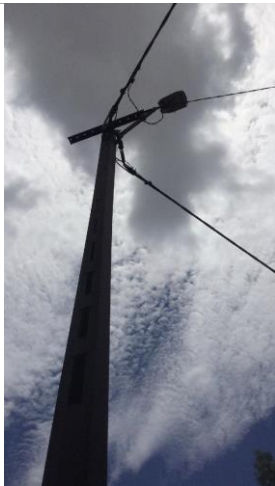
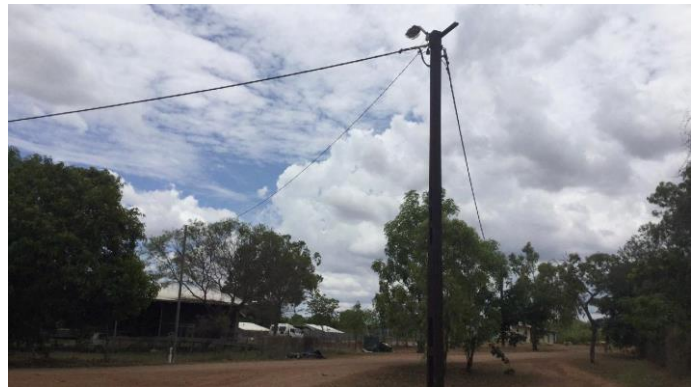
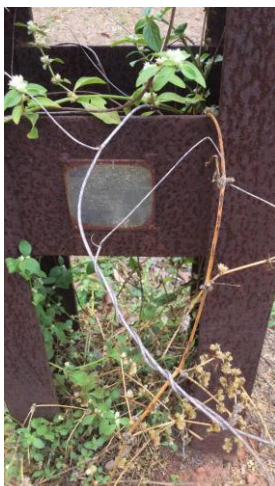
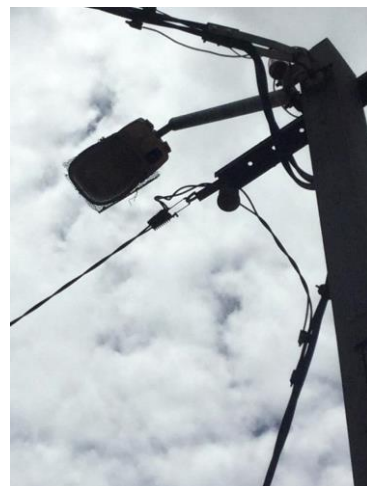
What is Pole Material type:	Welded
What is the condition of pole:	3
How is the pole planted:	Concrete
What is the Condition of plant:	3
Is street light fitted:	Yes
Street Light Power Supply:	
Street Light Type	Unknown
Street Light Watts	
Street Light Condition	3
Street Light Height	
What is the type of service:	Three
What is the HV voltage level:	400
What is the arrangement of connected cables:	Twisted
Are there isolators on the pole:	No
What is the Condition:	3
How many Lots are connected to this pole:	1
Overhead Pole Comments:	Surface rusted

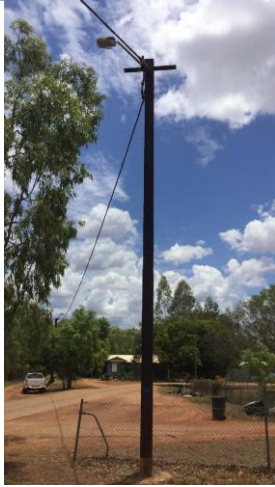
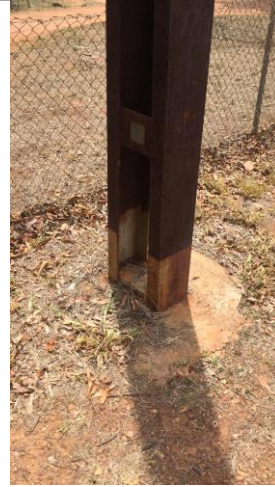
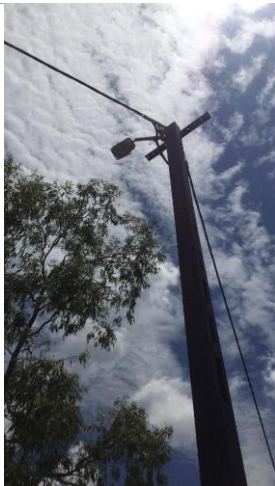
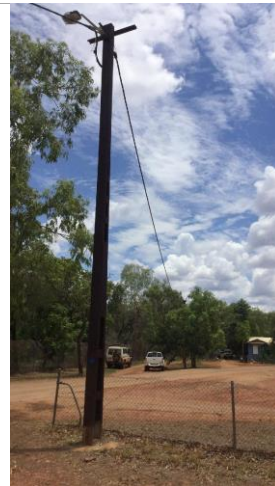
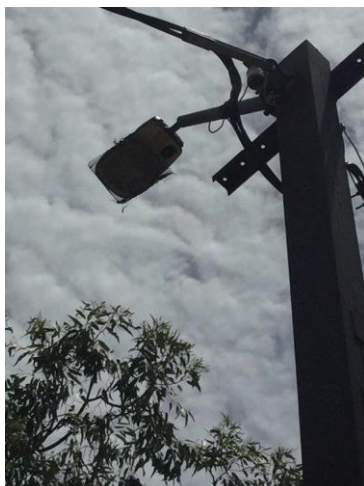
Overhead Pole Comments: Surface rusted

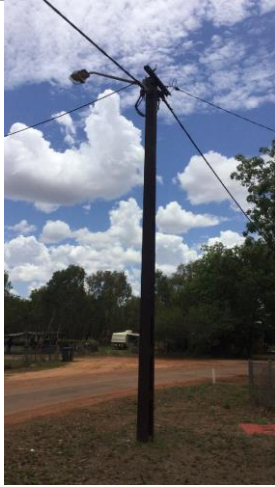
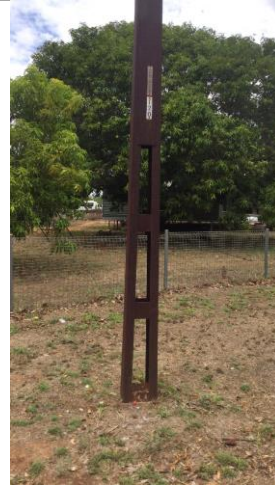
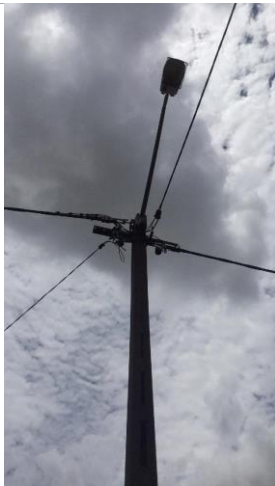
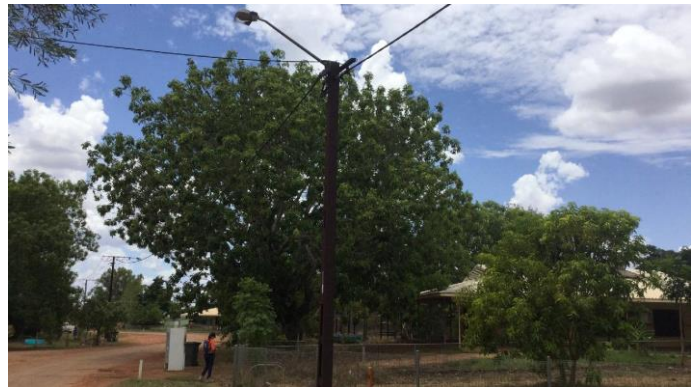
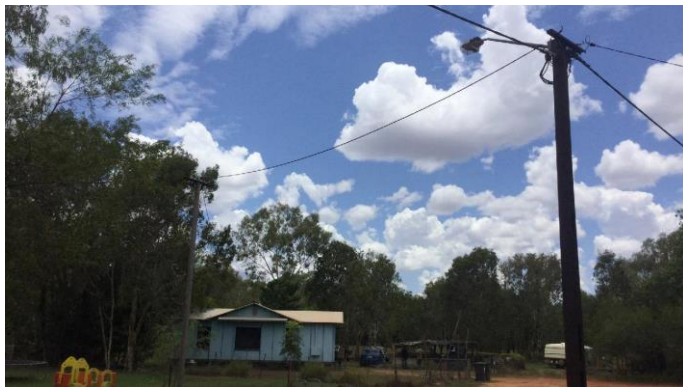
What is Pole Material type:	Welded
What is the condition of pole:	3
How is the pole planted:	Concrete
What is the Condition of plant:	3
Is street light fitted:	Yes
Street Light Power Supply:	
Street Light Type	M80d 06
Street Light Watts	
Street Light Condition	2
Street Light Height	
What is the type of service:	Three
What is the HV voltage level:	400
What is the arrangement of connected cables:	Twisted
Are there isolators on the pole:	No
What is the Condition:	3
How many Lots are connected to this pole:	2
Overhead Pole Comments:	Surface rusted

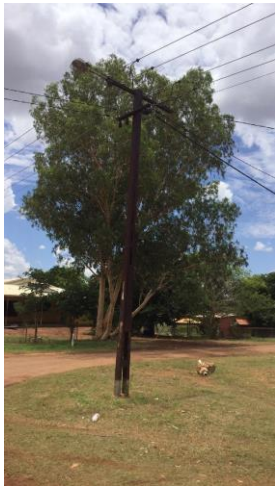
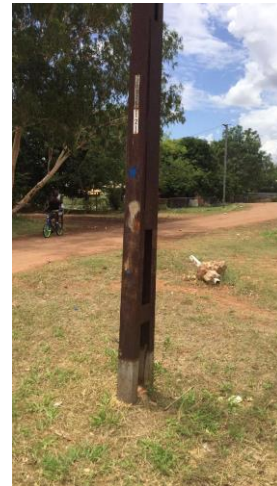
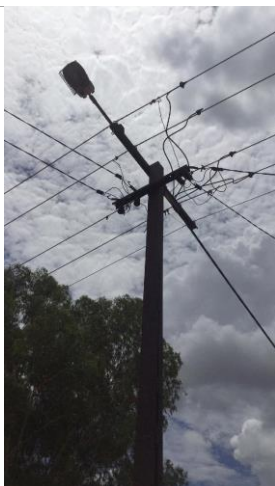
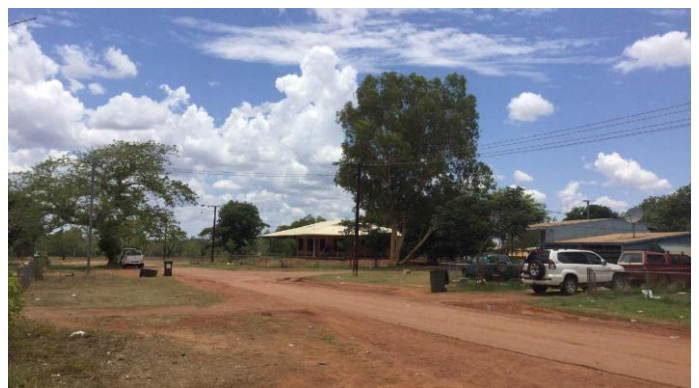
Street Light Condition 2

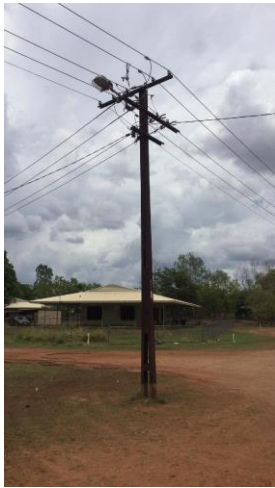
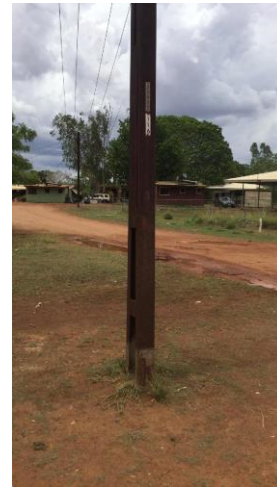
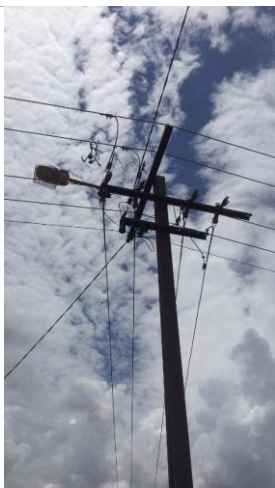
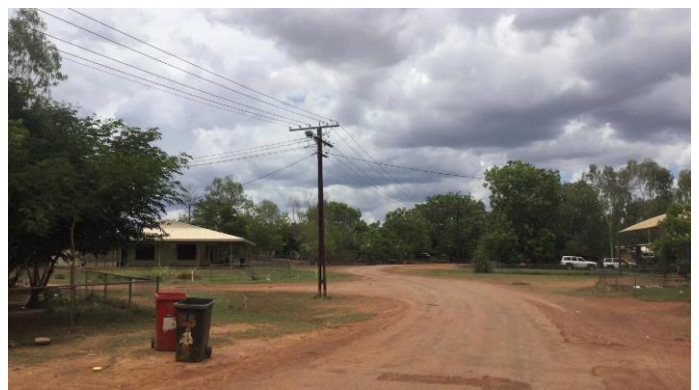
Street Light Condition 2

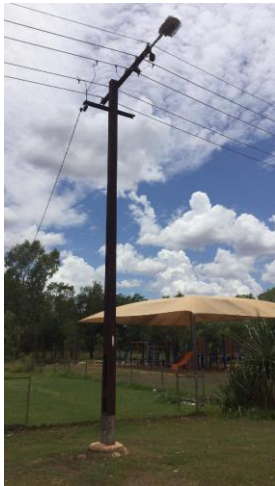
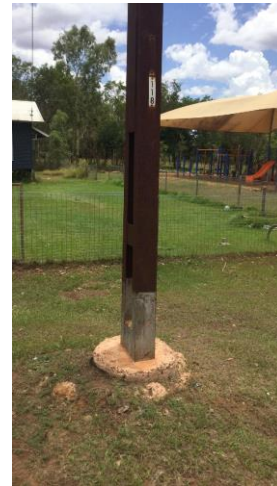
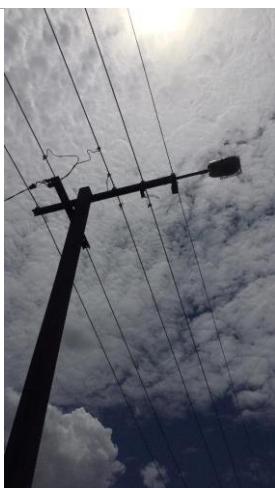
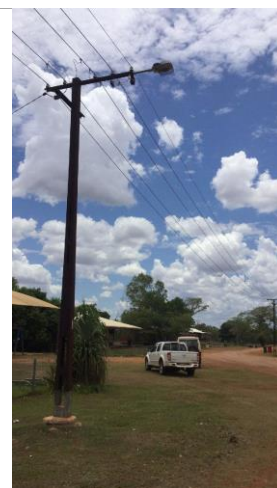
Street Light Condition 2

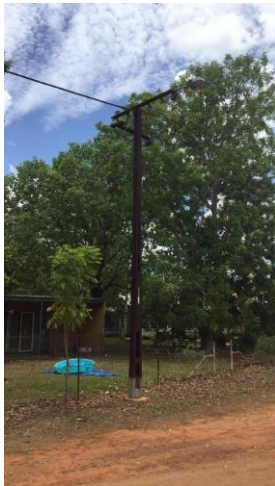
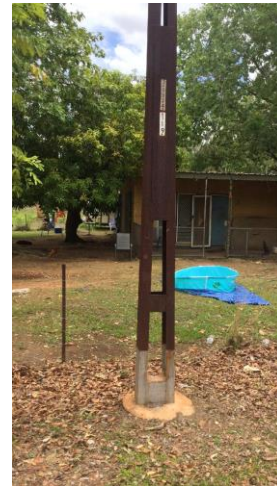
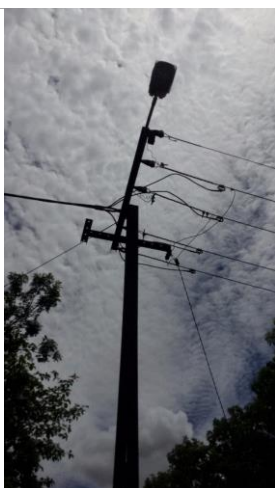
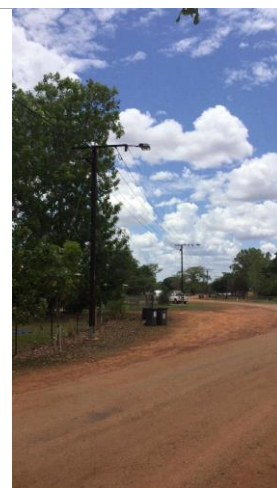
Street Light Condition 2

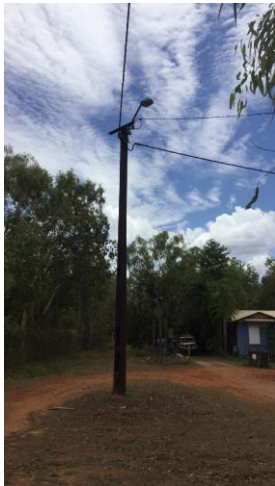
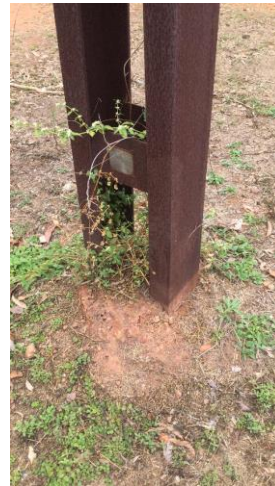
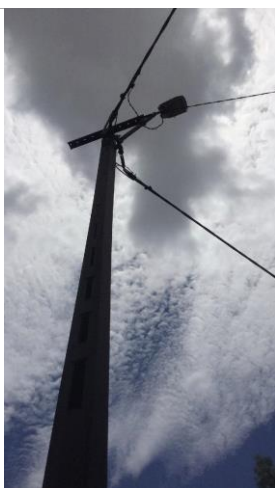
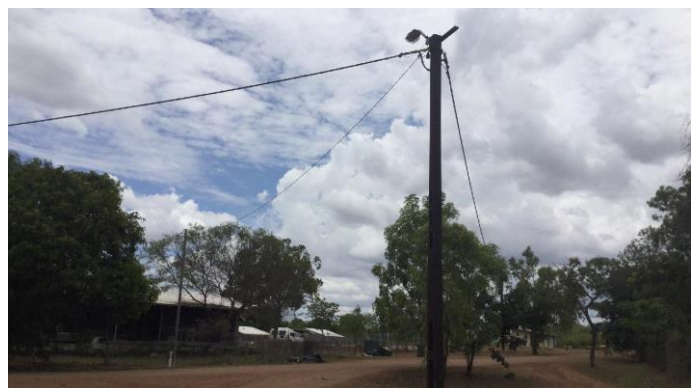
Street Light Condition 3

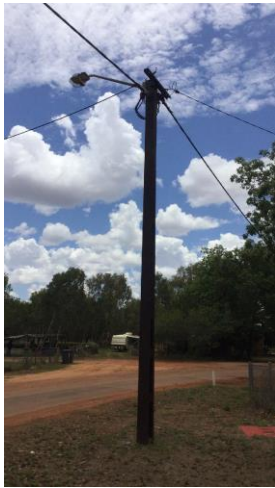
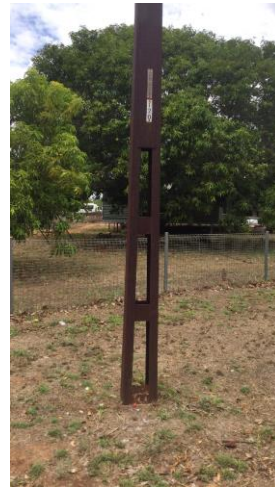
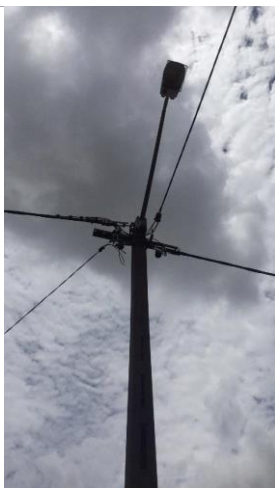
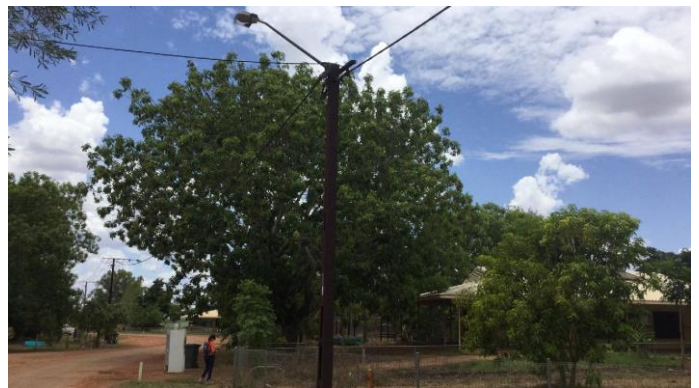
Street Light Condition 2
