Northern Territory Camps

Civil Infrastructure

Group 5 - Borroloola

Yanyula

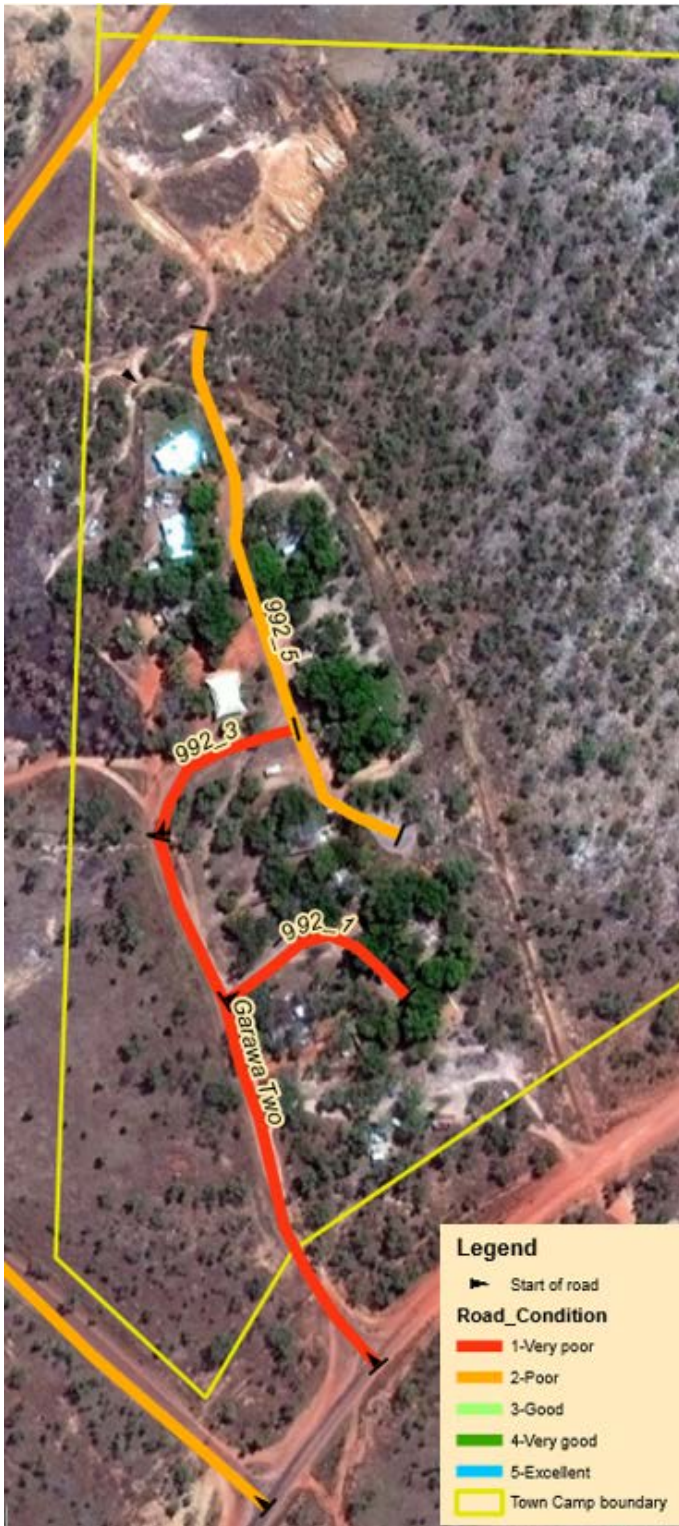
Figure 7 Garawa 2 community road network

Table 7 below details the condition of the roads within Garawa 2 for specific segments. Figure 7 shows a map of the community’s road network with the condition ratings, road name, and chainage direction.

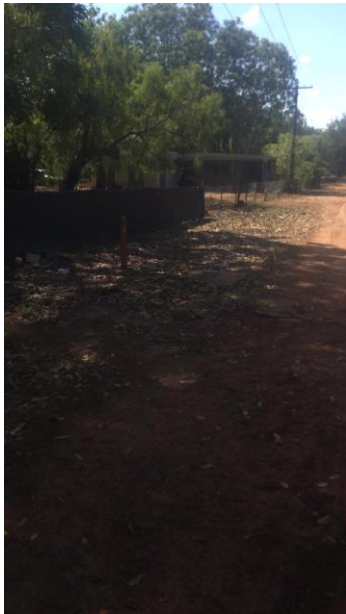
FH Condition: 3 - Good

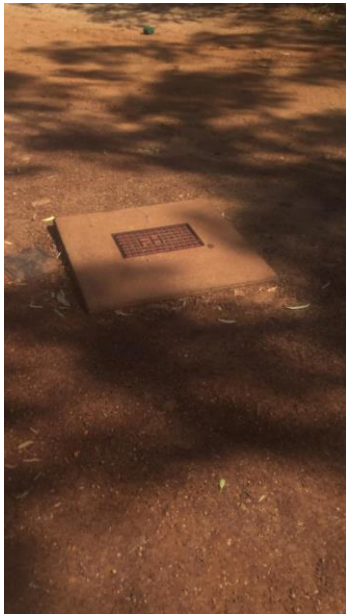
FH Condition: 3 - Good

FH Comment: Not painted red

The fire hydrants were assessed as being in good condition however, both require painting on the concrete cover. A single residential lot water meter requires a tap handle to be replaced.

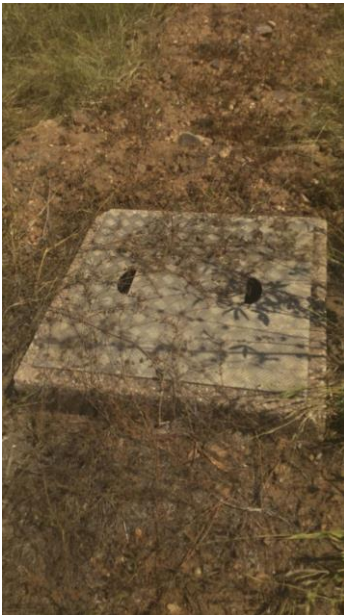
Notes on Lid:

Comments: Steel lid, assumed dimensions

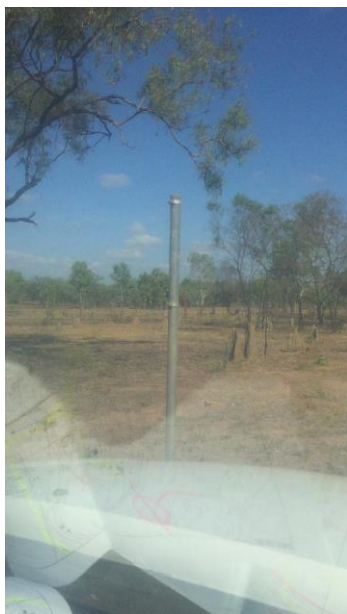
Sign Condition: 1 - Very Poor

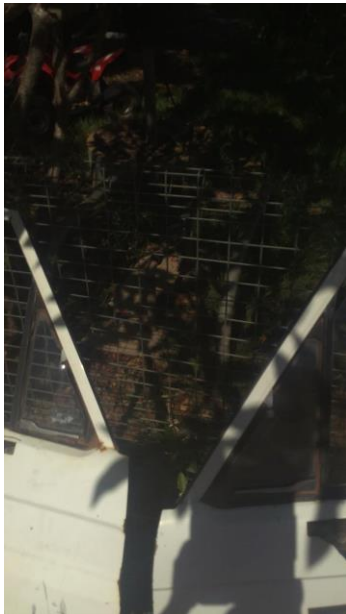
Tap Leakage: Yes

Tap Condition: 3 - Good

Tap Comment: Water main leaking nearby

Lot Water Meter Condition: 2 - Poor

Lot Water Meter Comment: No tap handles

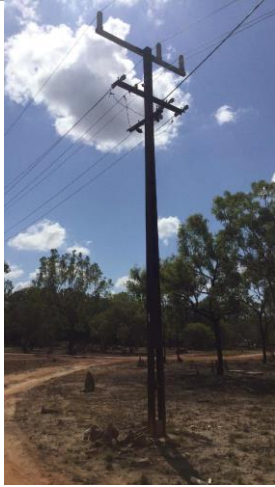
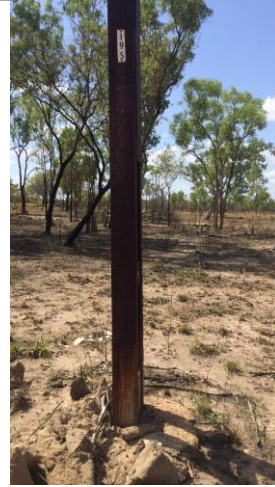
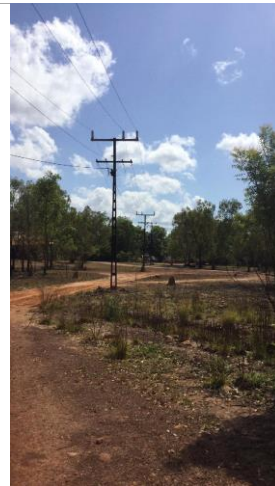
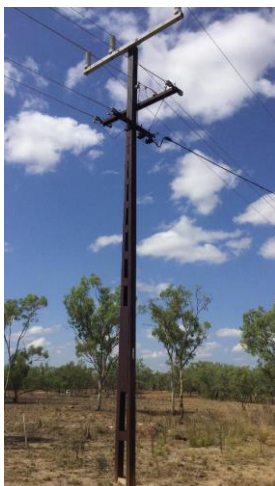
What is Pole Material type:	Welded
What is the condition of pole:	3
How is the pole planted:	Concrete
What is the Condition of plant:	3
Is street light fitted:	No
Street Light Power Supply:	
Street Light Type	
Street Light Watts	
Street Light Condition	
Street Light Height	
What is the type of service:	Three
What is the HV voltage level:	11000
What is the arrangement of connected cables:	Parallel
Are there isolators on the pole:	No
What is the Condition:	3
How many Lots are connected to this pole:	0
Overhead Pole Comments:	Surface rusted

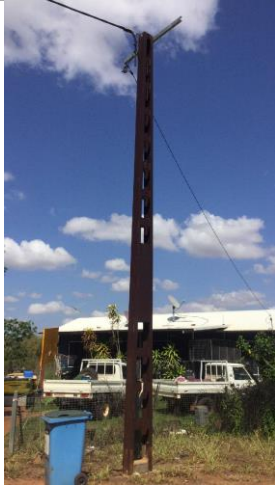
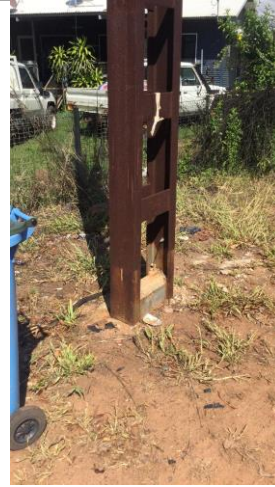
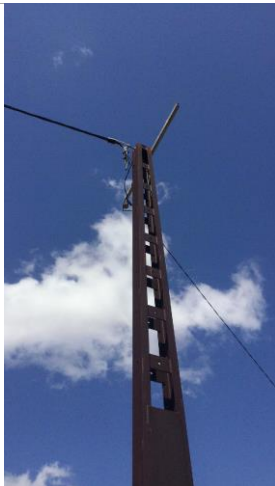
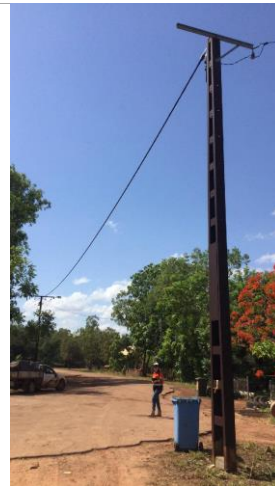
What is Pole Material type:	Welded
What is the condition of pole:	3
How is the pole planted:	Concrete
What is the Condition of plant:	3
Is street light fitted:	No
Street Light Power Supply:	
Street Light Type	
Street Light Watts	
Street Light Condition	
Street Light Height	
What is the type of service:	Three
What is the HV voltage level:	400
What is the arrangement of connected cables:	Twisted
Are there isolators on the pole:	No
What is the Condition:	3
How many Lots are connected to this pole:	1
Overhead Pole Comments:	Surface rusted

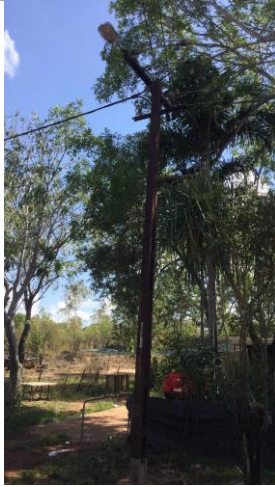
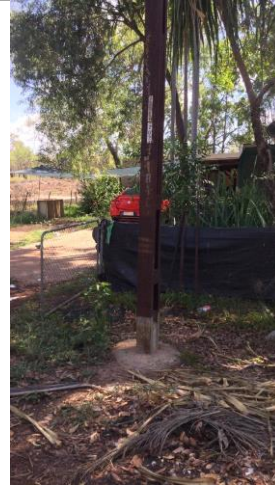
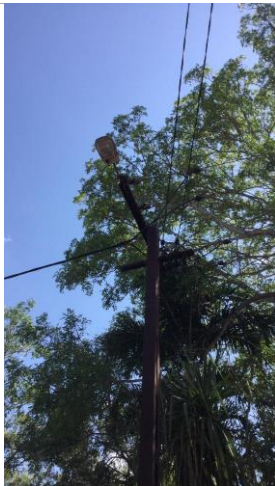
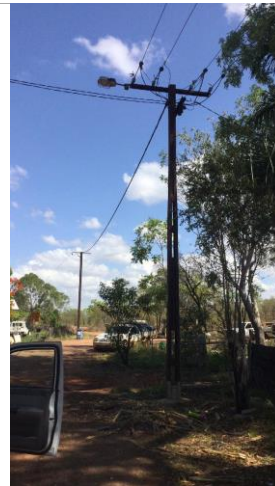
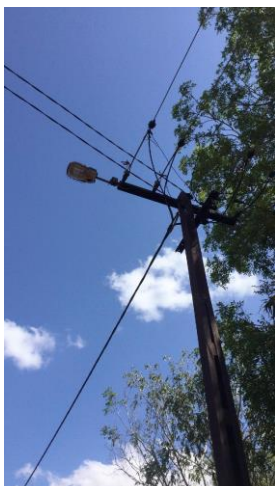
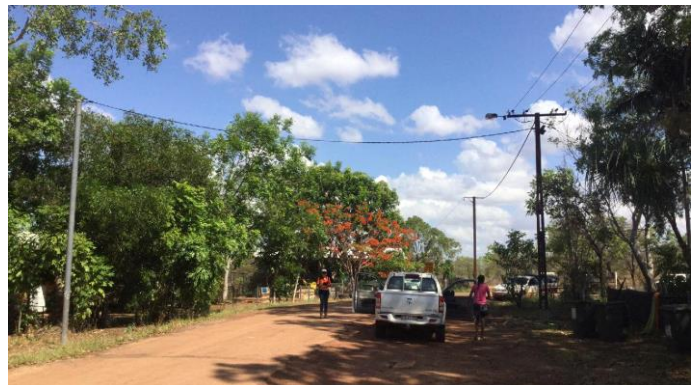
What is Pole Material type:	Welded
What is the condition of pole:	3
How is the pole planted:	Concrete
What is the Condition of plant:	3
Is street light fitted:	Yes
Street Light Power Supply:	
Street Light Type	M80d 11
Street Light Watts	80
Street Light Condition	3
Street Light Height	
What is the type of service:	Three
What is the HV voltage level:	400
What is the arrangement of connected cables:	Parallel
Are there isolators on the pole:	No
What is the Condition:	3
How many Lots are connected to this pole:	3
Overhead Pole Comments:	Surface rusted

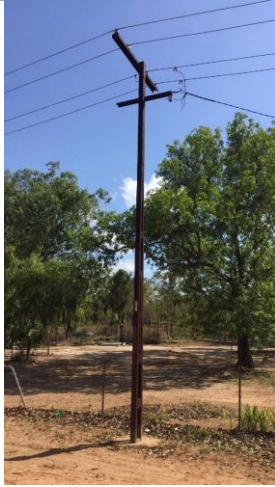
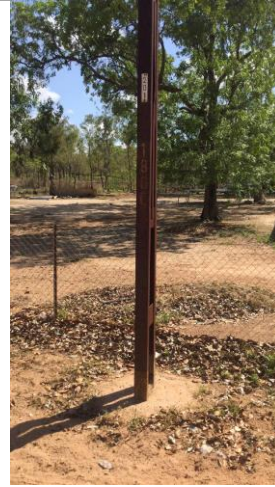
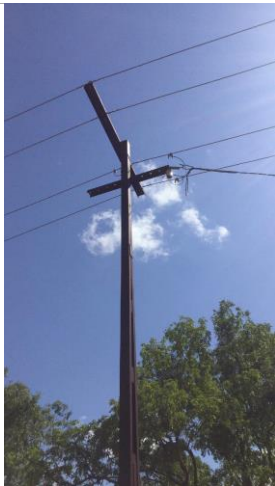
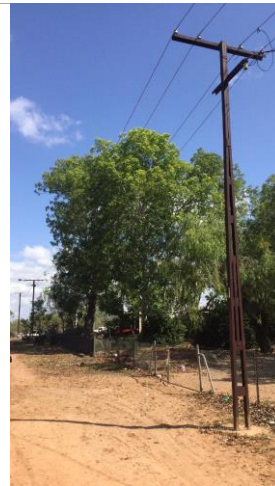
What is Pole Material type:	Welded
What is the condition of pole:	3
How is the pole planted:	Concrete
What is the Condition of plant:	3
Is street light fitted:	No
Street Light Power Supply:	
Street Light Type	
Street Light Watts	
Street Light Condition	
Street Light Height	
What is the type of service:	Three
What is the HV voltage level:	400
What is the arrangement of connected cables:	Twisted
Are there isolators on the pole:	No
What is the Condition:	3
How many Lots are connected to this pole:	1
Overhead Pole Comments:	Surface rusted

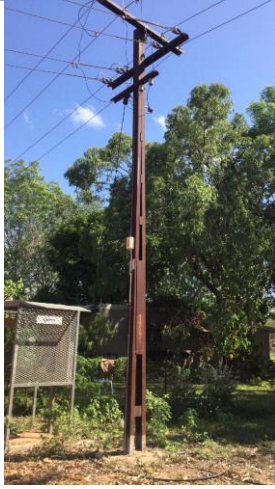
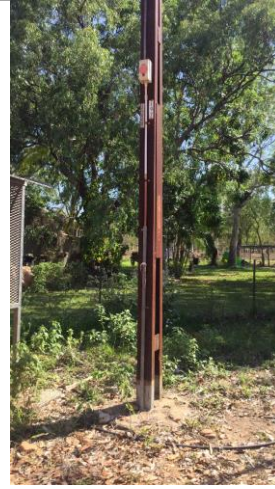
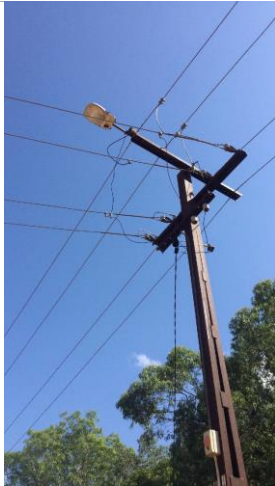
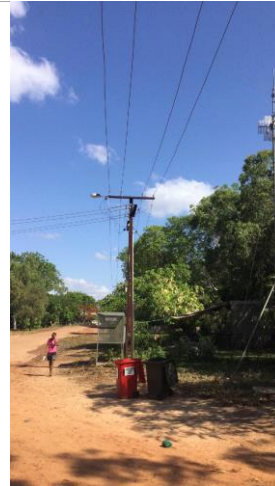
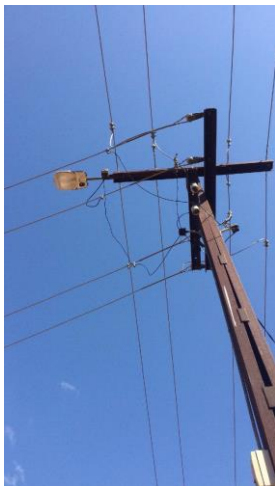
What is Pole Material type:	Welded
What is the condition of pole:	3
How is the pole planted:	Concrete
What is the Condition of plant:	3
Is street light fitted:	Yes
Street Light Power Supply:	
Street Light Type	M80d 06
Street Light Watts	
Street Light Condition	3
Street Light Height	
What is the type of service:	Three
What is the HV voltage level:	400
What is the arrangement of connected cables:	Parallel
Are there isolators on the pole:	No
What is the Condition:	3
How many Lots are connected to this pole:	1
Overhead Pole Comments:	Surface rusted

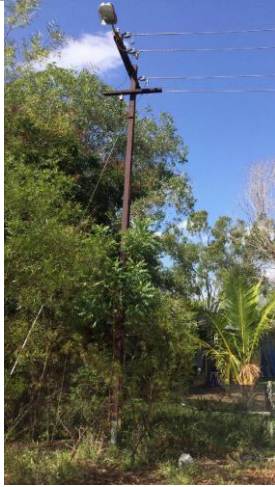
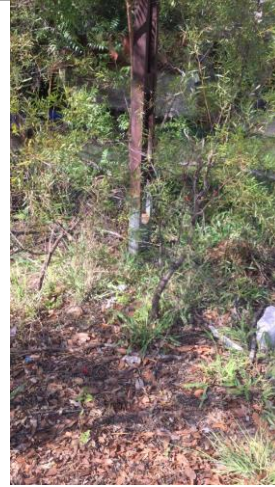
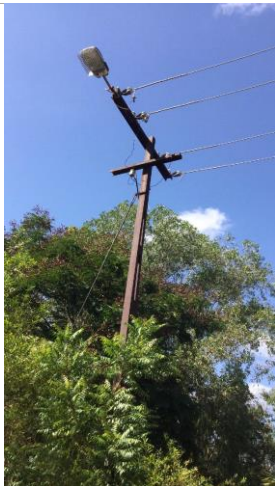
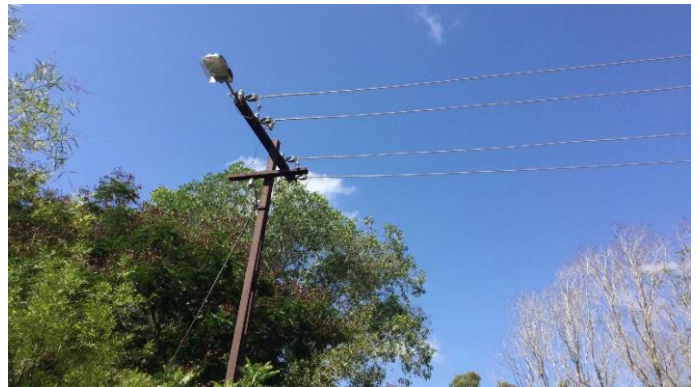
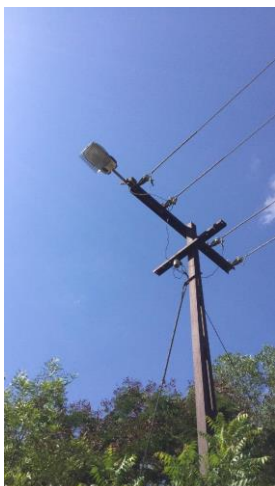
What is Pole Material type:	Welded
What is the condition of pole:	3
How is the pole planted:	Concrete
What is the Condition of plant:	3
Is street light fitted:	Yes
Street Light Power Supply:	
Street Light Type	M80d 06
Street Light Watts	
Street Light Condition	3
Street Light Height	
What is the type of service:	Three
What is the HV voltage level:	400
What is the arrangement of connected cables:	Parallel
Are there isolators on the pole:	No
What is the Condition:	3
How many Lots are connected to this pole:	1
Overhead Pole Comments:	Surface rusted

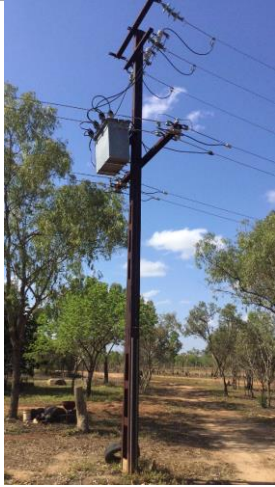
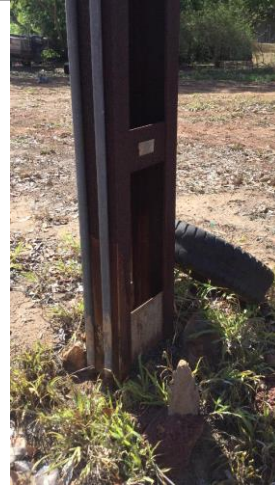
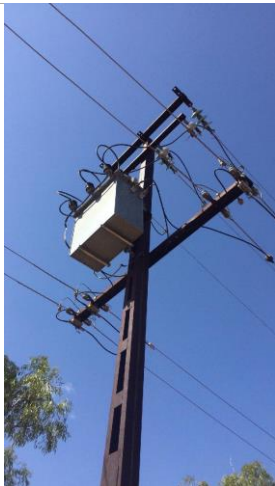
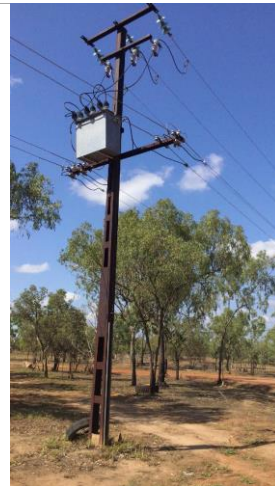
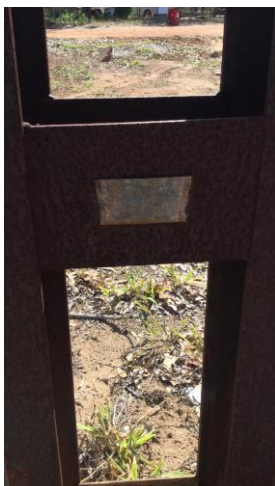
What is the condition of pole: 3

What is the Condition of plant: 3

What is the Condition: 3

Overhead Pole Comments: Surface rusted

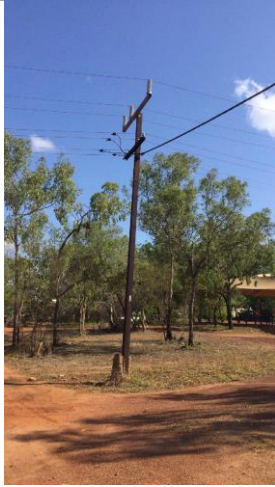
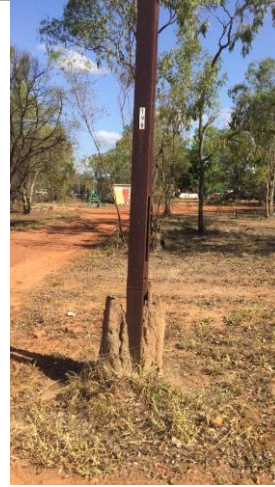
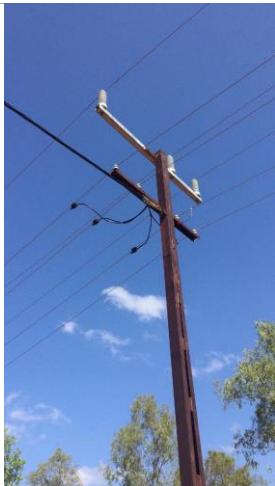
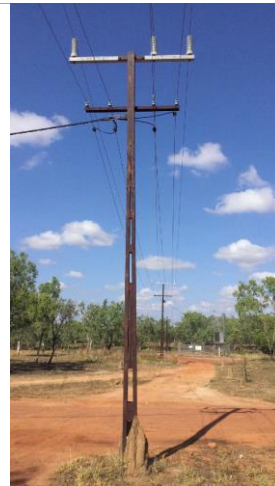
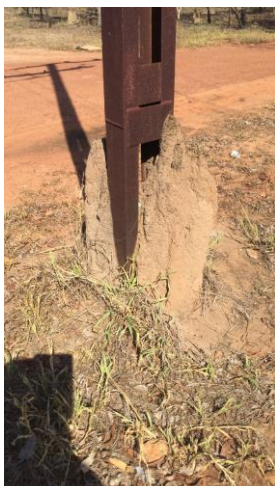
What is Pole Material type:	Welded
What is the condition of pole:	3
How is the pole planted:	Concrete
What is the Condition of plant:	3
Is street light fitted:	No
Street Light Power Supply:	
Street Light Type	
Street Light Watts	
Street Light Condition	
Street Light Height	
What is the type of service:	Combined
What is the HV voltage level:	11000
What is the arrangement of connected cables:	Parallel
Are there isolators on the pole:	No
What is the Condition:	3
How many Lots are connected to this pole:	0
Overhead Pole Comments:	Surface rusted

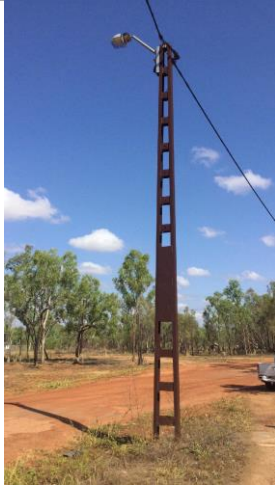
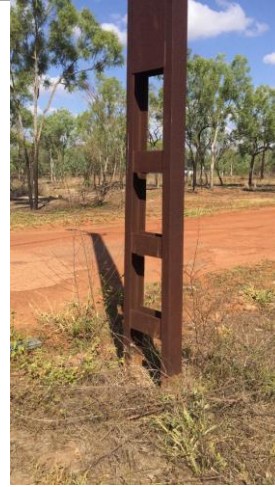
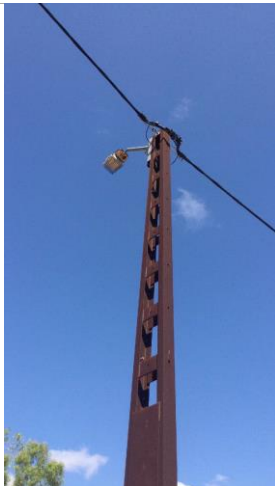
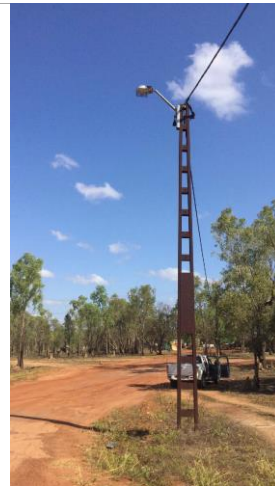
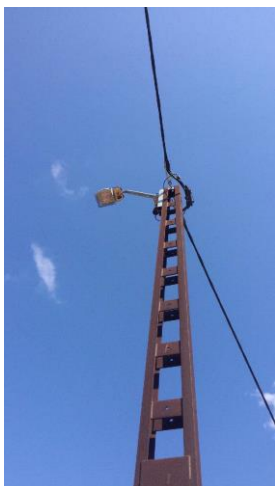
What is Pole Material type:	Welded
What is the condition of pole:	3
How is the pole planted:	Concrete
What is the Condition of plant:	3
Is street light fitted:	Yes
Street Light Power Supply:	
Street Light Type	M80d 06
Street Light Watts	
Street Light Condition	2
Street Light Height	
What is the type of service:	Three
What is the HV voltage level:	400
What is the arrangement of connected cables:	Twisted
Are there isolators on the pole:	No
What is the Condition:	3
How many Lots are connected to this pole:	0
Overhead Pole Comments:	Surface rusted

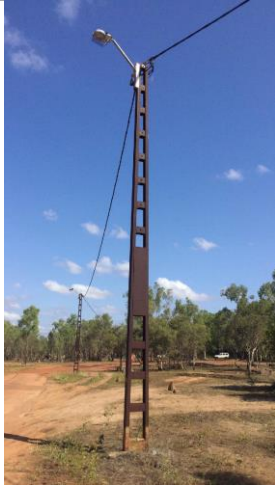
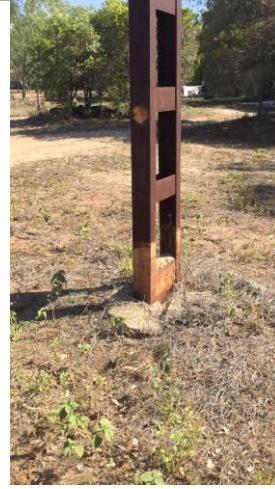
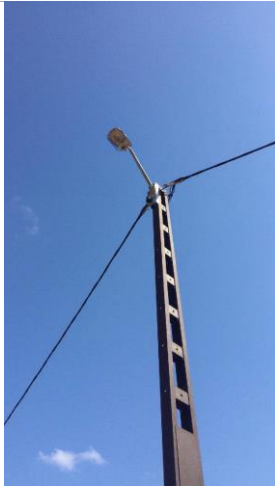
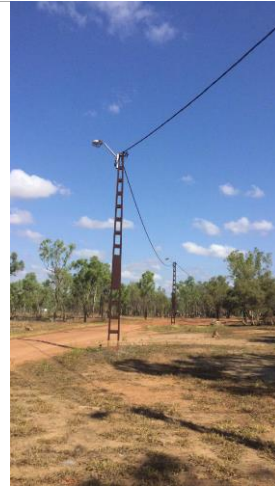
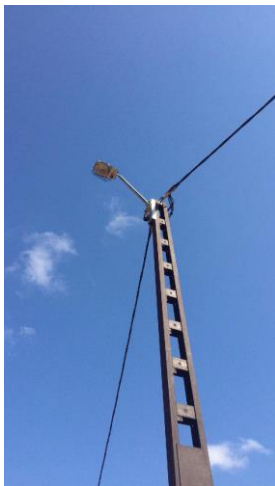
What is Pole Material type:	Welded
What is the condition of pole:	3
How is the pole planted:	Concrete
What is the Condition of plant:	3
Is street light fitted:	Yes
Street Light Power Supply:	
Street Light Type	M80d 06
Street Light Watts	
Street Light Condition	2
Street Light Height	
What is the type of service:	Three
What is the HV voltage level:	400
What is the arrangement of connected cables:	Twisted
Are there isolators on the pole:	No
What is the Condition:	3
How many Lots are connected to this pole:	0
Overhead Pole Comments:	Surface rusted

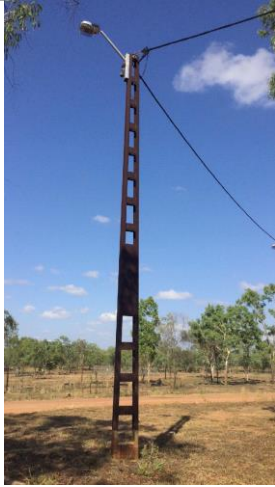
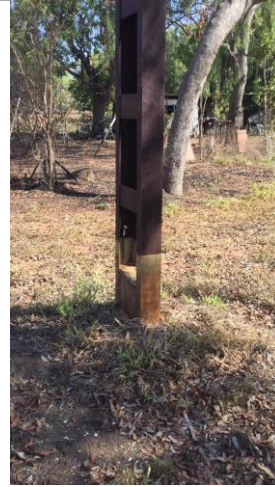
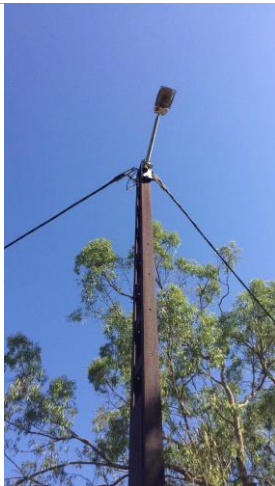
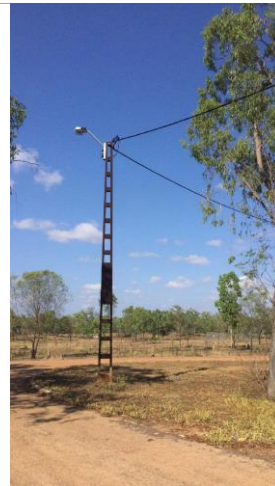
What is Pole Material type:	Welded
What is the condition of pole:	3
How is the pole planted:	Concrete
What is the Condition of plant:	3
Is street light fitted:	No
Street Light Power Supply:	
Street Light Type	
Street Light Watts	
Street Light Condition	
Street Light Height	
What is the type of service:	Three
What is the HV voltage level:	400
What is the arrangement of connected cables:	Twisted
Are there isolators on the pole:	No
What is the Condition:	3
How many Lots are connected to this pole:	0
Overhead Pole Comments:	Surface rusted

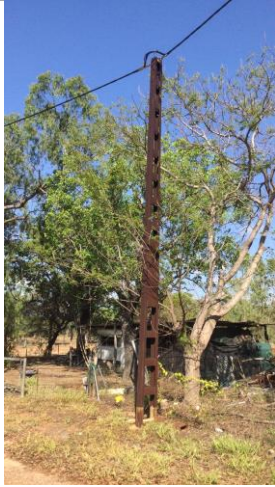
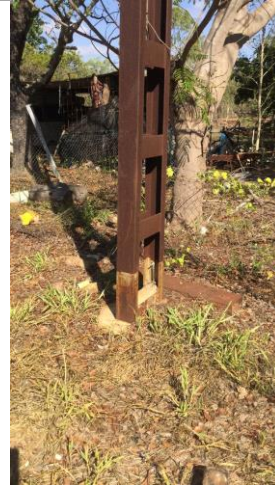
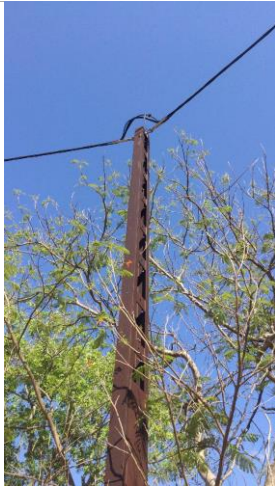
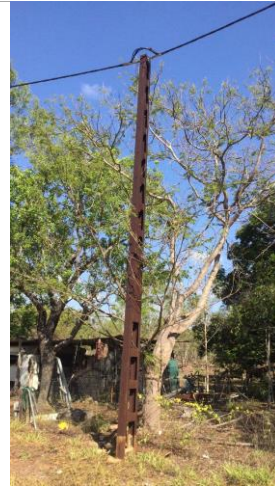
What is Pole Material type:	Welded
What is the condition of pole:	3
How is the pole planted:	Concrete
What is the Condition of plant:	3
Is street light fitted:	Yes
Street Light Power Supply:	
Street Light Type	M80d 06
Street Light Watts	
Street Light Condition	3
Street Light Height	
What is the type of service:	Three
What is the HV voltage level:	400
What is the arrangement of connected cables:	Twisted
Are there isolators on the pole:	No
What is the Condition:	3
How many Lots are connected to this pole:	2
Overhead Pole Comments:	Surface rusted

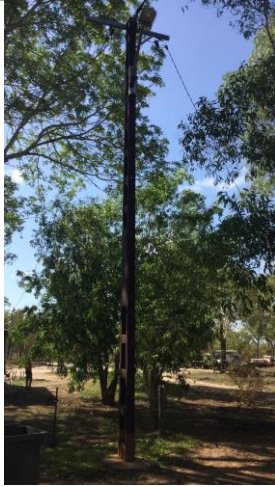
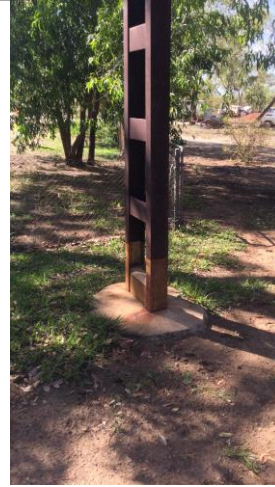
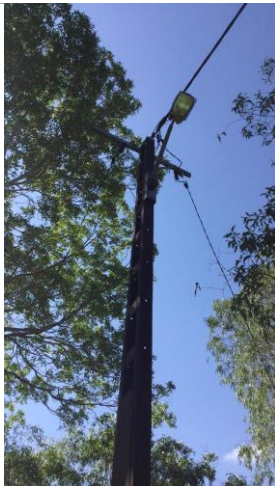
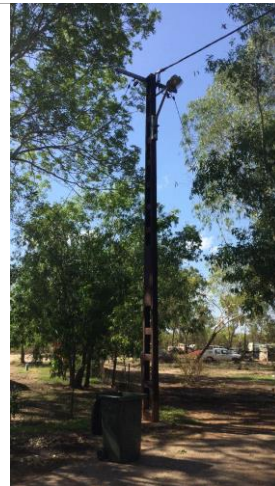
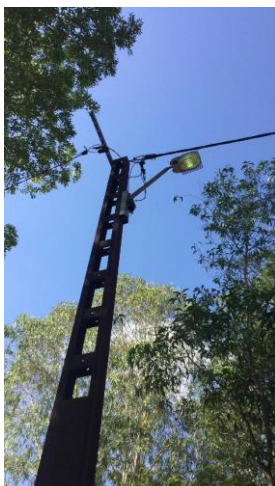
What is Pole Material type:	Welded
What is the condition of pole:	3
How is the pole planted:	Concrete
What is the Condition of plant:	3
Is street light fitted:	Yes
Street Light Power Supply:	
Street Light Type	M80d 06
Street Light Watts	
Street Light Condition	3
Street Light Height	
What is the type of service:	Three
What is the HV voltage level:	400
What is the arrangement of connected cables:	Twisted
Are there isolators on the pole:	No
What is the Condition:	
How many Lots are connected to this pole:	2
Overhead Pole Comments:	Surface rusted

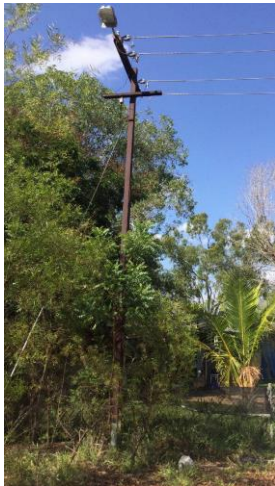
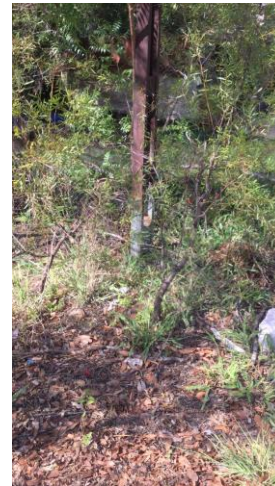
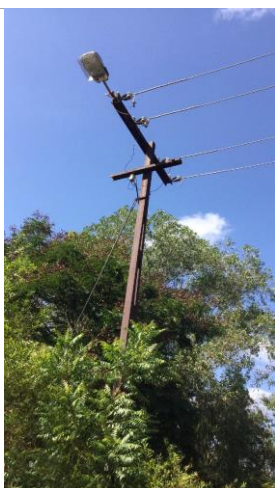
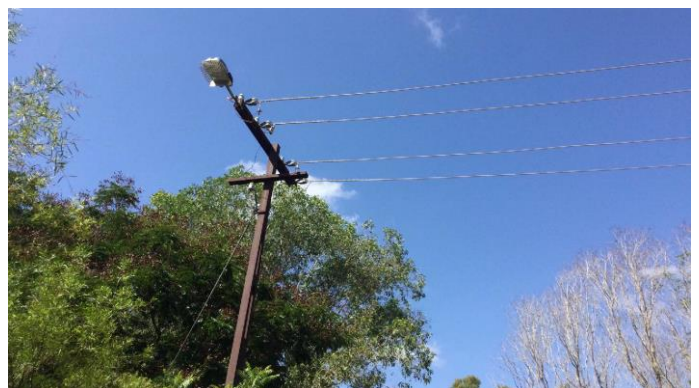
Street Light Condition 3

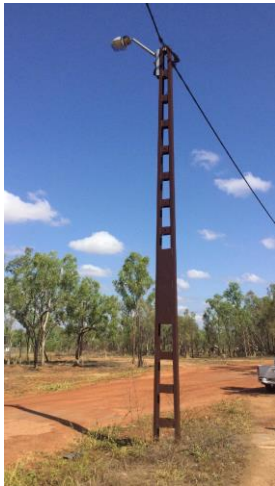
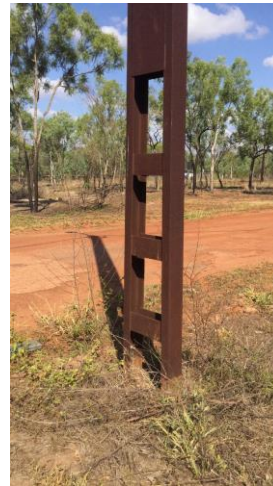
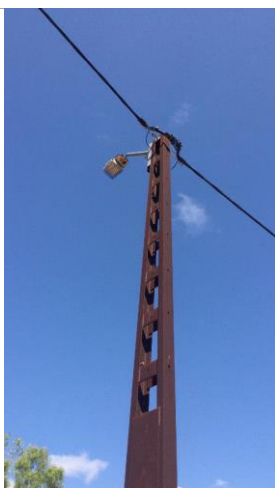
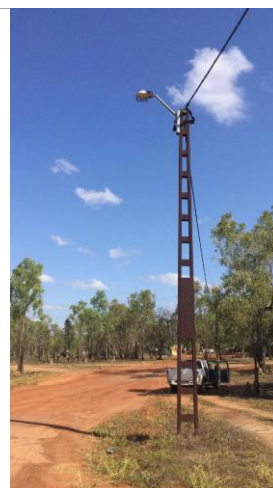
Street Light Condition 3

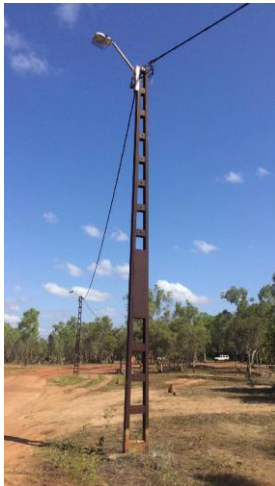
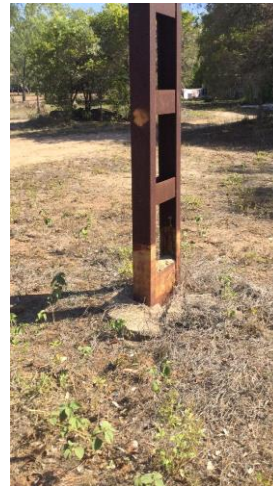
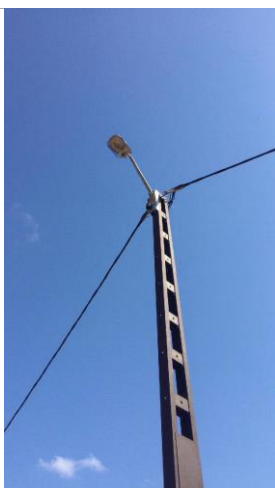
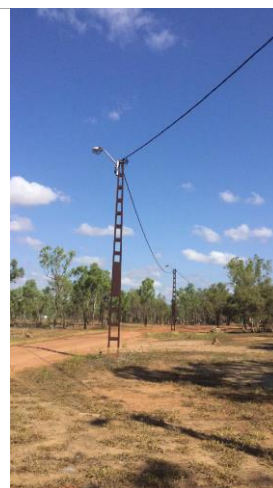
Street Light Condition 2

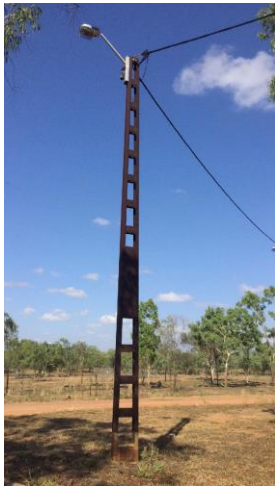
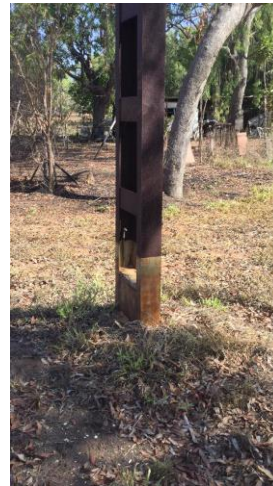
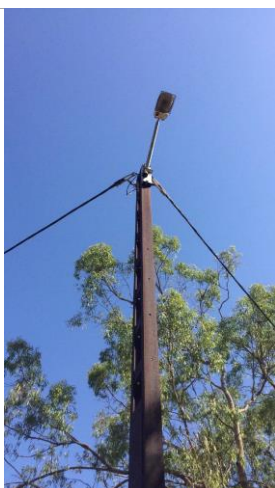
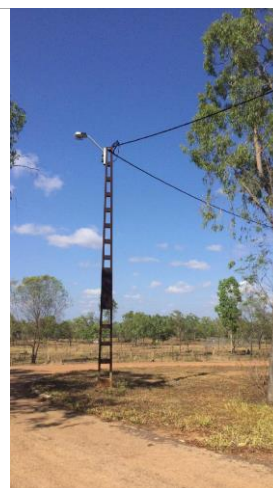
Street Light Condition 2

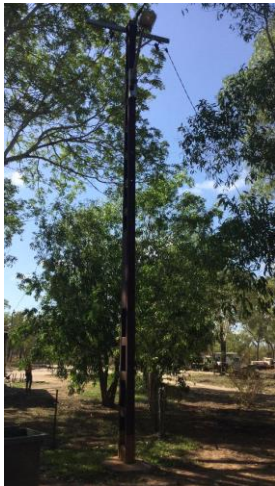
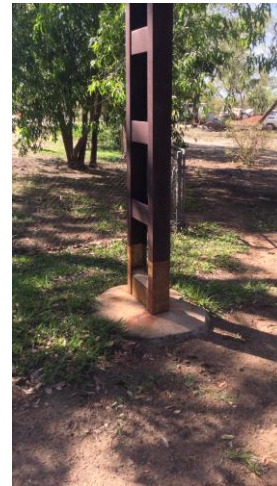
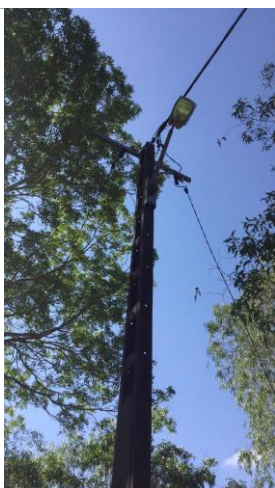
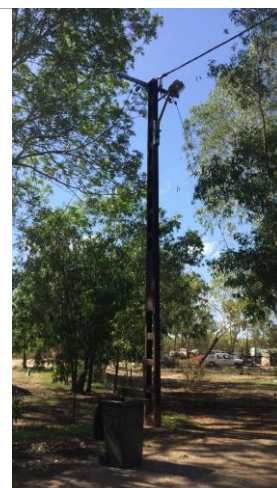
Street Light Condition 3

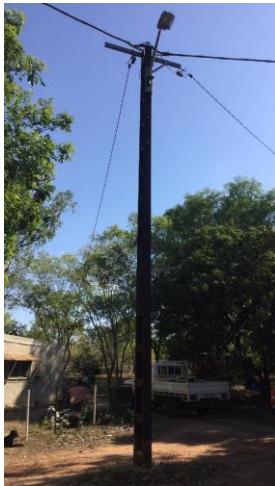
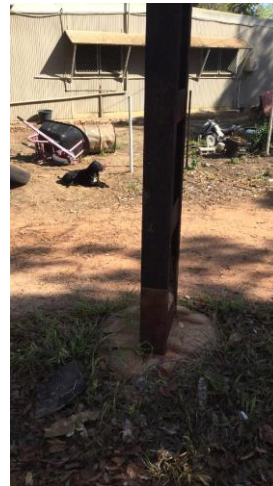
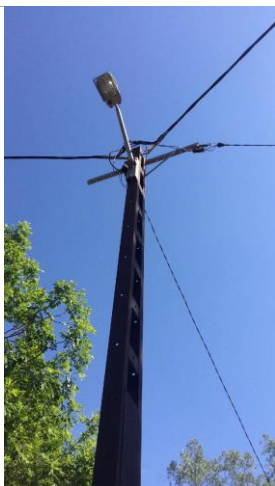
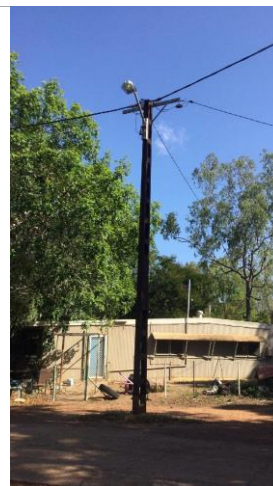
Street Light Condition 3

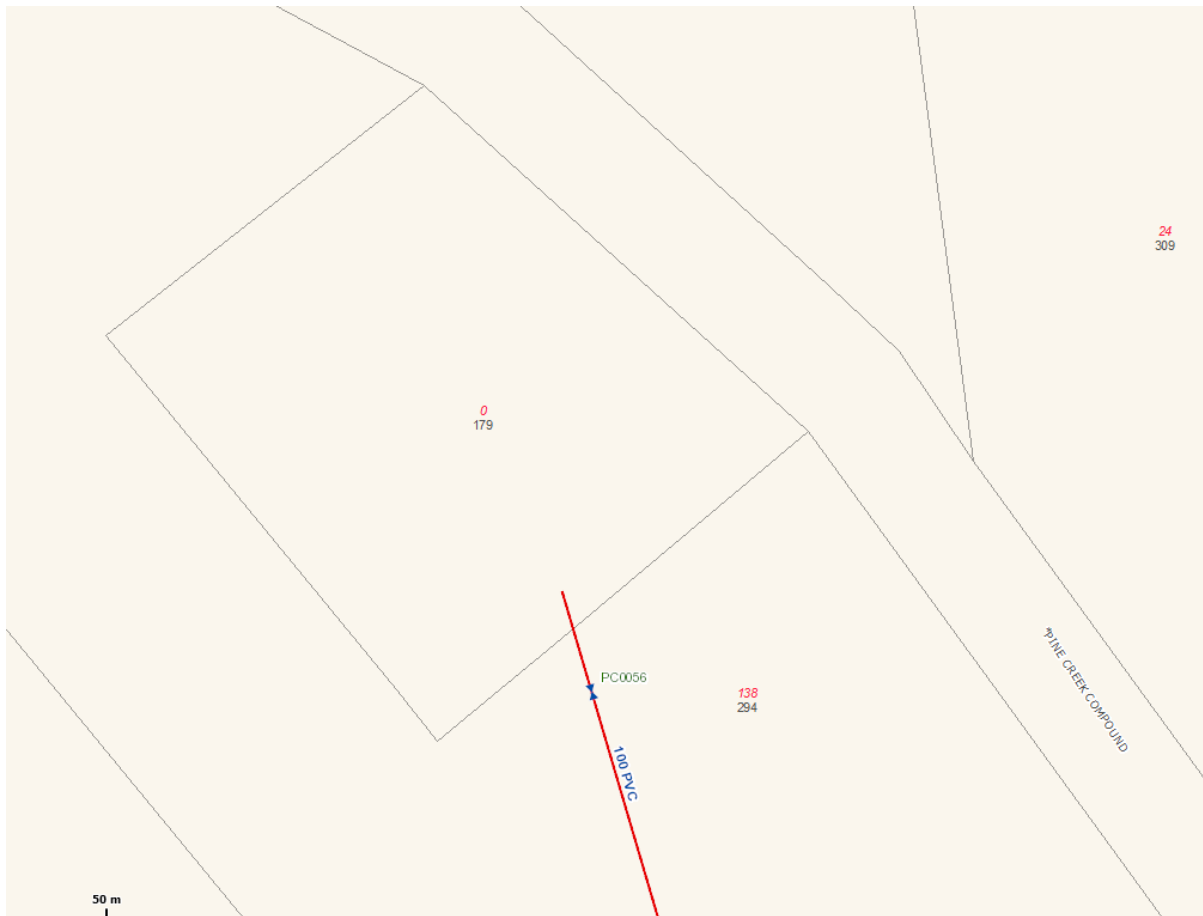
Figure 8 PWC water supply to pine creek

The water supply network within Pine Creek Compound is owned and maintained by the Pine Creek Aboriginal Advancement Association. The water is supplied from PWC water mains outside of the community. PWC have advised they currently do not manage maintenance works on any internal water supply infrastructure. The following figure shows water main supply to Pine Creek Compound.

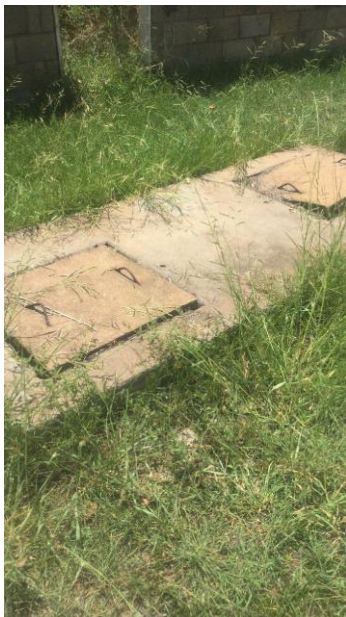
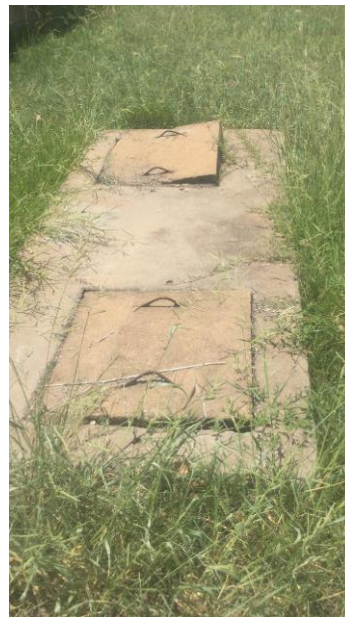
Comments: Lids not sitting in place

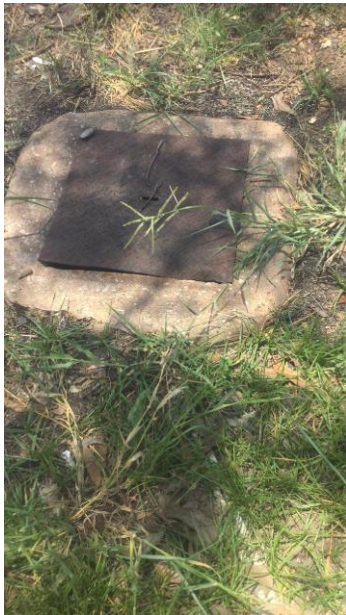
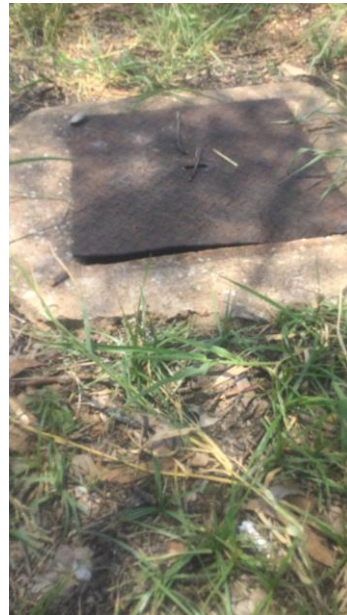
Comments: Lid is a steel plate

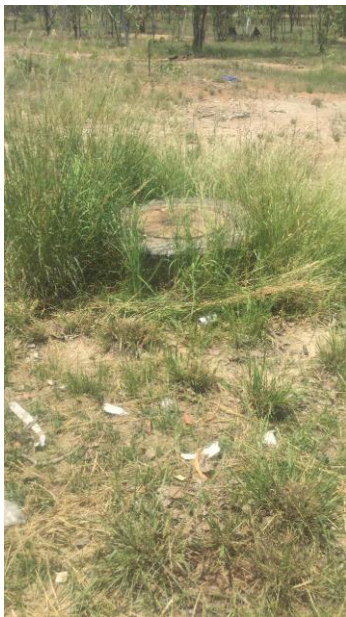
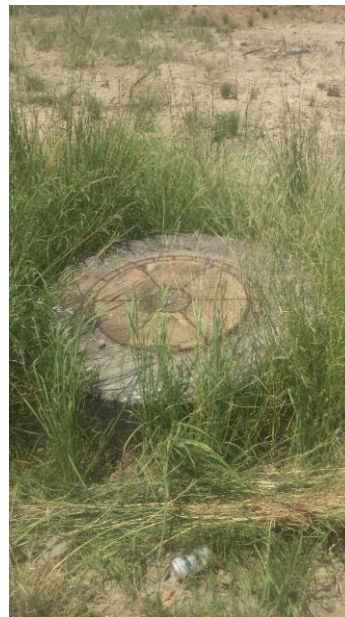
Comments: Grass overgrown around manhole

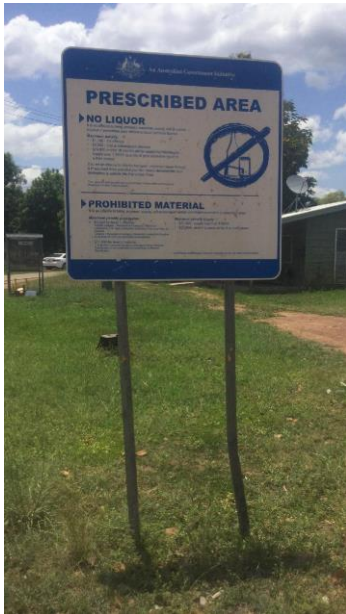
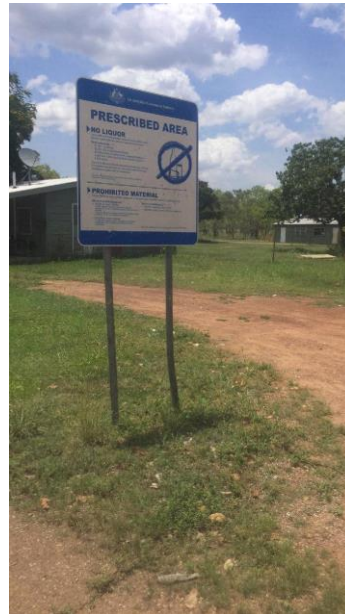
Sign Condition: 2 - Poor

Sign Comment: Slightly bent post

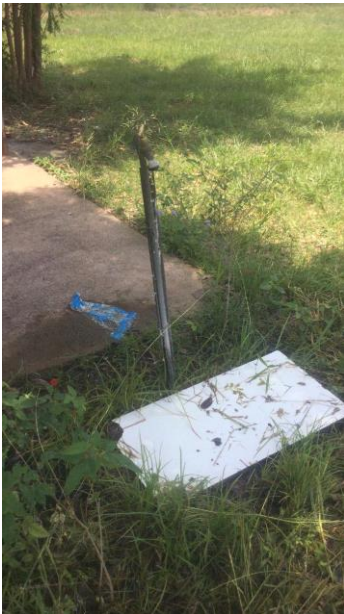
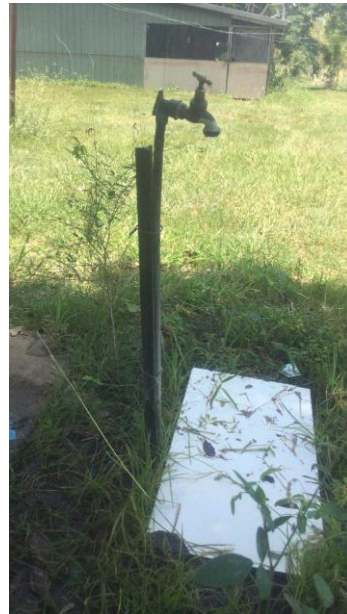
Tap Leakage: Yes

Tap Condition: 1 - Very Poor

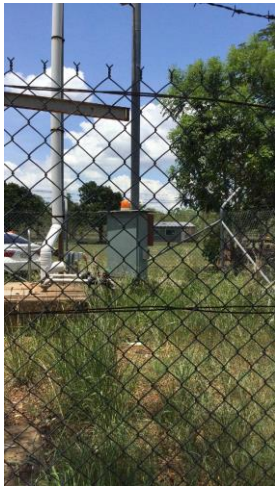
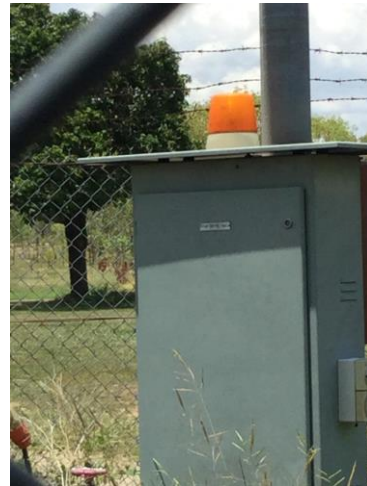
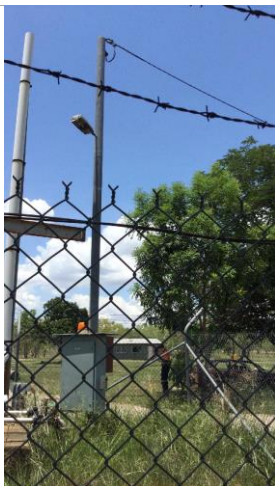
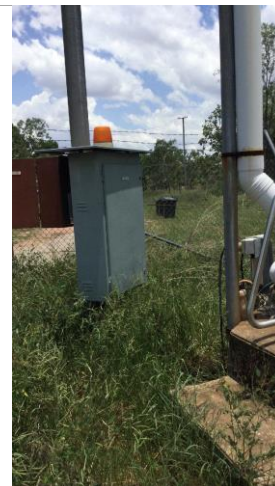
Good condition

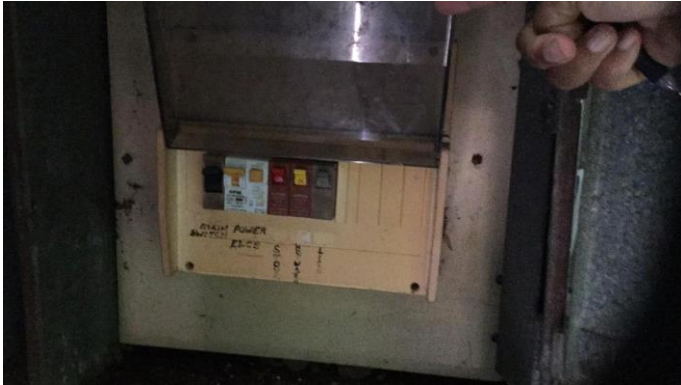
Meter Comment: Indoor SB, Cond 2, Blank plates are missing on CB slot.

Meter Comment: 3 Analogue Meters. Condition of CB not assessed. Indoor SB, Cond 3

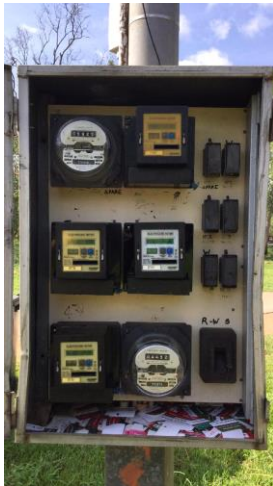
Meter Condition: 3

Meter Comment: 2 Analogue Meters & 4 Digital Meters. Condition of CB not assessed.

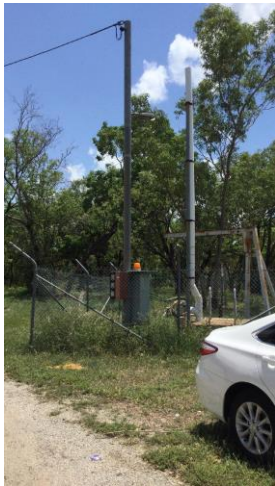
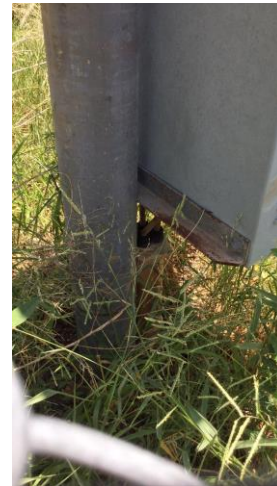
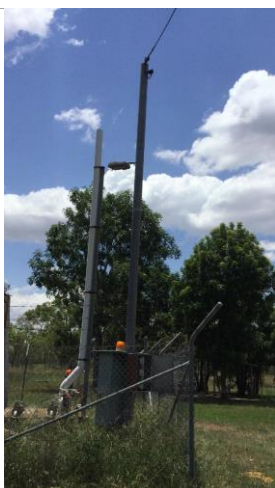
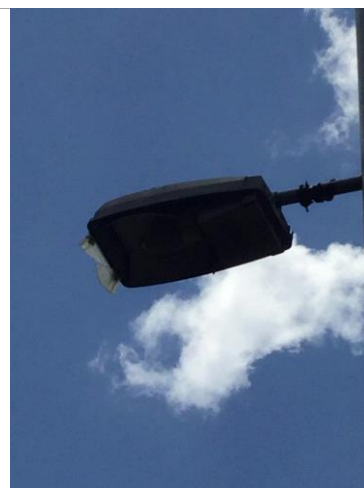
Street Light Condition 2

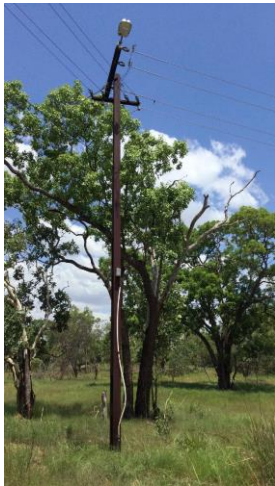
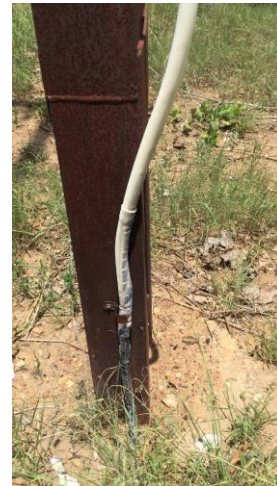
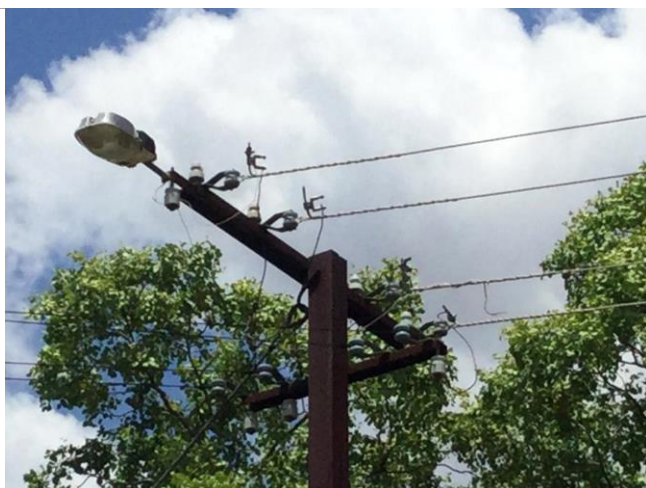
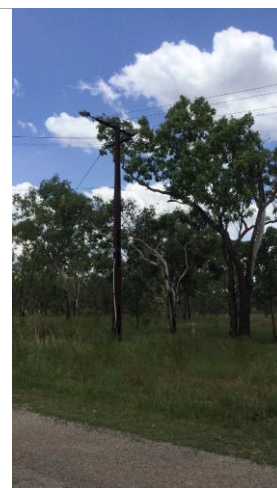
Street Light Condition 2

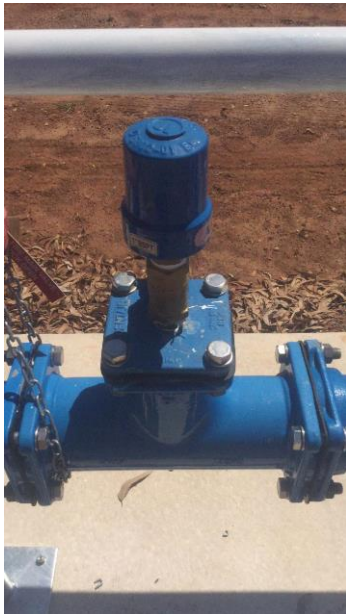
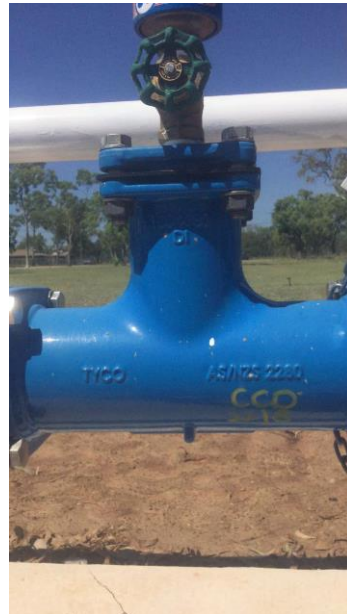
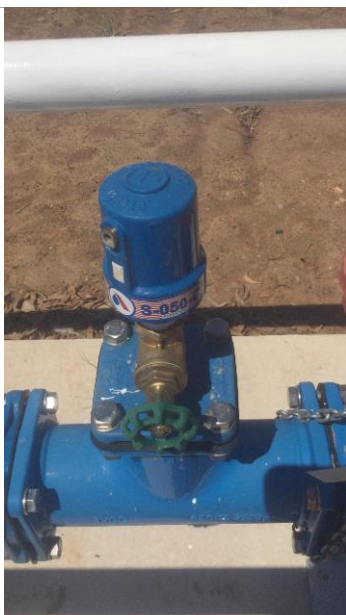
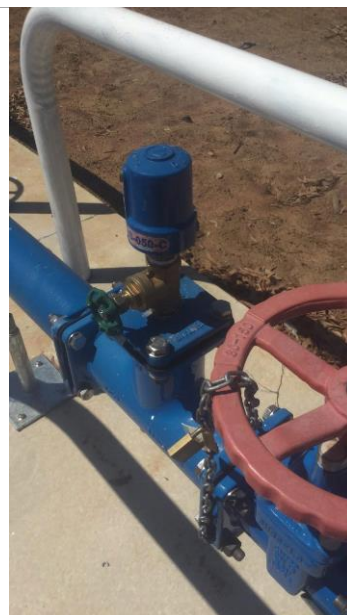
Air Valve Condition: 5 - Excellent
