Northern Territory Camps

Civil Infrastructure

Group 5 - Borroloola

Yanyula

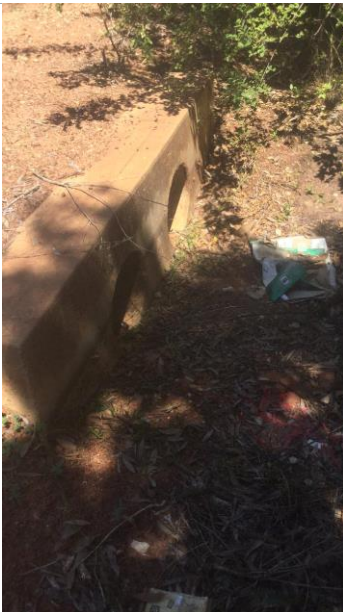
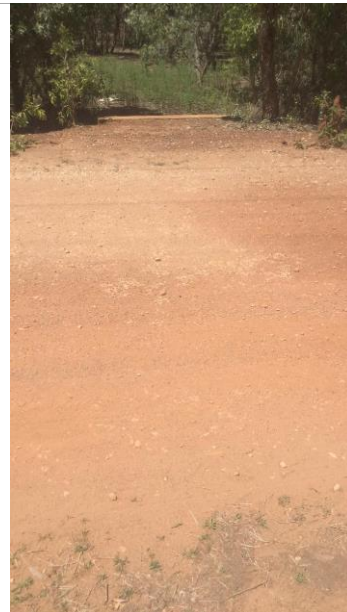
Insp ID: 1811 Group 2 - Katherine, Pine Creek, Mataranka Mulggan

Stormwater Infrastructure:	Culverts
Culvert Type:	RCP
Diameter (mm):	450
Width (mm):	
Culvert Depth (mm):	
Culvert Length (m):	11
Culvert Condition:	3 - Good
Culvert Blockage (%):	
Culvert Comments:	
Culvert Head Wall:	Yes
Safety Grate:	No
Headwall Blockage:	
Headwall Condition:	3 - Good
Headwall Comment:	
End Wall:	Yes
End Wall condition:	3 - Good
EW Comment:

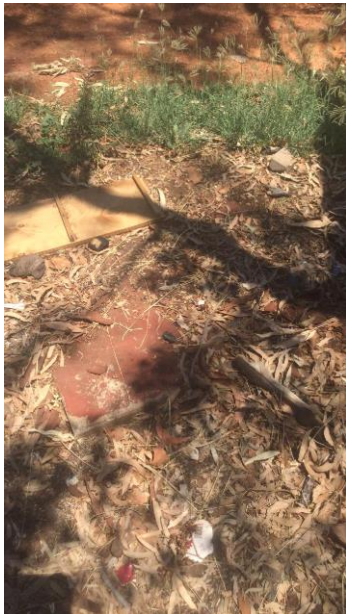
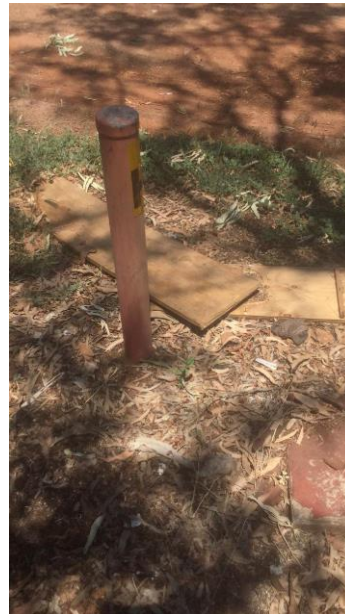
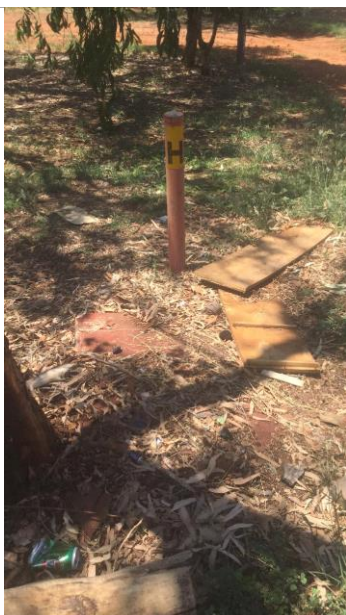
Single or Double: Single
Sluice Valve: No
Above or Below ground: Below ground
FH Leakage: No Access
Bollards around hydrant: Yes
FH Condition: 2 - Poor
FH Comment: Location bollard

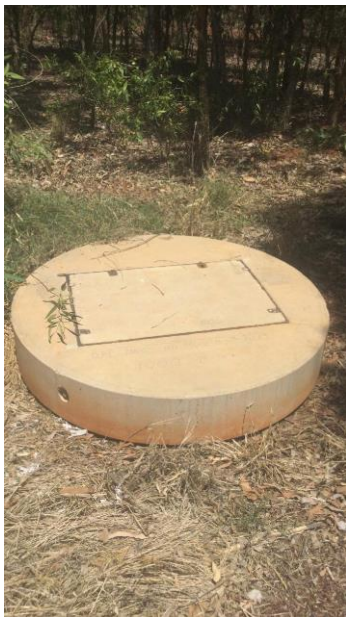
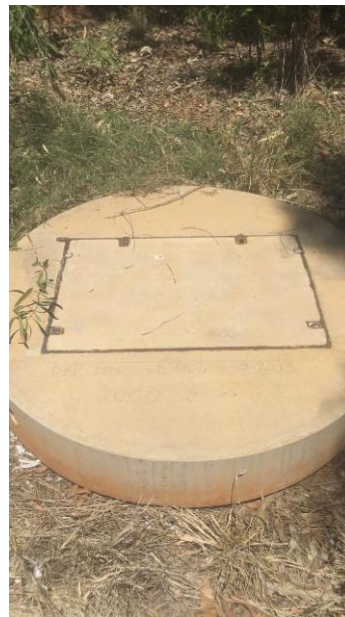
Manhole Condition: 4 - Very Good

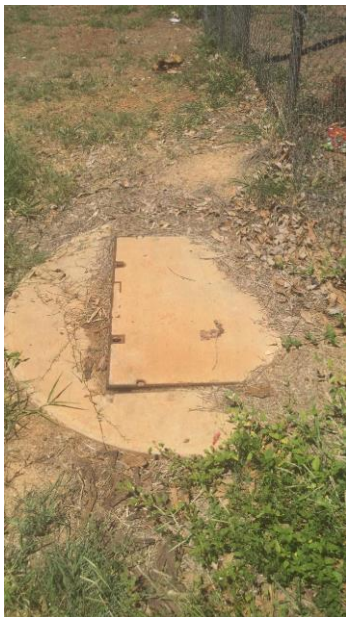
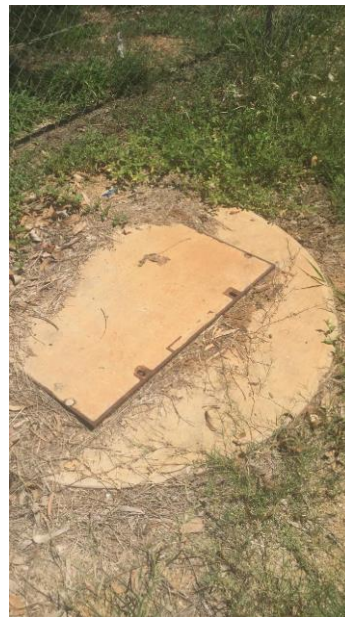
Manhole Condition: 3 - Good

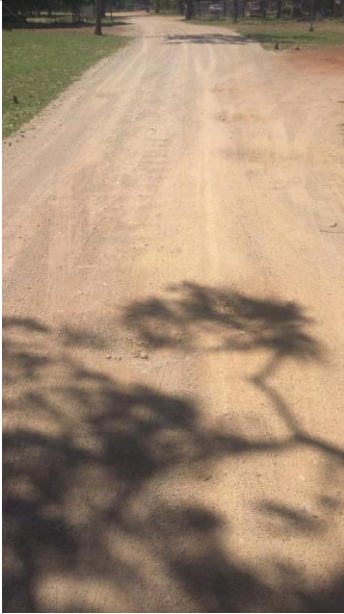
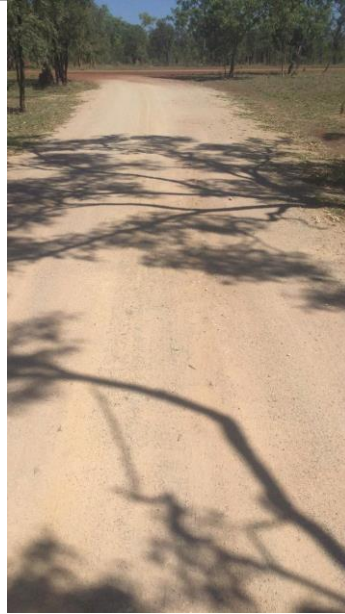
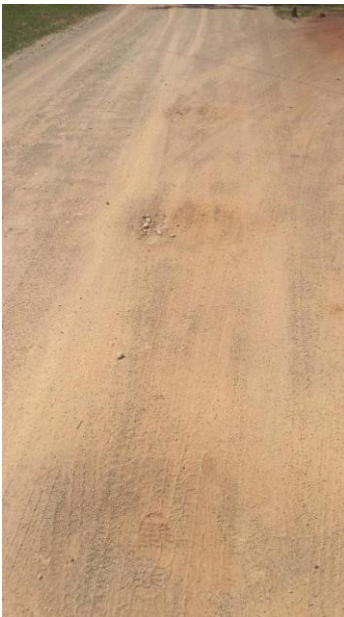
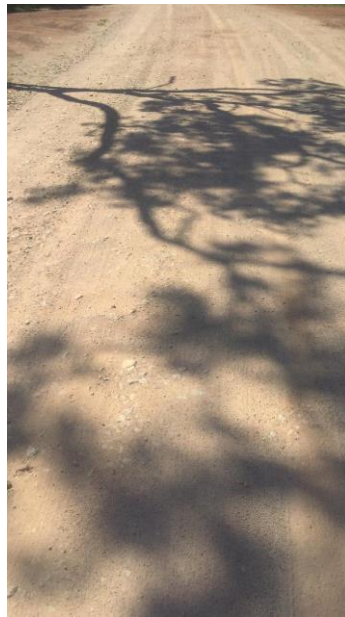
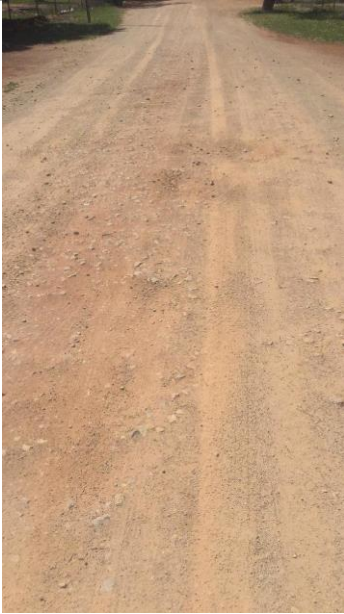
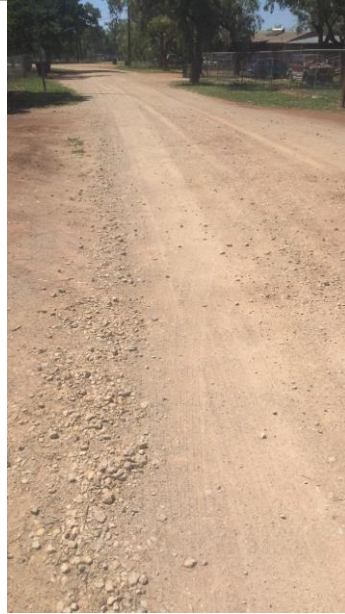
Road Name: 971_1
What are you inspecting: Pavements
Ch From (km): 0
Ch To (km): 0.15
Road Type: Unsealed
Section Width (m): 4.5
Road Condition: 2 - Poor

General Comment: Side roads to properties are in very poor condition and need to be levelled,as there are several undulations

Defect Type	Defect QTY	Defect Condition	Defect Comments
Potholes	15	2 - Poor	Number
	10	2 - Poor	Rocky road

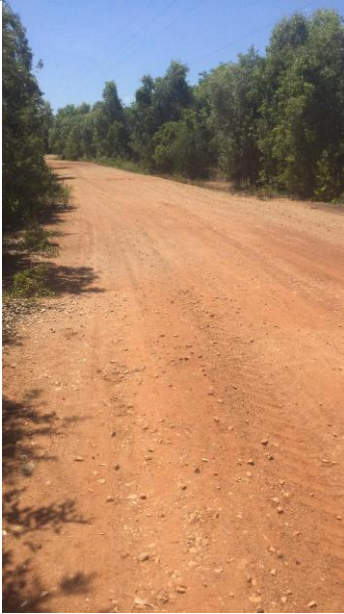
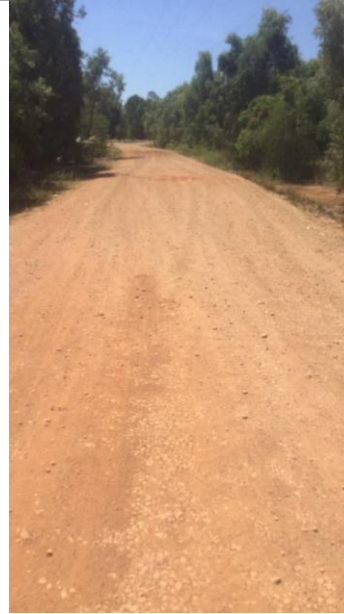
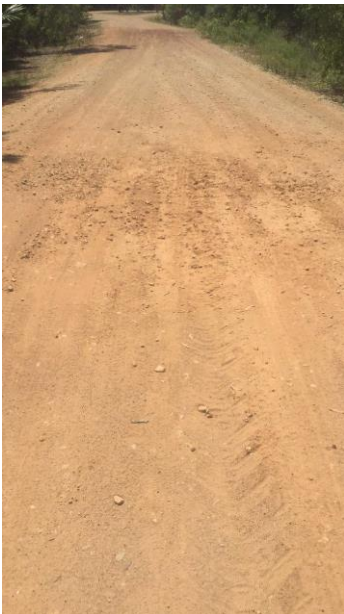
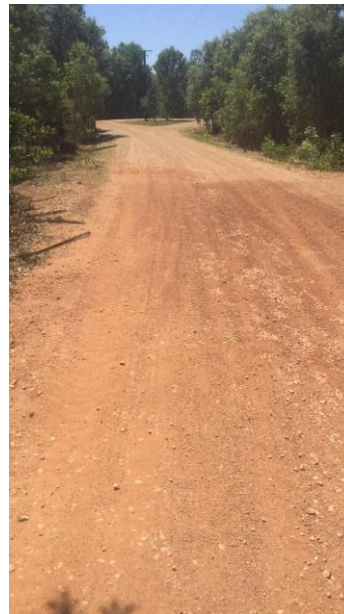
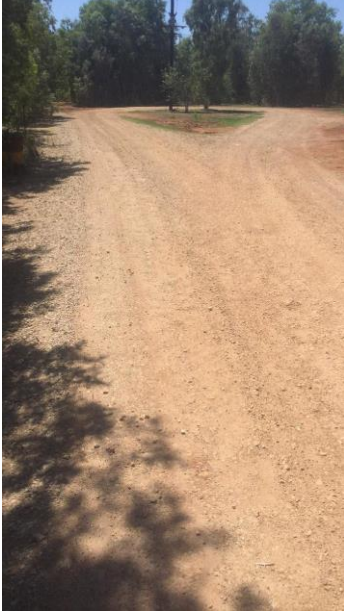
Road Condition: 2 - Poor

Defect Type	Defect QTY	Defect Condition	Defect Comments
Undulation/Settlement	10	1 - Very Poor	Percent
General Appearance	20	2 - Poor	Loose rocks

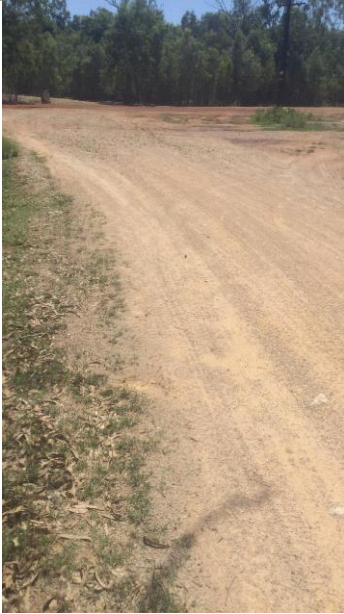
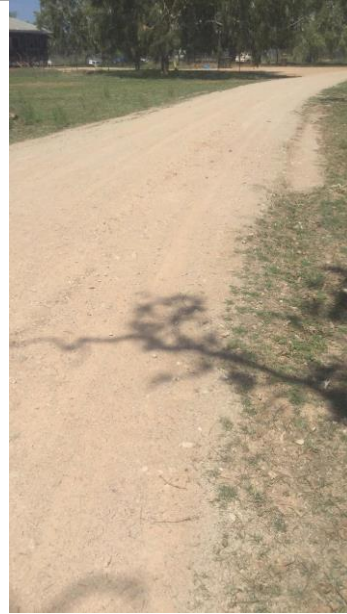
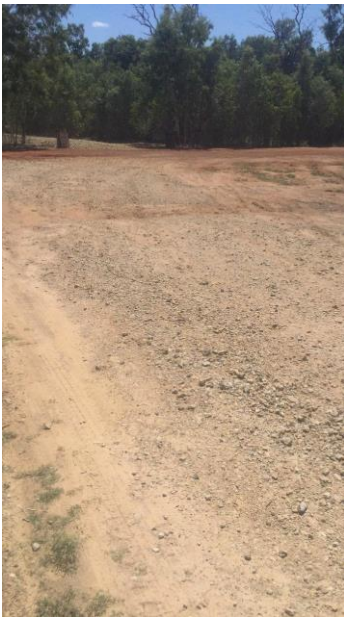
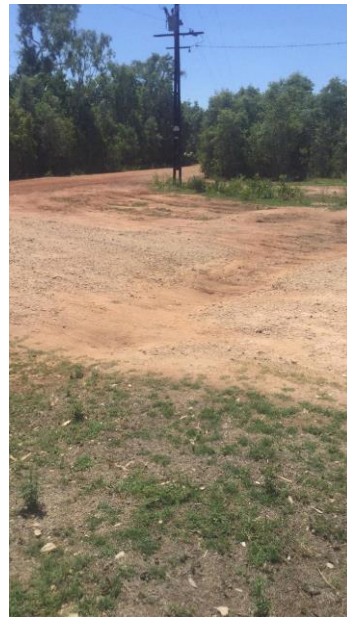
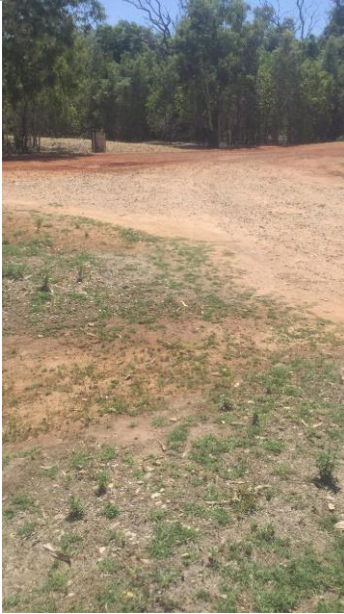
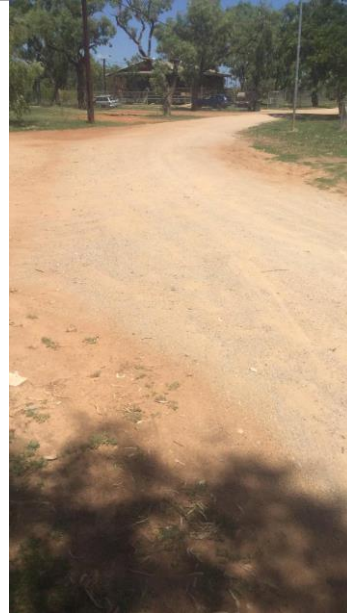
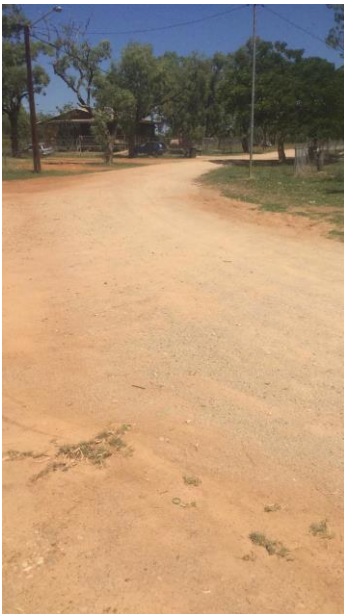
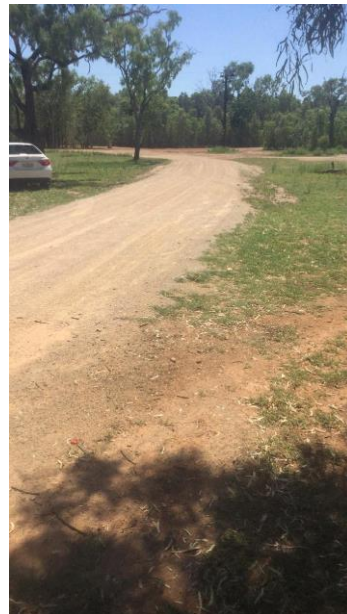
Road Condition: 2 - Poor

Defect Type	Defect QTY	Defect Condition	Defect Comments
General Appearance	10	2 - Poor	Percent, rocky
Undulation/Settlement	5	2 - Poor	Percent, area crossing table drain is in poor cor

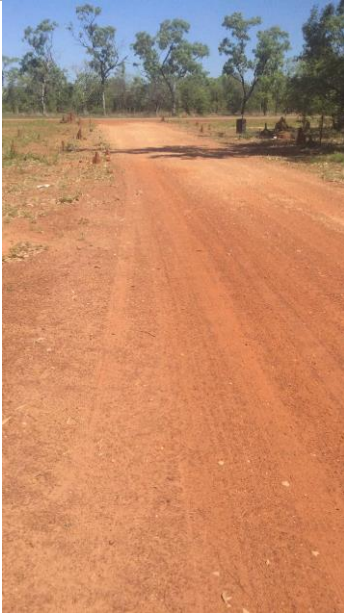
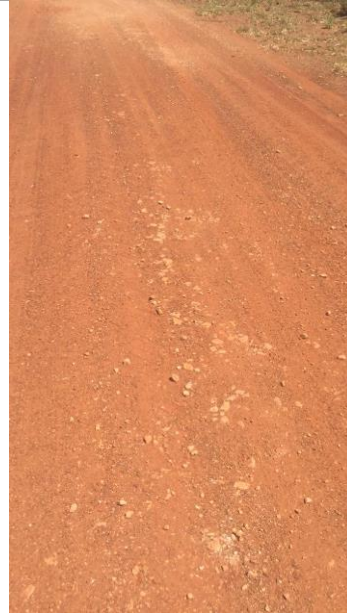
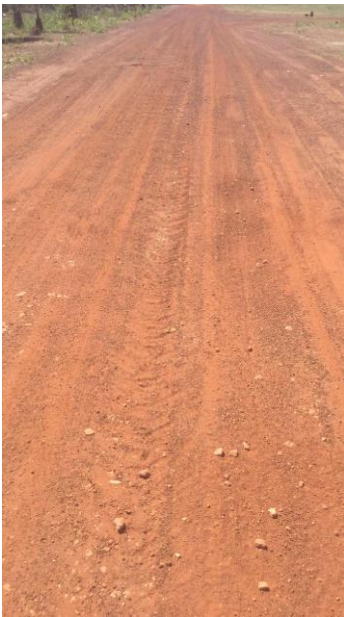
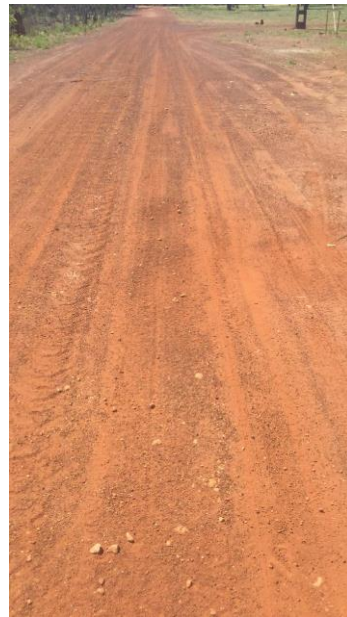
Road Condition: 2 - Poor

Defect Type	Defect QTY	Defect Condition	Defect Comments
Undulation/Settlement	5	2 - Poor	Percent
General Appearance	20	2 - Poor	Percent, rocky surface

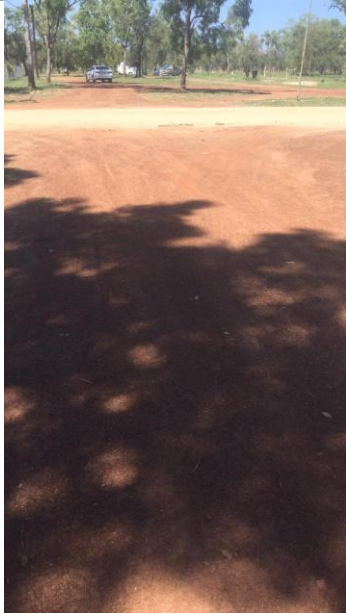
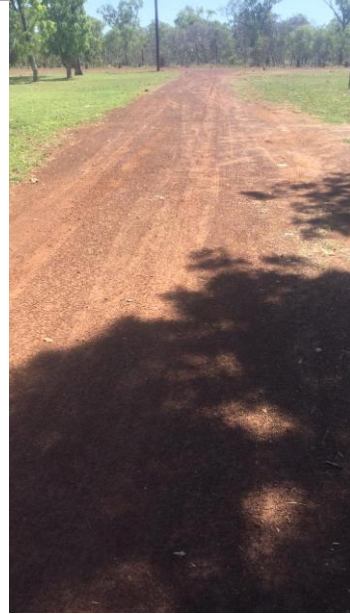
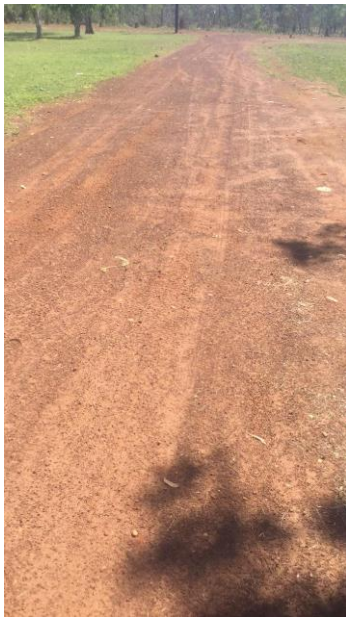
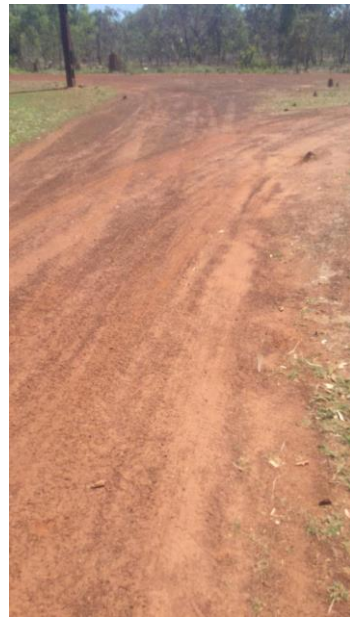
Road Name: 971_2
What are you inspecting: Pavements
Ch From (km): 0
Ch To (km): 0.09
Road Type: Unsealed
Section Width (m): 5
Road Condition: 3 - Good

Defect Type	Defect QTY	Defect Condition	Defect Comments
Undulation/Settlement	2	3 - Good	Metres squared

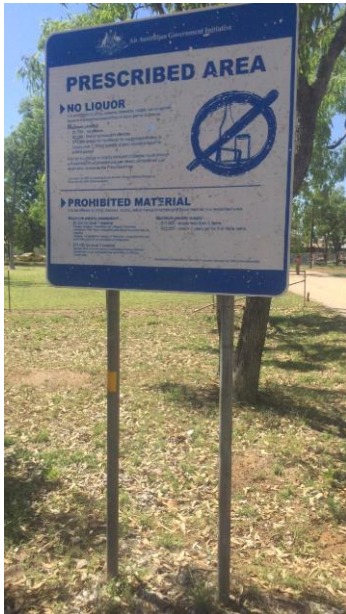
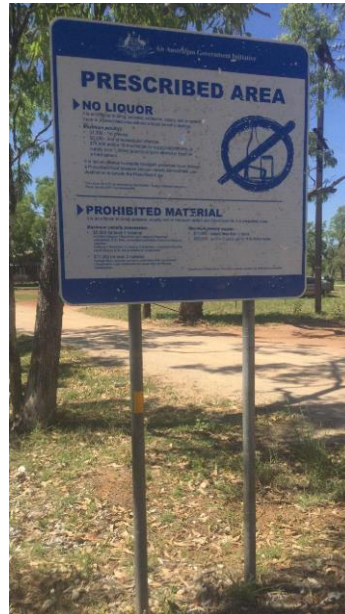
Sign Condition: 2 - Poor

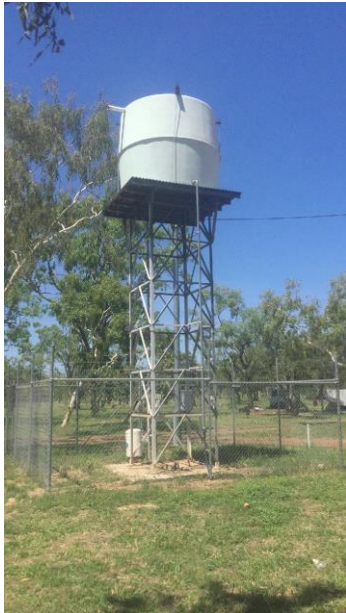
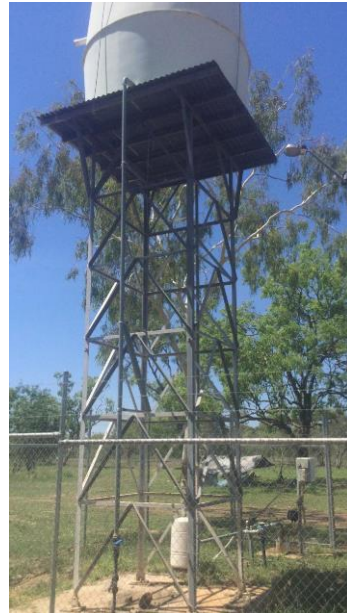
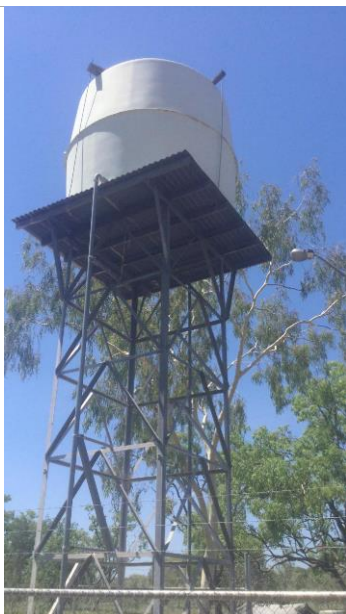
Water Tank Condition: 3 - Good

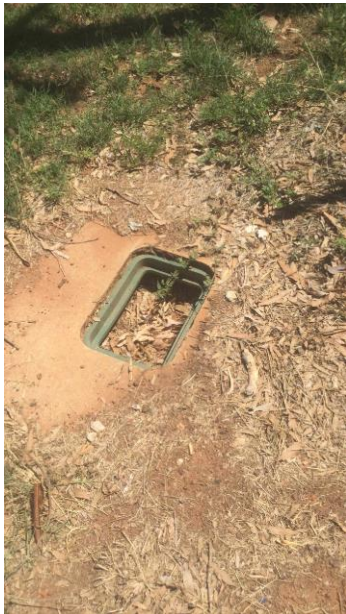
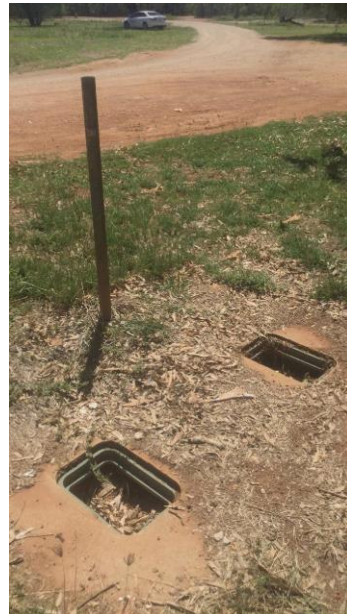
Lot Water Meter Condition: 1 - Very Poor

Lot Water Meter Comment: Unable to see meter itself,

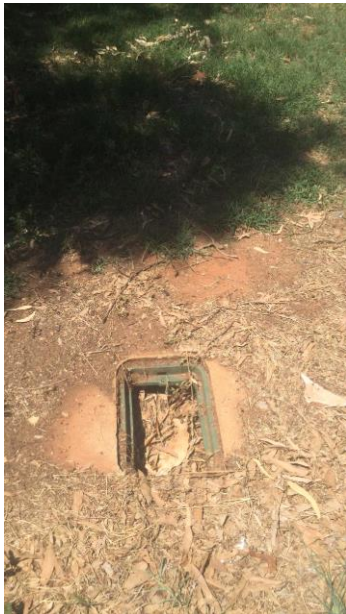
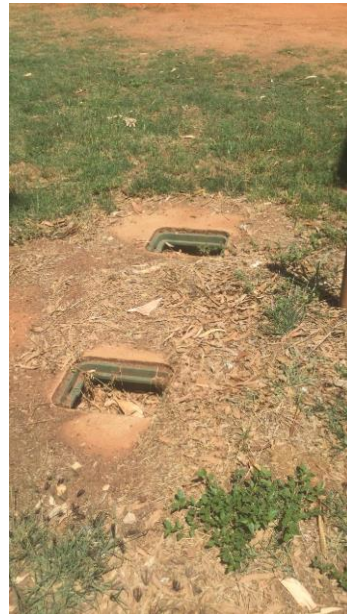
Lot Water Meter Condition: 1 - Very Poor

Lot Water Meter Comment: Water meter size Unknown, only box found. Cannot see meter itself

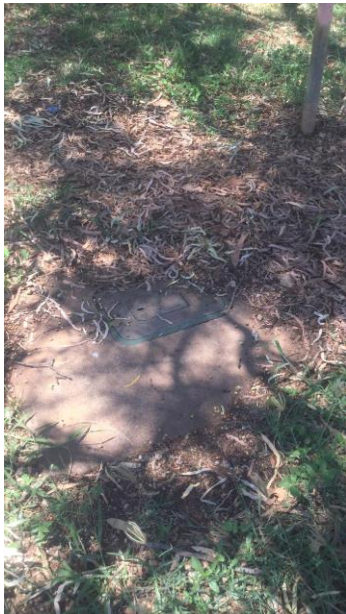
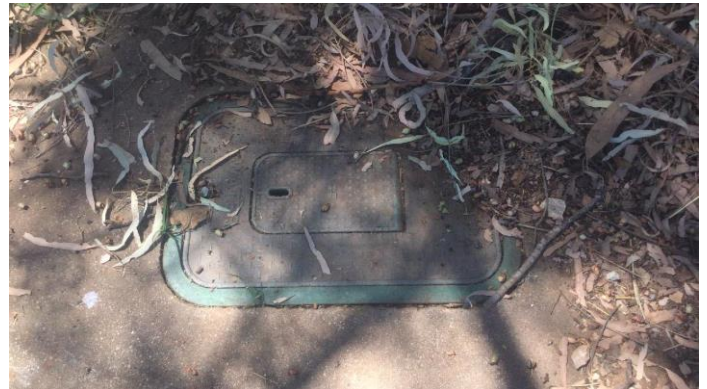
Lot Water Meter Comment: Water meter box, Unknown size and condition

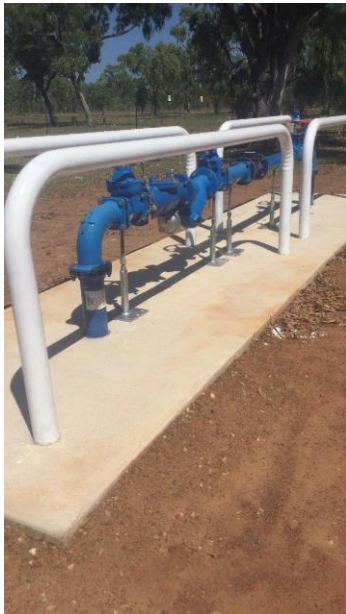
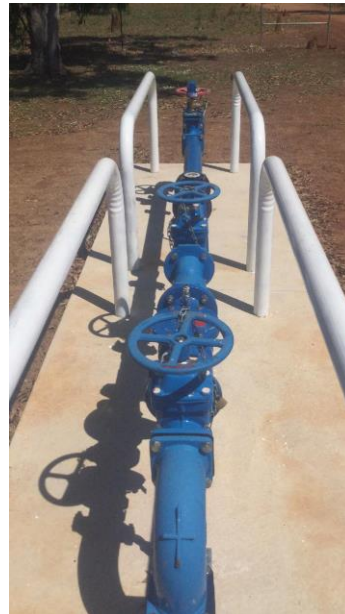
Water Meter Type: Bulk
Bulk Water Meter Size (mm): 100
Bulk Water Meter Condition: 5 - Excellent
Bulk Water Meter Comment: RPZD installed

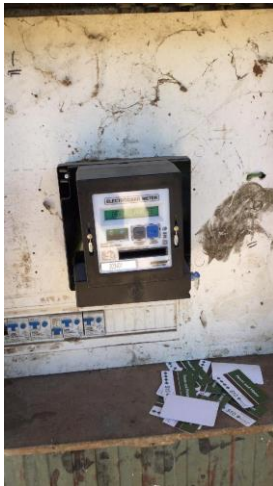
Meter Condition: 3

Meter Comment: Blank plates are missing on CB slot.

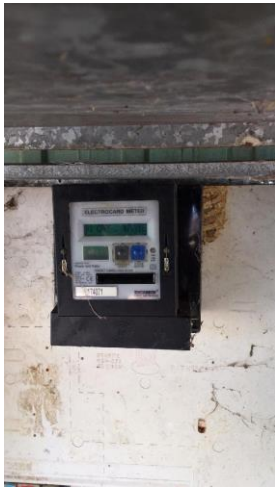
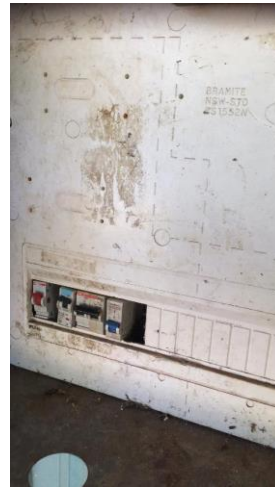
Meter Condition: 3

Meter Comment: Blank plates are missing on CB slot.

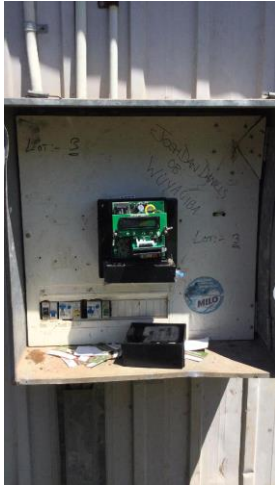
Meter Condition: 1

Meter Comment: Digital meter is out of service. Blank plates are missing on CB slot.

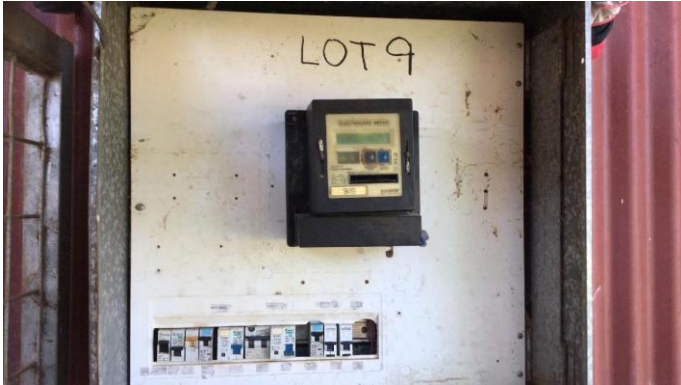
Meter Condition: 3

Meter Comment: Blank plates are missing on CB slot.

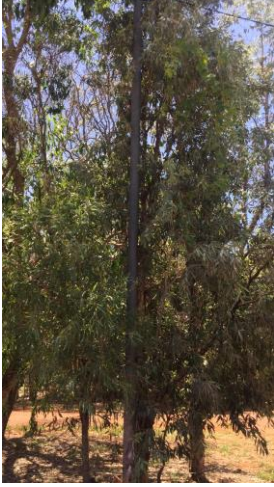
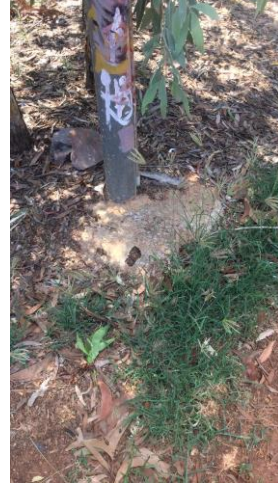
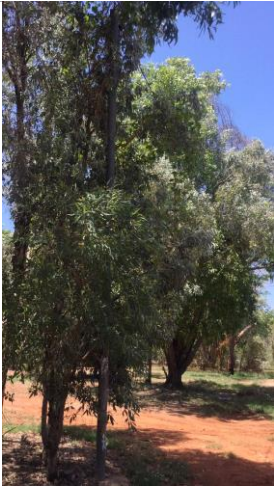
What is Pole Material type:	Welded
What is the condition of pole:	3
How is the pole planted:	Concrete
What is the Condition of plant:	3
Is street light fitted:	Yes
Street Light Power Supply:	
Street Light Type	M80 D 02
Street Light Watts	
Street Light Condition	2
Street Light Height	
What is the type of service:	Combined
What is the HV voltage level:	
What is the arrangement of connected cables:	Parallel
Are there isolators on the pole:	Yes
What is the Condition:	3
How many Lots are connected to this pole:	3
Overhead Pole Comments:	No ID

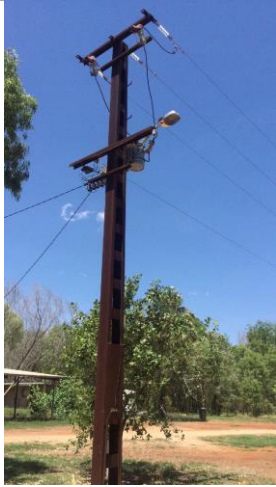
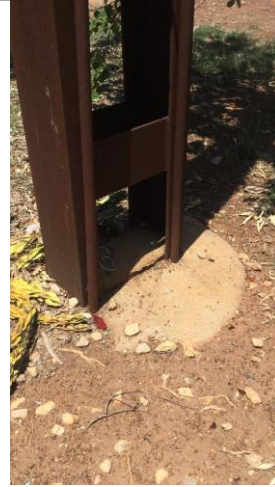
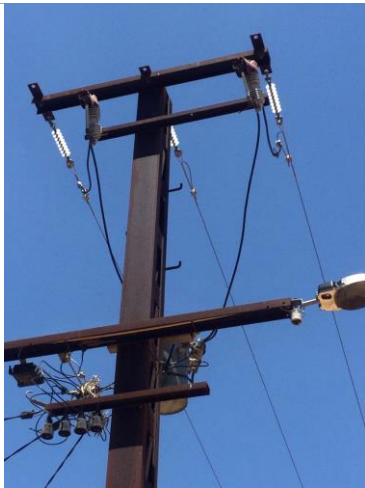
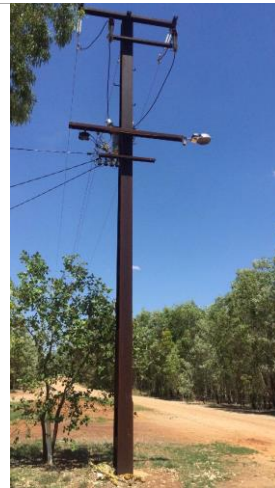
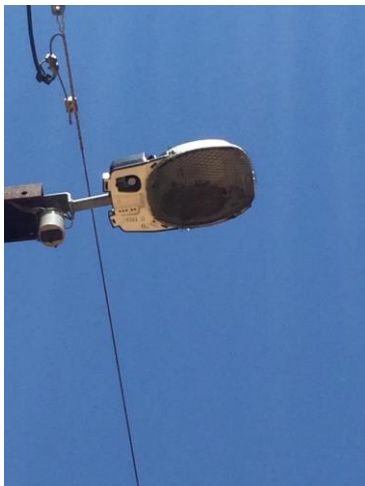
What is Pole Material type:	Welded
What is the condition of pole:	3
How is the pole planted:	Concrete
What is the Condition of plant:	3
Is street light fitted:	Yes
Street Light Power Supply:	
Street Light Type	M80 D 02
Street Light Watts	
Street Light Condition	2
Street Light Height	
What is the type of service:	Three
What is the HV voltage level:	
What is the arrangement of connected cables:	Twisted
Are there isolators on the pole:	No
What is the Condition:	
How many Lots are connected to this pole:	
Overhead Pole Comments:	No ID

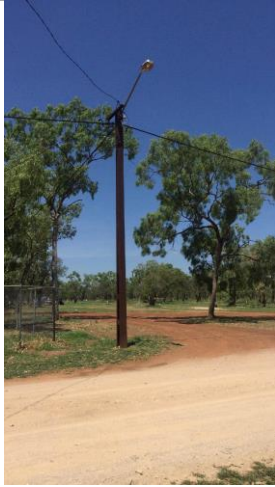
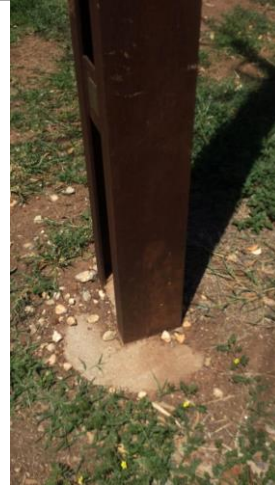
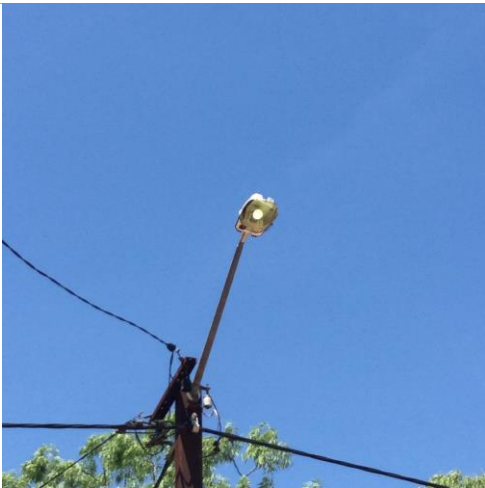
What is Pole Material type:	Welded
What is the condition of pole:	3
How is the pole planted:	Direct
What is the Condition of plant:	3
Is street light fitted:	Yes
Street Light Power Supply:	
Street Light Type	M80 D 02
Street Light Watts	
Street Light Condition	3
Street Light Height	
What is the type of service:	Three
What is the HV voltage level:	
What is the arrangement of connected cables:	Twisted
Are there isolators on the pole:	No
What is the Condition:	
How many Lots are connected to this pole:	1
Overhead Pole Comments:	No ID

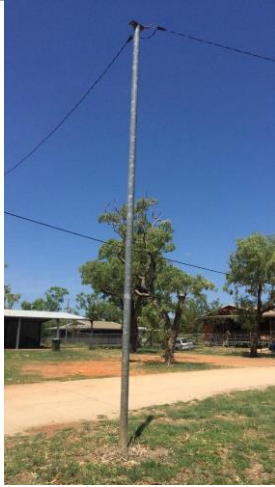
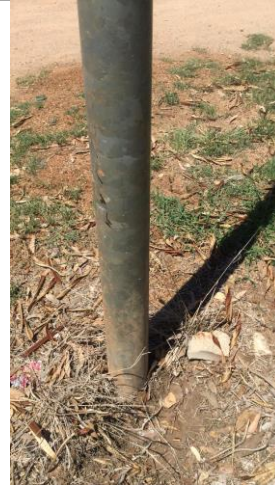
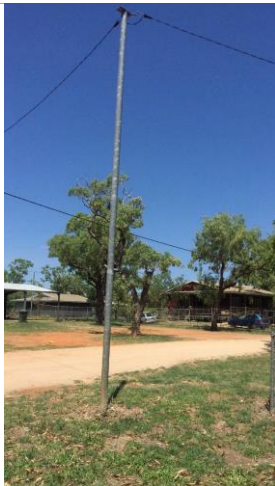
What is Pole Material type:	Welded
What is the condition of pole:	3
How is the pole planted:	Direct
What is the Condition of plant:	3
Is street light fitted:	Yes
Street Light Power Supply:	
Street Light Type	M80 D 02
Street Light Watts	
Street Light Condition	3
Street Light Height	
What is the type of service:	Three
What is the HV voltage level:	
What is the arrangement of connected cables:	Parallel
Are there isolators on the pole:	No
What is the Condition:	
How many Lots are connected to this pole:	2
Overhead Pole Comments:	NO ID

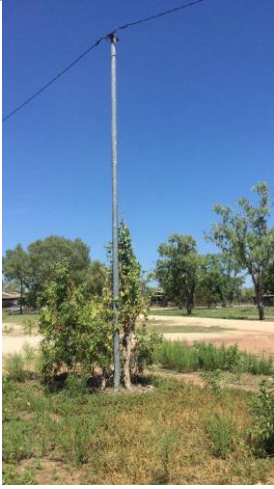
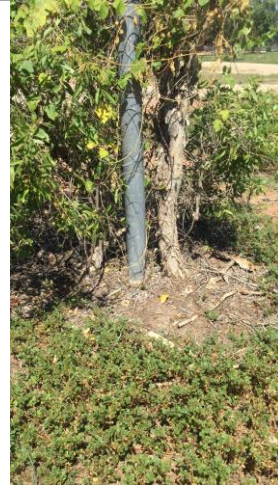
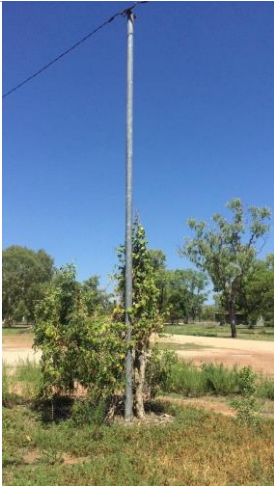
What is Pole Material type:	Welded
What is the condition of pole:	3
How is the pole planted:	Concrete
What is the Condition of plant:	3
Is street light fitted:	No
Street Light Power Supply:	
Street Light Type	
Street Light Watts	
Street Light Condition	
Street Light Height	
What is the type of service:	Three
What is the HV voltage level:	
What is the arrangement of connected cables:	Parallel
Are there isolators on the pole:	Yes
What is the Condition:	3
How many Lots are connected to this pole:	
Overhead Pole Comments:	No ID

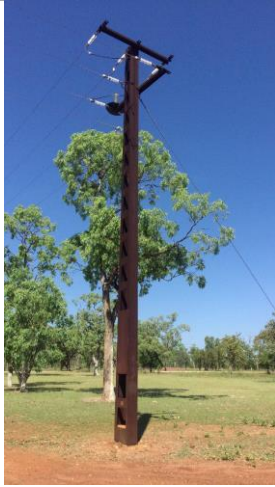
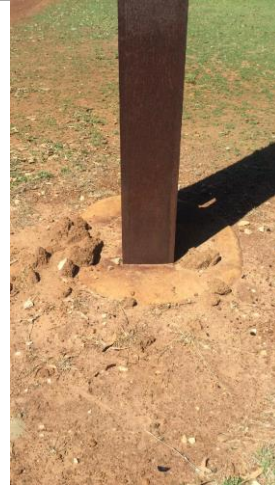
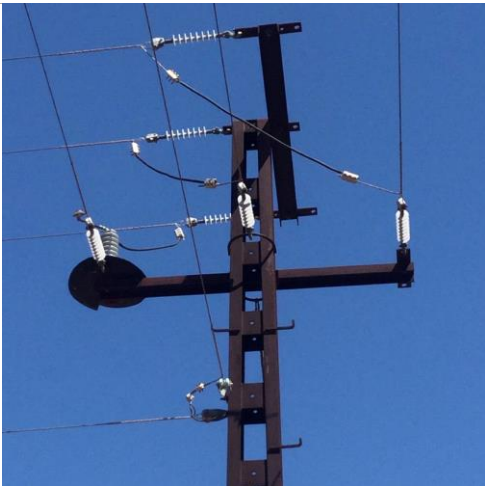
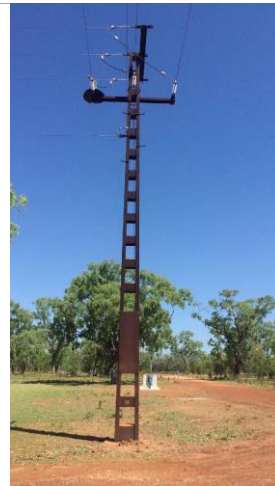
What is Pole Material type:	Welded
What is the condition of pole:	3
How is the pole planted:	Concrete
What is the Condition of plant:	3
Is street light fitted:	No
Street Light Power Supply:	
Street Light Type	
Street Light Watts	
Street Light Condition	
Street Light Height	
What is the type of service:	Three
What is the HV voltage level:	
What is the arrangement of connected cables:	Parallel
Are there isolators on the pole:	Yes
What is the Condition:	3
How many Lots are connected to this pole:	
Overhead Pole Comments:	No ID

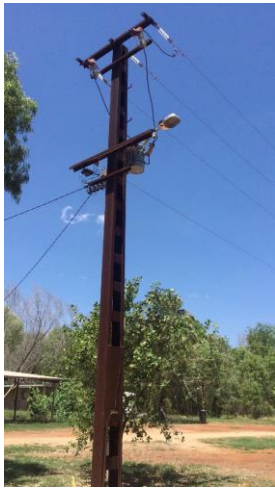
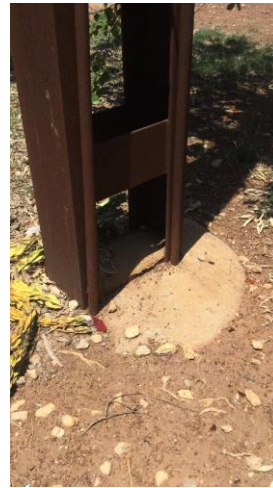
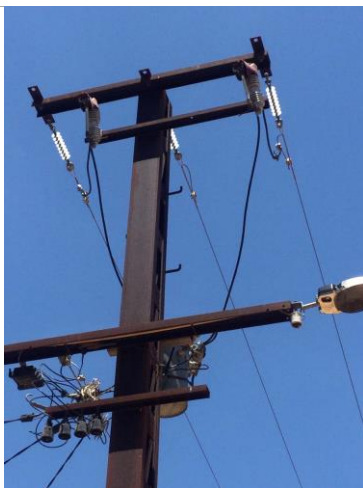
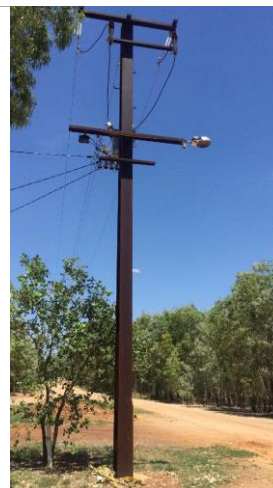
Street Light Condition 2

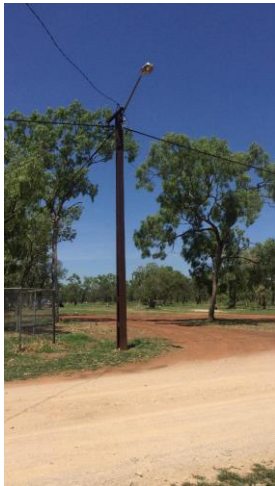
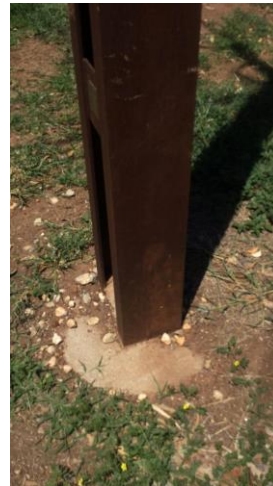
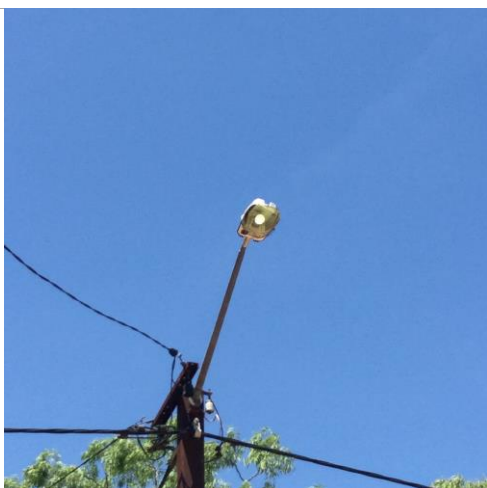
Street Light Condition 2
